GEOTEXTILE FABRICS UNDER AN ASPHALT CONCRETE OVERLAY TO RETARD REFLECTIVE CRACKING

FINAL REPORT

East 39th Avenue – East 47th Avenue Section
East Burnside Street, Portland

Experimental Features Project OR 91-03

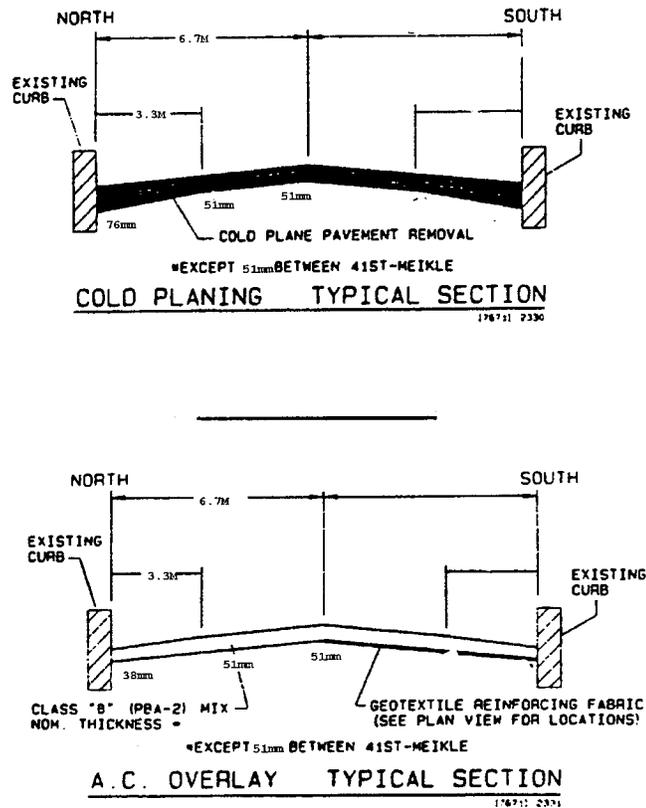
Figure 2.2: Pavement Cross-section

Typical cross-sections of the pavement are shown in Figure 2.2. The top 51 mm of the old pavement surface was cold planed. The new pavement surface is 51 mm of Class "B" (dense-graded) asphalt concrete. Underneath the new pavement surface is 180 mm of PCC. On the south side (eastbound lanes) of Burnside Street, Glasgrid 8501 and Polyguard NW-75 were placed between a leveling course and asphalt concrete overlay at four locations as shown in Figure 2.3. In addition, Glasgrid was placed for pavement reinforcement with no overlaps to a total width of 6.1 m and for 76.3 m on the south side of Burnside Street between 44th and 45th Avenues. On the north side of the street, no geotextiles were utilized.

The old pavement next to the curbs was rotomilled deeper than the rest of the cross-section and overlaid 13 mm less than the rest of the section, as shown in Figure 2.2. The taper effectively increased the curb height to improve drainage. Reflective cracks were first reported near the curb a couple of years after construction.
