Testing of State Roadside Safety Systems Volume III: Appendix B— Crash Testing and Evaluation of a Guardrail System for Low-fill Culvert

PUBLICATION NO. FHWA-RD-98-038

APRIL 1999

1. Report No. FHWA-RD-98-038		2. Government Accession No.	
4. Title and Subtitle TESTING OF STATE ROADSIDE SAFETY SYSTEMS VOLUME III: APPENDIX B - CRASH TESTING AND EVALUATION OF A GUARDRAIL SYSTEM FOR LOW-FILL CULVERT		5. Report Date April 1999

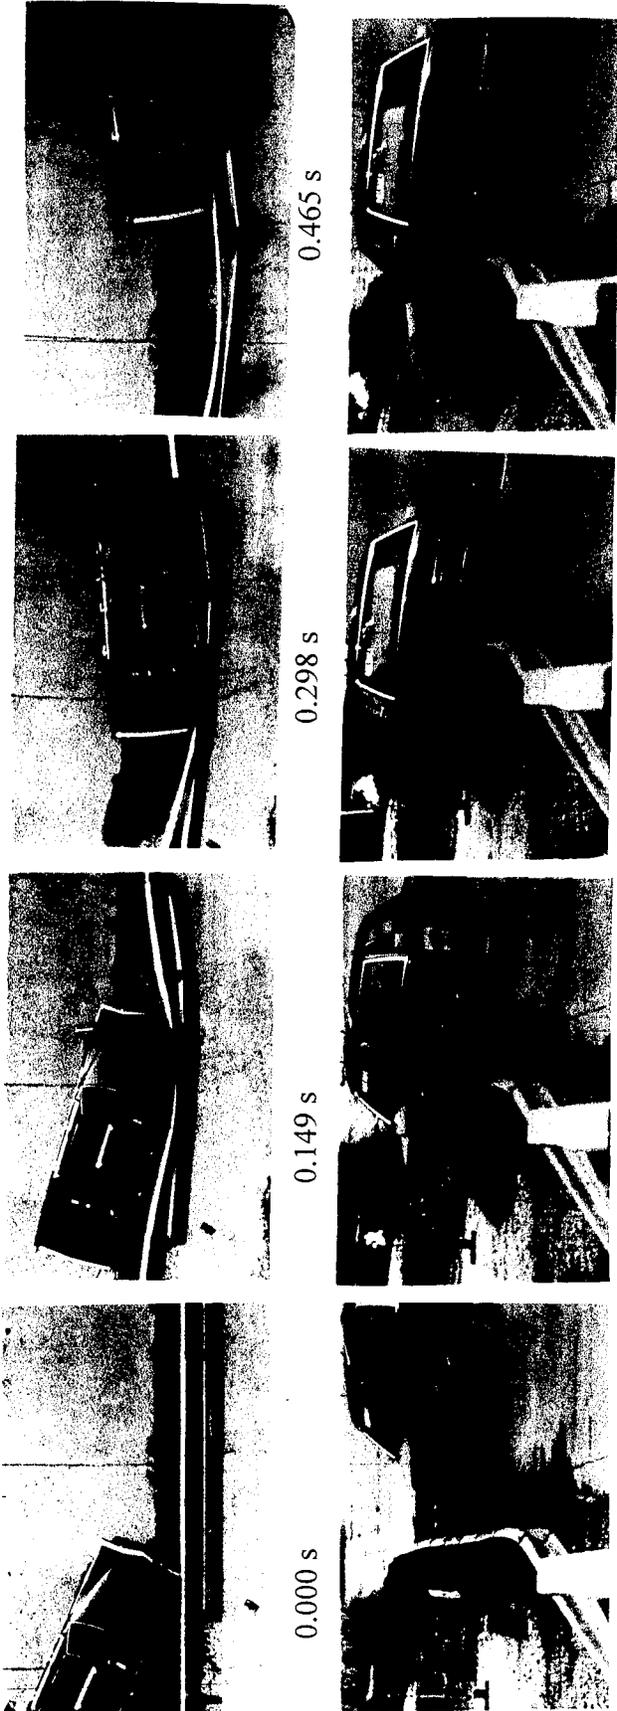
Test No. 7147-4
 Date 05/28/91
 Test Installation Washington Nested W-beam
 with Wood Posts
 Installation Length 46 m (150 ft)
 Max. Dynamic Deflection 0.9 m (3.1 ft)
 Max. Perm. Deformation 0.7 m (2.3 ft)
 Test Vehicle 1979 Cadillac Sedan deVille
 Vehicle Weight
 Test Inertia 2043 kg (4500 lb)
 Gross Static 2120 kg (4670 lb)
 Vehicle Damage Classification
 TAD 01FR4 & 01RD3
 CDC 01FREK2 & 01RDEW2
 Maximum Vehicle Crush 229 mm (9.0 in)

Impact Speed 90.4 km/h (56.2 mi/h)
 Impact Angle 24.0 deg
 Speed at Parallel 71.9 km/h (44.7 mi/h)
 Exit Speed 69.8 km/h (43.4 mi/h)
 Exit Trajectory 12.3 deg
 Vehicle Accelerations
 (Max. 0.050-s avg)
 Longitudinal -2.7 g's
 Lateral 7.1 g's
 Occupant Impact Velocity
 Longitudinal 4.5 m/s (14.8 ft/s)
 Lateral 4.5 m/s (14.7 ft/s)
 Occupant Ridedown Accelerations
 Longitudinal -2.8 g's
 Lateral 9.0 g's

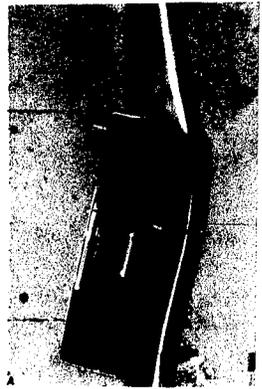
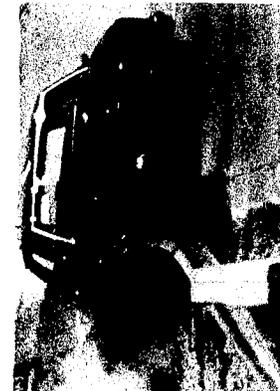
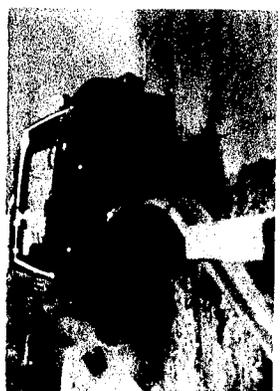
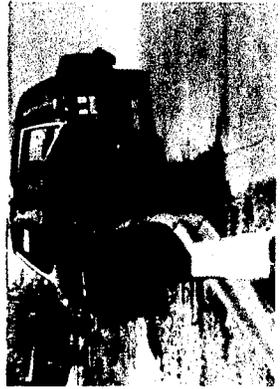
Figure 41. Summary of results for test 7147-5.

Test No. 7147-5
 Date 05/30/91
 Test Installation Washington Nested
 Installation Length W-beam with Wood Posts
 Max. Dynamic Deflection 46 m (150 ft)
 Max. Perm. Deformation 1.0 m (3.2 ft)
 Test Vehicle 0.8 m (2.5 ft)
 Vehicle Weight 1982 Oldsmobile Regency 98
 Test Inertia 2043 kg (4500 lb)
 Gross Static 2120 kg (4670 lb)
 Vehicle Damage Classification
 TAD 01FR4 & 01RD3
 CDC 01FREK2 & 01RDEW2
 Maximum Vehicle Crush 203 mm (8.0 in)

Impact Speed 98.0 km/h (60.9 mi/h)
 Impact Angle 25.1 deg
 Speed at Parallel 78.2 km/h (48.6 mi/h)
 Exit Speed 71.1 km/h (44.2 mi/h)
 Exit Trajectory 10.4 deg
 Vehicle Accelerations
 (Max. 0.050-s avg)
 Longitudinal -2.7 g's
 Lateral 6.8 g's
 Occupant Impact Velocity
 Longitudinal 4.5 m/s (14.7 ft/s)
 Lateral 4.3 m/s (14.2 ft/s)
 Occupant Ridedown Accelerations
 Longitudinal -3.5 g's
 Lateral 9.7 g's

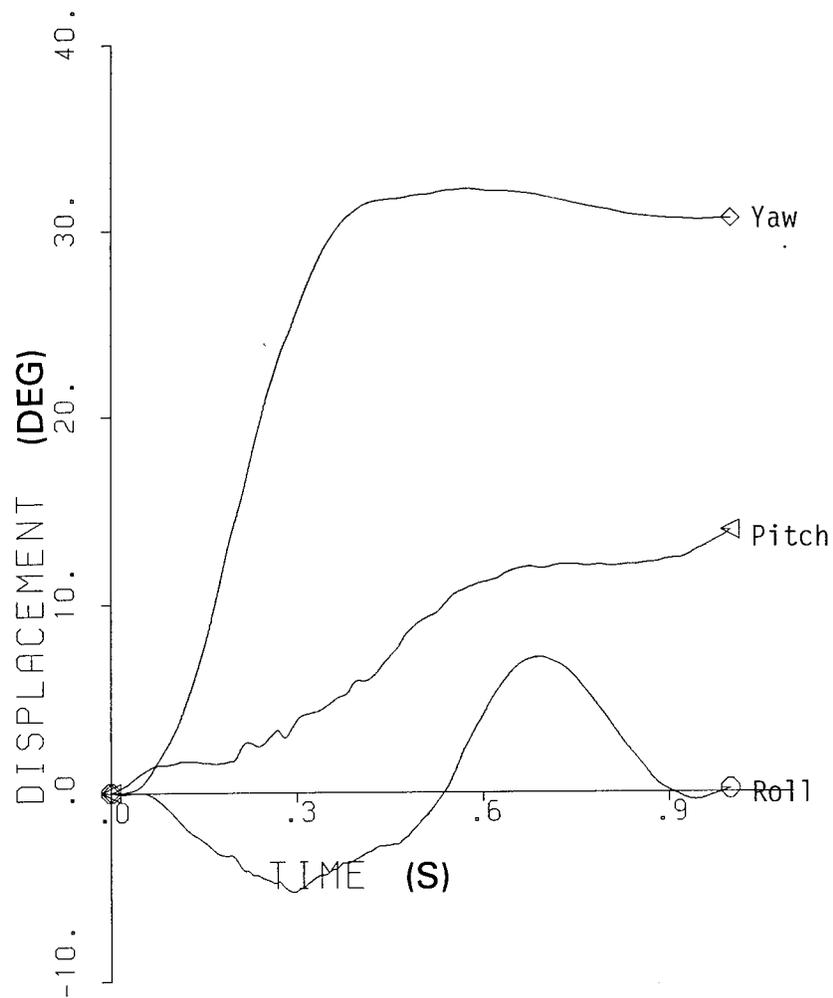
Figure 42. Vehicle angular displacements for test 7147-5.

A summary of pertinent data from the electronic instrumentation, high-speed film, and field measurements is given in figure 41. Vehicle angular displacements are displayed in figure 42, and vehicular accelerations versus time traces filtered at 300 Hz are presented in figures 43 through 45.
