ROADSIDE HAZARDS

An Evaluation of Roadside Hazards
on the Interstate System

THE ENO FOUNDATION FOR HIGHWAY TRAFFIC CONTROL, INC.
SAUGATUCK, CONNECTICUT, 1968

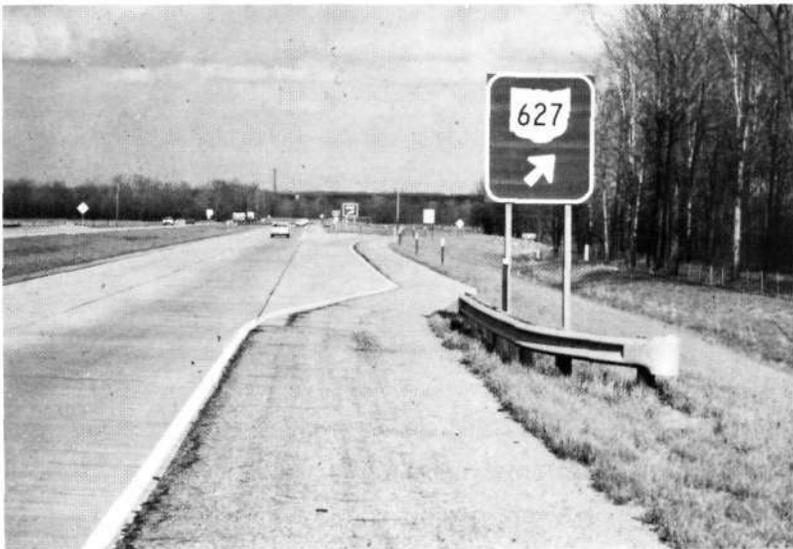
Figure 20. The route marker here is shielded by only a short section of guardrail, the end of which flares abruptly away from the roadway. A sign located farther from the roadway on a breakaway or yielding type support would improve the safety of the roadside and make the guardrail unnecessary.

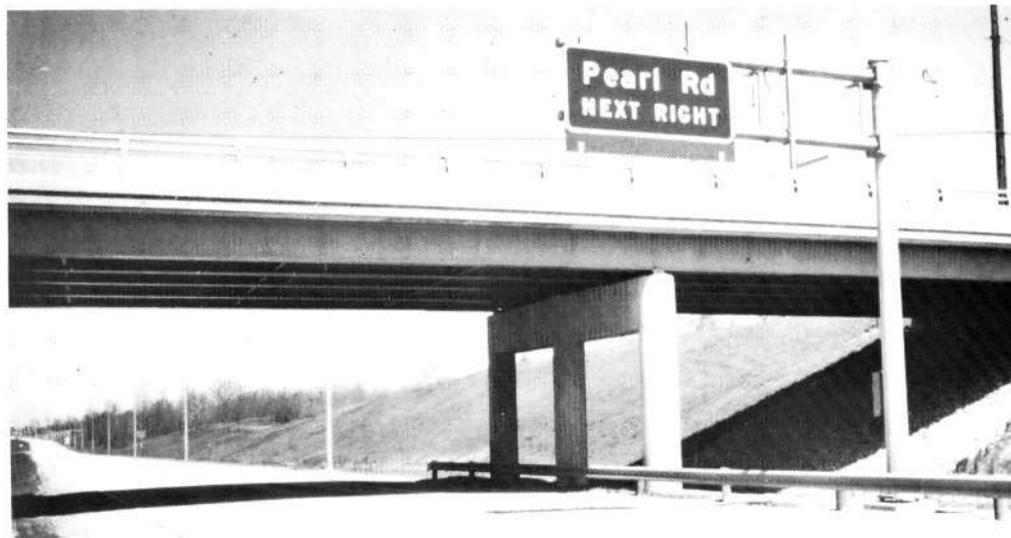
Figure 24. This overhead sign on a cantilevered support is just 25 feet in advance of the overhead structure. Although the support is behind the guardrail, it illustrates one situation where an overhead sign could be mounted on the face of the overcrossing structure without necessarily detracting from the aesthetic values.

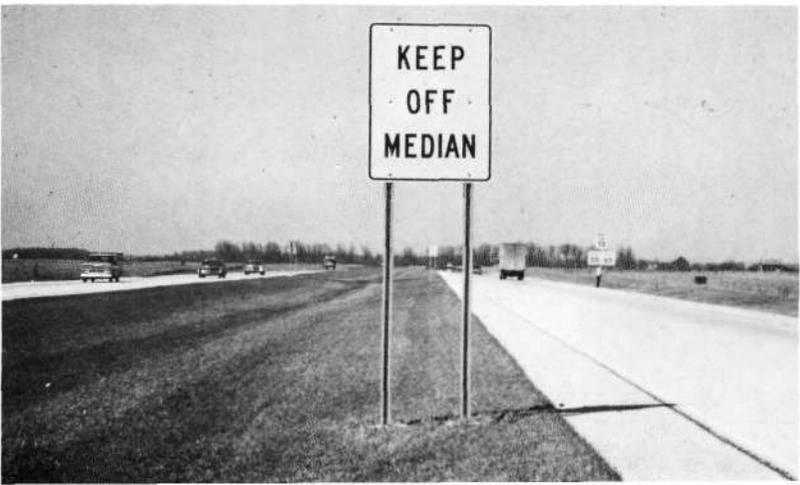
Figure 26. Many of the small regulatory and warning signs serve insufficient purpose and their installation should be avoided wherever possible. When used, they should be a substantial distance from the roadway. Thirty to fifty feet from the edge of pavement is often practical.

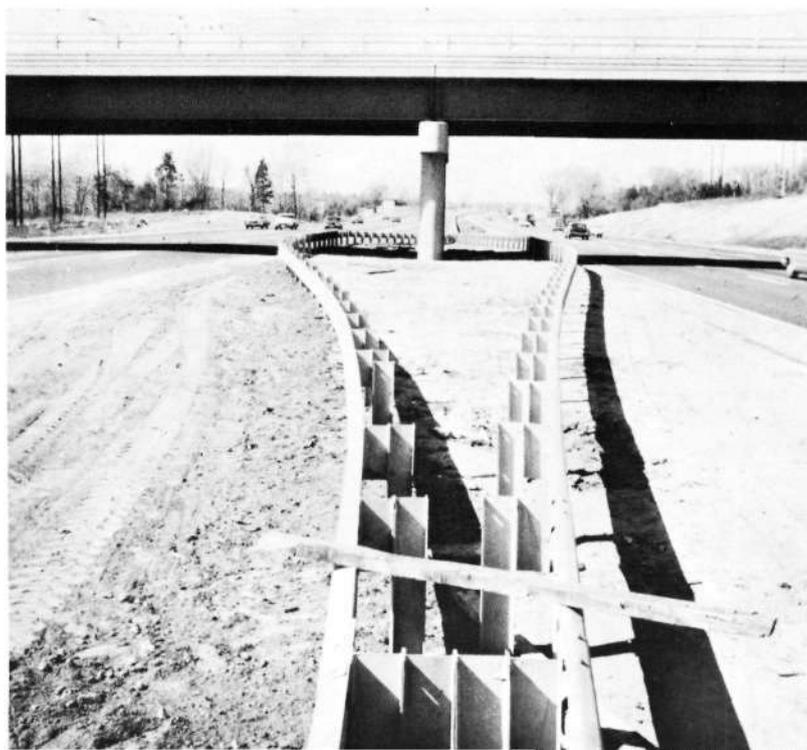
Figure 40. This guardrail installation has been placed close to the edge of the traveled surface. Most authorities agree that the guardrail would function effectively at a distance of three to five feet from the center pier, and in that location, give additional clear recovery room for vehicles that go out of control.

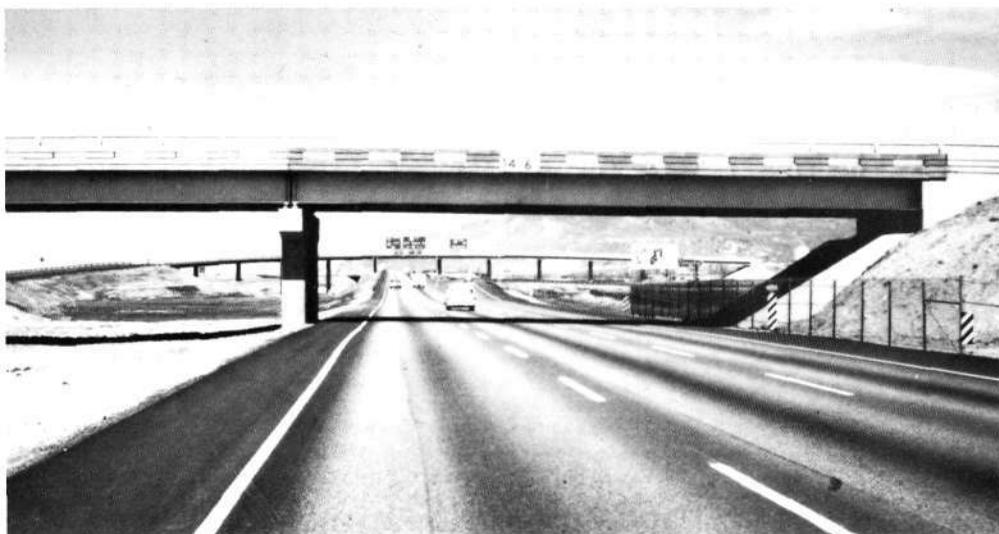
Figure 42. The median pier at this undercrossing is located close to the outer edge of the shoulder without protection. But on the other end of the span, the right side abutment is placed well up the slope. One would logically conclude that the right side is considerably safer than the left side, at least for vehicles whose vertical height would not be a factor.

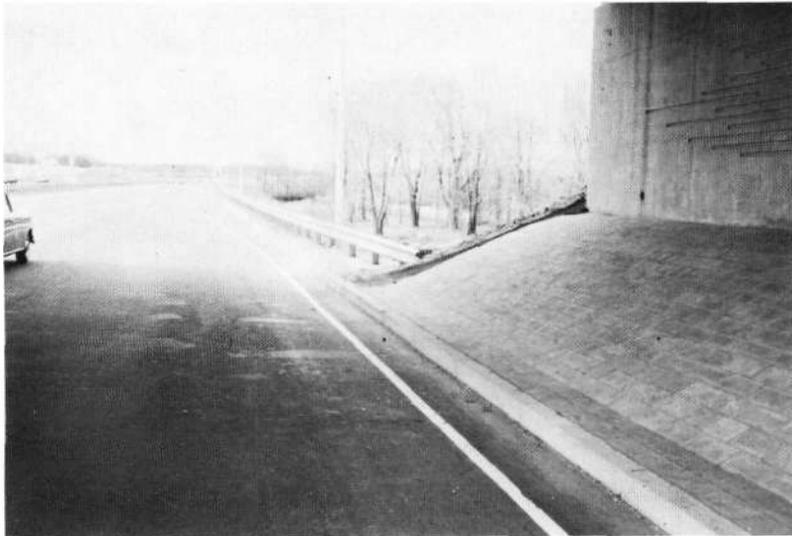
Figure 44. The safety feature to be noted at this two-span undercrossing structure is the abutment face, which is part way up the slope. With this design, the driver has some recovery space which he should be able to use safely in any average emergency.

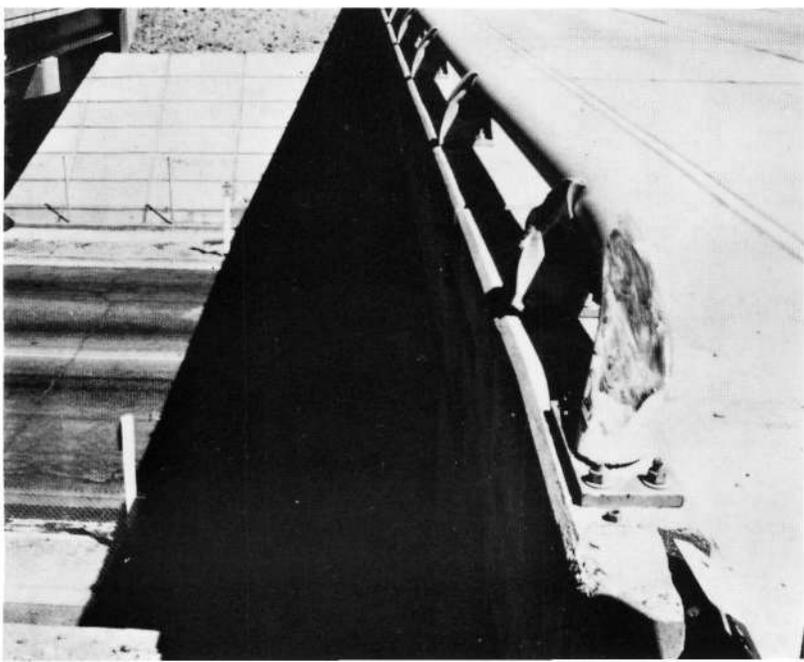
Figure 46. Here is evidence that drivers do leave the roadway. In this case, the vehicle straddled the guardrail on the approach to the bridge, and struck the bridge railing at the point where the damage is evident. The car and driver traveled 85 feet through the air between the two bridges and landed right side up on the roadway 26 feet below. In such a situation, a single bridge structure would have had a safety advantage over the twin bridges pictured. It would have eliminated both interior railings and made it possible to maintain a more consistent cross-section over the structure.

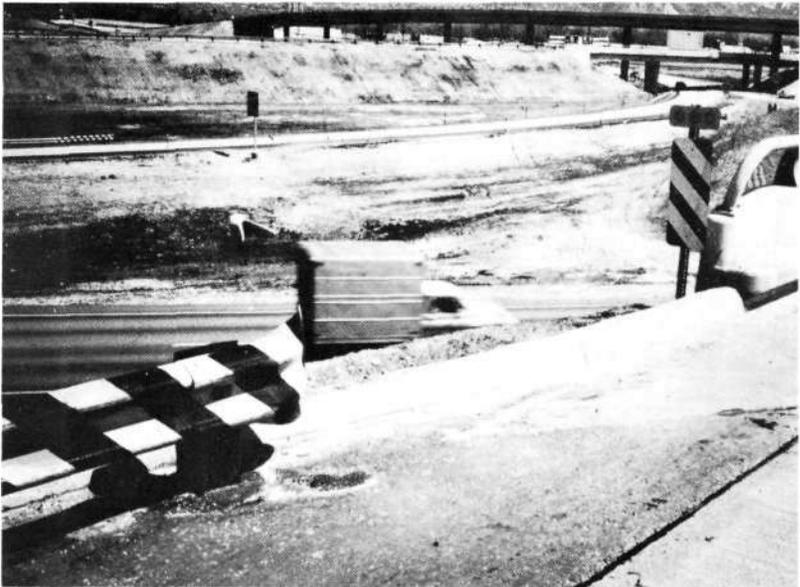
Figure 50. Here, the open gap of eight or ten feet between the end of the guardrail and the beginning of the structure makes the bridge end a more vulnerable target.

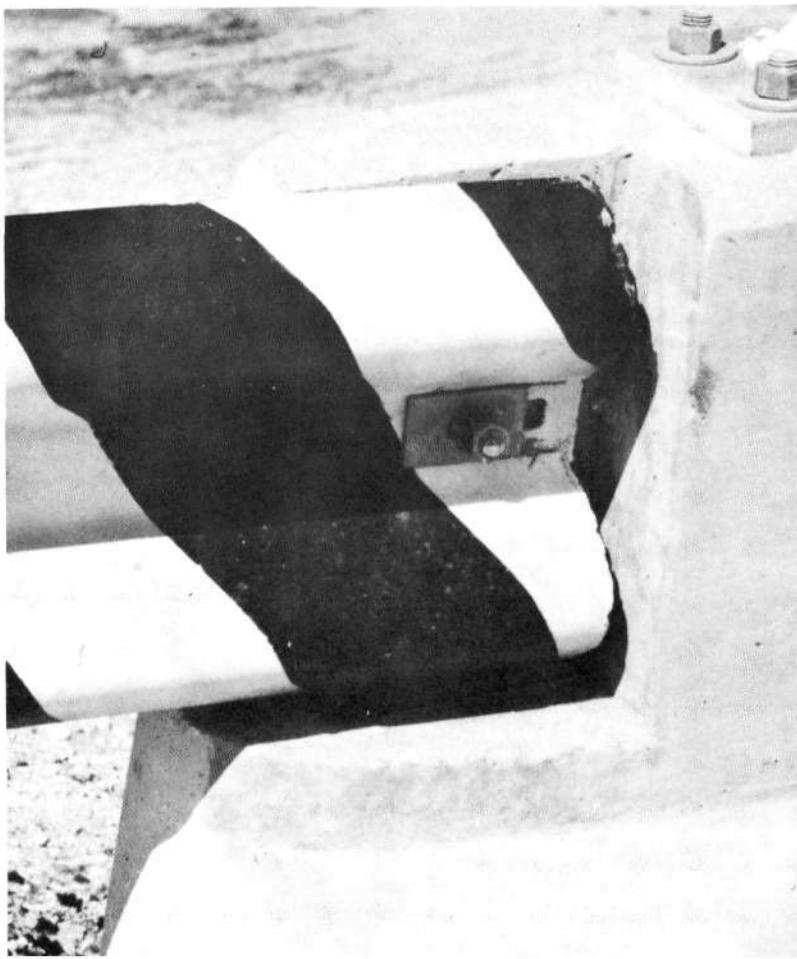
Figure 52. The highway department designed this physical connection between the guardrail and the bridge parapet. Additional design study is being given this feature to make it still more effective.

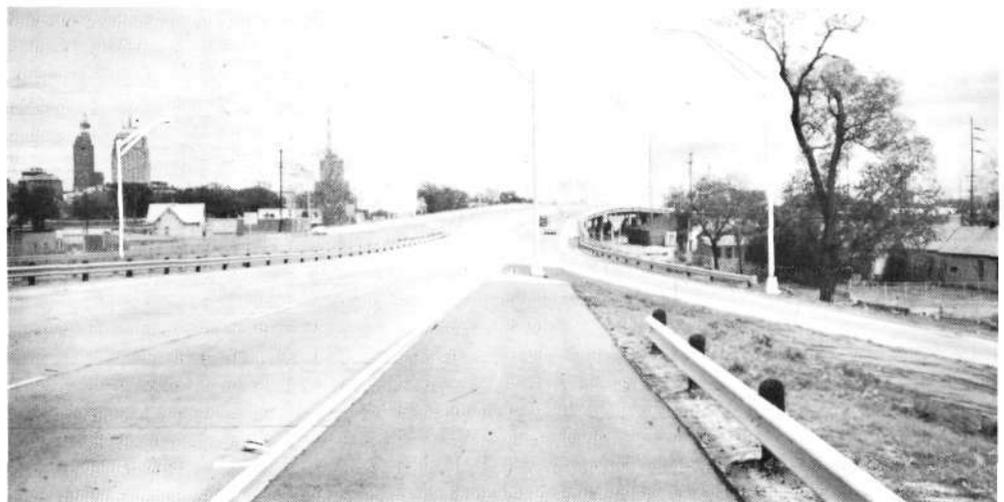
Figure 56. In this case the shoulder ends where an entrance ramp joins the freeway and the light standard was placed directly in line with the shoulder. Safer design would have continued the shoulder and relocated the light standard.

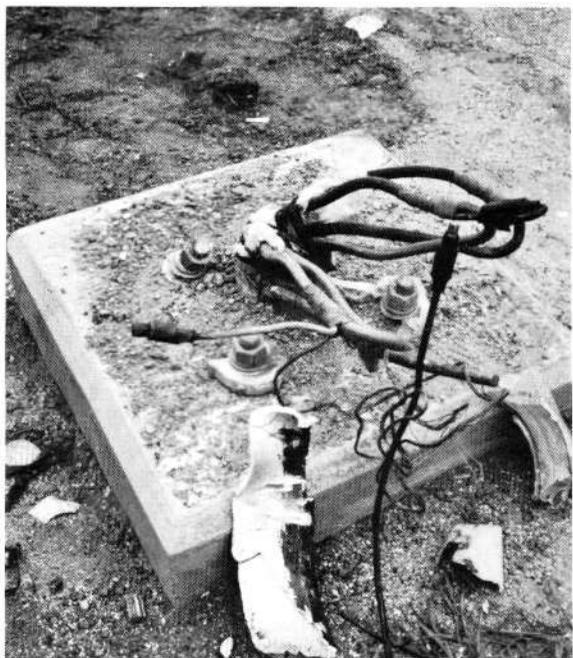
Figure 61 *left*. The slip-base unit shown can be used to adapt otherwise hazardous light poles to a safer design. When this installation is hit by a car, the lower section breaks readily and the pole is easily dislodged. The frangible insert can be rather cheaply added at many locations, sometimes for as little as \$25 per pole.
