Report No. FHWA-KS-07-6
FINAL REPORT

THE EFFECTIVENESS OF THE FLY-ASH SLURRY INJECTION METHOD TO ELIMINATE DEPRESSED TRANSVERSE CRACKS

Victoria Felker
William H. Parcels, Jr., P.E.
Kansas Department of Transportation
Topeka, Kansas

January 2009

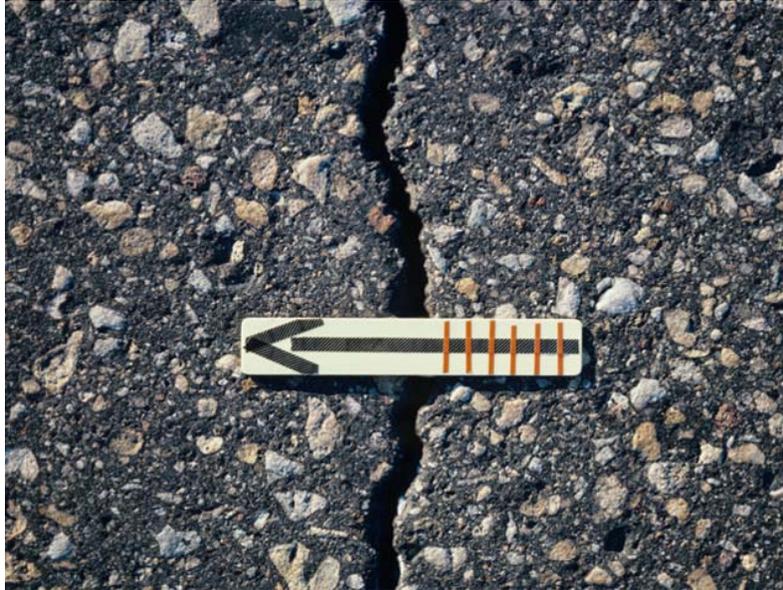
No.	Project no.	County	Completion date	Begin M. P.	End M. P.
1	K-5982-01	Ellsworth	2000	0	16.945
2	K-5983-01	Ellsworth	2000	16.945	23.248
3	K-5979-01	Thomas	1998	0	19.254
4	K-5979-01	Thomas	1998	19.254	37.508
Figure 9: Contraction of the asphalt concrete surface layer					
5	K-5980-01	Lincoln	1998	0	7.247
6	K-2610-02	Saline	1997	8	14.9
7	K-5572-01	Thomas	1996	0	4.393
8	K-5908-01	Thomas	1998	4.393	10.342
9	M-1775-01	Thomas	1996	19.070	28.031
10	K-5979-01	Thomas	1998	28.062	39.554

Transverse crack depressions are caused by an ingress of water through the cracks in the pavement to the subgrade soils. This causes softening of the subgrade soil and subsequent depression adjacent to the crack. Additionally, pumping of fines from the base and subgrade through the cracks contributes to the loss of support. The plastic limit of the fine-grained soils has been correlated with crack indexes such as number of cracks per 1,000 ft. This indicates that pavements overlying fine-grained soils have a greater risk of transverse cracking (Hicks, Kimberly, and Moulthrop 1997).
