**CORROSION EVALUATION OF
BRIDGES WITH EPOXY-COATED REBAR
Contract No. BD544-23
Final Report to Florida Department of Transportation**

UNIVERSITY OF SOUTH FLORIDA
Tampa, FL 33620
February 28, 2009

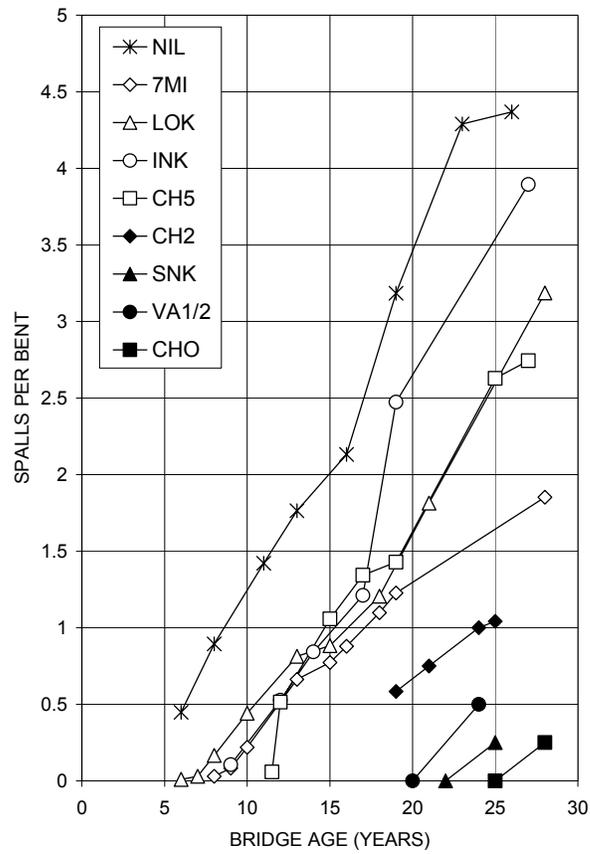
Figure 3. Progress of concrete corrosion damage as function of time.

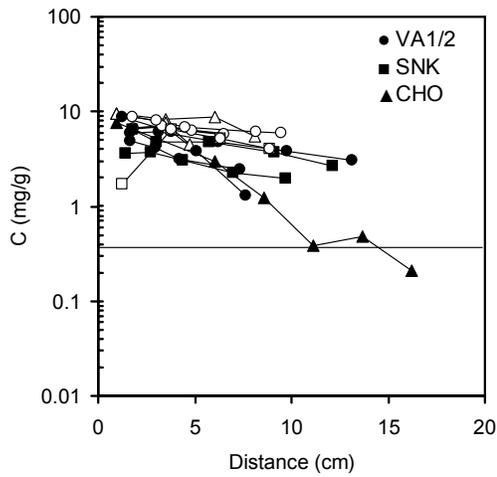
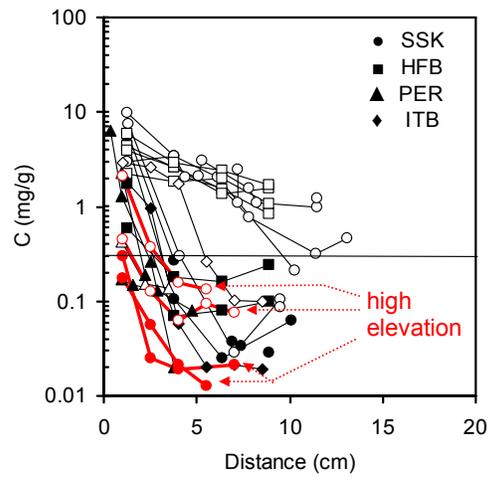
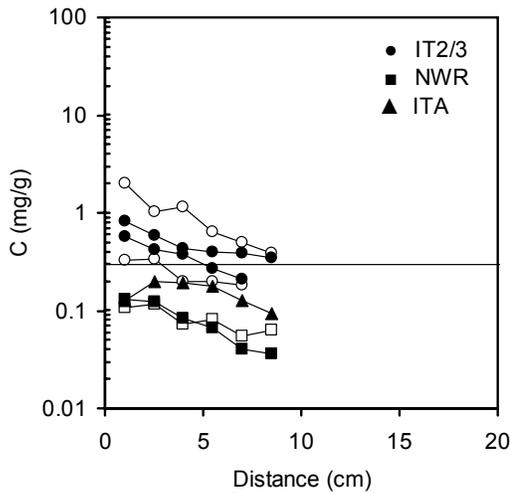
Distinct preferential chloride penetration at cracks was observed in this bridge (Figure 9b), similar to that noted for the SSK, at elevations exposed to sea

Figure 9. Chloride penetration profiles. Solid symbols: sound concrete. Open symbols: cracked concrete. Thick line, arrowed: high elevation trestle cap SSK locations. Horizontal line: conservative chloride threshold value ~ 0.3 mg/g ($C_T \sim 0.7$ kg/m³). Numeric chloride profile data and core identification are given in the companion project BD544-31 Final Report, Appendix I [10].

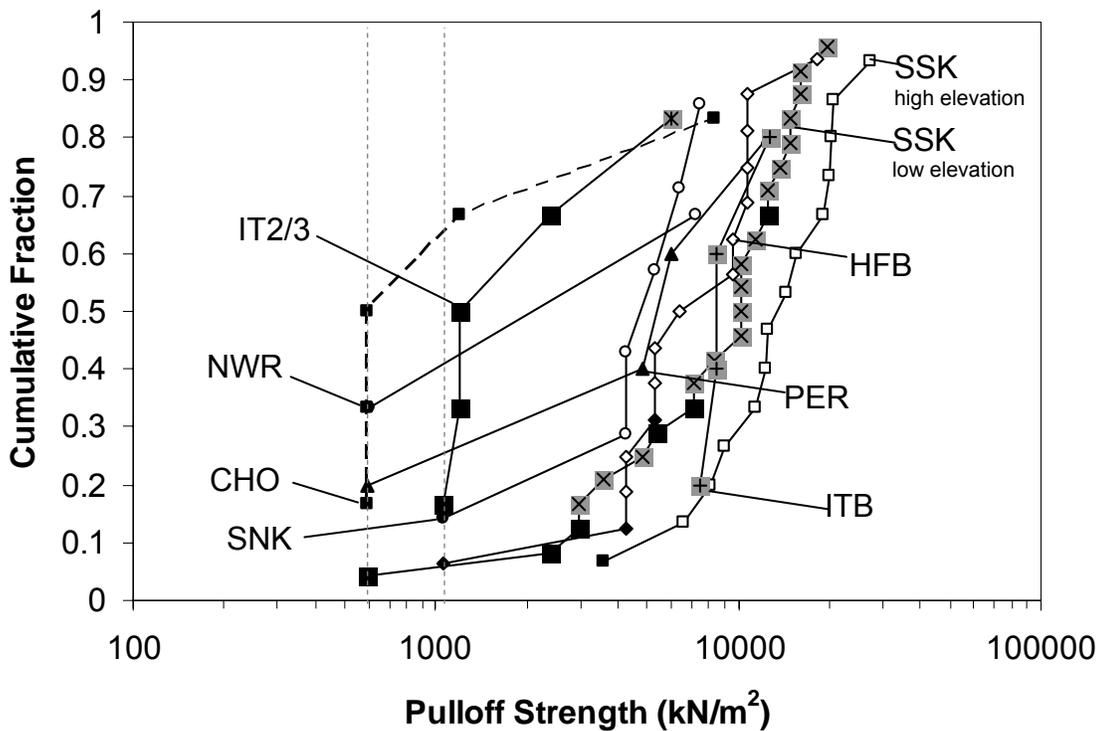
Figure 12. Epoxy coating pull-off strength. The pull-off strengths for Vaca Cut samples were negligible. Solid black symbols represent measured pull-off strengths. Other symbols represent lower bound pull-off strength failure at cyanoacrylate adhesive. Vertical lines represent minimum measurable strengths using metal dollies, nominal area 0.049 and 0.028 cm^2 .

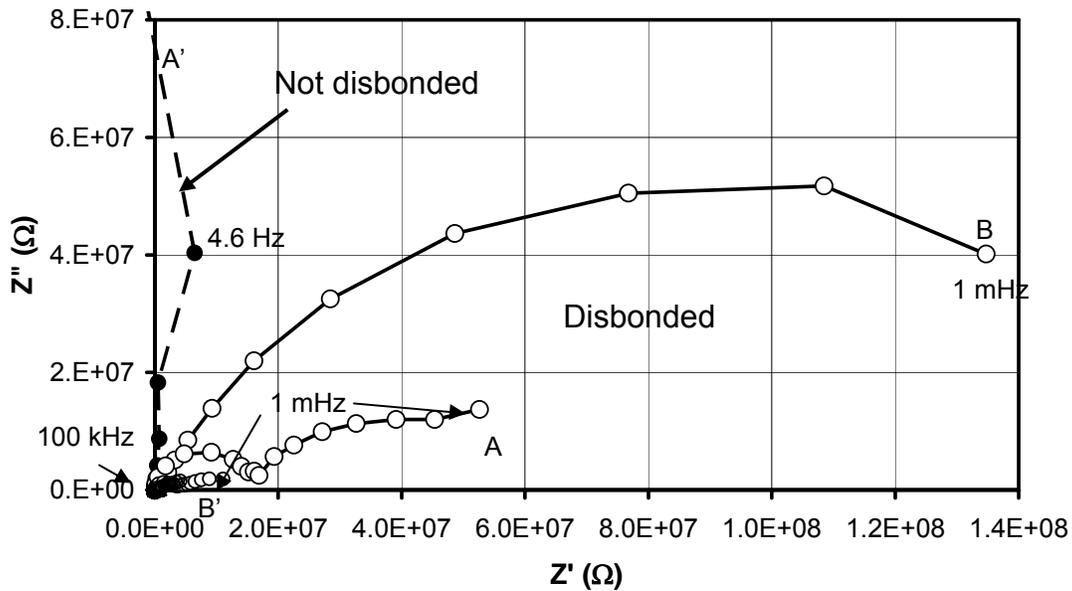
Figure 13. Impedance manifestation of disbondment. ECR from SSK high elevations. A,B Sound concrete core. A',B' Companion on crack core. (A, A': 140E2, 140E1. B, B':33W2, 33W1.)

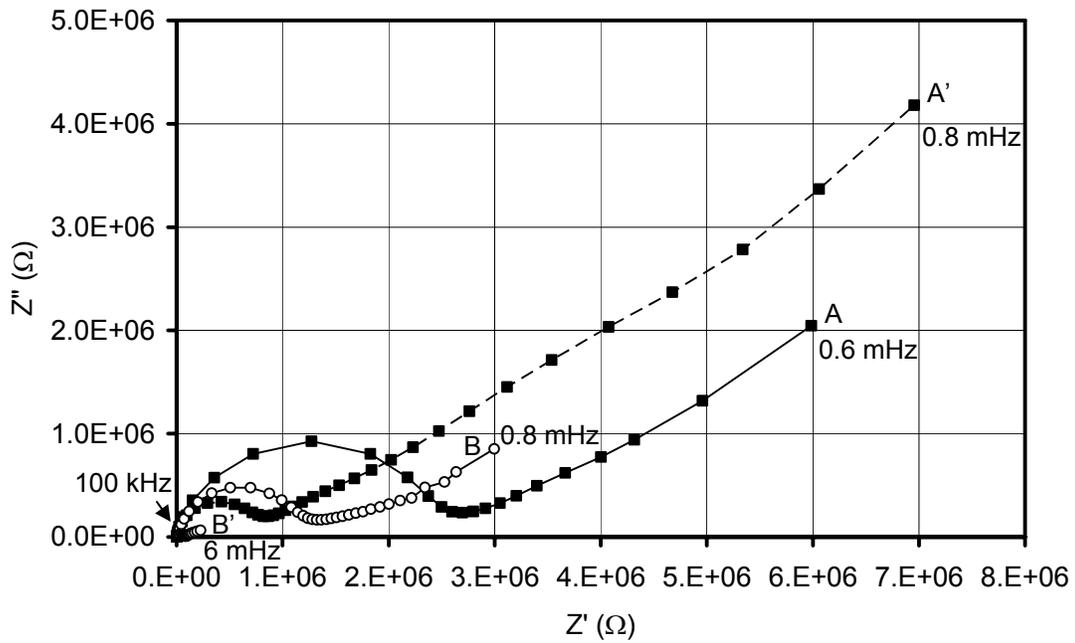
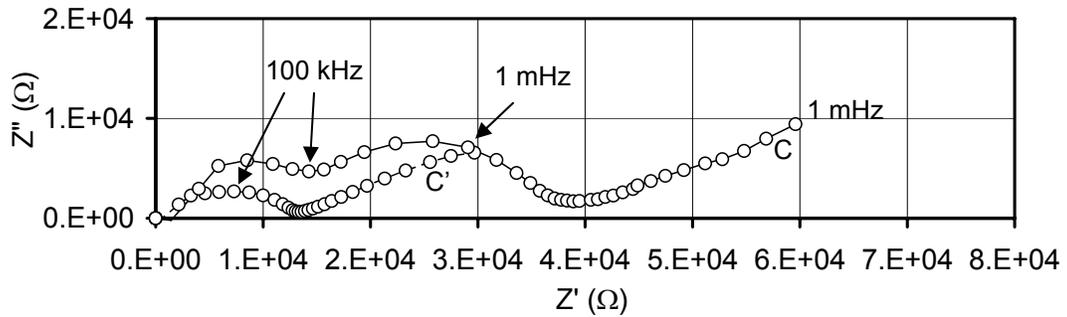
seen also in Figure 14 for samples with direct on- and off- crack sample comparisons. The EIS response was found to be sensitive to moisture content especially in the presence of cracks. The differences of R_{po} values from cracked to non-cracked samples are likely indicative of larger electrolyte conductance to the steel at crack locations. Test artifacts may result from current leakage to the exposed steel on the sides of the core sample, uneven moisture distribution, and concrete drying after field extraction.

Figure 14. ECR Impedance manifestation of presence of a crack in the core (low elevation SSK samples). A,B,C Sound concrete core; A',B',C' Companion on-crack core; crack widths were 0.13, 0.25 and 0.23 mm respectively. (A, A':118W4,118W3. B, B': 118W2, 118W1. C,C': 117E3, 117E1).

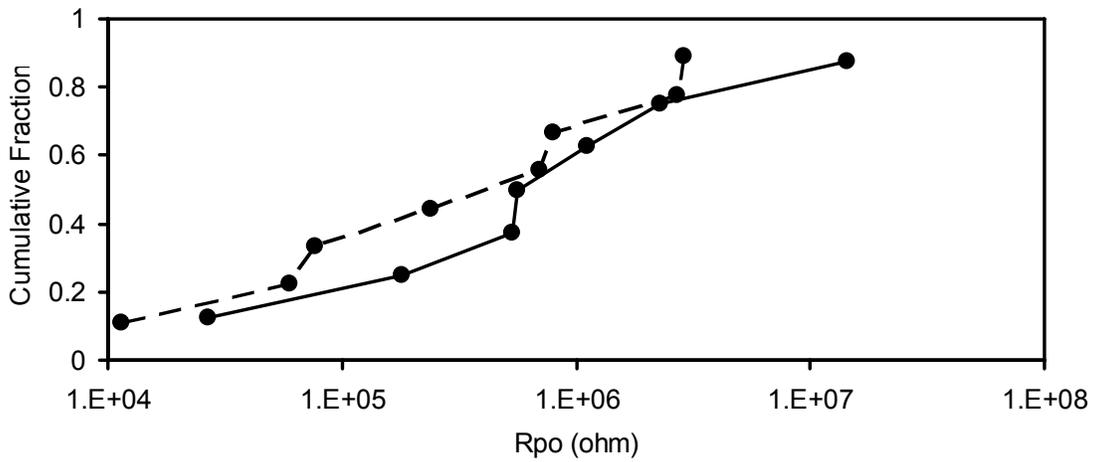
The hf loop diameter corresponds to the combined coating pore resistance, R_{po} . Cumulative fraction curves of the pore resistance for all ECR measured with EIS (cracked/non-cracked concrete coatings) are shown in Figure 18. Smaller R_{po} values were generally observed at cracked concrete locations as

Figure 18. Pore resistance in ECR from SSK sound and cracked concrete locations. – sound concrete, -- cracked concrete.

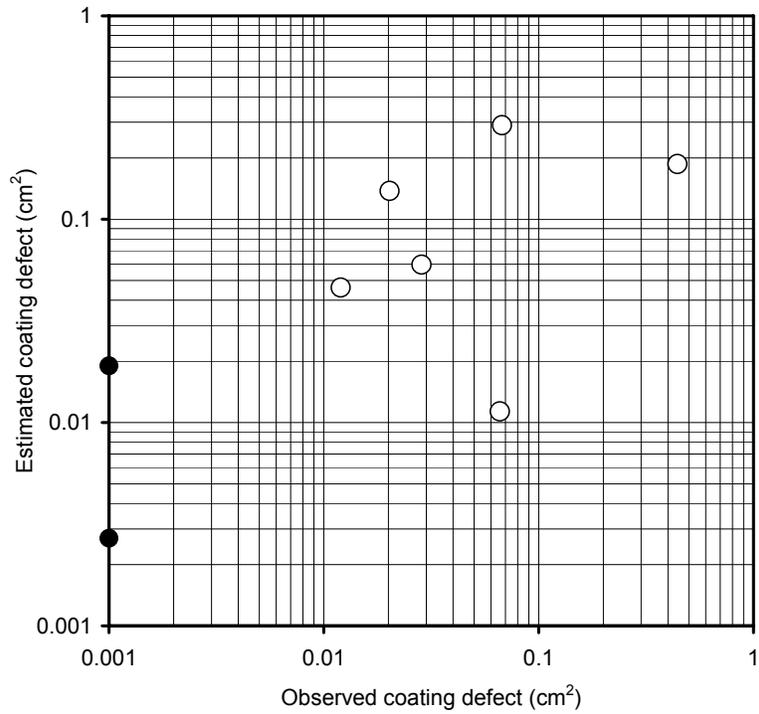
where k is a proportionality constant and ρ is the solution resistivity. The proportionality constant was determined by correlating the observed coating damage area with the pore resistance measured by EIS. For the sample population measured so far, $k \sim 0.2$. Figure 22 shows the comparisons for ECR samples where direct coating defect observations and impedance measurements could be made, indicating better than order-of-magnitude correlation (in cases where there were no observable coating breaks, a nominal detection area of 0.1

Figure 22. Comparison of observed coating defect area to estimated coating defect area (SSK). Solid symbol ● represents samples where no coating defects were observed but were assumed to be bound by a minimum detection limit, 0.001 cm².

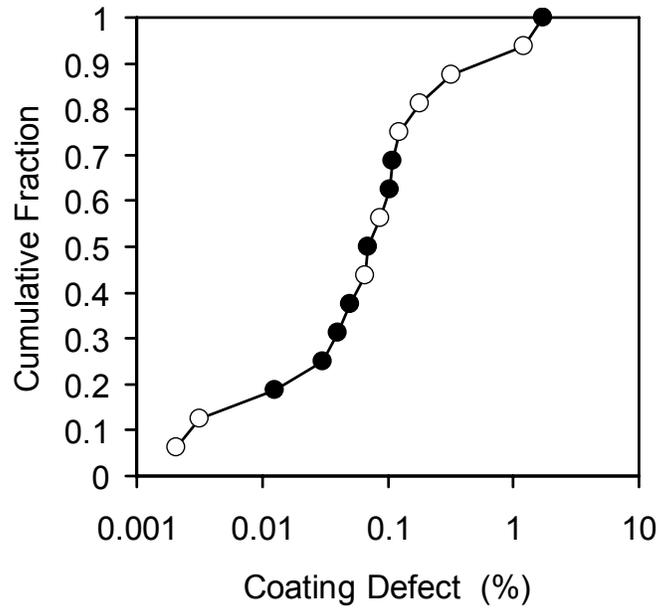
mm² was assumed). Figure 23 shows the cumulative fraction of the coating breaks as percentage of bar area either directly observed or estimated from impedance data when no direct observation autopsy was available. In the test samples, less than 2% damage was observed on ~10 cm segments, consistent with coating damage guidelines at the time of construction and subsequently updated.

Figure 23. Cumulative fraction of coating defect as percentage of bar area (SSK) by direct observation (open symbol) or by estimation from impedance data (solid symbol).

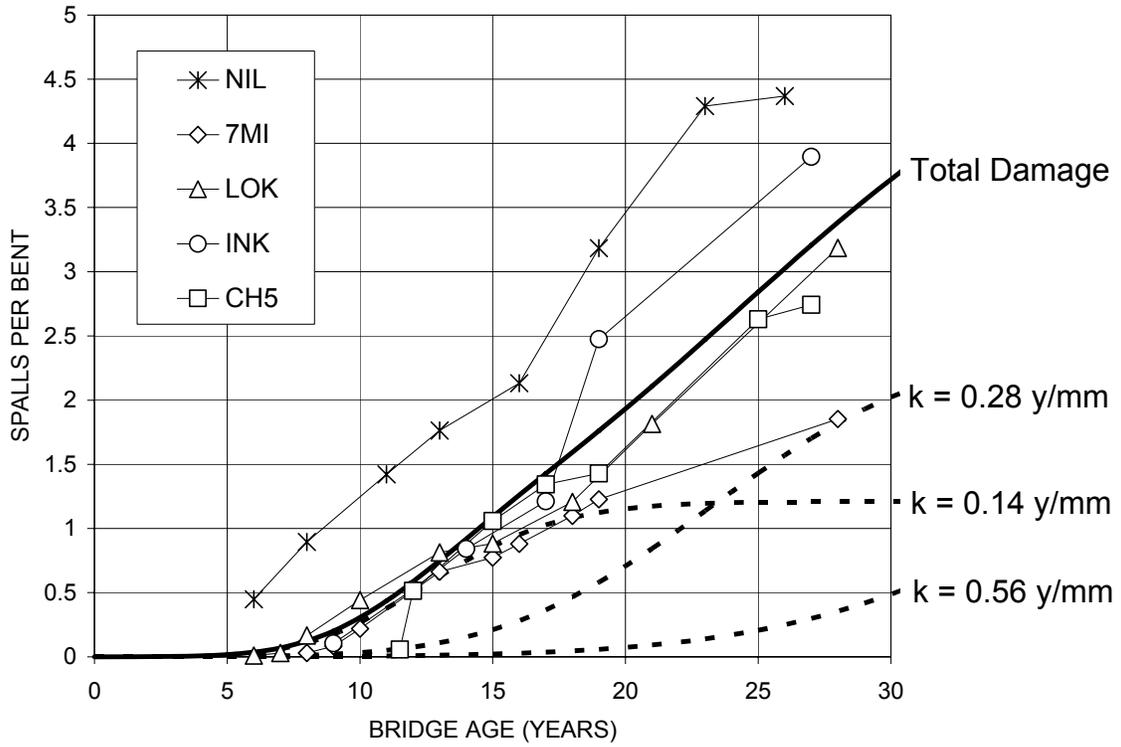
reproduced for each pertinent case. The model projection for Group 1 bridges (Figure 27) reasonably reproduced the duration of the initial period where damage was minimal, and the subsequent steady rise. The present choice of input parameters replicates that used in Ref 8, which was based on fitting to data that terminated at earlier times for two of the bridges (NIL and LOK), but the overall match continues to be similarly adequate for the newer data as well. Sensitivity tests confirmed that the damage projection was only modestly influenced by changes in the distribution of D_{app} or C_s , or by variations in C_T , in agreement with the basis for the choice of model parameters indicated above. Additional calculations with alternative k distributions indicated also that reasonable fit to observed behavior could be obtained only if the percentage of the assembly assigned low k values (yielding t_p values of only a few years) was quite small.

The dashed lines in Figures 27-28 represent the separate contribution to the total damage of each of the finite assumed distress fractions; addition of which corresponds to the thick solid line. As shown in Figure 27, as time progresses the projected damage increase results from fractions with increasingly greater k . Whether future damage will continue along the present trend depends, in this scheme, on the extent of coating distress on the rest of the rebar assembly. If the remaining rebar coating were in very good condition, damage would continue for some time at the present nearly constant rate and then saturate at some intermediate level. The present choice of k distribution assigns finite values to only the first 14% of the rebar assembly, so projected damage saturation would take place at ~ 9 spalls per bent. At present the highest recorded value (for NIL, evaluated in 2008)) reaches 4.4 spalls per bent without signs of slowing down, but the available data cannot preclude development of saturation in the relatively near future. Conversely, if the surface condition of the remaining rebar were poor or marginal, damage progression could easily continue to reach increasingly higher levels.

Figure 27. Projected damage function for Group 1 bridges. Thick bold line: total damage projection. Dashed lines: partial damage from each of the rebar assembly fractions considered; 2% of the rebar with $k=0.14 \text{ y/mm}$; 4% with $k=0.28 \text{ y/mm}$ and 8% with $k=0.56 \text{ y/mm}$.

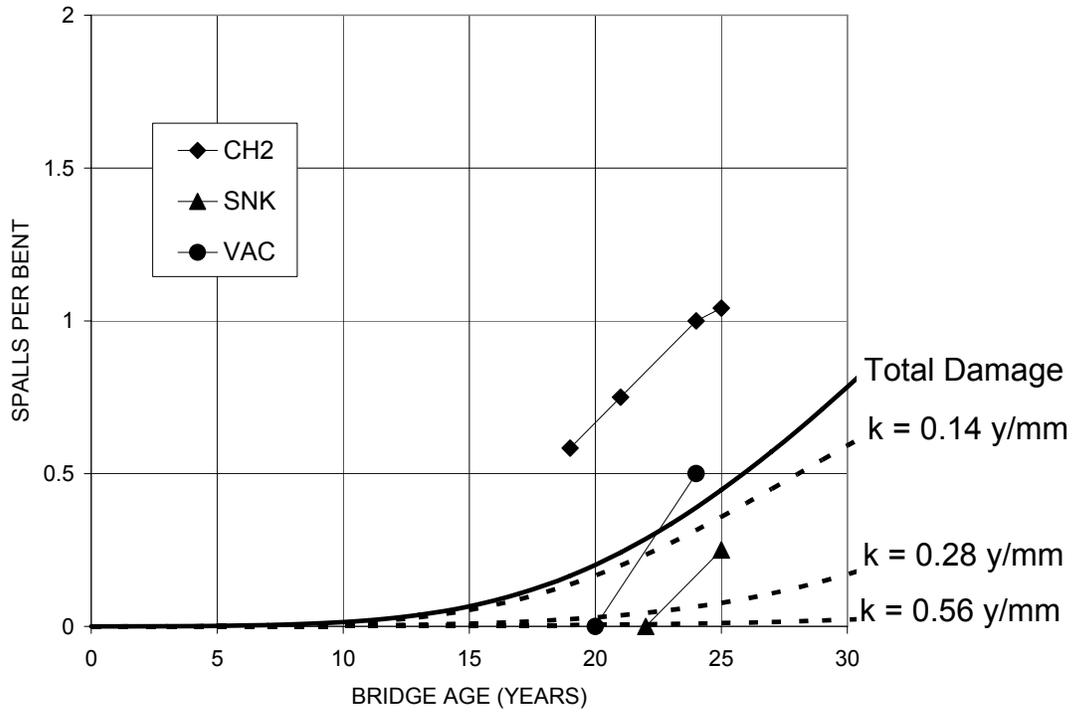
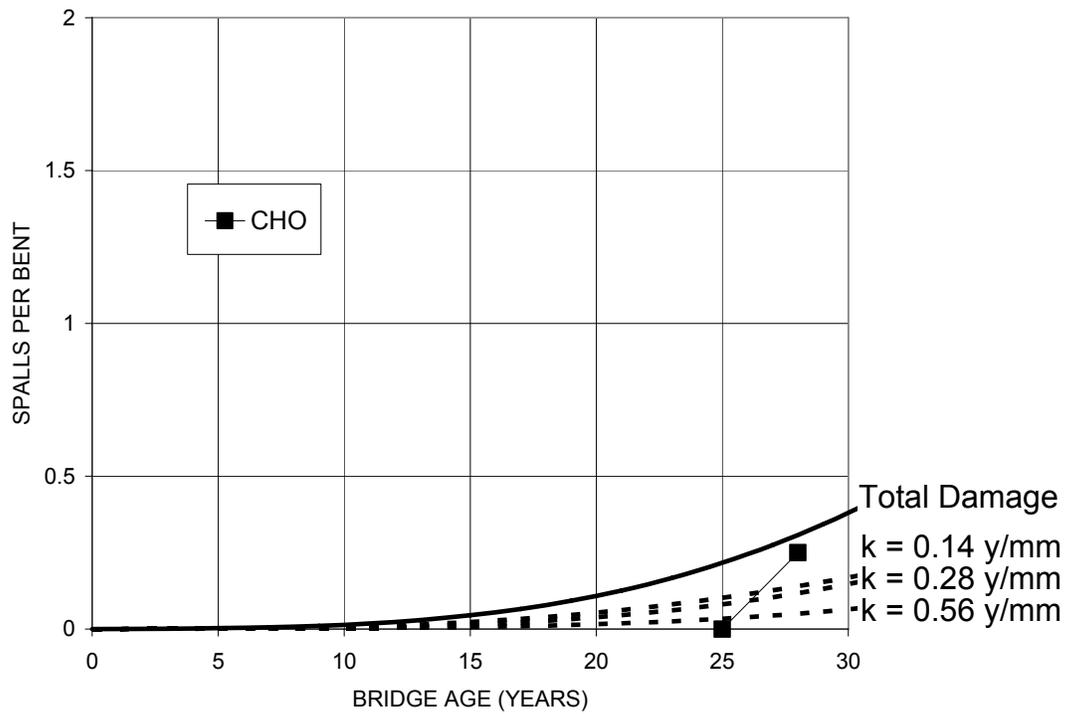
Figure 28. Projected damage function for Group 2 bridges. Thick bold line: total damage projection. Dashed lines: partial damage from each of the rebar assembly fractions considered; 2% of the rebar with $k=0.14 \text{ y/mm}$; 4% with $k=0.28 \text{ y/mm}$ and 8% with $k=0.56 \text{ y/mm}$.

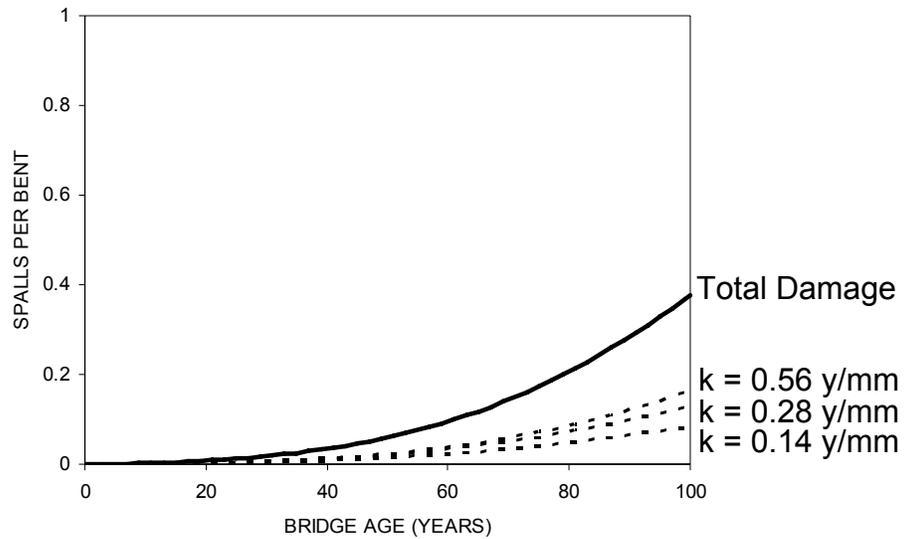
Figure 29. Projected damage function for Group 3 bridges. Thick bold line: total damage projection. Dashed lines: partial damage from each of the rebar assembly fractions considered; 2% of the rebar with $k=0.14$ y/mm; 4% with $k=0.28$ y/mm and 8% with $k=0.56$ y/mm.

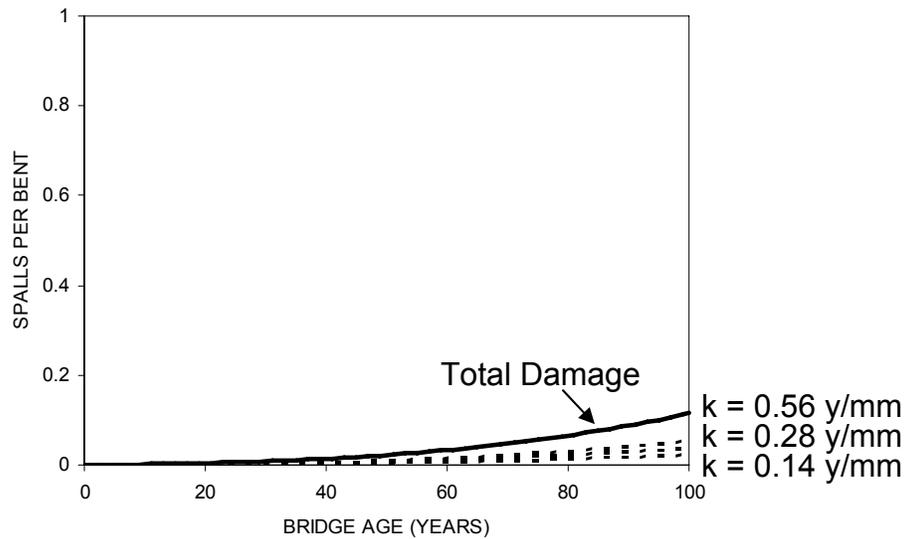
Figure 30. Projected damage function for Group 4 bridges. Thick bold line: total damage projection. Dashed lines: partial damage from each of the rebar assembly fractions considered; 2% of the rebar with $k=0.14$ y/mm; 4% with $k=0.28$ y/mm and 8% with $k=0.56$ y/mm.
