FINAL REPORT
Report No. FHWA-WY- 10/01F

**EVALUATION OF TREATMENT OPTIONS
FOR ASR-AFFECTED CONCRETE**

by
Kim Basham PhD, PE
KB Engineering, LLC
1716 Capitol Avenue
Cheyenne, WY 82001
kbasham@KBEngLLC.com

December 11, 2009

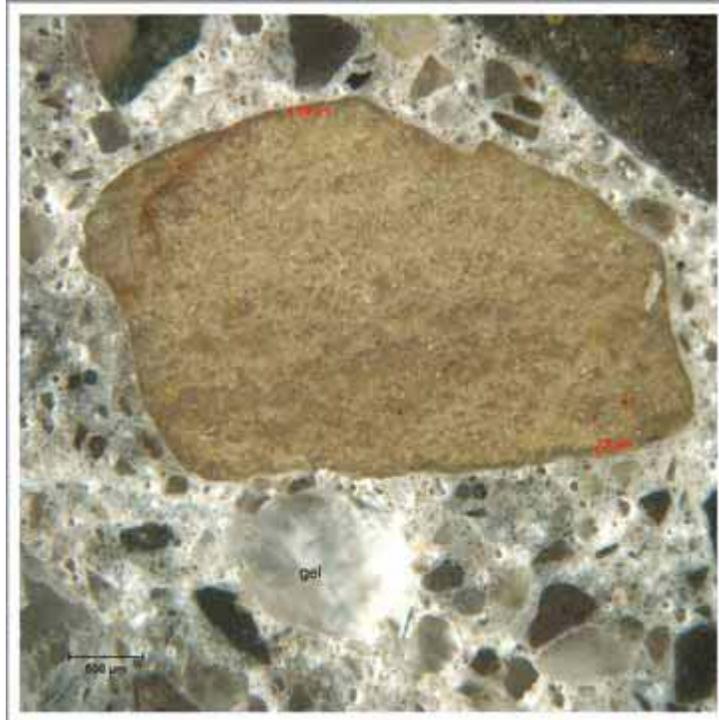
Figure 1.5 Reflected light photomicrograph of polished surface showing reaction rim (measured by red bars) or alkali-silica reaction product on fine aggregate particle. (Figure E4 from DRP's report (Appendix A).

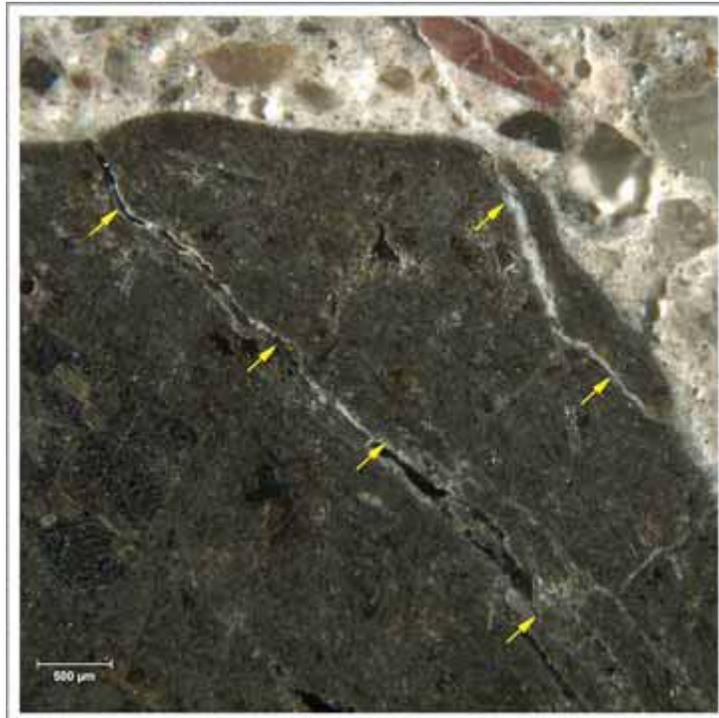
Figure 1.6 Reflected light photomicrograph of polished surface showing coarse aggregate particle with internal fractures that are filled with ASR gel (yellow arrows). (Figure E2 from DRP's report (Appendix A).

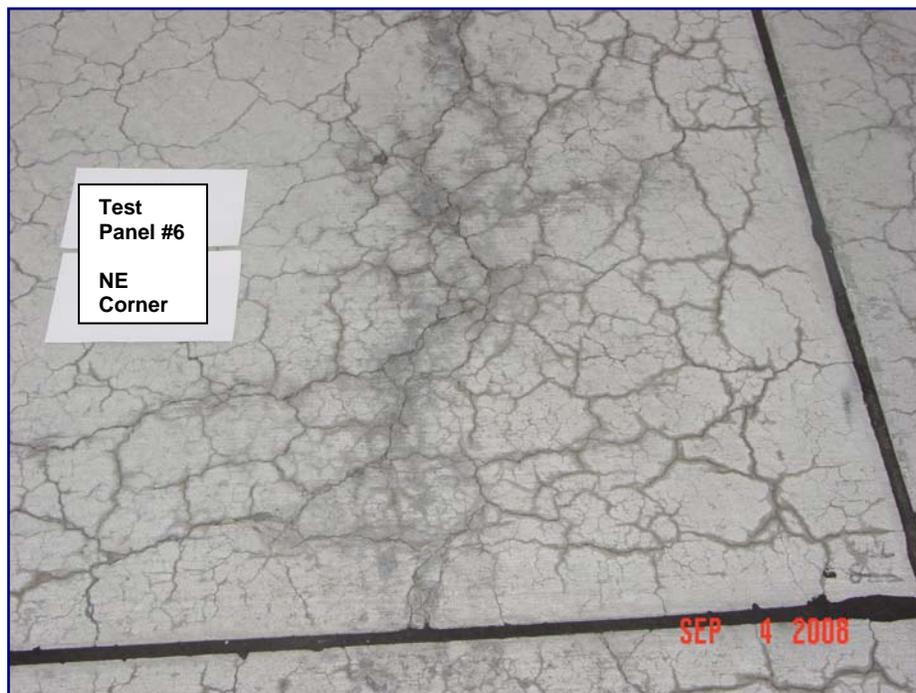
Figure 1.8 Typical, ASR “map cracking” observed on all concrete test panels. Cracking was worse along joints than in the center of the panels. Also, unsealed joints provided pathways for water and external alkalis to enter the concrete from the bottom.

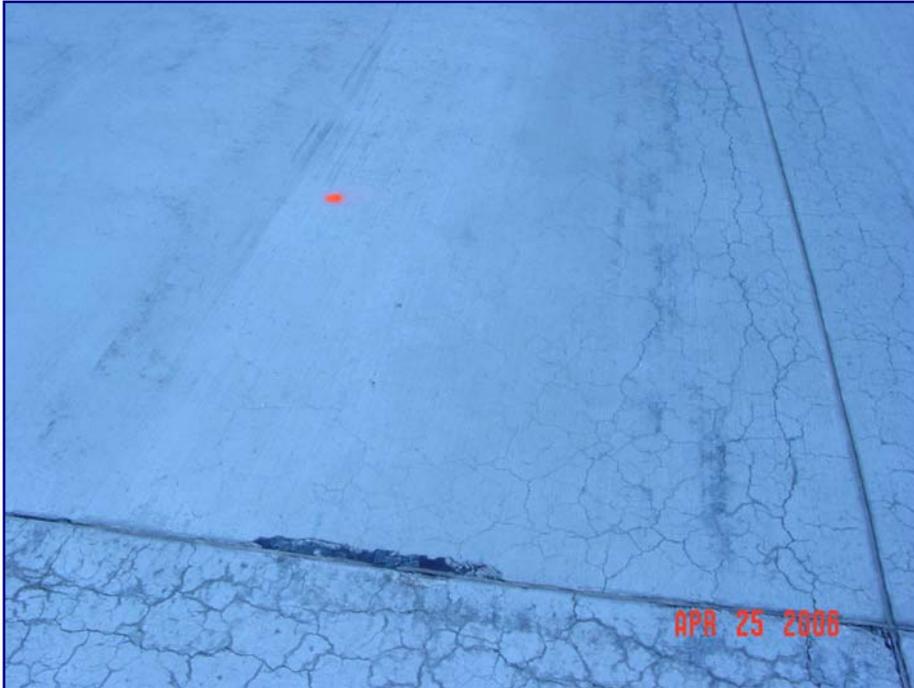
In addition to map cracking, cracks along the joint edges were oriented parallel to the joints. This is a common observation for ASR-affected pavements. As expansion occurs due to the swelling ASR gel, it expands unrestricted towards the free edge resulting in cracks oriented parallel to joints. In fact, the concrete apron had pushed the asphalt pavement along the north and east edges so that a roll or small asphalt bump formed. Paul Griffin with the airport reported that airport workers had ground down the asphalt bump several times in the past years but it always returned. Basically, the concrete apron was growing in both length and width due to the ASR expansion.

Figure 2.3 Typical ASR “map cracking” and cracks oriented parallel to panel joints. Free edges allow concrete to expand perpendicular to the edge resulting in cracks parallel to joint.

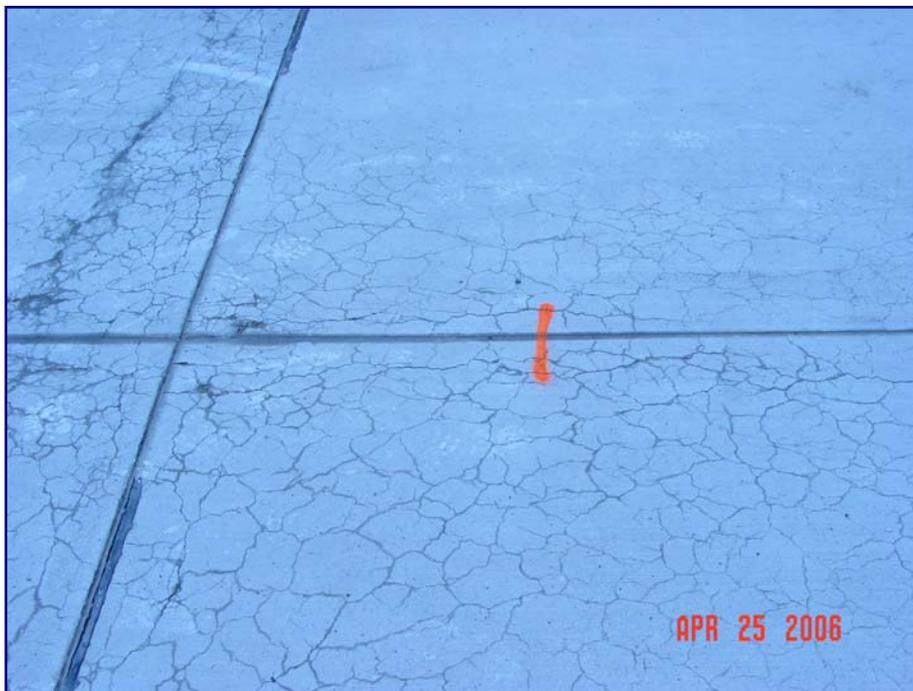
Figure 2.4 Map cracking was more severe along joints and especially in the corners of the panels due to additional sources of moisture feeding the ASR. Orange paint identifies the coring location for Core 10 – through the construction joint.

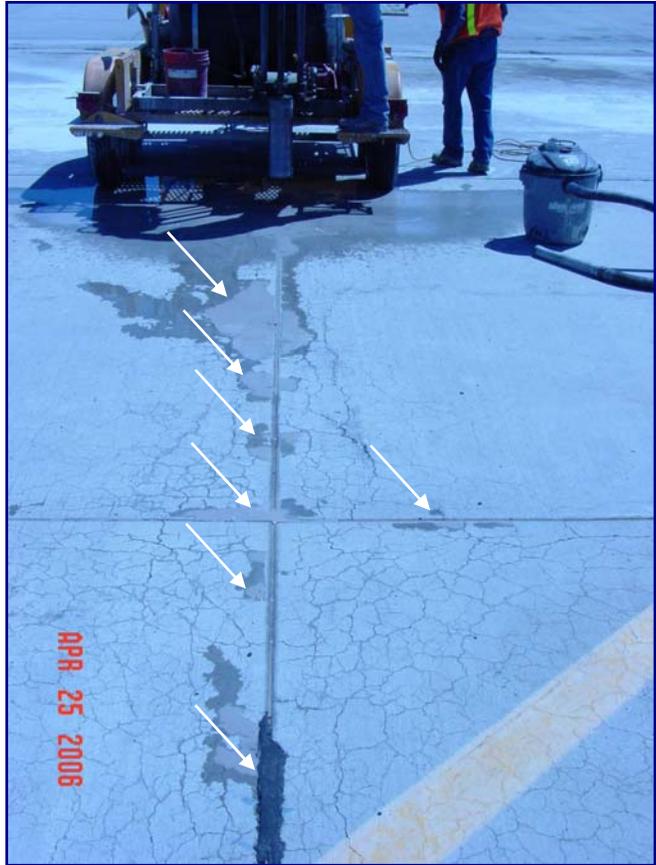
Figure 2.5 Water used during the coring operation bubbled up through joints away from the location being cored indicating pathways existed allowing water to move between the pavement and bituminous felt.

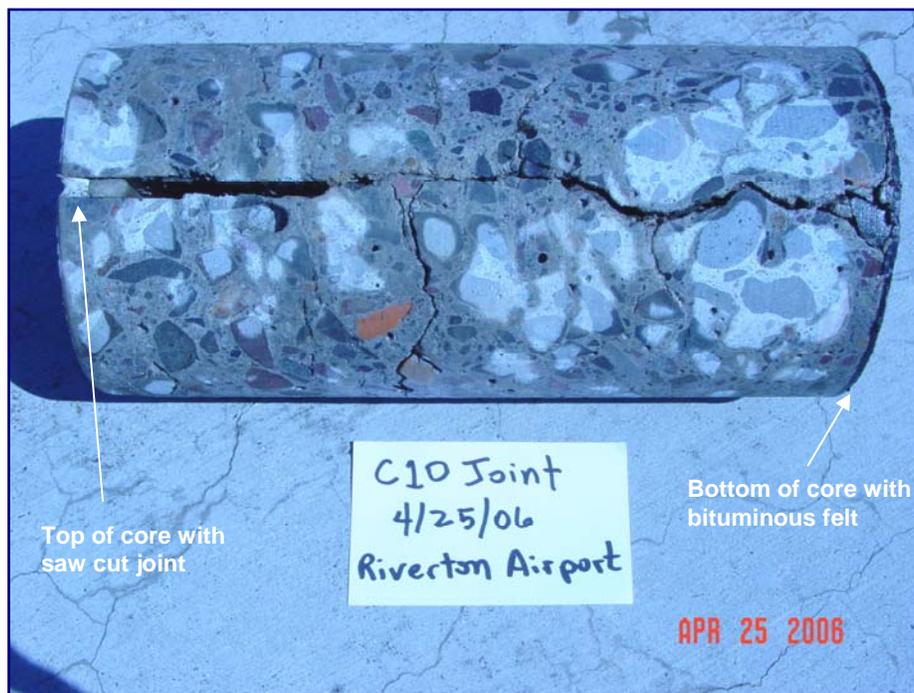
Figure 2.6 Core C10 showing an activated joint and other cracks that provided additional entry points for water to enter the concrete and to seep between the pavement and bituminous felt.

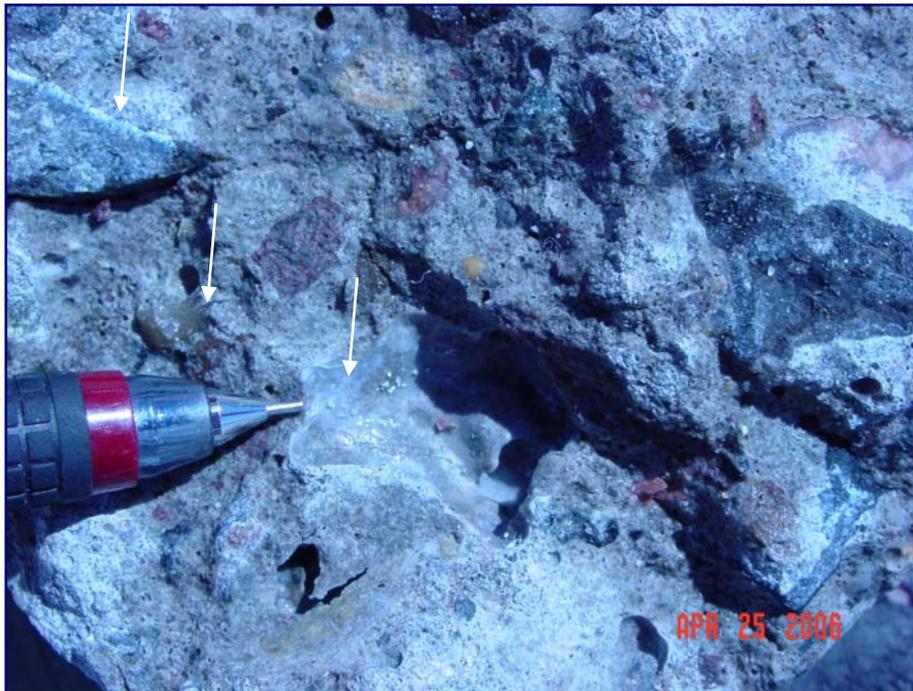
While drilling cores, several of the cores broke off before drilling full depth. ASR gel was observed in aggregate pockets and cracks of several of the core fragments without magnification as shown below in Figure 2.7. This illustrates the advanced stage of the ASR damage.

Figure 2.7 ASR gel was observed in aggregate pockets and connecting cracks on several drilled core fragments without magnification.

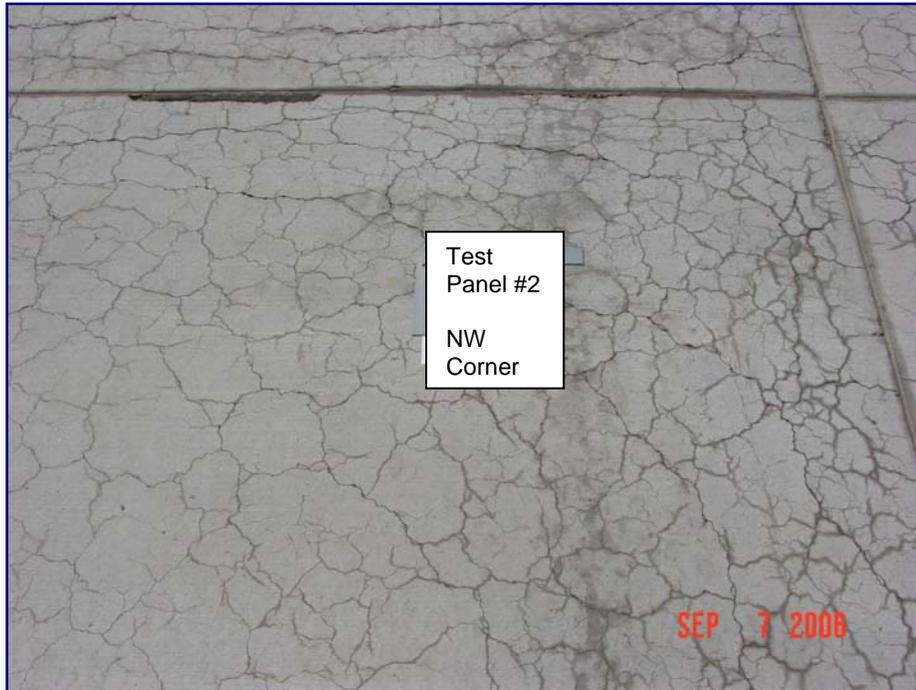
Figure 2.8 ASR damage of NW corner of test panel #2 as of September 7, 2006 commonly referred to as the “before” condition. Because other test panels exhibited similar levels of damage, their photos are not included.

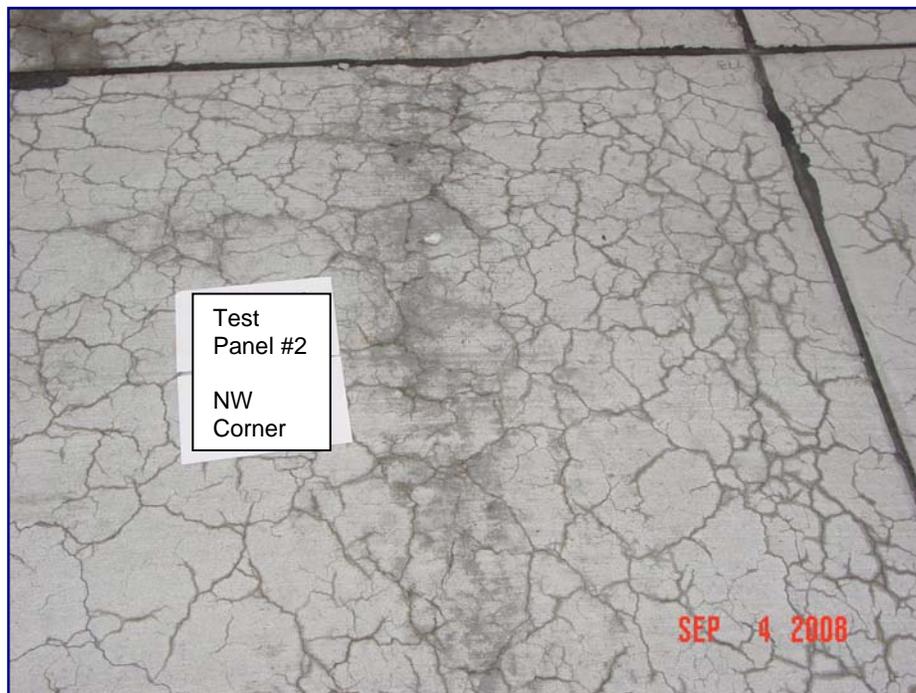
Figure 2.9 “After” condition of the NW corner of test panel #2 as of September 4, 2008. Crack widths had grown and new cracks had formed during the two year evaluation period. Some edge spalling had also occurred along joint edges. Test panel #2 was a control panel and had the largest DRI reduction of the test panels.

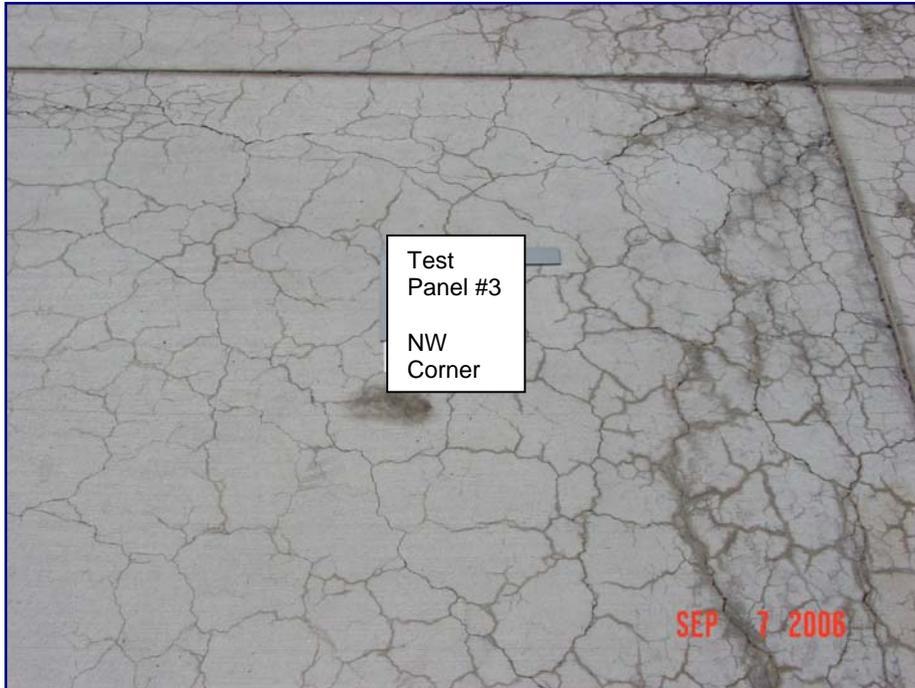
Figure 2.10 ASR damage of NW corner of test panel #3 as of September 7, 2006 commonly referred to as the “before” condition.

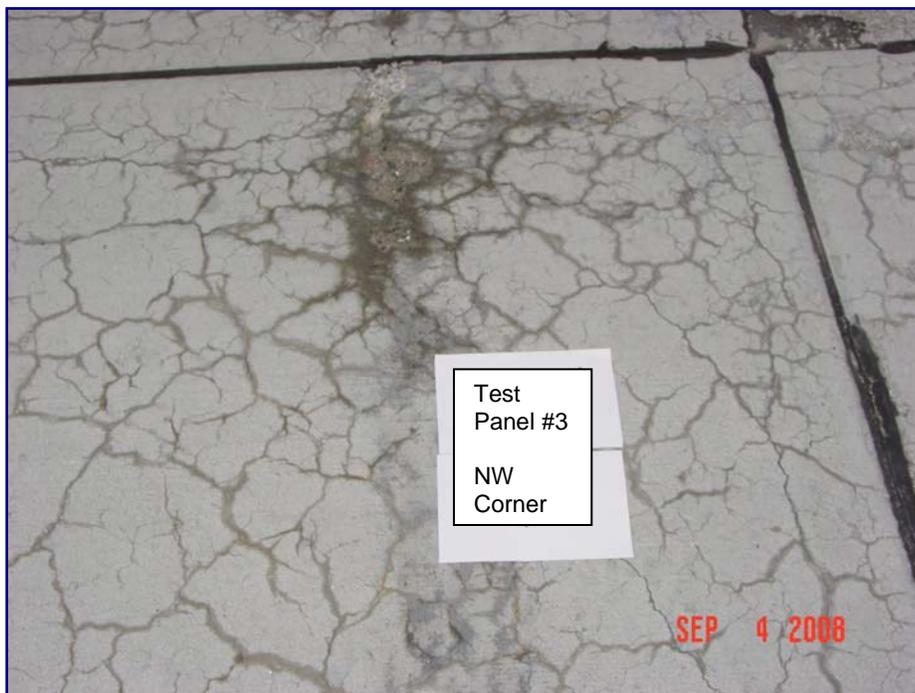
Figures 2.10 and 2.11 show the “before” and “after” condition of the NW corner of test panel #3. Lithium nitrate (LiNO_3) was applied to this panel and DRI results indicate this panel had the least amount of additional ASR damage during the evaluation period.

Figure 2.11 “After” condition of the NW corner of test panel #3 as of September 4, 2008. Cracks widths had grown and new cracks had formed during the two year evaluation period. Some minor edge spalling had also occurred along joint edges. Test panel #3 was treated with lithium nitrate and had the least DRI reduction of the test panels.

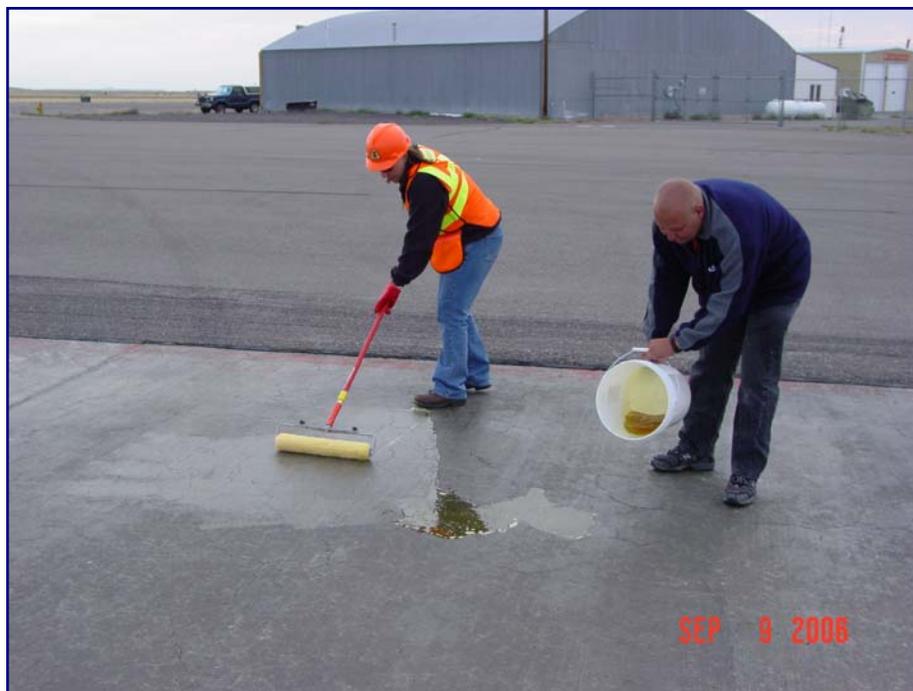
Figure 3.6 Workers followed the manufacturer's recommended application techniques and coverage rates. Here, boiled linseed oil is being applied to test panel #9. The oil darkened and created an extremely slippery surface when wet.

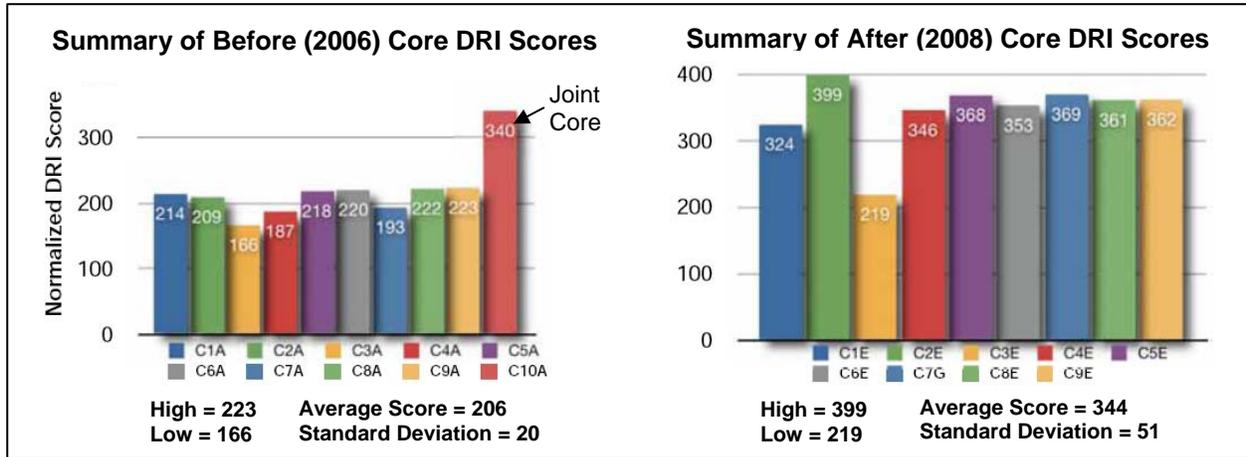
Figure 4.1 Comparison of before and after DRI scores for test panels 1 – 9 from DRP’s report.

As shown in Figure 4.1 above, all DRI scores increased indicating that ASR related concrete damage increased during the two-year evaluation period. Except for the DRI score of 340 for Core C10-A in the before set, these scores are fairly consistent with an average of 206 and a standard deviation of 20. However, the DRI score for Core C3-A is noticeable less than the other scores. Except for the Core C3-E in the after set, DRI scores are rather consistent with average of 344 and a standard deviation of 51.

The DRI score for Core C10-A, which was drilled from a construction joint in 2006, was 340 and considerable larger than other scores for cores extracted six feet away from joints. A larger DRI score at the joint agrees with the visual damage exhibited by all panels. As previously discussed, joints were exposed to more moisture than non-joint locations and were less restrained than interior panels cores resulting in more visual damage.

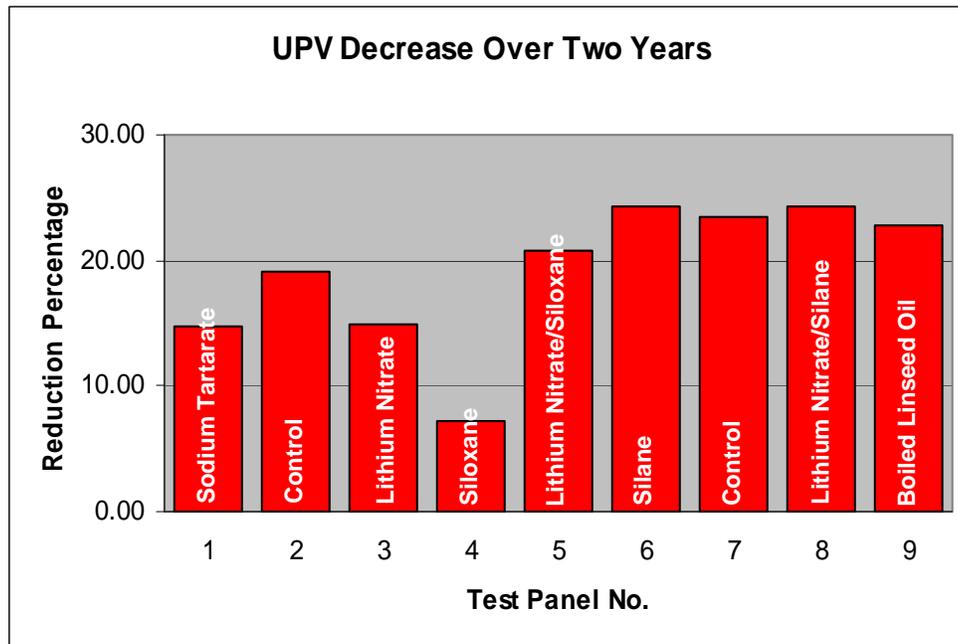
Figure 4.3 Summary of UPV decrease over the two-year evaluation period.

Figure 4.3 below summarizes the UPV reductions for cores removed from the test panels. UPV results for test panel #4 (siloxane) showed the smallest reduction followed by test panels #1 (sodium tartarate) and #3 (lithium nitrate). The remaining cores showed a UPV reduction of approximately 20 percent or slightly more. The two control panels (#2 and #7) had reductions of 19.1 and 23.5 percent, respectively.

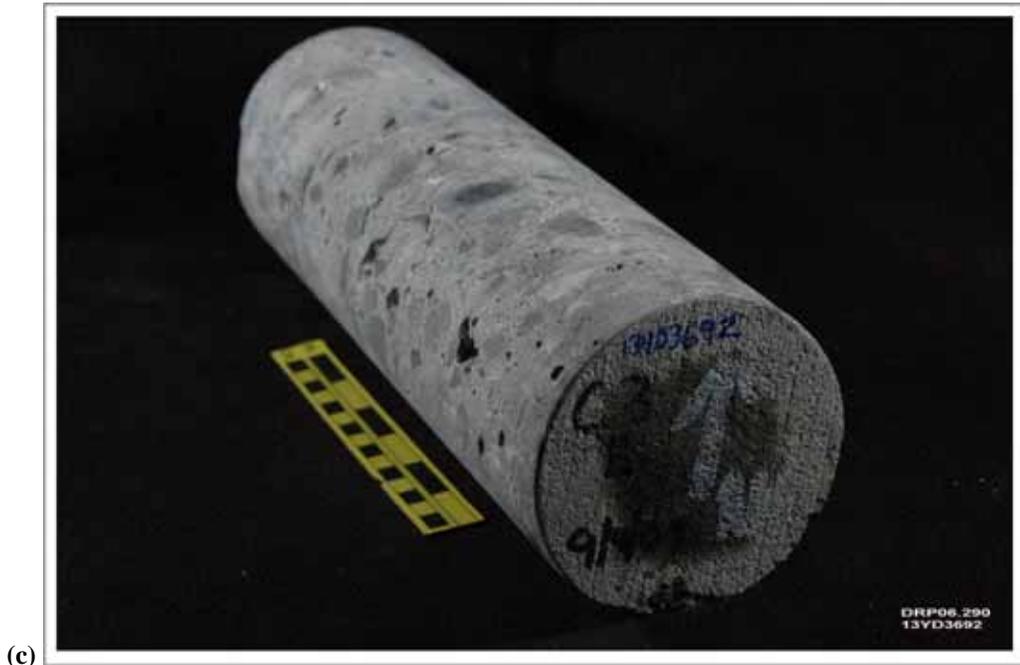
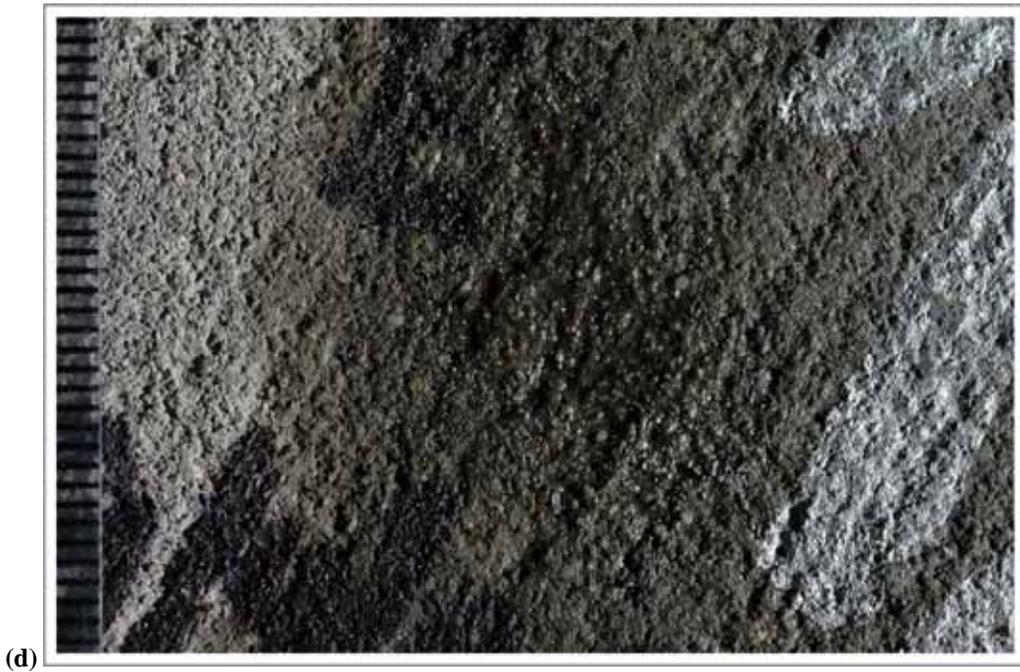
Figure A13. C3E. Photographs of sample in as-received condition showing (a) top and (b) bottom surface of core. Red and blue dots in (a) show the orientation of saw-cuts used to prepare the sample.

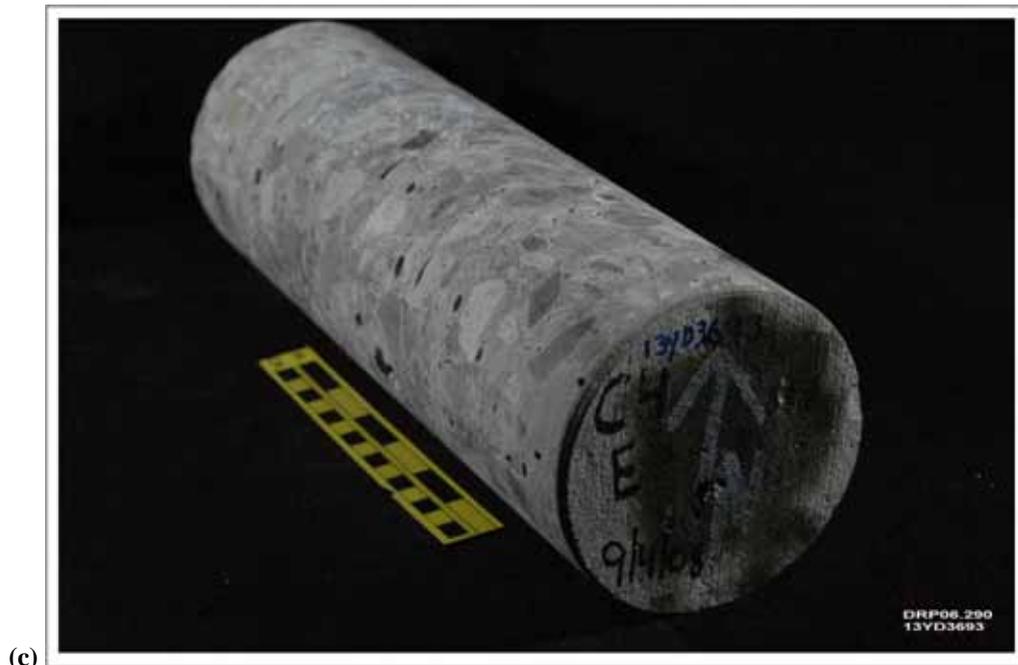
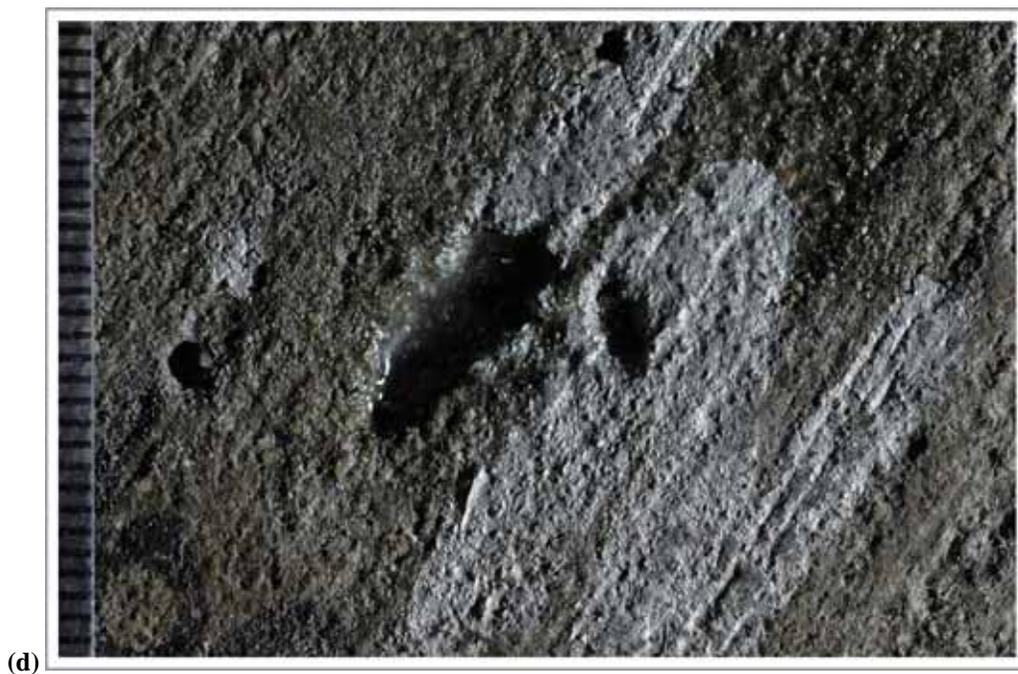
Figure A14. C4E. Photographs of sample in as-received condition showing (a) top and (b) bottom surface of core. Red and blue dots in (a) show the orientation of saw-cuts used to prepare the sample.

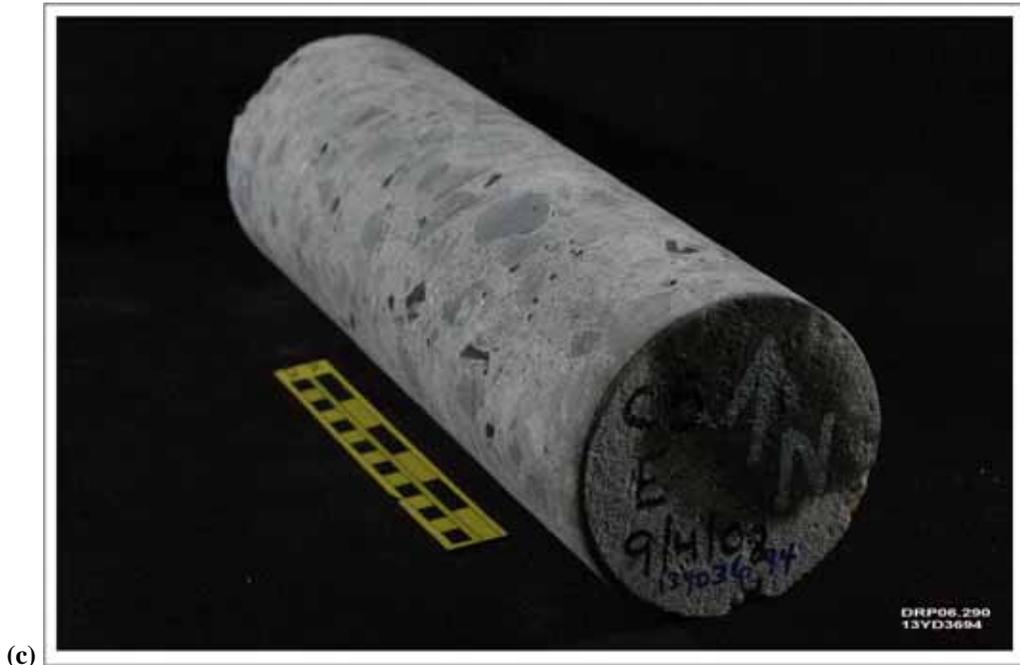
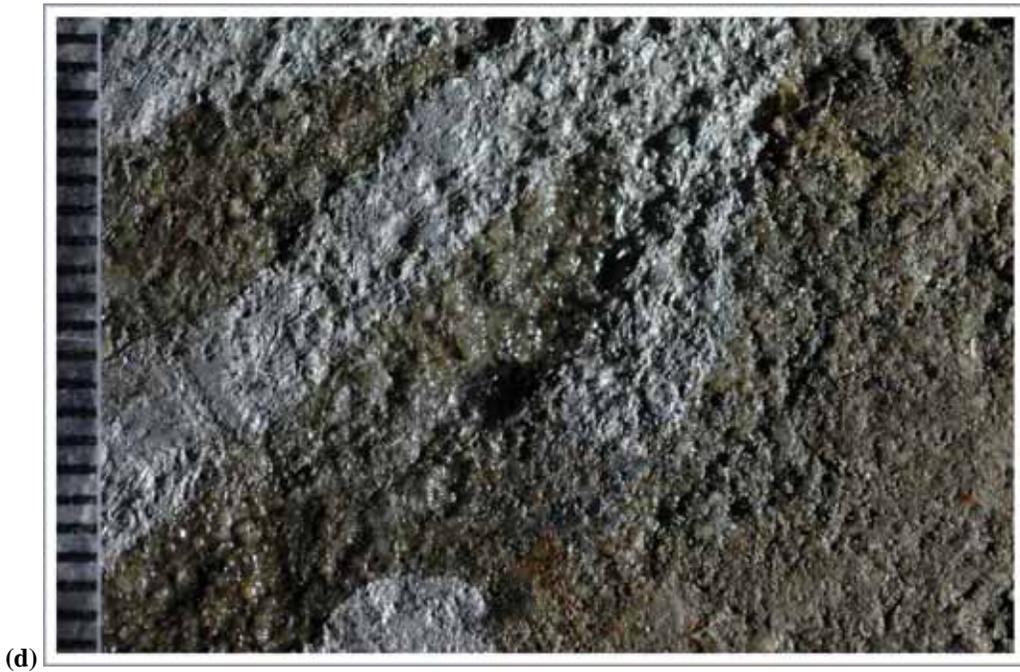
C5E	13YD3694	White deposits , consolidated air voids and reaction rims present along the side of the core; "grease" spots on top & bottom surface
C6E	13YD3695	100 mm long crack across the top surface, branches, up to 0.25 mm wide, continues along the side of core in three places as far as 25 mm down the side; consolidated air voids, white deposits and reaction rims present along the side of the core; A piece cracked off the top surface and end of crack; "grease" spots on top & bottom surface
C7G	13YD3696	50 mm long crack on top surface, 0.25 mm wide and travels 10 mm down the side of the core; white deposits, consolidated air voids and reaction rims present along the side of the core; "grease" spots on top & bottom surface
C8E	13YD3697	40 mm long crack, up to 0.75 mm wide on top surface, continues down the side of core 20 mm; white deposits, consolidated air voids and reaction rims present along the side of the core; Consolidated air voids on bottom surface; "grease" spots on top & bottom surface

Figure A15. C5E. Photographs of sample in as-received condition showing (a) top and (b) bottom surface of core. Red and blue dots in (a) show the orientation of saw-cuts used to prepare the sample.

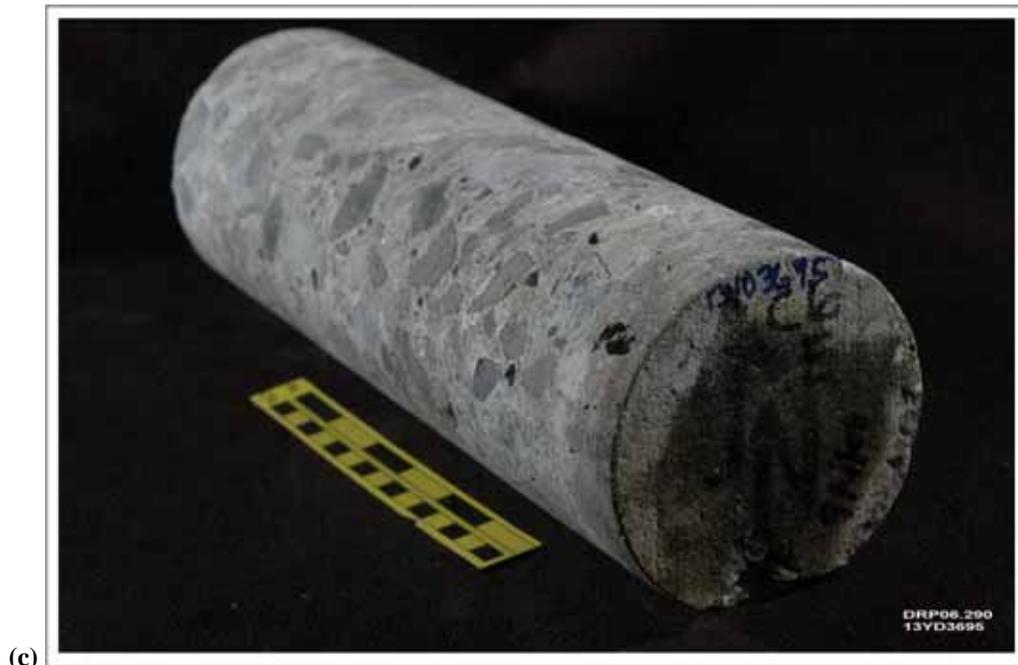
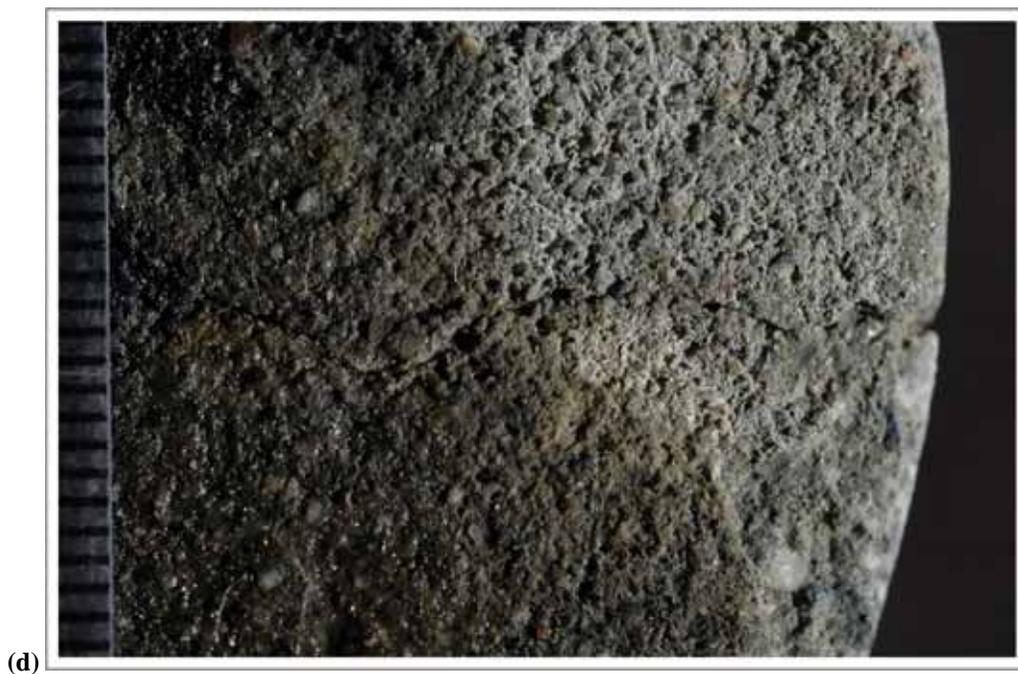
Figure A16. C6E. Photographs of sample in as-received condition showing (a) top and (b) bottom surface of core. Red and blue dots in (a) show the orientation of saw-cuts used to prepare the sample.

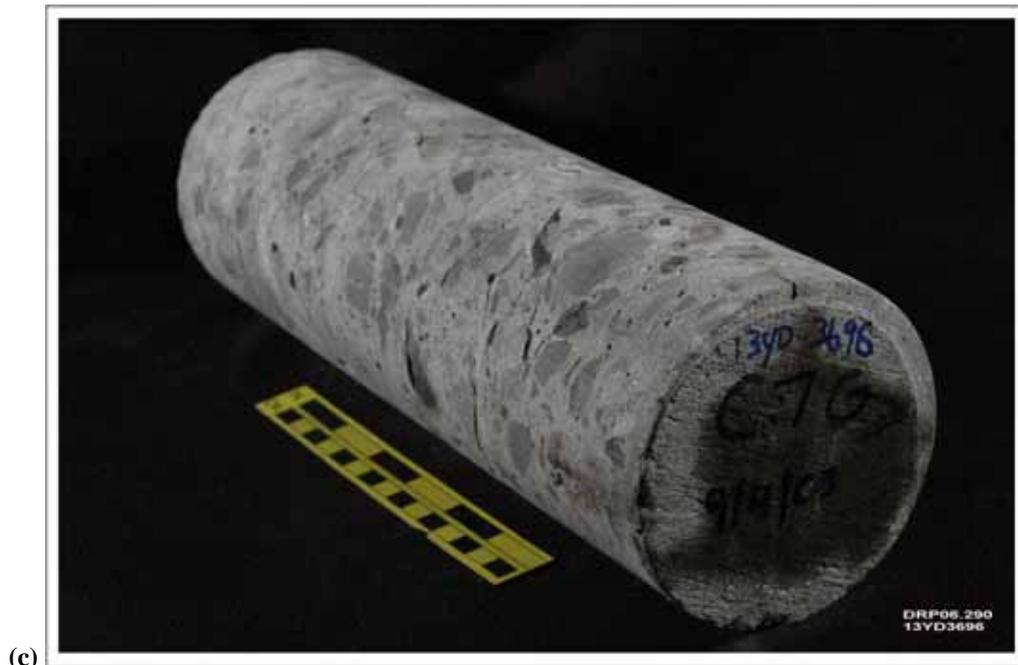
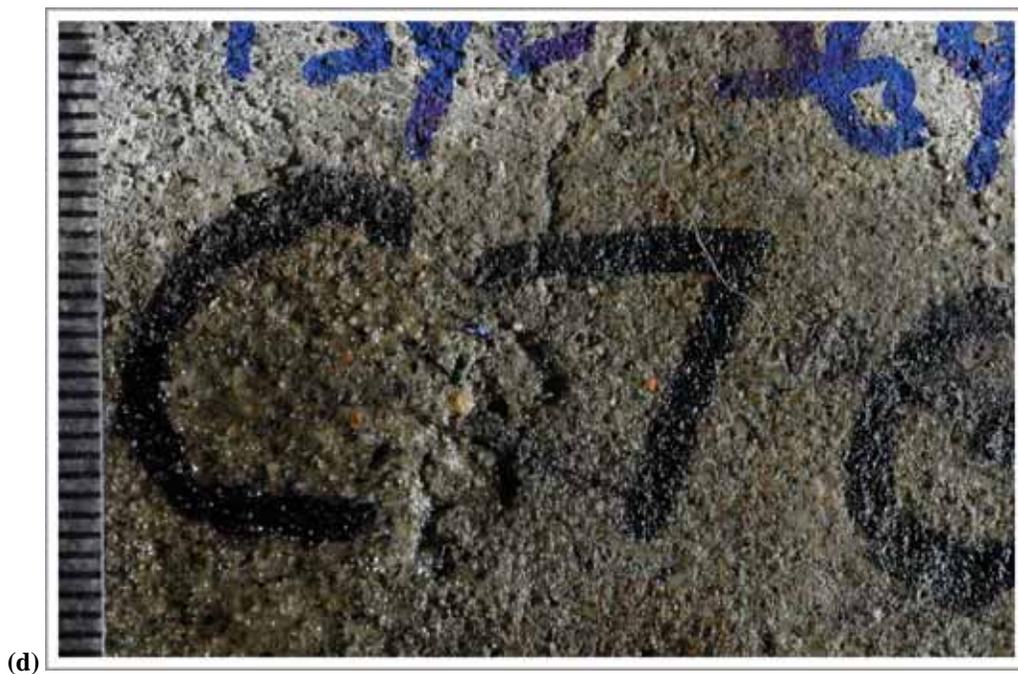
Figure A17. C7G. Photographs of sample in as-received condition showing (a) top and (b) bottom surface of core. Red and blue dots in (a) show the orientation of saw-cuts used to prepare the sample.

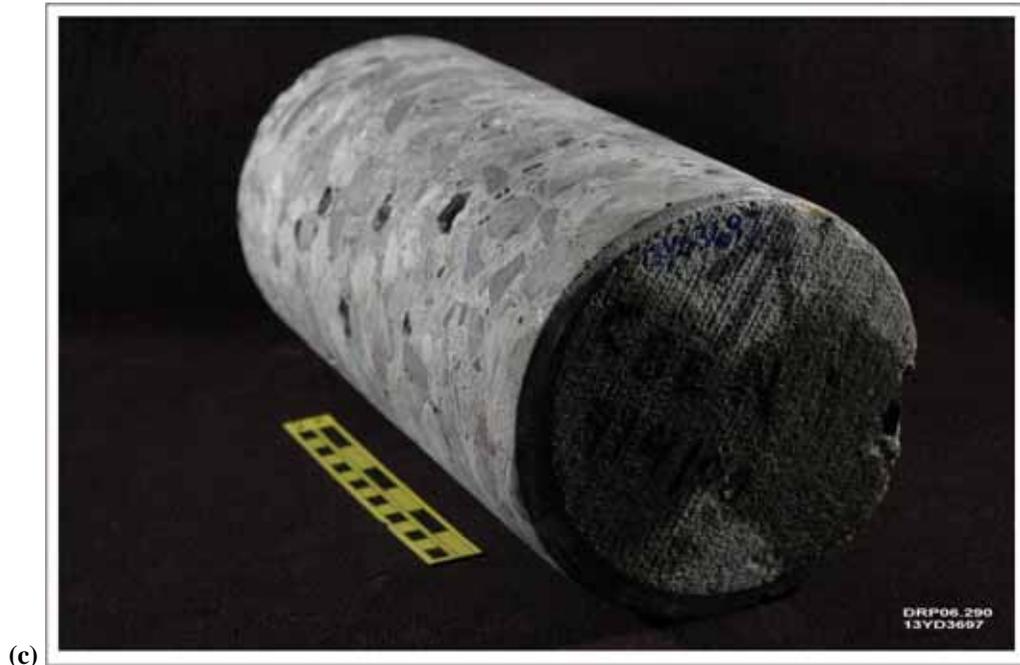
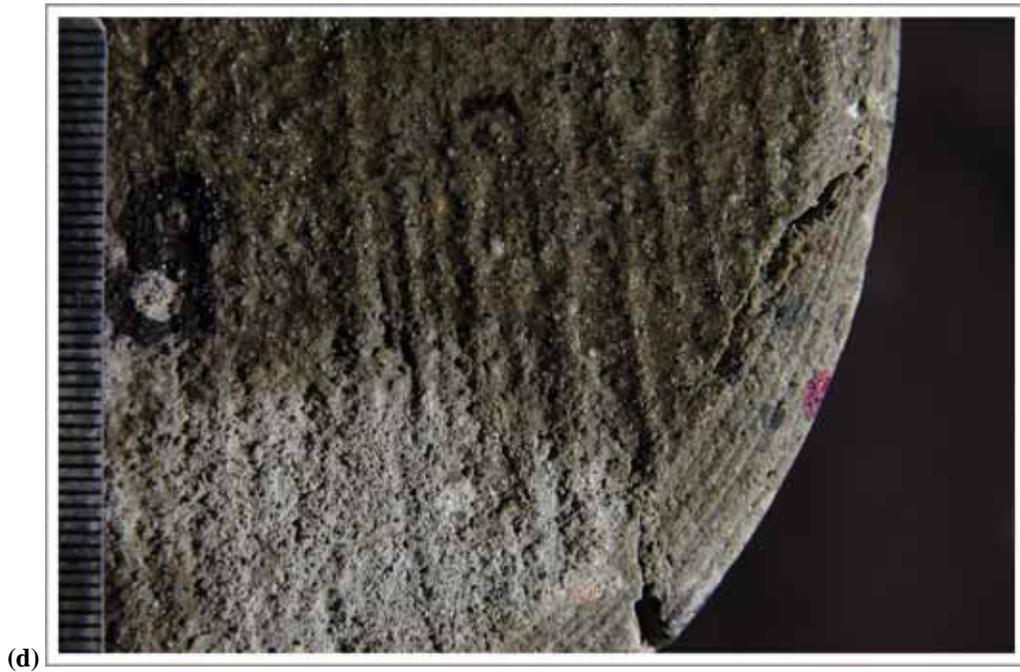
Figure A18. C8E. Photographs of sample in as-received condition showing (a) top and (b) bottom surface of core. Red and blue dots in (a) show the orientation of saw-cuts used to prepare the sample.

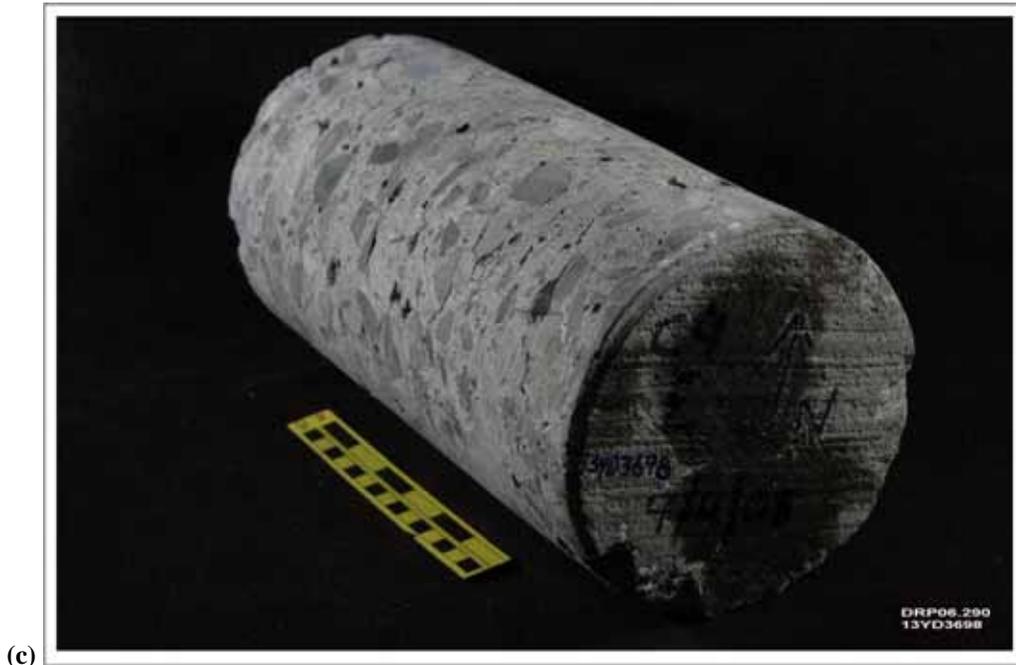
C9E	13YD3698	Cracking on the top surface of core 50 mm long, up to 0.5 mm wide ; scaling near the edges; white deposits on top surface; consolidated air voids and reaction rims present on the side of the core; grease spots on top & bottom surface

Figure A19. C9E. Photographs of sample in as-received condition showing (a) top and (b) bottom surface of core. Red and blue dots in (a) show the orientation of saw-cuts used to prepare the sample.

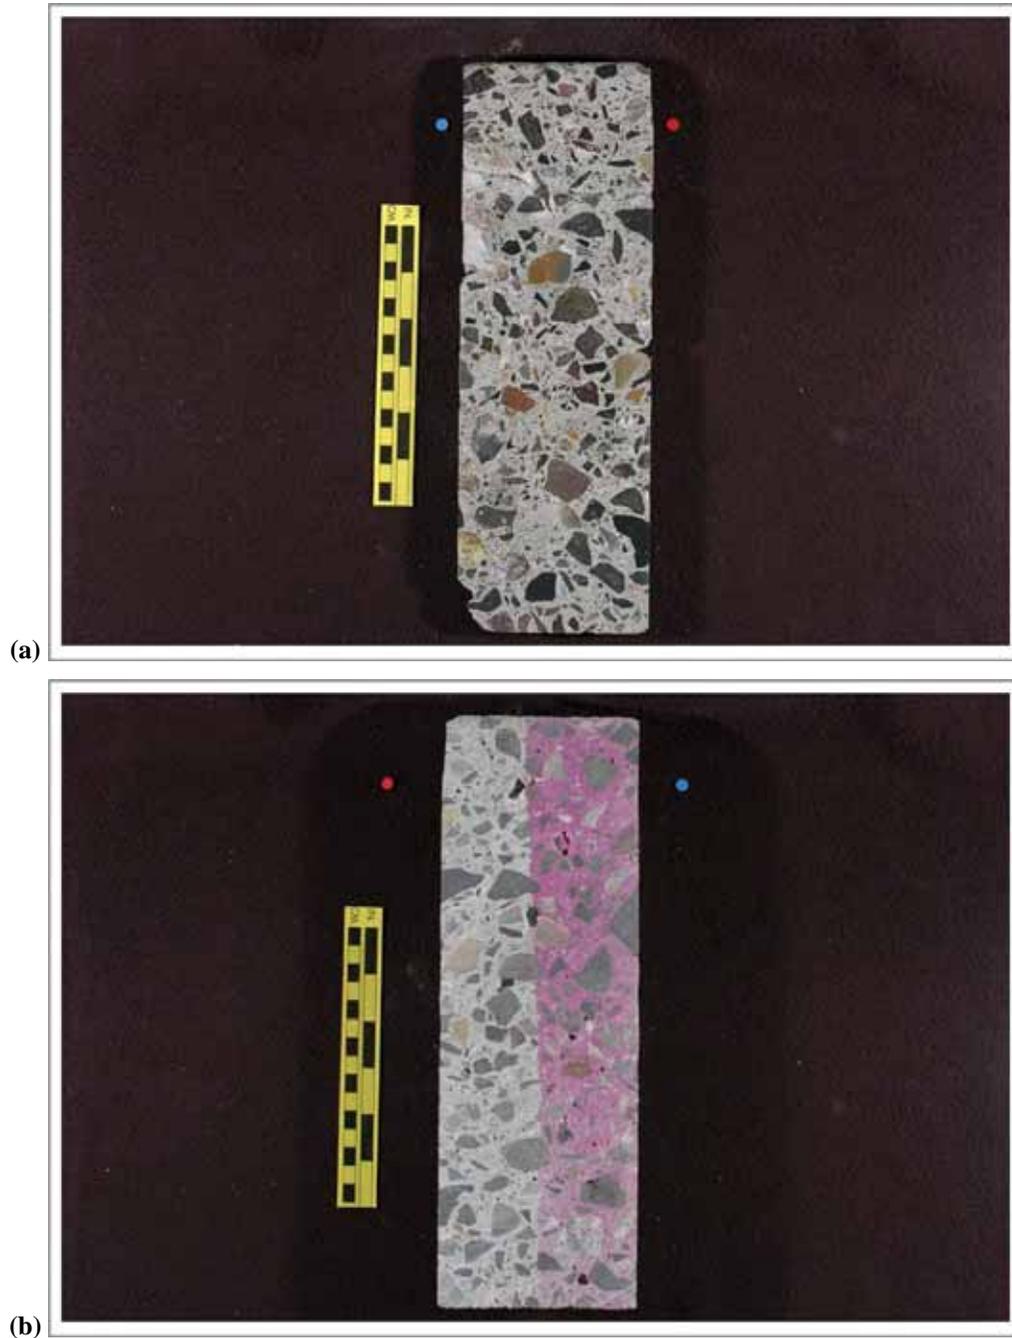
Figure B1. Core C1A. Photographs of (a) polished and (b) phenolphthalein-stained surfaces.

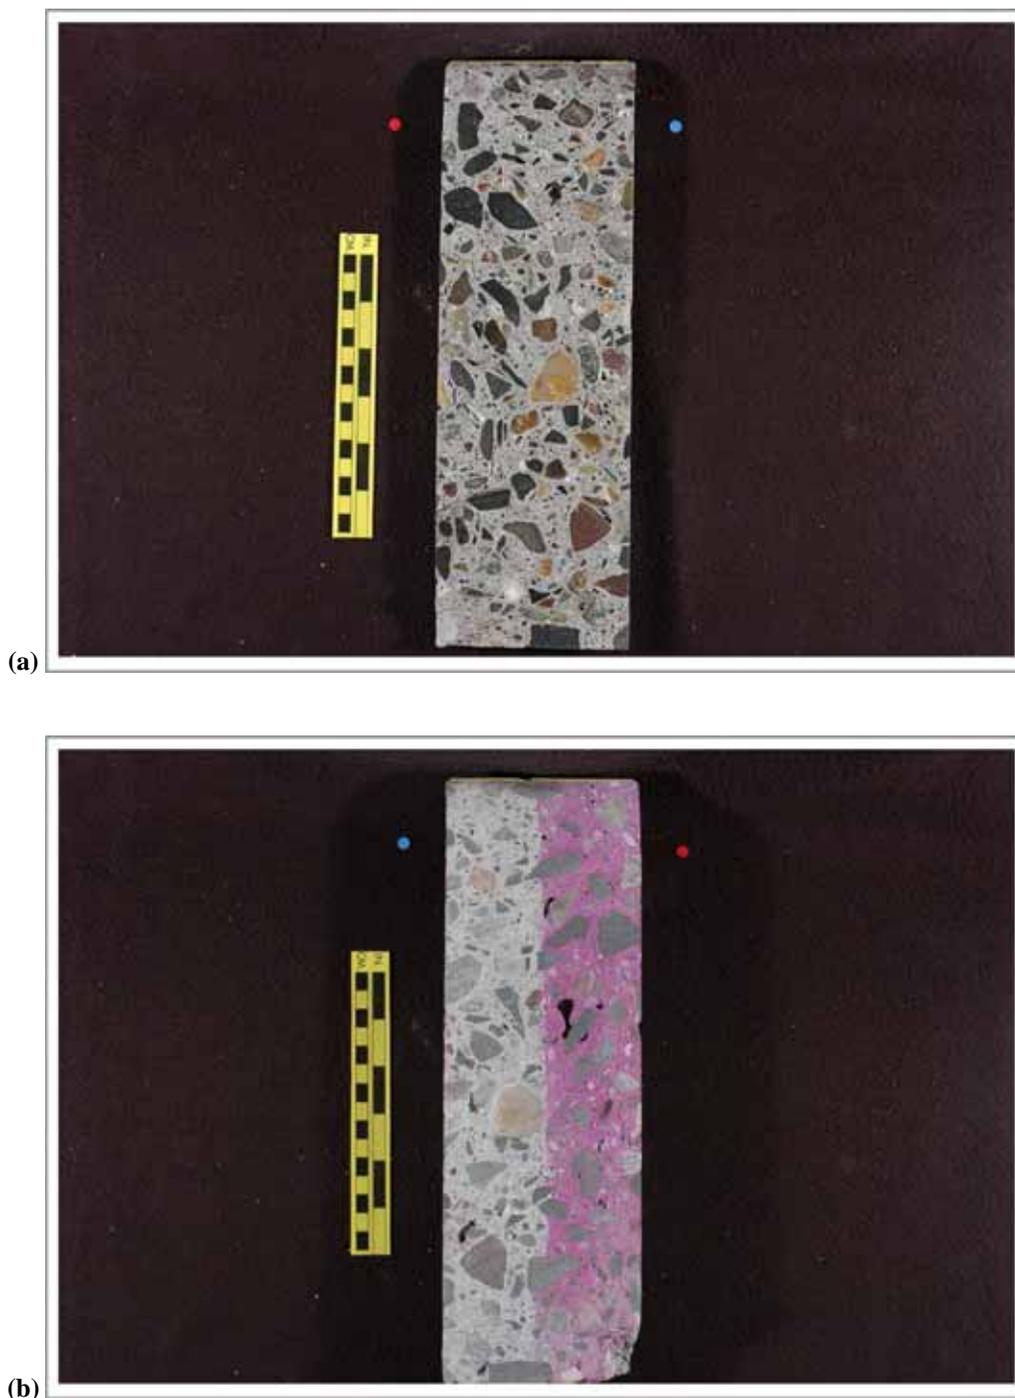
Figure B2. Core C2A. Photographs of (a) polished and (b) phenolphthalein-stained surfaces.
