FINAL REPORT
Report No. FHWA-WY- 10/01F

**EVALUATION OF TREATMENT OPTIONS
FOR ASR-AFFECTED CONCRETE**

by
Kim Basham PhD, PE
KB Engineering, LLC
1716 Capitol Avenue
Cheyenne, WY 82001
kbasham@KBEngLLC.com

December 11, 2009

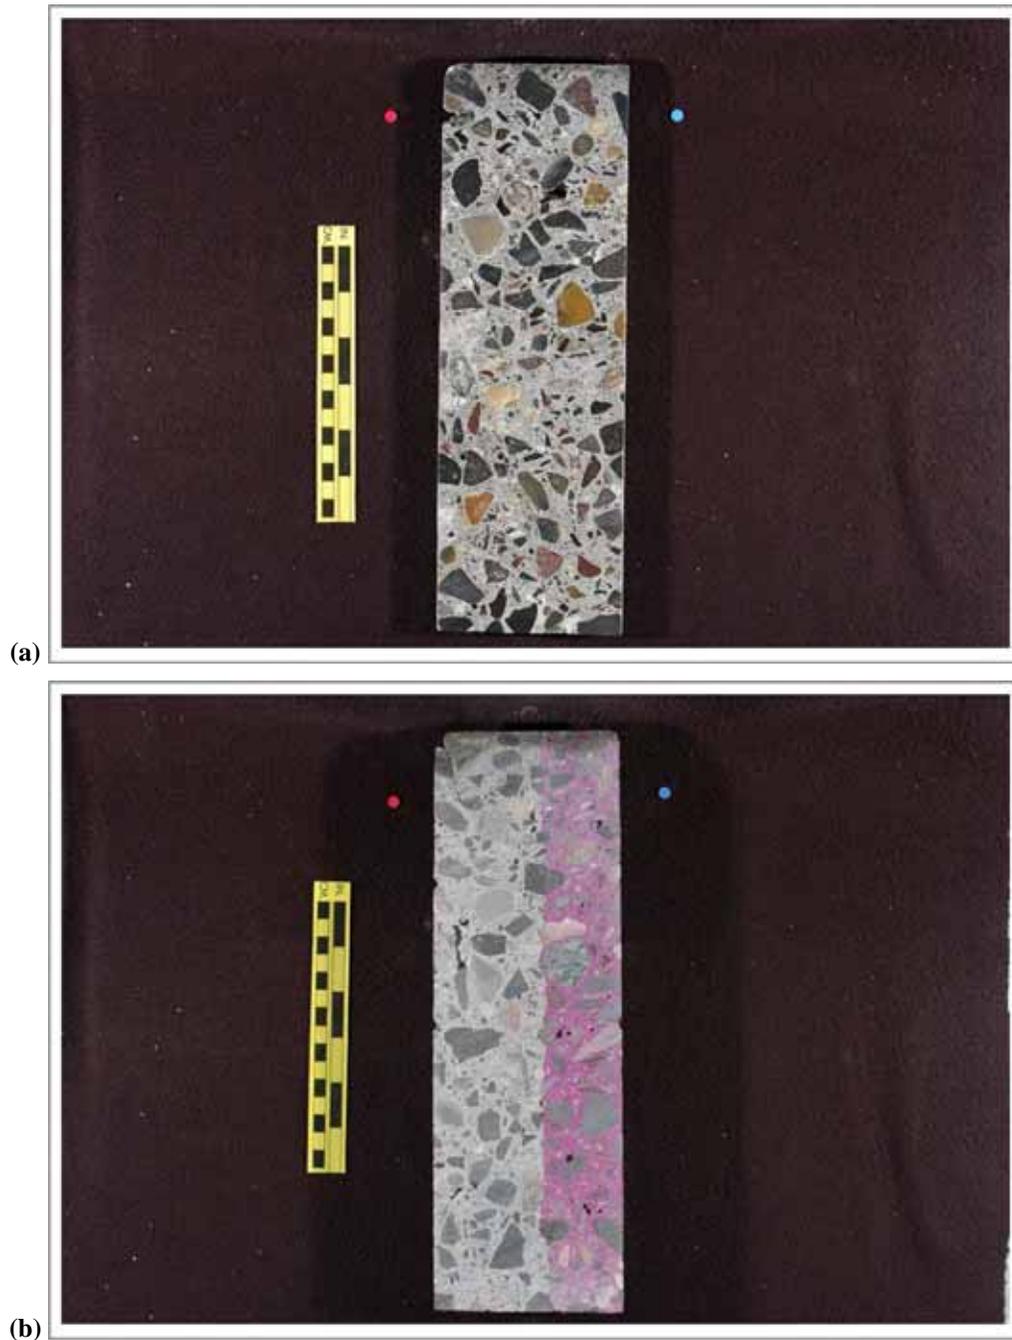
Figure B3. Core C3A. Photographs of (a) polished and (b) phenolphthalein-stained surfaces.

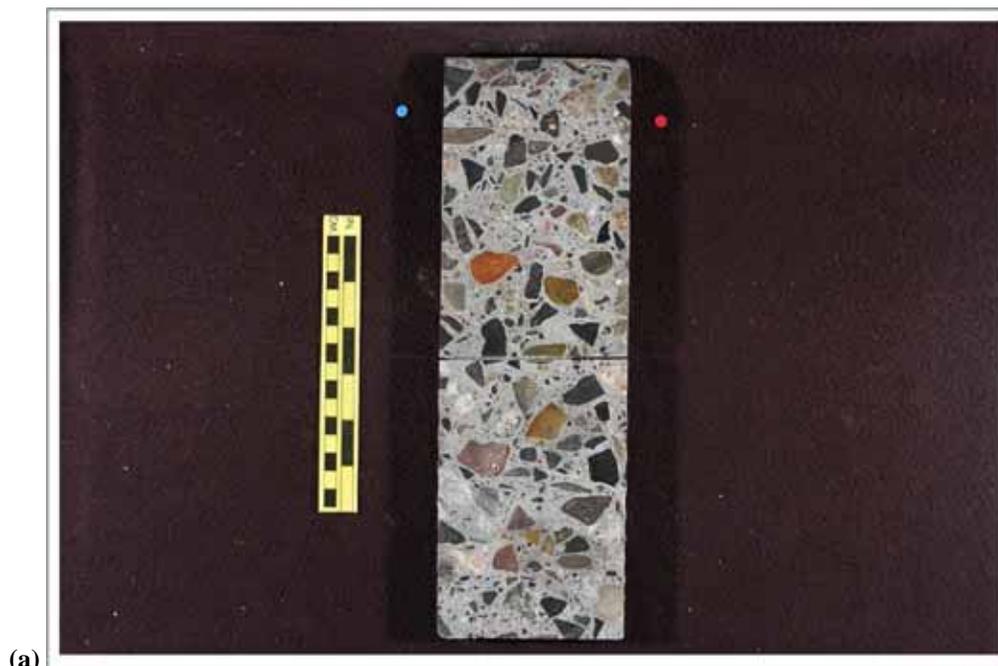
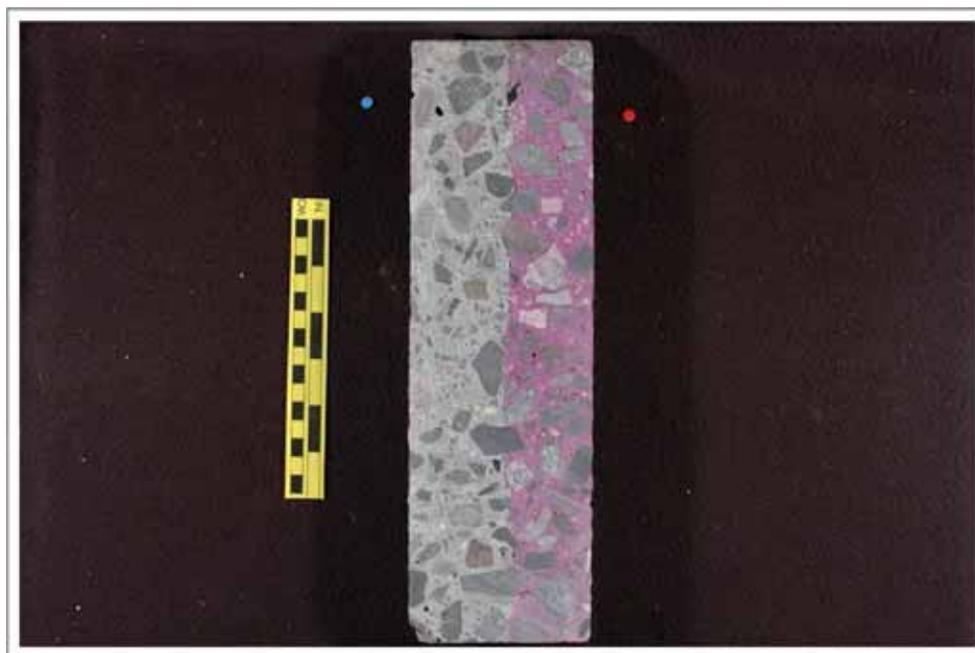
Figure B4. Core C4A. Photographs of (a) polished and (b) phenolphthalein-stained surfaces.

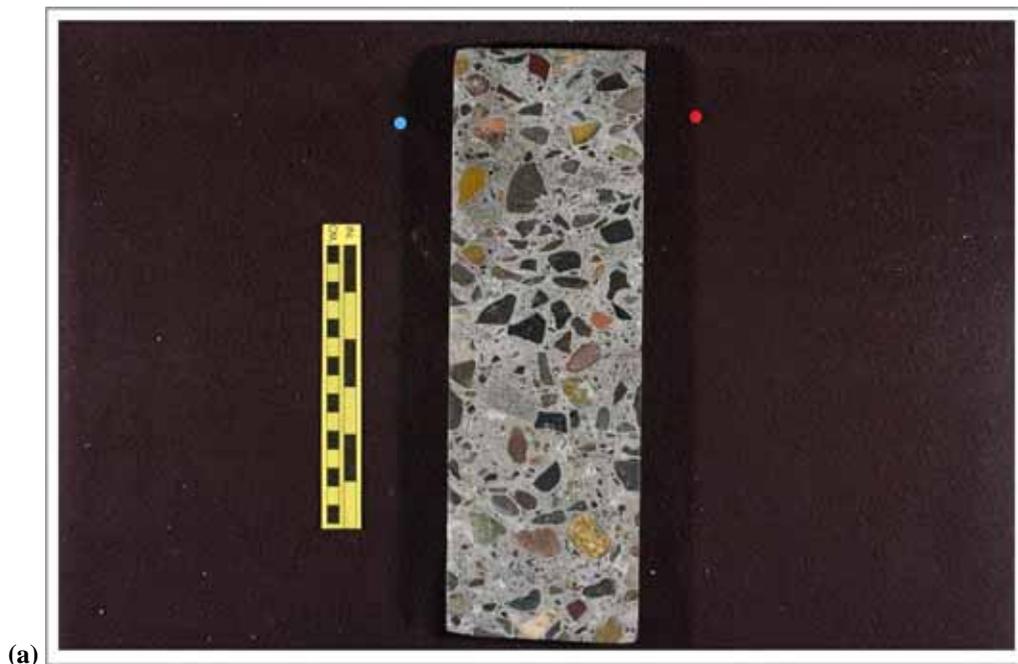
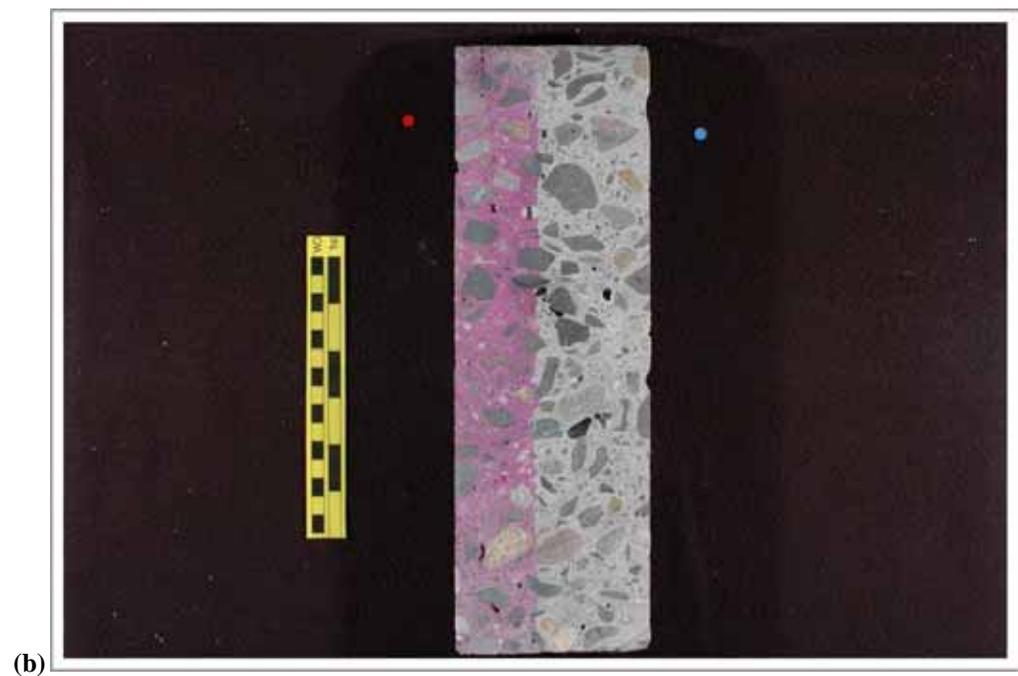
Figure B5. Core C5A. Photographs of (a) polished and (b) phenolphthalein-stained surfaces.

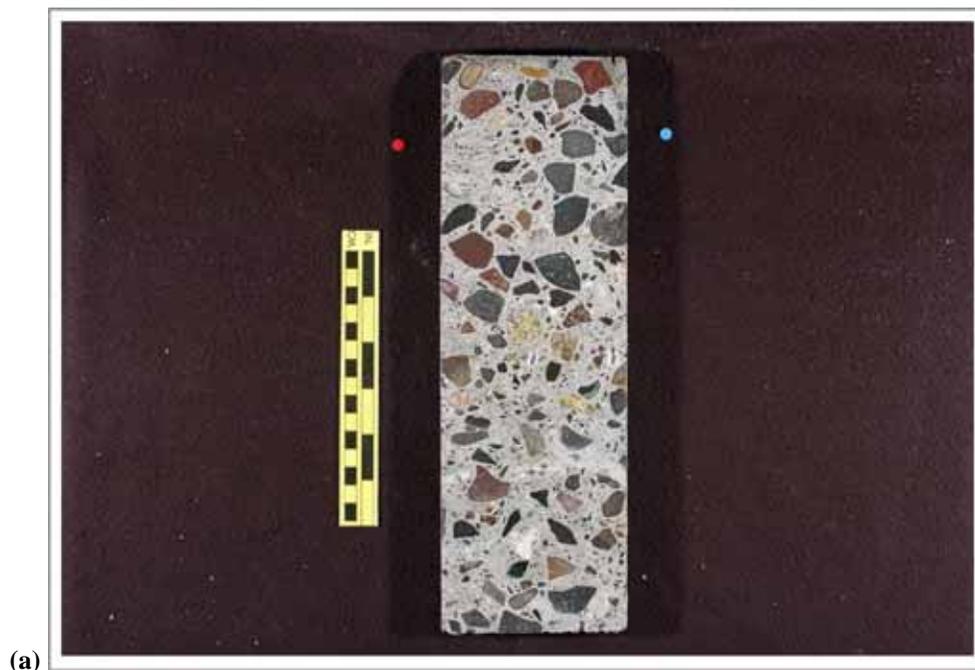
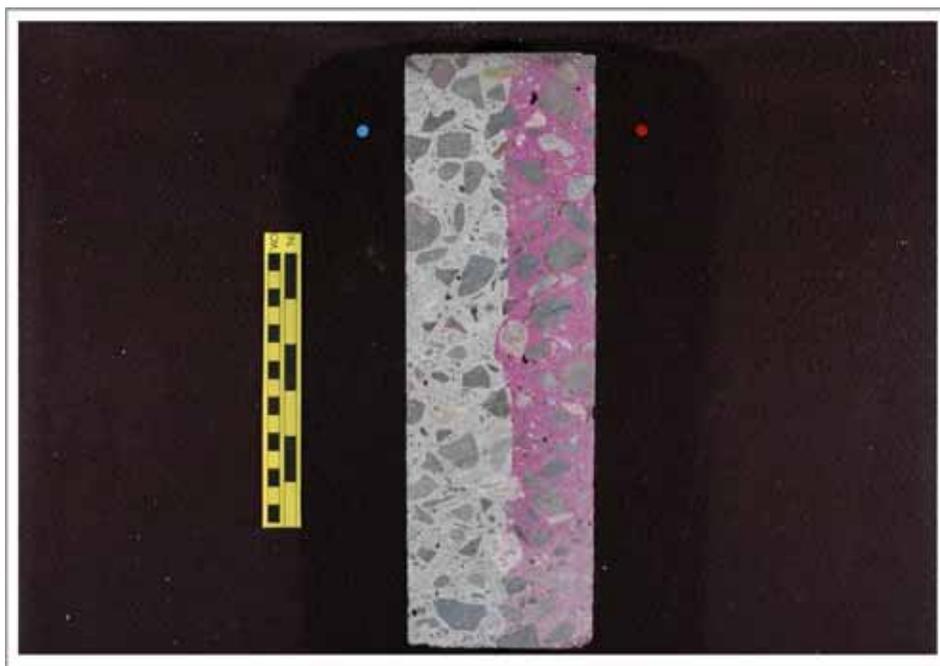
Figure B6. Core C6A. Photographs of (a) polished and (b) phenolphthalein-stained surfaces.

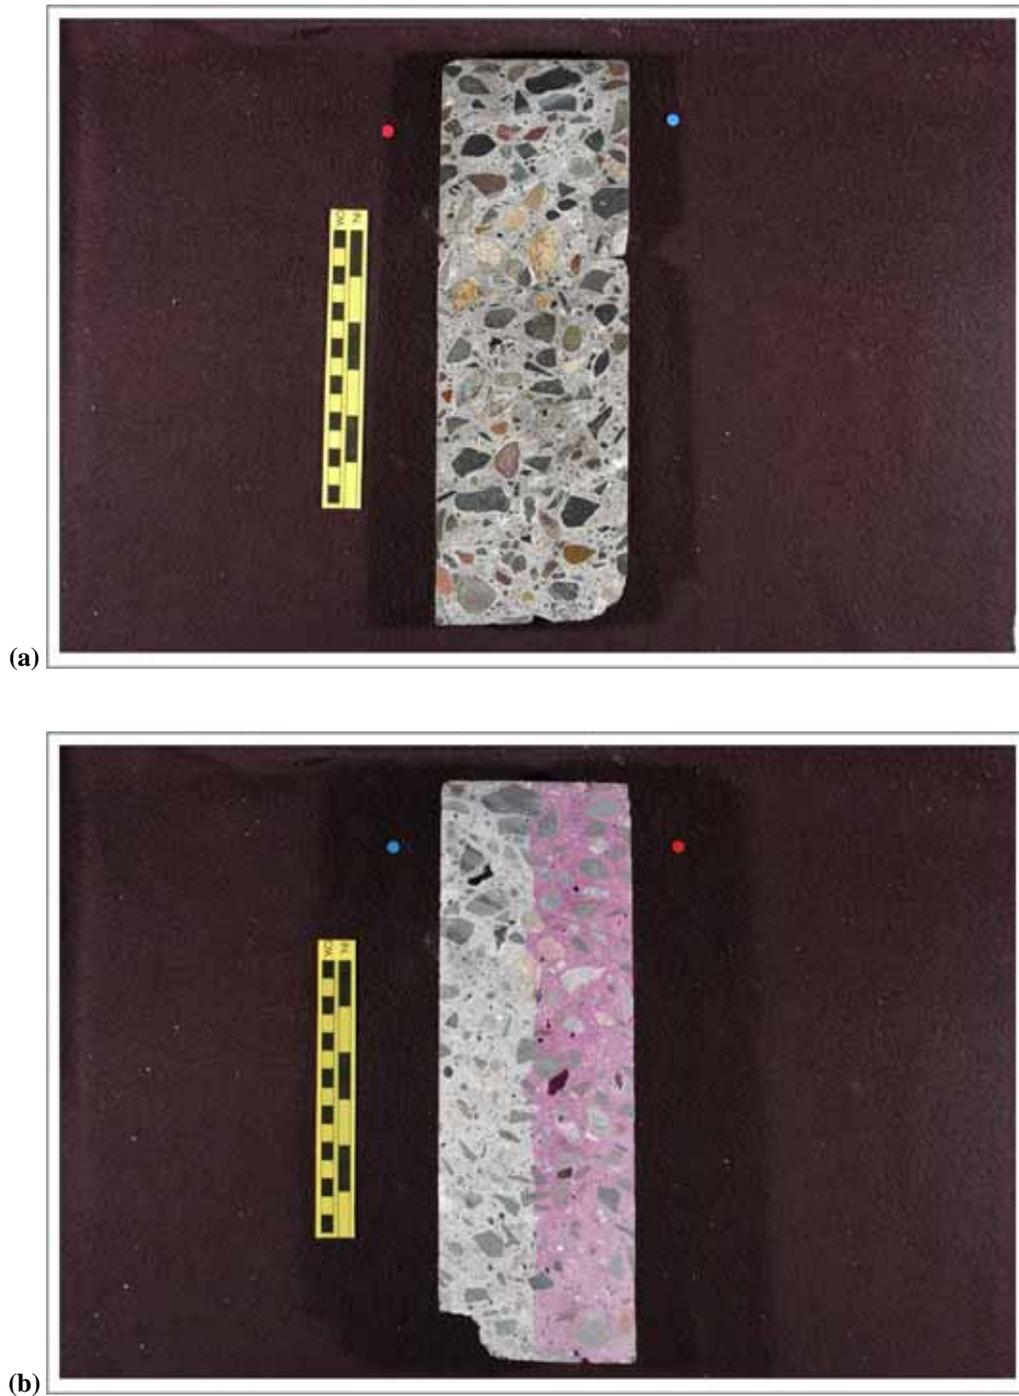
Figure B7. Core C7A. Photographs of (a) polished and (b) phenolphthalein-stained surfaces.

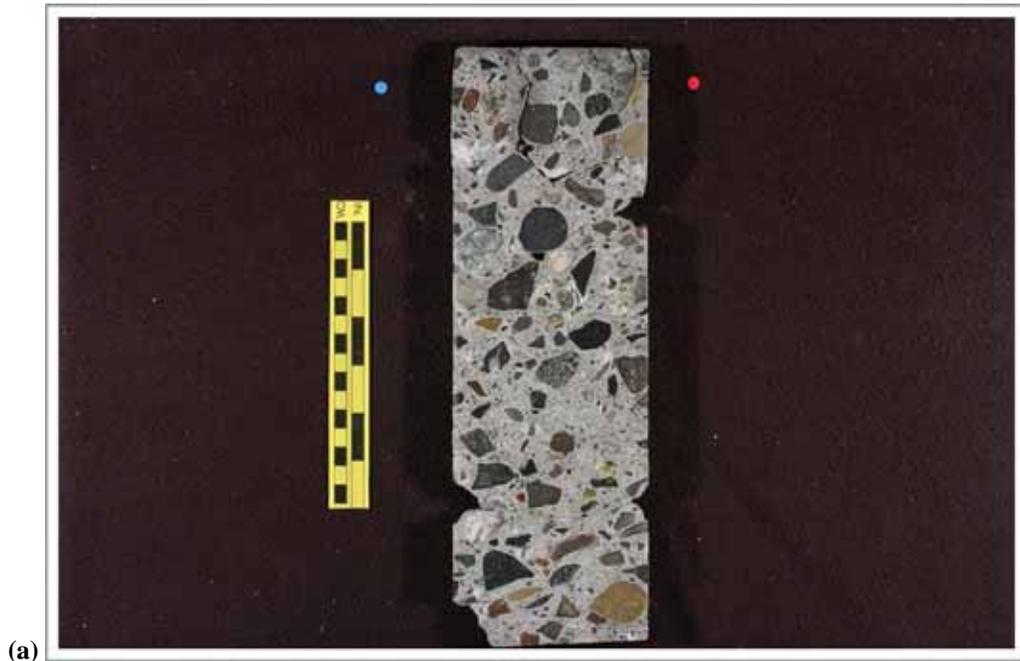
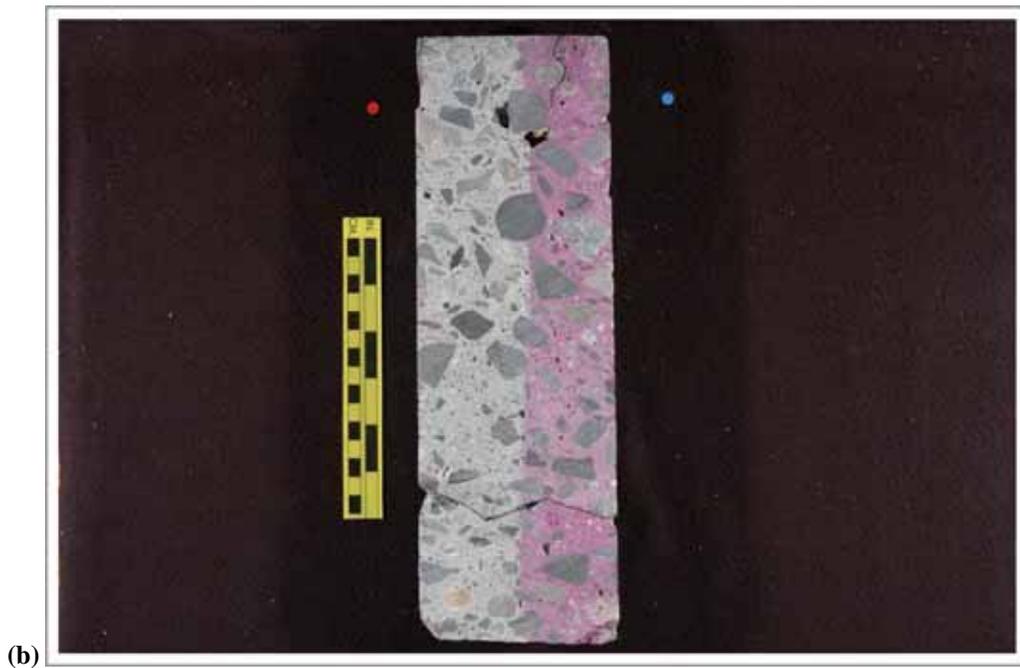
Figure B8. Core C8A. Photographs of (a) polished and (b) phenolphthalein-stained surfaces.

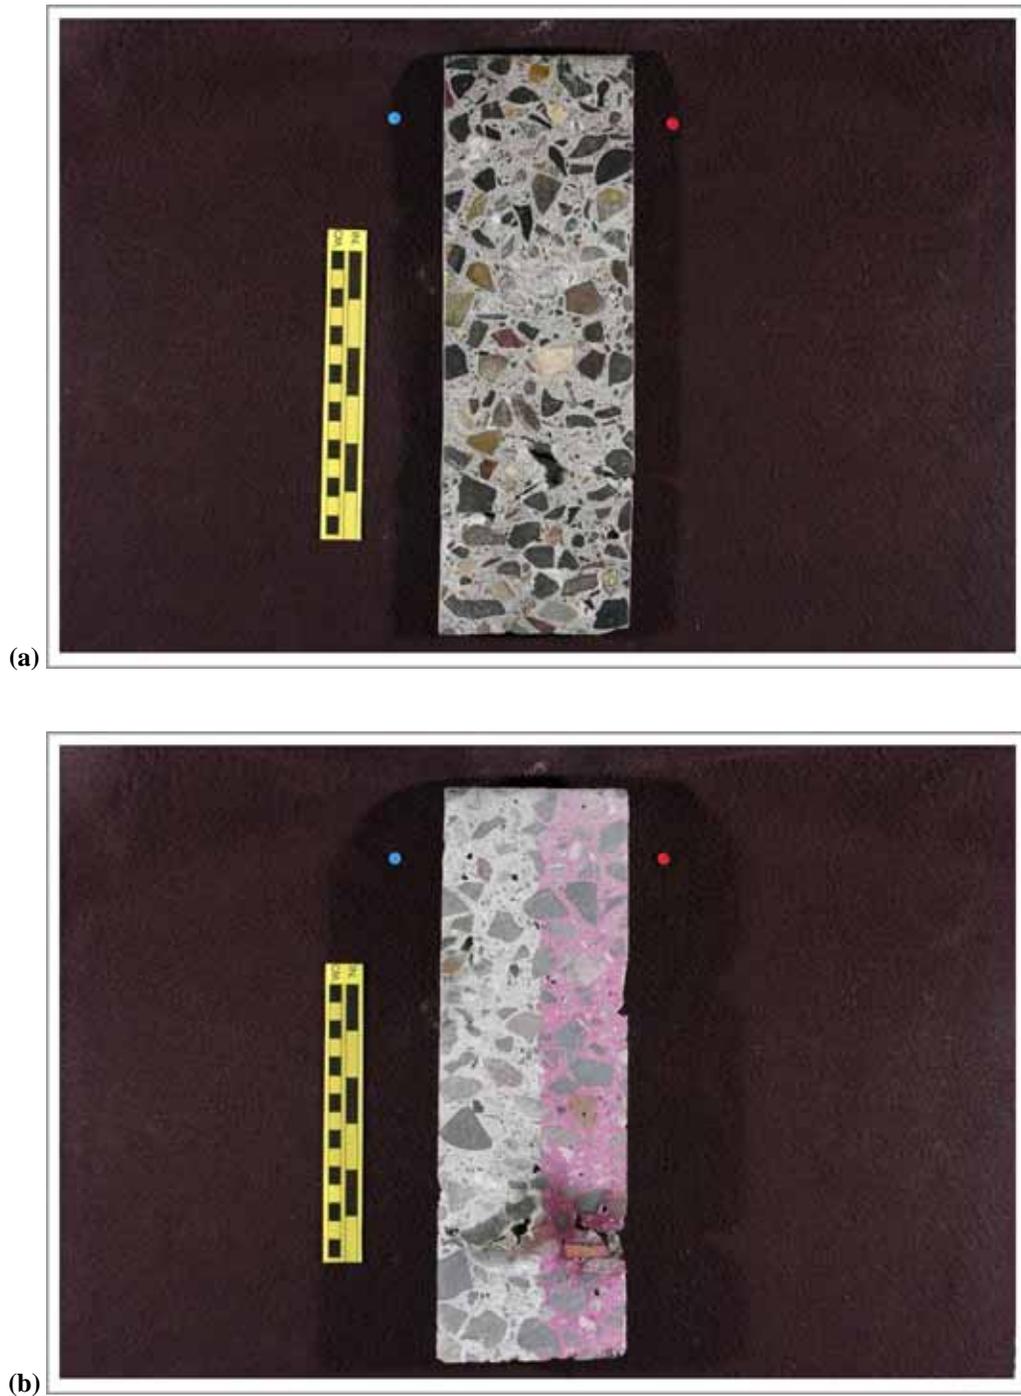
Figure B9. Core C9A. Photographs of (a) polished and (b) phenolphthalein-stained surfaces.

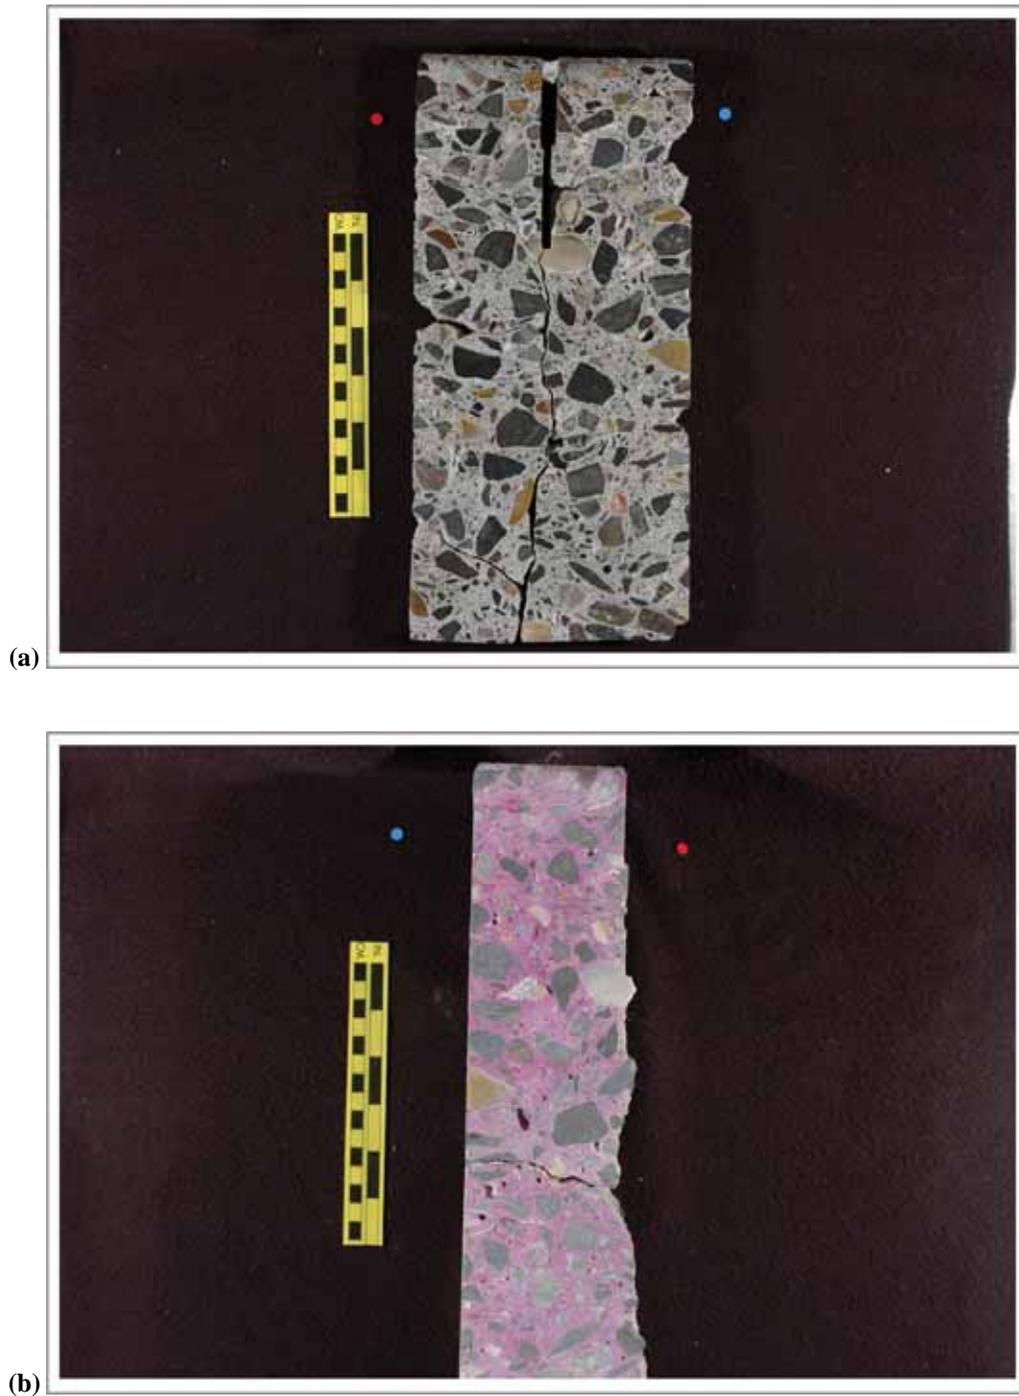
Figure B10. Core C10. Photographs of (a) polished and (b) phenolphthalein-stained surfaces.

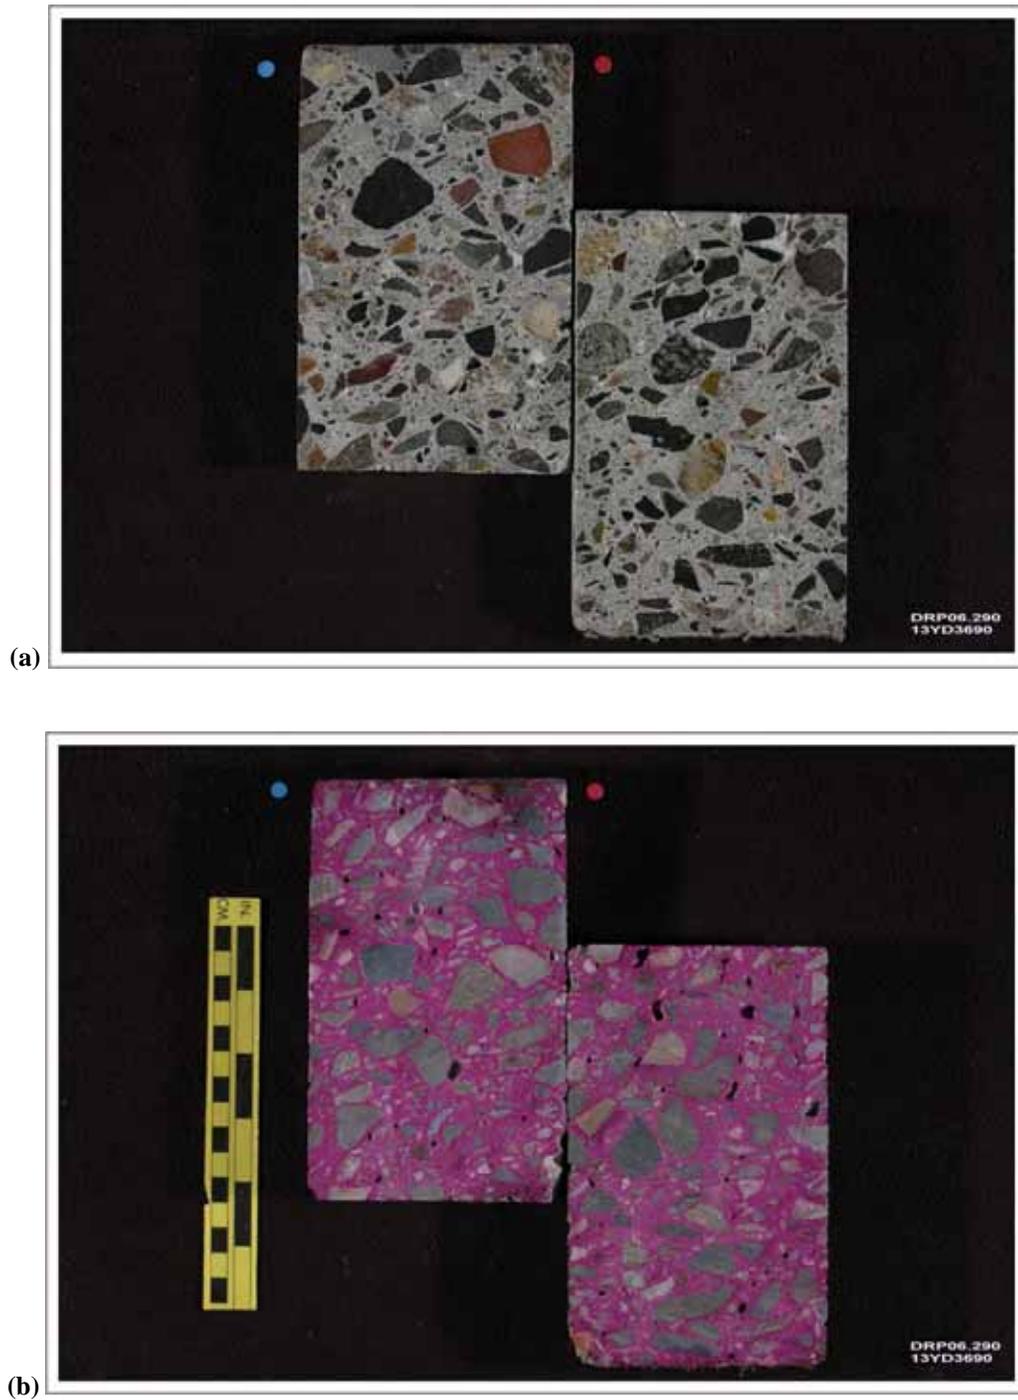
Figure B11. Core C1E. Photographs of (a) polished and (b) phenolphthalein-stained surfaces.

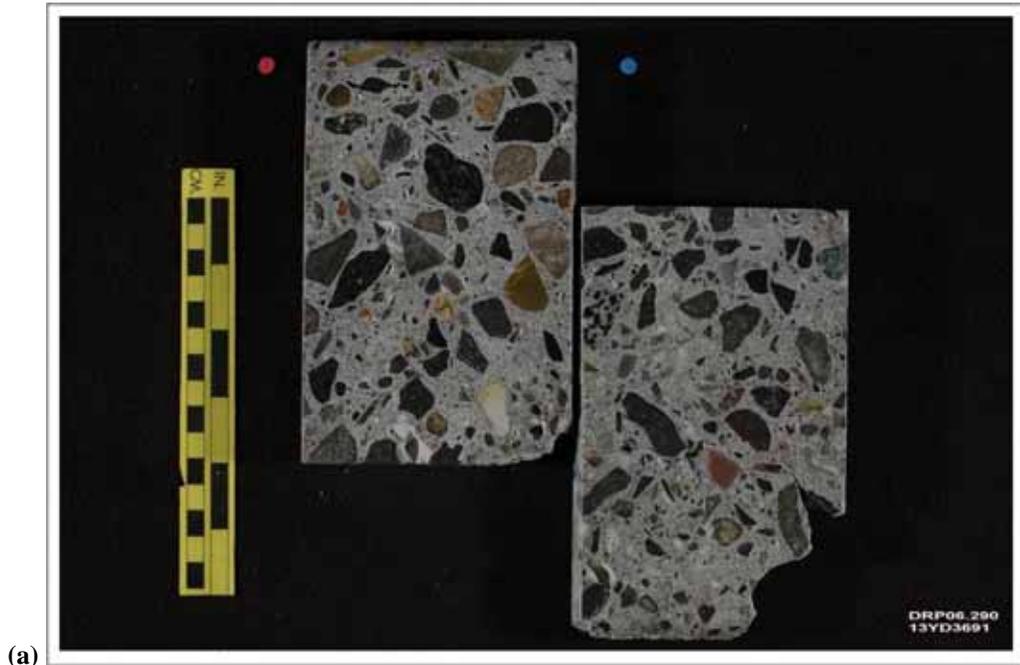
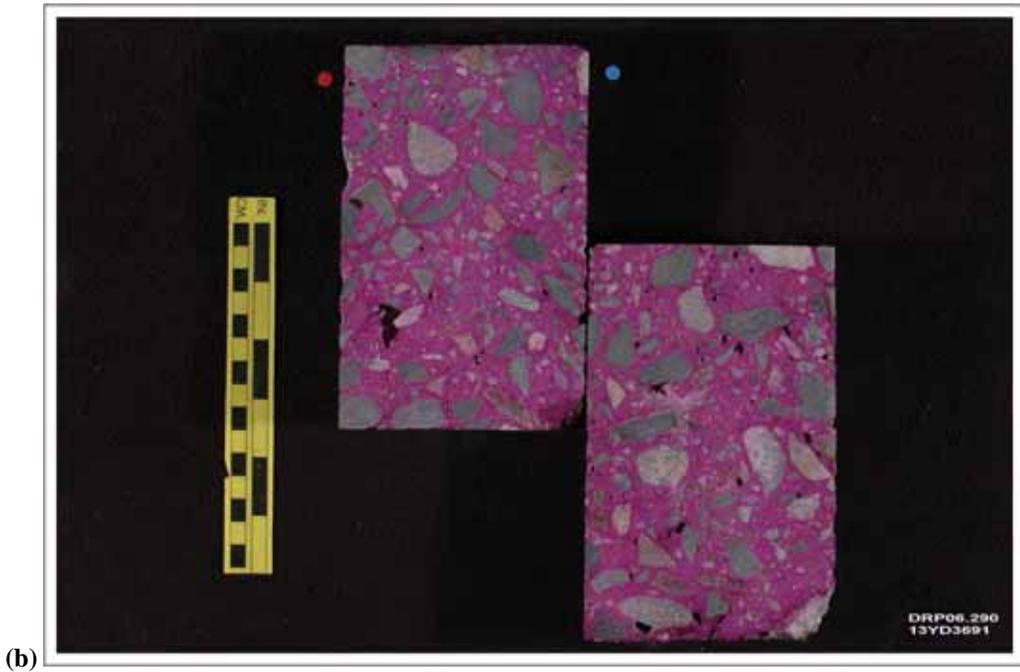
Figure B12. Core C2E. Photographs of (a) polished and (b) phenolphthalein-stained surfaces.

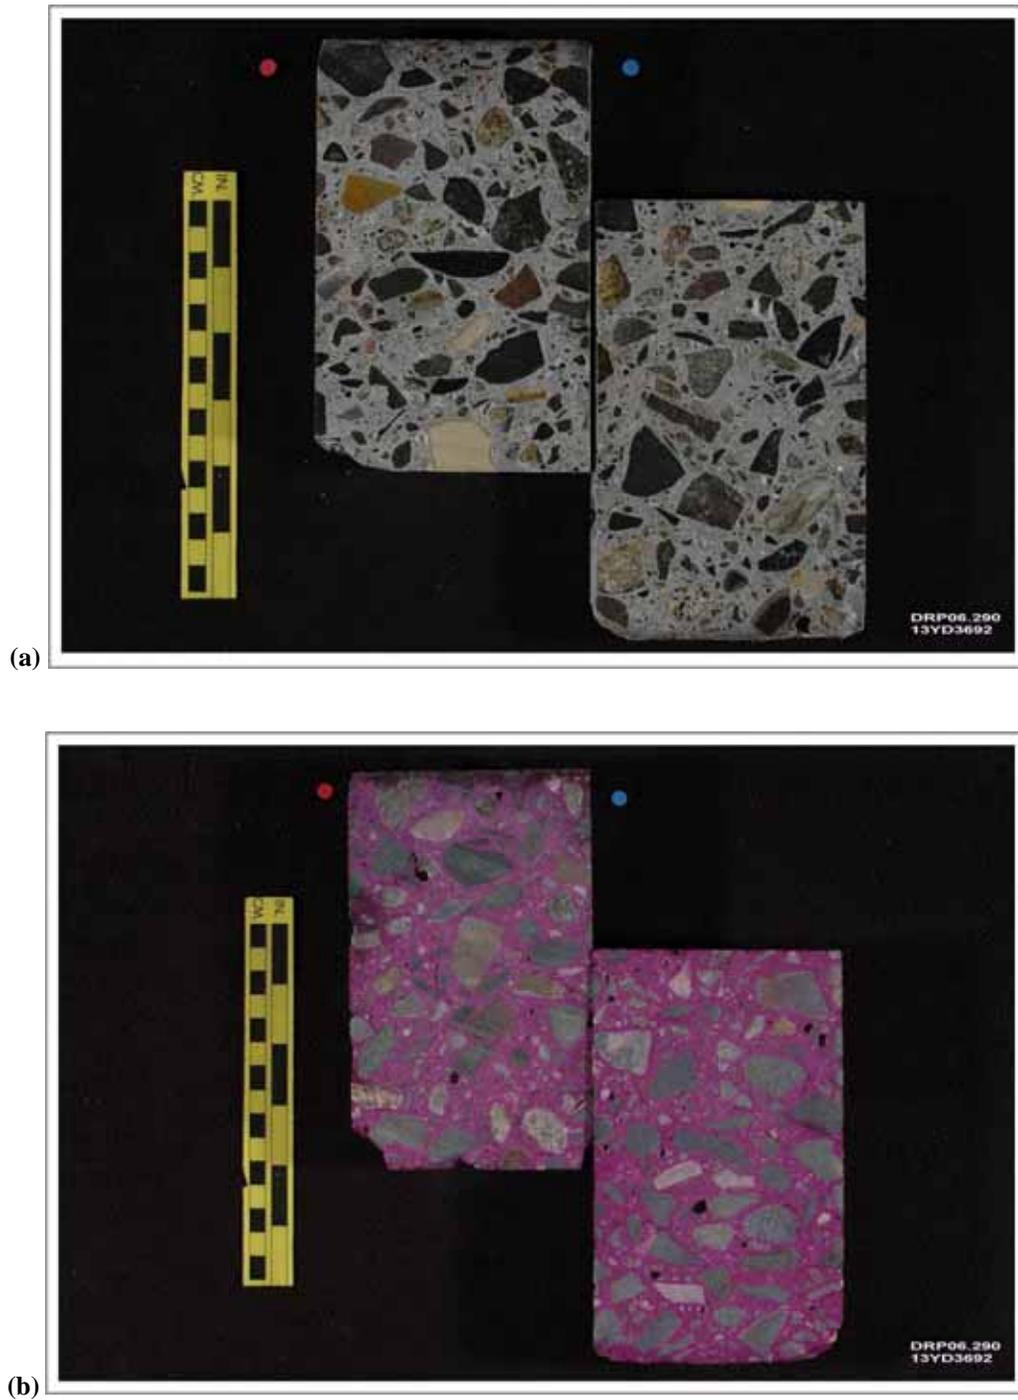
Figure B13. Core C3E. Photographs of (a) polished and (b) phenolphthalein-stained surfaces.

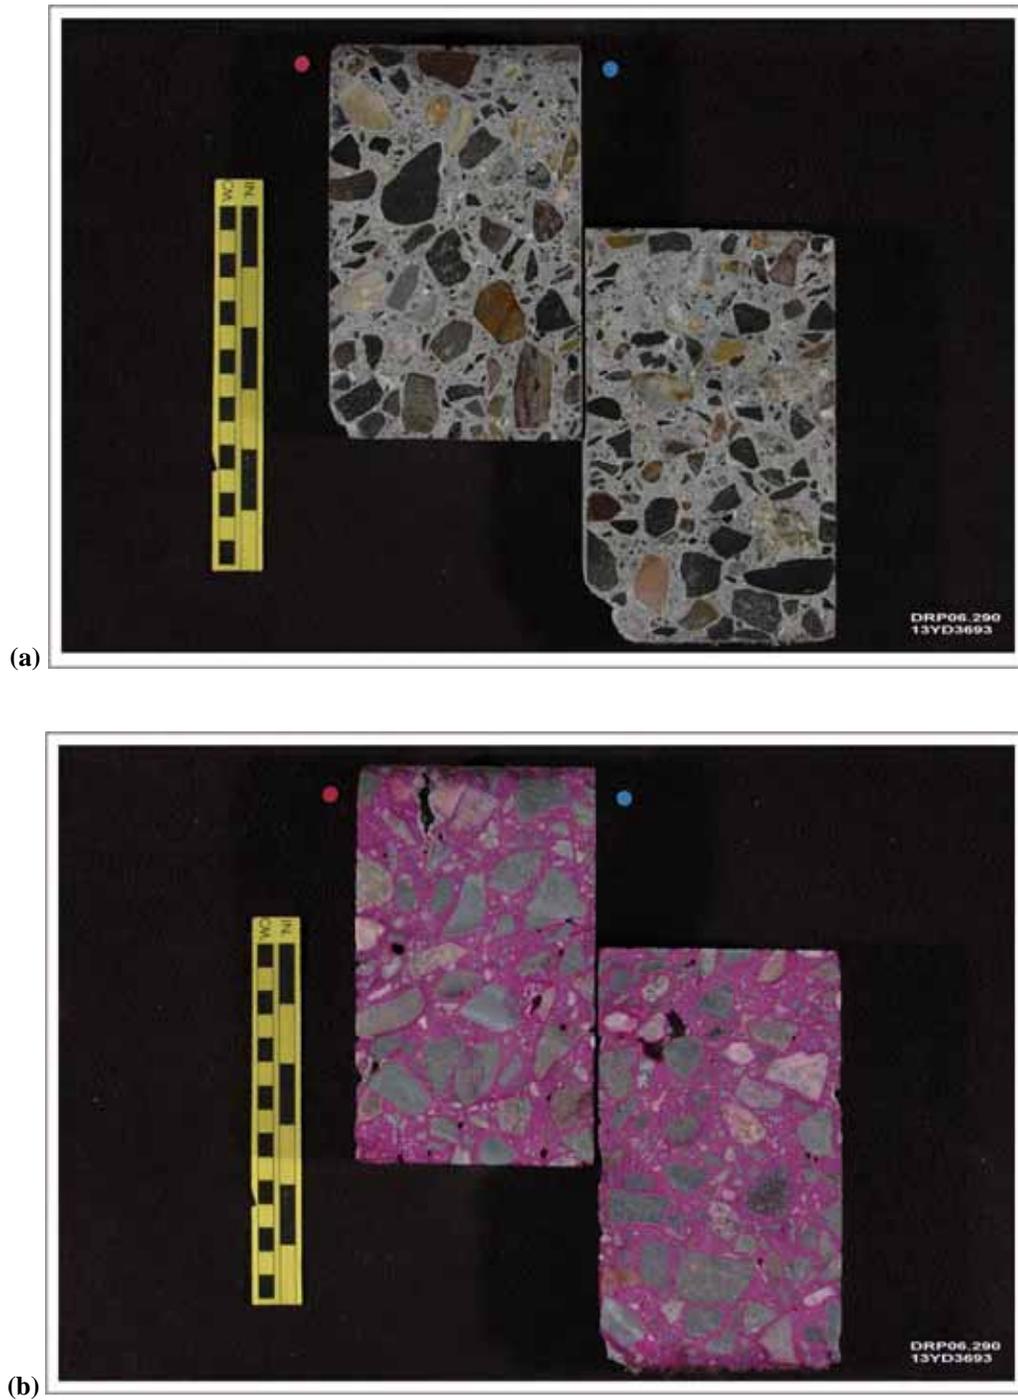
Figure B14. Core C4E. Photographs of (a) polished and (b) phenolphthalein-stained surfaces.

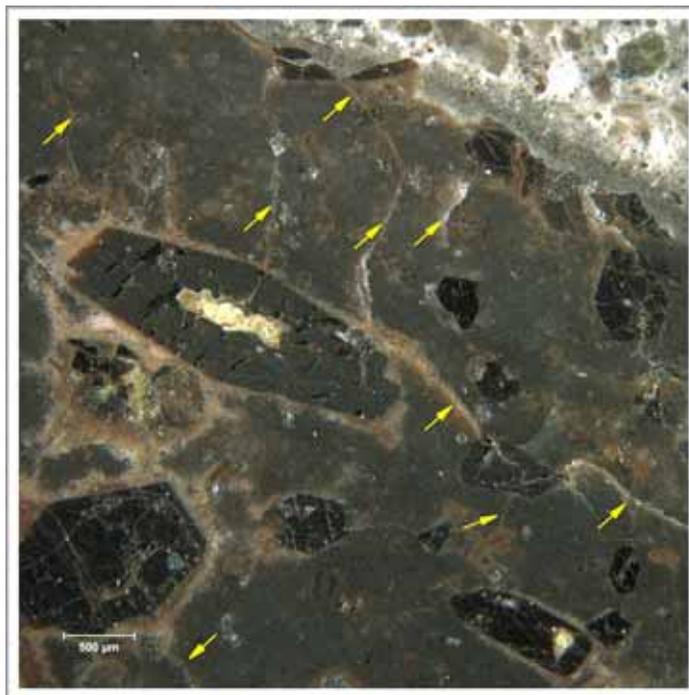
Figure E1. Reflected light photomicrograph of polished surface showing coarse aggregate particle with internal fractures (yellow arrows).

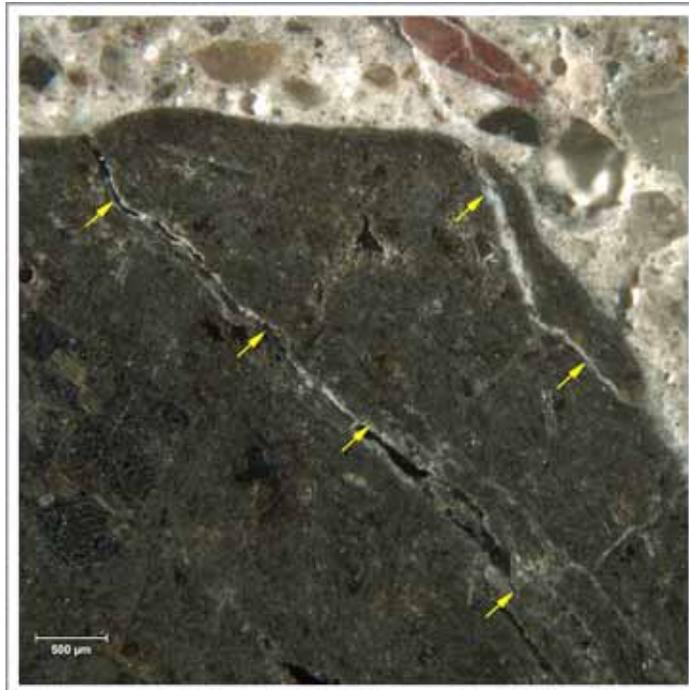
Figure E2. Reflected light photomicrograph of polished surface showing coarse aggregate particle with internal fractures that are filled with ASR gel (yellow arrows).

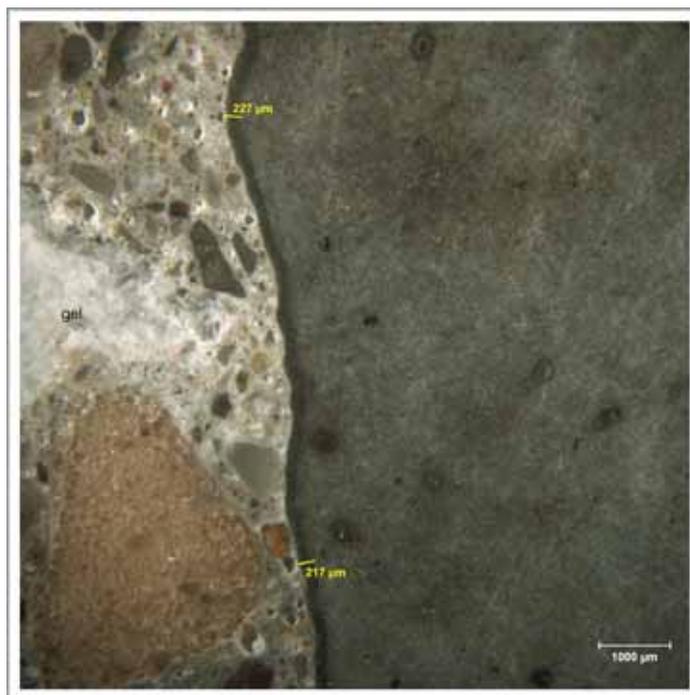
Figure E3. Reflected light photomicrograph of polished surface showing reaction rim (measured by yellow bars) on coarse aggregate particle.

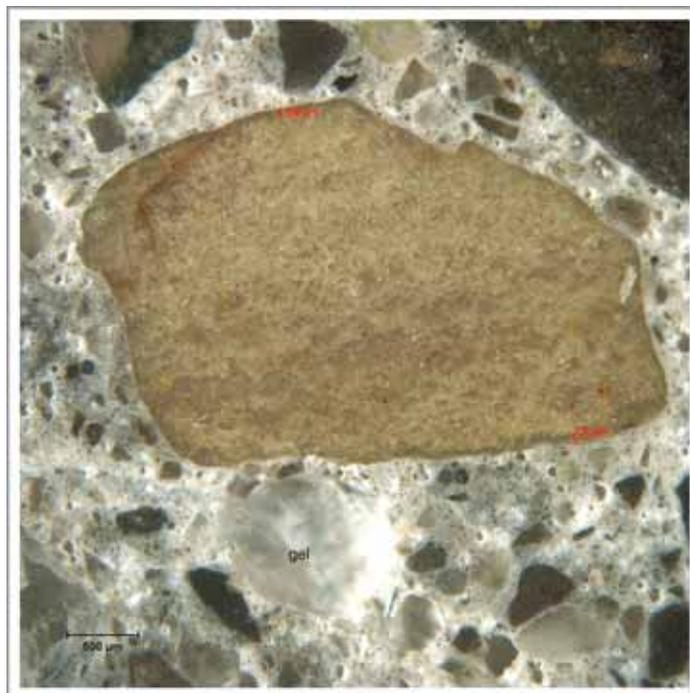
Figure E4. Reflected light photomicrograph of polished surface showing reaction rim (measured by red bars) on fine aggregate particle.

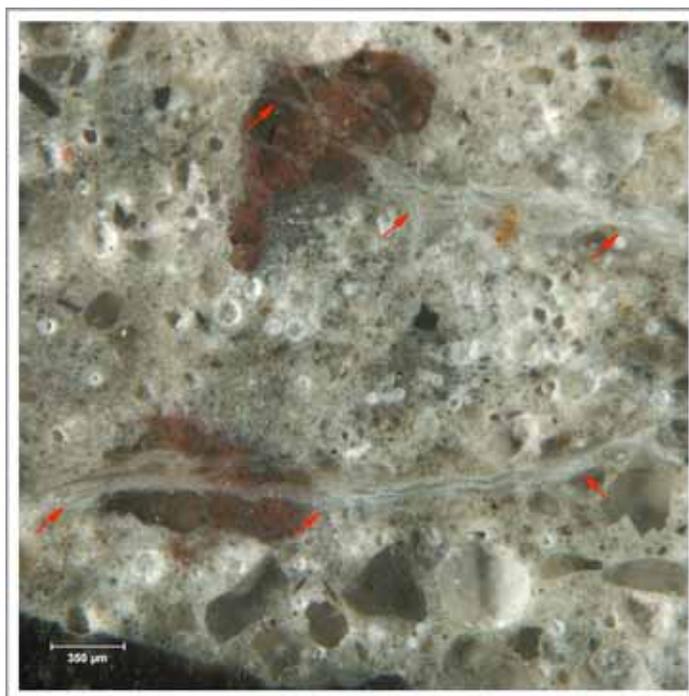
Figure E5. Reflected light photomicrograph of polished surface showing microcracks filled with ASR gel (red arrows) cutting through fine aggregate particles and the paste.

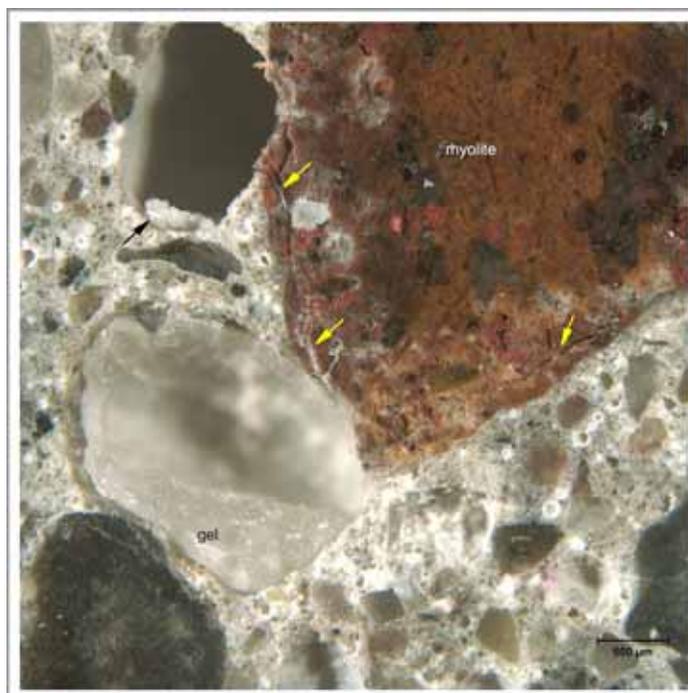
Figure E6. Reflected light photomicrograph of polished surface showing fine aggregate particle with microcracks filled with ASR gel (yellow arrows). Note gel in void next to the particle.

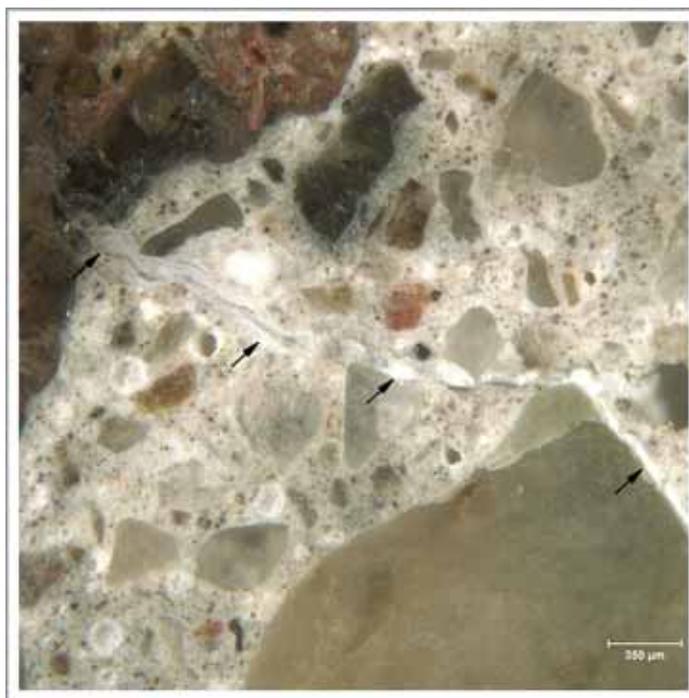
Figure E7. Reflected light photomicrograph of polished surface showing microcrack filled with ASR gel (black arrows) cutting through the paste.

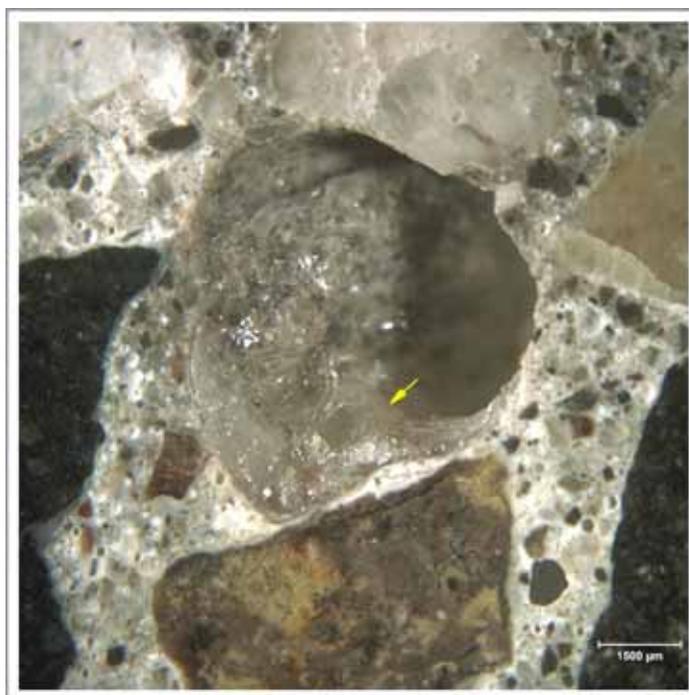
Figure E8. Reflected light photomicrograph of polished surface showing void partially filled with clear ASR gel (yellow arrow).

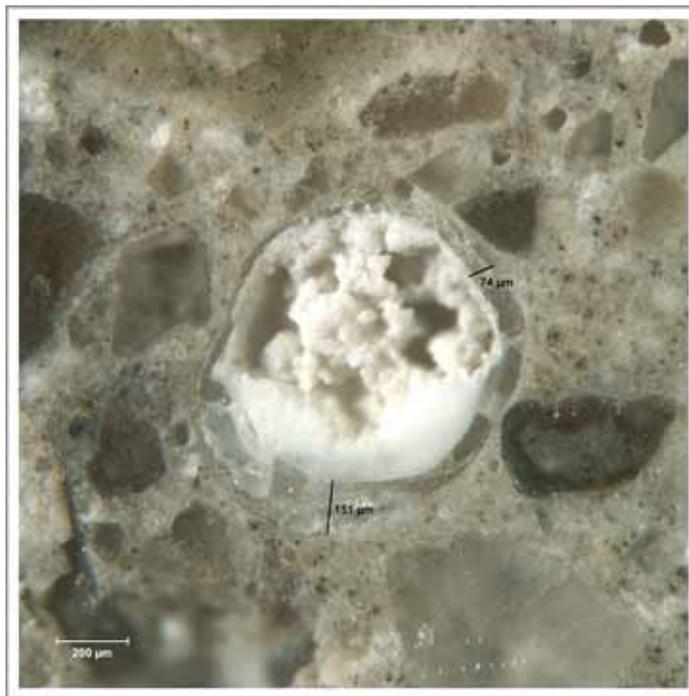
Figure E9. Reflected light photomicrograph of polished surface showing void rimmed by clear gel (width measured by black bars) and filled with milky white gel.
