Appendix C
M-59 Core Site

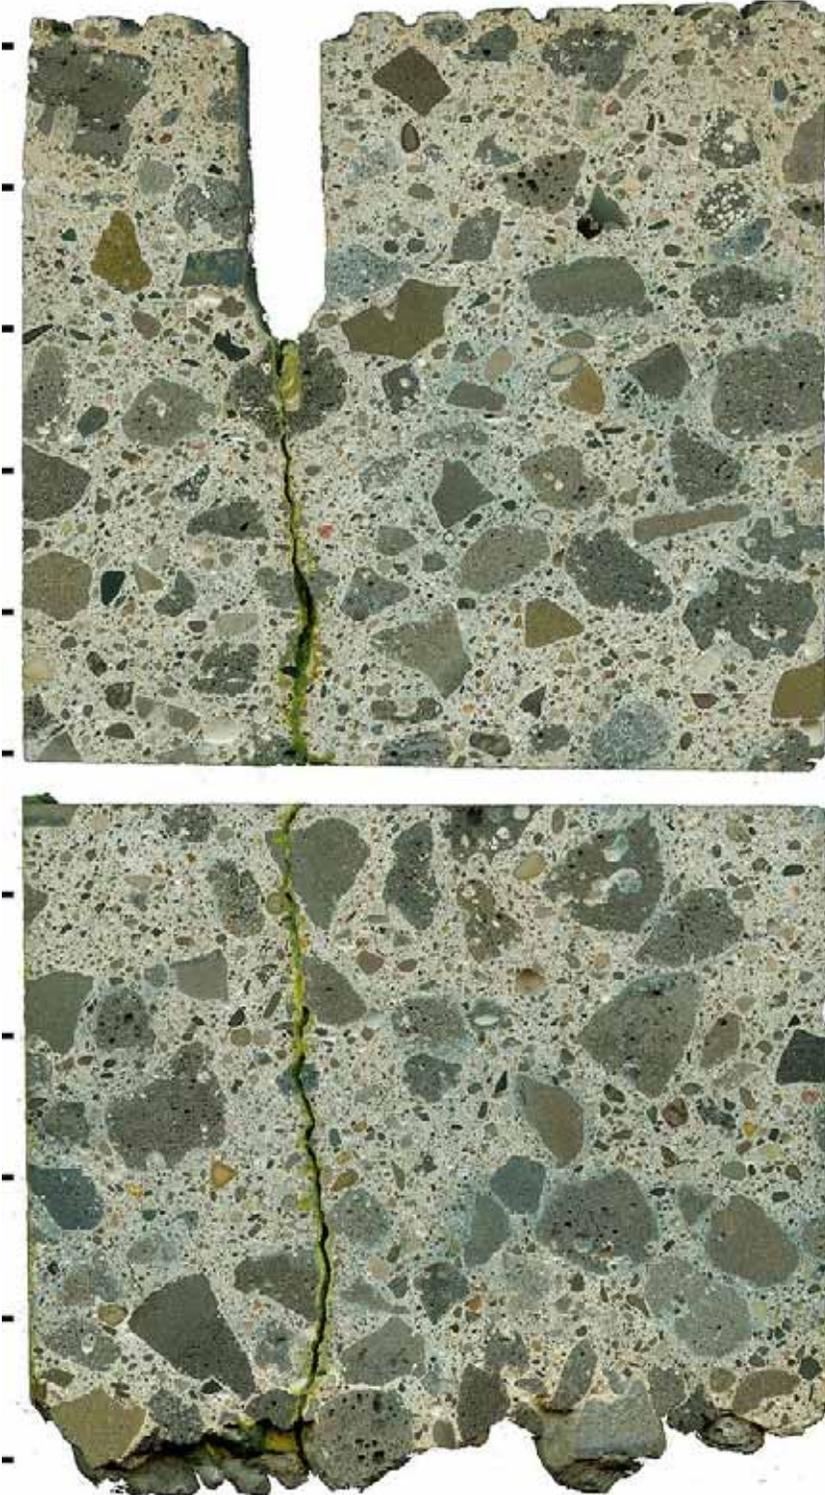
Slabs representing full cross section through pavement, as polished, EB M-59, constructed 1997/98, outside lane, at transverse joint, core A, MTU ID M59-01, tic marks every inch.

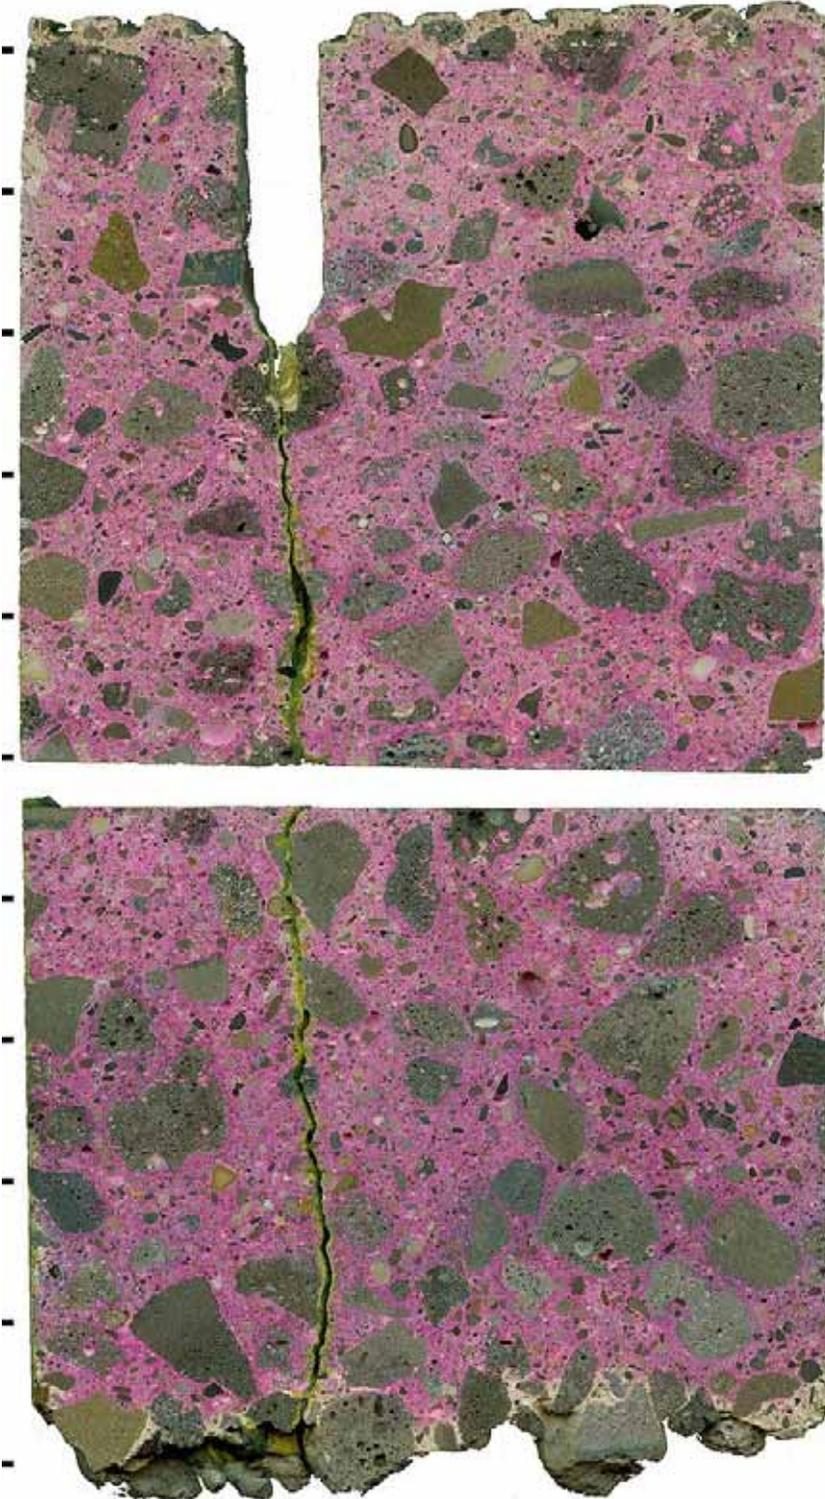
Slabs representing full cross section through pavement, after phenolphthalein stain, EB M-59, constructed 1997/98, outside lane, at transverse joint, core A, MTU ID M59-01, tic marks every inch.

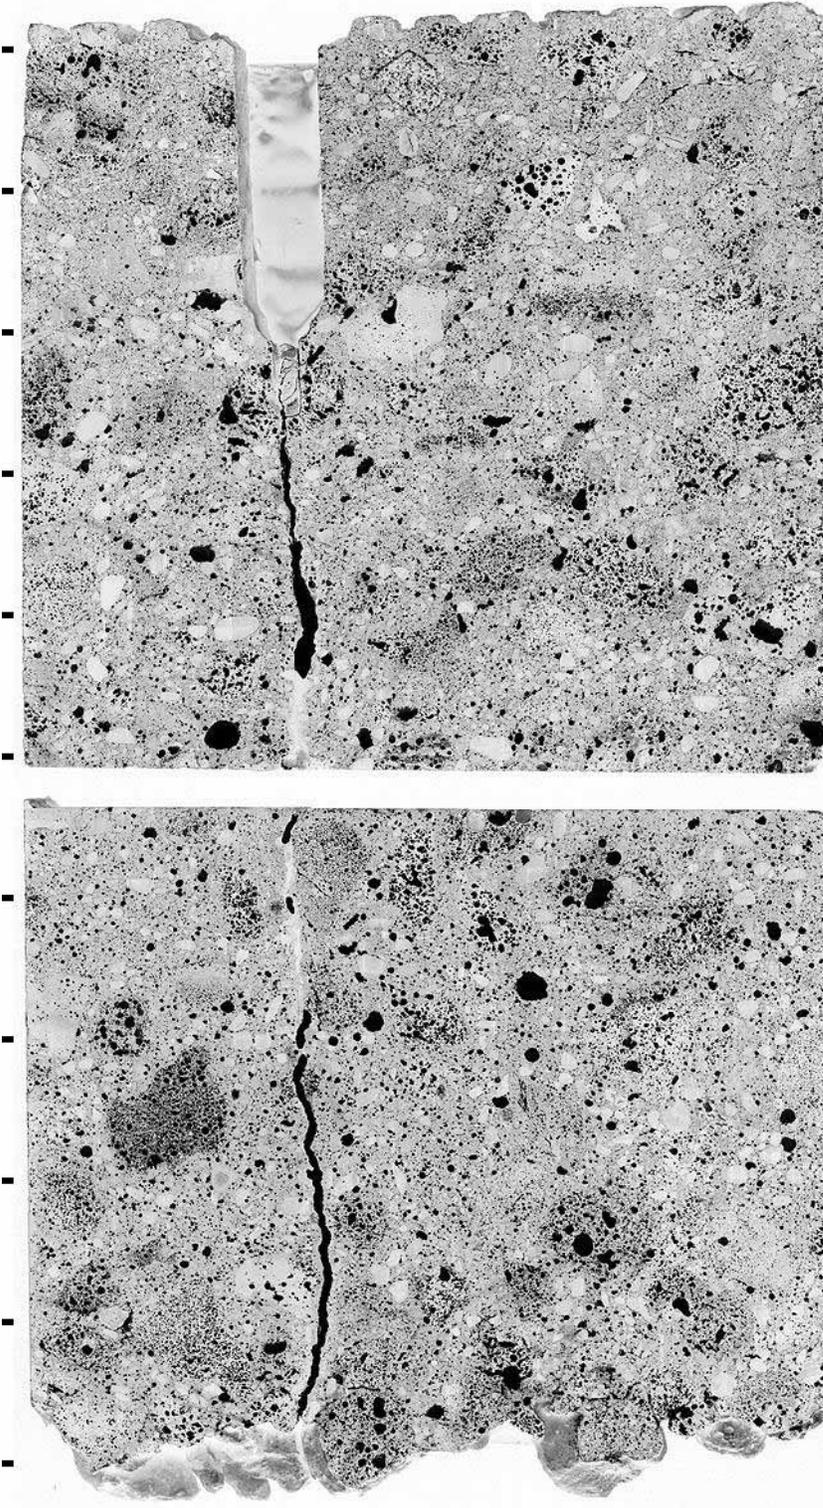
Slabs representing full cross section through pavement, after treatment to enhance air voids and cracks, EB M-59, constructed 1997/98, outside lane, at transverse joint, core A, MTU ID M59-01, tic marks every inch.

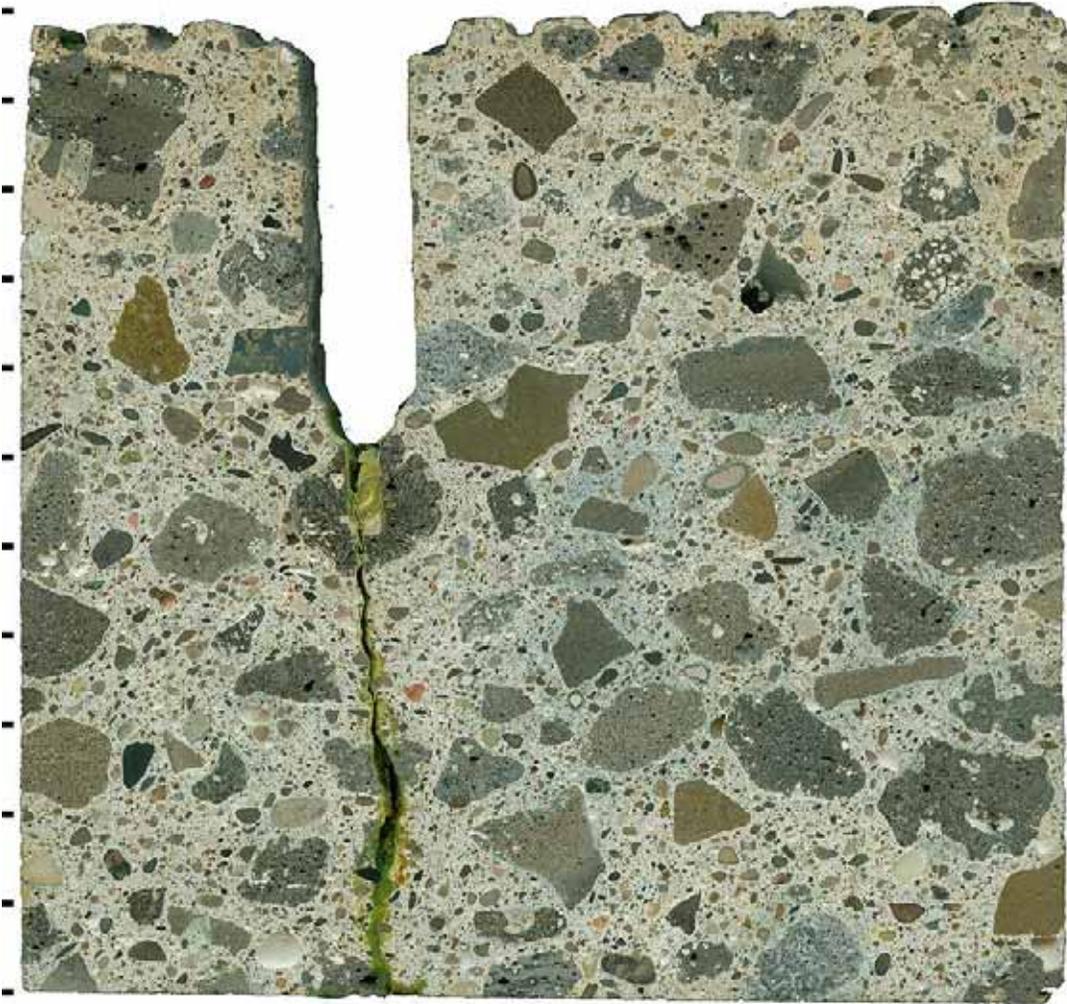
Slab representing cross section through top half of pavement, as polished, EB M-59, constructed 1997/98, outside lane, at transverse joint, core A, MTU ID M59-01, tic marks every half inch.

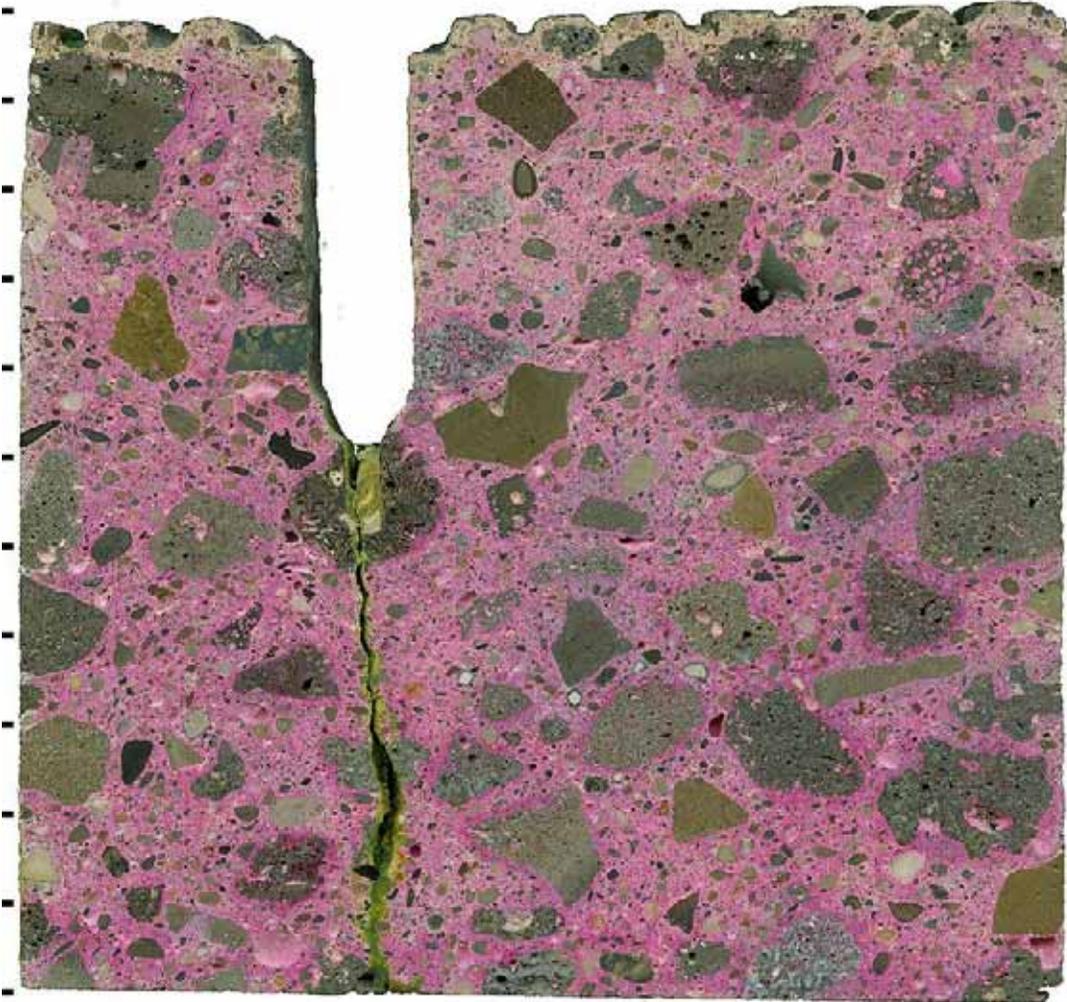
Slab representing cross section through top half of pavement, after phenolphthalein stain, EB M-59, constructed 1997/98, outside lane, at transverse joint, core A, MTU ID M59-01, tic marks every half inch.

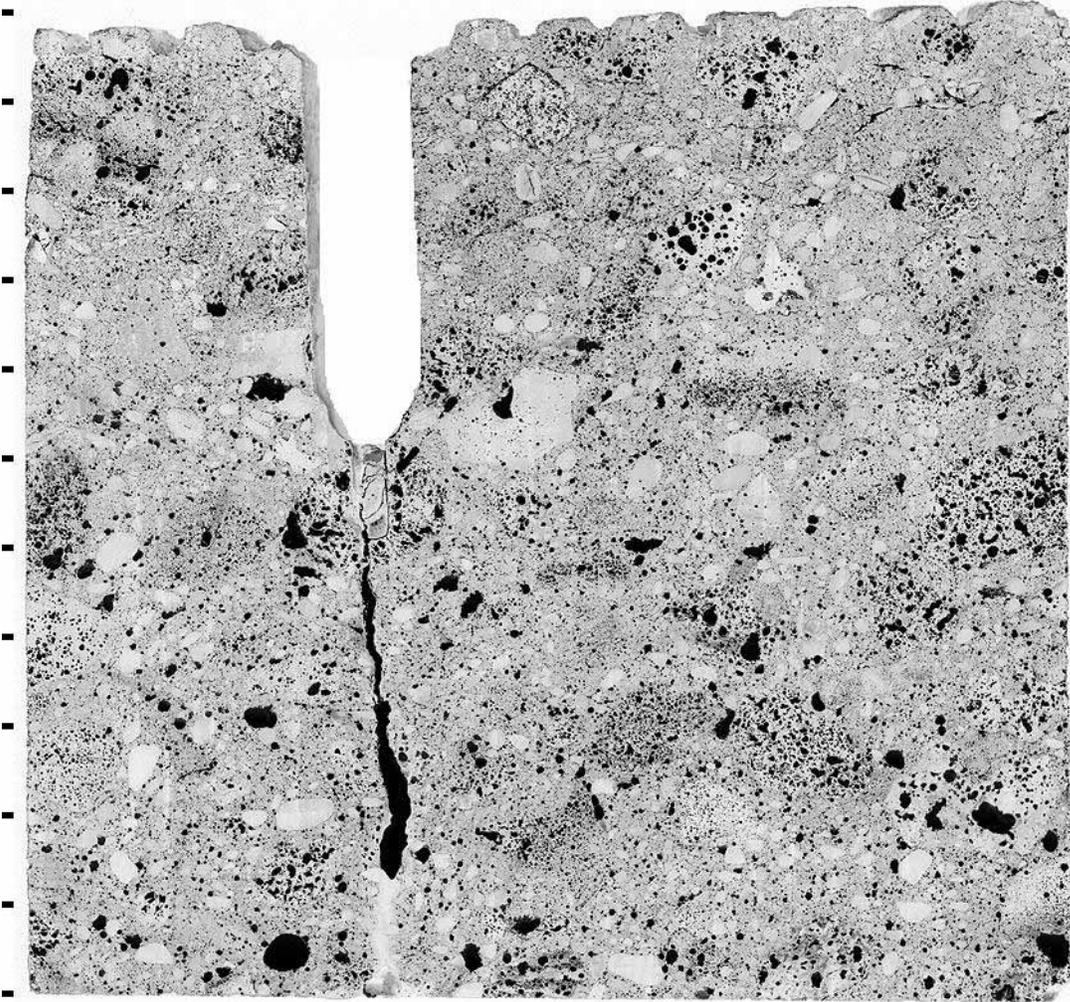
Slab representing cross section through top half of pavement, after treatment to enhance air voids and cracks, EB M-59, constructed 1997/98, outside lane, at transverse joint, core A, MTU ID M59-01, tic marks every half inch.

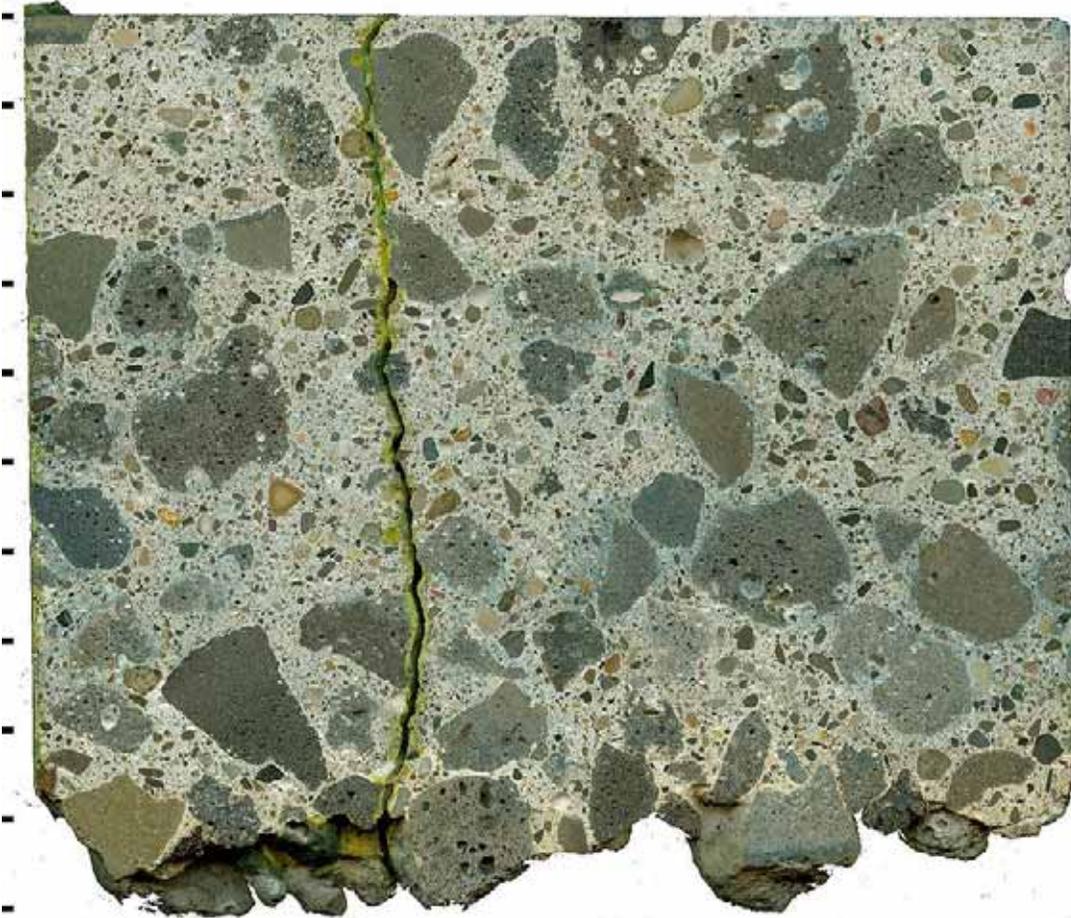
Slab representing cross section through bottom half of pavement, as polished, EB M-59, constructed 1997/98, outside lane, at transverse joint, core A, MTU ID M59-01, tic marks every half inch.

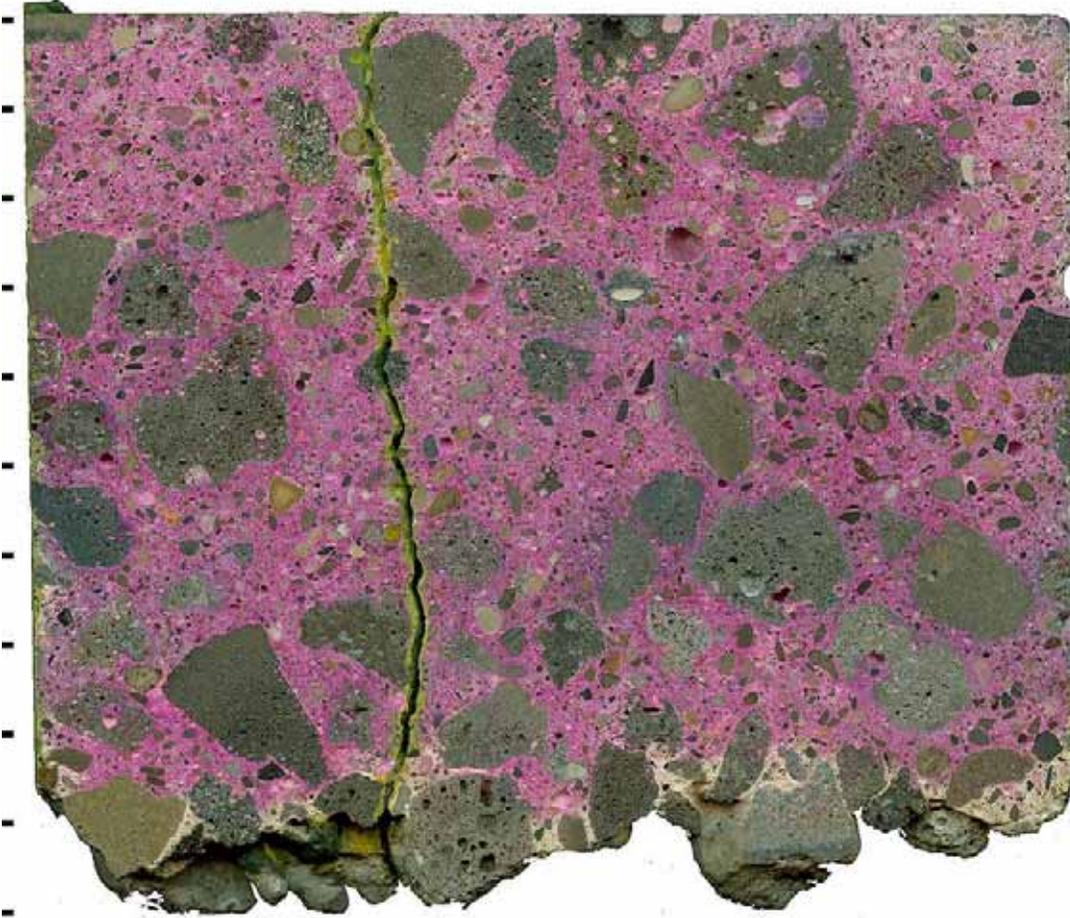
Slab representing cross section through top half of pavement, after phenolphthalein stain, EB M-59, constructed 1997/98, outside lane, at transverse joint, core A, MTU ID M59-01, tic marks every half inch.

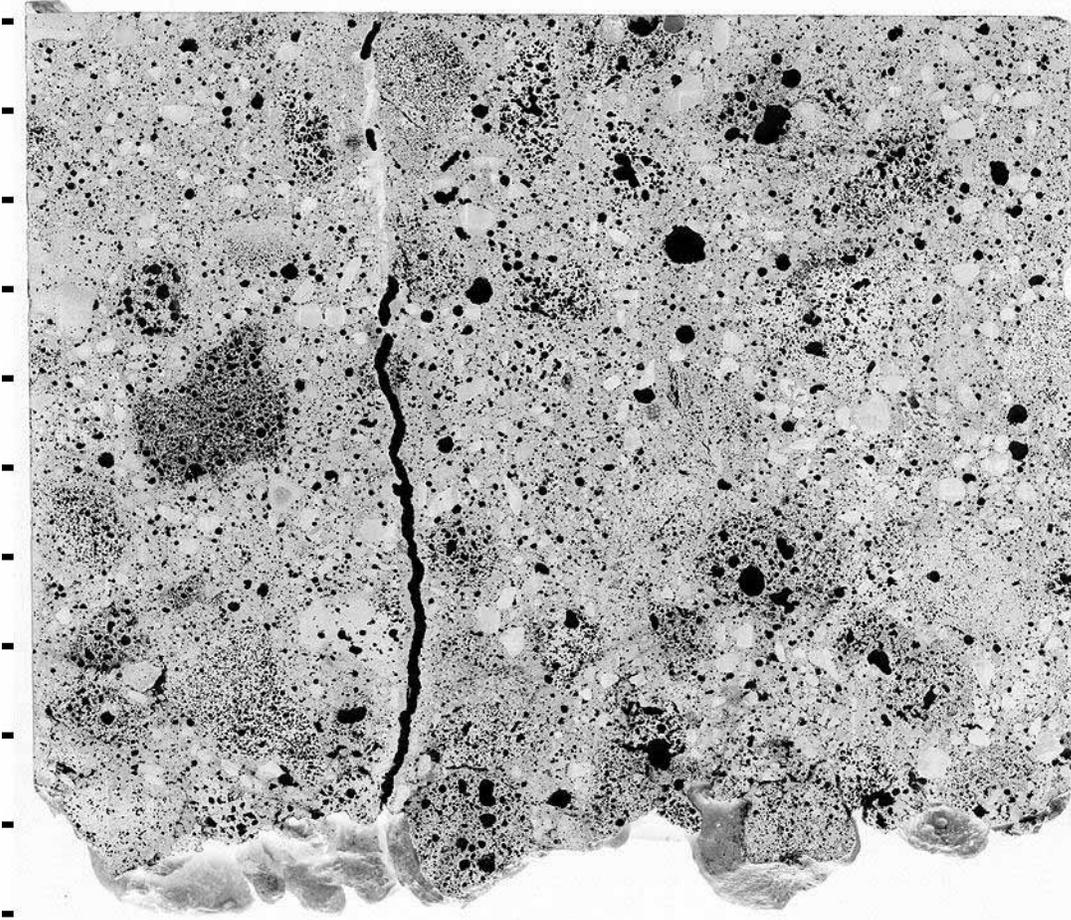
Slab representing cross section through top half of pavement, after treatment to enhance air voids and cracks, EB M-59, constructed 1997/98, outside lane, at transverse joint, core A, MTU ID M59-01, tic marks every half inch.

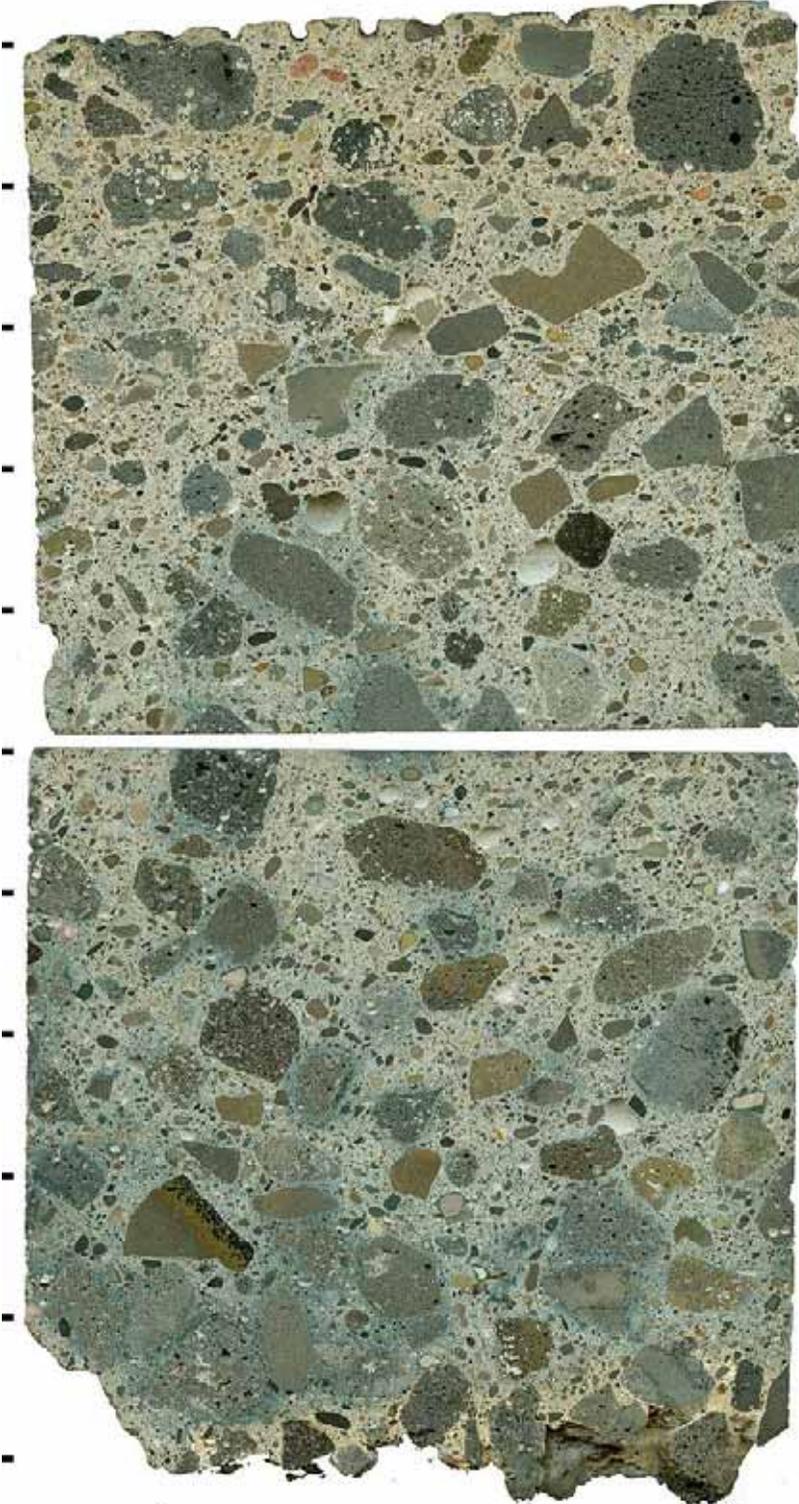
Slabs representing full cross section through pavement, as polished, EB M-59, constructed 1997/98, outside lane, away from transverse joint, core C, MTU ID M59-02, tic marks every inch.

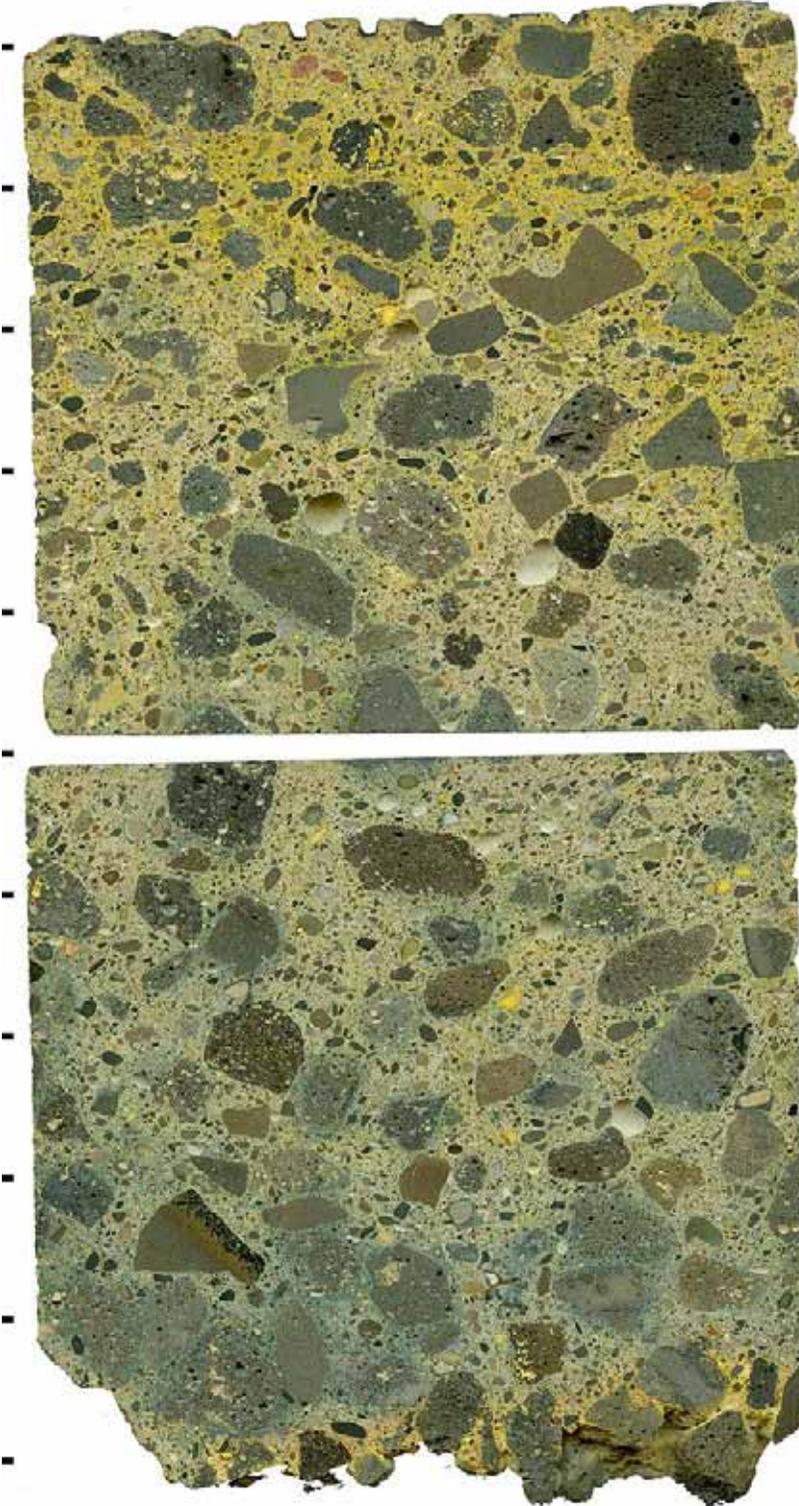
Slabs representing full cross section through pavement, after sodium cobaltinitrite stain, EB M-59, constructed 1997/98, outside lane, away from transverse joint, core C, MTU ID M59-02, tic marks every inch.

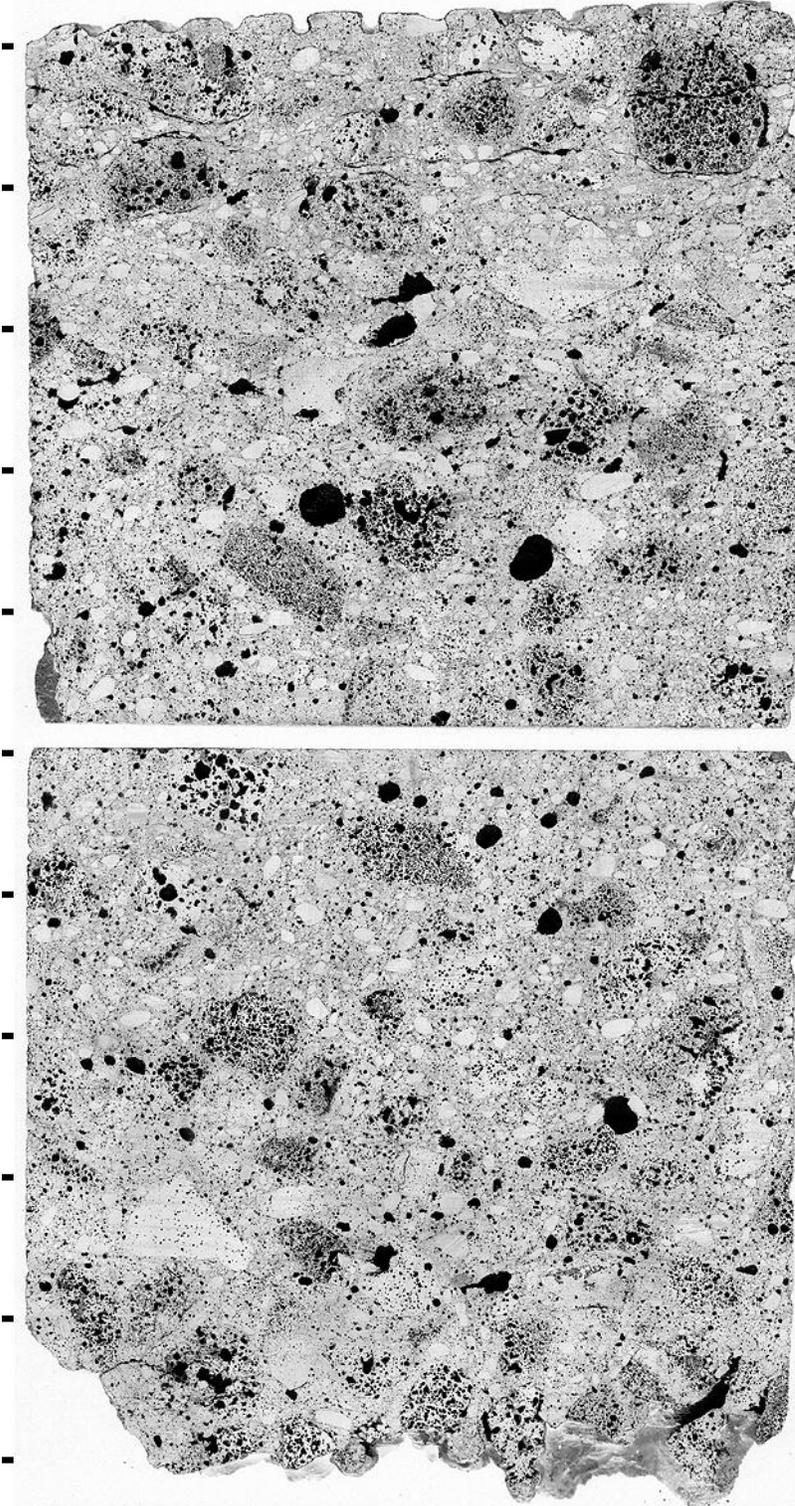
Slabs representing full cross section through pavement, after treatment to enhance air voids and cracks, EB M-59, constructed 1997/98, outside lane, away from transverse joint, core C, MTU ID M59-02, tic marks every inch.

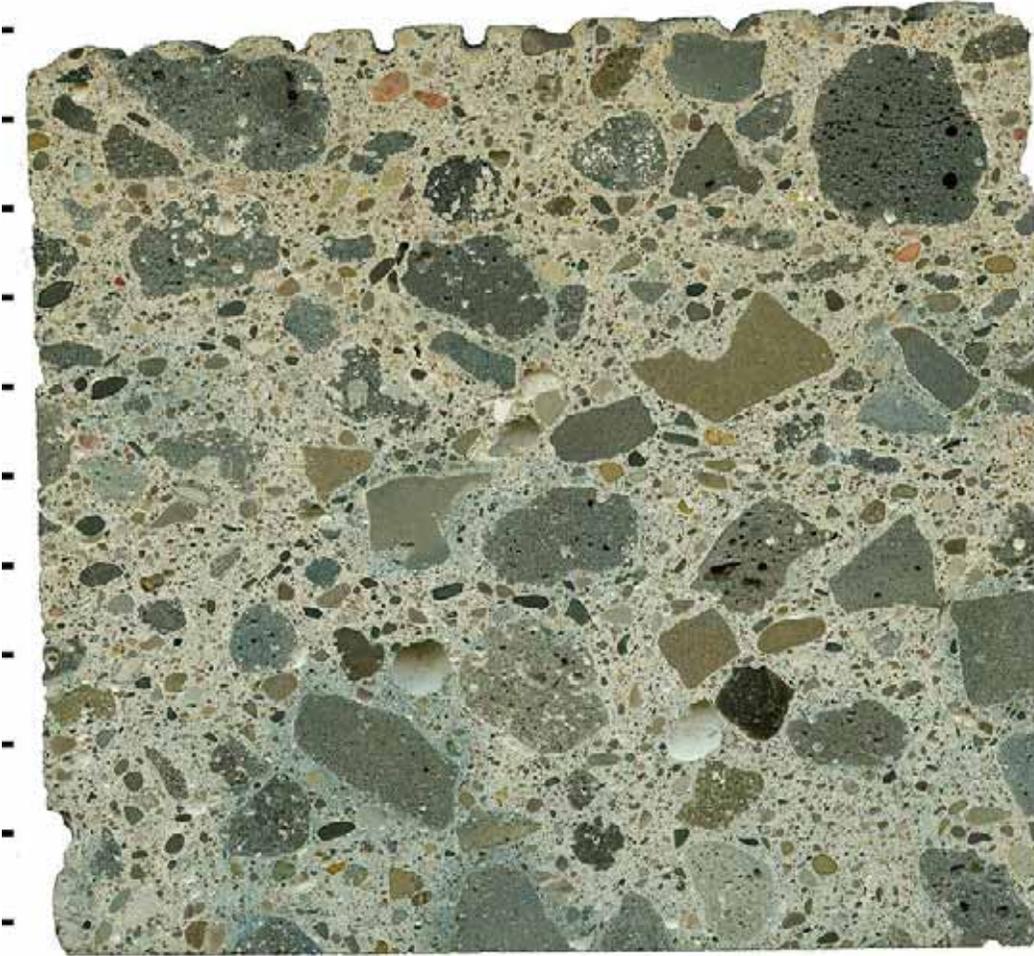
Slab representing cross section through top half of pavement, as polished, EB M-59, constructed 1997/98, outside lane, away from transverse joint, core C, MTU ID M59-02, tic marks every half inch.

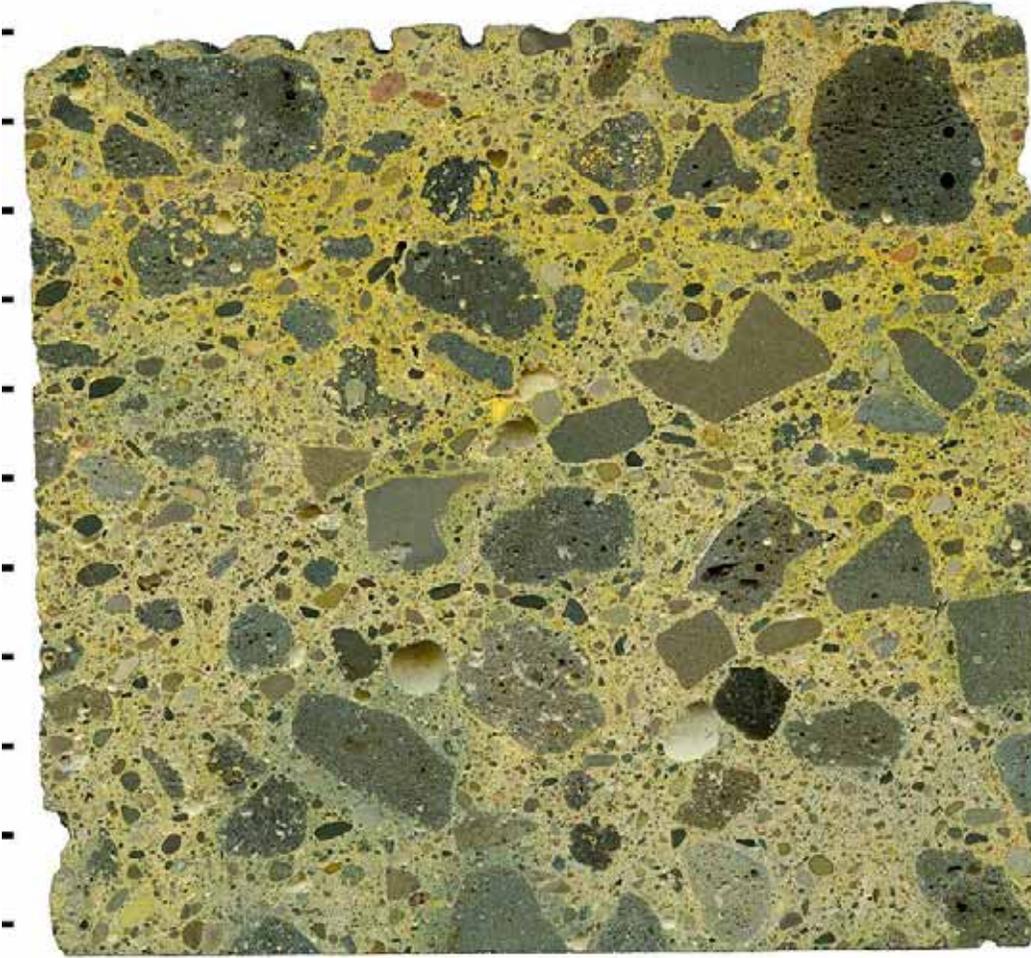
Slab representing cross section through top half of pavement, after sodium cobaltinitrite stain, EB M-59, constructed 1997/98, outside lane, away from transverse joint, core C, MTU ID M59-02, tic marks every half inch.

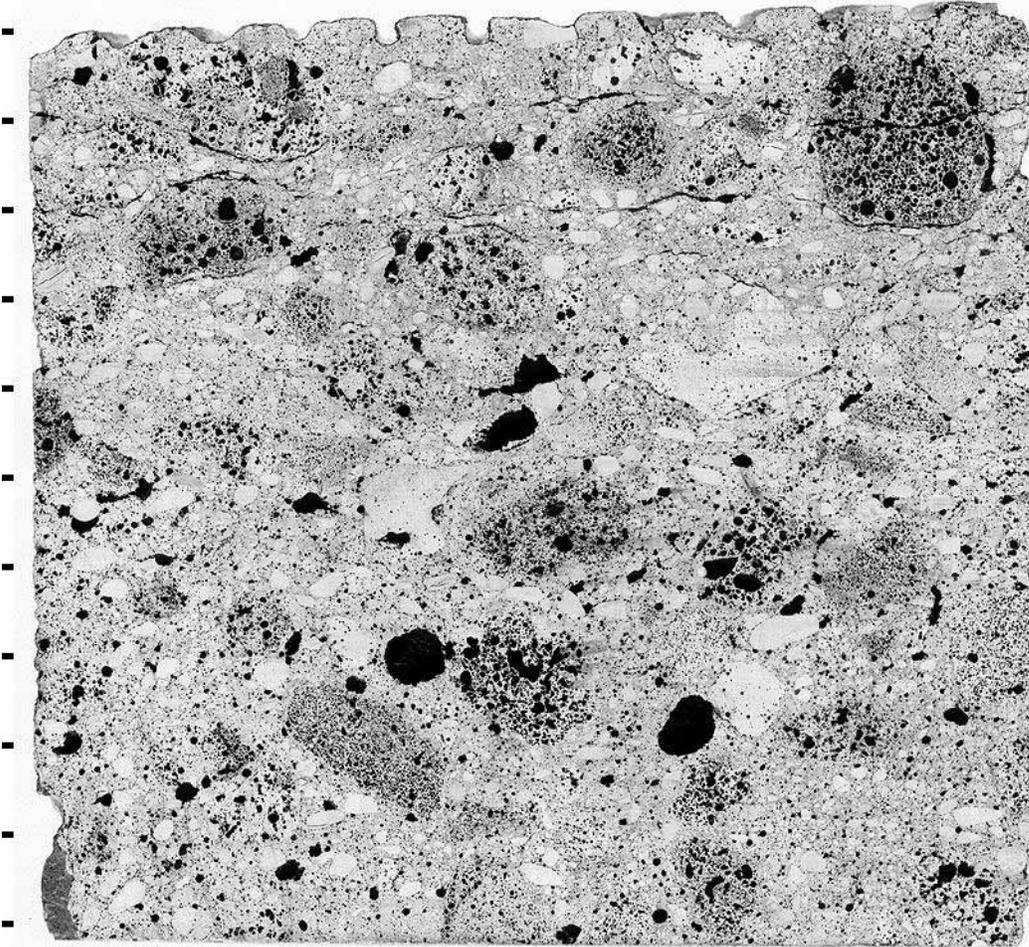
Slab representing cross section through top half of pavement, after treatment to enhance air voids and cracks, EB M-59, constructed 1997/98, outside lane, away from transverse joint, core C, MTU ID M59-02, tic marks every half inch.

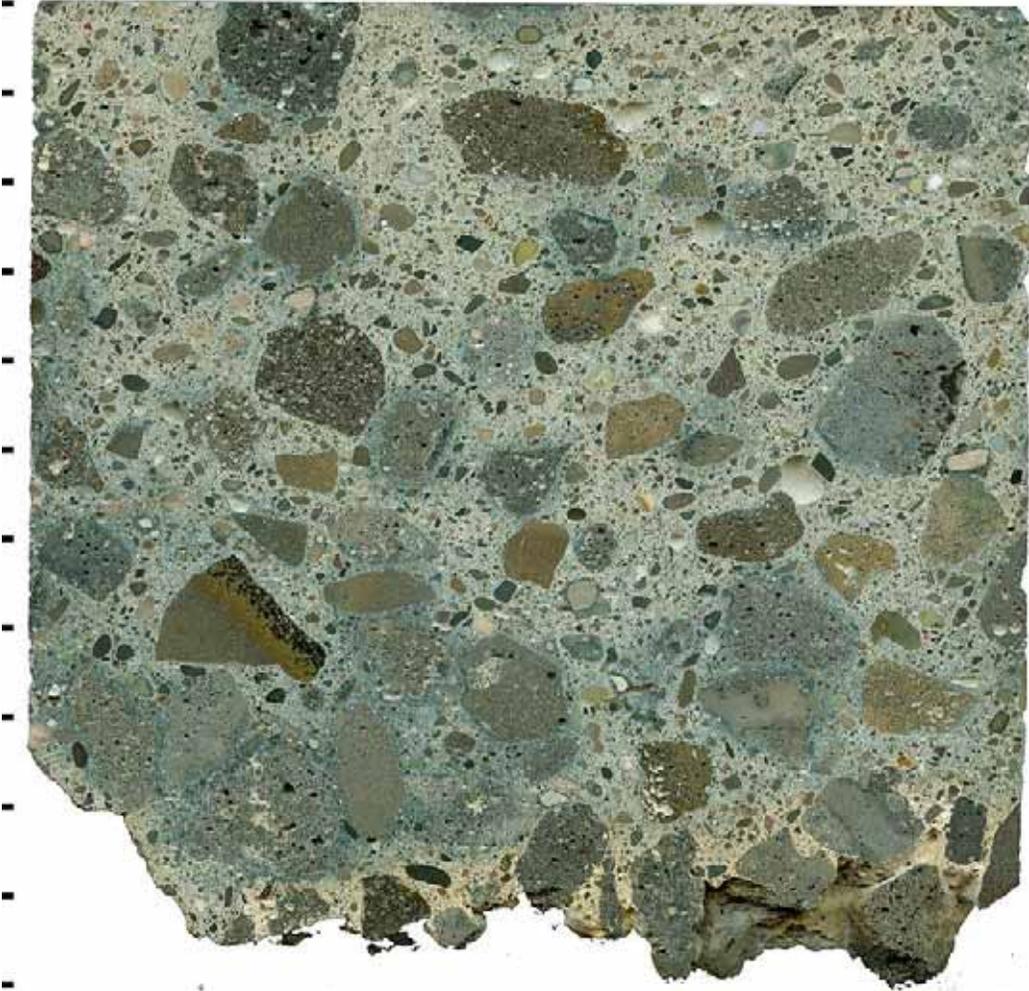
Slab representing cross section through bottom half of pavement, as polished, EB M-59, constructed 1997/98, outside lane, away from transverse joint, core C, MTU ID M59-02, tic marks every half inch.

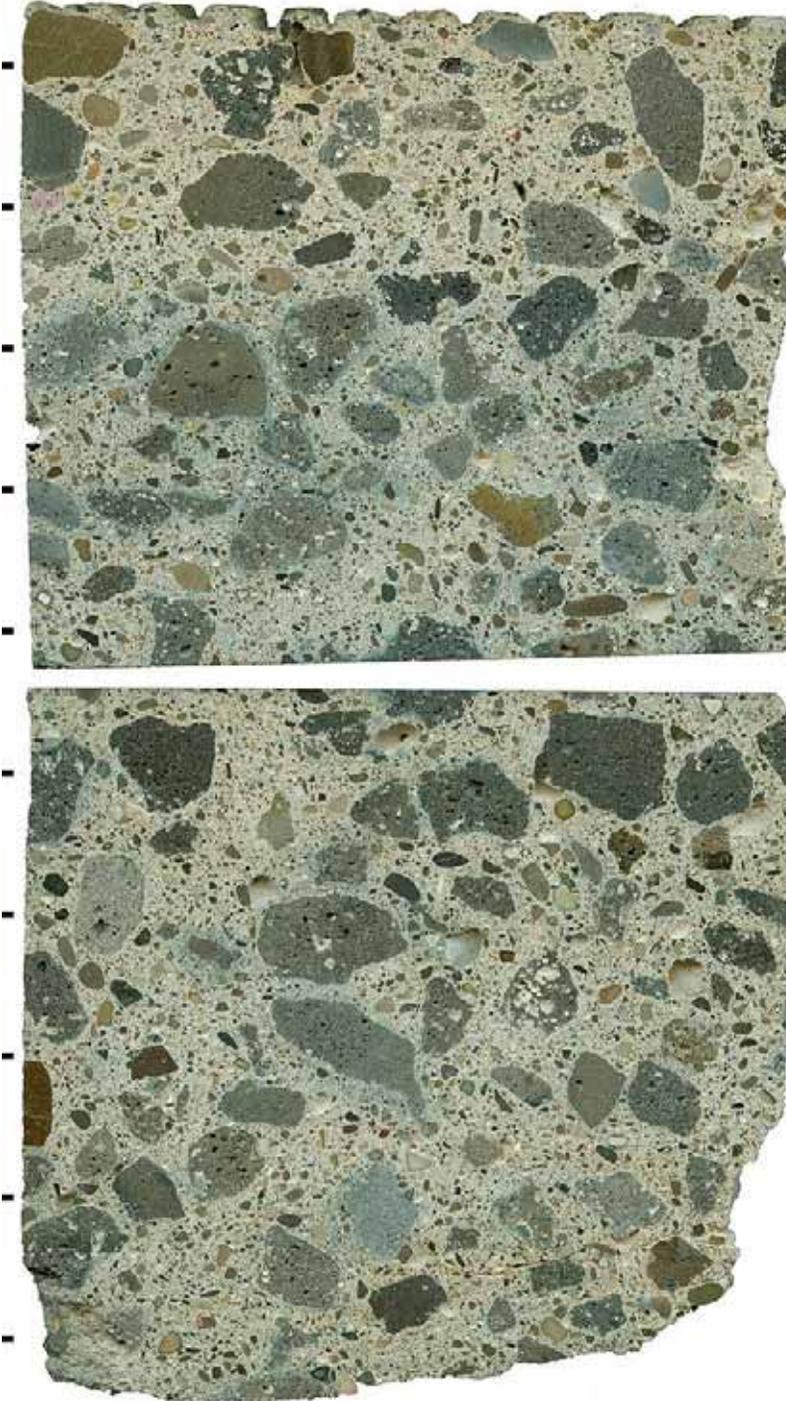
Slabs representing full cross section through pavement, as polished, EB M-59, constructed 1997/98, shoulder, near joint?, core B, MTU ID M59-04, tic marks every inch.

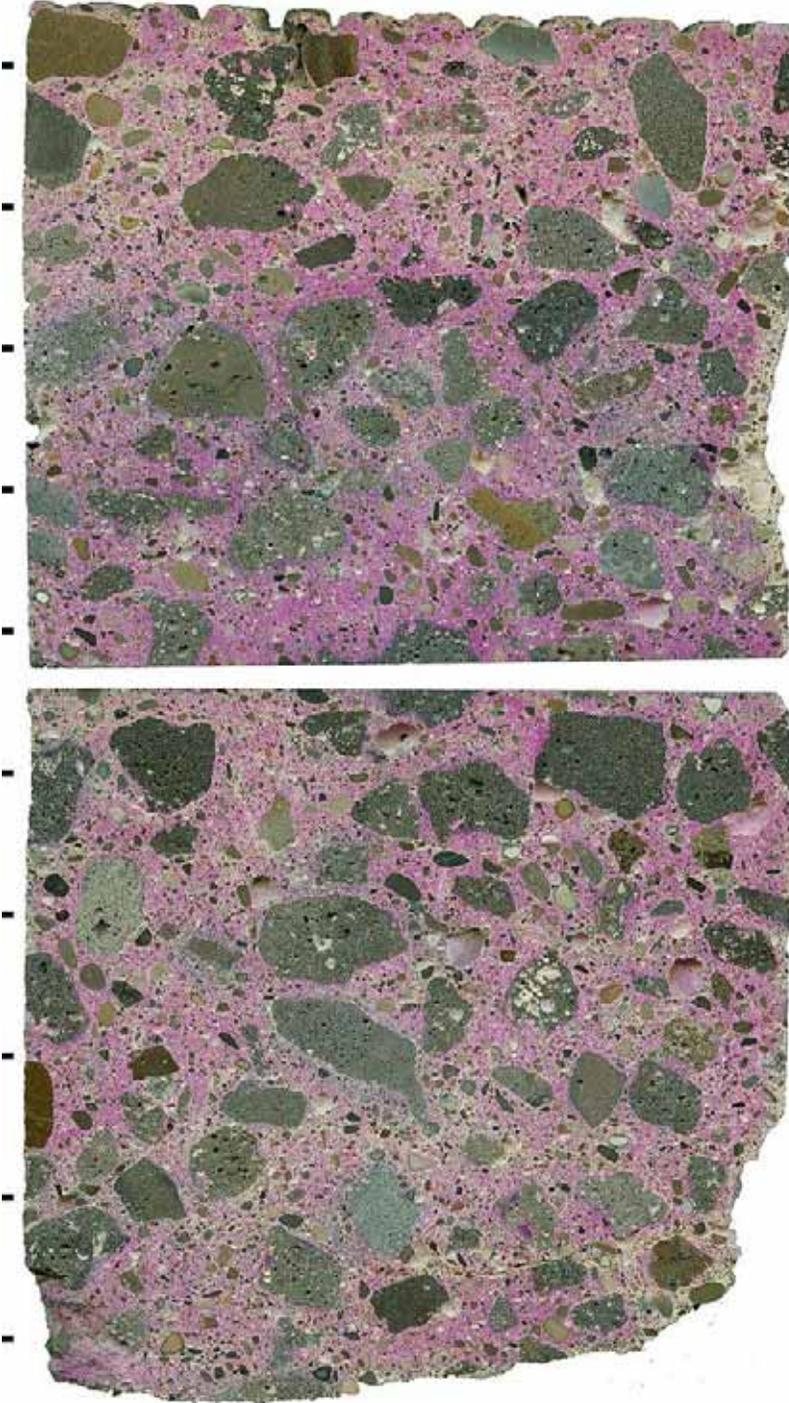
Slabs representing full cross section through pavement, after phenolphthalein stain, EB M-59, constructed 1997/98, shoulder, near joint?, core B, MTU ID M59-04, tic marks every inch.

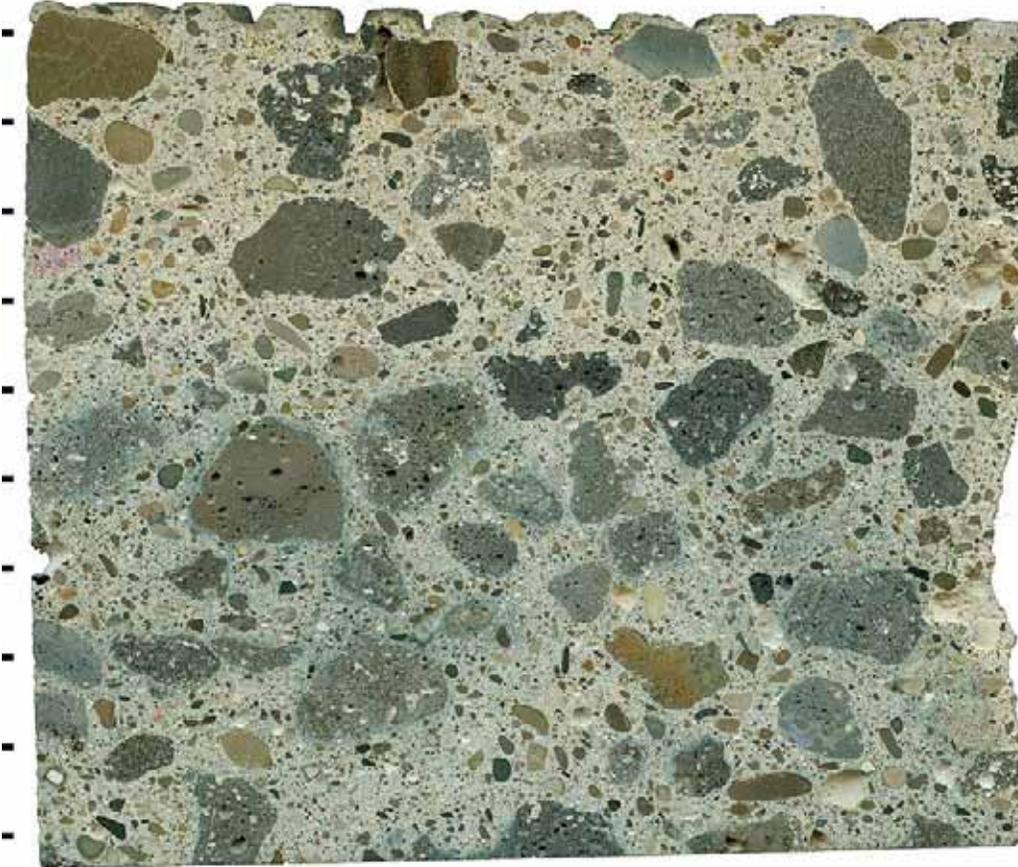
Slab representing cross section through top half of pavement, as polished, EB M-59, constructed 1997/98, shoulder, near joint?, core B, MTU ID M59-04, tic marks every half inch.

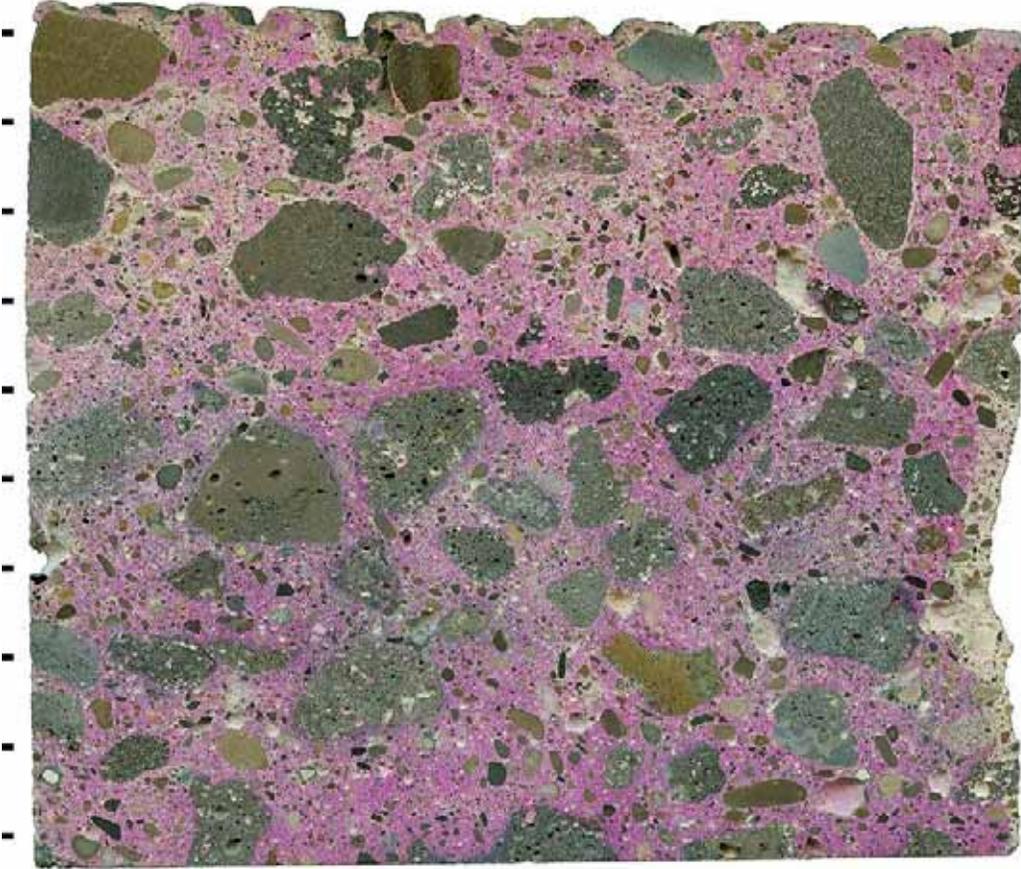
Slab representing cross section through top half of pavement, after phenolphthalein stain, EB M-59, constructed 1997/98, shoulder, near joint?, core B, MTU ID M59-04, tic marks every half inch.
