Appendix C
M-59 Core Site

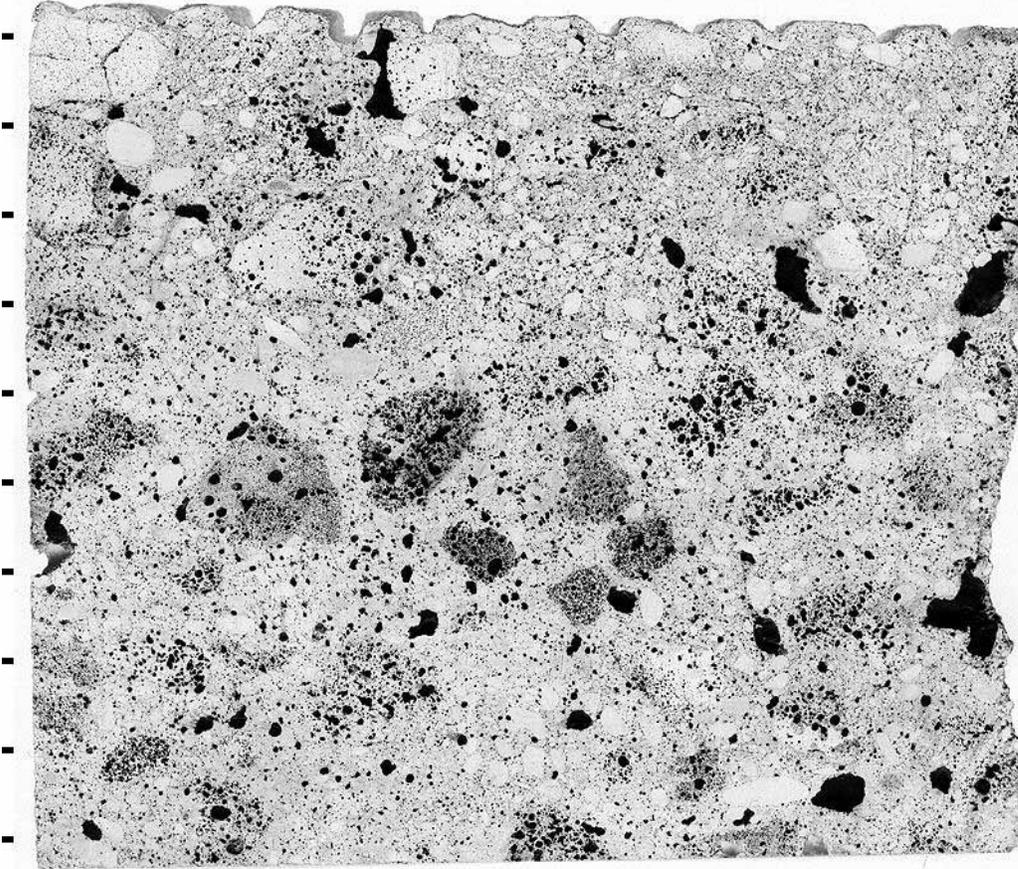
Slab representing cross section through top half of pavement, after treatment to enhance air voids and cracks, EB M-59, constructed 1997/98, shoulder, near joint?, core B, MTU ID M59-04, tic marks every half inch.

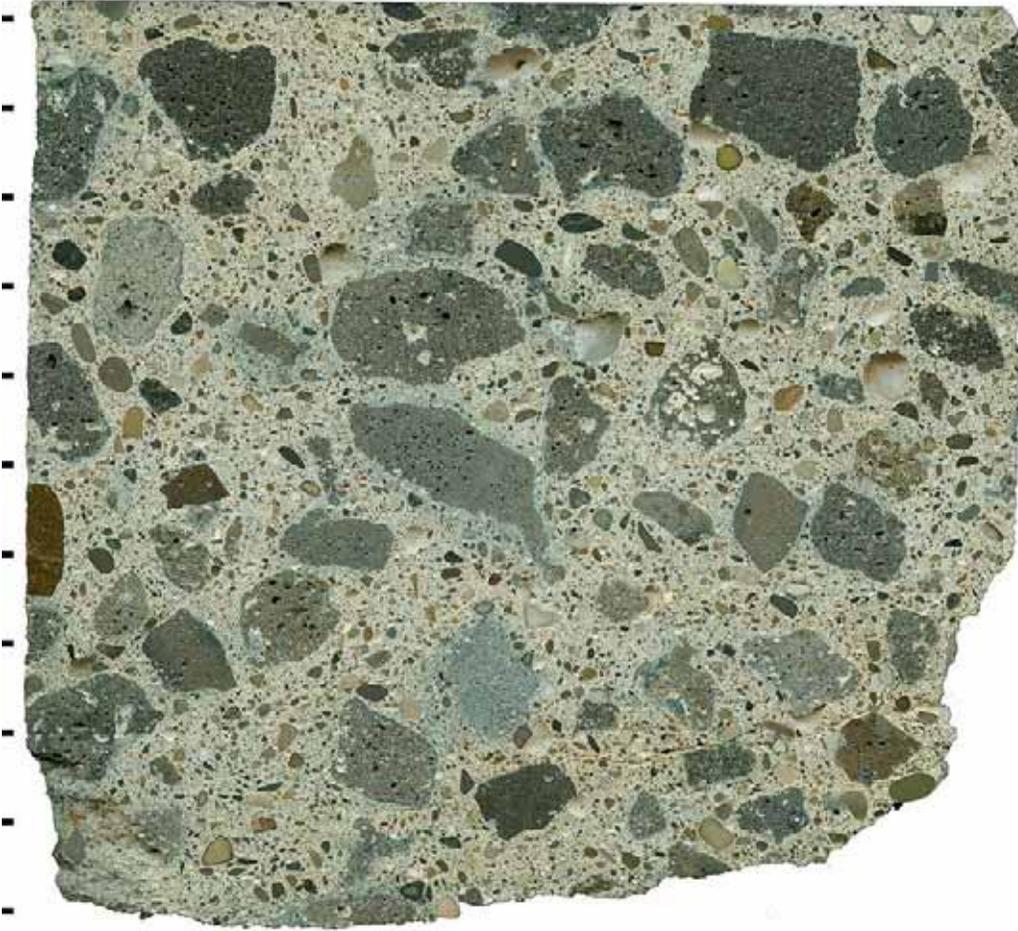
Slab representing cross section through bottom half of pavement, as polished, EB M-59, constructed 1997/98, shoulder, near joint?, core B, MTU ID M59-04, tic marks every half inch.

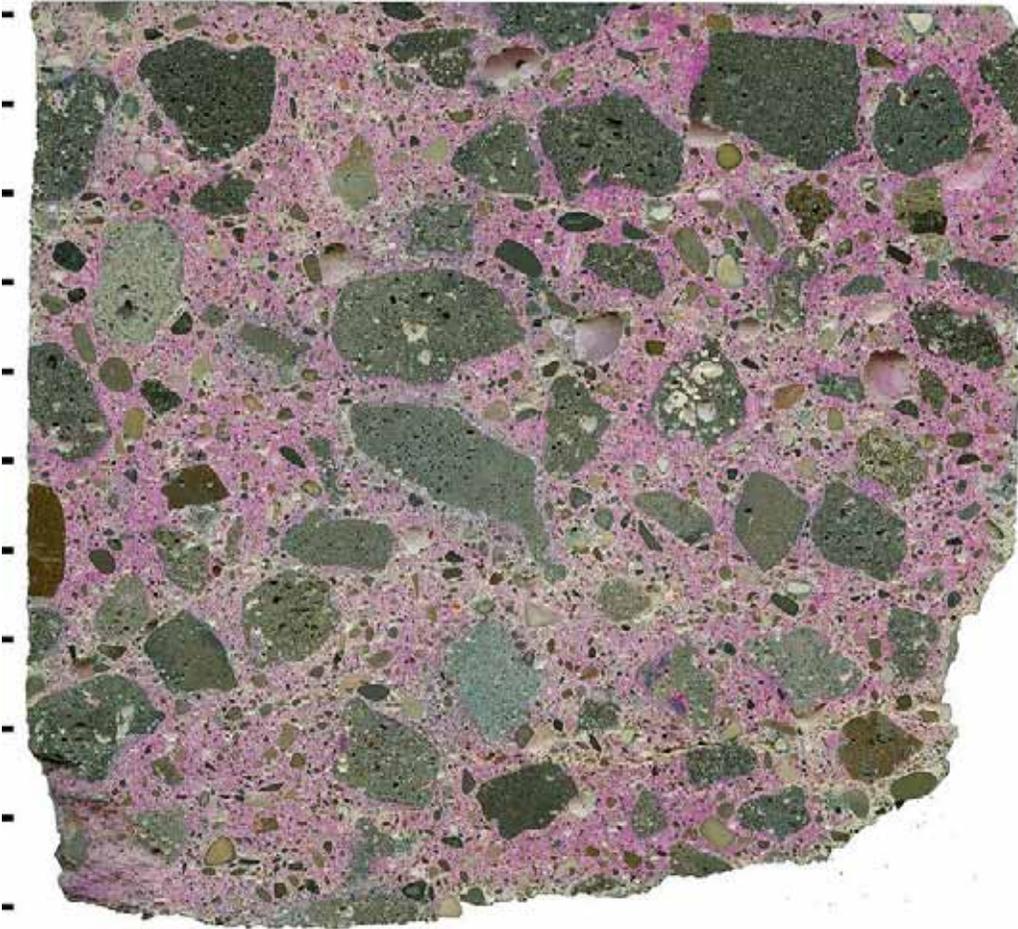
Slab representing cross section through bottom half of pavement, after phenolphthalein stain, EB M-59, constructed 1997/98, shoulder, near joint?, core B, MTU ID M59-04, tic marks every half inch.

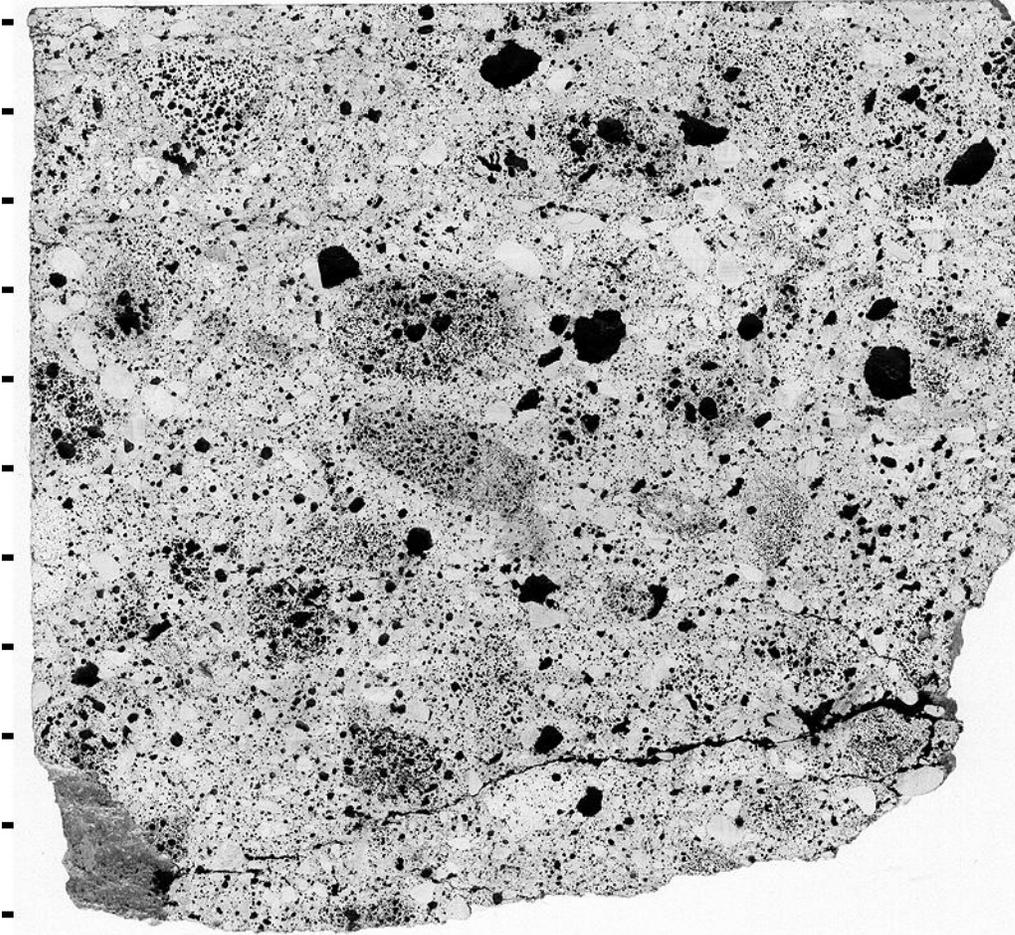
Slab representing cross section through bottom half of pavement, after treatment to enhance air voids and cracks, EB M-59, constructed 1997/98, shoulder, near joint?, core B, MTU ID M59-04, tic marks every half inch.

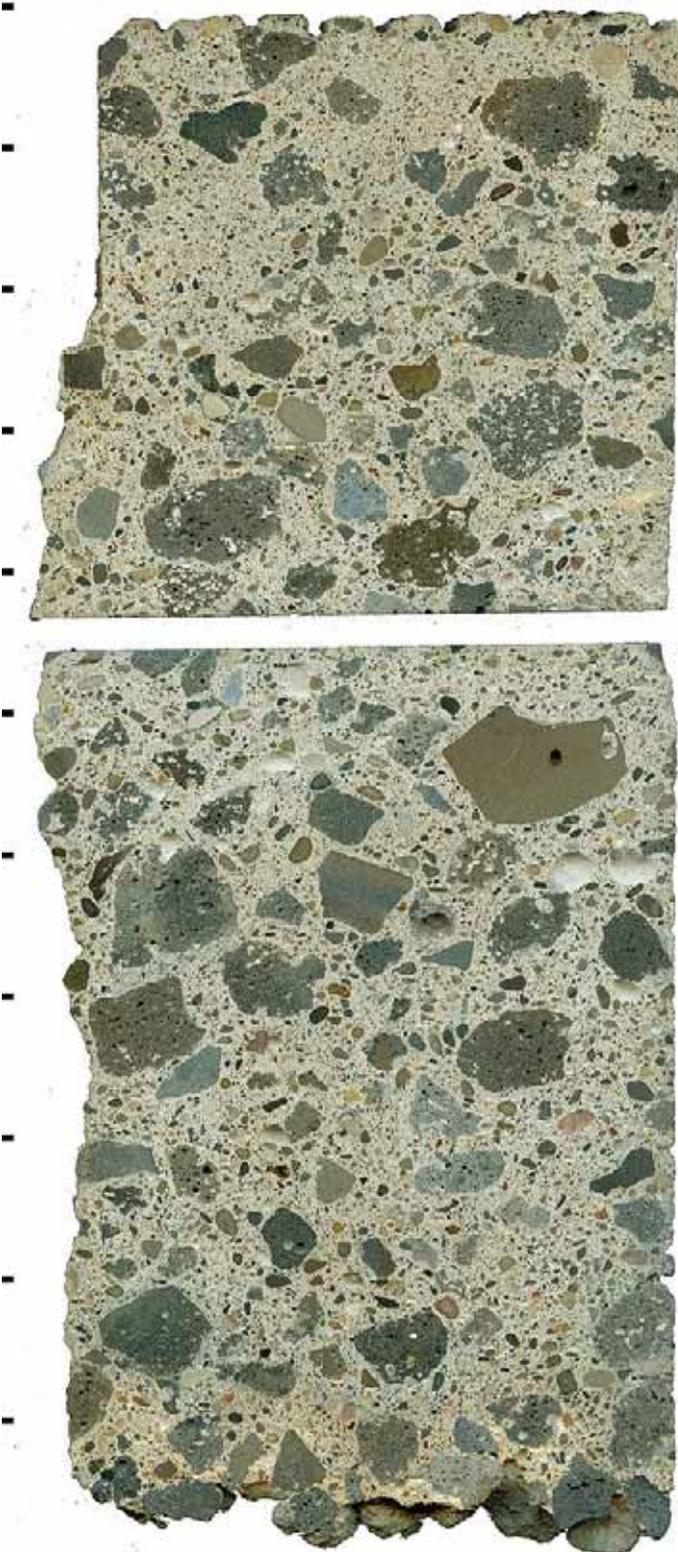
Slabs representing full cross section through pavement, as polished, EB M-59, constructed 1997/98, shoulder, at transverse joint, core A, MTU ID M59-05, tic marks every inch.

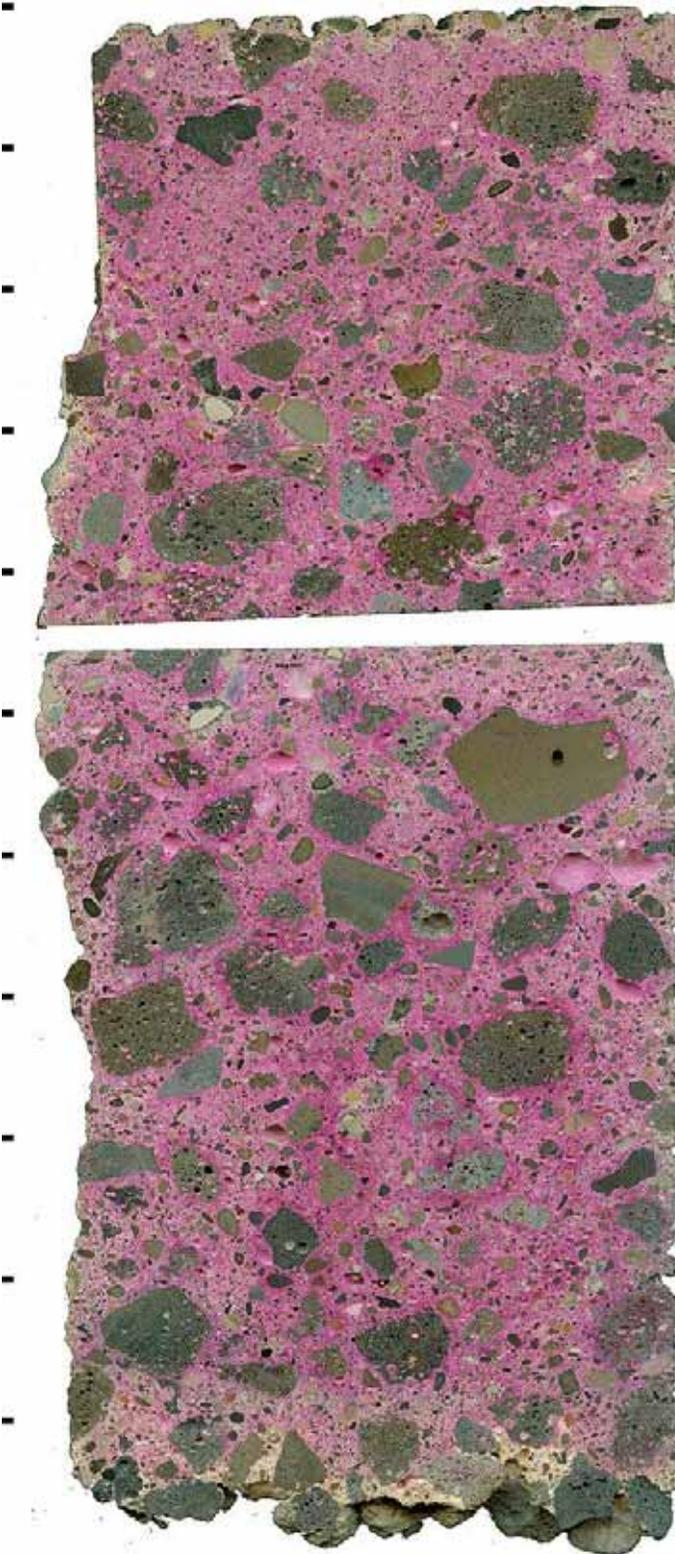
Slabs representing full cross section through pavement, after phenolphthalein stain, EB M-59, constructed 1997/98, shoulder, at transverse joint, core A, MTU ID M59-05, tic marks every inch.

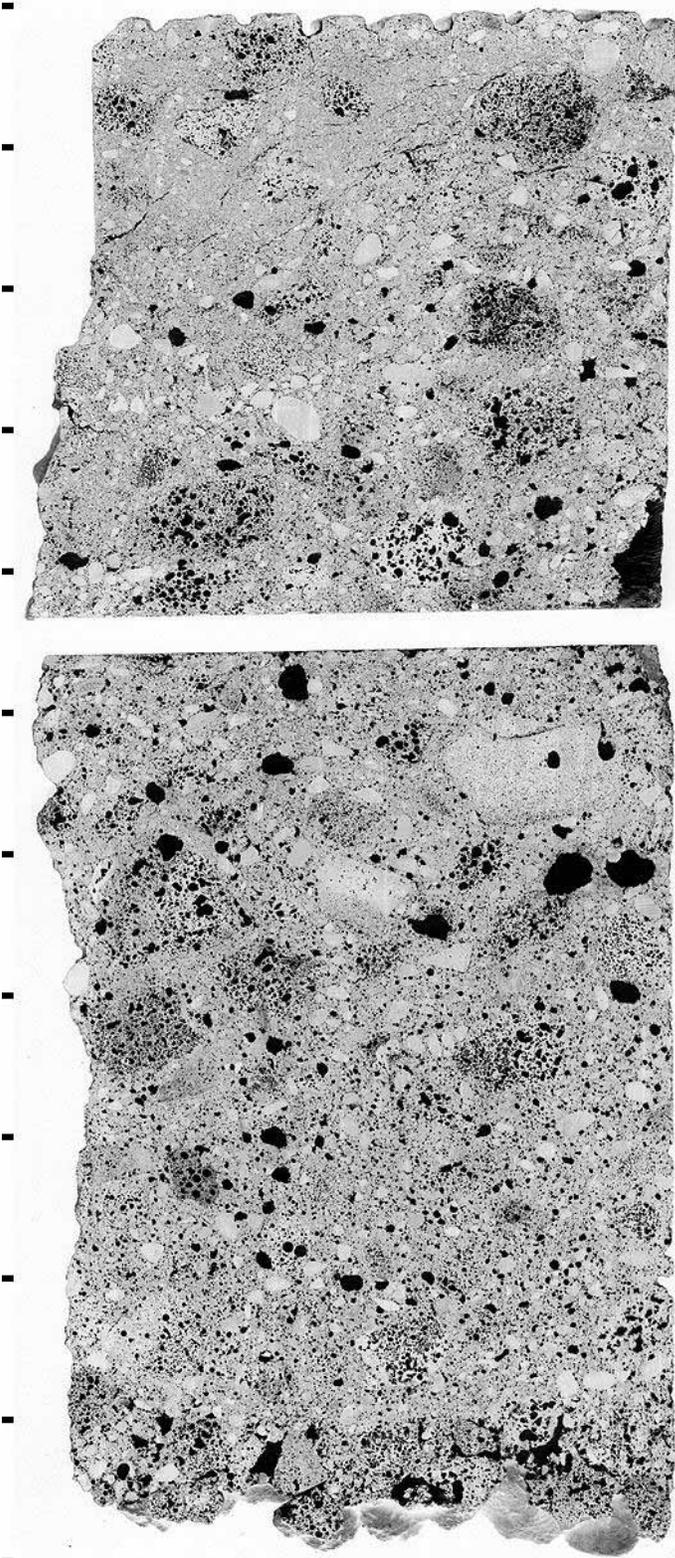
Slabs representing full cross section through pavement, after treatment to enhance air voids and cracks, EB M-59, constructed 1997/98, shoulder, at transverse joint, core A, MTU ID M59-05, tic marks every inch.

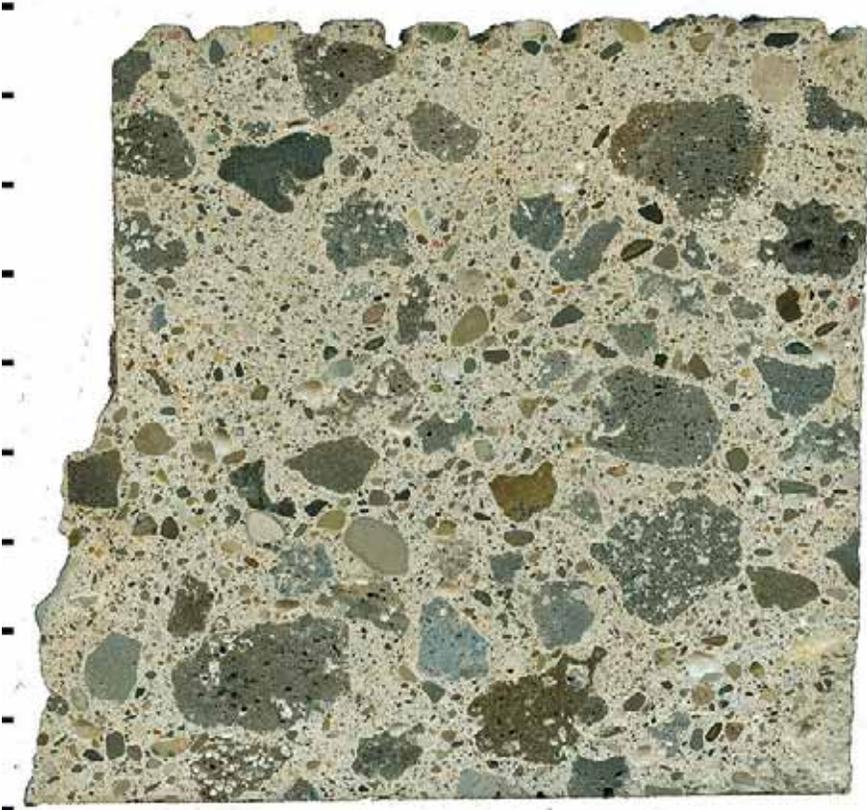
Slab representing cross section through top half of pavement, as polished, EB M-59, constructed 1997/98, shoulder, at transverse joint, core A, MTU ID M59-05, tic marks every half inch.

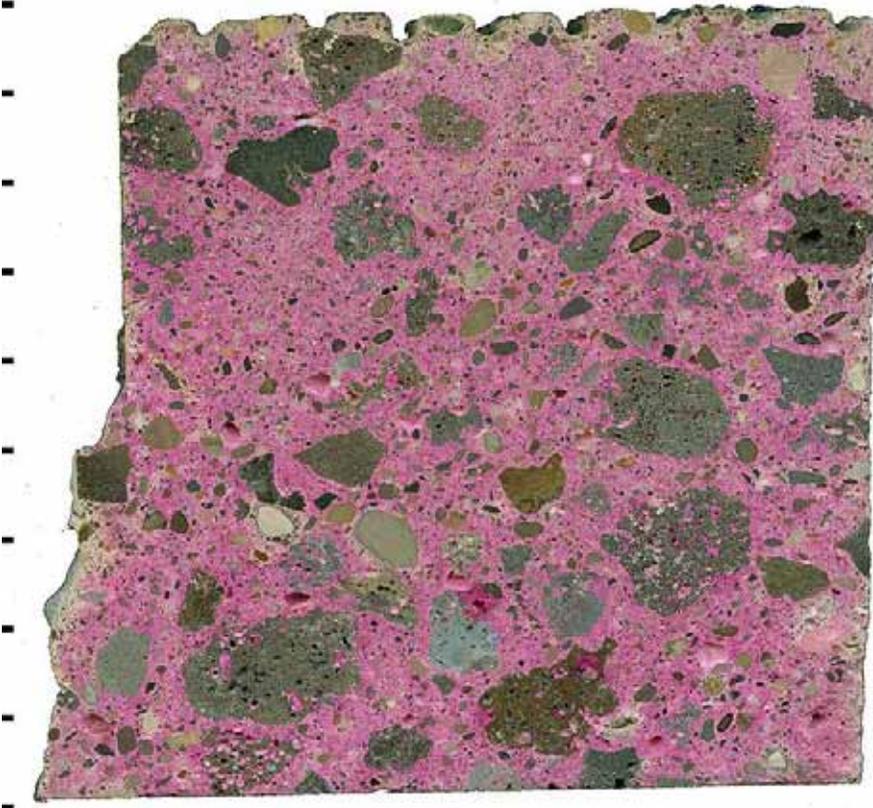
Slab representing cross section through top half of pavement, after phenolphthalein stain, EB M-59, constructed 1997/98, shoulder, at transverse joint, core A, MTU ID M59-05, tic marks every half inch.

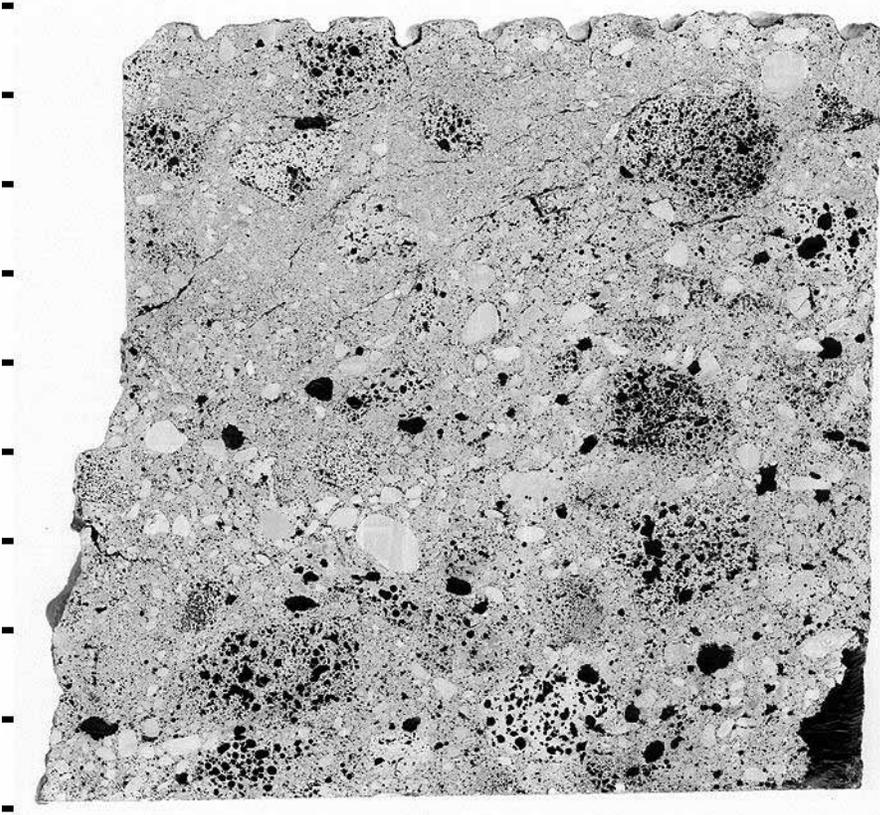
Slab representing cross section through top half of pavement, after treatment to enhance air voids and cracks, EB M-59, constructed 1997/98, shoulder, at transverse joint, core A, MTU ID M59-05, tic marks every half inch.

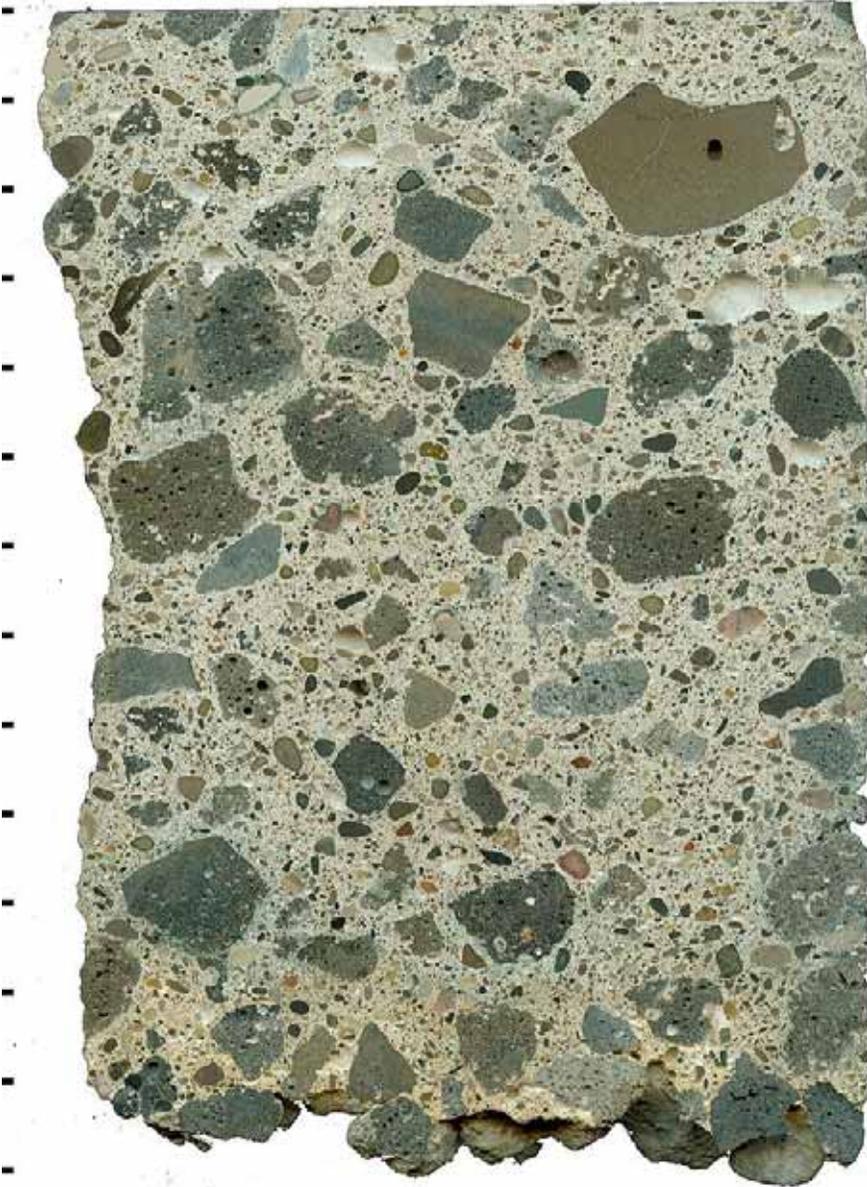
Slab representing cross section through bottom half of pavement, as polished, EB M-59, constructed 1997/98, shoulder, at transverse joint, core A, MTU ID M59-05, tic marks every half inch.

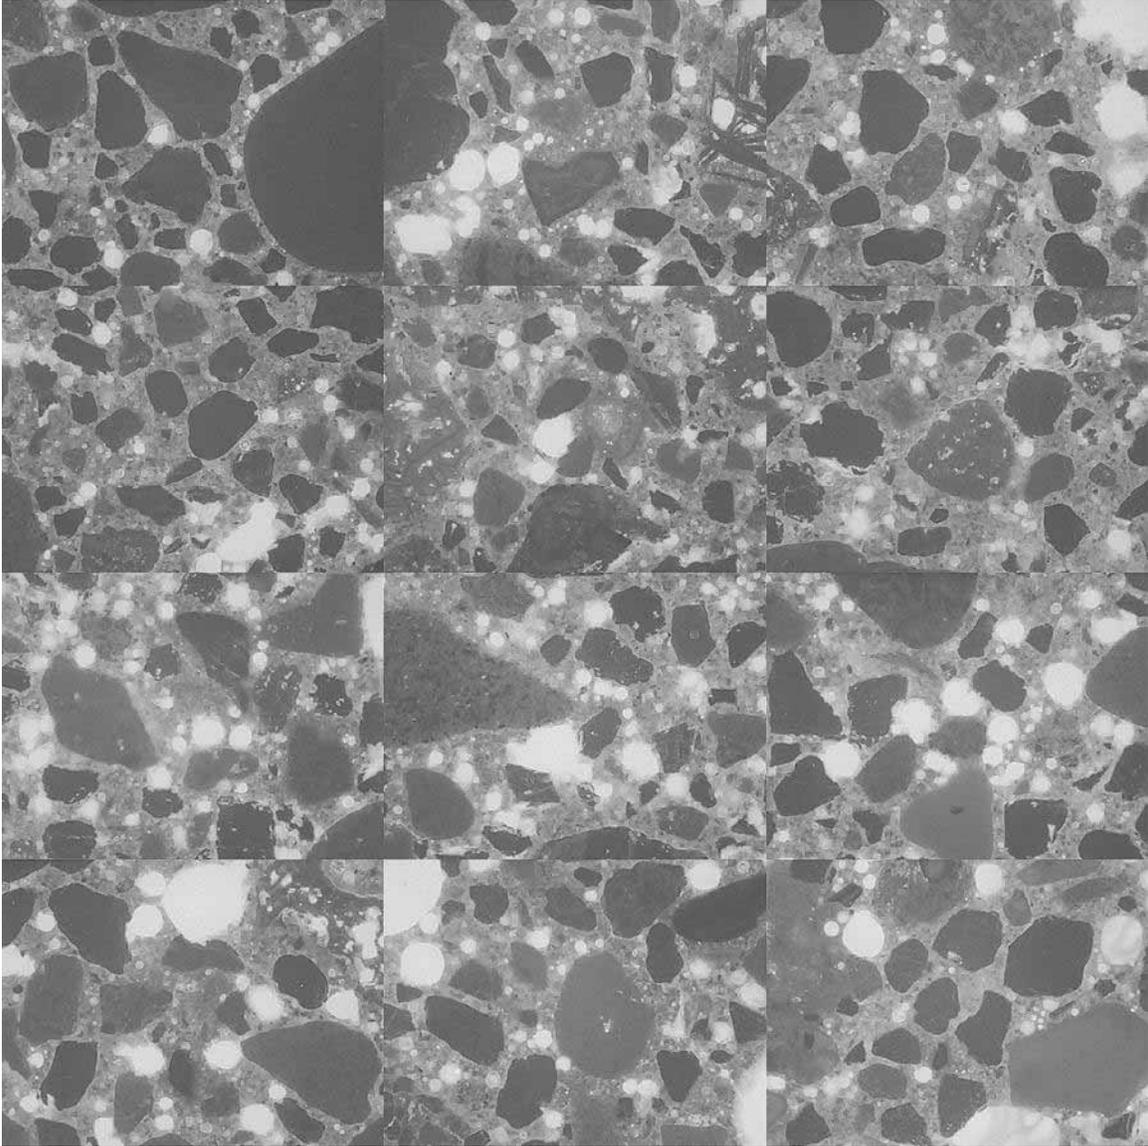
Mosaic of 12 epifluorescent mode images collected from thin sections prepared from core M-59, constructed, outside lane, away from transverse joint, MTU ID M59-02 (each individual frame measures 2.612 x 1.959 mm).

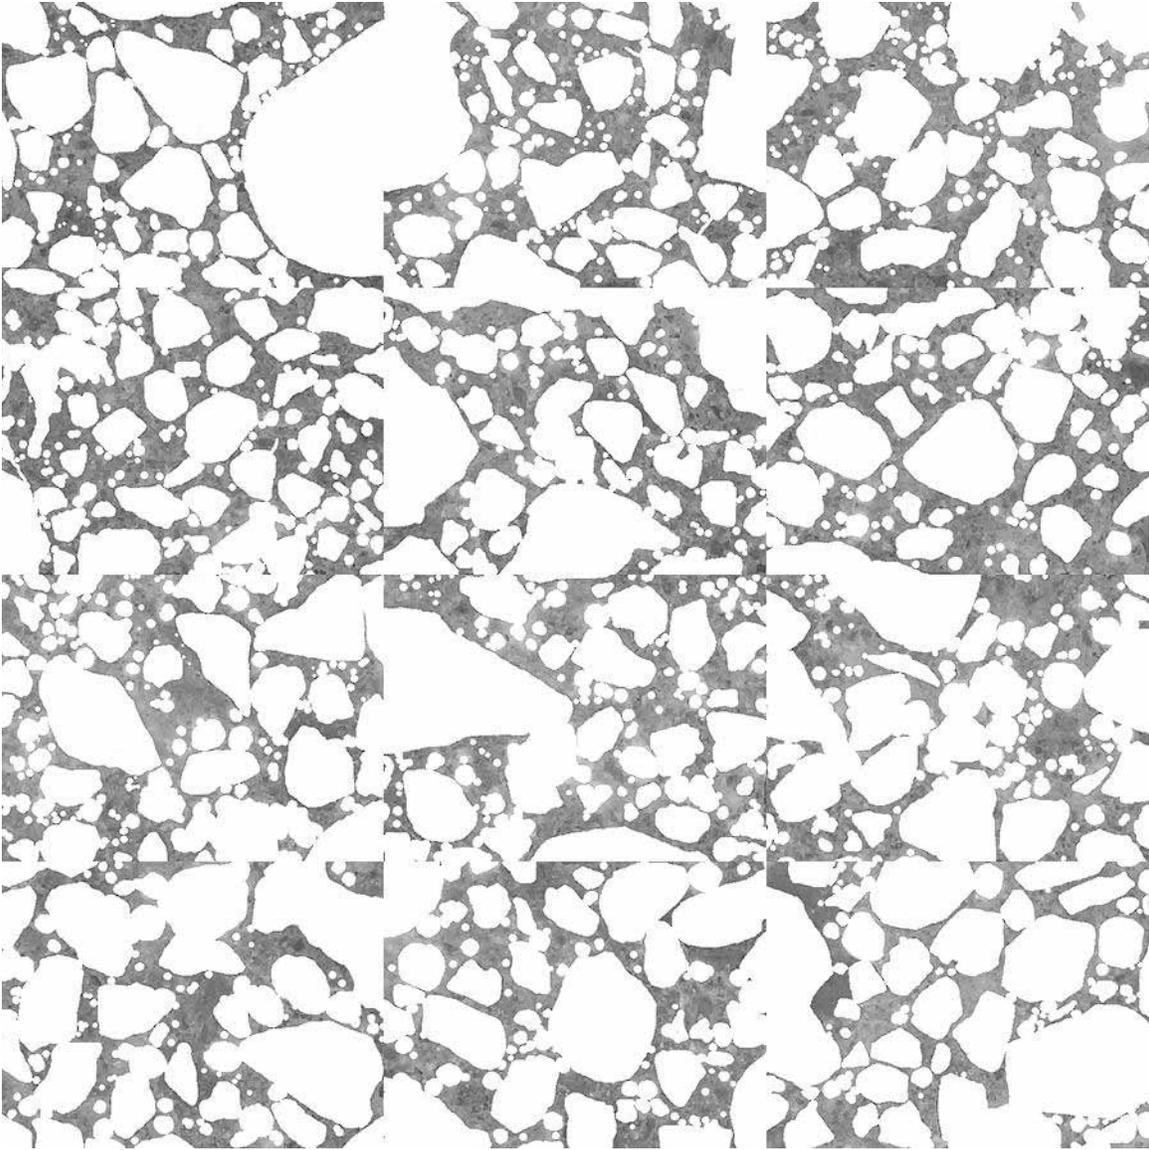
Mosaic of 12 epifluorescent mode images collected from thin sections prepared from core M-59, constructed, outside lane, away from transverse joint, MTU ID M59-02, after masking out air voids and fine aggregate to isolate cement paste (each individual frame measures 2.612 x 1.959 mm).
