Publication No. FHWA-RD-93-121

Testing of Small and Large Sign Support Systems FOIL Test Numbers: 92F040

U.S. Department of Transportation
Federal Highway Administration

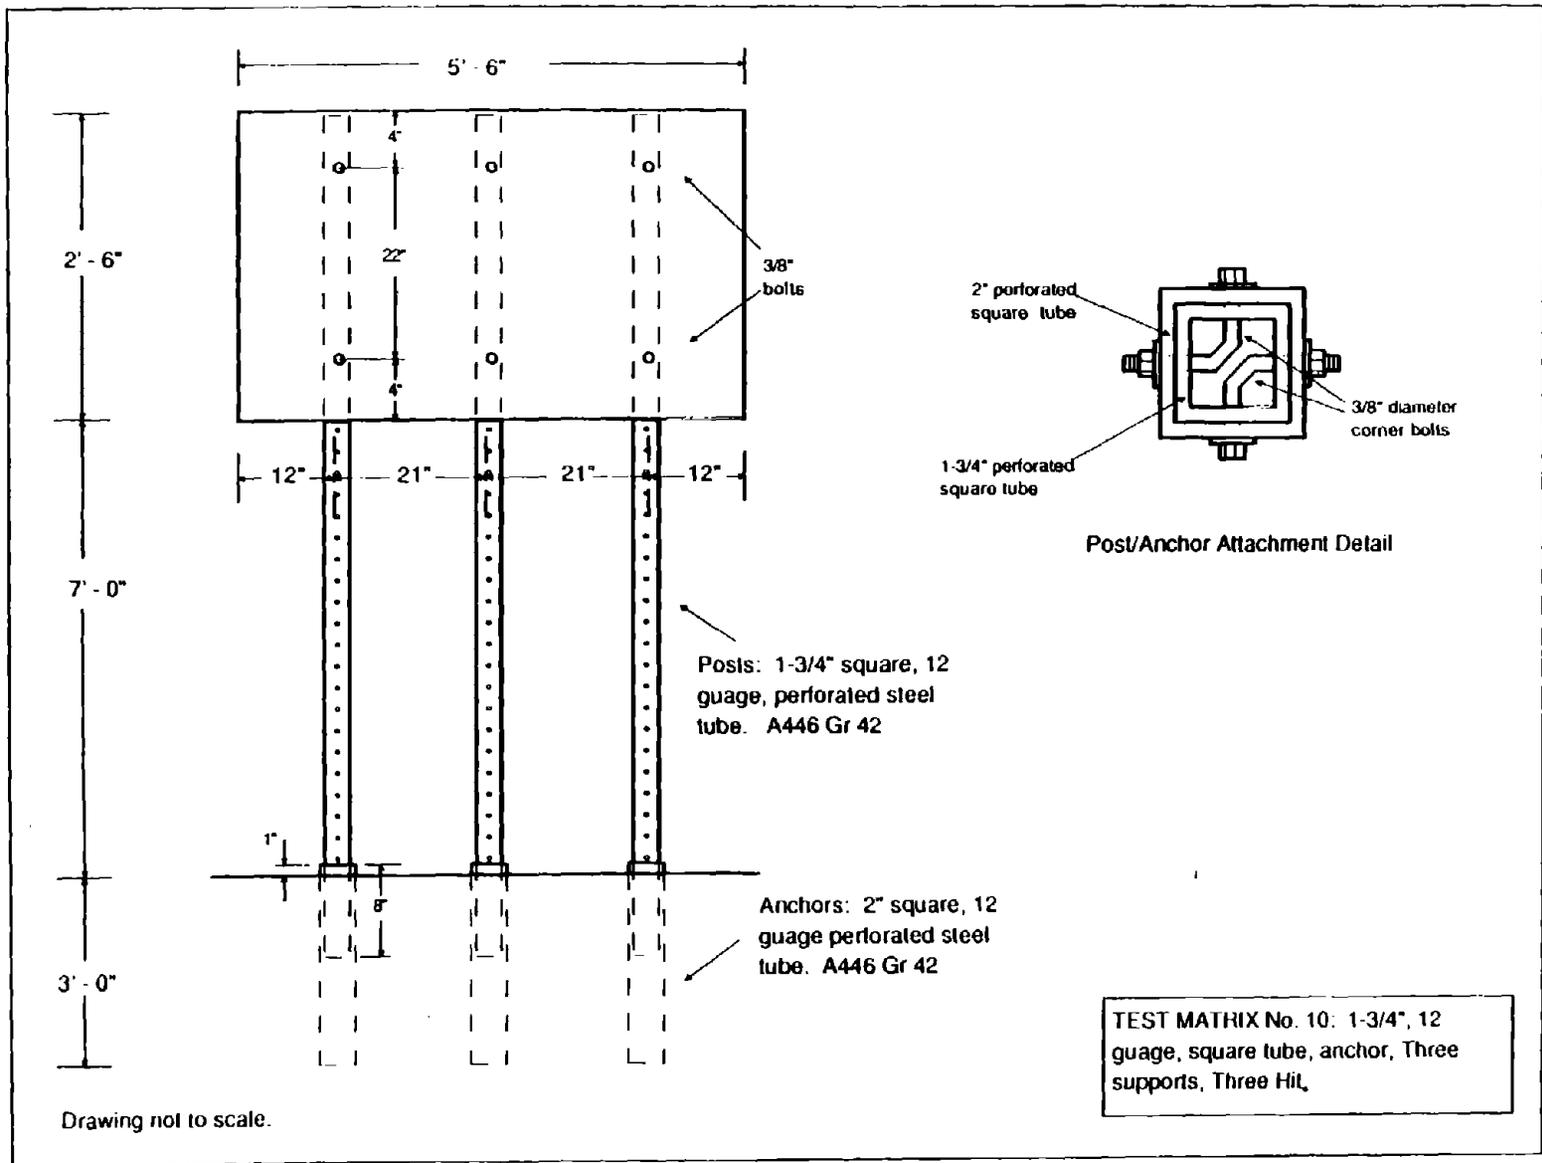
Figure 1. Sketch of small sign support.

The sign support system consisted of three square tube posts embedded 3 ft (0.9 m) in NCHRP Report 230 S-1 strong soil. Each leg consisted of a 1-3/4-in (44.4-mm) 12-gauge perforated square tube inserted into a 2-in (50.8-mm) 12-gauge perforated square tube anchor. The splice was 9 in (228.6 mm) long with 8 in (203.2 mm) below ground. The square tubes were spliced using two 3/8-in (9.5-mm) diameter corner bolts at ground level. The posts were spaced 1.75 ft (0.53 m) apart with a 2.5-ft by 5.5-ft (0.76-m by 1.68-m) aluminum sign blank attached. Figure 1 presents a sketch

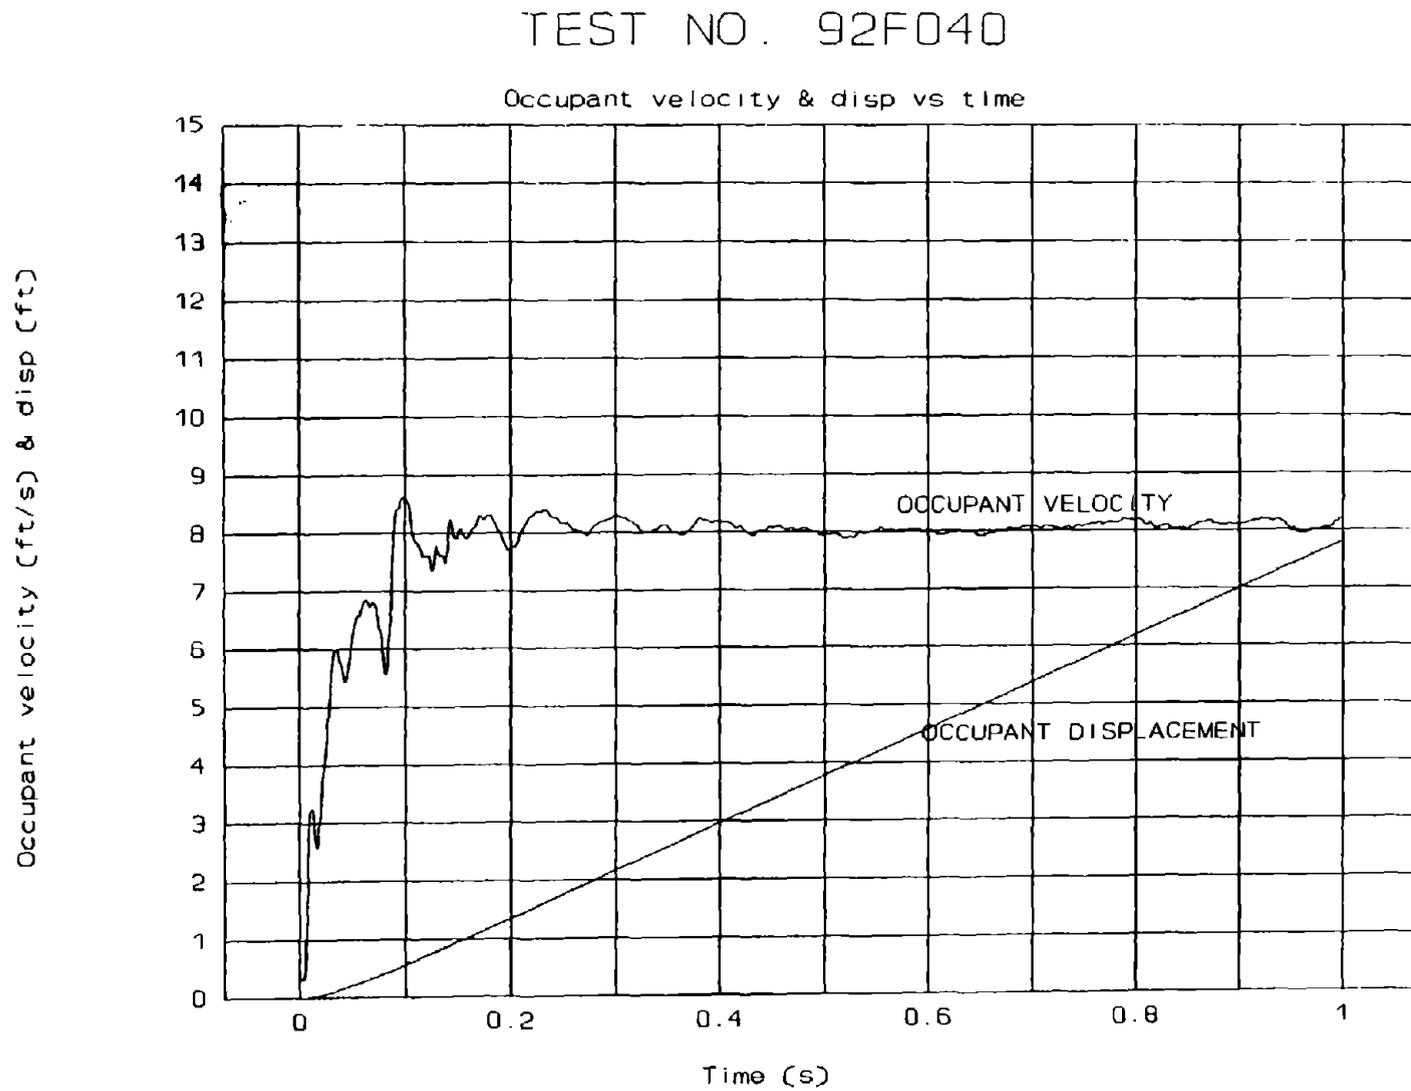
Figure 7. Occupant velocity and relative displacement versus time, X-axis, test 92F040.

The test results indicate that the small sign support system does not meet all of the applicable criteria for the high-speed test in strong soil. The occupant impact velocity was 8.1 ft/s (2.5 m/s) which is less than or equal to the 16-ft/s (4.9-m/s) limit specified by the FHWA and the significant test article stub height remaining after the test was 1.75 in (44.4 mm) which is less than or equal to the 4-in (101.6-mm) limit. However the impact between the sign panel/posts and the roof and windshield, caused severe collapse of the vehicle's roof and shattered the windshield. The occupant compartment was severely damaged and could put an occupant at a higher risk of injury.
