Publication No. FHWA-RD-93-111

# Testing of Small and Large Sign Support Systems FOIL Test Number: 92F023

U.S. Department of Transportation  
**Federal Highway Administration**

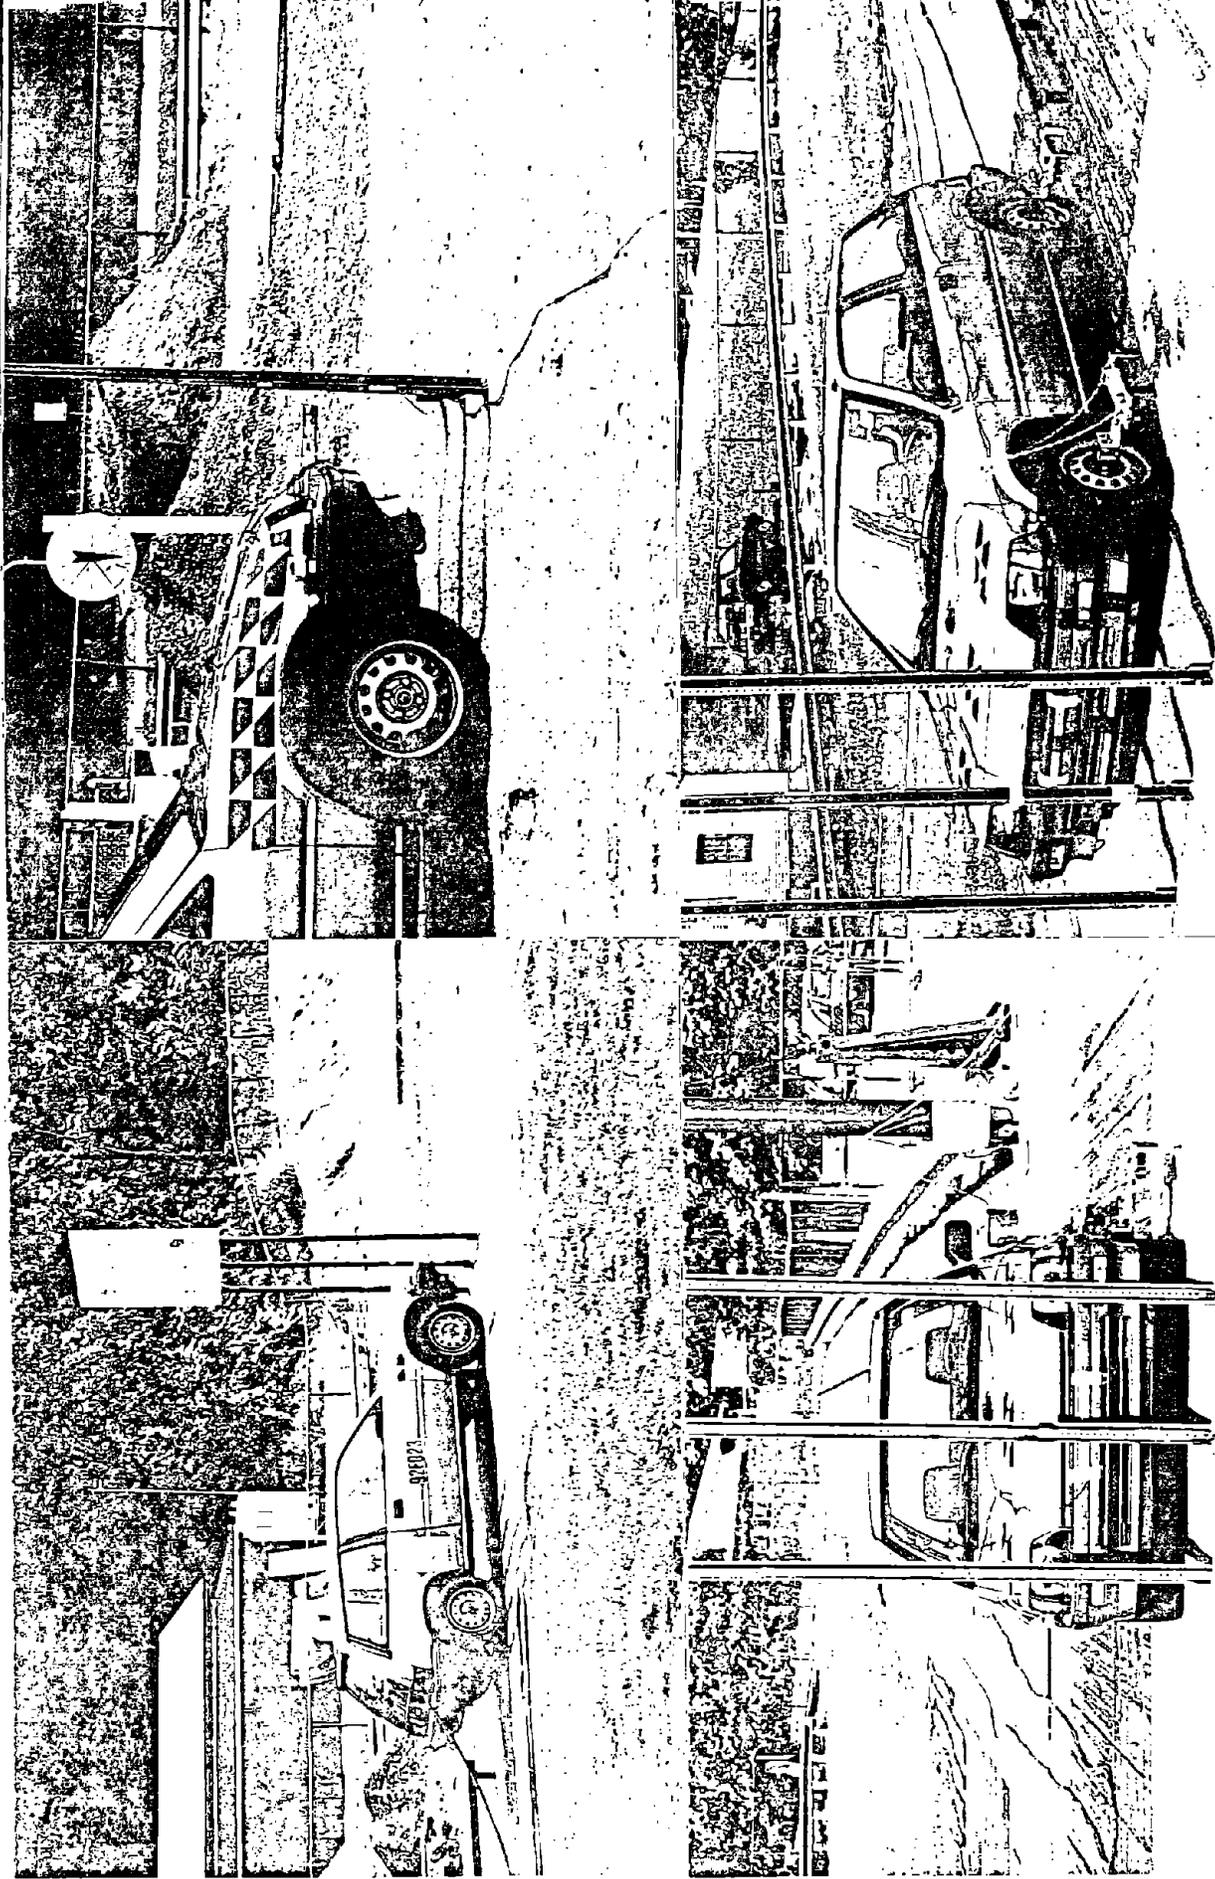
Figure 9. Pretest photographs of test 92F023.

Damage to the vehicle consisted of minor damage to the bumper and grill. The center of the bumper was dented 3 in (76.2 mm), the right and left side of the vehicle sustained minor damage to the cosmetic plastic bumper elements. The occupant compartment was intact after the test. Damage to the sign system consisted of three bent and twisted u-channel posts. The sign posts were removed from the ground after the test and a bend was recorded 12 in (304.8 mm) below the groundline. The panel was in good condition after the test. No sign components impaled the occupant compartment.
