Publication No. FHWA-RD-93-098
July 1994

Testing of Small and Large Sign Support Systems FOIL Test Number: 92F011

U.S. Department of Transportation
Federal Highway Administration

This test report contains the results of a crash test performed at the Federal Outdoor Impact Laboratory (FOIL) in McLean, Virginia. The test was performed on a small sign support system at 20 mi/h (8.9 m/s), test 92F011. The vehicle used for this test was a 1984 Honda Civic. The purpose of this test was to evaluate the low-speed safety performance of a dual legged steel 4 lb/ft (5.95 kg/m) u-channel sign support. The performance evaluation was based on the latest requirements for breakaway supports as specified in Volume 54, Number 3 of the Federal Register dated January 5, 1989. These criteria specify, in part, that the occupant change in velocity must be 16 ft/s (4.9 m/s) or less, that the significant test article stub height remaining after impact be no more than 4 inches (102 mm), and that there can be no occupant compartment intrusion.

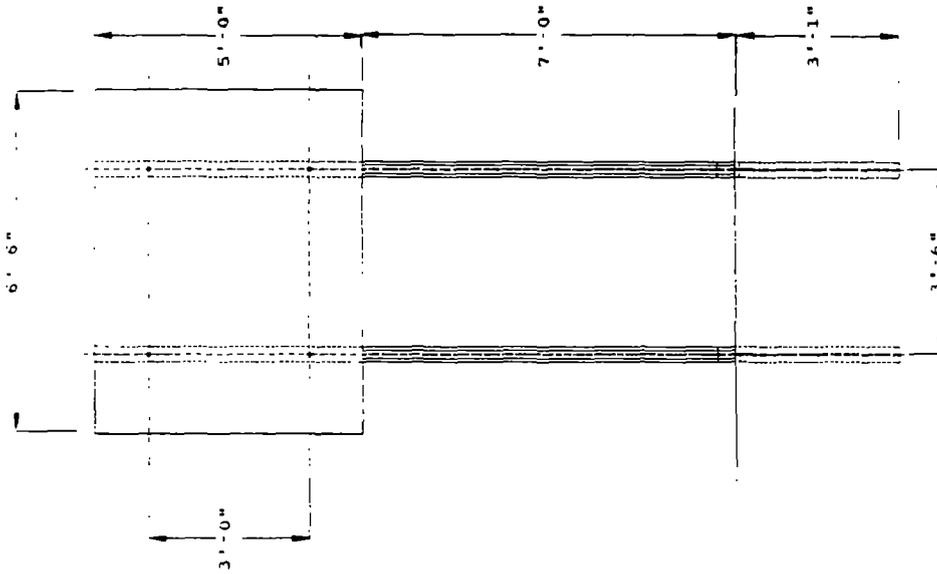
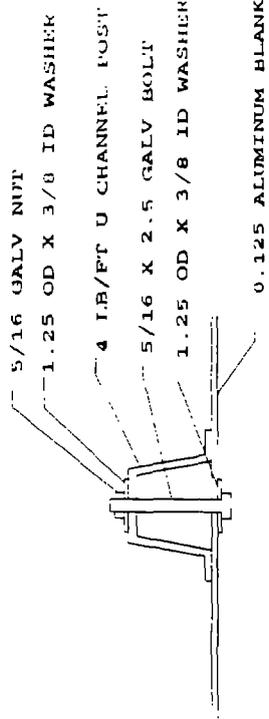
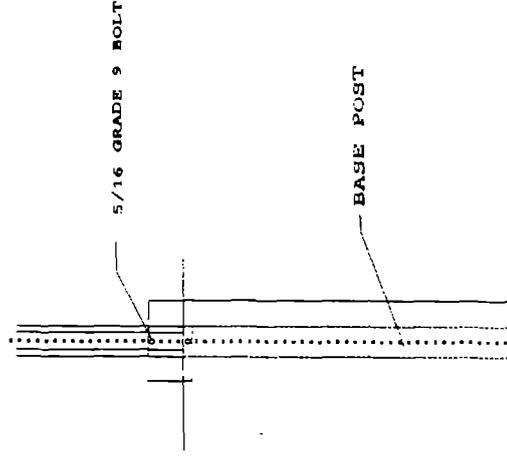
NOTE:
 USE SPLICE PARTS AND TECHNIQUES AS
 SUPPLIED BY MARION STEEL

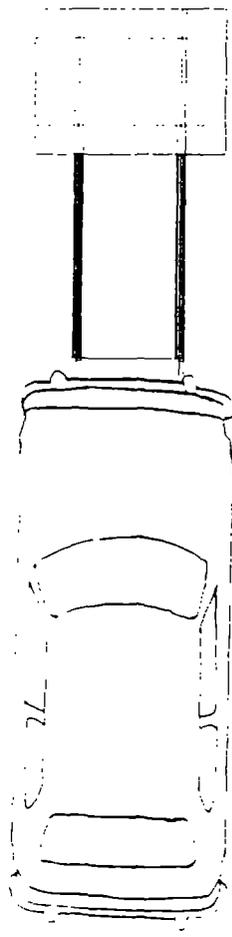
Figure 4. Summary of test 92F011.

The test results indicate that the small sign support system does not meet all of the applicable criteria for the low speed test in weak soil. There was no occupant compartment intrusion and no significant stub remaining after the test, however the occupant impact velocity was 21.4 ft/s (6.5 m/s) which is not less than or equal to the 16 ft/s (4.9 m/s) limit specified by the FHWA.

Test number.....	92F011	Vehicle analysis:	<u>Observed</u>	<u>Design/Limit</u>
Date.....	May 19, 1992	Longitudinal:		
Test vehicle.....	1984 Honda Civic	Occupant Delta V at 2 ft.....	21.4 ft/s	≤16 ft/s
		Ridedown Acceleration.....	3.0 g's	15/20 g's
Vehicle weight.....	1850 lb (839 kg)	Lateral:		
Test article.....	Small Sign Support	Occupant Delta V at 1 ft.....	no contact	no spec
		Ridedown Acceleration.....	no contact	no spec
Material.....	4 lb/ft v-channel 5 inch splice	Peak 50 msec acceleration		
Embedment depth.....	2-Leg, 2-Hit	Longitudinal.....	4.2 g's	
3 feet	Lateral.....	NA	
Panel type.....	5 foot by 6.5 foot by 0.125 thick aluminum sheet	Vehicle Damage (IAD)		12-FC-2
Height.....11 feet	(VDI).....		12FDEN1
Foundation.....S-2 Weak Soil	Vehicle crush.....		9.5 inches
Impact speed.....29.7 ft/s (9.1 m/s)	Vehicle velocity change.....		28.4 ft/s
Impact angle.....0 degrees	Exit angle.....		no exit
Impact location.....	Head-on, centerline
