Publication No. FHWA-RD-93-102

# Testing of Small and Large Sign Support Systems FOIL Test Number: 92F014

6. Performing Organization Code	
7. Author(s) Christopher M. Brown		8. Performing Organization Report No.	
9. Performing Organization Name and Address Advanced Technology & Research Corp. 15210 Dino Drive Burtonsville, MD 20866		10. Work Unit No. (TRAIS) 3A5f3142

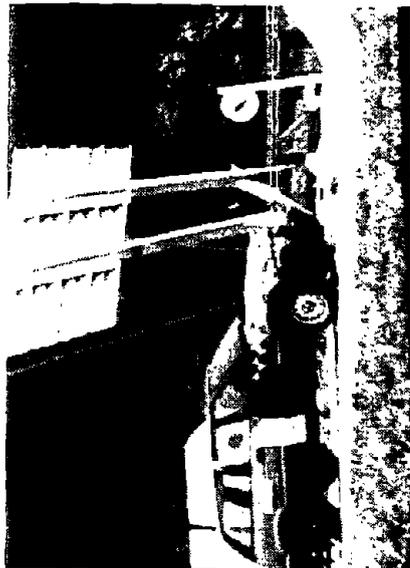
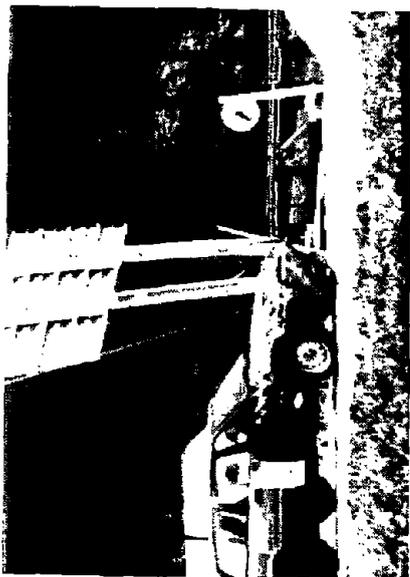
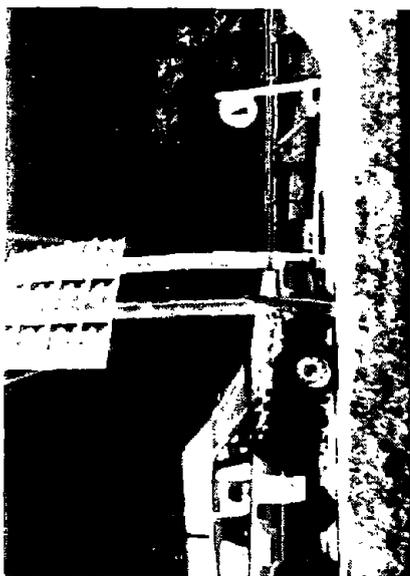
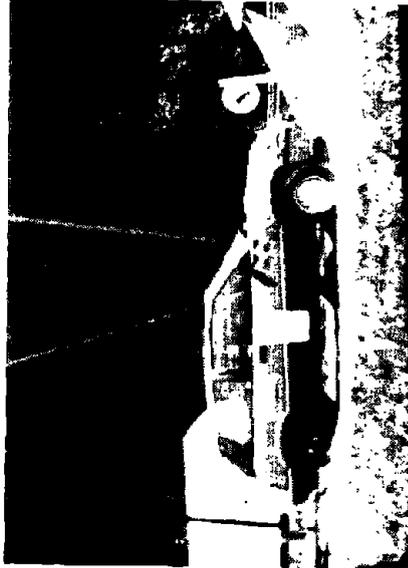
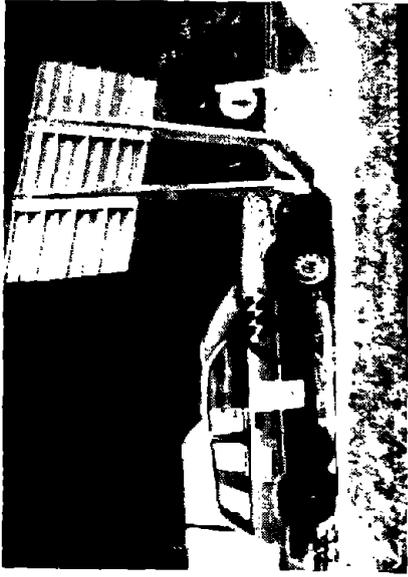
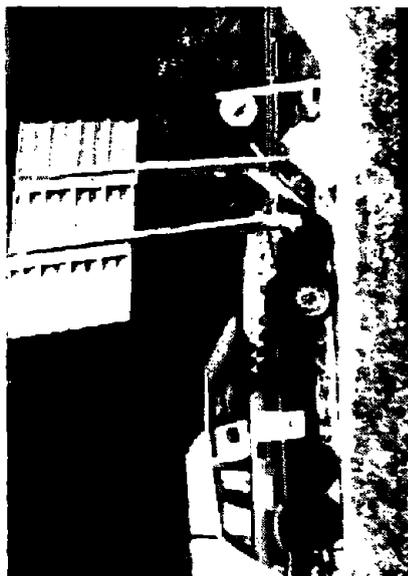
Figure 3. Test photographs during impact, test 92F014.

The bumper made contact with both sign legs and began to collapse. The brunt of the impact occurs to outside edge of the bumper supports on either side of the test vehicle. The bumper had collapsed to the headlight socket 0.020 s into the event. During the collapse of the bumper, the wooden legs were bowed outward away from the vehicle. At 0.022 s the wooden legs began to fracture. The right leg fractured approximately 3 ft (1.2 m) above ground. The left leg began to fracture 4 ft (0.9 m) above ground. Thirty milliseconds into the event, the right leg had broken completely at 3 ft (0.9 m) and had begun fracture down at the steel sleeve insert. The left had not broken completely at 4 ft (1.2 m). The right leg had completely fractured in two places 0.050 s after initial contact. The left leg continued to resist fracture but had begun to split vertically. At 0.114 s the left leg continued to split vertically and the vehicle continued to push on the lower segment of the wooden leg. The moment exerted on the left leg by the vehicle pushing 19 in (0.483 m) above ground did not fracture the wood at the ground line, instead the soil collapsed in front of the foundation and the concrete foundation rotated up towards the surface. Because the left leg never completely fractured and the left foundation rotated well after the right leg failed, the vehicle yawed counter-clockwise approximately 20 degrees. No secondary impact occurred between the vehicle and the sign support. The remainder of the wood legs with the panel attached fell backwards away from the vehicle.

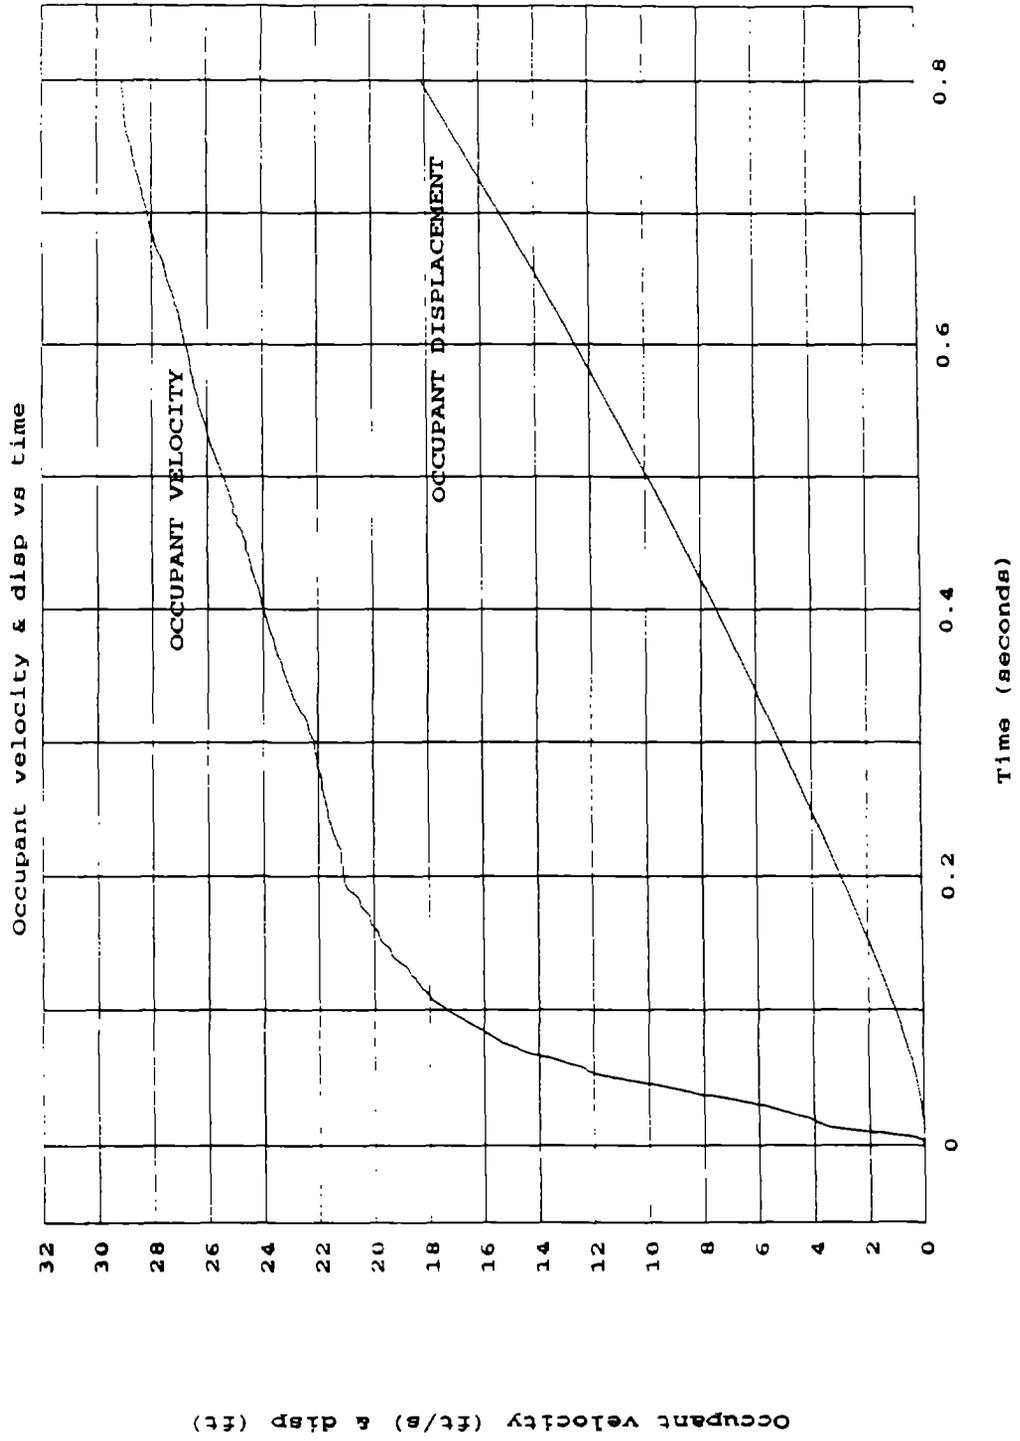
Figure 8. Occupant velocity and relative displacement versus time, X-axis, test 92F014.

The test results indicate that the small sign support system does not meet all of the applicable criteria for the low-speed test in weak soil. There was no occupant compartment intrusion and no significant stub remaining after the test, however the occupant impact velocity was 19.8 ft/s (6.0 m/s) which is not less than or equal to the 16 ft/s (4.9 m/s) limit specified by the FHWA.
