Publication No. FHWA-RD-93-105

July 1994

Testing of Small and Large Sign Support Systems FOIL Test Number: 92F017

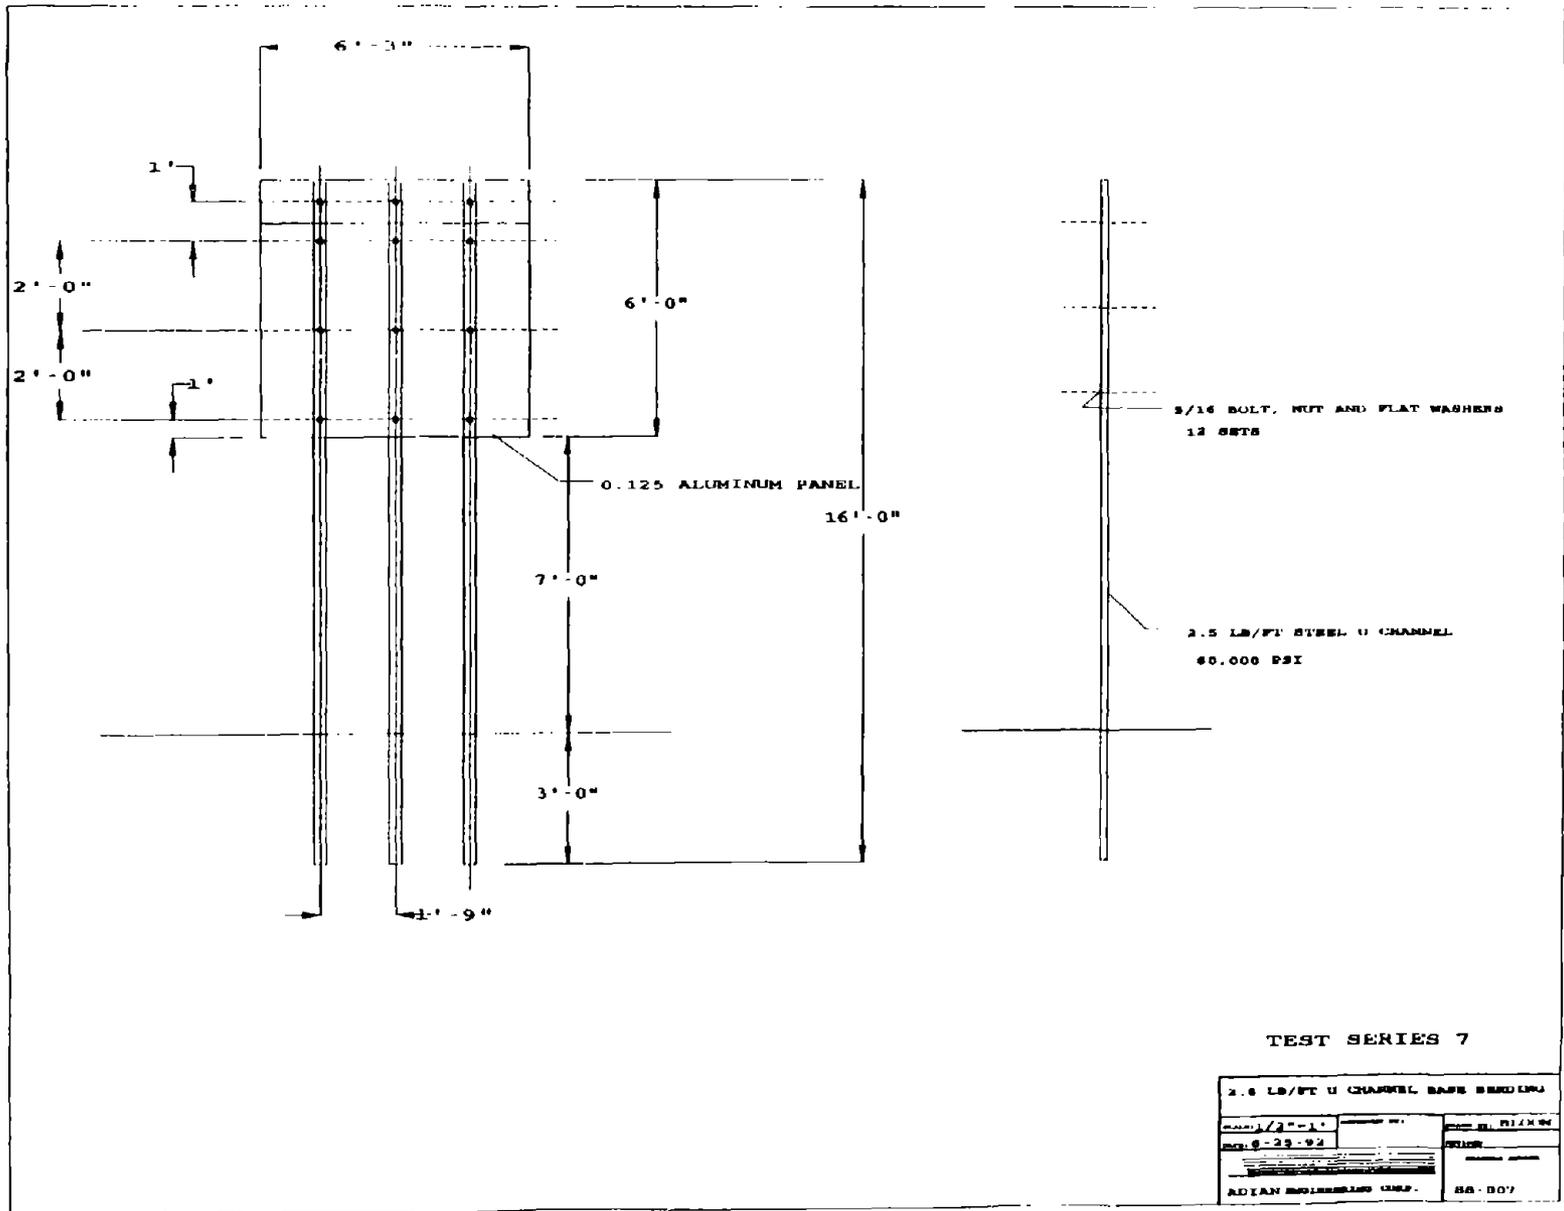
Figure 1. Sketch of small sign support.

The sign support system consisted of three 2.5 lb/ft (3.72 kg/m) steel u-channel legs 15 ft (4.6 m) long. Three feet (0.9 m) of each leg was buried in NCHRP Report 230 S-2 weak soil (sand). Attached to the 2 legs was a 6-ft high by 6-ft 3-in wide (1.8-m by 1.9-m) aluminum sign panel. The panel was a 0.125-in (3-mm) thick aluminum sheet and was installed 7-ft (2.1-m) above ground. The three legs were installed 1.7-ft (0.5-m) apart. The whole sign support system was assembled and inserted in a hole in the weak soil.

The hole was backfilled in 6-in (0.152-m) lifts and compacted until the final grade was reached. Figure 1 is a drawing of the sign support system.

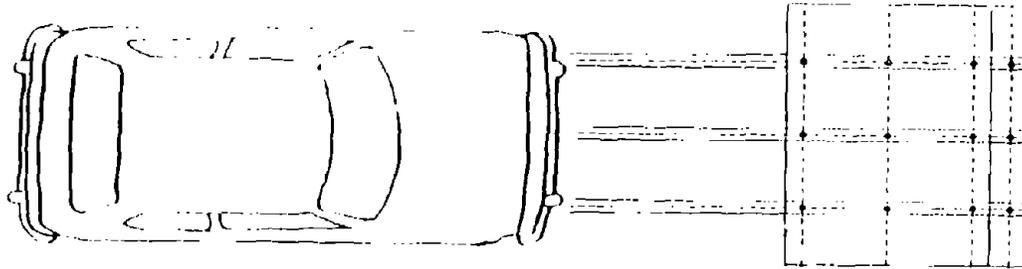
Figure 3. Summary of test 92F017.

The test results indicate that the small sign support system does not meet all of the applicable criteria for the low-speed test in weak soil. There was no occupant compartment intrusion and no significant stub remaining

after the test, however the occupant impact velocity was 21.1 ft/s (6.4 m/s) which is not less than or equal to the 16 ft/s (4.9 m/s) limit specified by the FHWA.

Test number..... 92F017
 Date..... June 30, 1992
 Test vehicle.....1985 Honda Civic
 Vehicle weight.....1850 lb (839 kg)
 Test article.....Small Sign Support
 Material.....2.5 lb/ft u-channel
 3-Leg, 3-Hit
 Embedment depth......3 feet
 Panel type.....6 foot 3 inch by 6 foot aluminum sheet
 Height......13 feet
 Foundation.....S-2 Weak Soil
 Impact speed.....31.6 ft/s (9.6 m/s)
 Impact angle......0 degrees
 Impact location.....Head-on, centerline

Vehicle analysis:	<u>Observed</u>	<u>Design/Limit</u>
Longitudinal:		
Occupant Delta V at 2 ft.....	21.1 ft/s	≤16 ft/s
Ridedown Acceleration.....	2.5 g's	15/20 g's
Lateral:		
Occupant Delta V at 1 ft.....	no contact	no spec
Ridedown Acceleration.....	no contact	no spec
Peak 50 msec acceleration		
Longitudinal.....		0.9 g's
Lateral.....		NA
Vehicle Damage (TAD).....12-FC-2		
(VDI).....		12FDEN2
Vehicle crush.....		7.5 inches
Vehicle velocity change.....		31.1 ft/s
Exit angle.....		no exit
