EVALUATION OF THE PERFORMANCE OF A PRESS-LAM TIMBER BRIDGE

Bridge Performance and Load Test After Five Years

June 1982  
VHTRC 82-R56

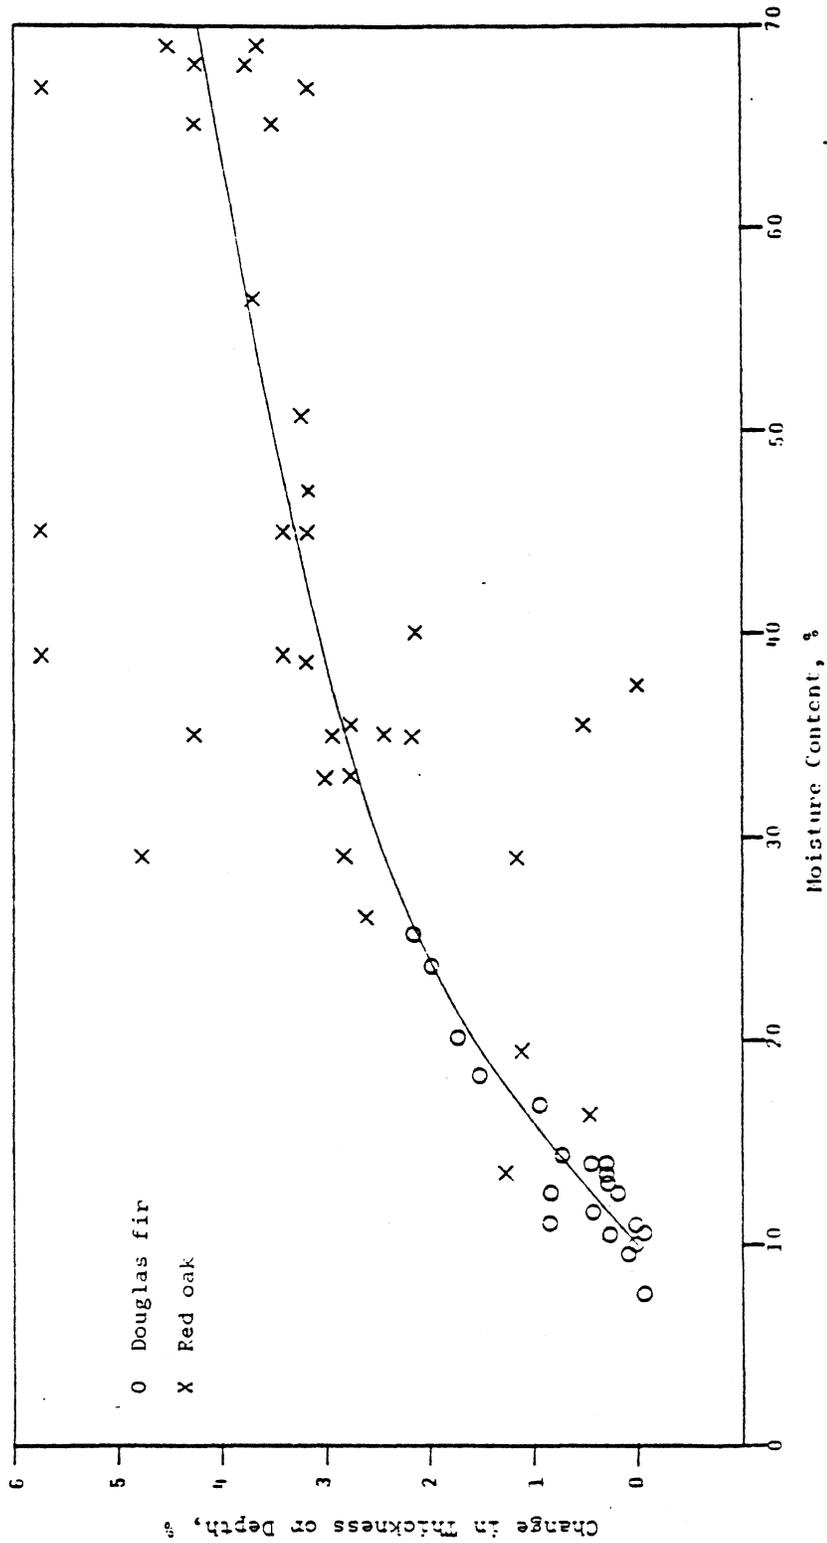
Figure 6 shows the relationship between the moisture content and the change in the thickness or depth of the members based on the data in Tables 4 and 5. It's interesting to note that the members exhibiting the highest moisture content also exhibited the greatest delamination and dimensional changes.

Figure 6. Relationship between moisture content and change in thickness or depth of Pres-lam members.
