INVESTIGATION OF DELAYED CRACKING IN PIVOT STEEL BOX GIRDERS

Report No. VTRC 97-R18	Report Date June 1997	No. Pages 110	Type Report: Final Period Covered: April 96- June 97	Project No.: 9133-010
Title and Subtitle: Investigation of Delayed Cracking in Pivot Steel Girders				Key Words: high-strength steel, box girder, delayed cracks, nondestructive evaluation, metallurgical and failure analyses, crack growth, brittle and fatigue failure assessment
Authors: M. G. Lozev, G. A. Washer, and W. J. Wright				
Performing Organization Name and Address: Virginia Transportation Research Council 530 Edgemont Road Charlottesville, VA 22903				
Sponsoring Agencies' Name and Address Virginia Department of Transportation 1401 E. Broad Street Richmond, VA 23219				
Supplementary Notes				
<p>Abstract:</p> <p>This report describes the results of an investigation to find the cause of the delayed cracking in the welds of the fracture-critical steel pivot box girders fabricated for the George P. Coleman Bridge. Through the use of different nondestructive methods, more than 200 transverse and longitudinal cracks were found.</p> <p>The possibility of unique, rare, and very long-term delayed cracking (co

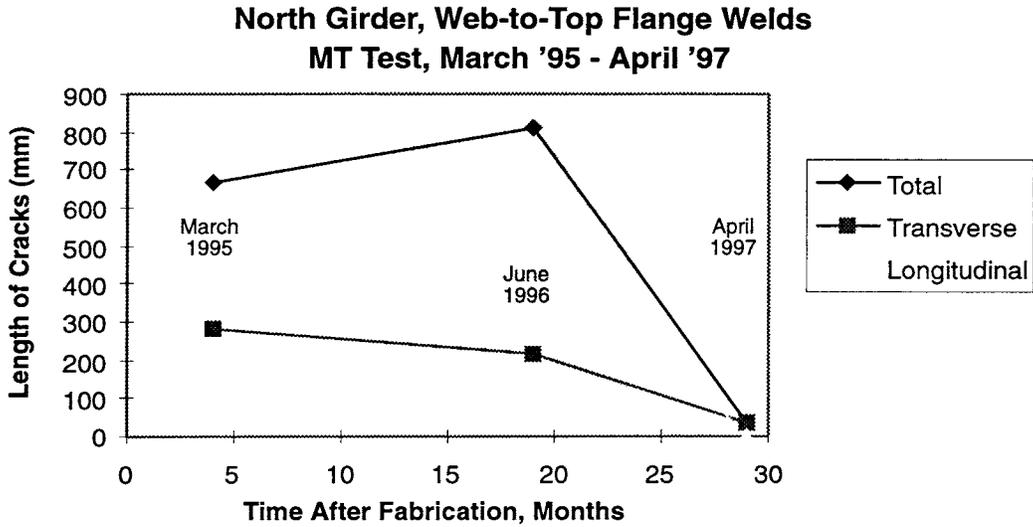
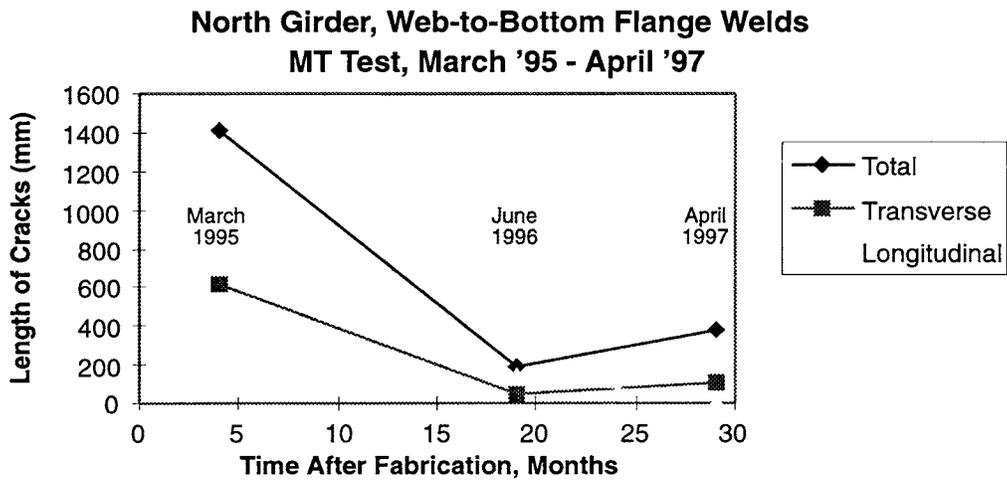
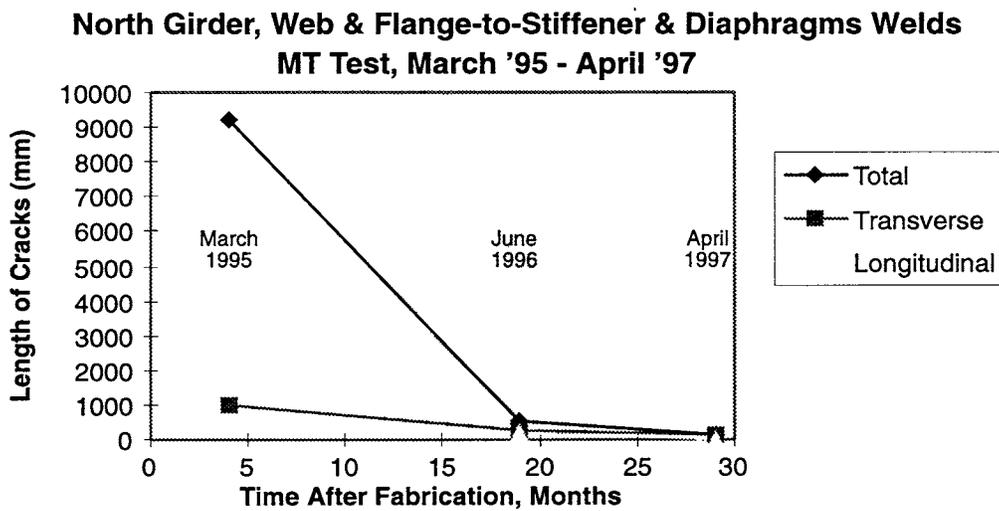
Figure 8. Distribution of Number of Cracks vs. Time After Fabrication.

The distribution of the number and length of cracks in the north girder vs. time after fabrication is shown in Figures 8 and 9. Increased delayed cracking was observed in the web-to-top flange groove weld in June 1996 and in the web-to-bottom flange weld in April 1997. A steady decline of cold cracking was noticed in the web and flange-to-stiffener and diaphragm welds. The distribution of the number of cracks vs. length of crack for these three MTs is shown in Figures 10 through 12. Most of the transverse cracks were less than 50 mm (2 in) long. The longest longitudinal crack was more than 0.5 m (20 in) long and was detected in the web-to-stiffener and flange-to-diaphragm welds. Two longitudinal cracks longer than 375 mm (15 in) were detected in the web-to-top flange welds. MT reinspection after field repairs detected five transverse cracks 13 mm (½ in) long 13 to 25 mm (½ to 1 in) outside the repair areas and only one transverse crack 13 mm (½ in) long in the repair areas.

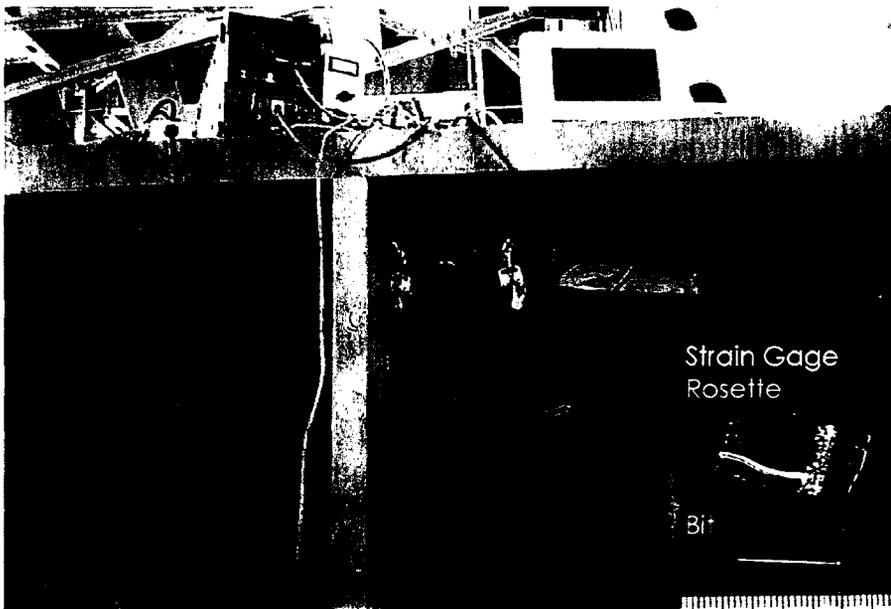
Figure. 16

200 Milling Guide with the fixture attached to the web-to-top flange groove weld is shown in Figure 16, as are a cone bit and a rosette with three strain gages at 45° increments around the target.

Figure 16. Equipment for Blind Hole-Drilling Strain-Gage Residual Stress Measurements at Groove Web-to-Top Flange Weld.

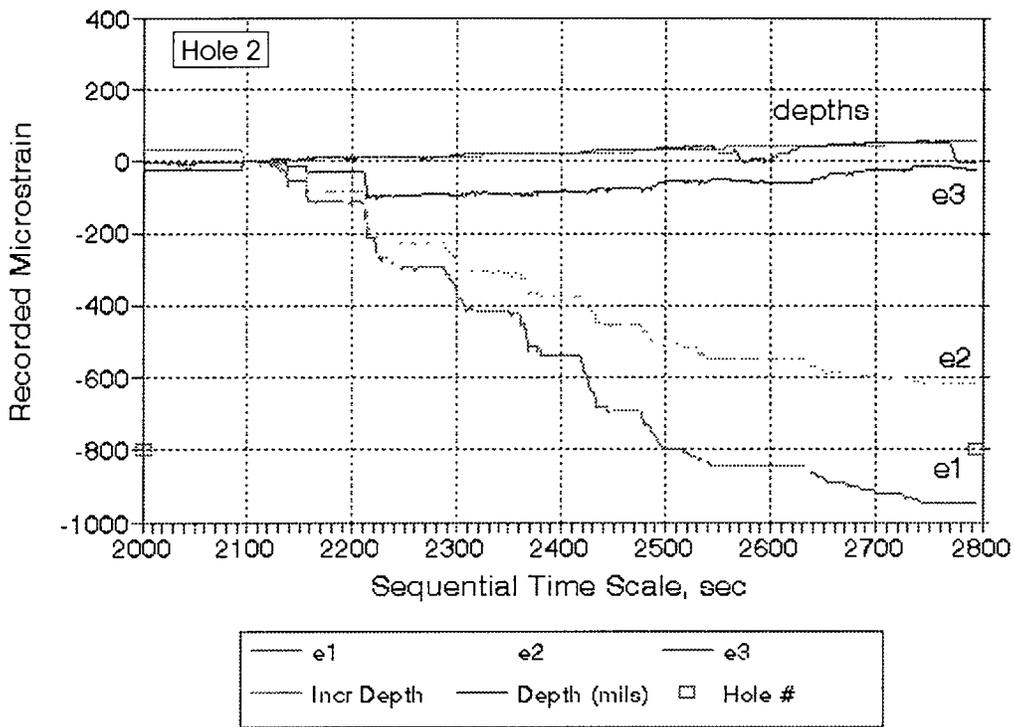
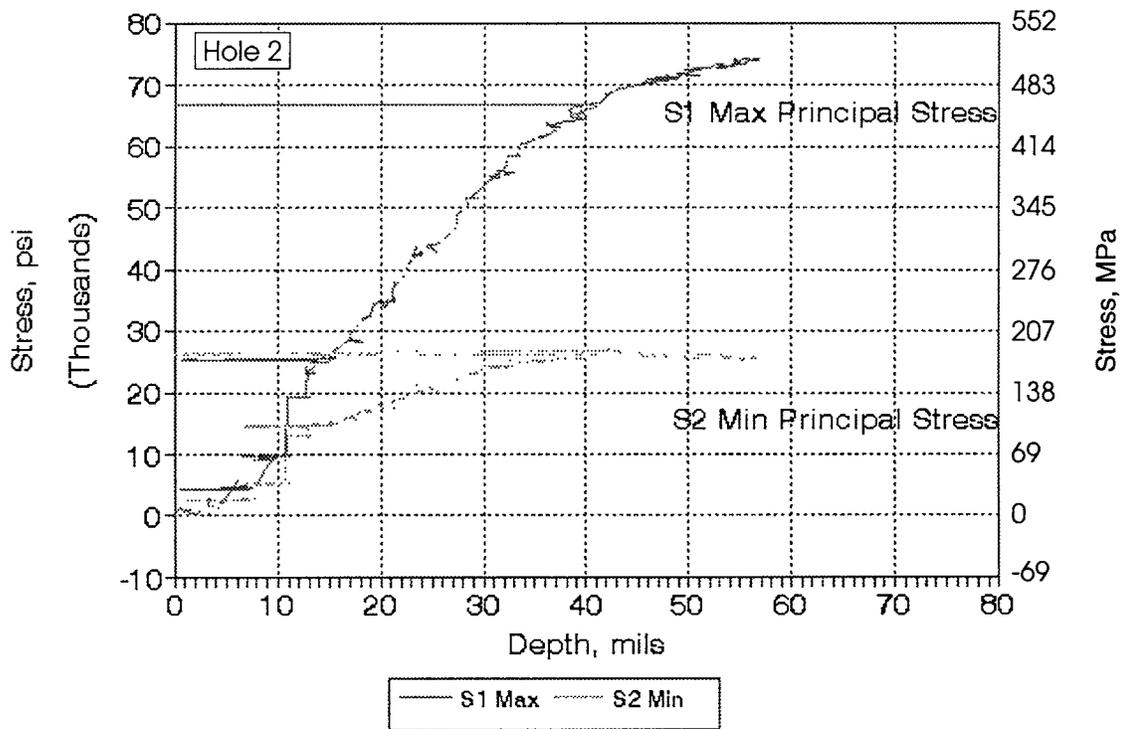
Figure 18. Microstrain vs. Elapsed Time and Stress vs. Depth for Hole 2.

Hole 2. This was the maximum stress location, on the web-to-stiffener fillet (tee) weld of stiffener 8, 380 mm (15 in) above the flange and 38 mm (1½ in) below the longitudinal crack at core location H. The maximum tensile stress was 511 MPa (74,117 psi) in the longitudinal direction, essentially at yield of the base material. The depth of the hole was 1.4 mm (0.055 in). The plots for microstrain vs. elapsed time and stresses vs. depth are shown in Figure 18.

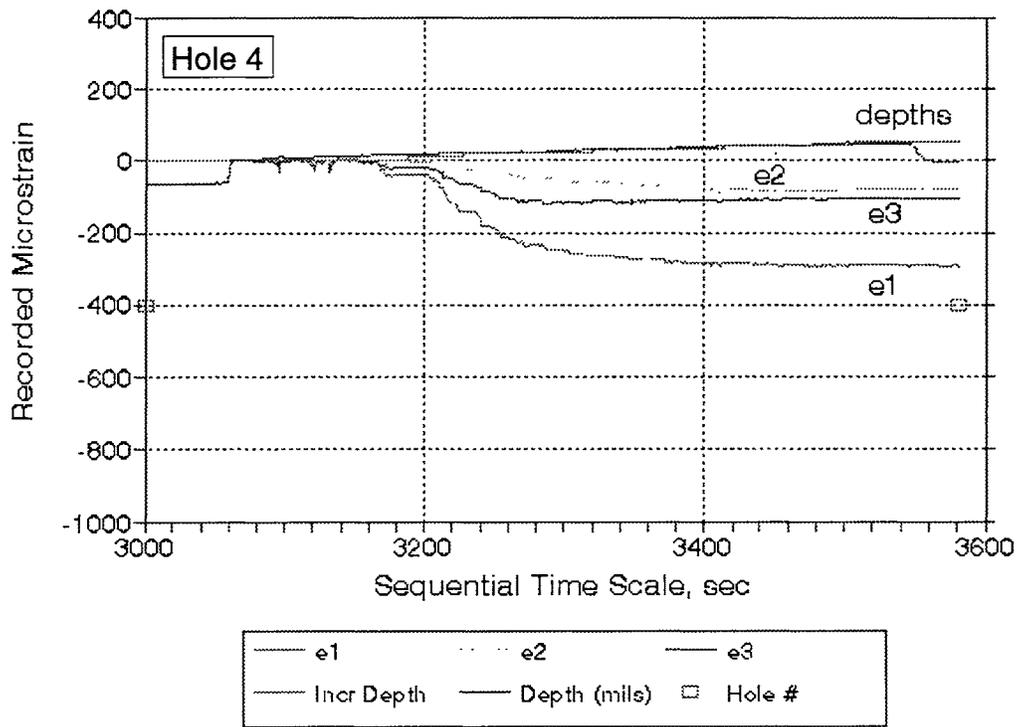
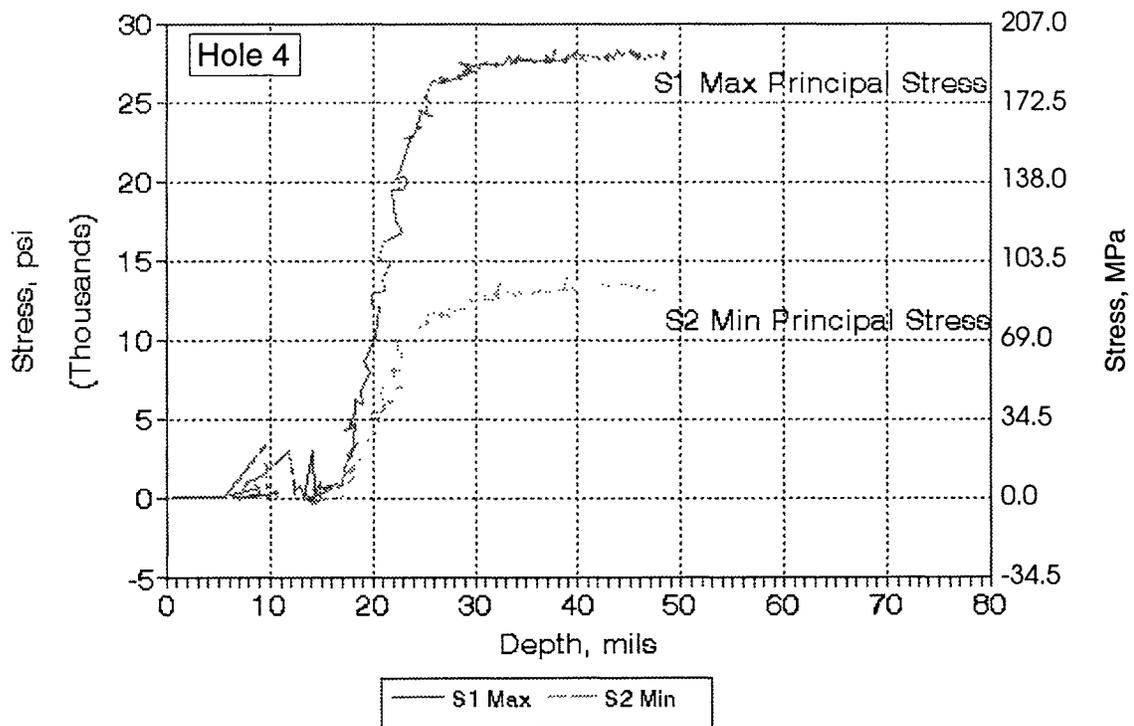
Figure 19. Microstrain vs. Elapsed Time and Stress vs. Depth for Hole 4.

Hole 4. This location was near a crack on the web-to-bottom flange fillet weld between stiffeners 8 and 9. As the surface of the weld was being ground, a new crack was discovered. The measurement was approximately 19 mm (¾ in) from the new crack. The maximum tensile stress was 194 MPa (28,076 psi), approximately in the direction of the weld. The depth of the hole was 1.3 mm (0.05 in). The plots for microstrain vs. elapsed time and stresses vs. depth are shown in Figure 19.

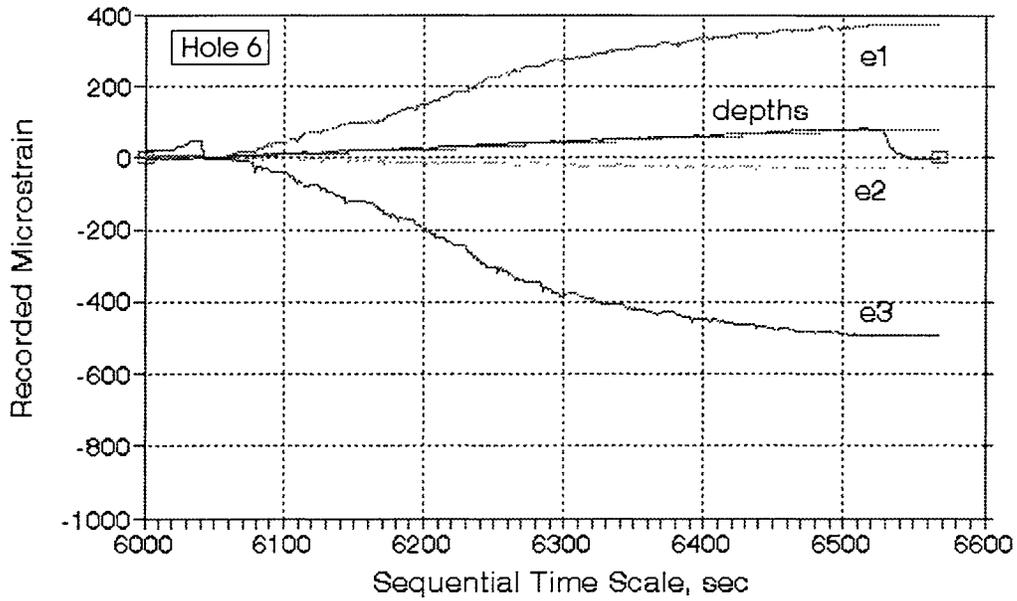
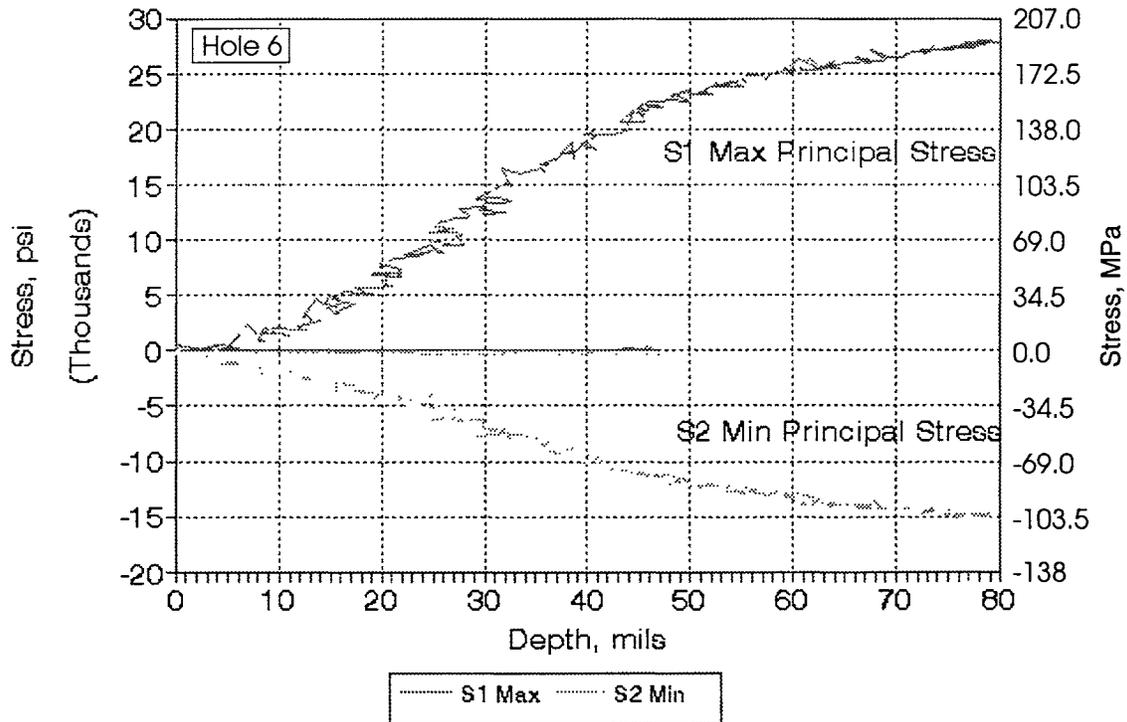
Figure 20. Microstrain vs. Elapsed Time and Stress vs. Depth for Hole 6.

Hole 6. This was a repeat near hole 5, with the hole located 130 mm (5 1/8 in) from the stiffener. This time, the results were acceptable, with a maximum tensile stress of 192 MPa (27,759 psi) using the full 2-mm (0.080-in) depth. The stress was along the weld. The plots for microstrain vs. elapsed time and stresses vs. depth are shown in Figure 20.

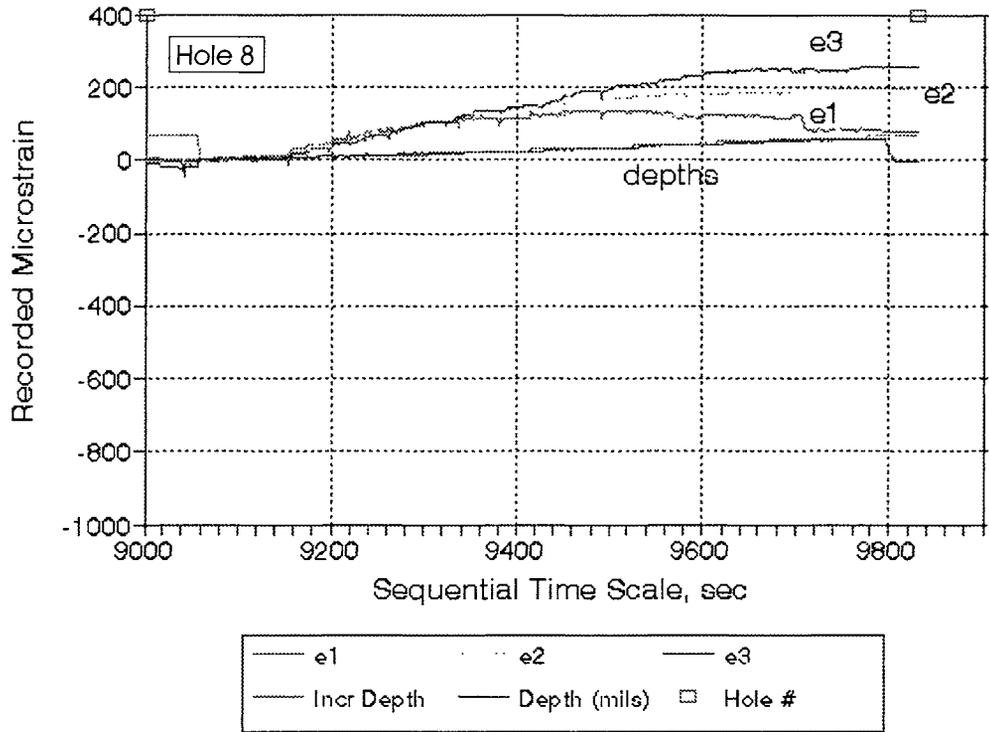
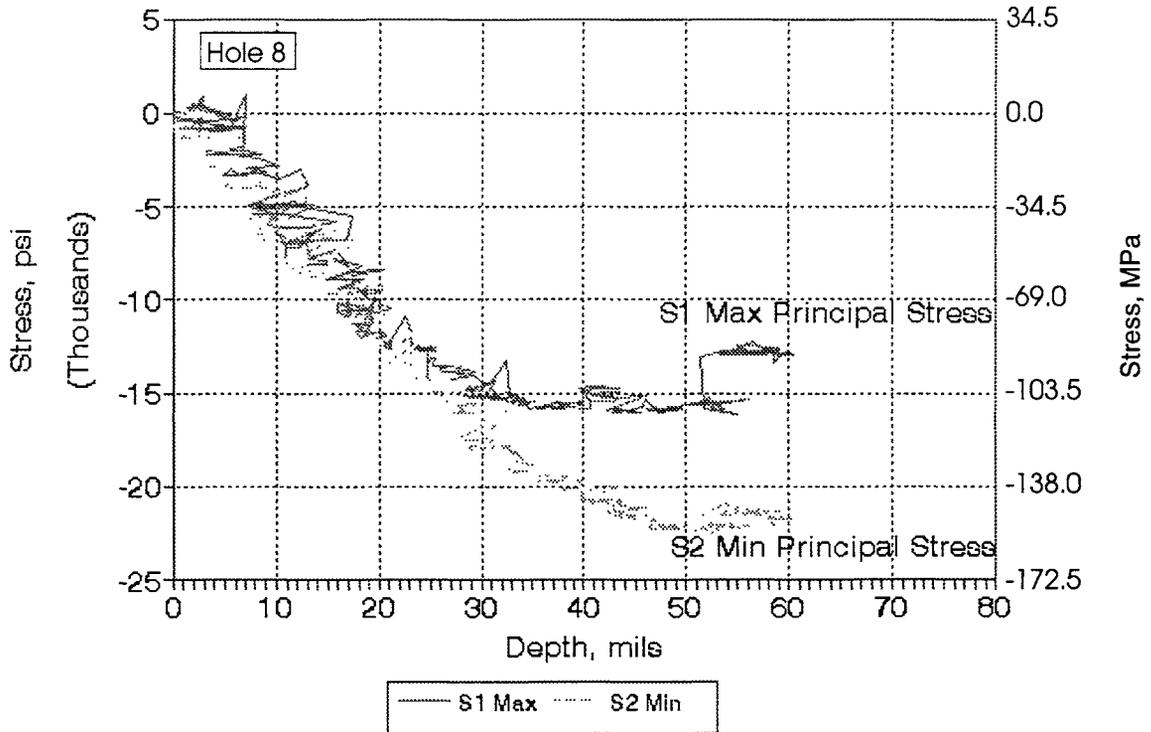
Figure 21. Microstrain vs. Elapsed Time and Stress vs. Depth for Hole 8.

Hole 8. The final location was on the bottom flange itself and not on a fillet weld. This location was 106 mm (4¼ in) from the corner of stiffener 9 toward the end and 57 mm (2¼ in) from the edge of the flange. The maximum compression stress was -87 MPa (-12,688 psi), and the minimum compression stress was -152 MPa (-22,013 psi). The minimum stress was along the length of the beam, and the maximum was along the transverse. Drilling was halted at 1.5 mm (0.06 in) to minimize the grinding required to remove the hole. The plots for microstrain vs. elapsed time and stresses vs. depth are shown in Figure 21.

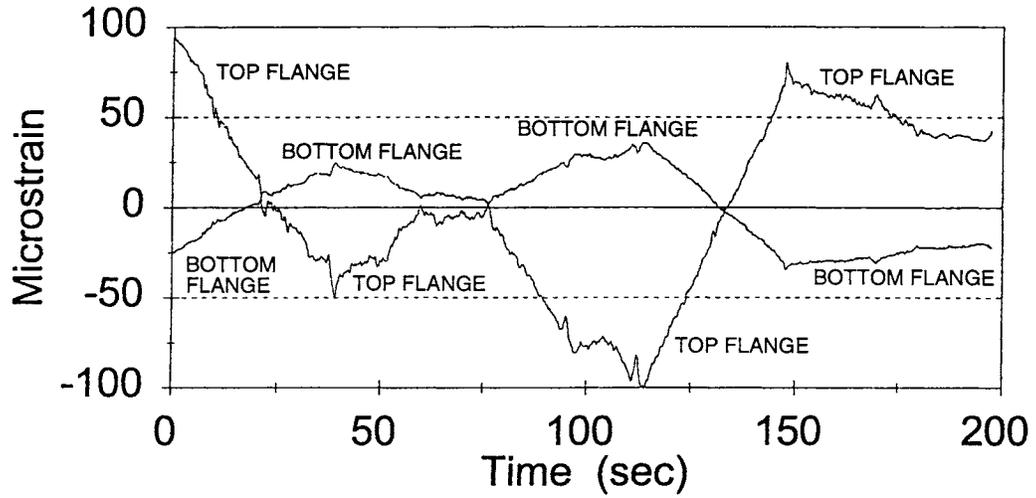
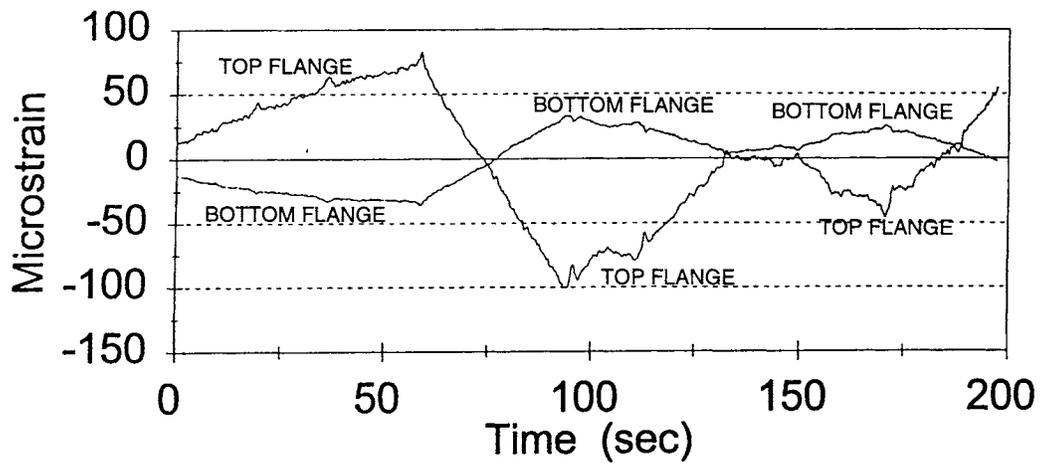
Figure 24. Average Strain in Top and Bottom Flange During Bridge Opening and Closing.

Strain Data, Bridge Closing. Figure 24b shows the average flange strain during closing. Data collection was initiated after the girder began to rotate and was stopped before the girder

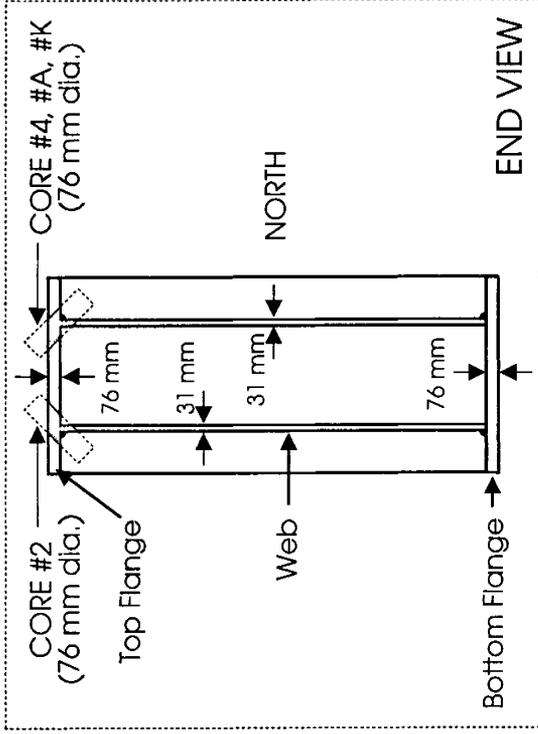
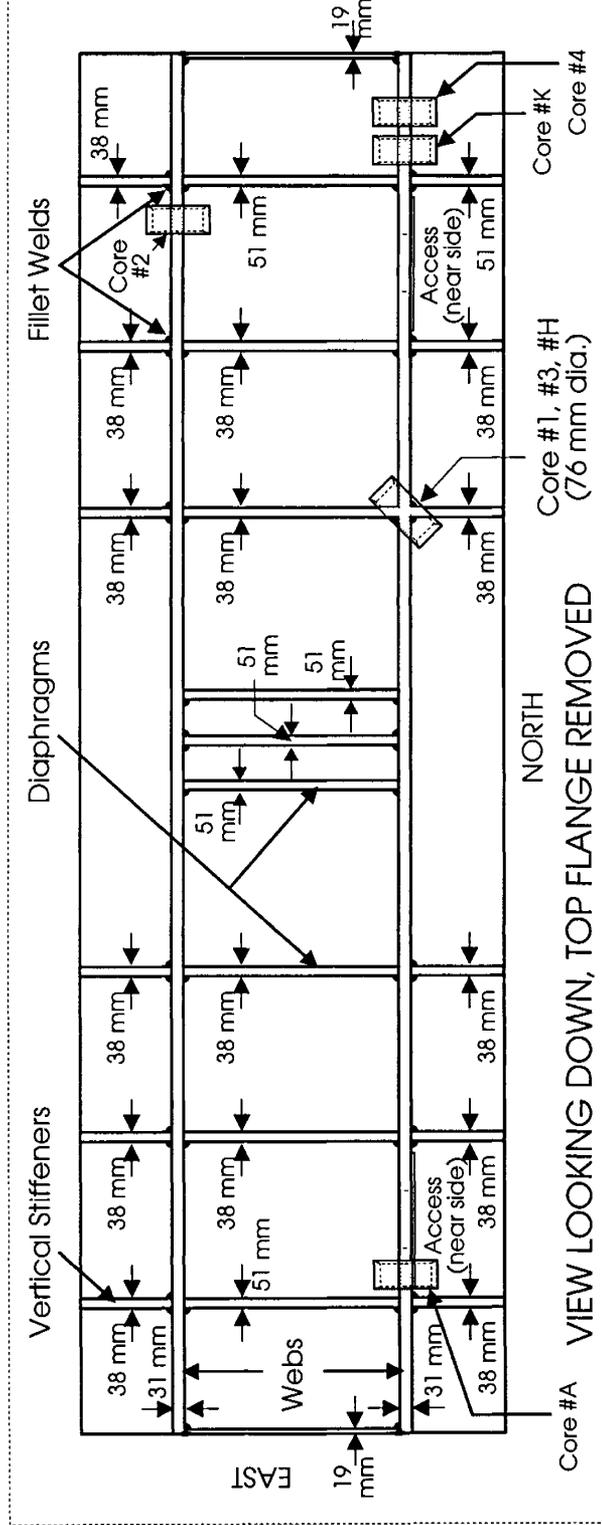
Figure 27. Locations of the Cores in the Pivot Girders.

COLEMAN BRIDGE
ROUTE 17 OVER YORK RIVER, VA.
 PIVOT GIRDERS A121, B121
 ASTM A709 GRADE 70W STEEL

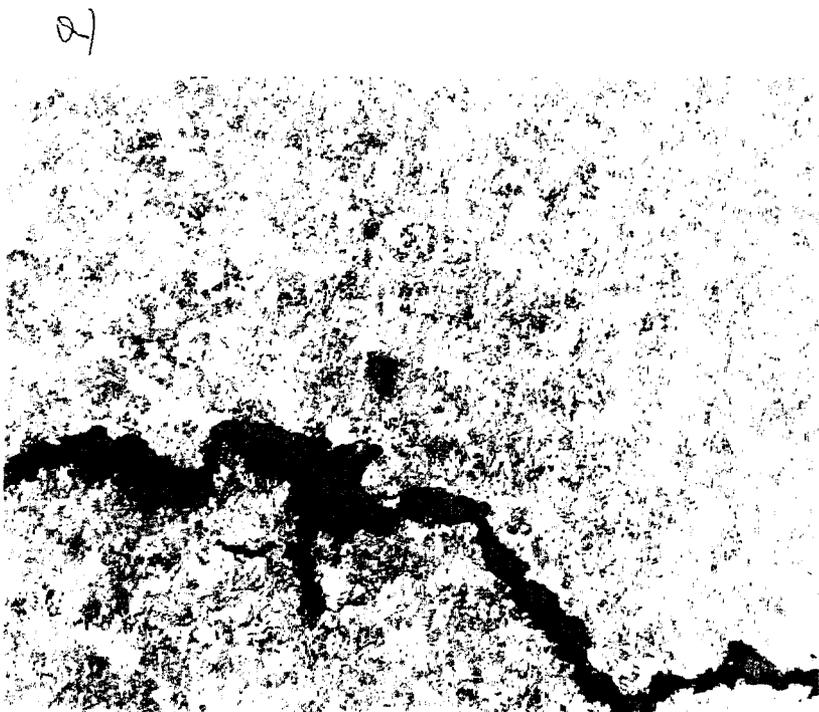
Figure 31. Fine Surface-Breaking Crack in Core 3.

The crack depth of surface-breaking cracks measured with DPT varied from microns to weld-through cracks 25 mm (1 in) deep. The crack width on the weld face varied from microns to 1 to 2 mm (0.2 to 0.5 in). Figure 31a shows a very fine crack averaging 30 μ wide on the surface of core 3. This crack was detected by MT in March 1995. Figure 31b is a photomicrograph of the tangential longitudinal section taken from this area with a suspected fracture. The microstructure is polygonal ferrite with lower bainite. A suspected slag inclusion within the fracture is shown, too. This very fine crack at the weld face probably developed at the time of fabrication, before the first painting system was applied. Attempts to separate a fracture at this location revealed surfaces extensively coated with organic matter that inhibited imaging in the electron microscopy. The crack was probably very small during the first MT inspection in the shop and was not detectable, or it may have developed after MT but before the coating was applied.

(a) digital image of crack at higher magnification

(b) metallurgical microstructure of weld metal in cracked area (polygonal ferrite with lower bainite/martensite) (500x).

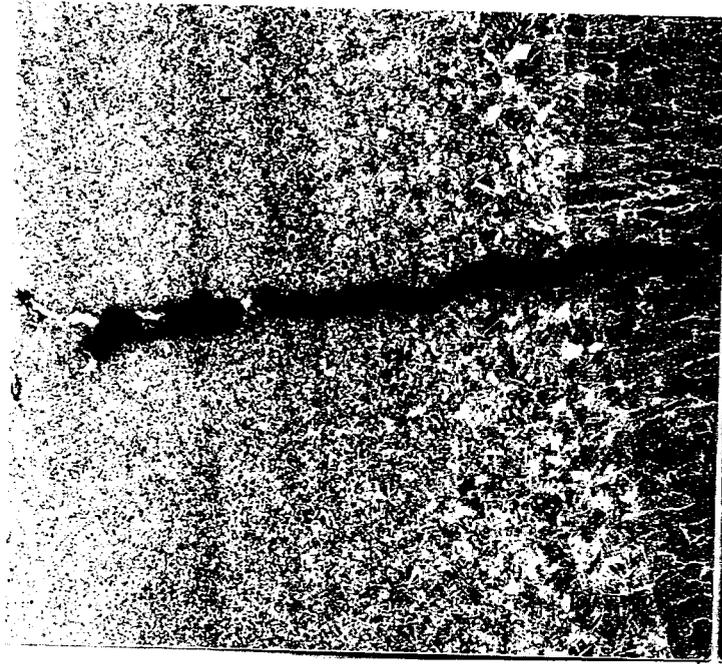
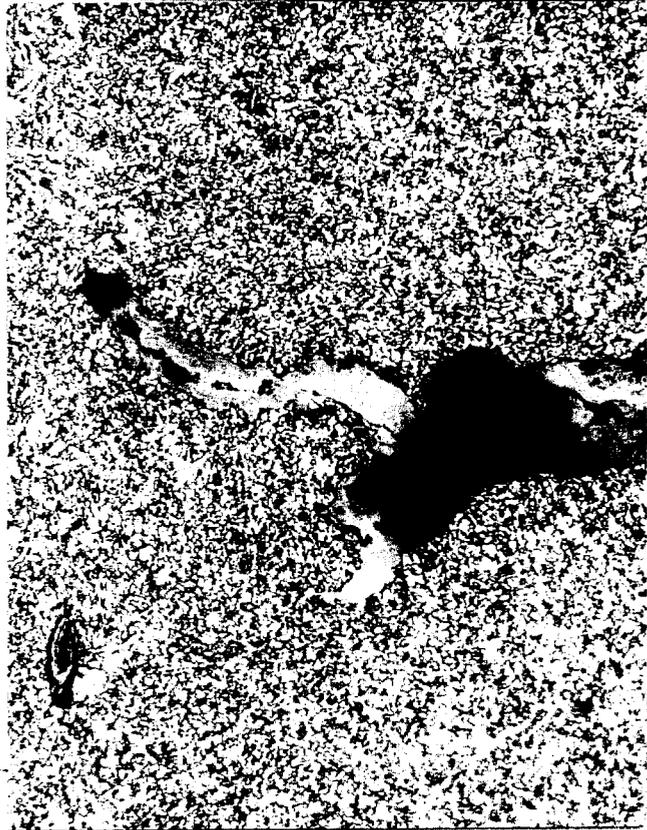
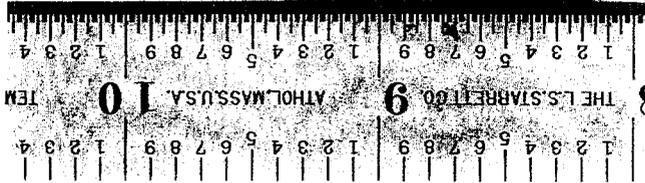
**Figure 32. Macro-Micro Examination of Weld-Through Transverse Crack A1
Detected in Core A.**

Some cracks at the weld root probably developed at the time of fabrication and grew very slowly. SEM examination of the exposed fracture surface of the root crack A1 (approximately 25 mm [1 in] long) at core A revealed features that were obscured by surface oxidation (see Figure 32a). The heavy rusting indicated that the crack had been present for a long time.

Macrofractographic examination revealed a transverse crack approximately 25 mm (1 in) long and approximately 25 mm (1 in) deep. **An additional metallographic sectioning of the same core revealed the root crack A2 propagating about 2 to 3 mm (0.1 to 0.12 in) in the base metal of the top flange (see Figure 32b).** The projected crack path is shown in Figure 32c. The microstructure at the crack tip shown in Figure 32d is acicular ferrite and tempered martensite.

(c) projected crack path (200x)

(d) metallurgical microstructure (tempered martensite and acicular ferrite) at crack tip
(1000x).

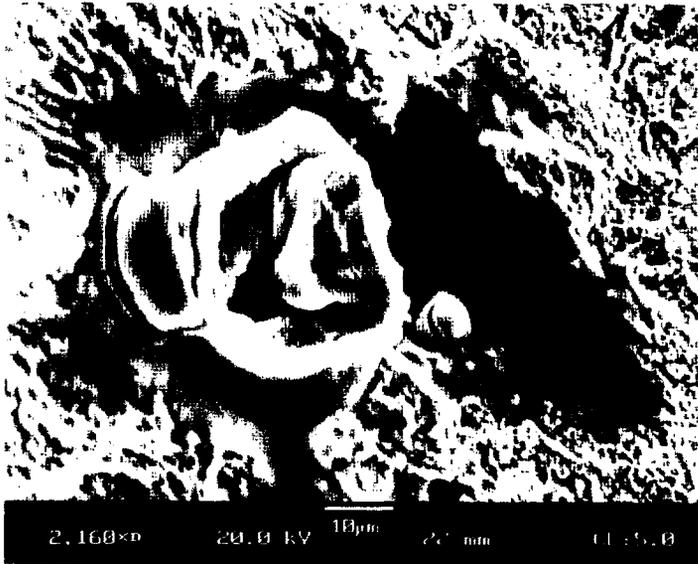
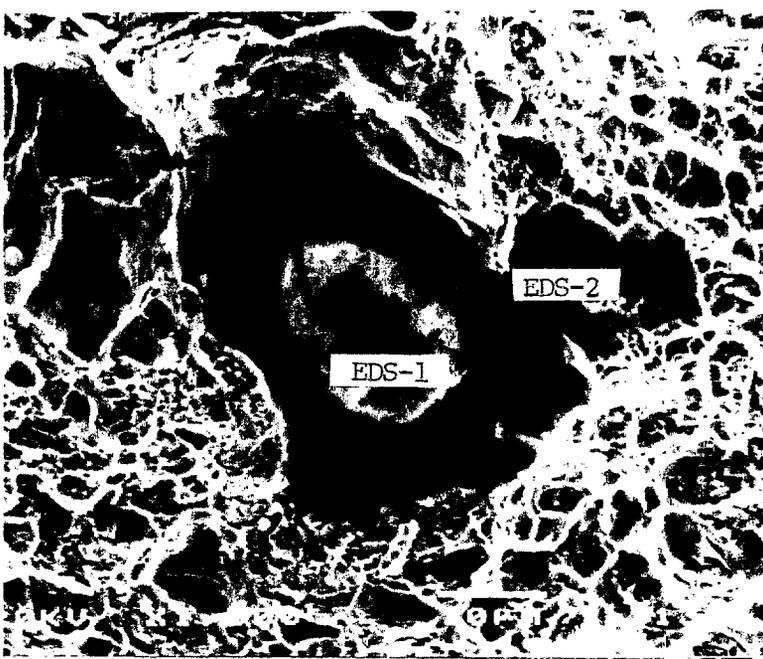
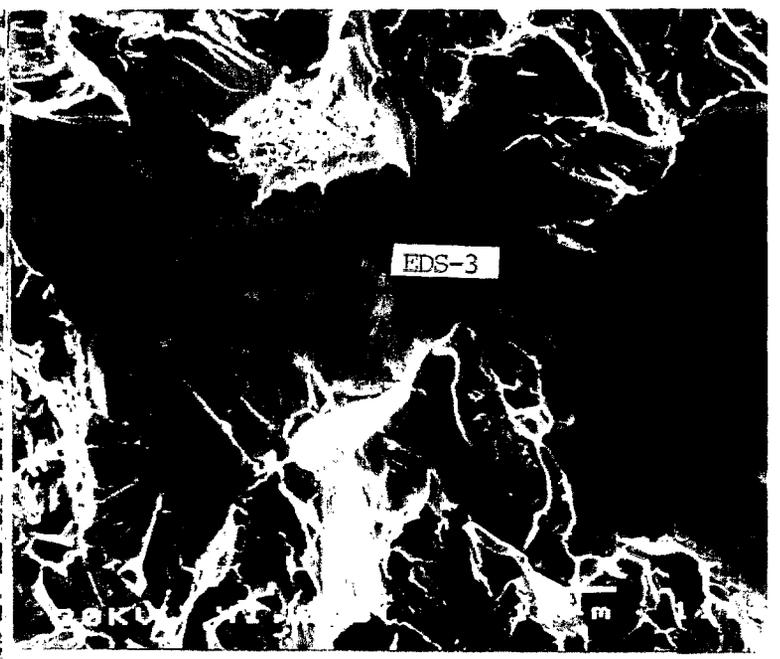
Figure 35. Fractography of Small Inclusions in Surface of Weld and Base Metal CVN Samples.

Very small inclusions (10 to 100 μ), most likely aluminum, silicon, or manganese sulfides, were observed in the fracture surfaces of the specimens taken from the north girder. Figures 35a and b show the inclusions in the weld metal of core 4, and Figures 35c and d show inclusions in the base metal of core A. These inclusions, in the presence of existing stress, may develop high local areas of tensile stresses and may serve as crack initiation or continuation sites. The latest model of hydrogen-induced cracking initiated at preexisting small defects is consistent with the relatively slow and discontinuous nature of the cracking process in this case.

(c) base metal CVN sample, core A, locations EDS-1 and EDS-2

(d) base metal CVN sample, core A, location EDS-3.

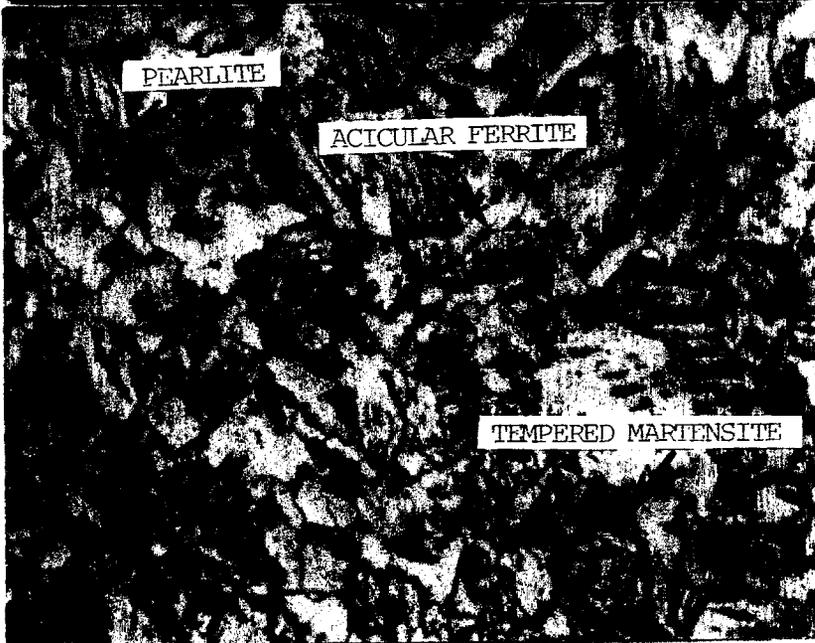
Figure 36. Metallurgical Microstructure of Base Metal (top flange, web and stiffener).

The microstructure of the base metal plates (top flange, web, and stiffener) is typical for quenched and tempered C-Mn low-alloy high-strength steels (see Figure 36). The microstructure of the weld metal, fusion zone, and HAZ for cores 2, 3, 4, A, H, and K is shown in Figure 37. The microstructure of the weld metal in the north and south girder was predominantly columnar with acicular ferrite, grain boundary ferrite (widmanstatten), and areas of lower bainite and tempered martensite. A microstructure with components of grain boundary ferrite (widmanstatten) and areas of lower bainite and tempered martensite is more susceptible to hydrogen-induced cracking than a microstructure with acicular ferrite. An intergranular fracture bound by polygonal ferrite grains and tempered martensite of the fusion zone of the web on the side and the HAZ, a fusion zone, and weld metal of the vertical stiffener in the north girder was observed (see Figure 38). There was no significant microstructural difference between the weld metal in the north and south girders. Table 4 summarizes the grain size determinations in the base metal and HAZ in each core and in the welds of cores 2, 3, and 4. The coarse grain structure is typical for HAZ.

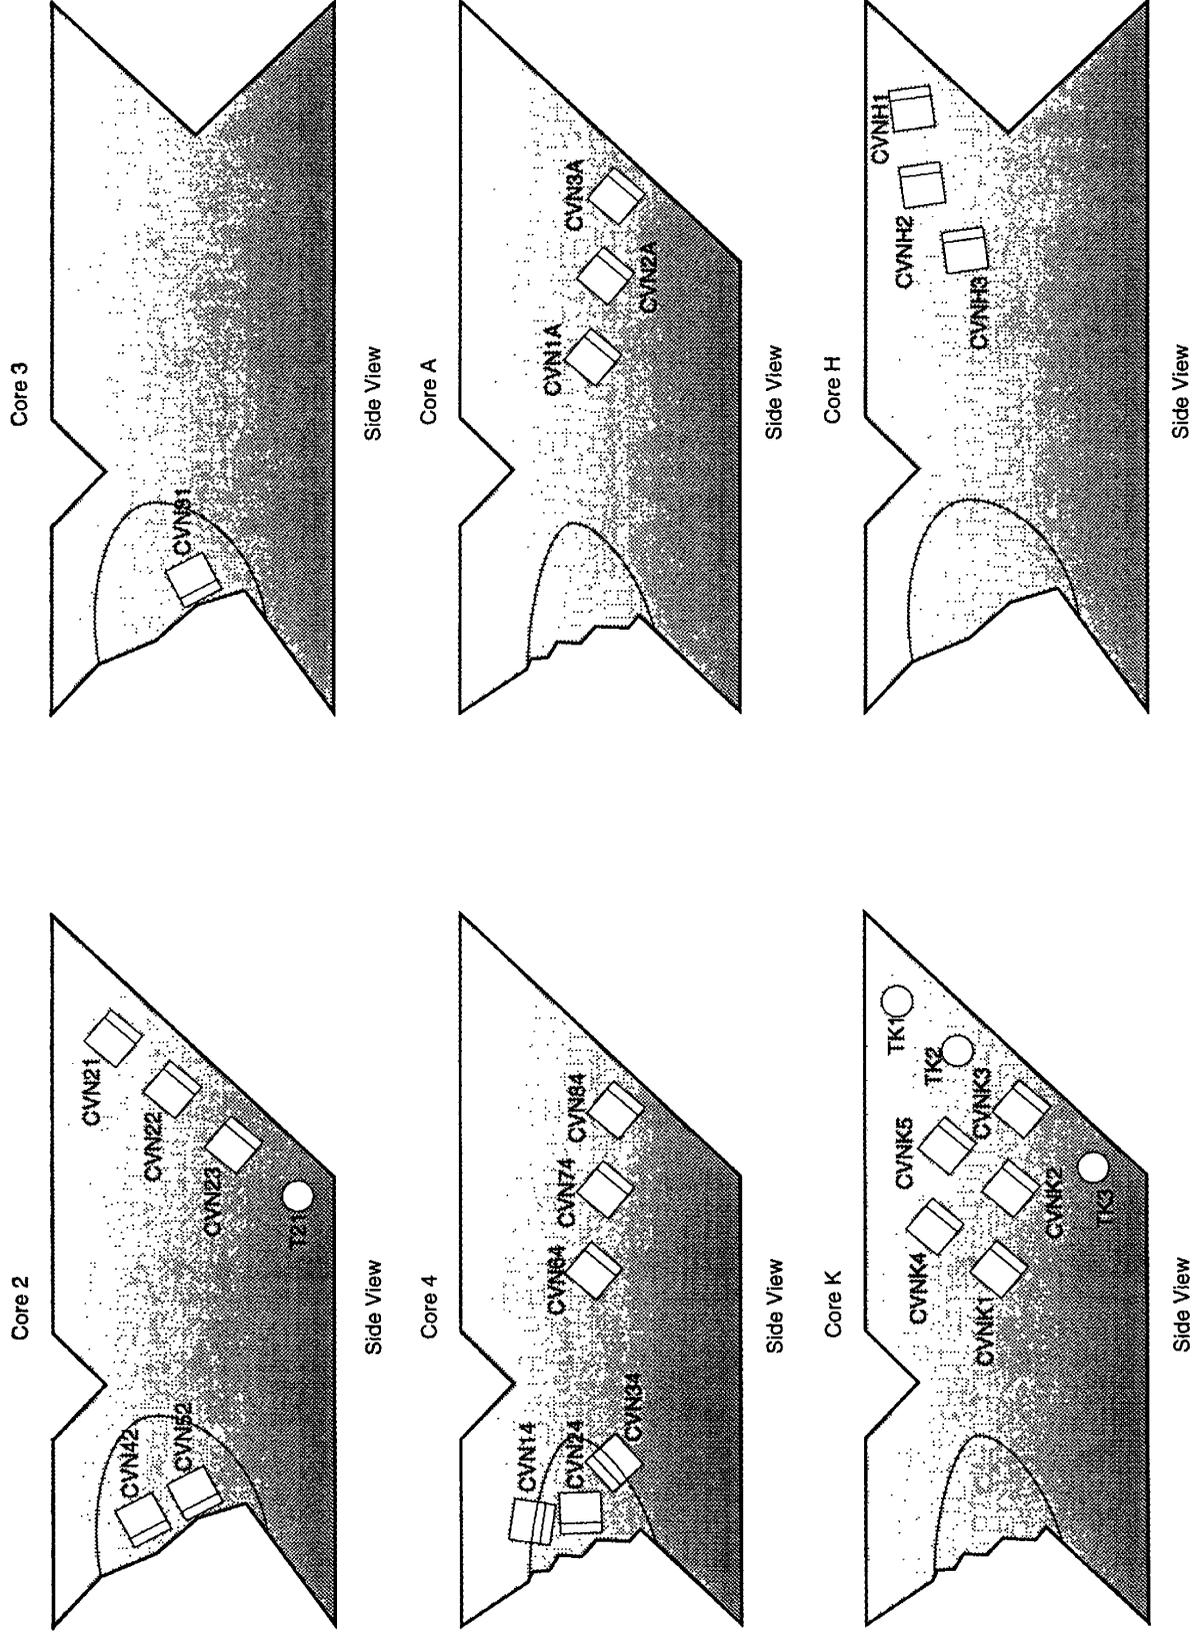
Impact testing, tensile testing, fracture testing, and hardness testing were performed in accordance with ASTM E23-96, E8-96, E399-90, E384-89, and E18-94. The specimens for mechanical and fracture testing were parallel with the top flange rolling direction and the weld length. The locations of test specimens fabricated (extracted) from different cores are shown in Figure 39.

Figure 39. Locations of Test Specimens Fabricated from Cores.

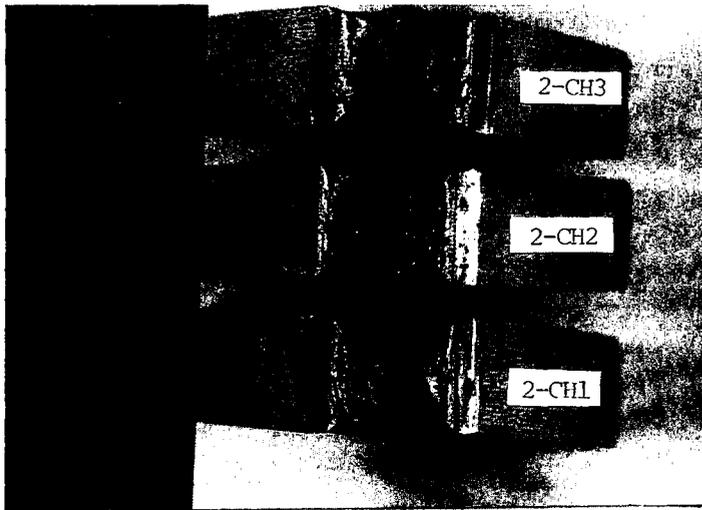
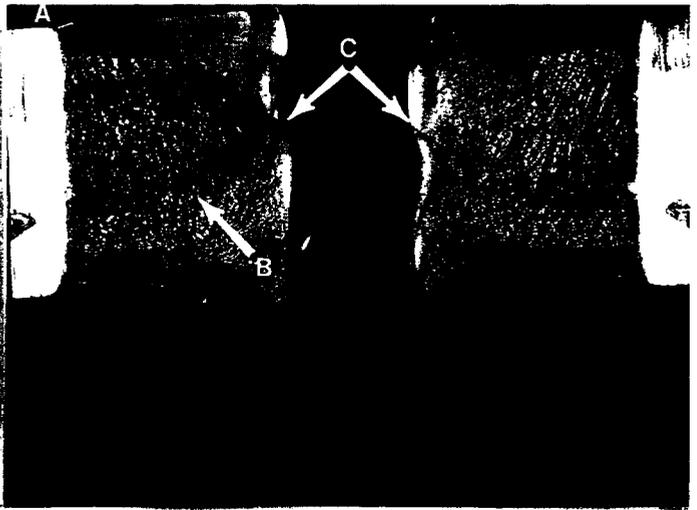
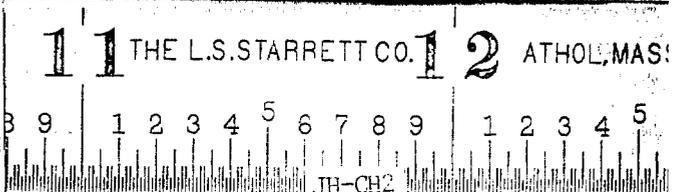
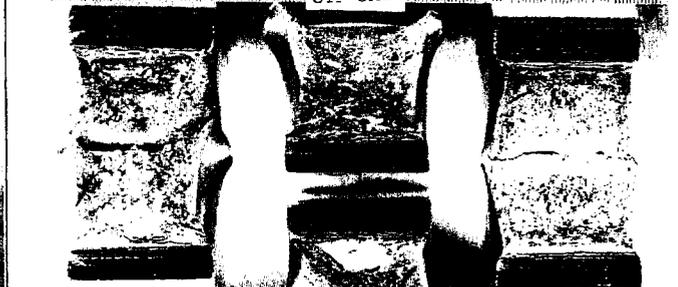
Figure 40

The CVN test results for different temperatures are given in Table 8. Broken CVN samples from cores 2, 4, K, A, and H are shown in Figure 40. The value of 200 J (148 ft-lb) for the absorbed impact energy at -7°C (20°F) for the flange plate material was well above the ASSHTO Zone 2 requirement of 48 J (35 ft-lb). The web impact toughness was 176 J (130 ft-lb) at -23°C (-10°F). The ASSHTO Zone 2 requirement for the web plate is 41 J (30 ft-lb) at -7°C (20°F).

Figure 40. Broken CVN Samples.

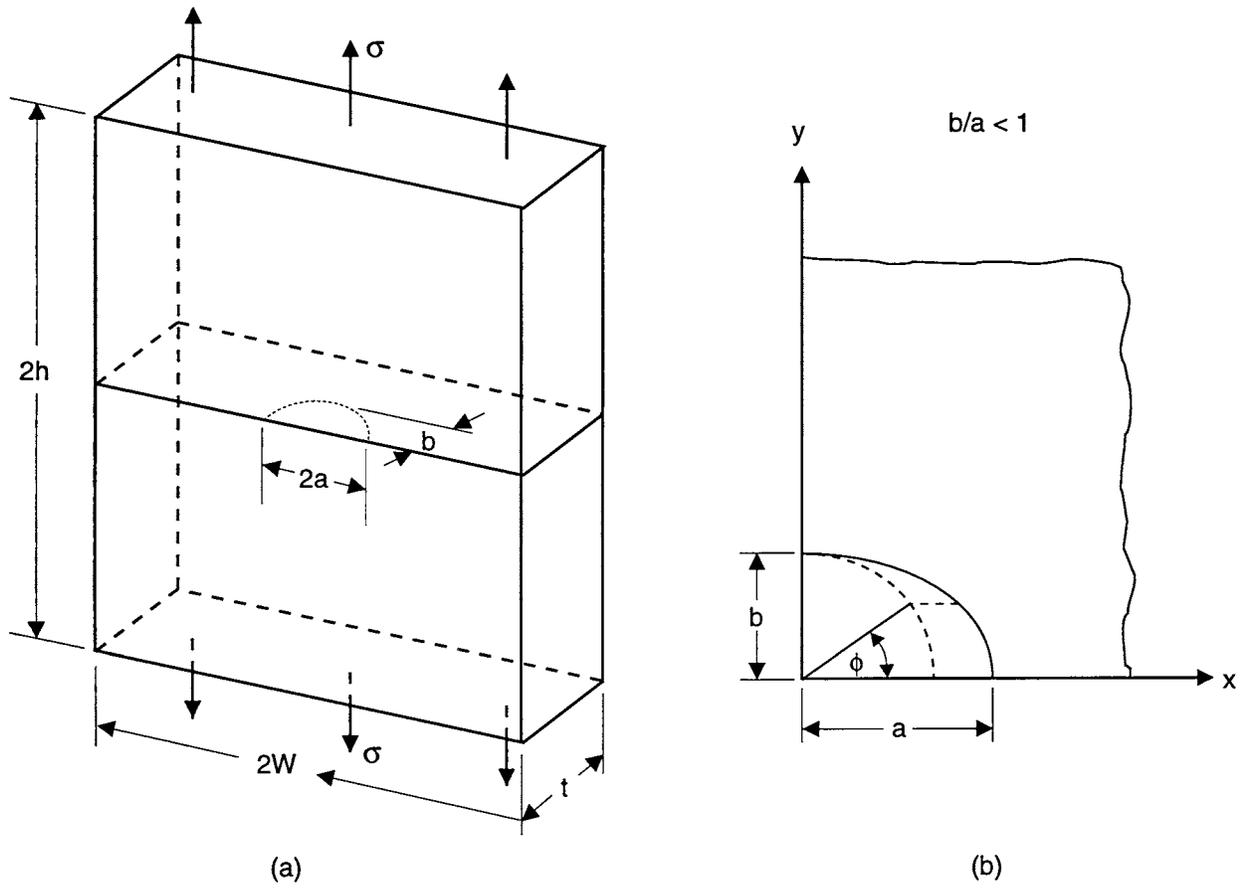
Figure A1. Crack Dimensions for Fracture Mechanics Analysis.

b - Depth of crack
 $2a$ - Surface length of crack
 t - Thickness of top flange

W - Width of top flange overhanging the web
 $2h$ - Length of top flange (essentially infinite)
 ϕ - Location around crack profile

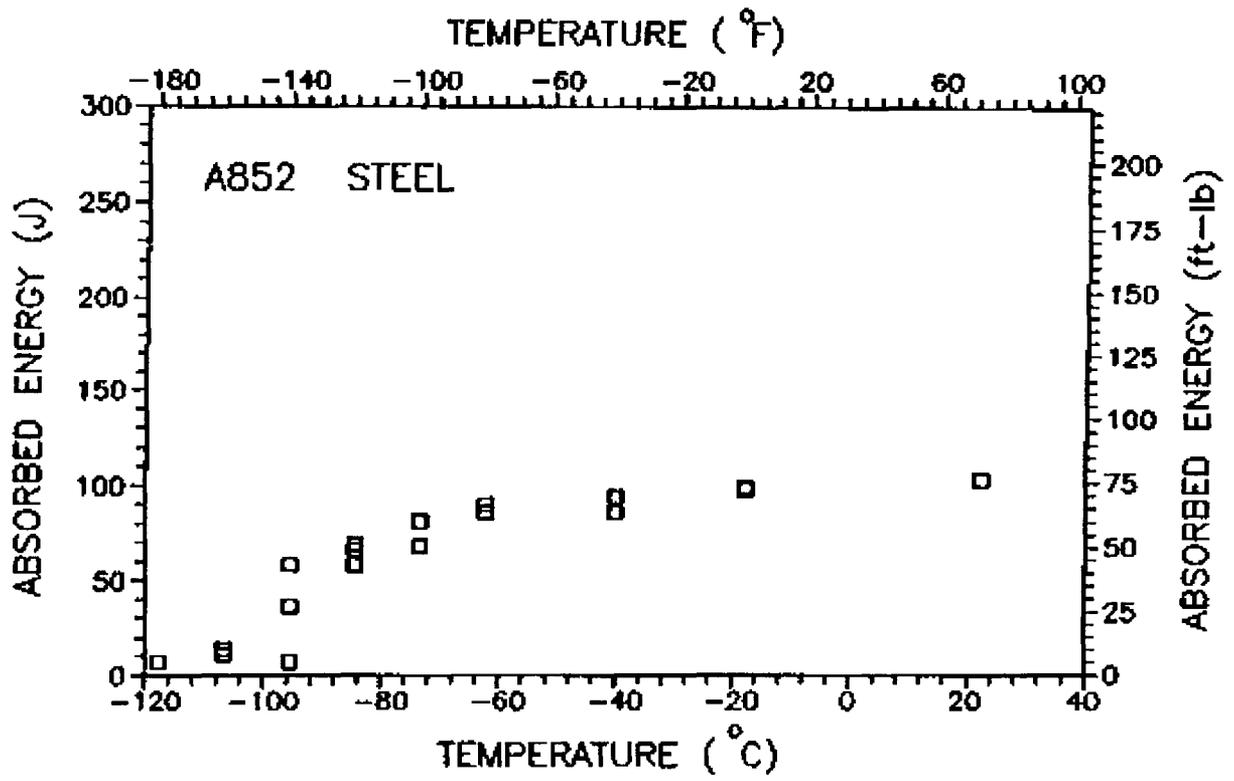
Figure A2. Absorbed Energy vs. Temperature.
