CORRELATION OF ROCK QUALITY DESIGNATION AND ROCK SCOUR AROUND BRIDGE PIERS AND ABUTMENTS FOUNDED ON ROCK

**Research Report KTC-99-57
KYSPR-94-157**

**Correlation of Rock Quality Designation and Rock Scour Around
Bridge Piers and Abutments Founded on Rock**

September 1999

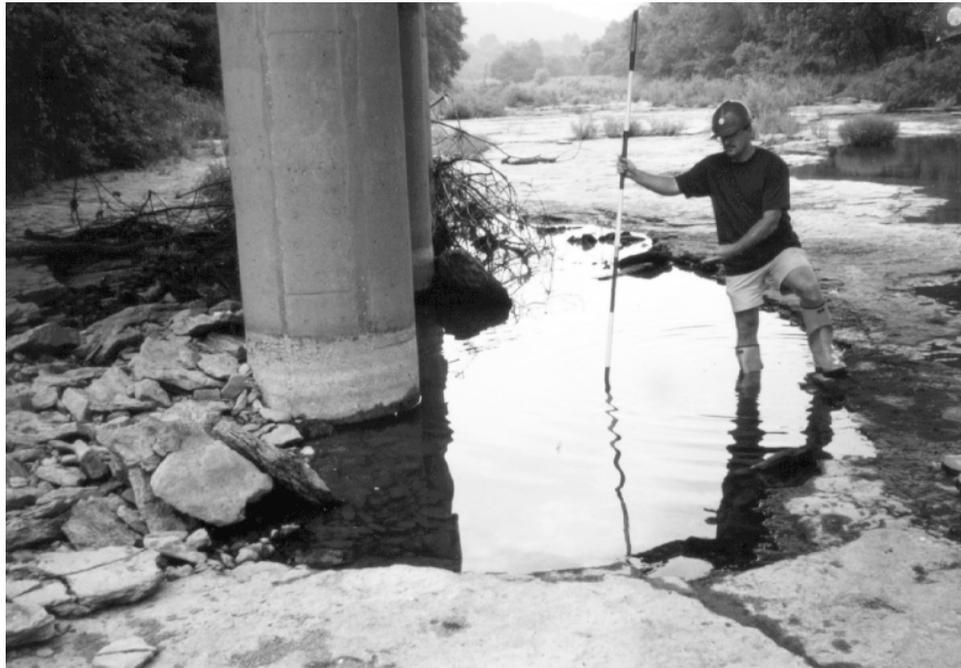
to large variations in temperature from day to night. However, frost action or ice wedging is much more effective than heat in producing mechanical weathering. Water that has entered cracks, crevices, and pores of a rock mass usually starts to freeze at the upper surface, where it is in contact with the cooling air. As it passes from the liquid to solid state, water expands. In time, the water below is confined by an ice plug at the surface. Then, as the freezing continues, trapped water expands, and large pressures are exerted outward that can be great enough to dislodge fragments at the rock's surface. The frequency of frost action depends on the climate and the amount of rock surface exposed to the atmosphere. Dislodged fragments of mechanically weathered rock are angular in shape-- the size depends on the type of rock. An example of a weathered bedrock around a scour hole is shown in Figure 4.

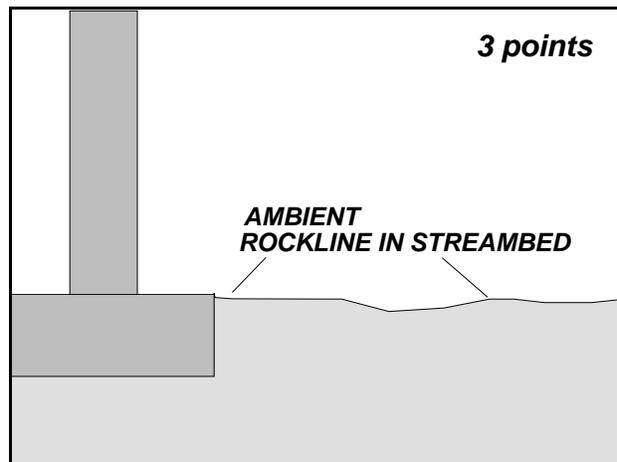
Figure 16. None or slight rock scour.

16, no scour is apparent and the scour condition is rated low, or given a numerical value of zero to three points. In Figure 17, a local scour hole is visible around the footer. However, the bottom of the footer is not readily visible. In this situation, erosion of the rock unit adjacent to the footer may be actual erosion or the hole may be due to over excavation. This condition is given a moderate rating and assigned a value of about nine points.

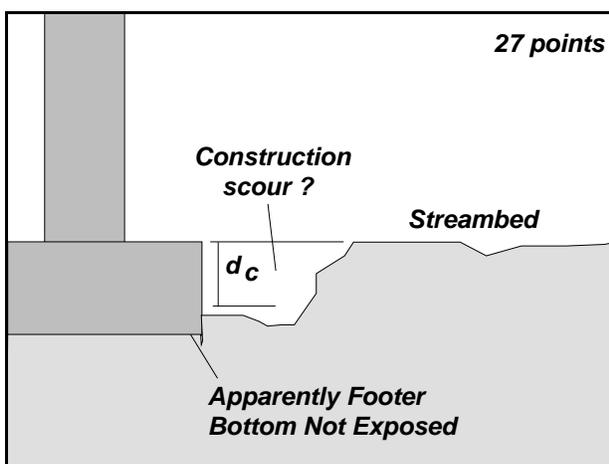
Figure 18. Scour depth near the bottom of the footer.

In Figure 18, the bottom of the apparent scour hole appears to be at the same level as the bottom of the footer -- a condition that is rated as high, or a value of 27 points is assigned to this situation. Finally, as shown in Figure 19, whenever the bottom of the scour is at the bottom of the footer or below, the condition is rated very high and a value of about 81 points to 100 points would be assigned to this situation. In addition to a maximum d_c score, a quantitative measurement, d_s , as shown in Figure 20, from the bottom of the apparent scour to the exposed footer line is taken and scored in this case, as illustrated in Table 2.

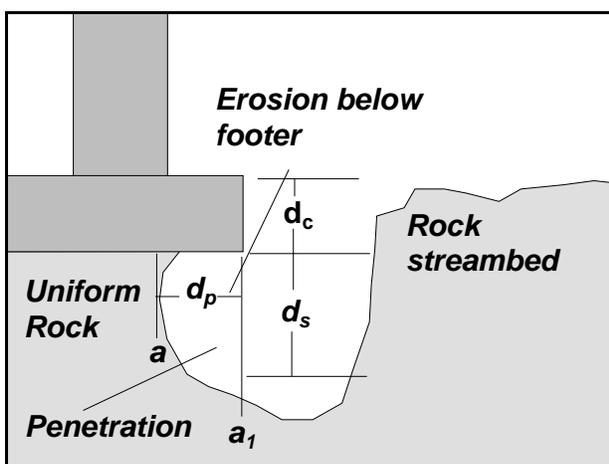
Figure 21. Erosion penetration under footer foundation.

The third factor considered critical to the performance and service of the abutment or pier footer is erosion penetration beneath the footer. Penetration of rock scour is the horizontal distance (line $a-a_1$ in Figure 21) measured from the face of the footer to the eroded face of the rock unit beneath the footer. Two different conditions have commonly been observed in Kentucky (sedimentary rocks). In the first case, Figure 21, the rock unit is uniform in structure and erosion occurs directly below the footer. The second case, Figure 22, involves a footer resting on interbedded layers of hard, or durable,

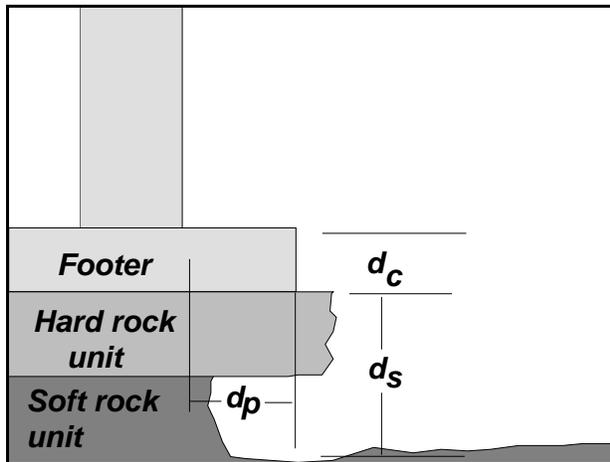
Figure 22. Erosion penetration occurring within interbedded layers.

and soft, nondurable, rock units. Erosion penetration occurs indirectly as a result of differential erosion between the durable and nondurable units. Generally, the footer is oftentimes located on the durable rock unit. However, if the hard member is thin, the footer may be undercut as the softer member erodes. If the penetration is merely adjacent or zero, then the condition is rated low. When penetration is about two inches, the condition is rated moderate. For a penetration of two to six inches, the condition is serious. When the penetration is greater than 6 inches, the condition is rated very serious. Although these penetration values were arbitrarily selected, they

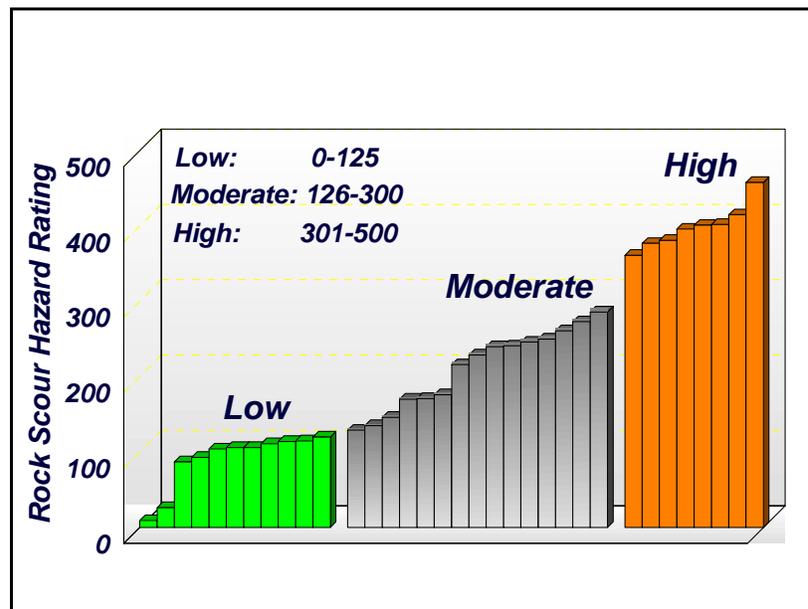
Details, including numerical ratings of the 34 sites, previously identified by UKTC, and initially rated as “high” scour, are summarized Tables 5, 6, and 7 (according to the rock scour rating system). Based on the relationship shown in Table 4, those bridges would be rated “Scour Critical.” Numerical ratings of high scour sites, as shown in Table 5, ranged from 307 to 458. Numerical ratings of sites classified as “moderate” ranged from 129 to 273, as shown in Table 6. Numerical ratings of sites that classified as “low” ranged from 26 to 120.

Figure 27. Numerical ratings of sites previously rated as having a “High” scour condition.

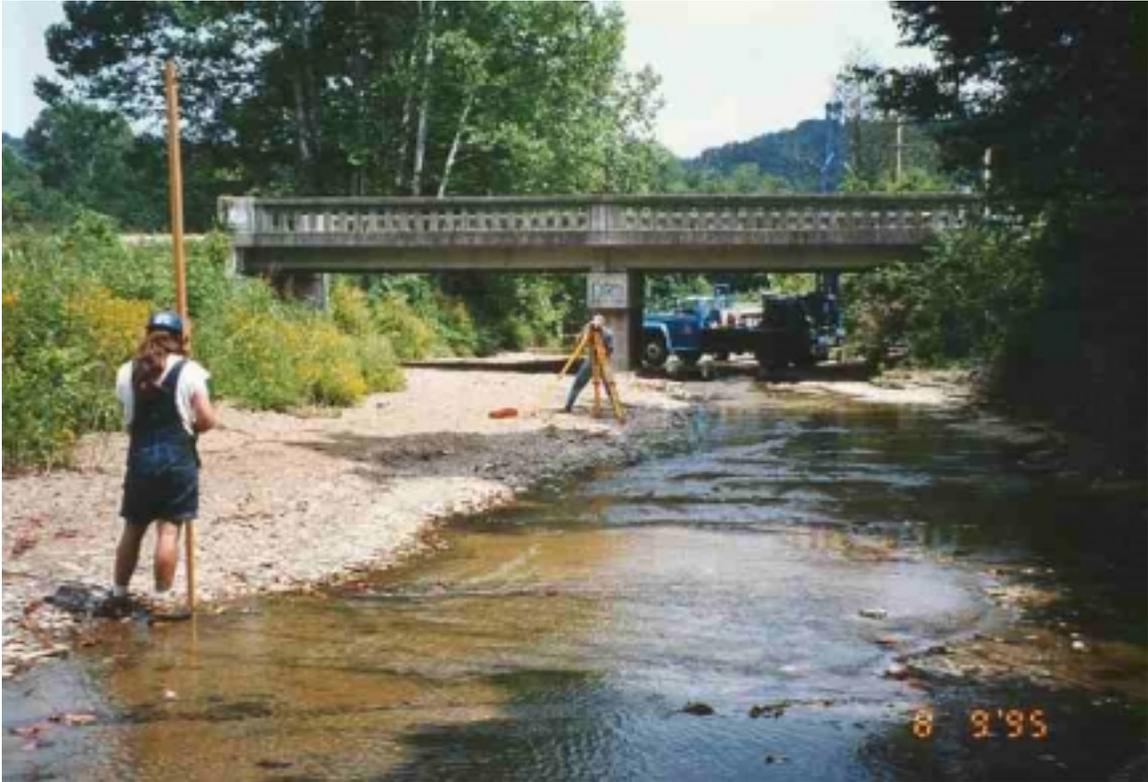
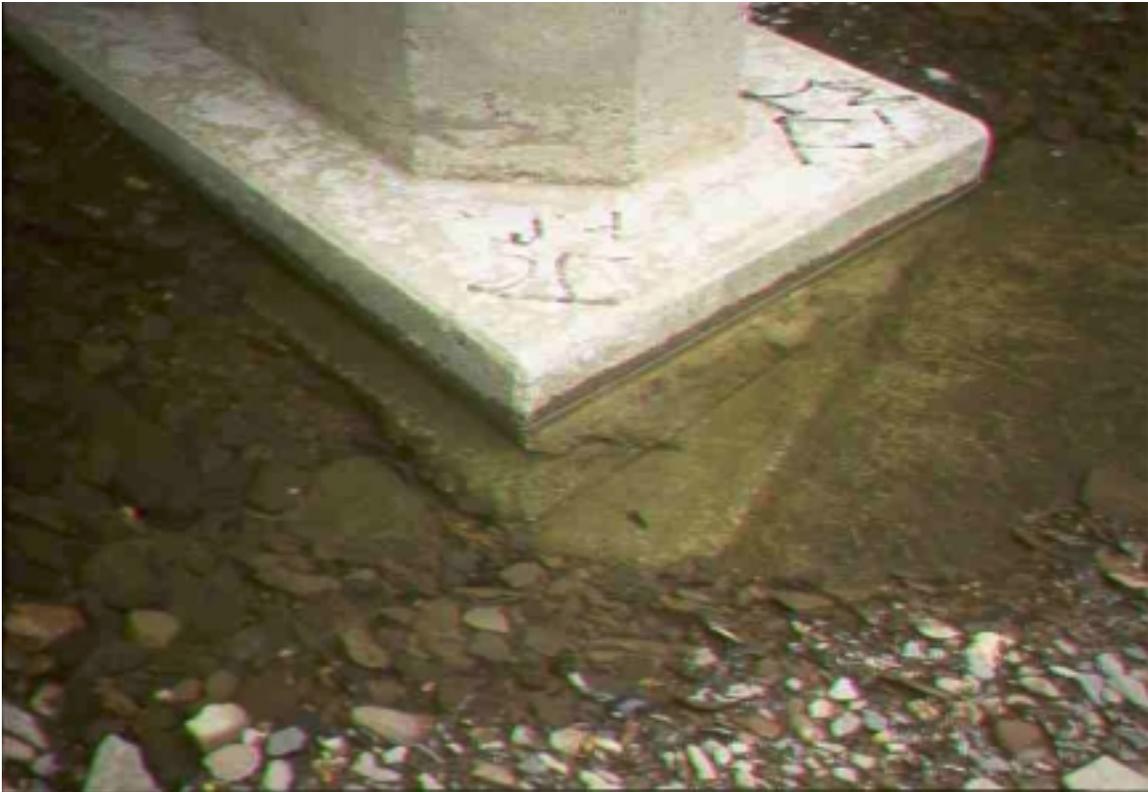
Adair County KY 704 Burns Creek

Constructed 1952
Scour Rating = 106
Small (1 in.) Penetration Scour at
Corner of Pier Footer
2 in. Scour Below Footer

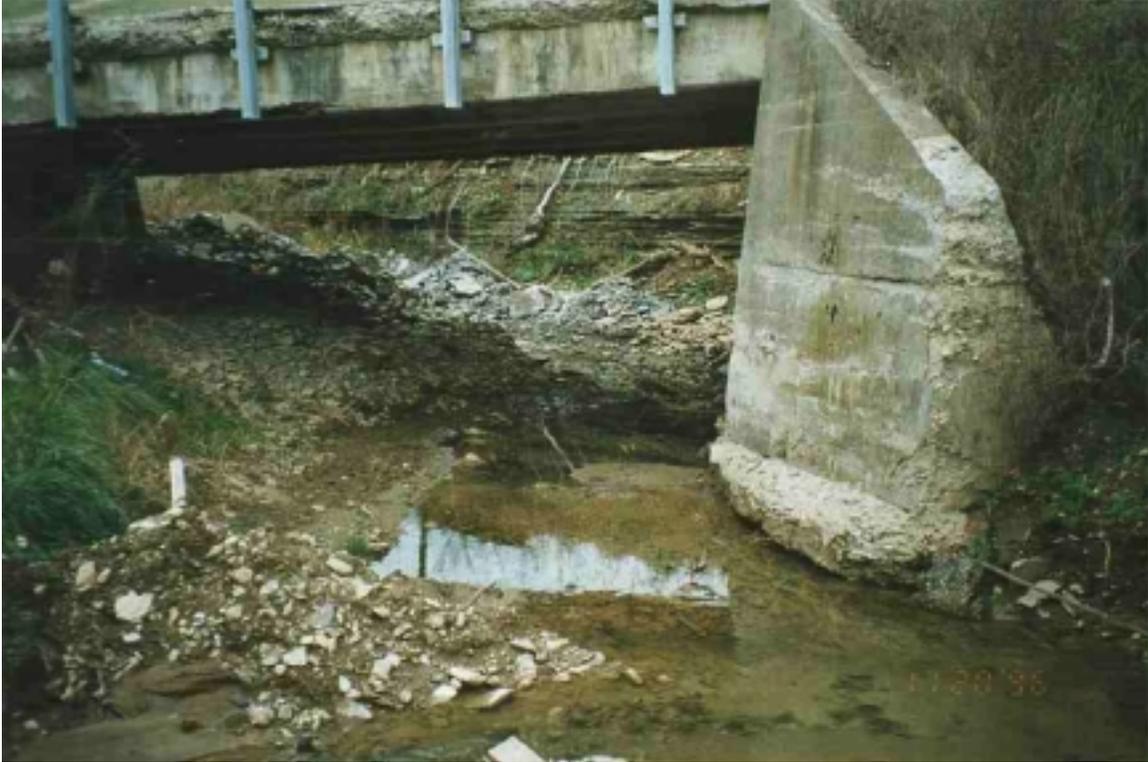
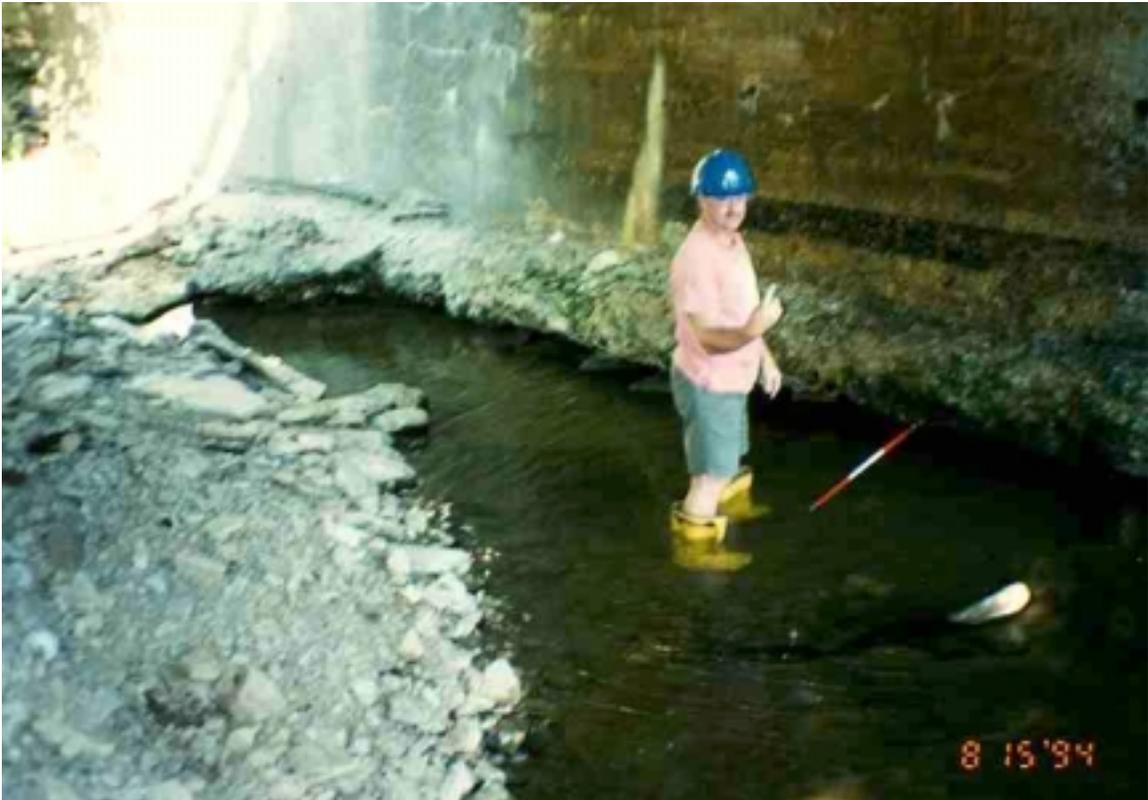
Bath County US 60 Hurricane Creek

**Scour Rating = 458
2 Ft. Penetration Scour Below Footer**

Bridge Replaced in 1996

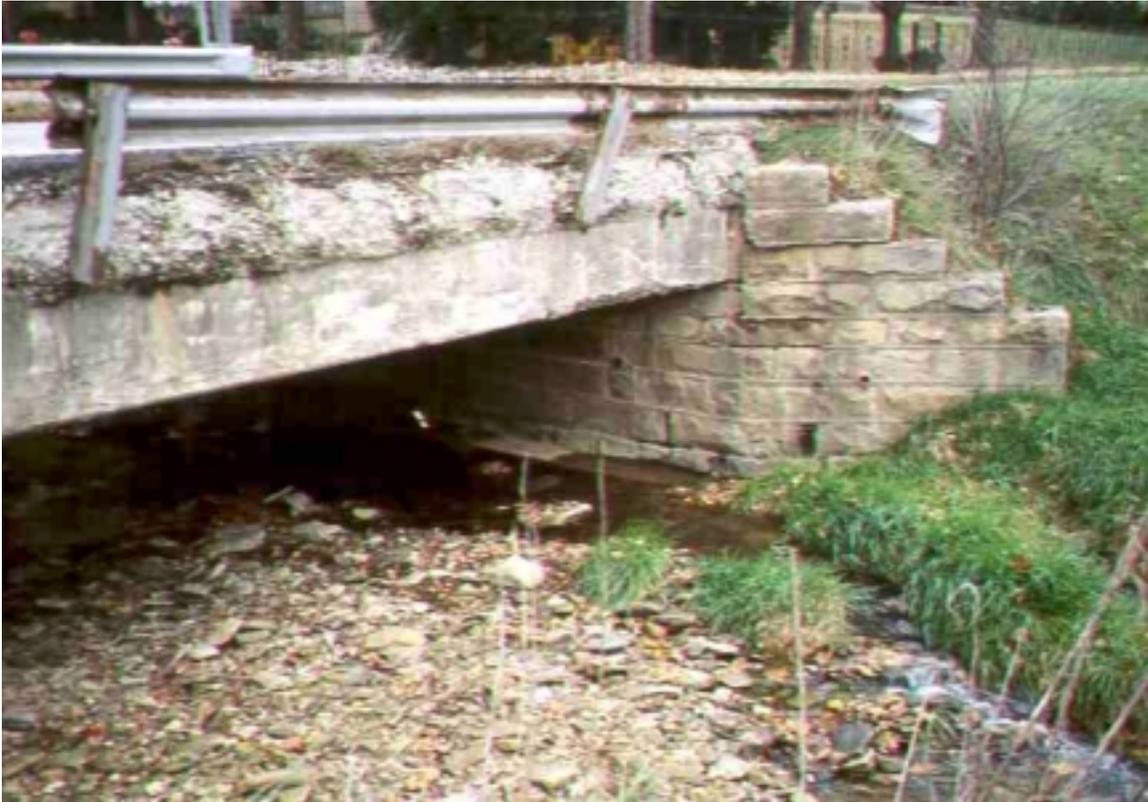
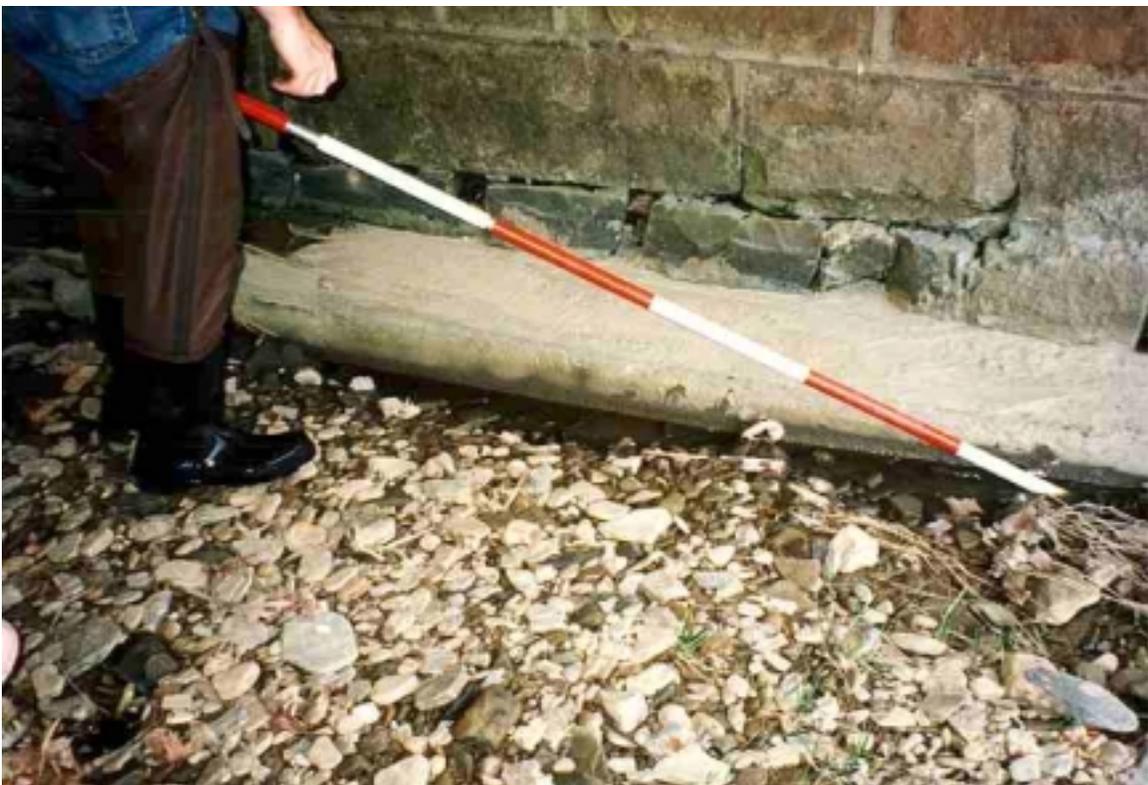
Carter County US 60 Fleming Fork

No Major Problems
Footer Slightly Exposed

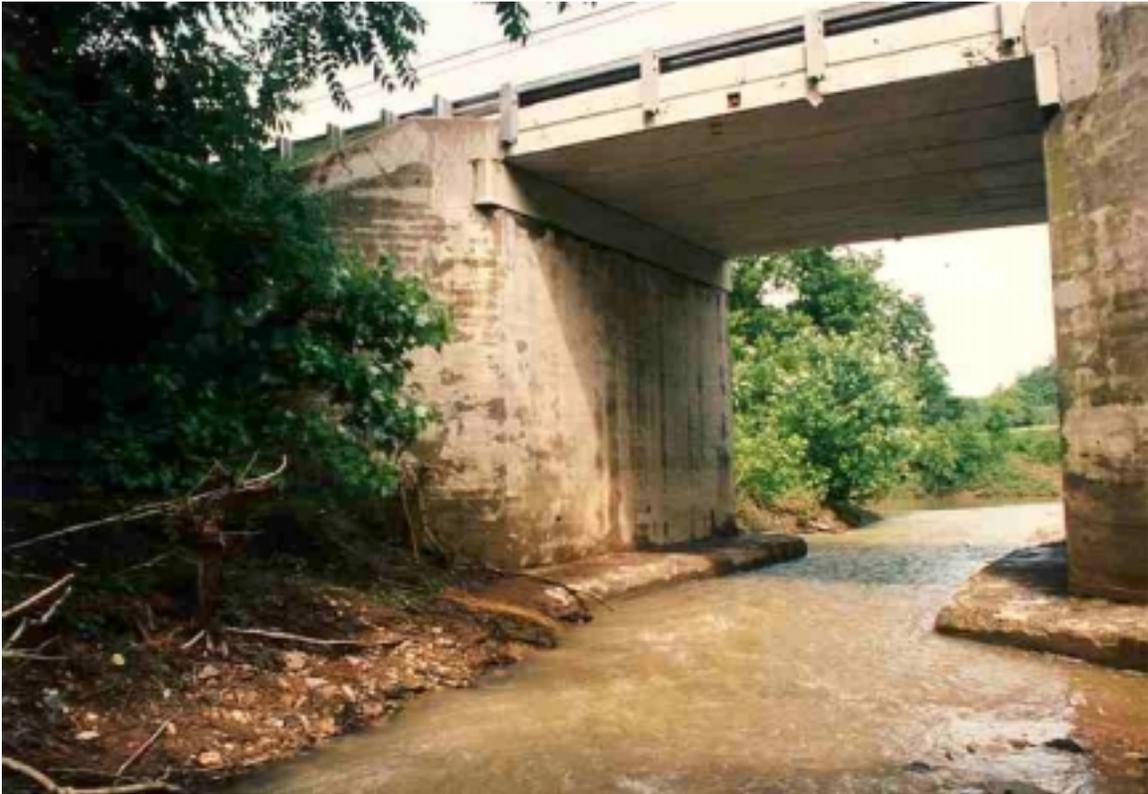
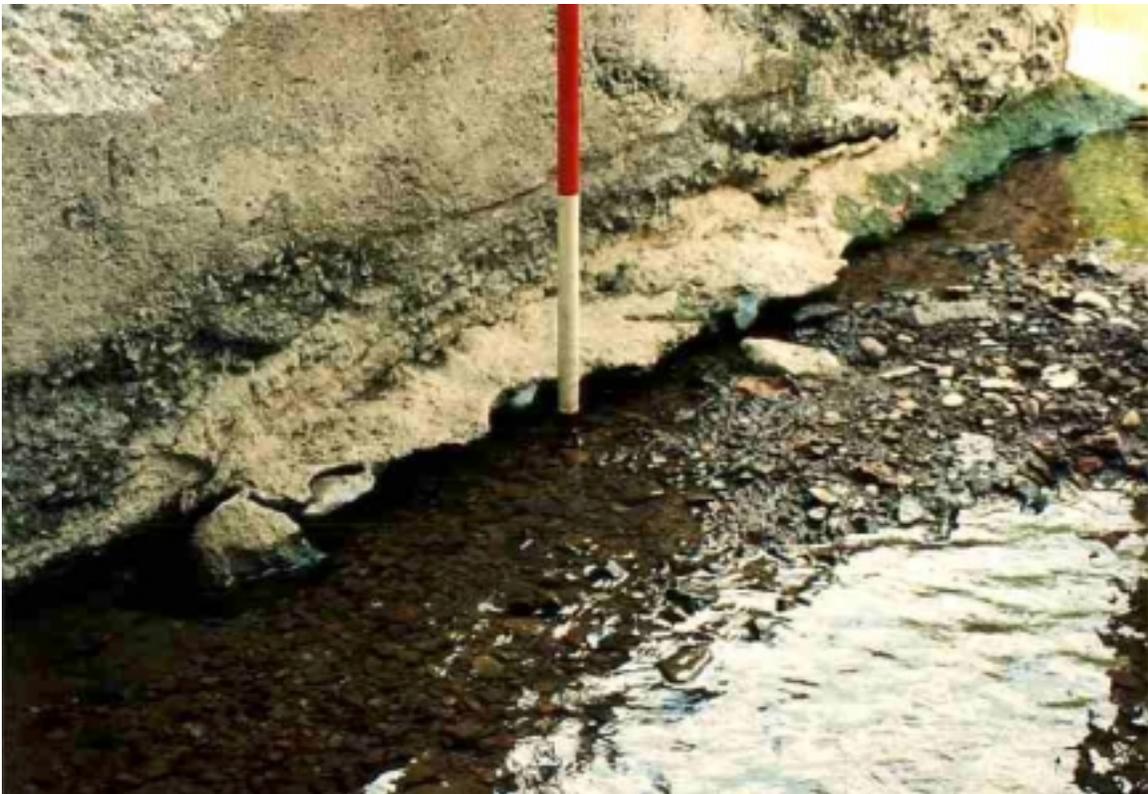
Cumberland County KY 704 Pine Branch

Footers Exposed

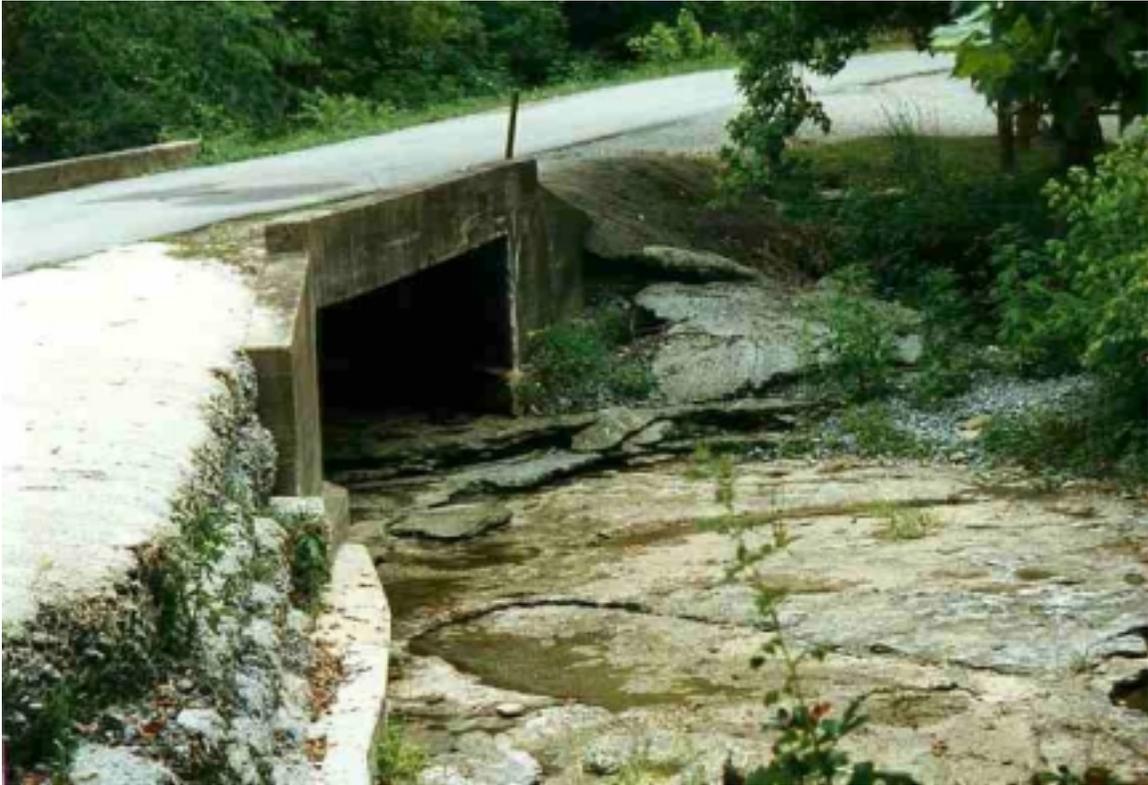
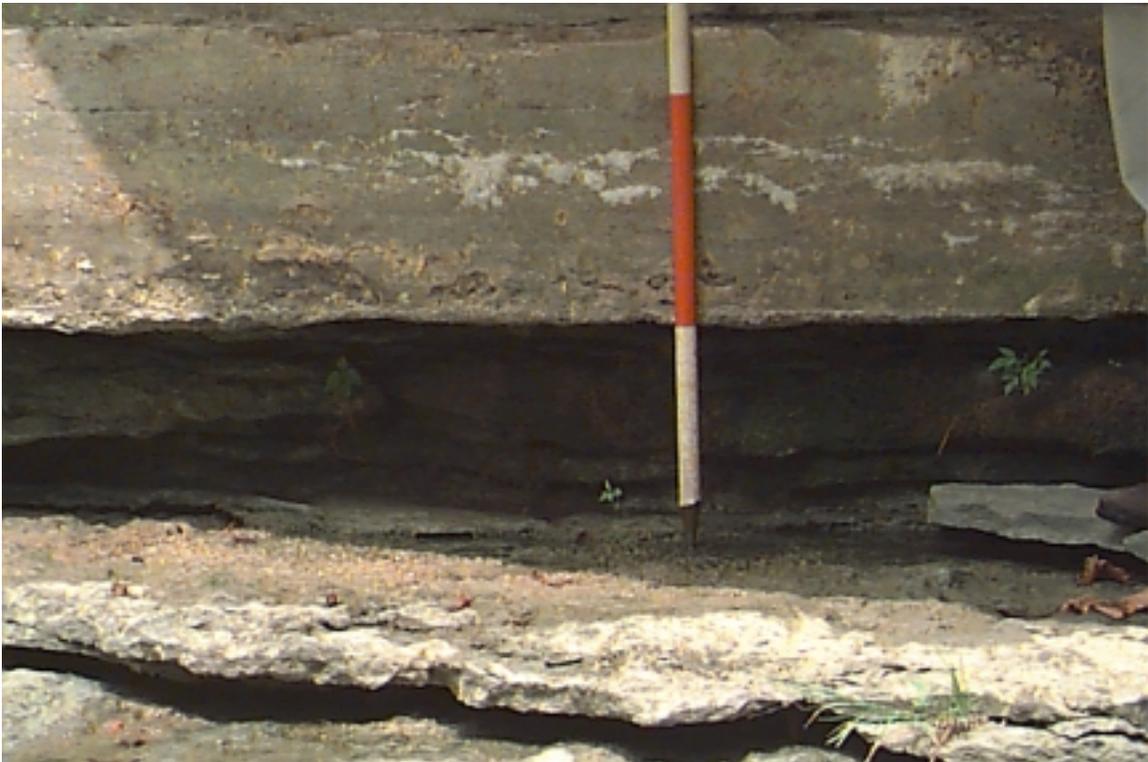
Harrison County CR 1006 Elk Lick Creek

Scour Rating = 327 Consultant

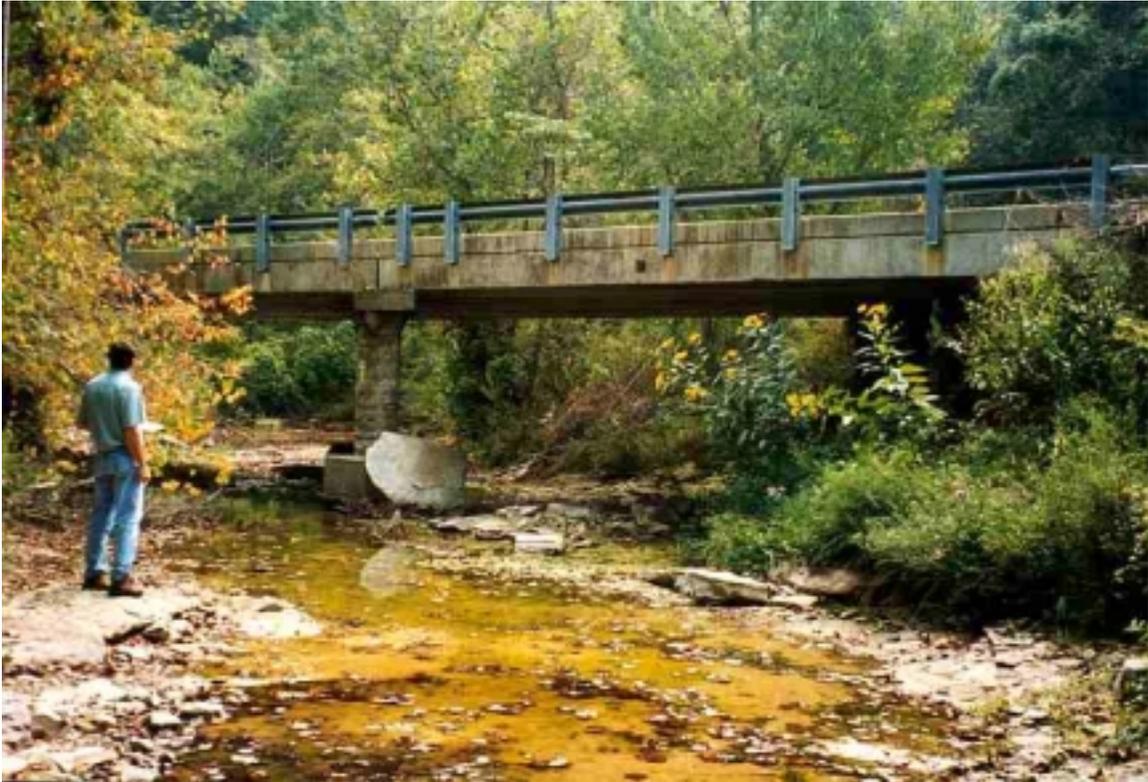
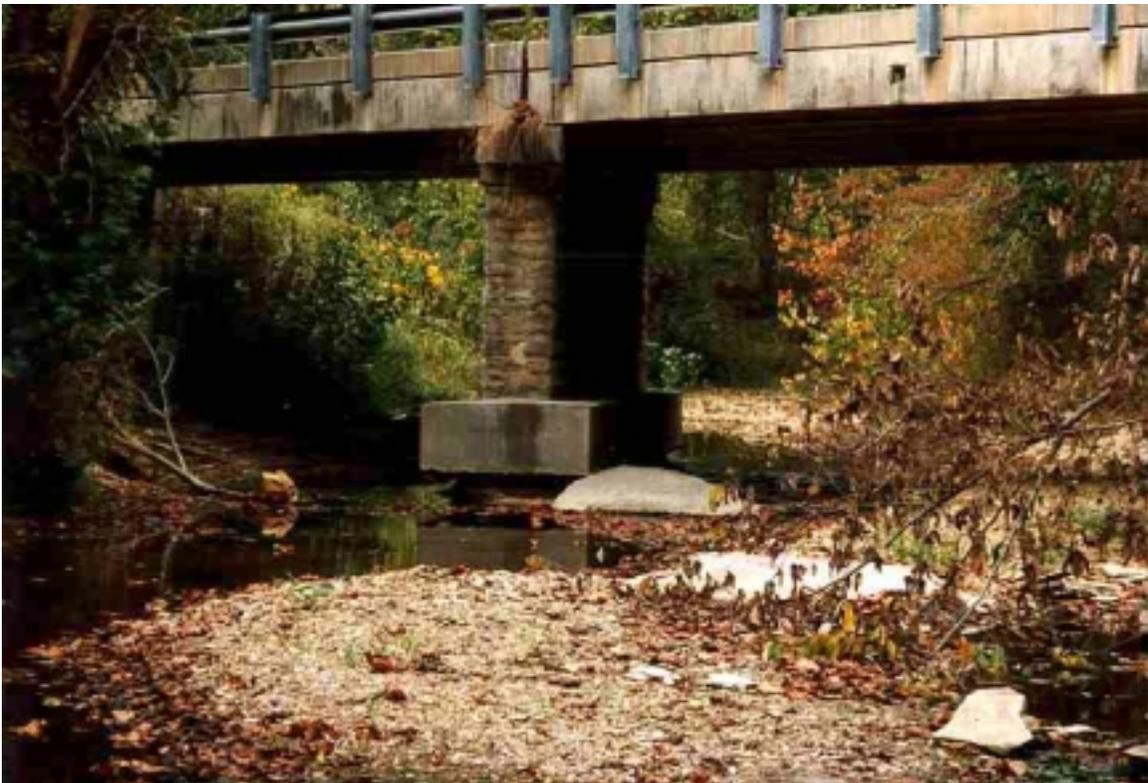
Jackson County KY 2004 South Fork Station Camp Creek

1.0 Feet Penetration Scour

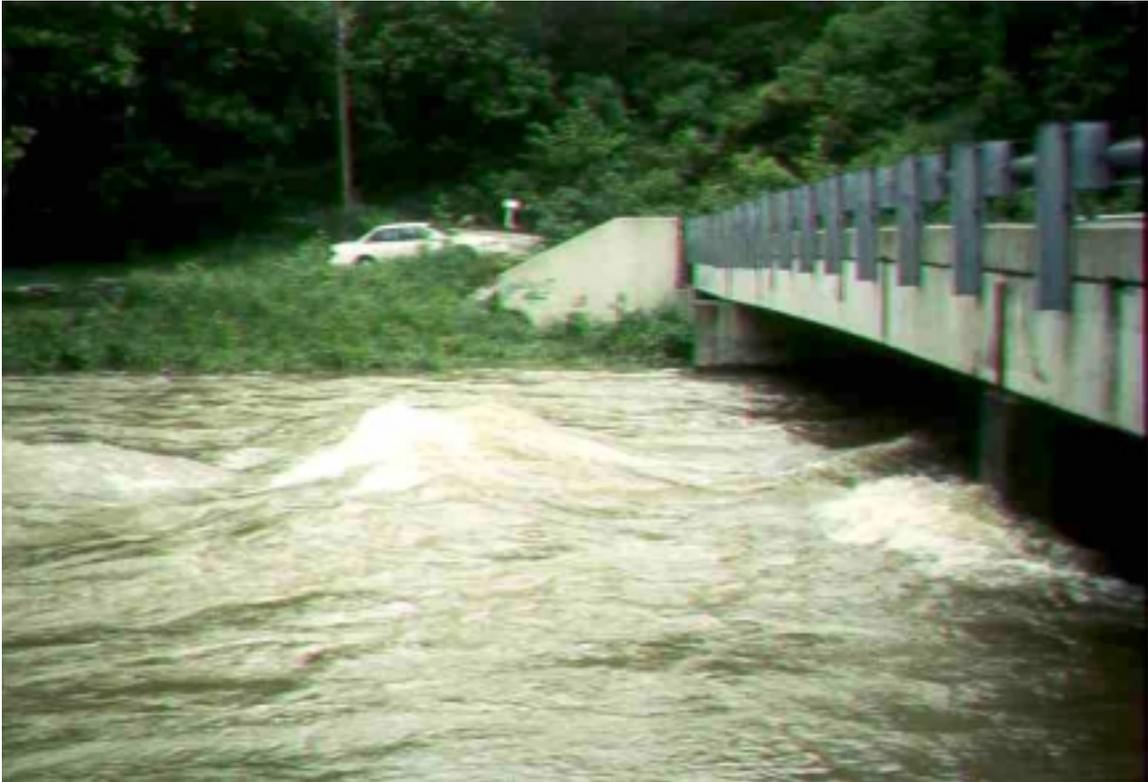
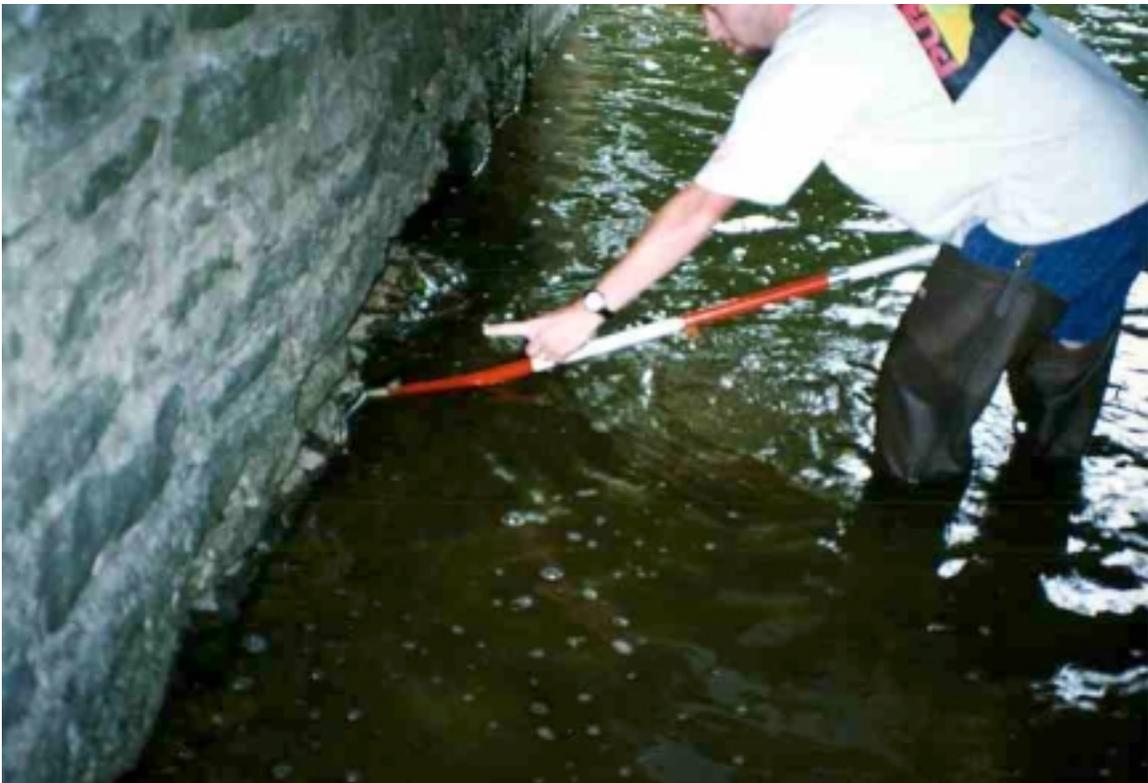
Jessamine County Elm Fork Road Hickman Creek

0.5 Feet Scour below Abutment Footer
2 Ft. Penetration Scour

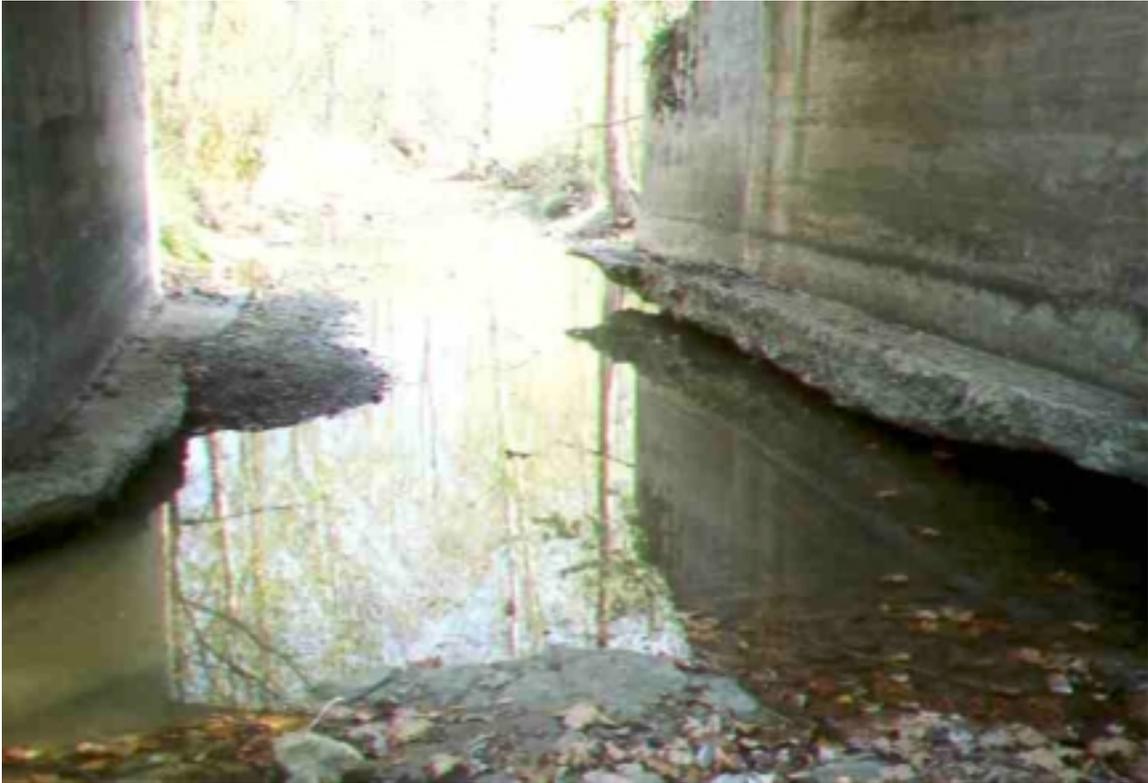
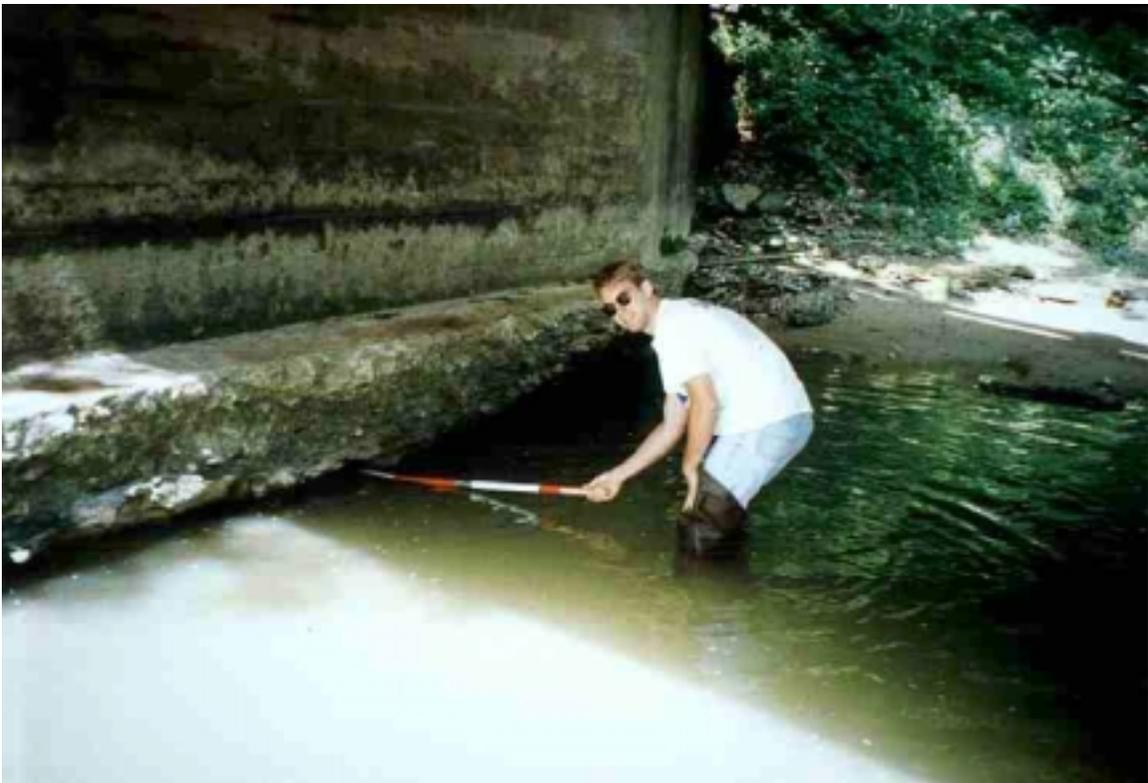
Lawrence County KY 707 Adam's Branch

Bridge # 64-B00035
Constructed 1930 - 1933?
Scour Rating = 401
5 Ft. Penetration Scour
3 Ft. Scour Below Footer

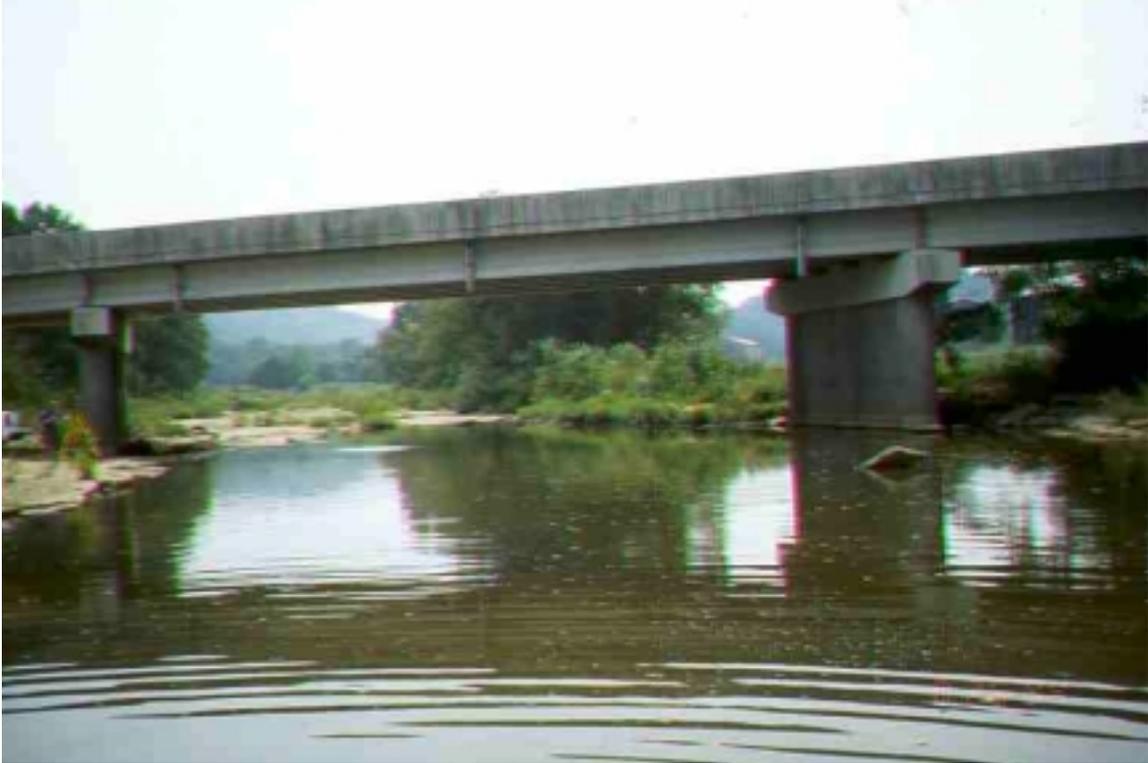
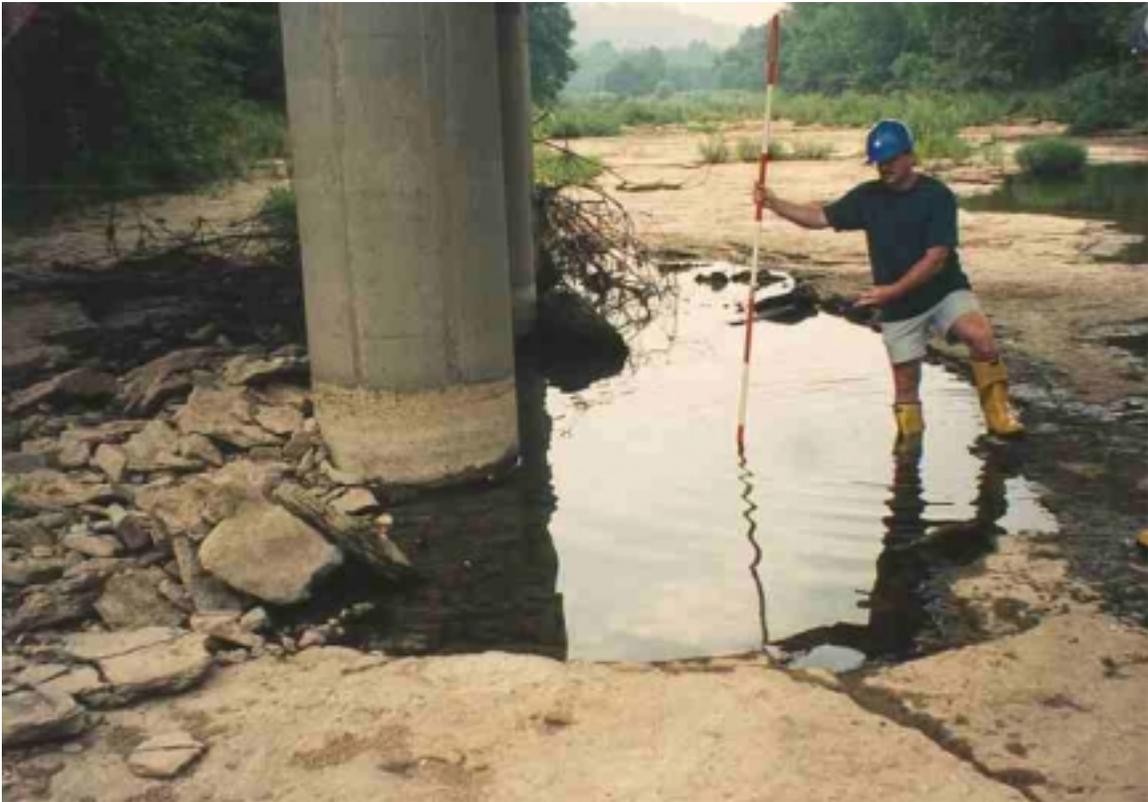
KY 607 Owen County Cedar Creek

Pier Footer Partially Exposed

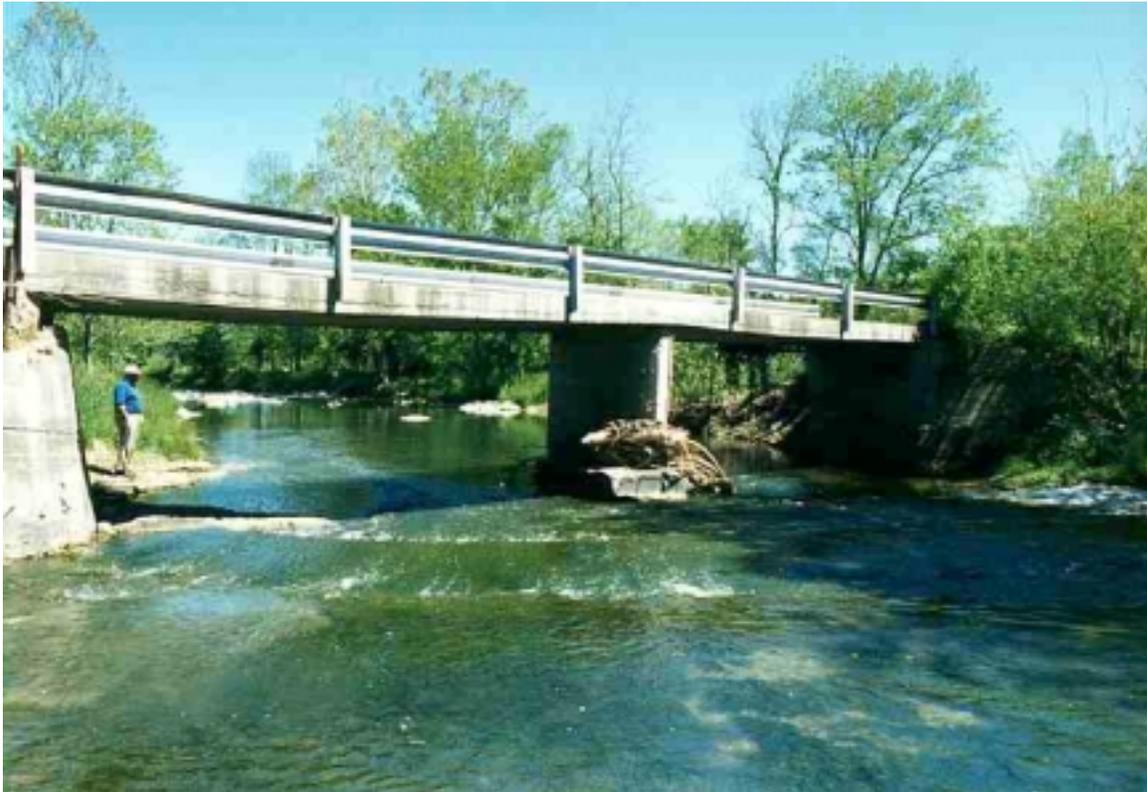
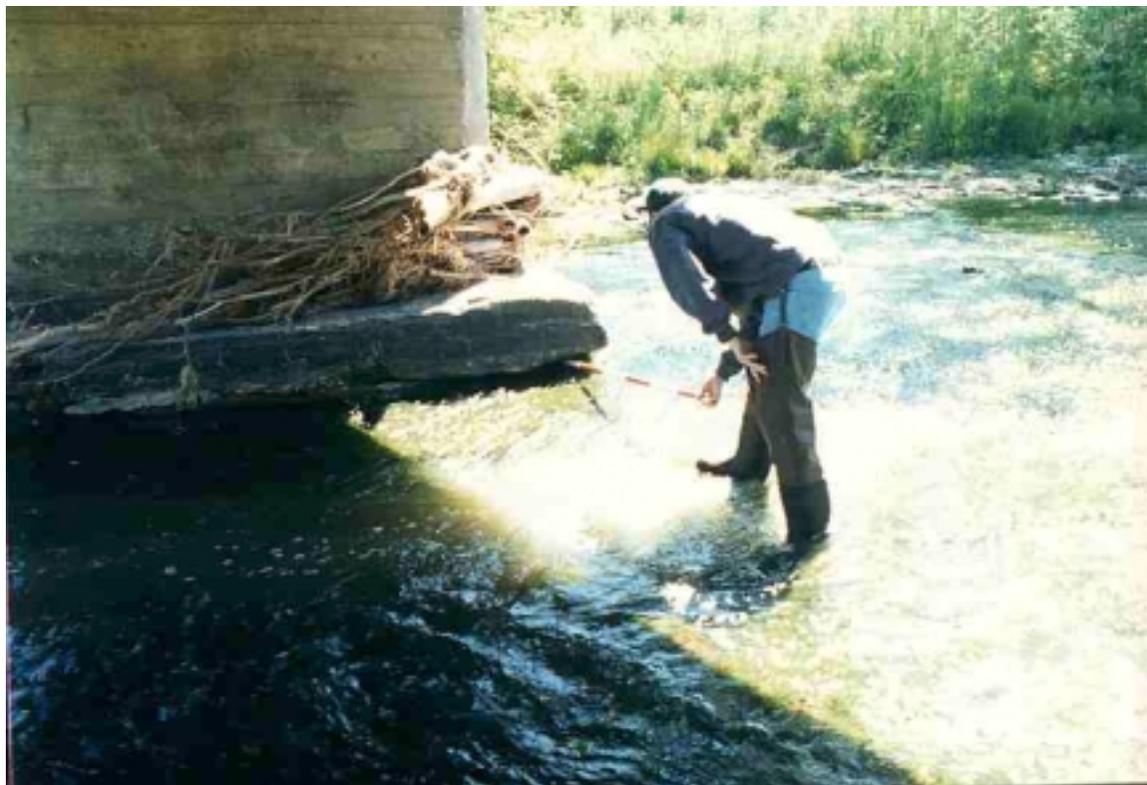
Washington County CR 1243 Road Run Branch

**1 Ft. Vertical Scour and
3 Ft. Penetration Scour at Pier**
