Final Report

Non-Destructive Bridge Testing With Advanced Micro-II Digital AE system

Hampton University

BRIDGE ON COAST GUARD BOULEVARD

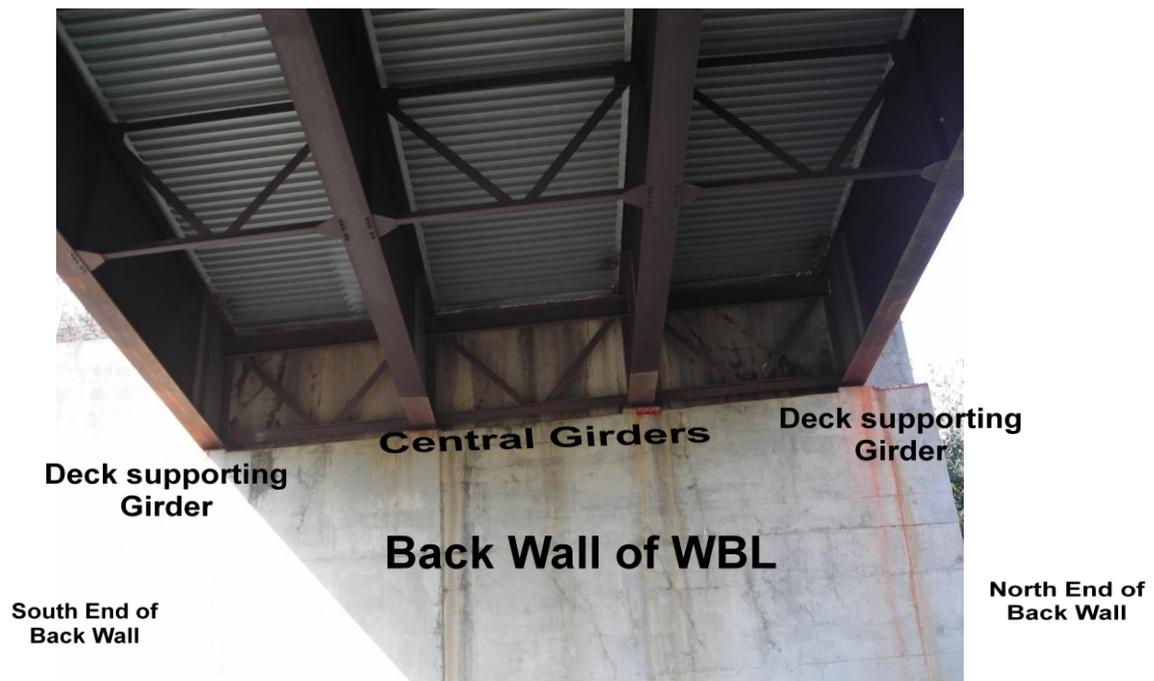
Figure 2. The West Bound Lane (WBL) supported by 4 steel girders

The WBL on the bridge is supported by 2 central steel girders and 2 deck supporting steel girders, as shown in Figure 2. The west ends of the steel girders are anchored to the concrete back wall (Figure 2). Because of the high truck volume on the bridge and a heavy freight transport by trains that run under the bridge, the concrete back wall is expected to be under high stress not only because of the traffic volumes on the bridge but also due to traffic that runs on the rail tracks (Figure 3). It was, therefore, decided to investigate the back wall using the NDE technique of Acoustic Emission (AE) in consultation with VDOT/VCTIR.

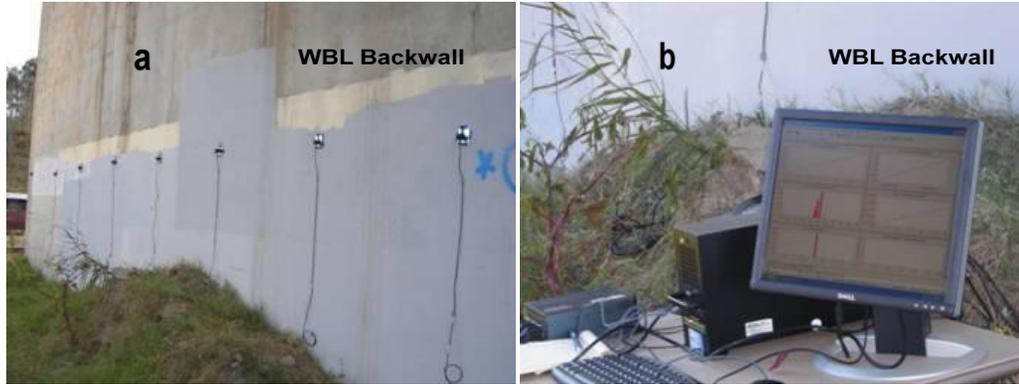
Figure 4. (a) 8 AE sensors installed on the WBL back wall at locations given in Table 1; and (b) The micro-II Digital AE DAQ system acquiring data

In Table 1, the vertical locations from the ground are 7.00 feet. The installed sensors are shown in Figure 4 (a). The data was recorded using the Micro-II Digital DAQ system of Figure 4(b).

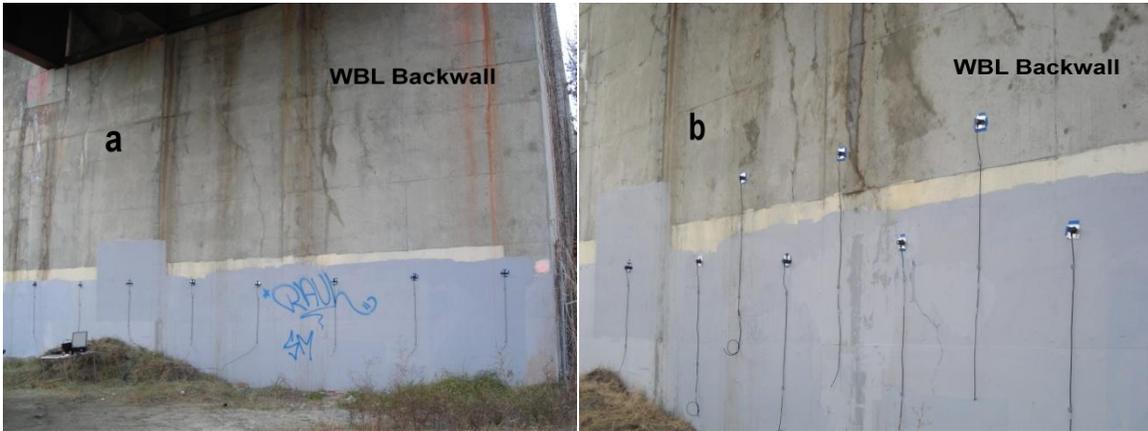
Figure 8: The AE sensors relocated to cover: (a) the entire width of the back wall; and (b) the most active areas

Figure 8 (a) shows installations of the relocated sensors (see Table 2 for locations) to cover the wall area between 16 feet – 51 feet. Considering the width of the back wall of the bridge as 54.5 feet, this relocation covers the entire width of the wall at 7.75 feet from the ground. The responses from sensors 5-8 in this configuration acquired on December 22, 2010 are demonstrated in Figure 9 in the absence of any freight movement under the bridge. However, when the freight train arrived on the same day, the data showed a significant change in AE activity shown in Figure 10. Figure 9 shows responses from sensors 5 – 8 for locations given in Table 2 for the traffic situation in item 1 above where AE events have been plotted against the sensor locations. Figure 10 shows the cluster of events in the wall stretch between sensors 5 - 6 and between 6 -7 are from locations falling around the central steel girders in Figure 2. The situation in Figure 10 corresponds to the condition of item 2 above where there is also the presence of train freight apart from the normal traffic on the bridge. These AE events are resulted from the existing cracks in these regions as well as generation/expansion of new cracks. Comparison of Figures 9 and 10 clearly demonstrates the effect of freight train movement on the AE activity in the wall. The effect is significant as indicated by a large number of recorded hits, specifically in the sensor 6 - 7 stretch and in the vicinity of sensor 7 towards sensor 8.

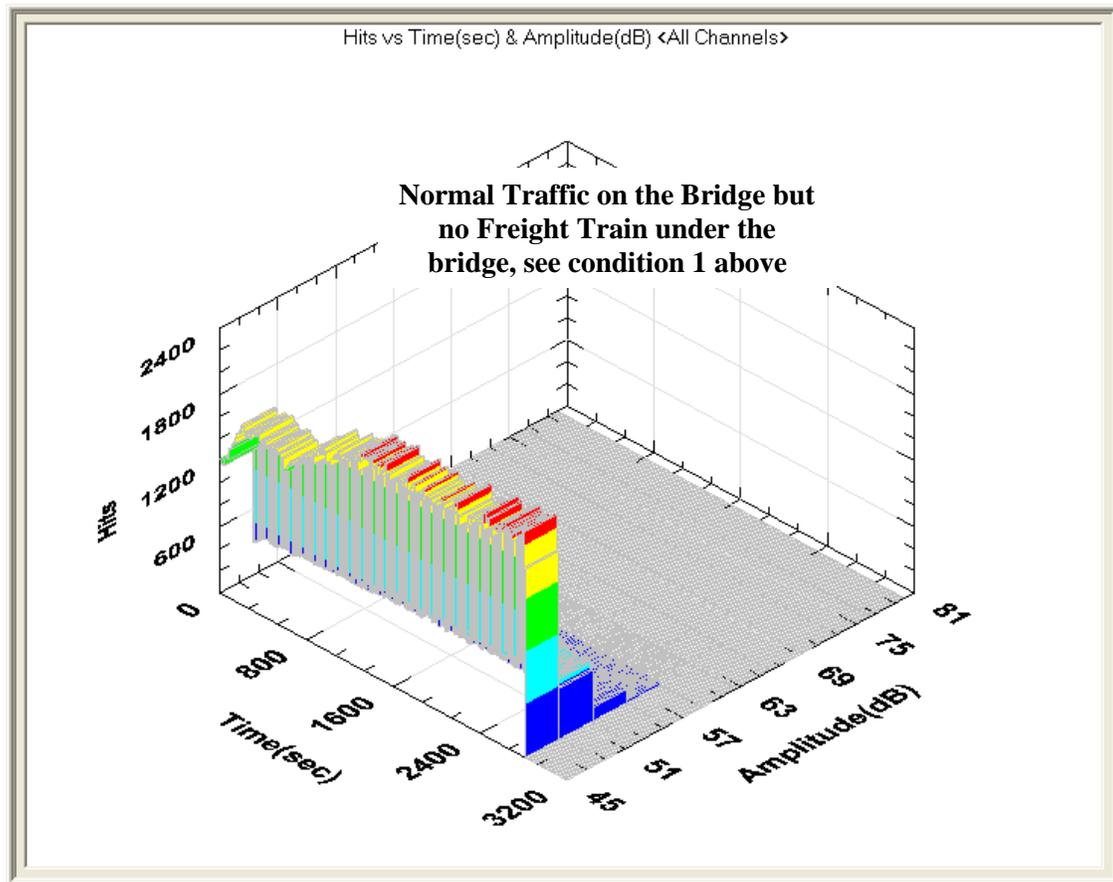
Figure 11. 3D representation of responses from AE sensors 5 – 8 recorded on December 22, 2010 for the sensor locations in Table 2 for a regular traffic on the bridge and no freight train movement under the bridge.

The data of Figures 9 and 10 for the absence and presence of the freight train component has further been analyzed to give a 3 D perspective in Figures 11 and 12, respectively. In 3D diagrams, the AE hits and their amplitudes have been plotted against the time of the hits being recorded at a given sensor. A “hump” of hits related to AE activity due to arrival of freight train in Figure 12 is absent in Figure 11.
