**Ohio Route 50 Joint Sealant Experiment**  
*State Job No.: 14668(0)*  
**FINAL REPORT**

**April 2002**

**Ohio Rout 50 Joint Sealant Experiment**  
*State Job No.: 14668(0)*  
**FINAL REPORT**

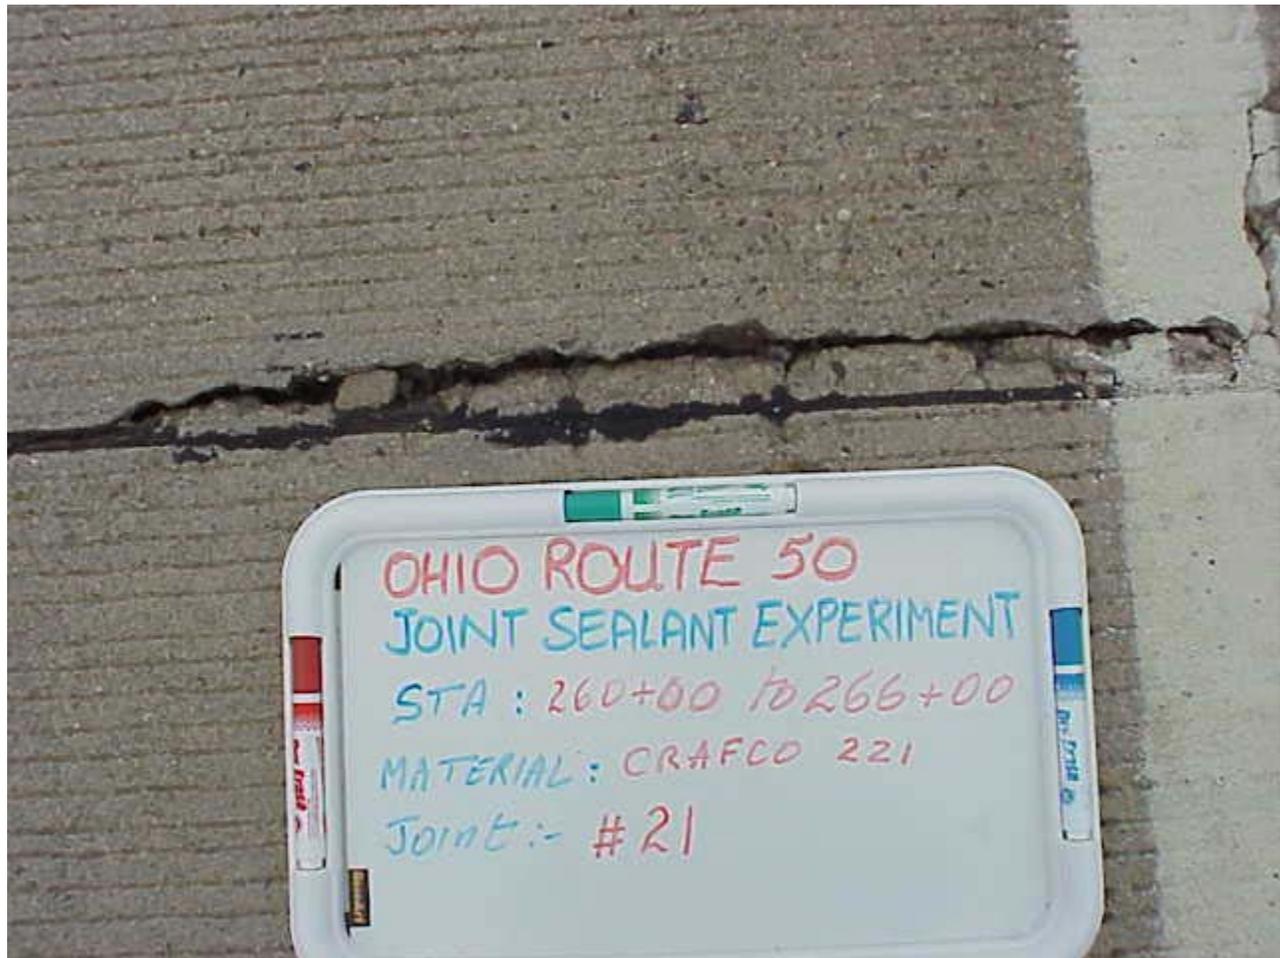
**Figure 4.2** Severe cracking and spalling in Joint 21 of the eastbound CrafcO 221 (1) section

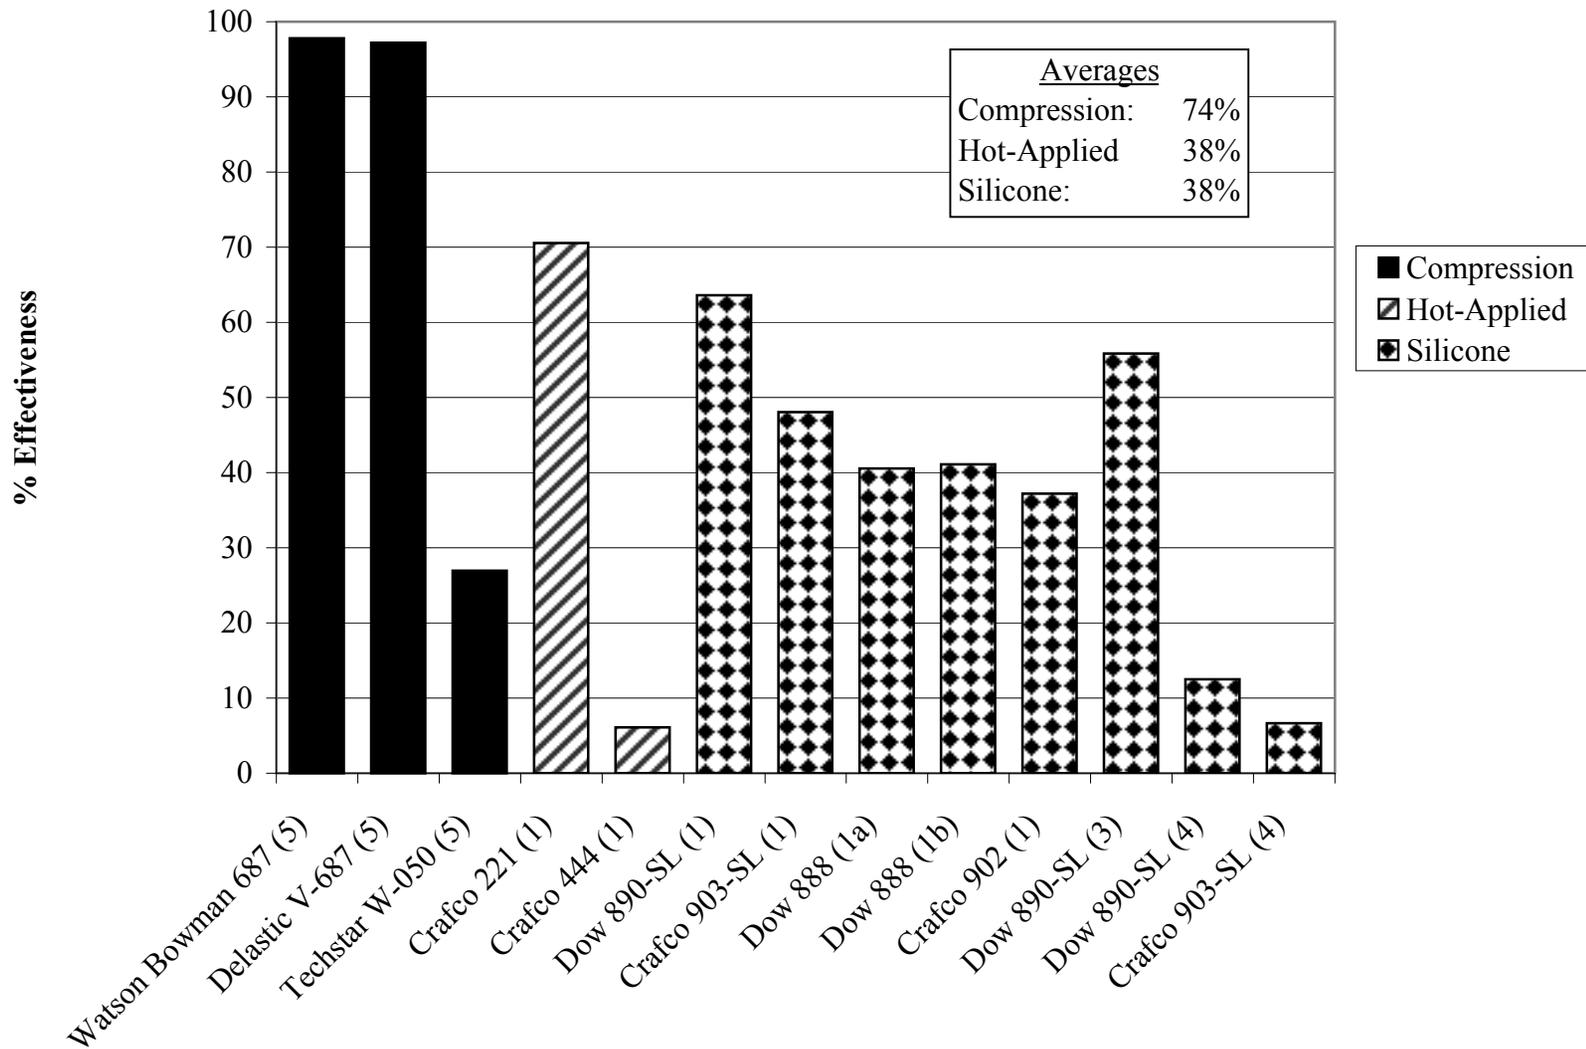
**Figure 5.1** Comparison between silicone, hot-applied, and compression sealants during EBOC00

The silicone sealants are in very poor condition, averaging only 38% effectiveness. Figure 5.1 suggests that their value is influenced greatly by the joint configuration. In general, silicone sealants with the wider joint configuration No. 1 seem to perform significantly better than those with the narrower joint configuration No. 4. The former are averaging 46% effectiveness, compared to only 10% for the latter. Moreover, self-leveling silicones appear superior to non-sag ones, even when the somewhat narrower joint configuration No. 3 is used: the Dow 890-SL (3) section has an effectiveness value of 56%. Joint configurations 1, 3, and 4 have nominal widths of  $10 \pm 2$  mm ( $3/8 \pm 1/16$  in.),  $6 \pm 2$  mm ( $1/4 \pm 1/16$  in.), and  $3 \pm 2$  mm ( $1/8 \pm 1/16$  in.), respectively.

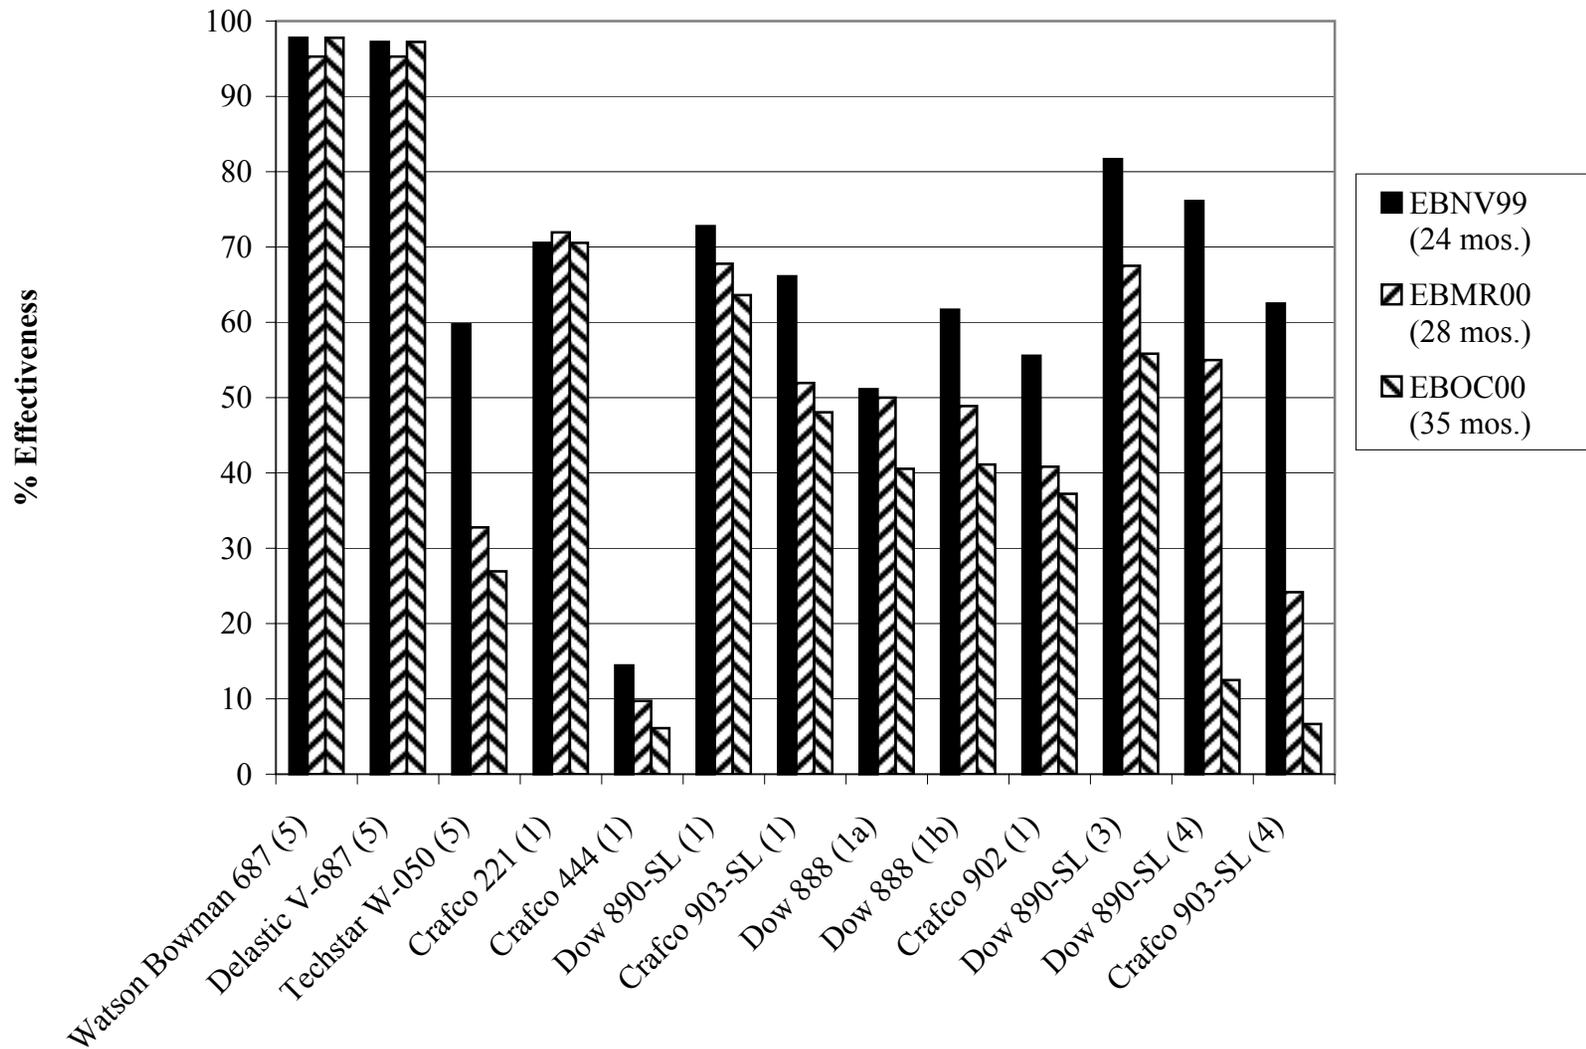
**Figure 5.3** Deterioration of sealants from EBNV99 to EBOC00

In order to reach sound conclusions regarding the effectiveness of each sealant, monitoring must continue for a substantial period of time. Figure 5.3 shows the effectiveness trends for all sealant sections emerging from the three surveys conducted as of EBOC00. Separate Figures for each sealant type, i.e. compression, hot-applied, and silicone, are provided as well (Figures 5.4 to 5.6).

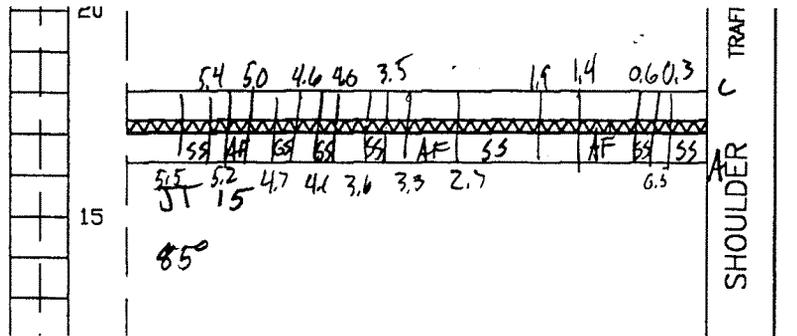
(b) From Survey EBJN01

**Figure 5.9** Comparison between field logs from EBOC00 and EBJN01 for Joint 15 in the Crafc0 903-SL (4) section.

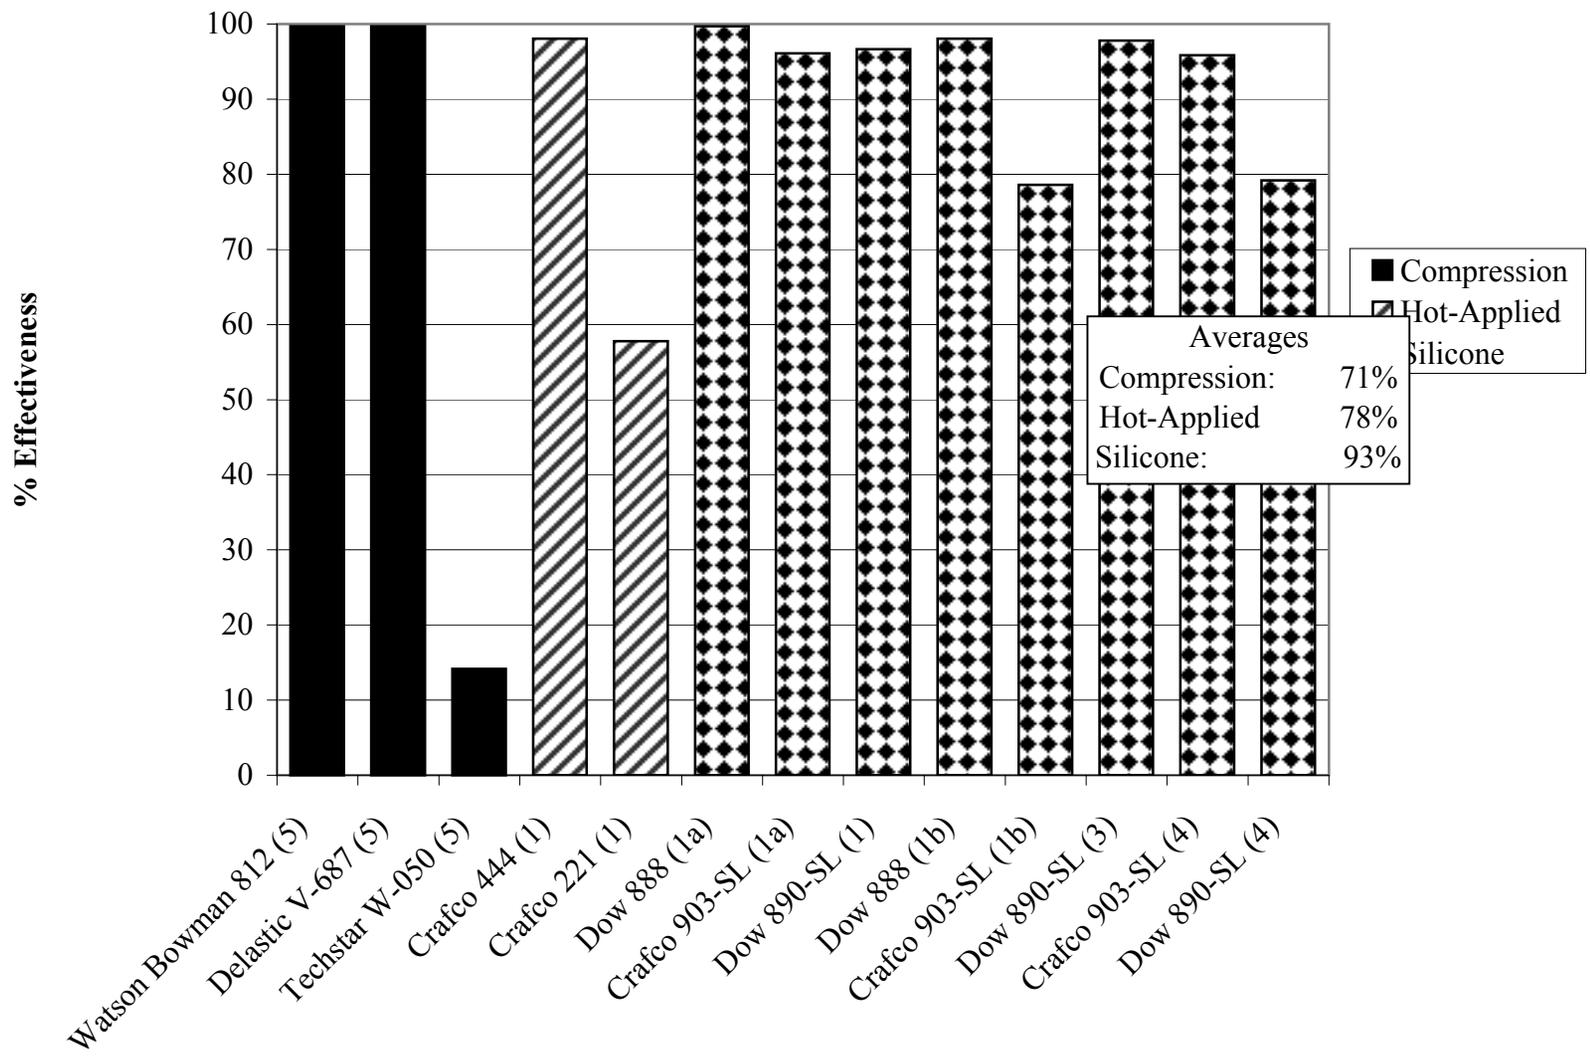
**Figure 5.27** Comparison between silicone, hot-applied and compression sealants during WBJN01

the fourth sealant evaluation in the westbound driving lane. The survey was performed in the same manner as previous inspections (Sander, 2002), and the data set collected is code-named WBJN01. Effectiveness values calculated are shown in Figure 5.27. The sections are grouped by sealant type: silicone, hot-applied, or compression, for which average effectiveness values are listed. The joint configuration is denoted by the number in parentheses.

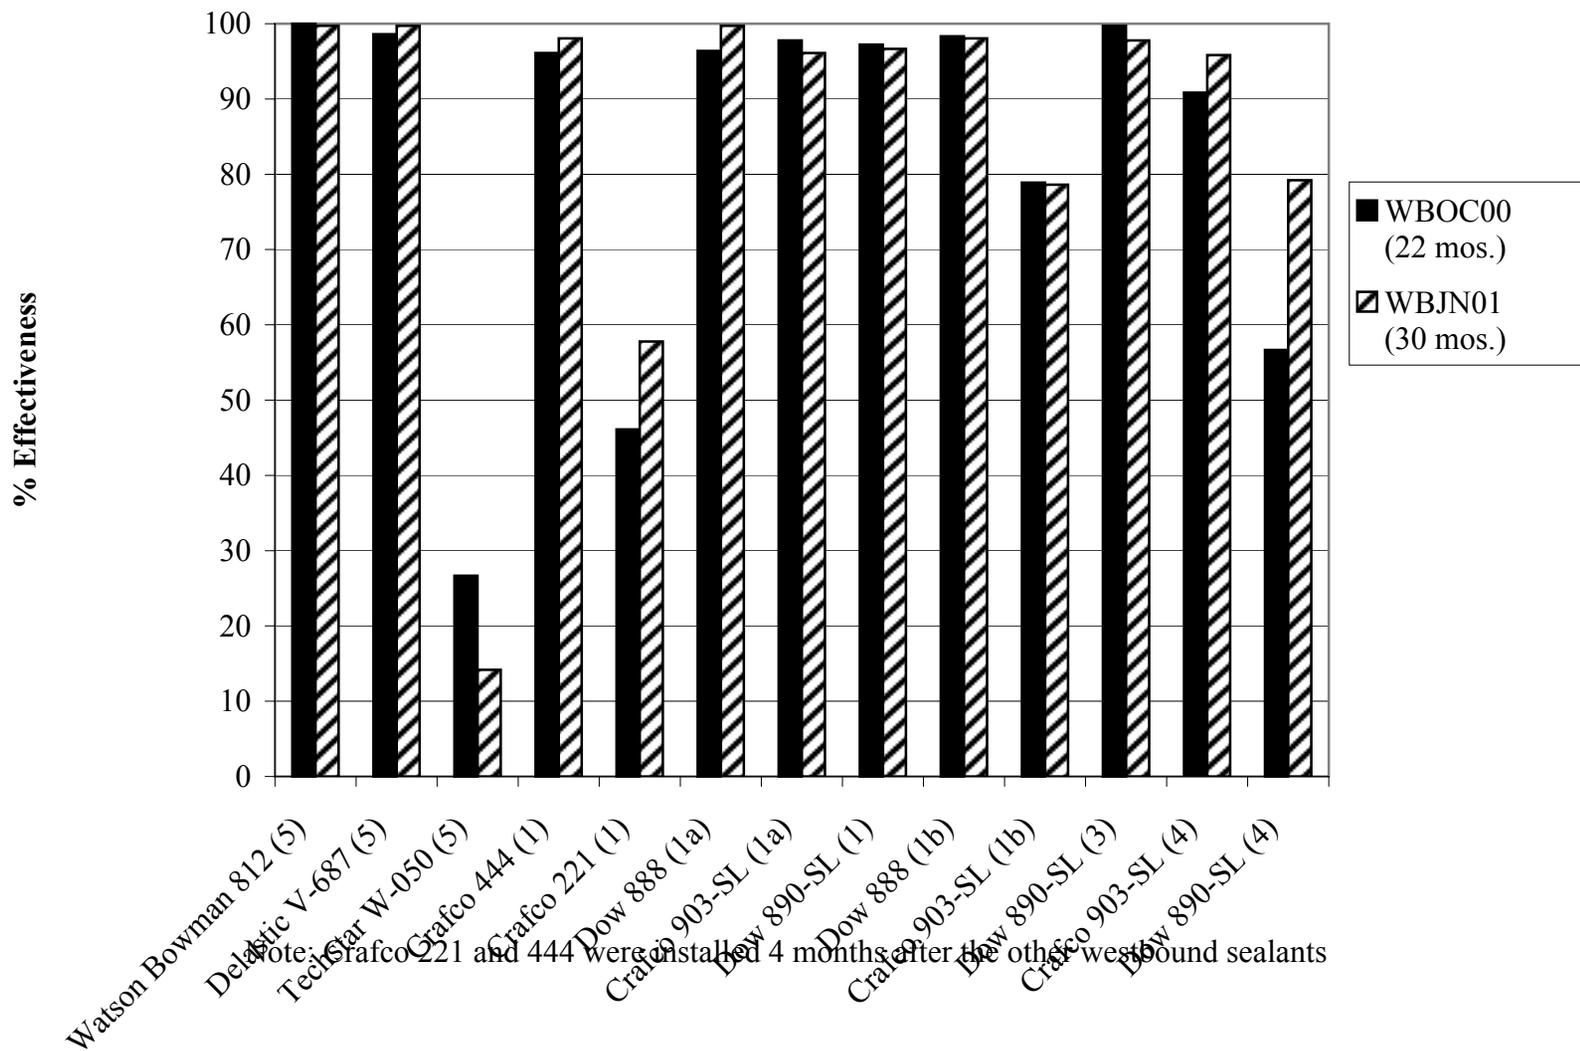
**Figure 5.28** Deterioration of sealants from WBOC00 to WBJN01

The results of the last two surveys are compared in Figure 5.28. Table 5.5 also lists the effectiveness values and differences from the previous two surveys and ranks the sections accordingly. Techstar W-050 (1) lost more effectiveness (13%) than all other sealant sections. The effectiveness values for the compression seal sections, Watson Bowman 812 (5) and Delastic V-687 (5), has varied by only 1%. Both of the hot-applied sections have increased in effectiveness. The 12% increase in Crafc0 221 (1) is the second highest; the Crafc0 444 (1) apparently improved by 2%. The large increases in effectiveness observed previously in the eastbound lanes are generally nonexistent in the

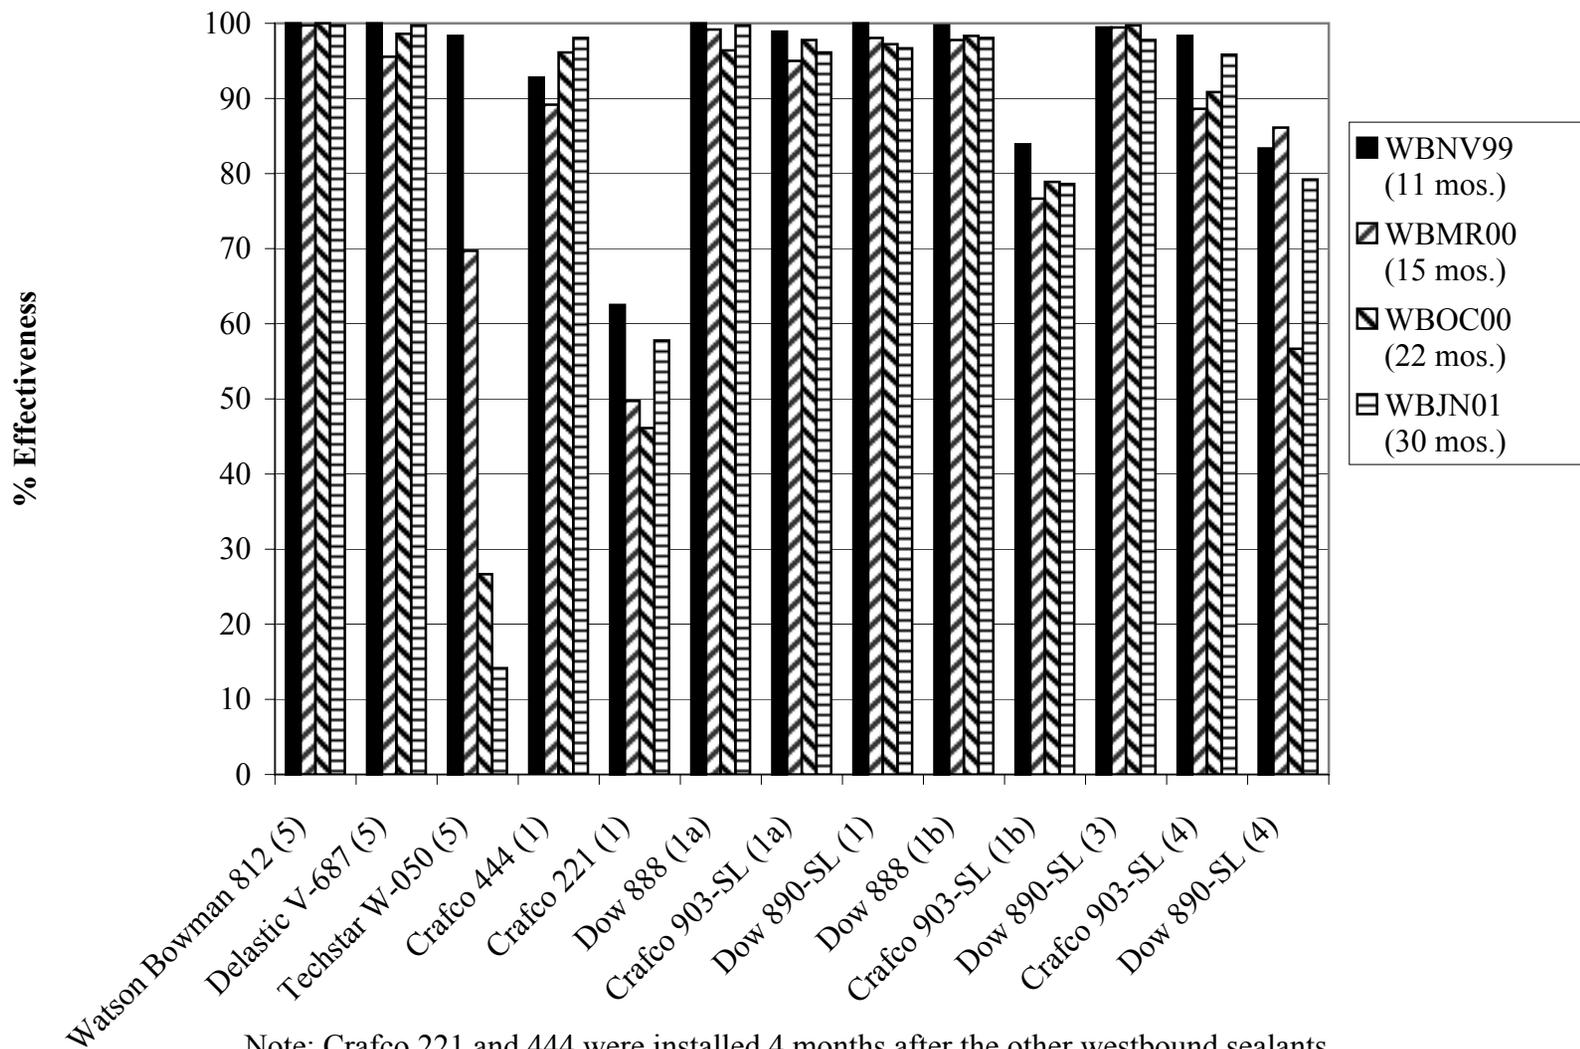
**Figure 5.29** Deterioration of sealants from WBNV99 to WBJN01

The deterioration of all westbound sealant sections since the first survey (Fall 1999) is displayed in Figure 5.29. The long-term loss of effectiveness for the pre-formed compression seals is also shown in Figure 5.30. Watson Bowman 812 (5) and Delastic V-687 (5) continue to maintain most of their effectiveness. It is unlikely that these two superior seals will lose much effectiveness in the near future. Techstar W-050 (5) has already failed and continues to decline toward 0% effectiveness. After failing in just a short period of time, the Techstar seals in both the eastbound and westbound lanes have no long-term durability.

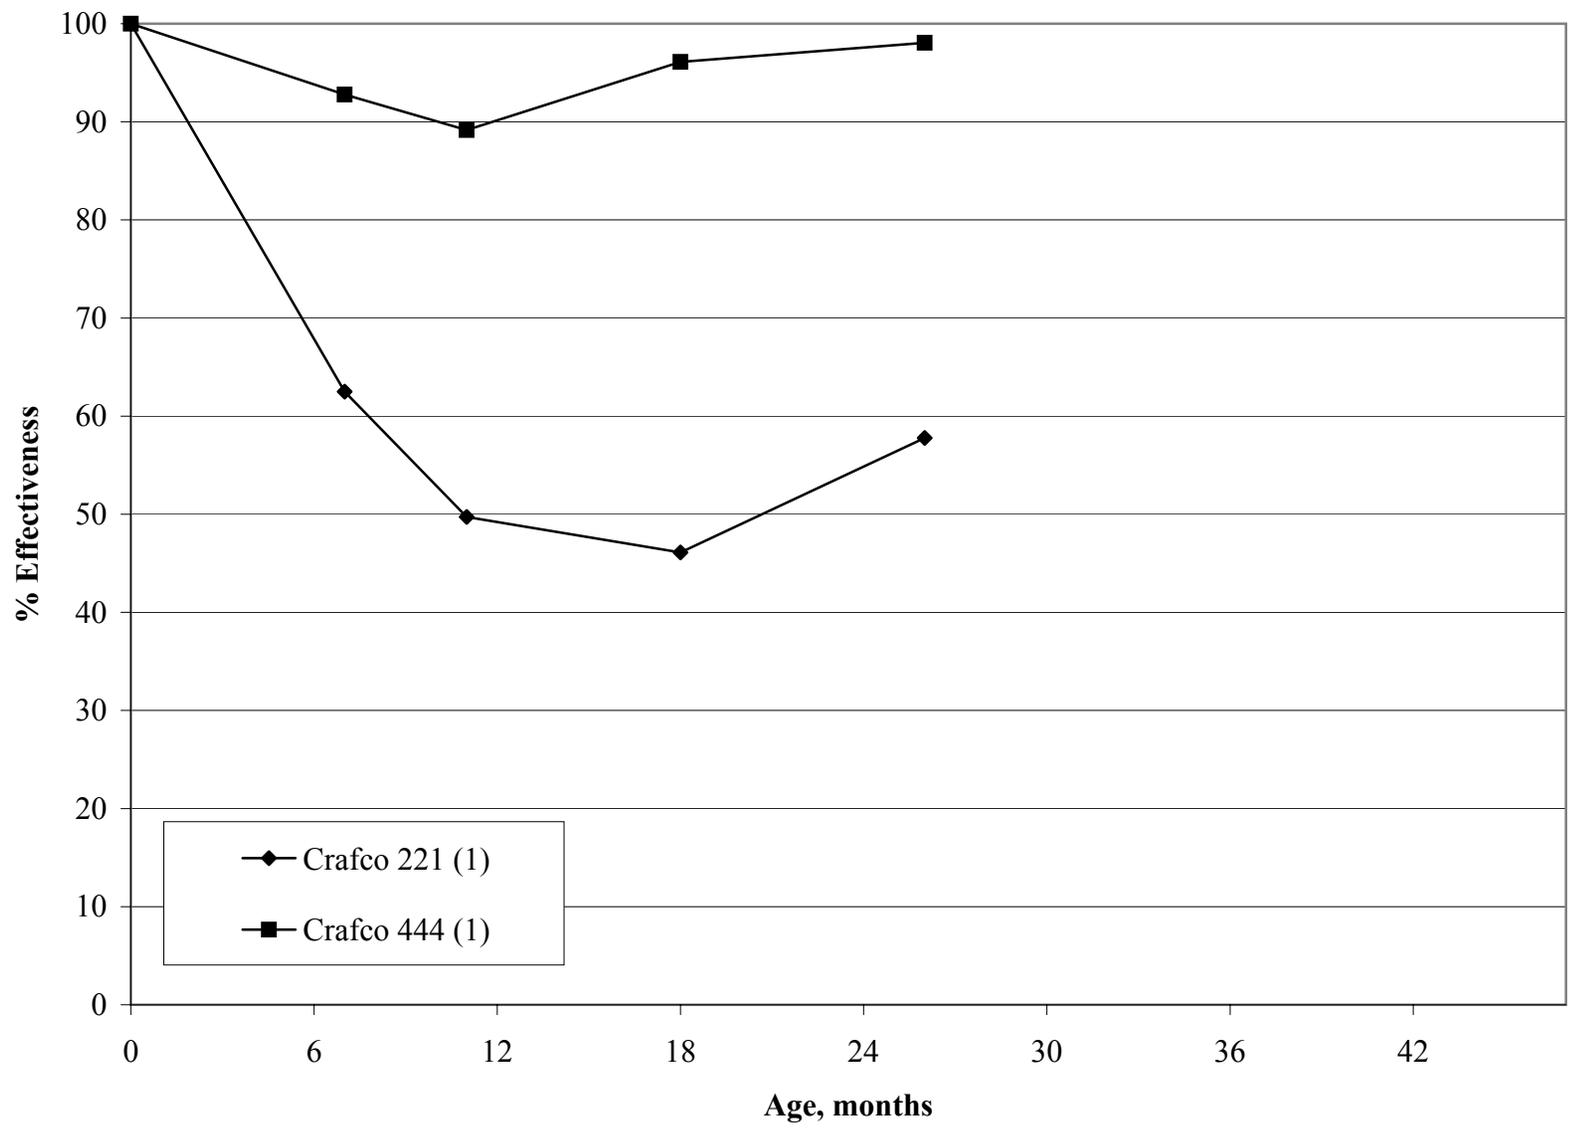
**Figure 5.31** Deterioration of hot-applied sealants in the westbound lanes as of WBJN01

Figure 5.31 illustrates the results of the past four surveys for the hot-applied sealants. The section containing Crafc0 444 (1) has increased slightly in effectiveness during the past two surveys, but this total increase accounts to only 9%. Crafc0 221 (1) was thought to be steadily losing effectiveness but it seems to have stabilized and even shows a slight increase.

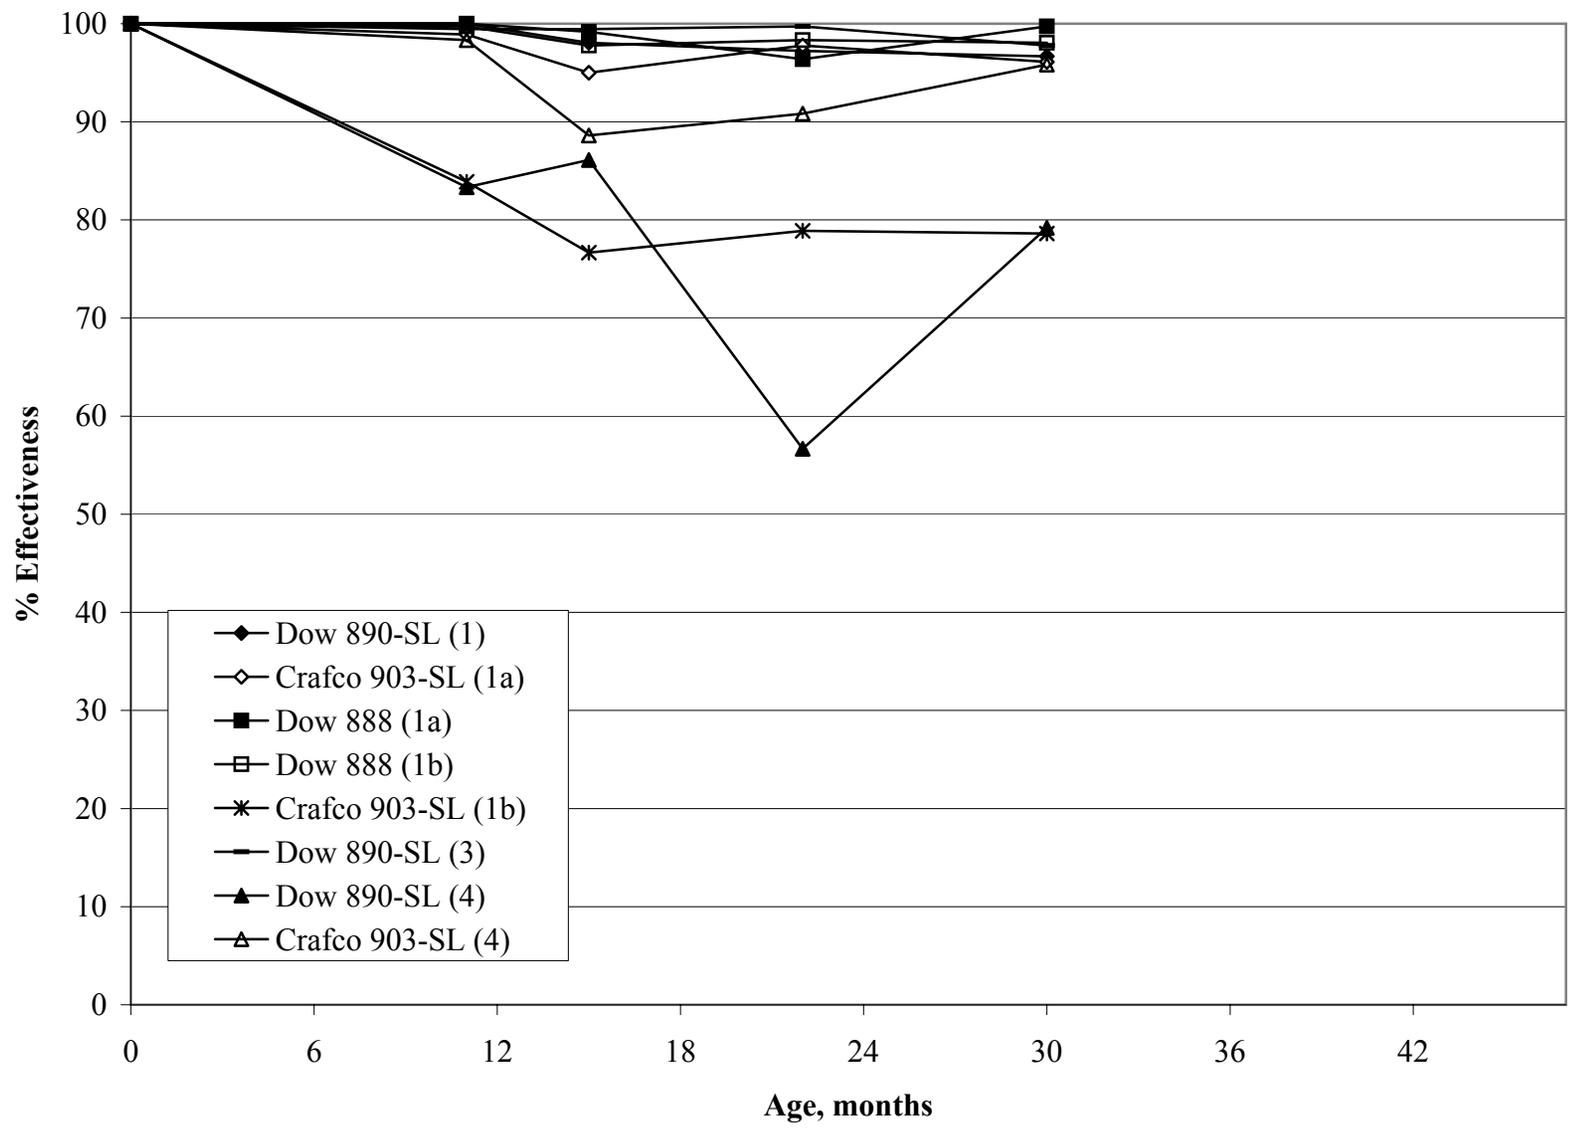
**Figure 5.32** Deterioration of silicone sealants in the westbound lanes as of WBJN01

The trendline for the silicone sealants over the past four surveys is shown in Figure 5.32. With the exception of Dow 890-SL (4) at the time of WBOC00, all of these sections have maintained most of their effectiveness as measured during the first survey

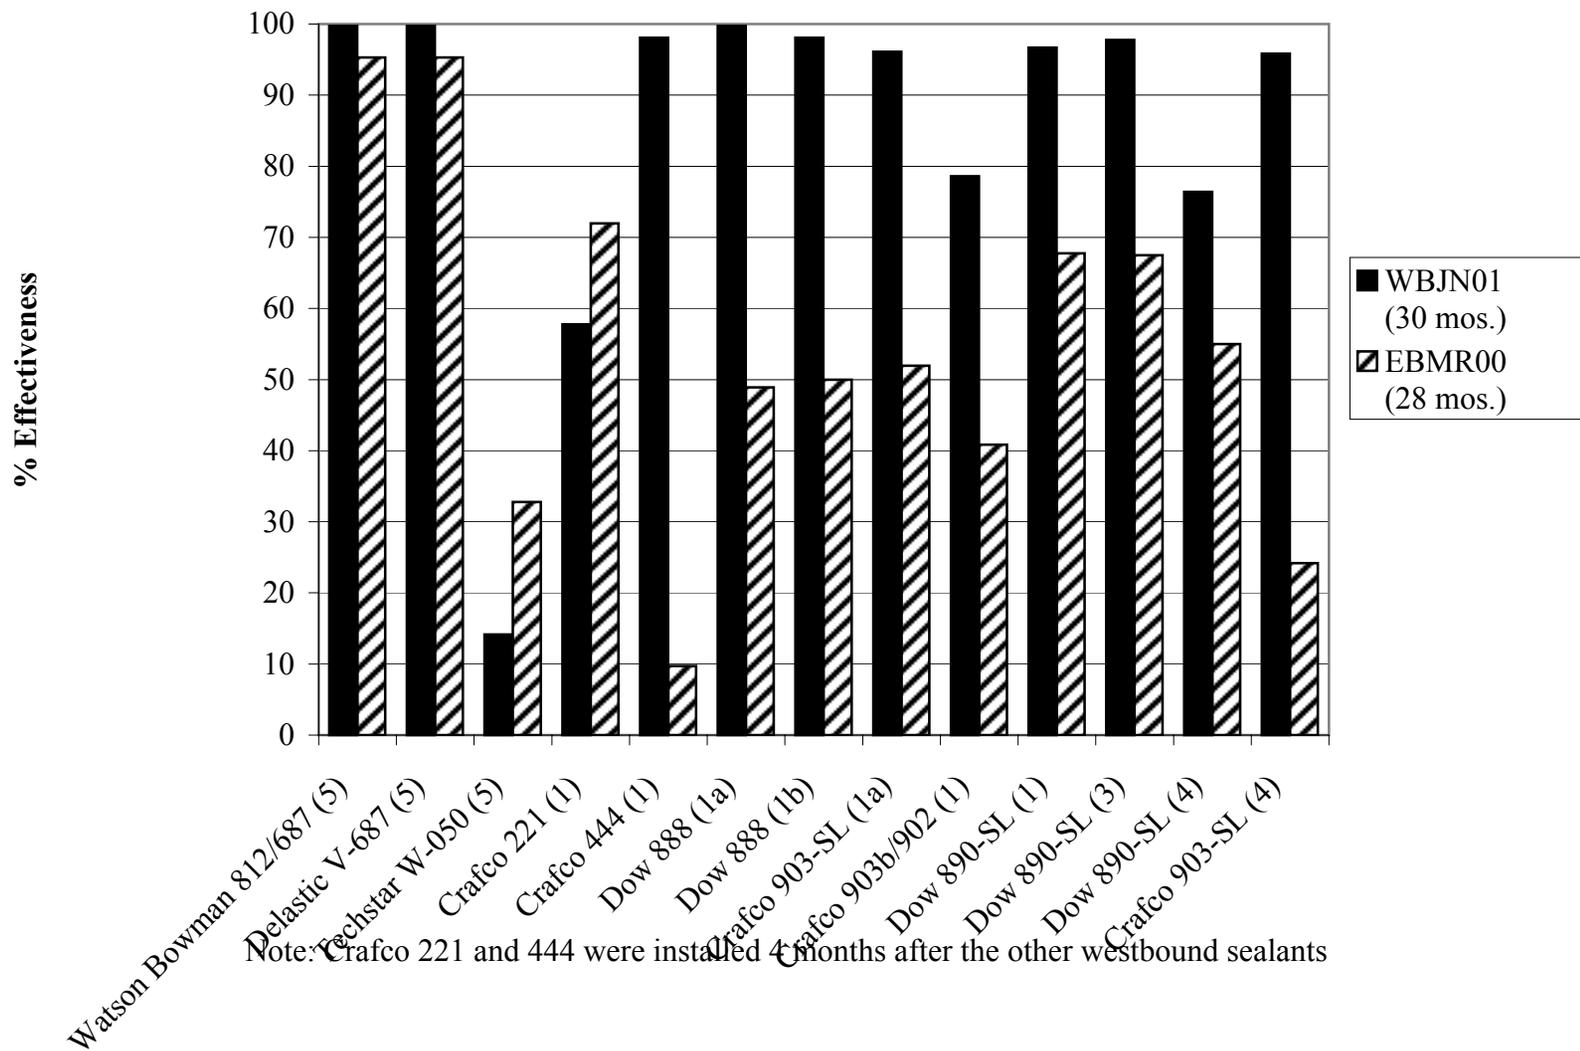
**Figure 5.33** Comparison of eastbound and westbound lane sealants after 2 1/2 years in service

Results from these two surveys are compared in Figure 5.33, which shows that the sealants in the westbound lane continue to outperform those in the eastbound. This trend is the same as had been observed in the last comparison. All but two of the westbound sections retain greater effectiveness values than their eastbound counterparts. In fact, the difference between the two lane directions is more pronounced now than before. The average difference is now 31%, up from 17% in the last comparison. This shows that the westbound sealants are not deteriorating nearly as rapidly their counterparts in the eastbound lanes.

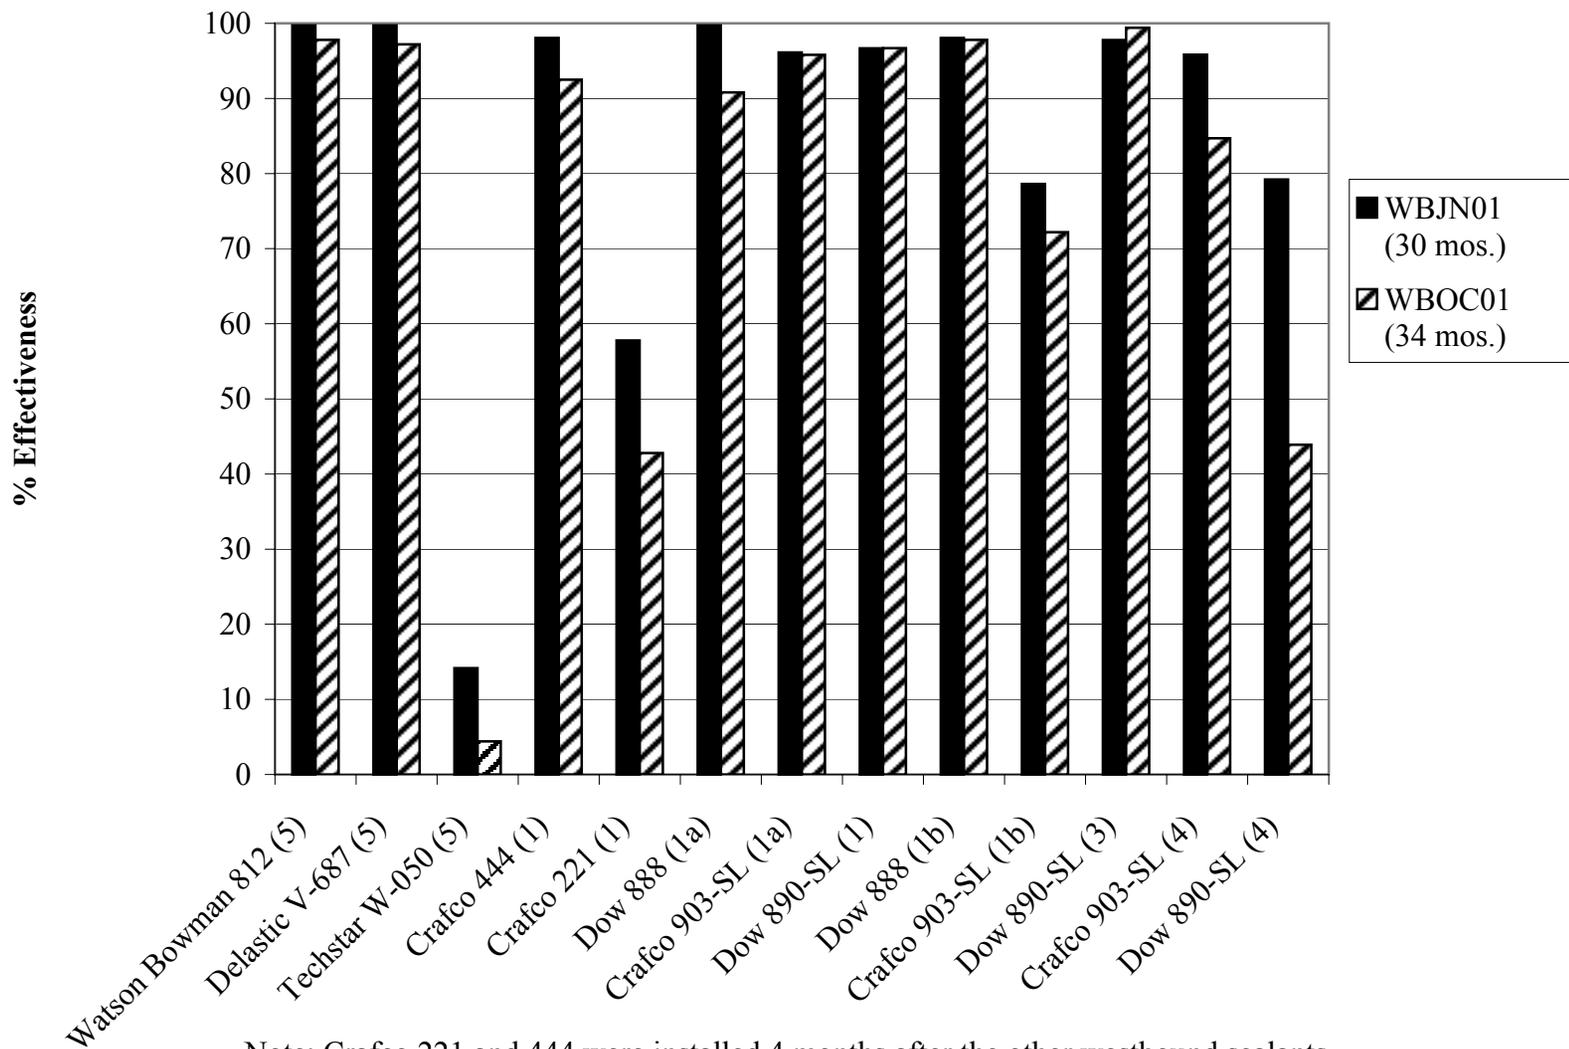
**Figure 5.35** Deterioration of sealants from WBJN01 to WBOC01

In Figure 5.35, the results of the current survey are compared to those from the previous one. Numerical values for effectiveness and deterioration, as well as corresponding rankings, are listed in Table 5.6. Watson Bowman 812 (5) and Delastic V-687 (5), which were both 99.7% effective during WBJN01, maintained their excellent performance, each decreasing by only 2%. Techstar W-050 (5), which had little effectiveness left, lost 10%, falling to 4% effectiveness. The Crafcoc 444 (1) section lost 6%, but it is still in very good condition ( $\geq 90\%$ ). Crafcoc 221 (1) fell from a poor to very poor rating by losing 15%, and so ranks second in terms of lost effectiveness. The section containing Dow 890-SL (4) exhibits the largest decrease in effectiveness (35%),

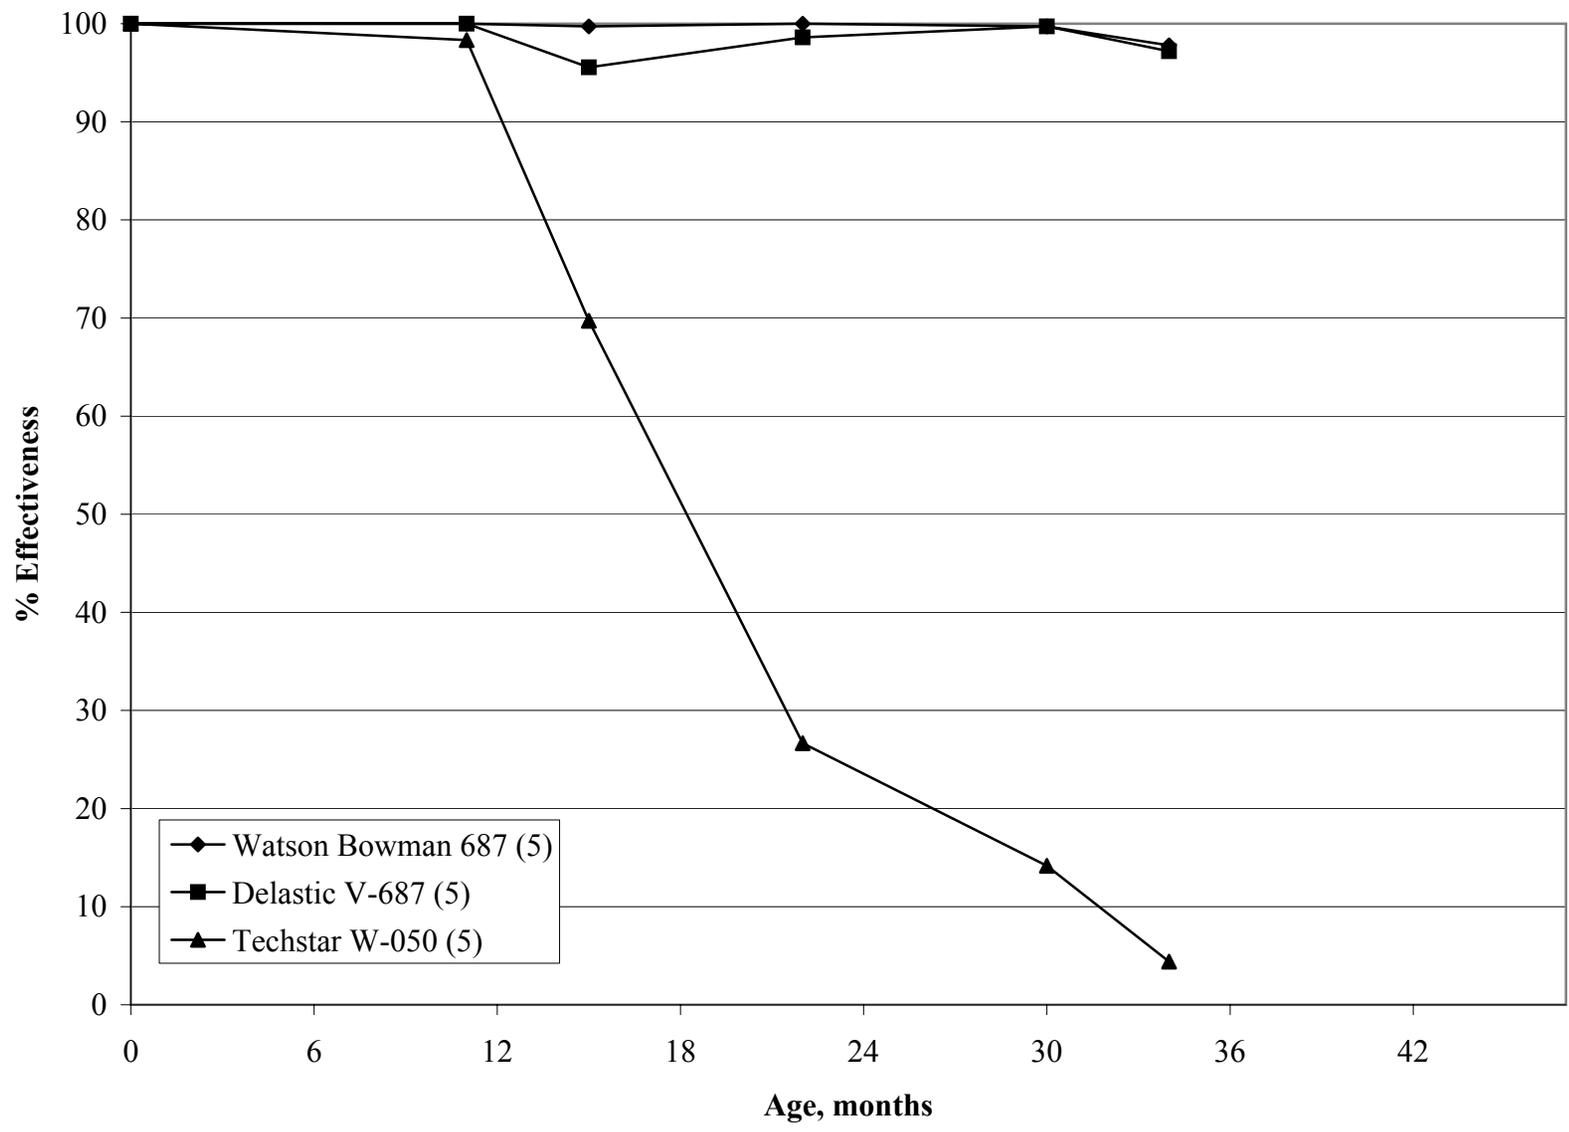
Figure 5.36 Deterioration of sealants from WBNV99 to WBOC01

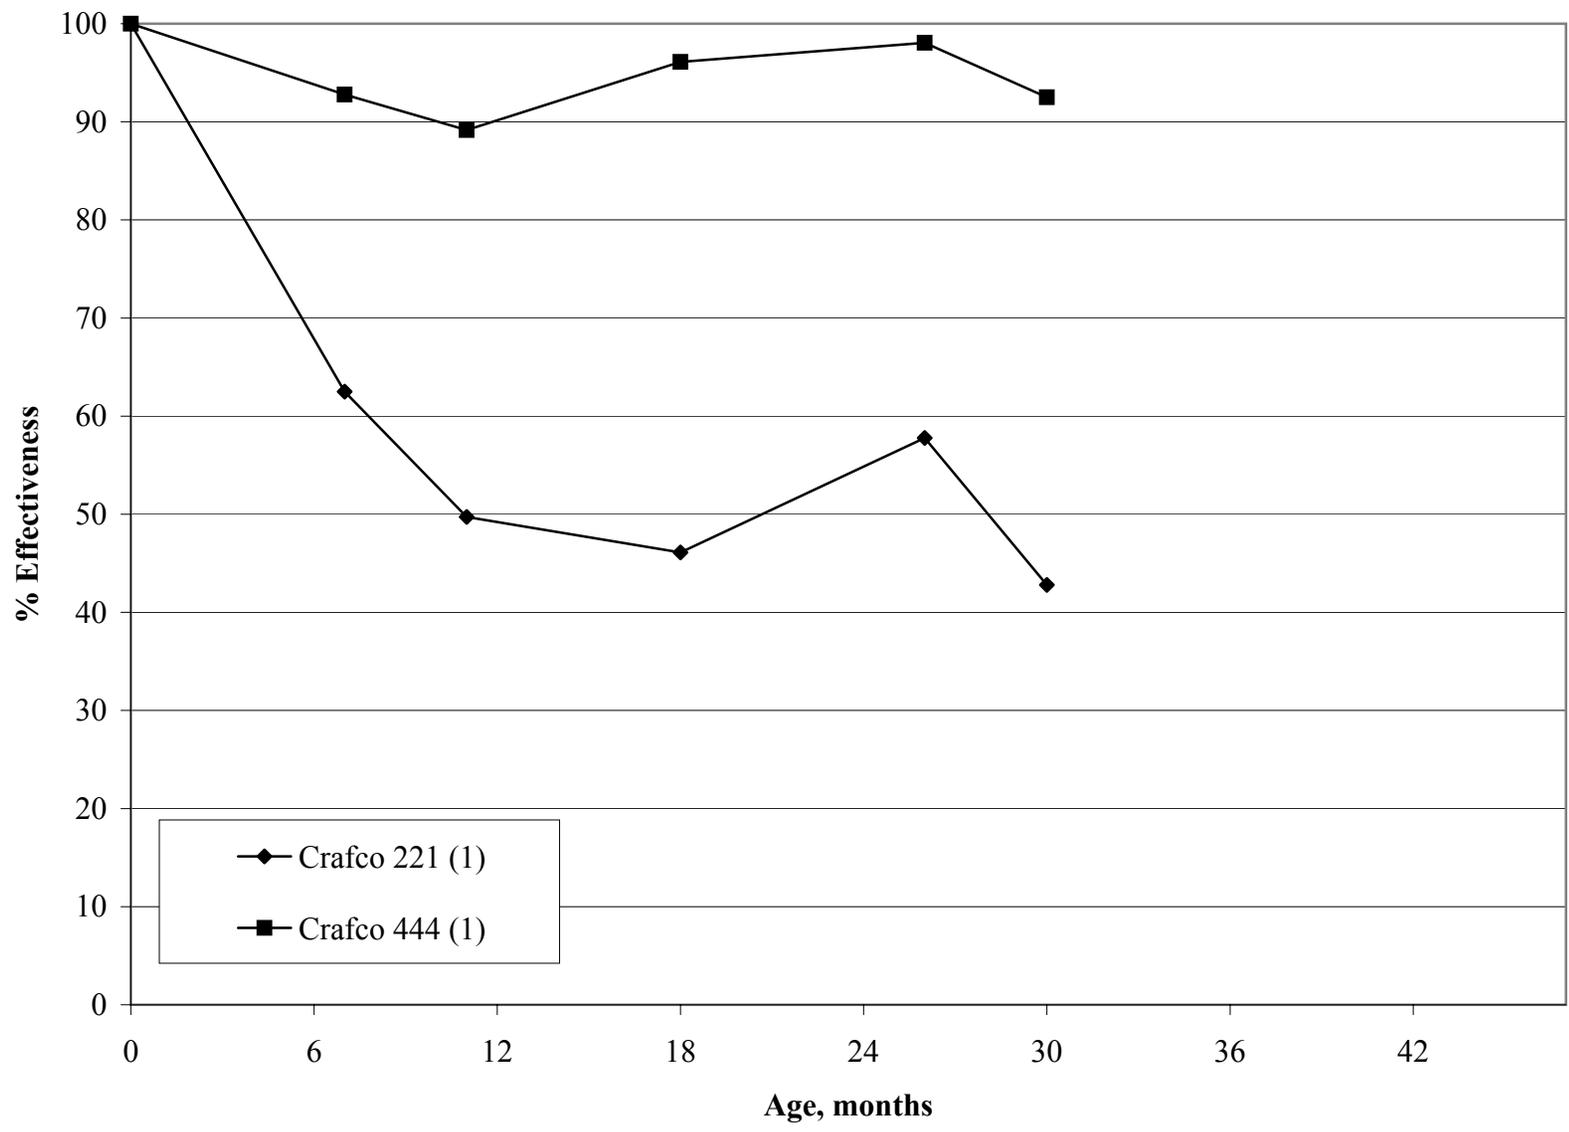
**Figure 5.37** Deterioration of compression seals in the westbound lanes as of WBOC01
