**Ohio Route 50 Joint Sealant Experiment**  
*State Job No.: 14668(0)*  
**FINAL REPORT**

**April 2002**

**Ohio Rout 50 Joint Sealant Experiment**  
*State Job No.: 14668(0)*  
**FINAL REPORT**

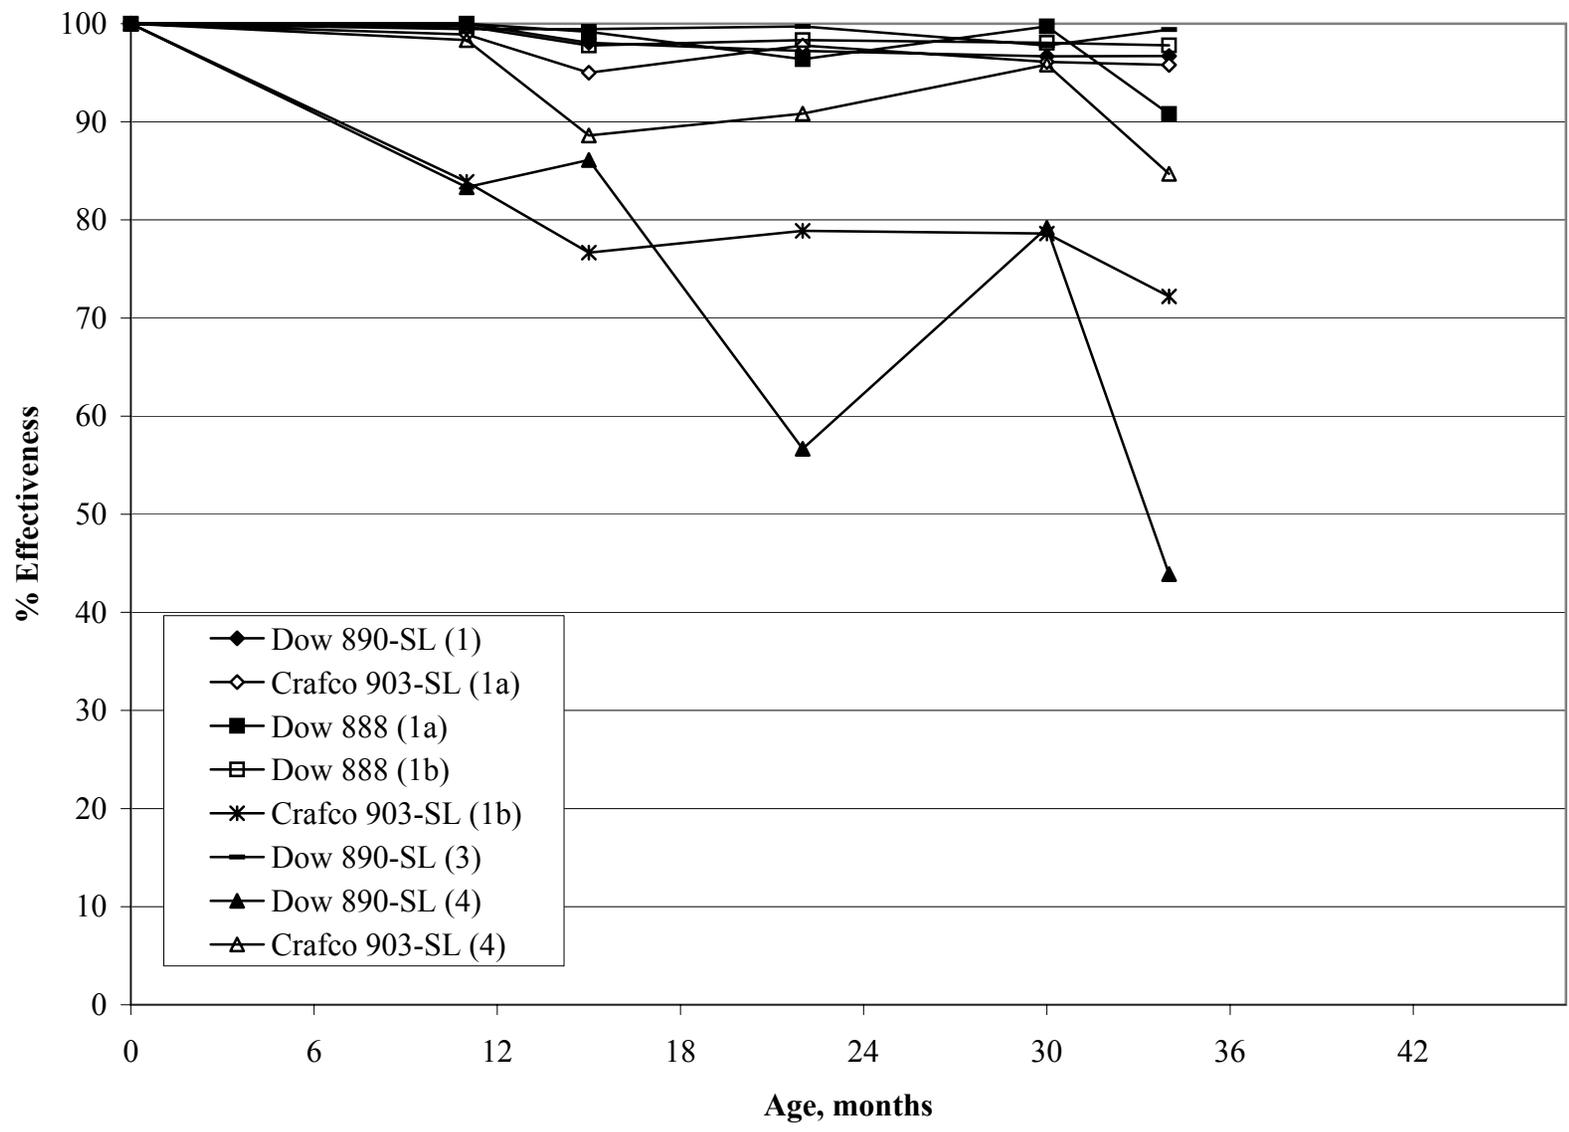
**Figure 5.38** Deterioration of hot-applied sealants in the westbound lanes as of WBOC01

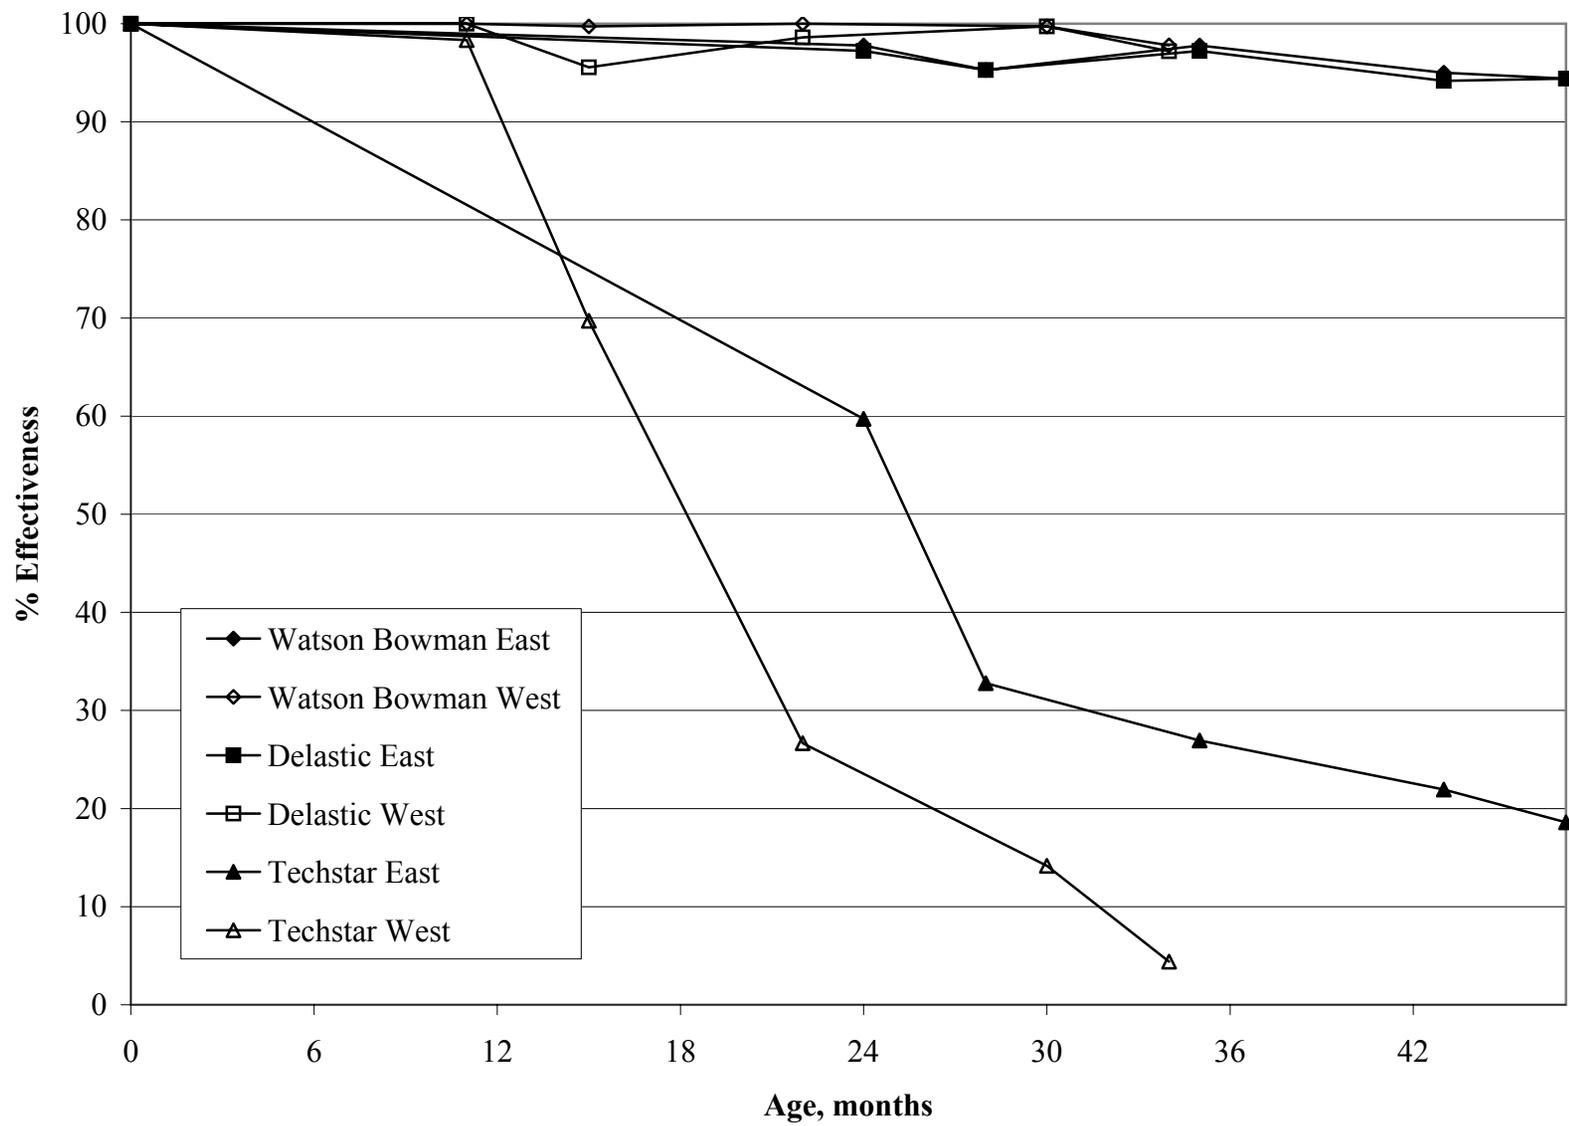
**Figure 5.40** Comparison of eastbound and westbound lane sealants after 3 years in service

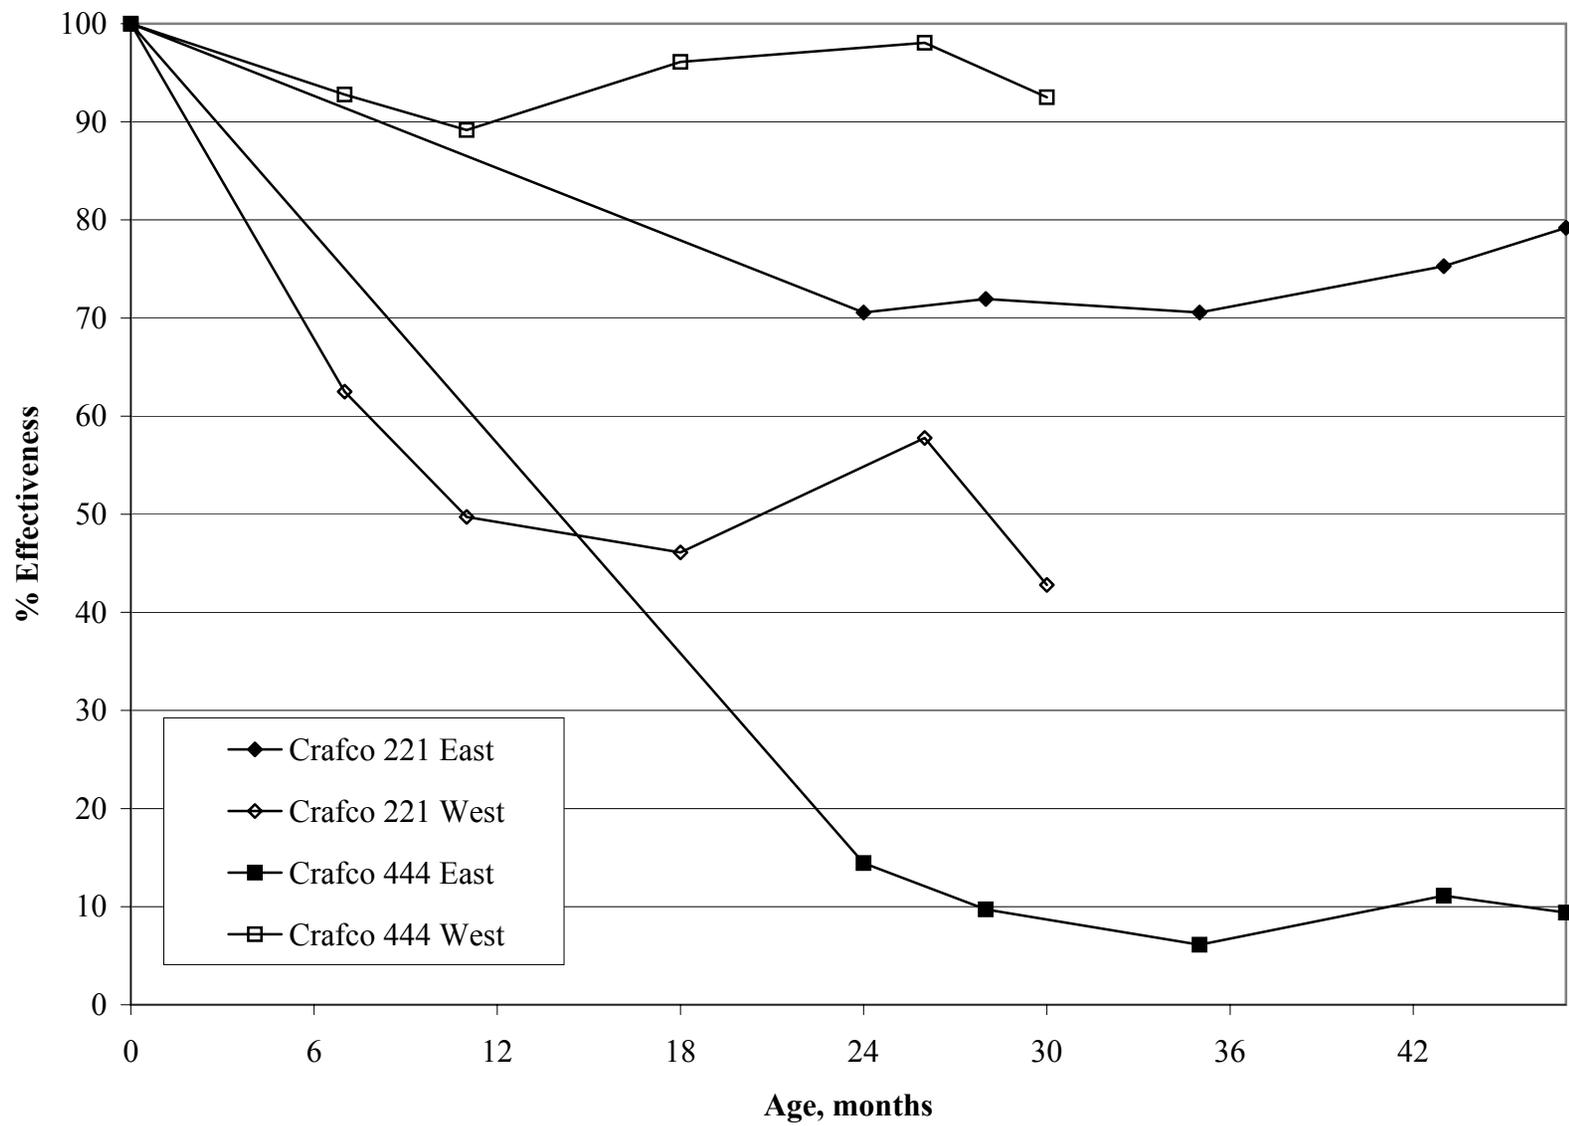
**Figure 5.41** Deterioration of compression seals in the eastbound and westbound lanes

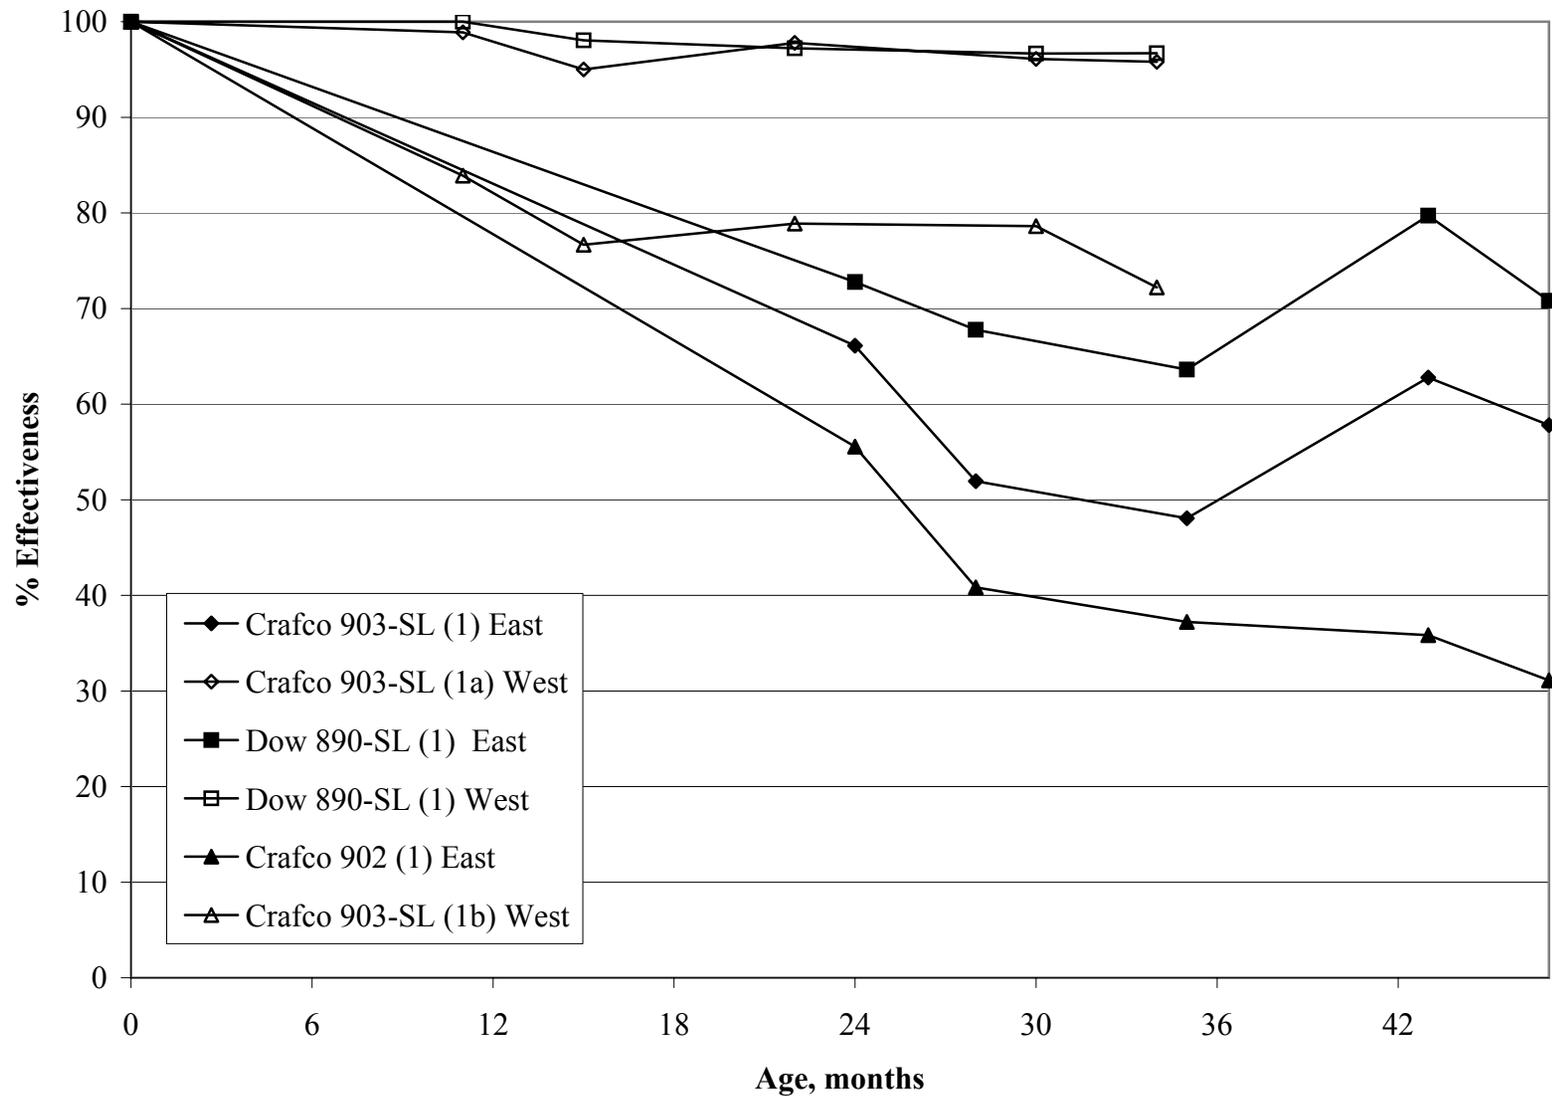
**Figure 5.42** Deterioration of hot-applied sealants in the eastbound and westbound lanes

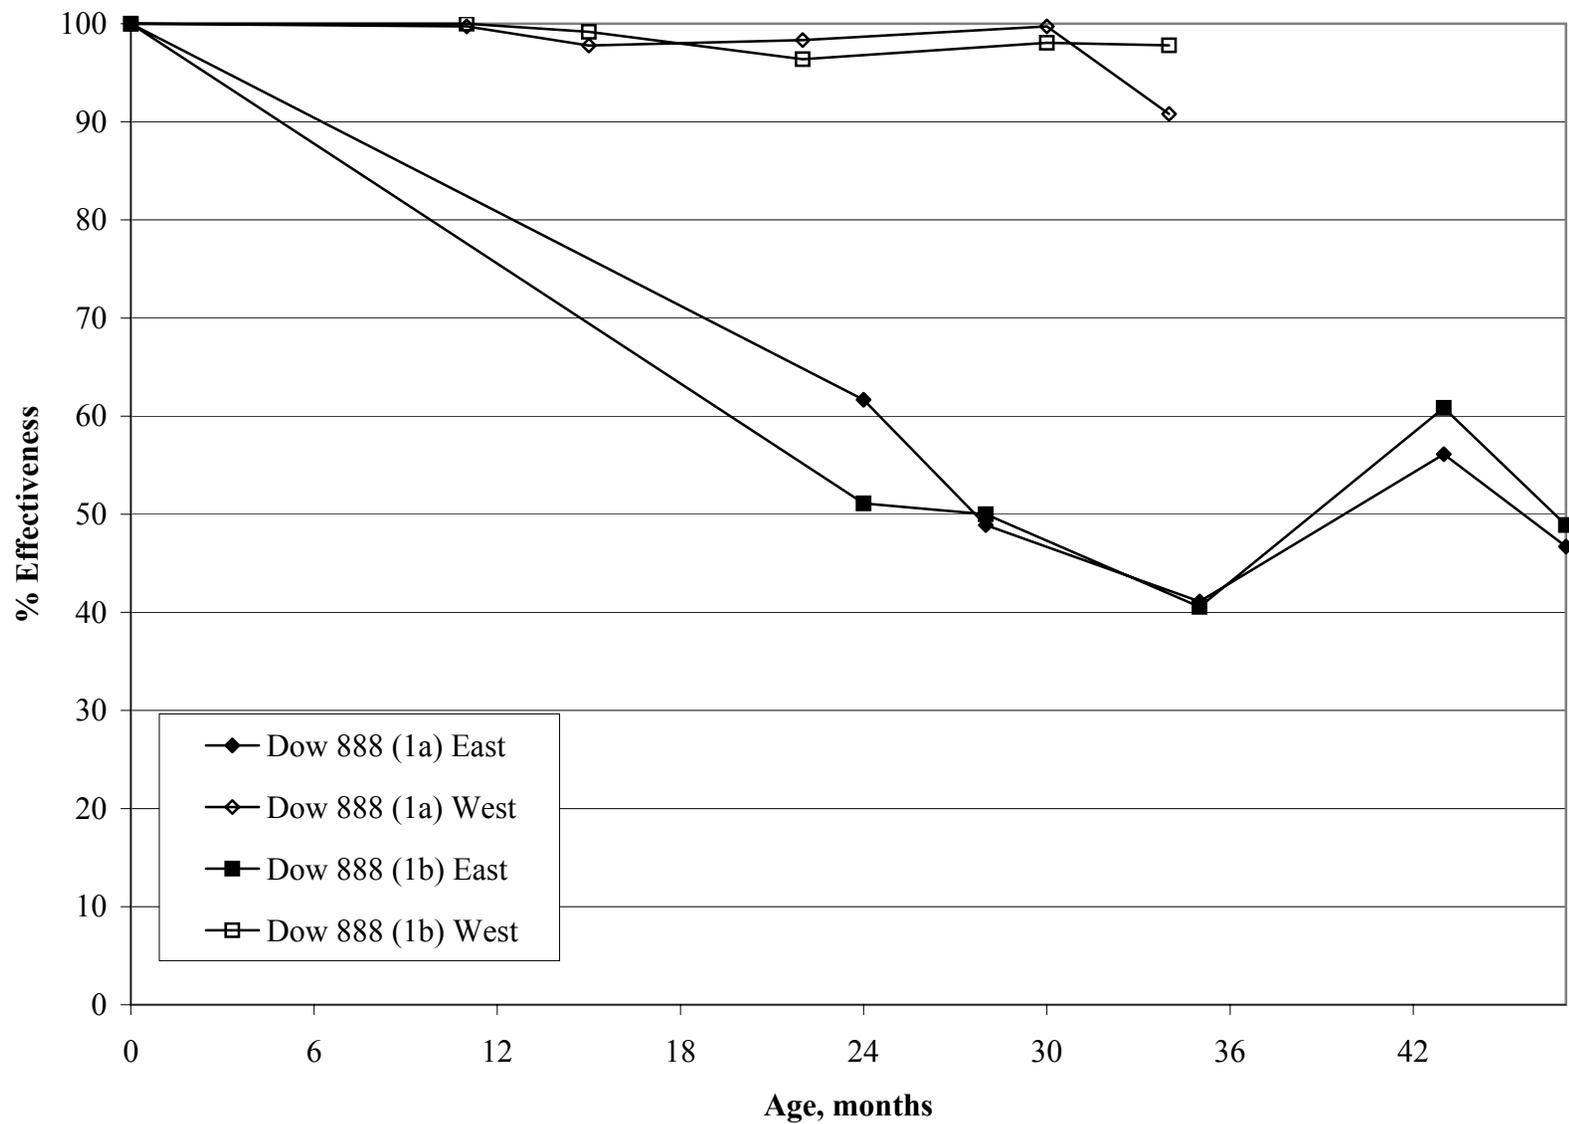
**Figure 5.43** Deterioration of self-leveling silicone sealants with Joint Configuration 1 in the eastbound and westbound lanes

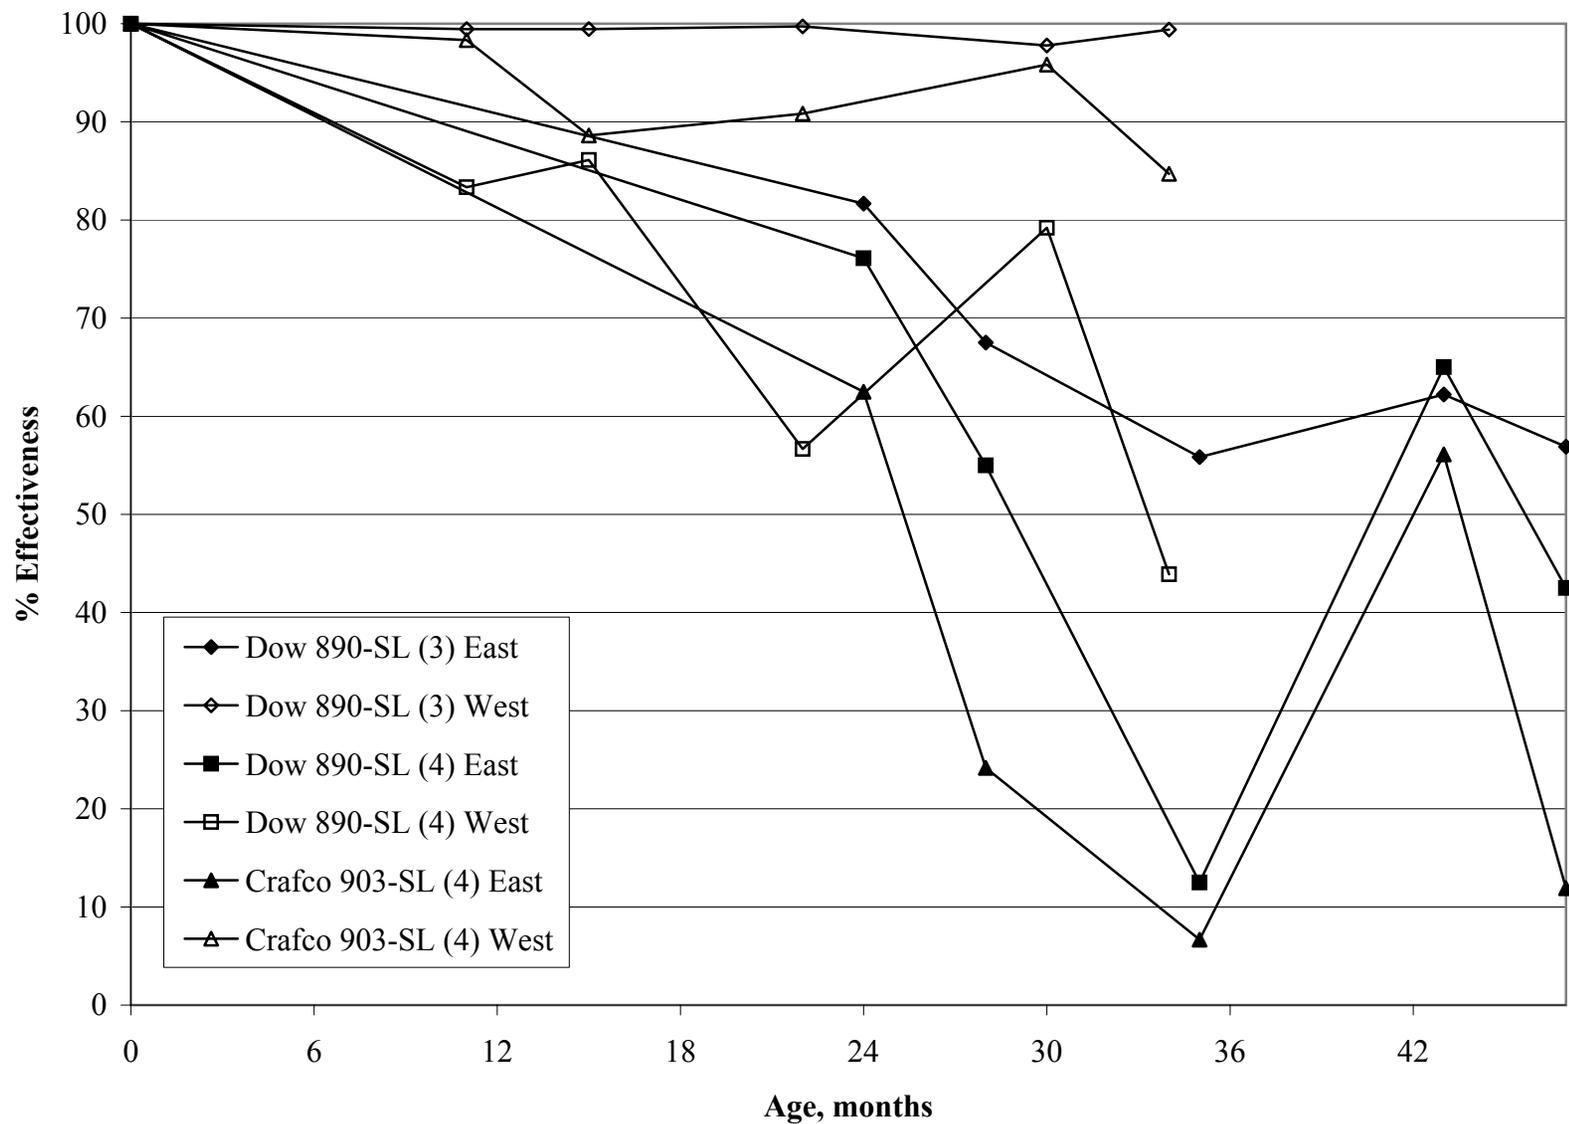
**Figure 5.44** Deterioration of non-sag silicone sealants in the eastbound and westbound lanes

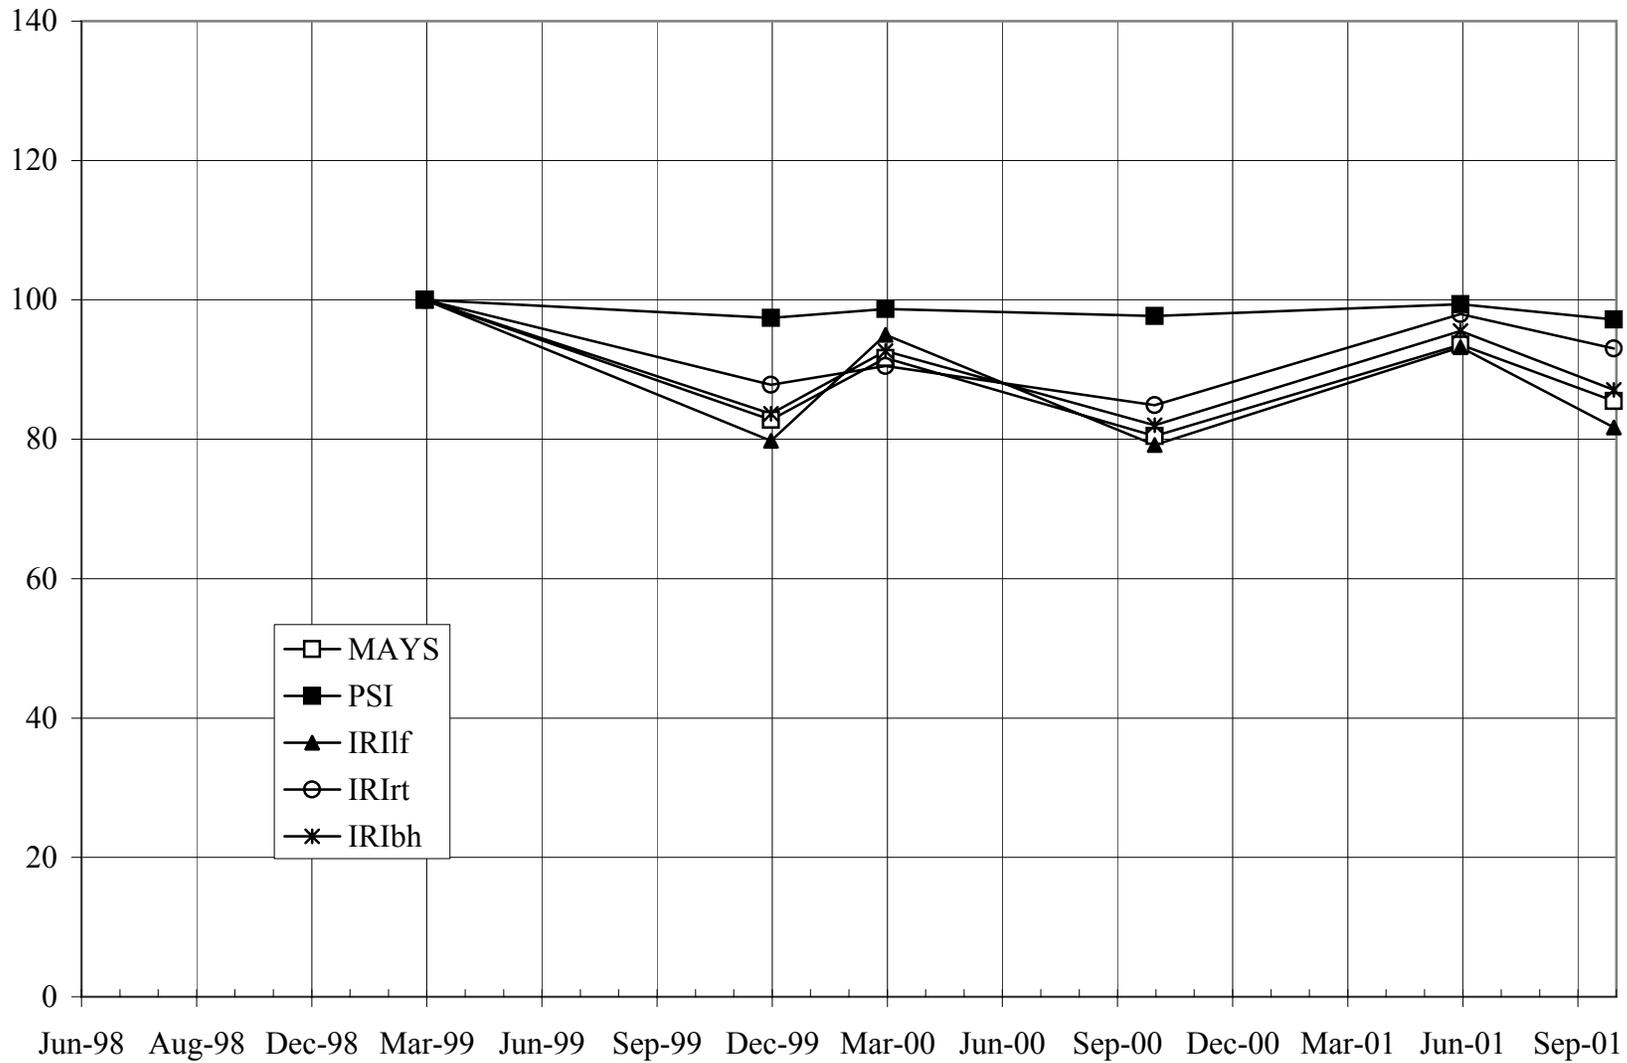
The results of the past six profilometer surveys are shown in Figure 5.60. As in the passing lane, the wavy nature of the surveys are apparent but to a larger degree. All five indices decreased in smoothness during this survey, yet during the previous survey all five increased. This pattern is repeated throughout the life of the pavement, which would suggest cyclic warping and curling effects as postulated for the passing lane.

**Figure 5.60** Trendlines for the Westbound Driving Lane through October 2001

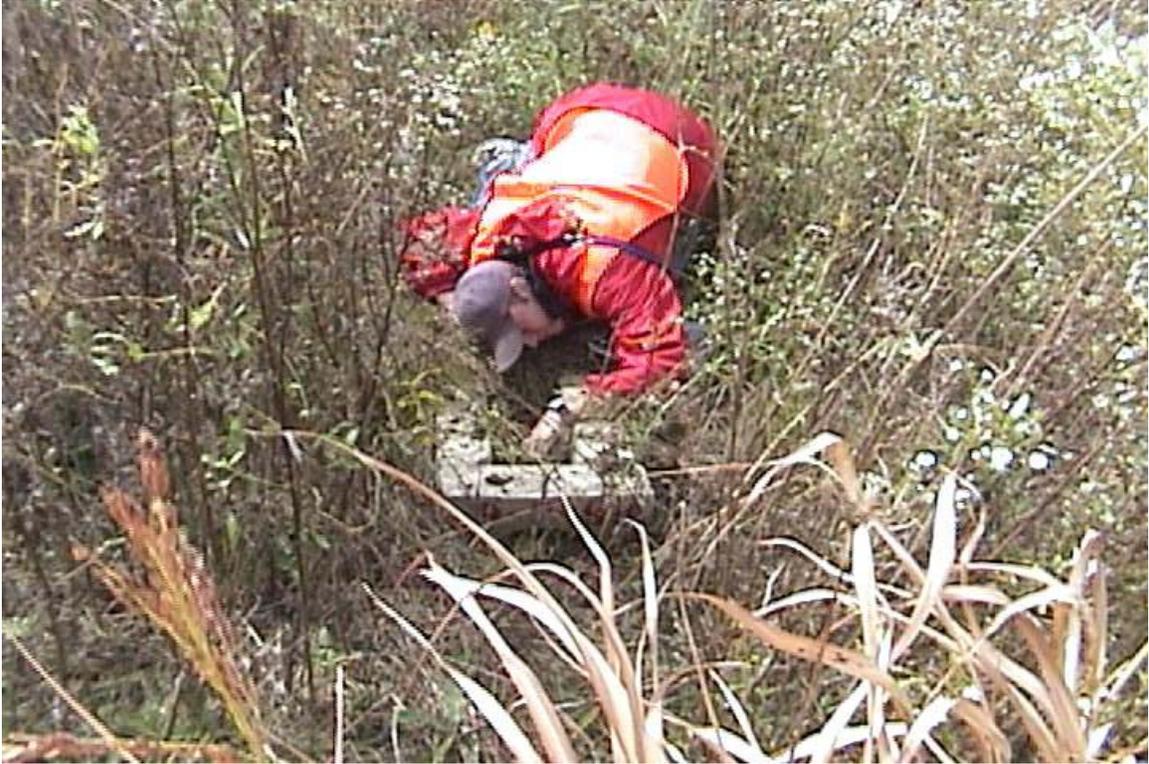
Consequently, collector pipes could be viewed only near the outlet, with the help of a flashlight (Figure 6.1). At one of the outlets, a video camera was placed near the end of the collector pipe and using the infrared feature, a picture of the inside of the pipe was obtained (Figure 6.2). Large amounts of silt and debris, which impede the flow of water, are observed. If the collector pipes cannot discharge the infiltrating water quickly, the base may become saturated and significantly weaker, which may explain some of the observed transverse cracking.

**Figure 6.1** Inspecting the inside of a drain

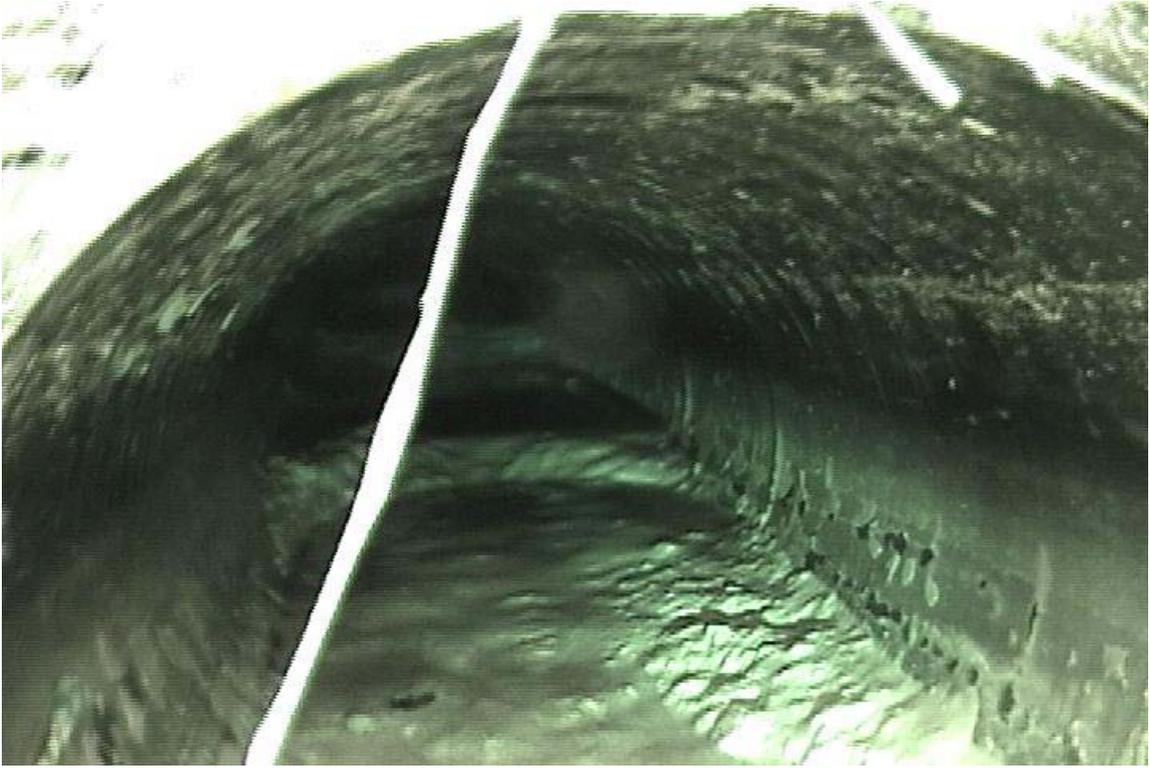
**Figure 6.2** View of inside of collector pipe using the infrared device

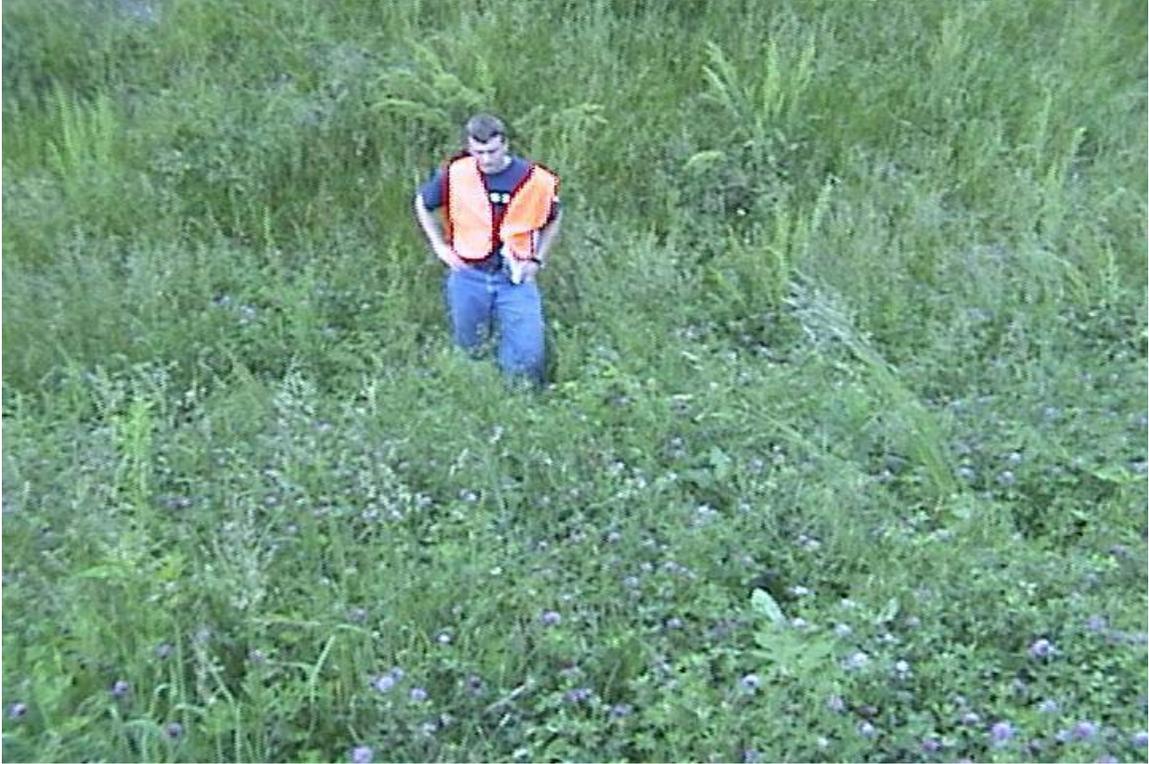
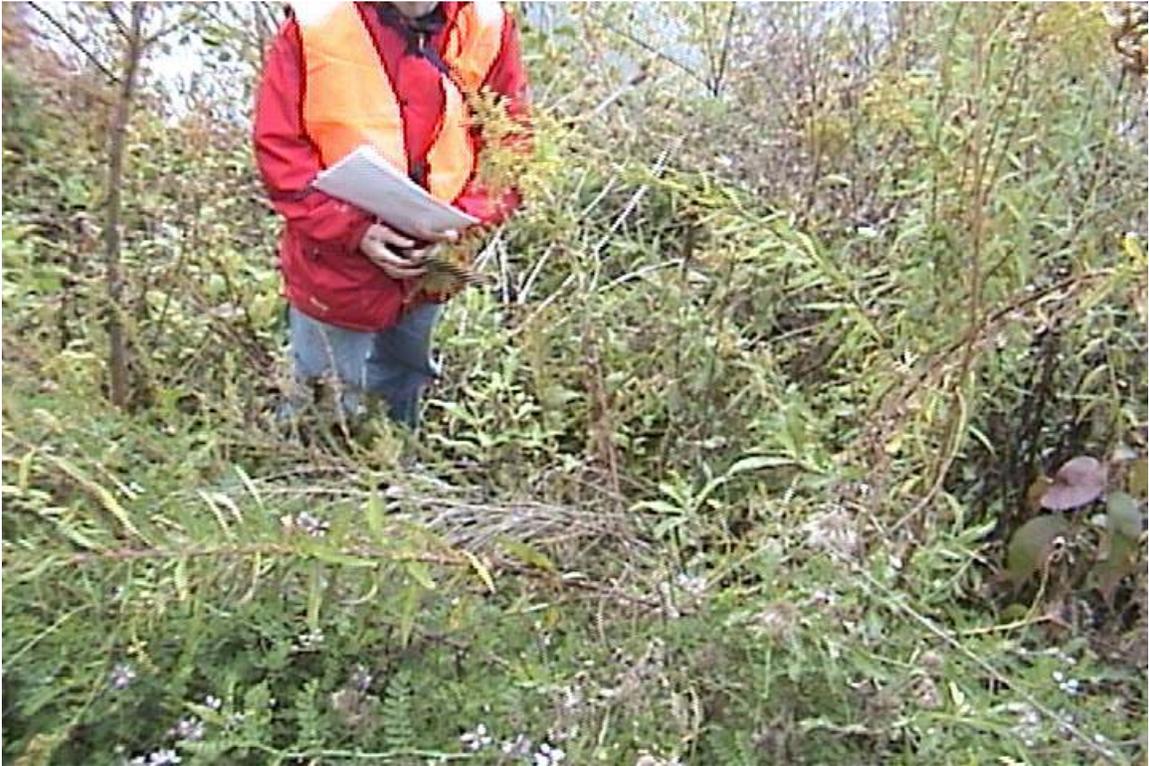
Some of the outlets that listed on the Ohio Department of Transportation (ODOT) specifications and plans (ODOT, 1995) were not found. Of the 26 outlets listed in the project span, 19 were found (73%). Many of the outlets were engulfed by tall vegetation growth (Figure 6.3), which had to be cleared before they could be examined (Figure 6.4). The area adjacent to the shoulder had been mowed, but the region further back, where the outlets are located, had not been (Figure 6.5). Such regions are intentionally left unmowed for environmental conservation reasons (Bob McQuiston, 2001: personal communication). It is believed that some of the outlets were not found because of the thick vegetation, even after the area had been thoroughly searched. Other locations, however, did not have large amounts of vegetation, yet some outlets were not found there either. These outlets were probably never constructed in accordance with the ODOT (1995) plans. The experience of the UC research team is not untypical. Baldwin and Long (1987) conducted a similar evaluation in the mid-1980s, inspecting drain outlets once a year for three years. During their inspections, they never found more than 60% of the total 533 possible outlets. Compared to their efforts, the number of outlets discovered at the Athens project site may be considered remarkable.

**Figure 6.3** Tall vegetation made finding the outlets difficult

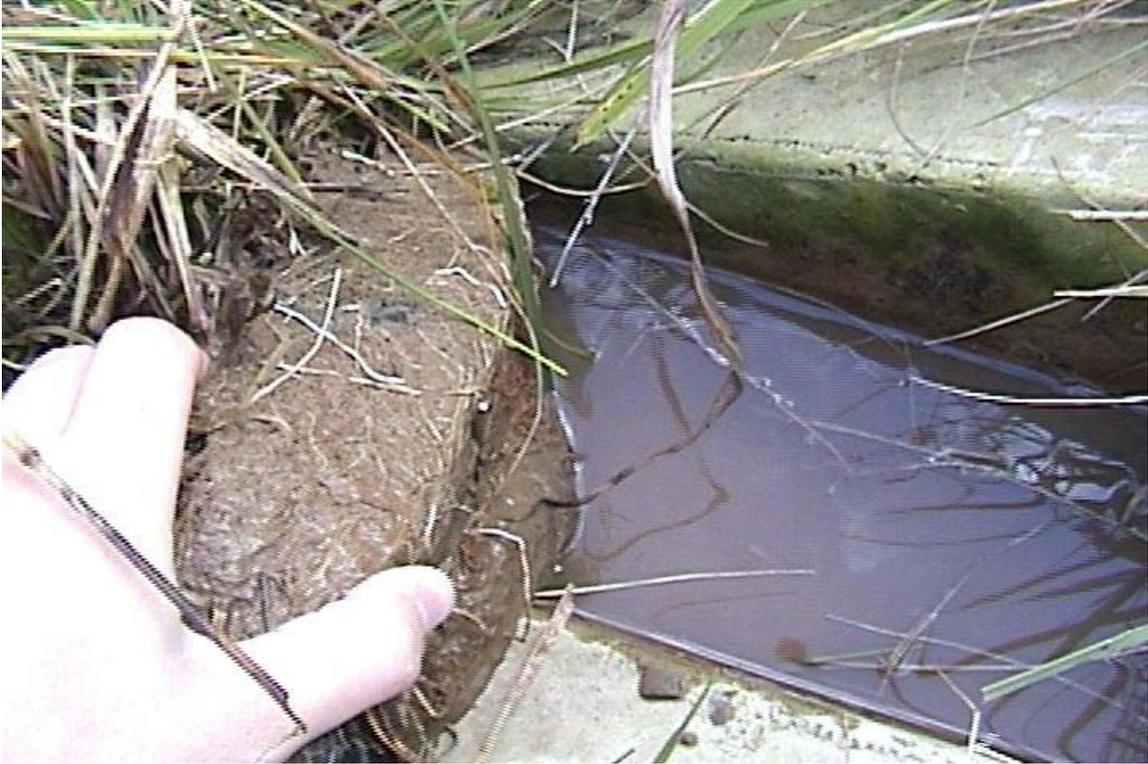
Most of the outlets that were found had large amounts of silt, moss, and weeds in them, and at times this combination was several inches thick (Figure 6.6). One outlet even had a large weed growing out of its rodent screen (Figure 6.7). All outlets were checked for standing or flowing water, which is a telltale sign as to whether the collector pipes are functioning properly. If water is found flowing out of the outlet, the drain is obviously working (Figure 6.8), but if the water is standing, the drain is probably not

**Figure 6.6** Combination of silt, moss and weeds that has collected in the outlet

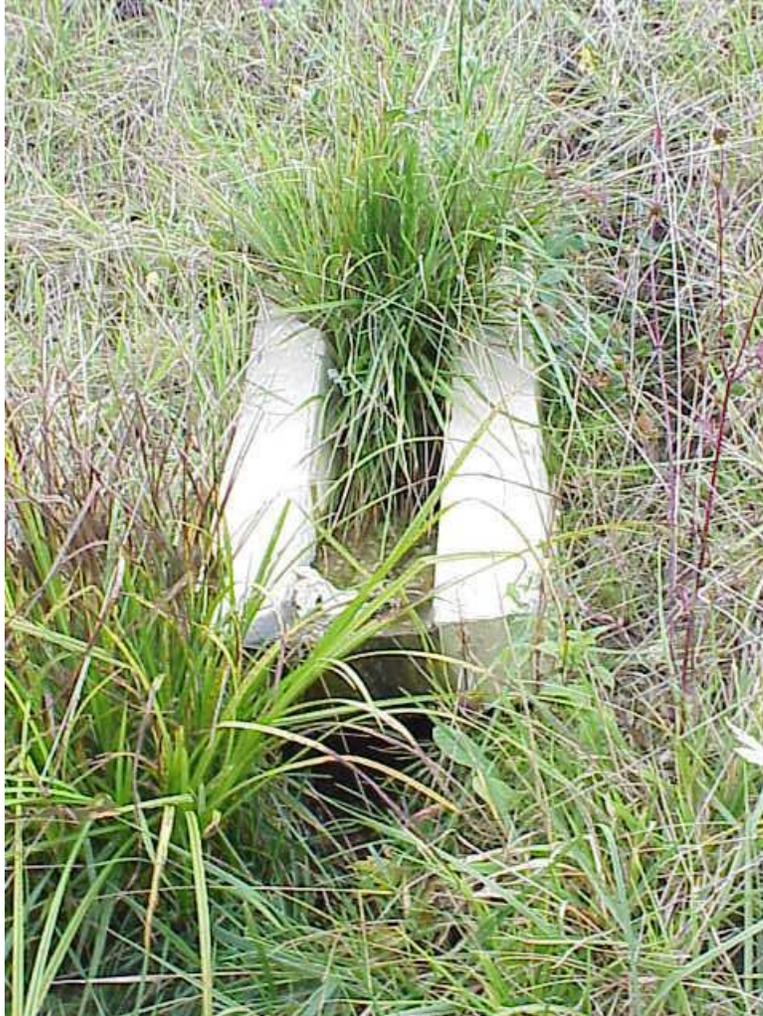
**Figure 6.7** A large weed growing out of one of the outlets

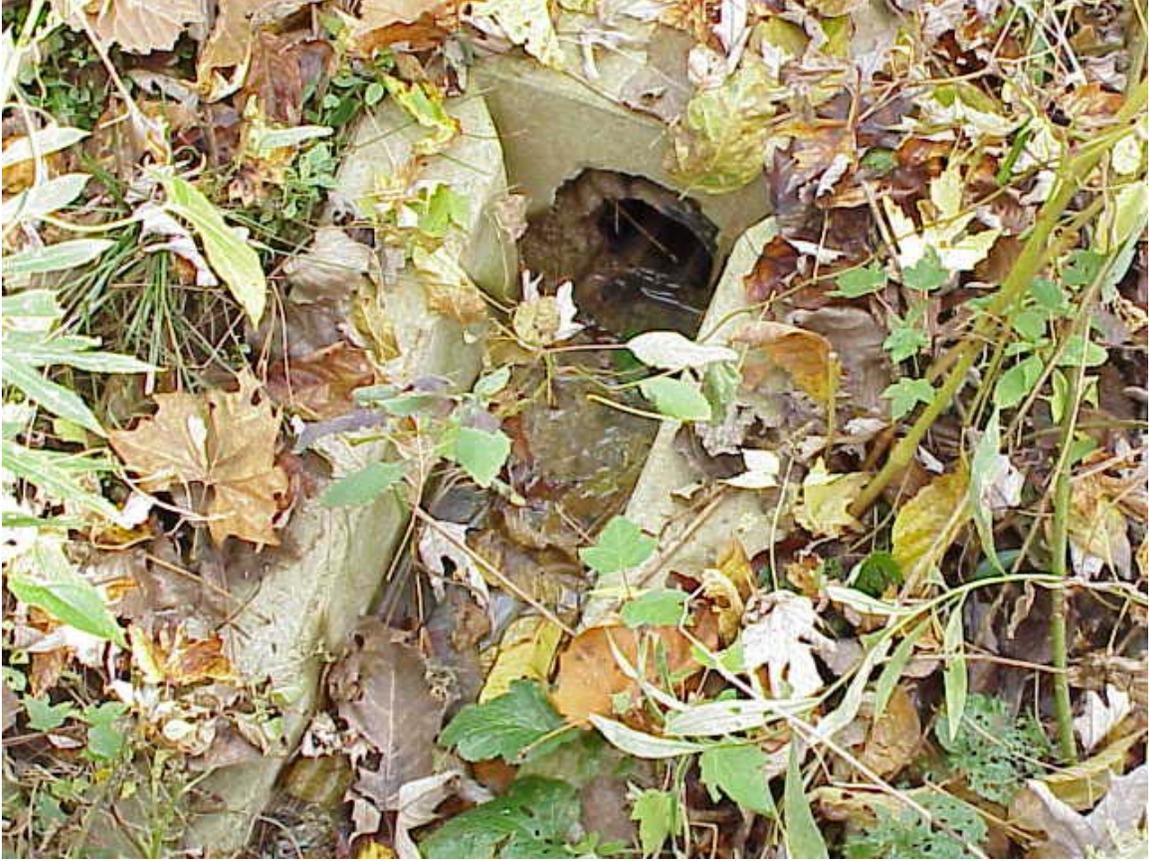
**Figure 6.8** Water flowing out of the outlet

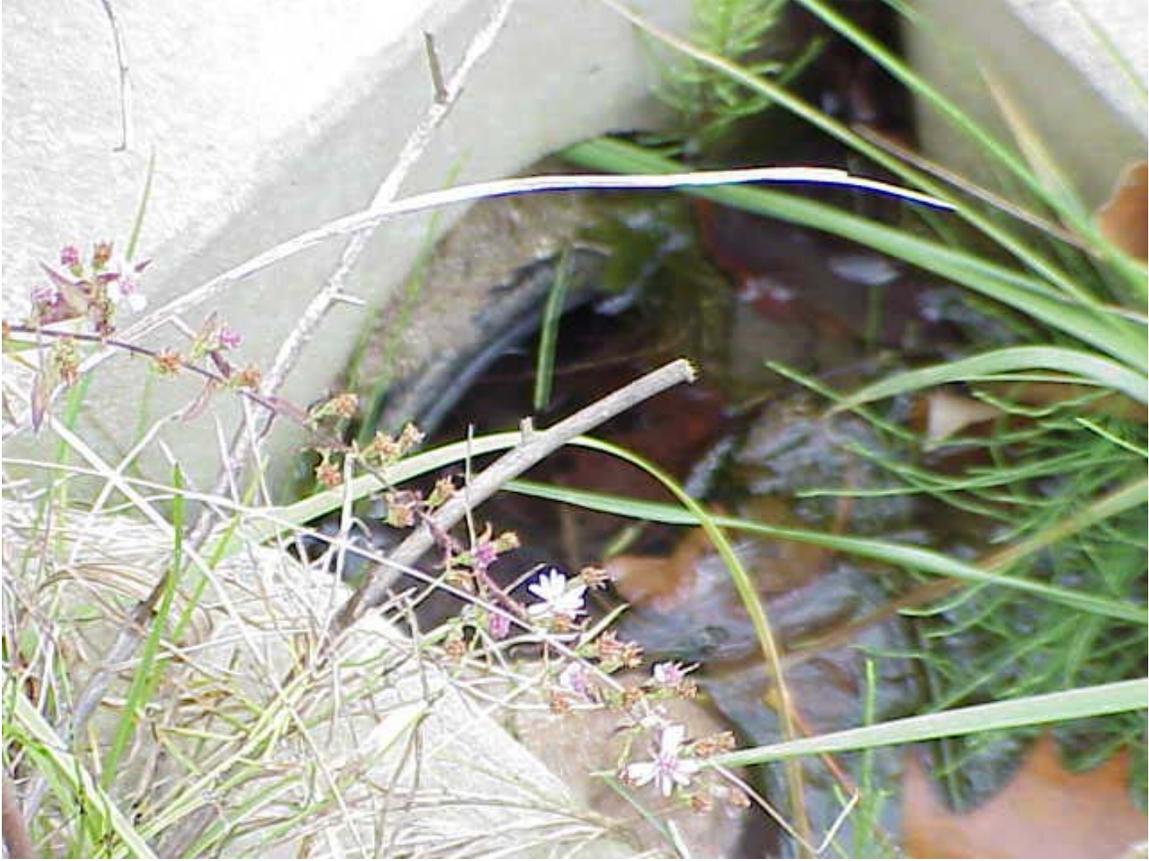
capable of removing the water quickly enough (Figure 6.9). Some drains are found completely dry, which may indicate that the pipe is broken or clogged and that water is not reaching the outlet. It is unlikely that the water had already drained away leaving the pipe dry, since there was rainfall during the day prior to the inspection.

**Figure 6.9** Standing water, approximately 1” deep, unable to flow out

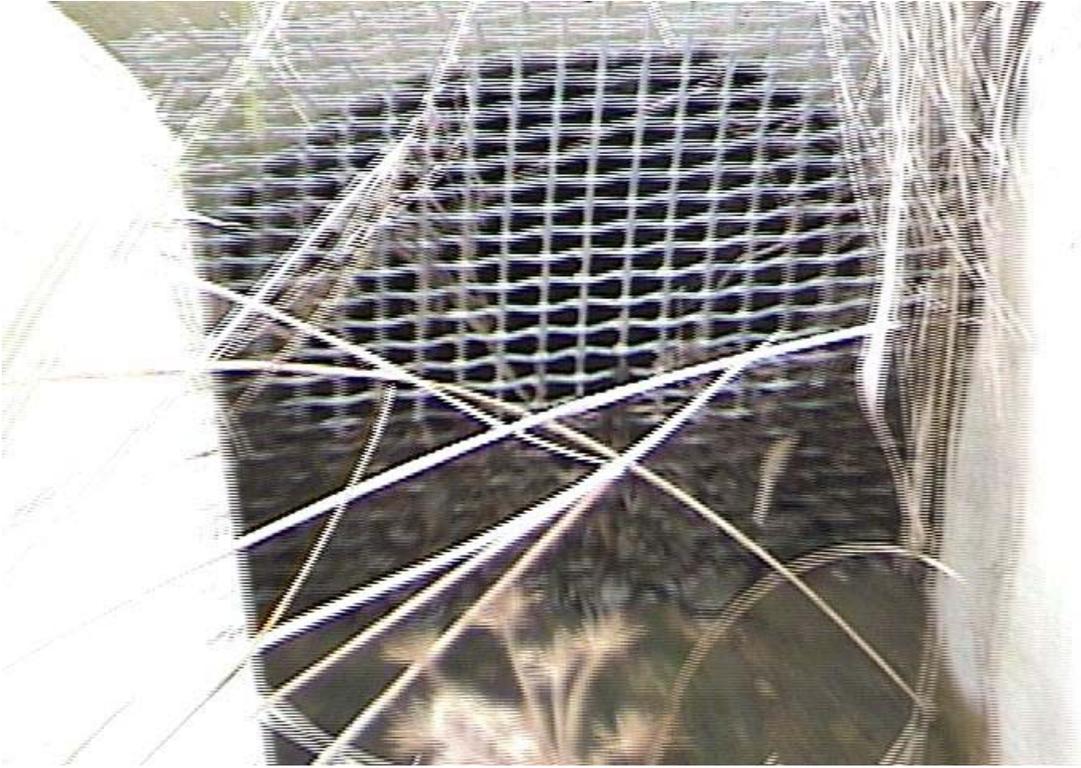
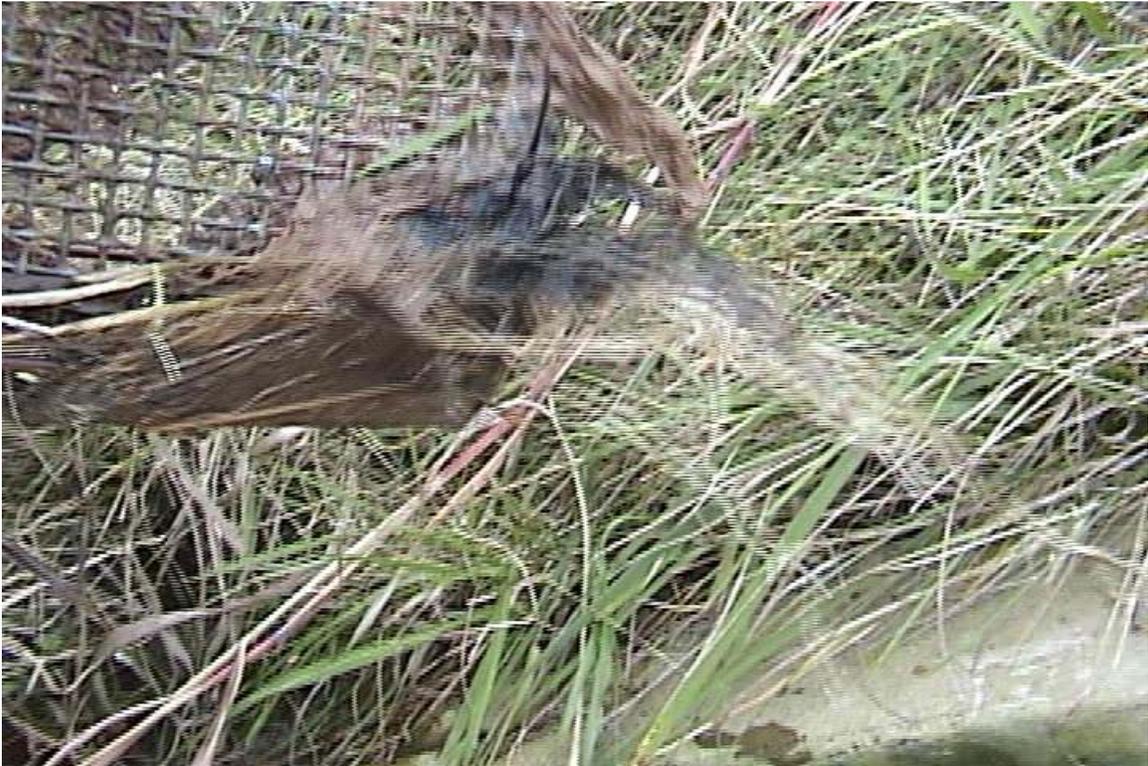
None of the outlets in the eastbound lanes have rodent screens, whereas all but one of the outlets in the westbound lanes have them. The investigators found that the absence of a screen may actually be beneficial. At the outlets with the rodent screens, moss, weeds, and eventually silt is allowed to gather on them (Figure 6.10), transforming them in some cases into small dams that prevent any drainage water from flowing out. When the screen was temporarily removed during the survey, water was able to flow out. The rodent screen did not appear capable of serving its intended purpose: several of the screens had been bent, creating a gap large enough for small rodents to fit through (Figure 6.11). It is unclear why these screens had been bent, but two hypotheses emerge: (a) The screens had been bent on purpose during construction, possibly to provide a snugger fit with the concrete outlet, even though this is not a method endorsed by ODOT; and (b) they had been bent accidentally during construction or subsequent periodic mowing operations.

**Figure 6.10** Moss and silt that has gathered on the rodent screen
