**Ohio Route 50 Joint Sealant Experiment**  
*State Job No.: 14668(0)*  
**FINAL REPORT**

**April 2002**

**Ohio Rout 50 Joint Sealant Experiment**  
*State Job No.: 14668(0)*  
**FINAL REPORT**

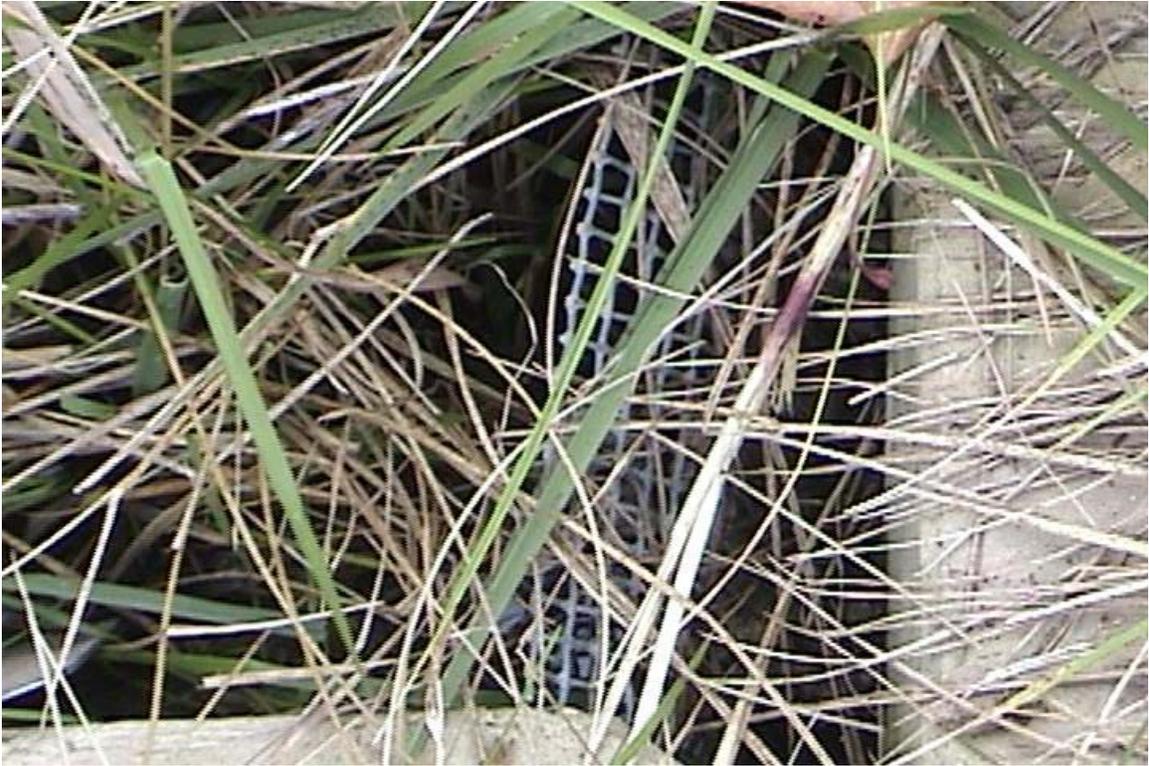
None of the outlets in the eastbound lanes have rodent screens, whereas all but one of the outlets in the westbound lanes have them. The investigators found that the absence of a screen may actually be beneficial. At the outlets with the rodent screens, moss, weeds, and eventually silt is allowed to gather on them (Figure 6.10), transforming them in some cases into small dams that prevent any drainage water from flowing out. When the screen was temporarily removed during the survey, water was able to flow out. The rodent screen did not appear capable of serving its intended purpose: several of the screens had been bent, creating a gap large enough for small rodents to fit through (Figure 6.11). It is unclear why these screens had been bent, but two hypotheses emerge: (a) The screens had been bent on purpose during construction, possibly to provide a snugger fit with the concrete outlet, even though this is not a method endorsed by ODOT; and (b) they had been bent accidentally during construction or subsequent periodic mowing operations.

**Figure 6.11** The rodent screen has been bent back, creating a gap for small rodents

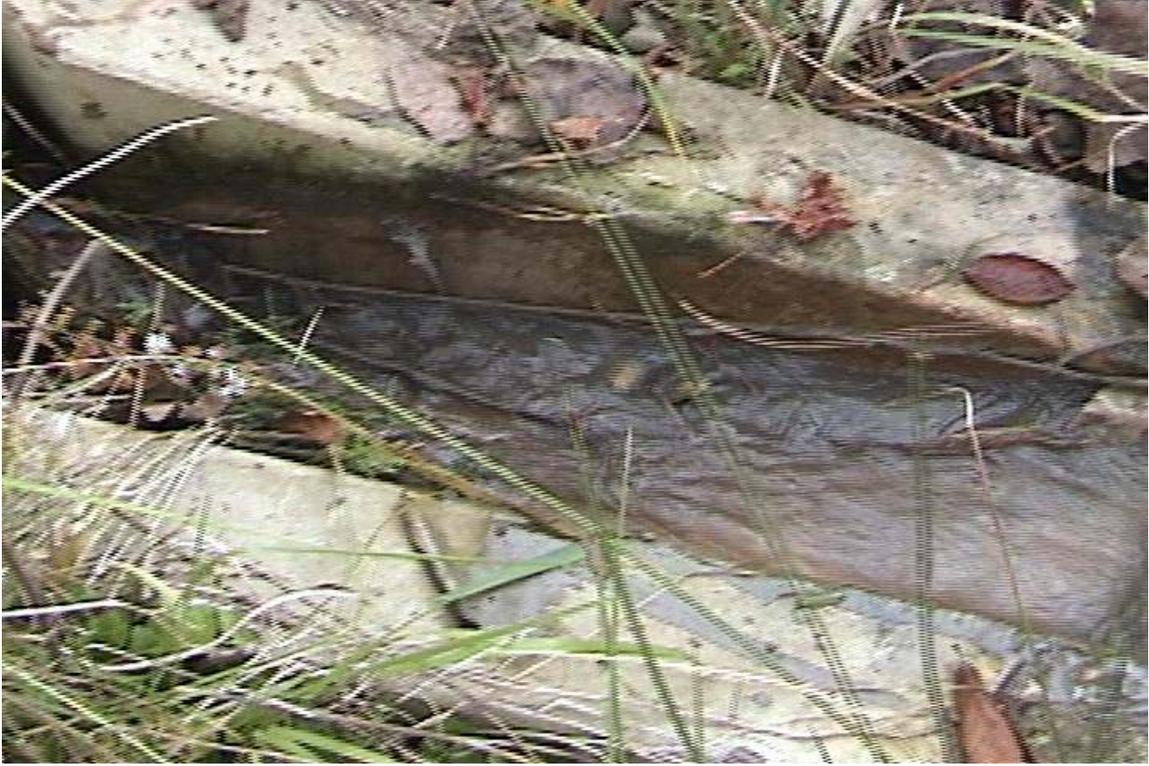
**Figure 6.12** A large amount of water is able to drain after removing sediments

Once the outlet was visually inspected and recorded, the vegetation and sediments were removed. In most outlets, this permitted the trapped water to flow fast and freely (Figure 6.12). Figure 6.13 displays the difference cleaning an outlet makes. Figure 6.13 (a) shows a clogged outlet before cleaning, whereas in Figure 6.13 (b) the water is observed flowing freely once the silt and weeds are removed. Such observations reaffirm the need for regular maintenance of the outlets. If the outlets are kept free of obstructions, water from the base layer will be free to escape preventing prolonged exposure of the material to saturation levels. The underdrains should be periodically cleaned or flushed, and this process can be aided by the placement of clean-out boxes (Moulton, 1980). No such clean-out boxes are located on the U.S. 50 project site, and, therefore, flushing may be more difficult and not as effective.

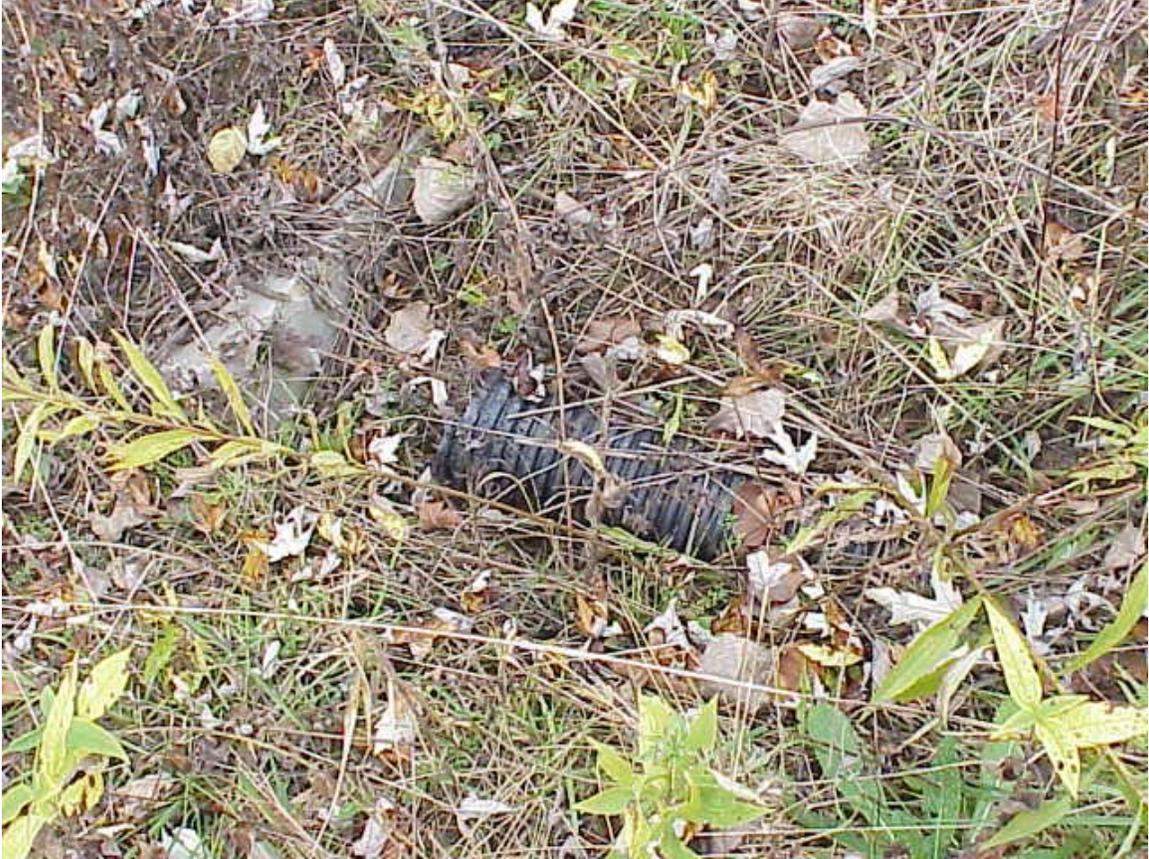
The precast reinforced concrete outlets are generally in good condition, with only few distresses observed. Outlet No. 209 appears to be recycled from another roadway (Figure 6.14). It is noticeably older as evidenced by the discoloration and deterioration of the concrete. This concrete outlet has been improperly placed and does not provide adequate protection to the conduit. Consequently, the pipe has been crushed and its lip forms a "V" at the tip, impeding water flow. Standing water is found inside the pipe. Outlet No. 143 has slipped down the hillside, leaving the underdrain pipe completely exposed (Figure 6.15). The pipe seems to be in good condition, but it was not inspected very closely because of the presence of a snake, which was sunbathing on the concrete outlet (Figure 6.16). The UC research team felt it was better to leave the pipe uninspected rather than disturb the reptile!

**Figure 6.15** A concrete outlet that has slipped down the hillside, exposing the drain
