REPORT NO. **FAA-75-1**  
FAA-RD-75-16

SURVEY OF VISUAL GROUND AIDS  
AT O'HARE INTERNATIONAL AIRPORT

INTERIM REPORT

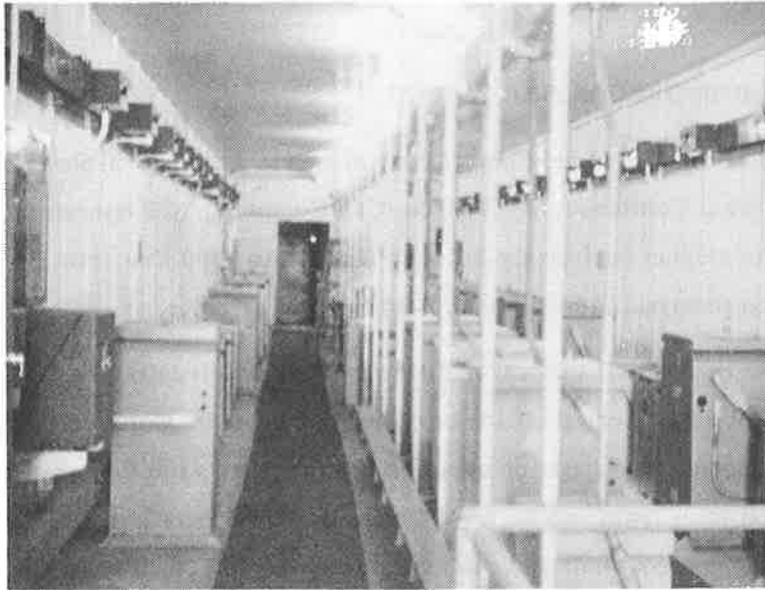
Figure 2-1. Taxiway Lighting Room

The present lighting control vault is a one-story building. The basement area houses the 4160 Vac power source breakers and disconnects. The main floor is divided into the Taxiway Room (see Figure 2-1), the Runway Room (see Figure 2-2), and an additional section contains the emergency diesel generator. In the event of commercial power failure, this emergency power system can be connected to either Runway 14R or Runway 9R including the associated taxiway circuits to permit continued airport operations during the power failure period. The vault houses all taxiway and runway constant current regulators and control circuits for the entire field lighting system.

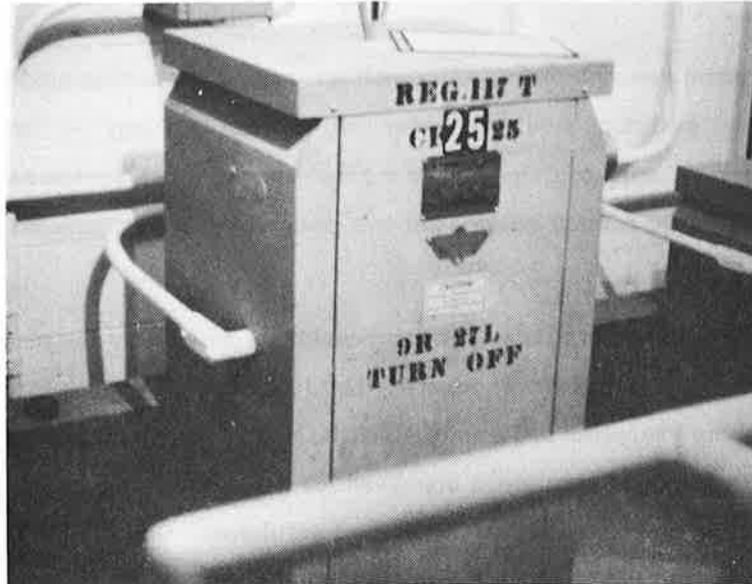
Figure 2-3. Typical Taxiway Regulator

Figure 2-3 shows a closeup view of the taxiway regulator serving the 9R-27 turnoff area. Figure 2-4 shows the automatic primary power disconnect units serving several adjacent taxiway regulators.

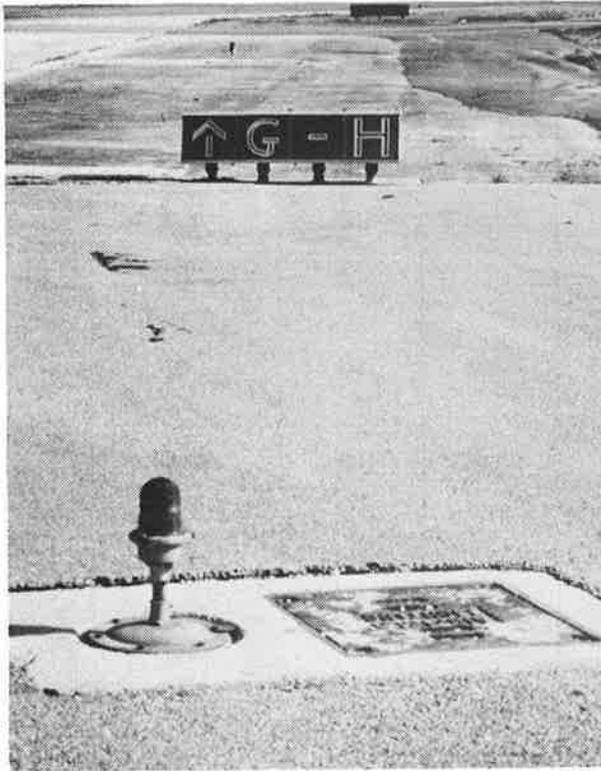
Figure 2-5. Typical Taxiway Edge Light Installation

At O'Hare Airport all taxiway areas are provided with edge lighting. The majority of the edge lighting installations use standard taxiway edge lights, type L822, base mounted, with a standard 6.6 amp, 30-watt lamp housed in a symmetric, blue globe. Figure 2-5 provides a view of a typical installation. At several locations, principally in the peripheral area near the Ramp area at the intersections of taxiway stubs and the automotive service road, the blue globe has been replaced with an amber globe to identify to pilots the intersection of the service road. The basic fixture remains unchanged at these locations.

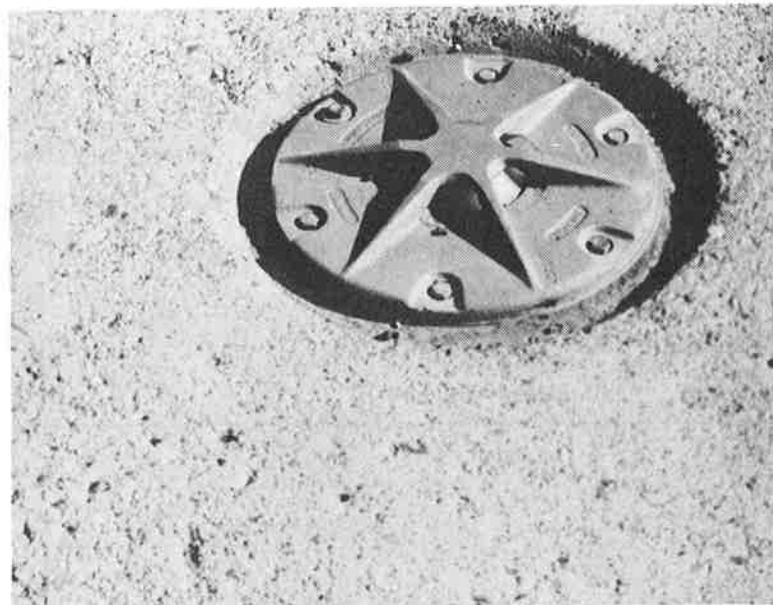
Figure 2-6. Installed Class B3 Taxiway Marker Light

In a number of locations, again especially in the periphery of the Ramp area, where past history has indicated the susceptibility to fixture damage by frequent vehicular activity, the standard taxiway edge light fixture has been replaced with a semi-flush, medium intensity, omni-directional fixture. This fixture is manufactured in accordance with MIL-L-26202D, Class B3, and contains a 6.6 amp, 45-watt lamp with a clear screen. Approximately 84 of these fixtures are currently in place including the bridge as described below. Figure 2-6 shows a typical installation of this fixture.

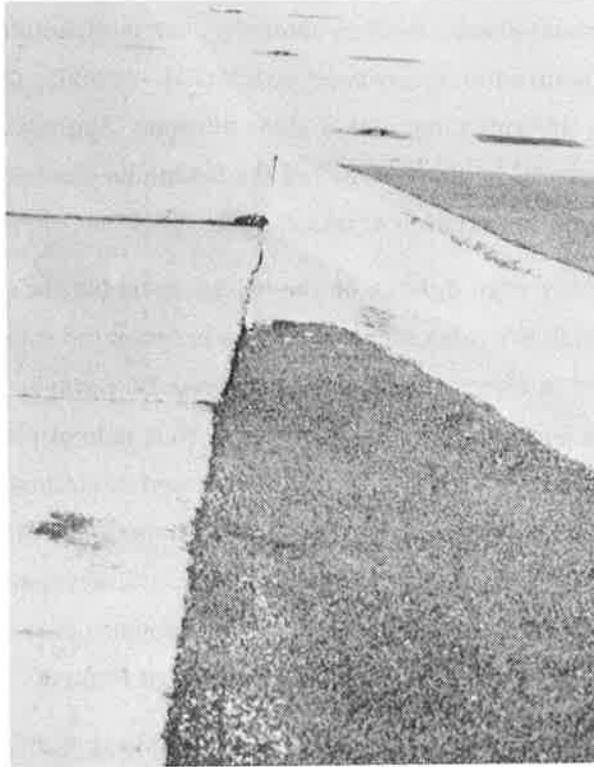
**Figure 2-7. View of Bridge Taxiway Edge Lighting**

Taxiway edge lighting on the bridge spanning the entrance roadway to the airport which provides aircraft access between the terminal area and the 32R warm-up pad is also equipped with the Class B3 fixture. Figure 2-7 provides a view of a portion of the bridge taxiway (left side of photograph) and a raised curb (denoting the outer edge of the taxiway) containing the taxiway edge lighting. The reason for installing this type of fixture here is that the increased elevation resulting from the curb construction would increase the height of the standard fixture beyond allowable limits. The opposite side of the bridge is similarly constructed and also contains this type of fixture.

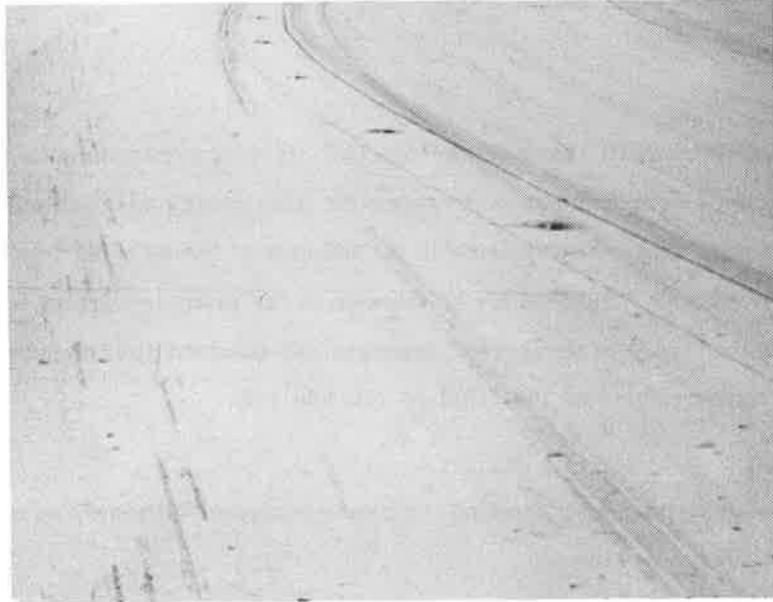
Figure 2-8. Centerline Lighting Installation on Bridge

Also included under the category of taxiway lighting are two circuits serving the bridge centerline and Runway 4R-22L, high-speed turnoff centerline lighting systems. The bridge C/L fixtures are the L852, Type I bidirectional designed for bonding into existing taxiway pavement. These fixtures are equipped with 45-watt lamps and provide a narrow beam light output in both directions. Figure 2-8 shows a segment of this installation.

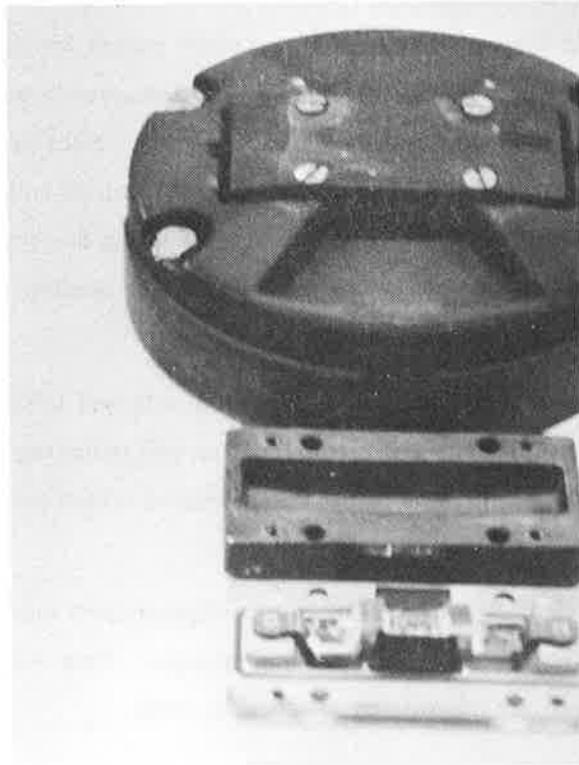
Figure 2-9. L-852, Type II  
Centerline Fixture  
and Assembly  
Breakdown

The high-speed turnoff C/L fixtures are the L852, Type II fixtures designed for shallow base installations. In this case, the lamp rating is 65 watts and the light output is widebeam and unidirectional. Figure 2-9 provides a view of the L850 Type II fixture mounted on the shallow base (top) as well as an assembly view of the optical housing and lamp holder. Both the bridge and turnoff C/L fixtures are equipped with green filters for guidance purposes.

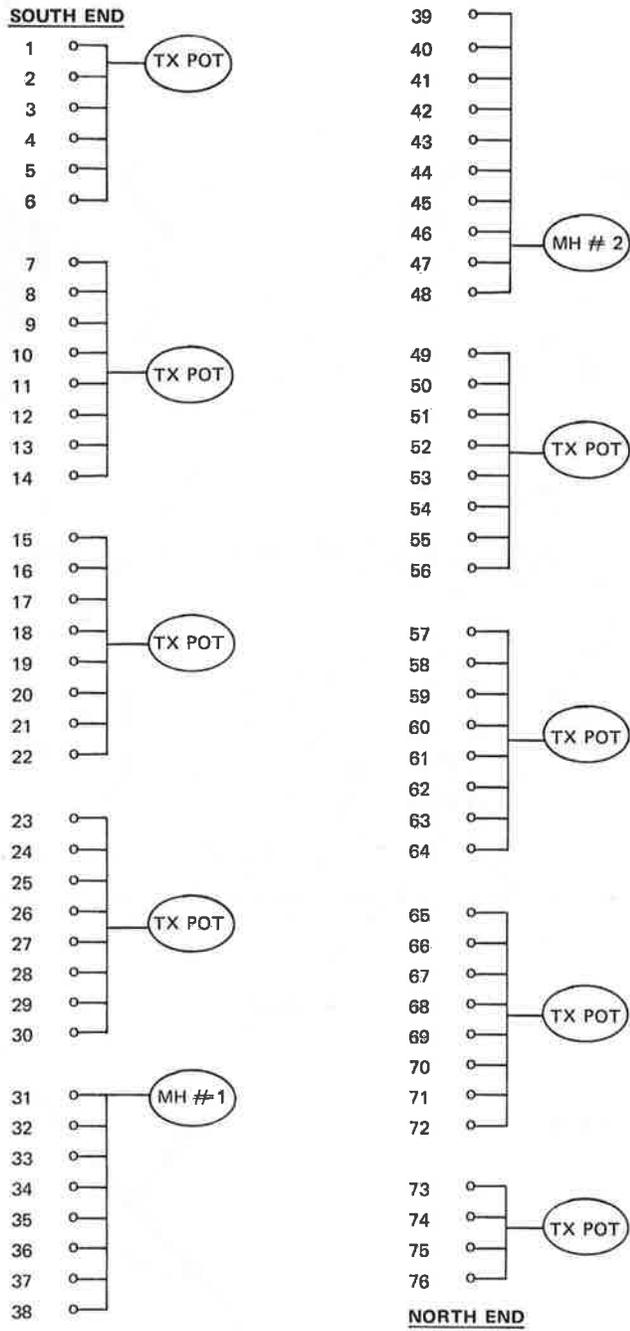
Figure 2-10. Bridge C/L Lighting Arrangement

Figure 2-10 shows the bridge C/L lighting arrangements and numbering scheme used by maintenance personnel in identifying and troubleshooting defective fixtures. Note the variation in the number of lamps tying into the different transformer pots or manholes for connection to the primary circuit feeding these lamps. Similar types of numbering schemes are used for the touchdown zone and centerline lighting systems installed on 14L and 14R.

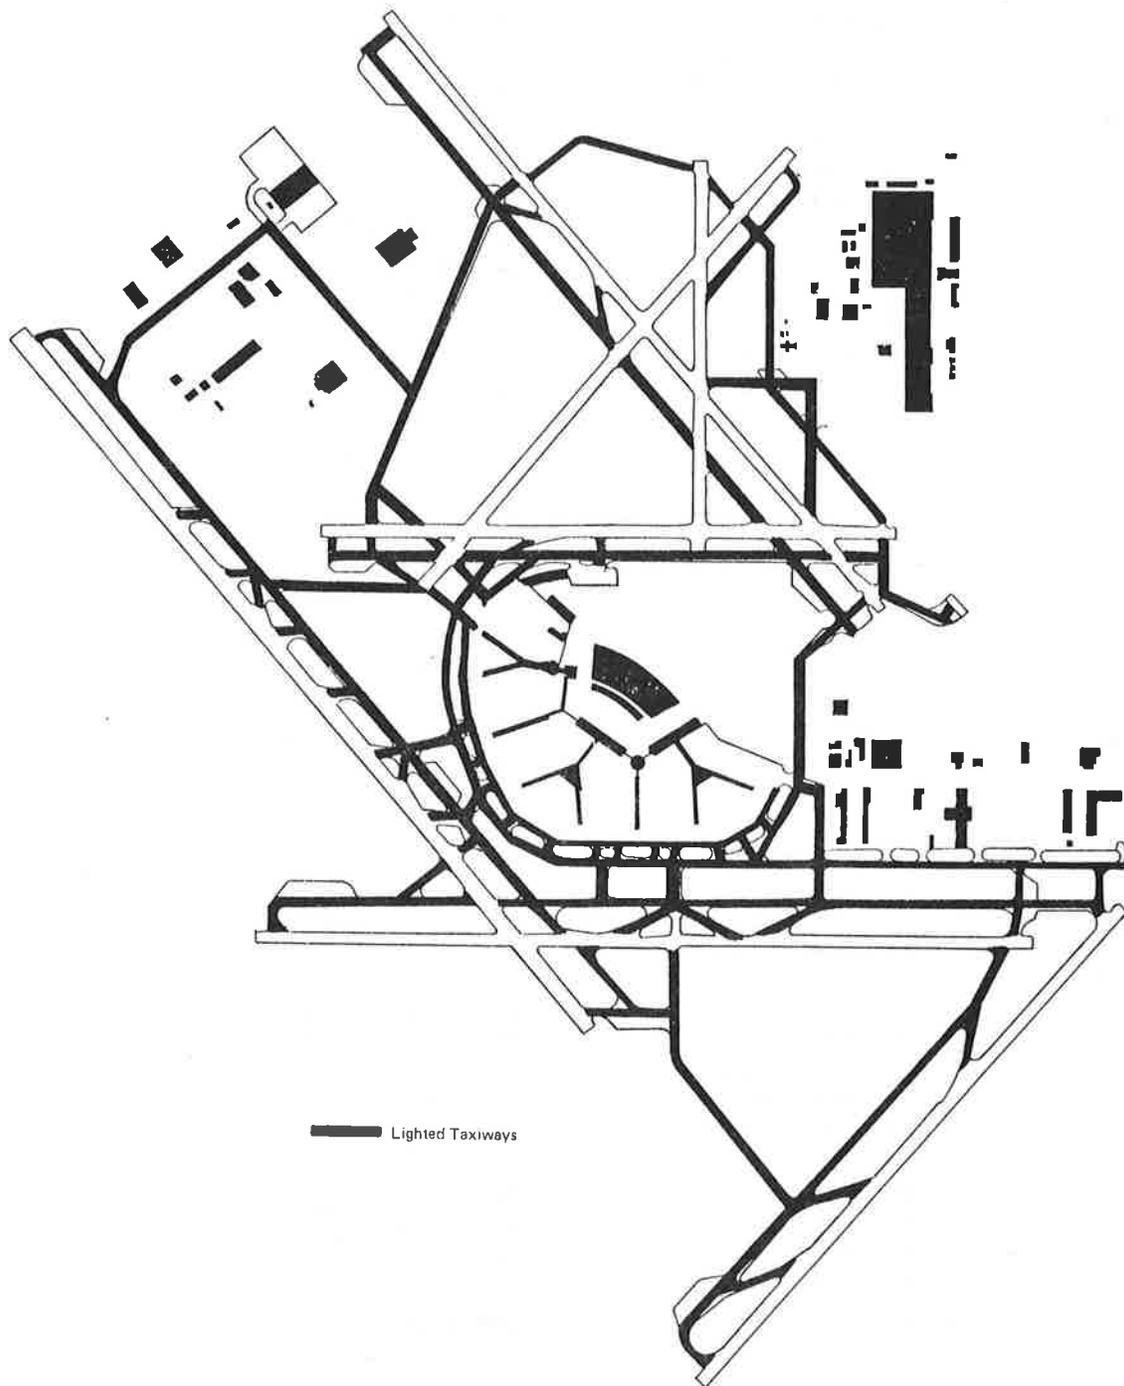
Figure 2-11. Areas of the Airport With Taxiway Lighting Installed

An airport map showing the areas equipped with taxiway edge lighting is shown in Figure 2-11.

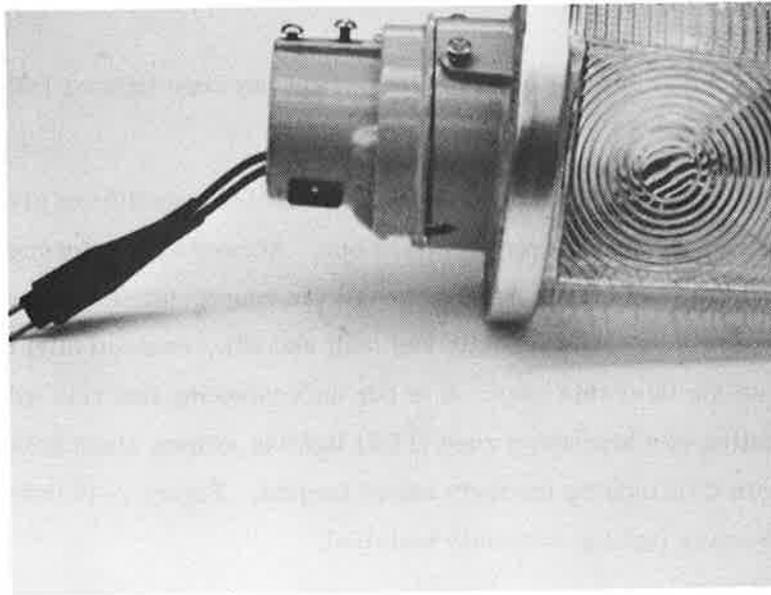
**Figure 2-12. Typical L-819 Fixture**

Figures 2-12 and 2-13 are photographs of typical L-819 and L-802 fixtures, respectively, showing the differences in construction and mounting details as well as the power plugs for connection to the transformers which are contained within the base.

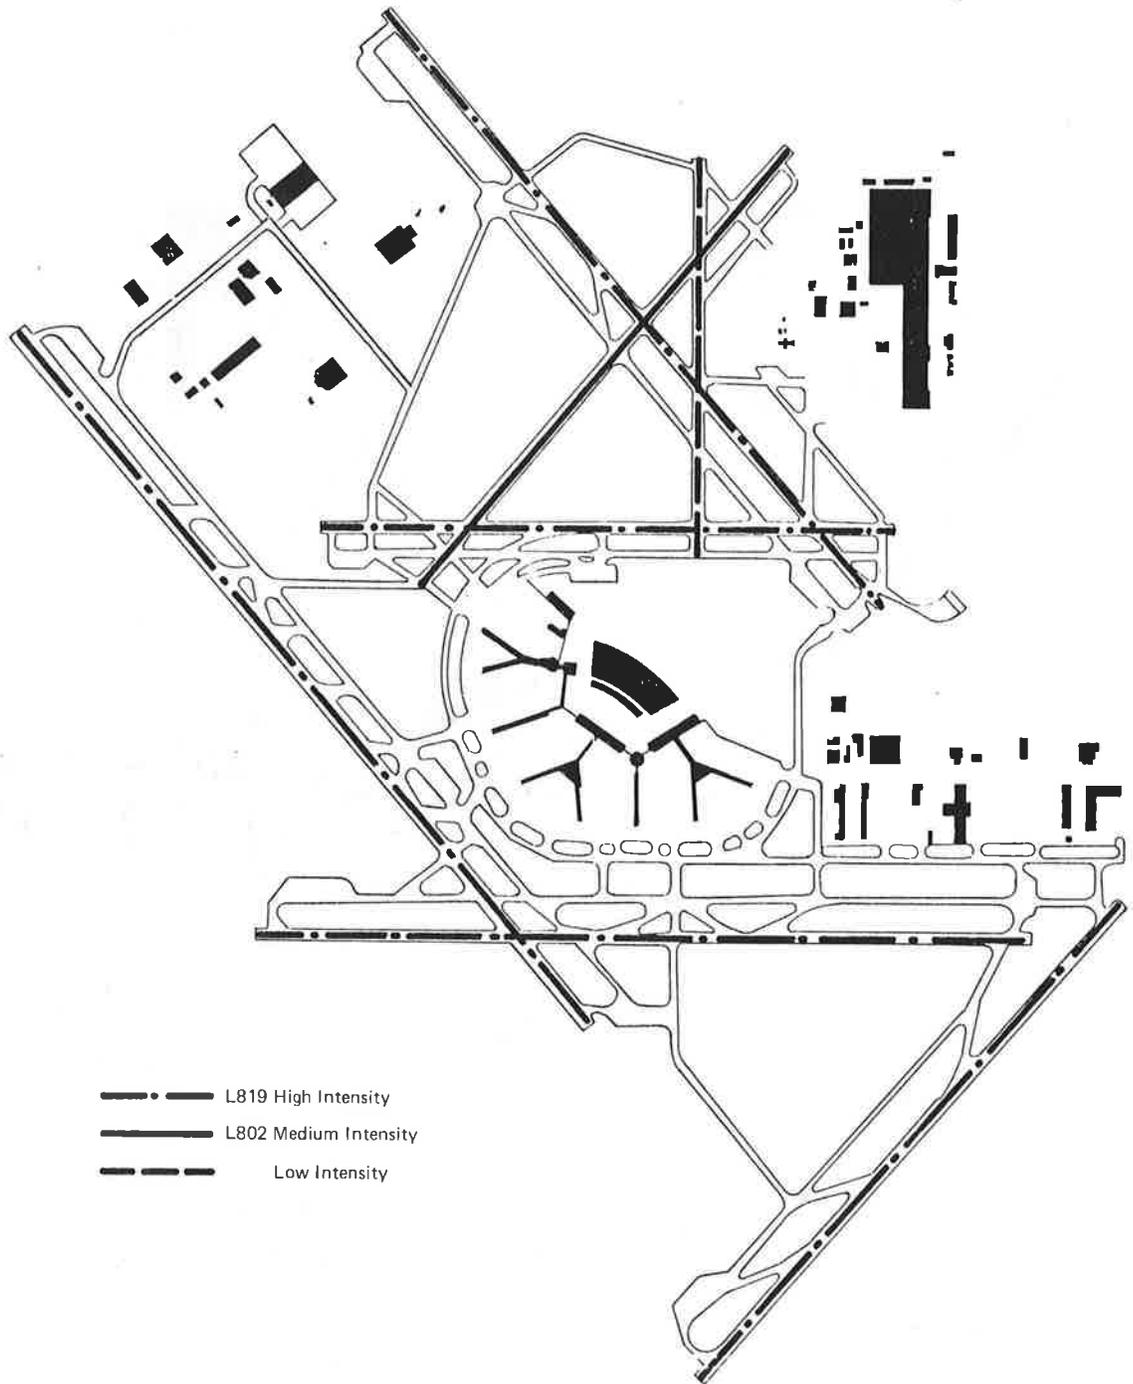
Figure 2-14. Runway Edge Lighting

Figure 2-14 identifies the types of runway edge lighting installed for the various runways.

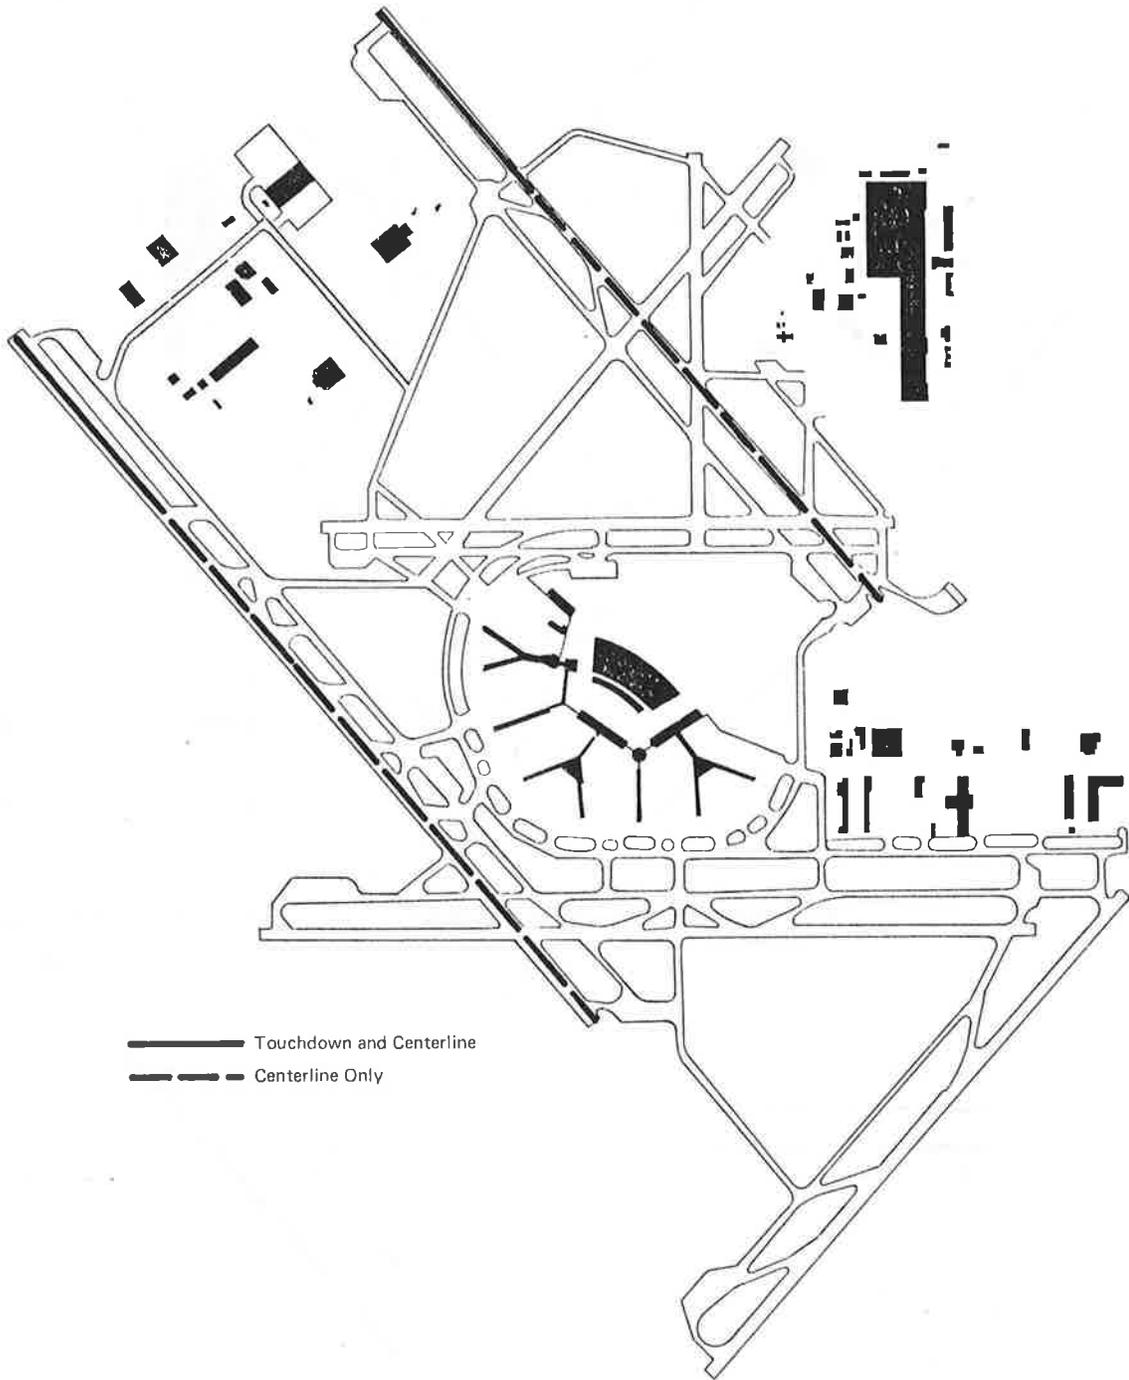
Figure 2-15. Category II Runway Lighting

At present, only two runways--14L and 14R--at O'Hare are equipped to handle aircraft during Category II conditions. According to information provided during the survey it is planned to install the appropriate facilities to permit Category II operations at the opposite end (32R and 32L, respectively) of these runways sometime later this year. It is our understanding that this will only entail installation of a touchdown zone (TDZ) lighting system since both runways already contain C/L lighting for their entire lengths. Figure 2-15 indicates the Category II Runway lighting currently installed.

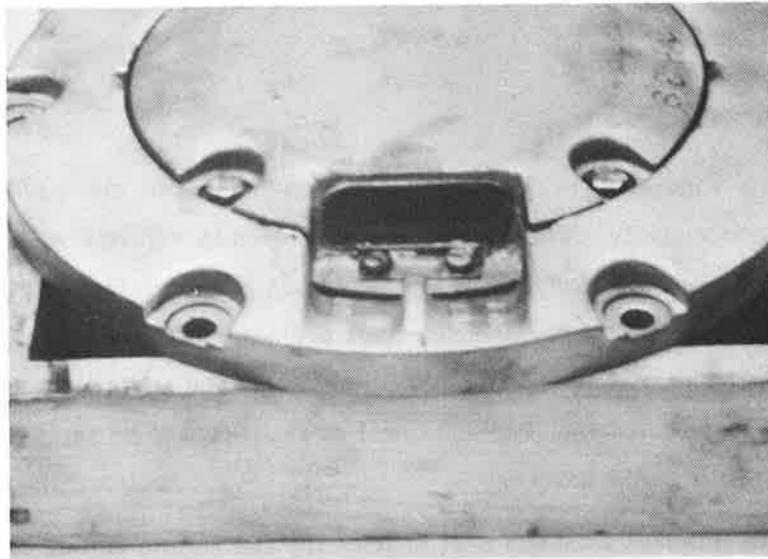
Figure 2-16. View of L+850 Fixture

Centerline lighting on both of these runways utilizes the L-850A, 200-watt, bidirectional fixtures. These fixtures are installed at 50-foot intervals resulting in a total of 198 fixtures on 14L-32R and 230 fixtures on 14R-32L. Figure 2-16 provides a view of the basic fixture while Figure 2-17 provides an assembly view showing the lamp and lens mounting arrangement. Note also the slots available at the outer side of the lens holders which are provided for insertion of color filters. At each end of these parallel runways the fixtures located in the first 1000 feet are provided with red filters (in both directions) while in the next 2000 feet only alternate fixtures are provided with red filters. The use of these filters aids the pilot in determining remaining runway lengths available to him. Runway edge lights above these runway segments are provided with yellow globes rather than the usual clear globes as an additional guidance aid.

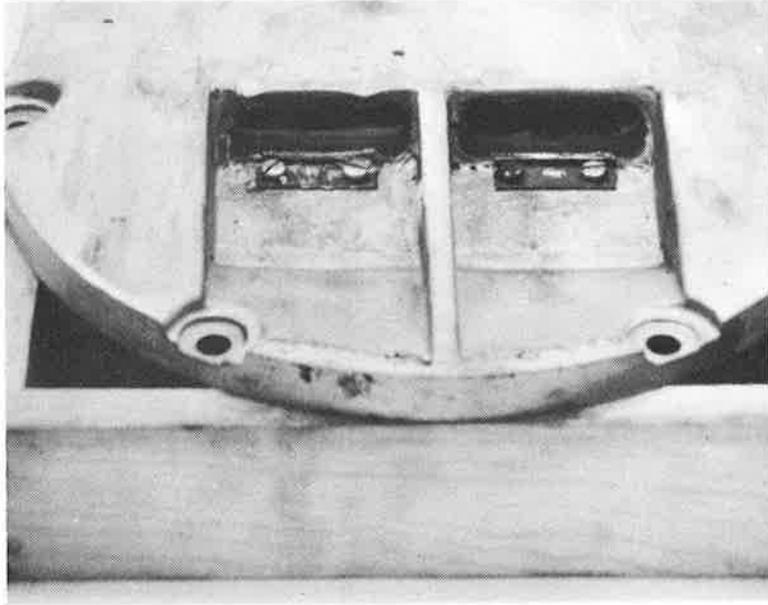
Figure 2-20. Top View of L-850 TDZ Fixture

Figures 2-20 and 2-21 provide top and bottom views, respectively, of the L-850 touchdown zone fixture. Note the differences in the construction of this fixture compared to the L-843. The lamp for this fixture is a bayonet-mounted type (see lamp detail in Figure 2-21), and the socket has wire pigtails for direct connection to the contact posts located in the installed base for this fixture.

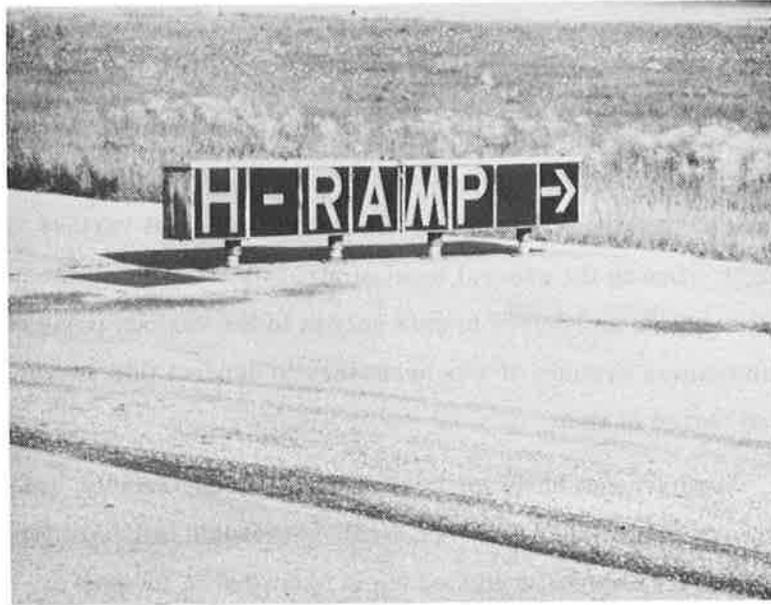
Figure 3-1. Internally Lighted Type L-829 Taxi Guidance Sign

There are two basic types of signs installed, namely, internally lighted, elevated taxi guidance signs, and non-lighted, elevated billboard type informational signs. Of the 179 internally lighted signs identified in the survey, approximately 150 are the standard L-829 type signs as depicted in Figure 3-1. These signs are constructed with various numbers of sections depending on the information content to be displayed. The number of sections ranged from 1 to 8 with an average being approximately 4 sections per sign.

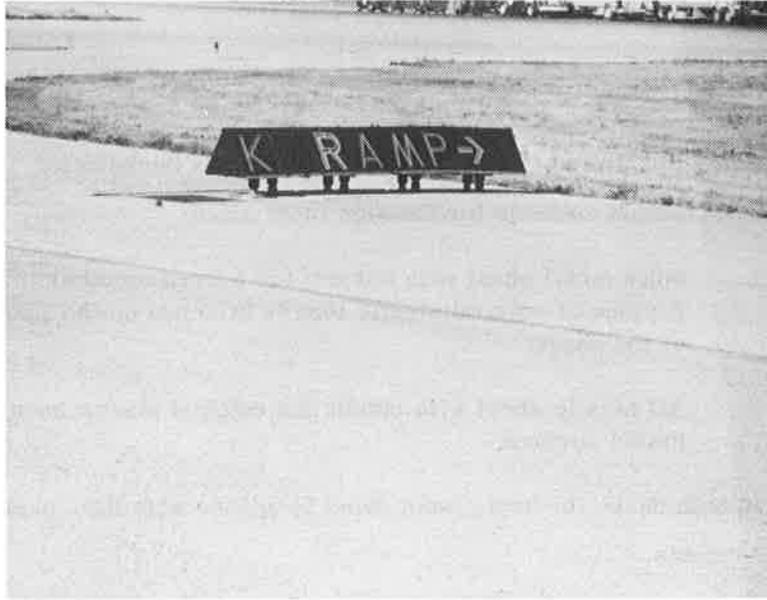
Figure 3-2. Internally Lighted "TRI-PAC" Taxi Guidance Sign

The remaining internally lighted signs were developed by one of the electrical maintenance foremen at O'Hare. Figure 3-2 is a picture of one of the installed signs on the bridge taxi route near the K ramp. This type of sign, called a "TRI-PAC" sign, provides upward slanted panels which serve a dual purpose since they are more nearly perpendicular to the viewing line of the cockpit crew of an aircraft and also are more capable of withstanding the effects of jet blast from aircraft passing by. Variations of this sign have been installed at O'Hare for several years and recently have gained formal approval from the FAA. Patents are pending for the design features of this sign as well as the name.

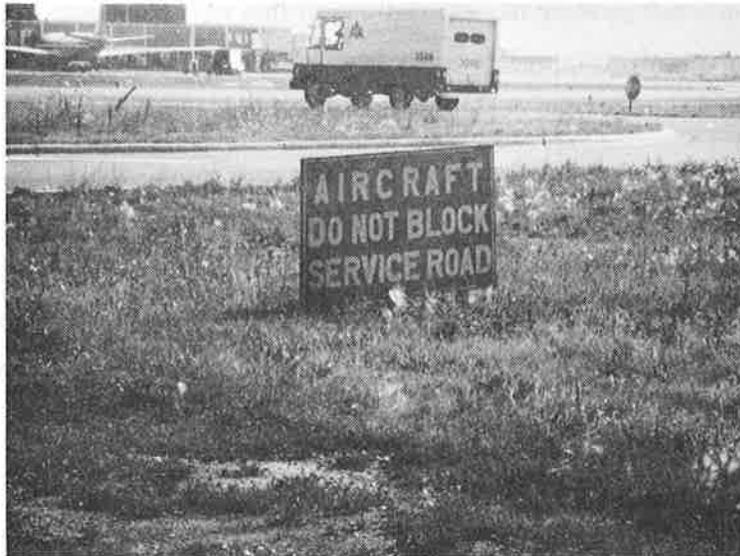
Figure 3-3. Typical Billboard Sign Installation

These signs are constructed by personnel in the carpenter's shop and the painting and lettering is done by personnel in the painter's section. The background of these signs is black and the lettering is white except for the "747 NO STOP ON BRIDGE" sign which has a red background with white lettering. A typical sign installation is shown in Figure 3-3.

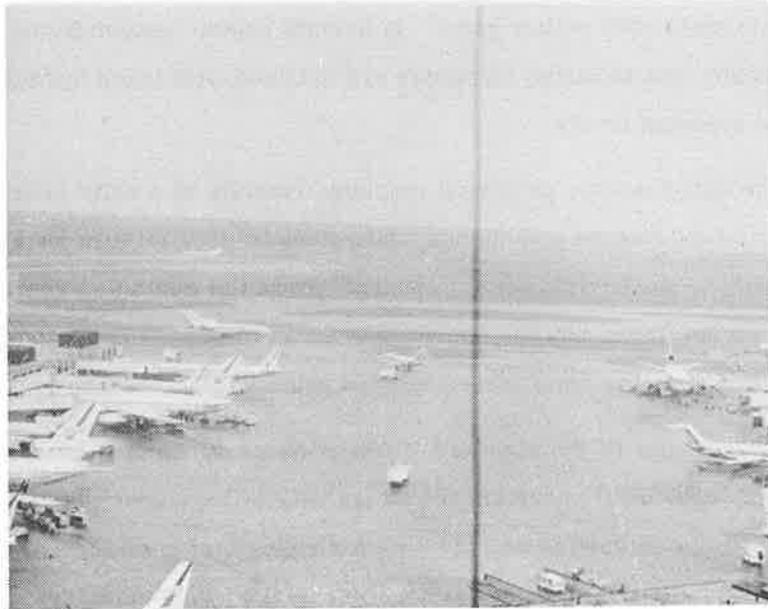
**Figure 5-1. Typical View of Pavement Marking in Apron Area**

A typical view of the standard apron area markings may be seen in Figure 5-1. Any additional pavement markings within these so-called "lease lines" or between the centerline and the gate for nosewheel tracking are the responsibility of the individual tenant airlines. Typical of such markings are guidance lines to assist the pilots in approaching the specific gates and for docking purposes.

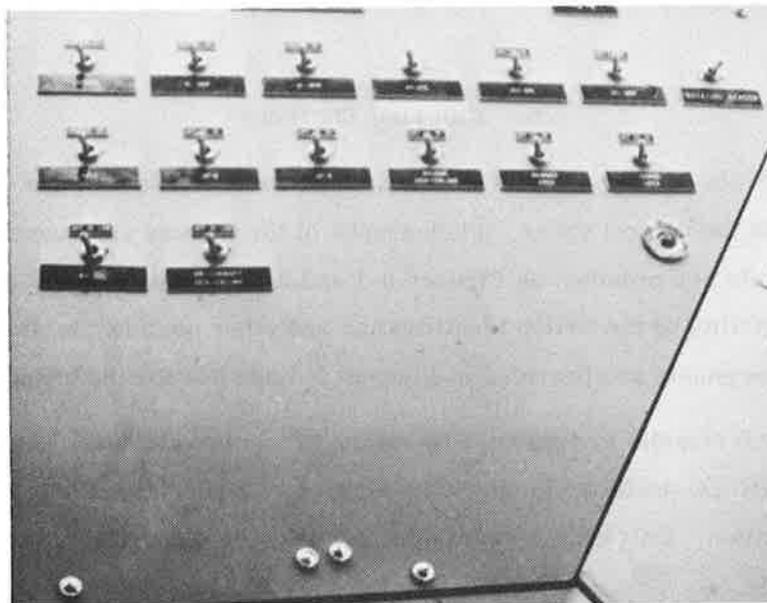
Figure 6-1. Taxiway Circuit Control Panel

Field lighting circuits are controlled from two lighting panels installed in the cab of the control tower. Photographs of the taxiway and runway circuit control panels are provided as Figures 6-1 and 6-2, respectively. To provide greater legibility of the switch identification and other pertinent material, drawings of these panels are provided in Figures 6-3 and 6-4 for the respective panels.

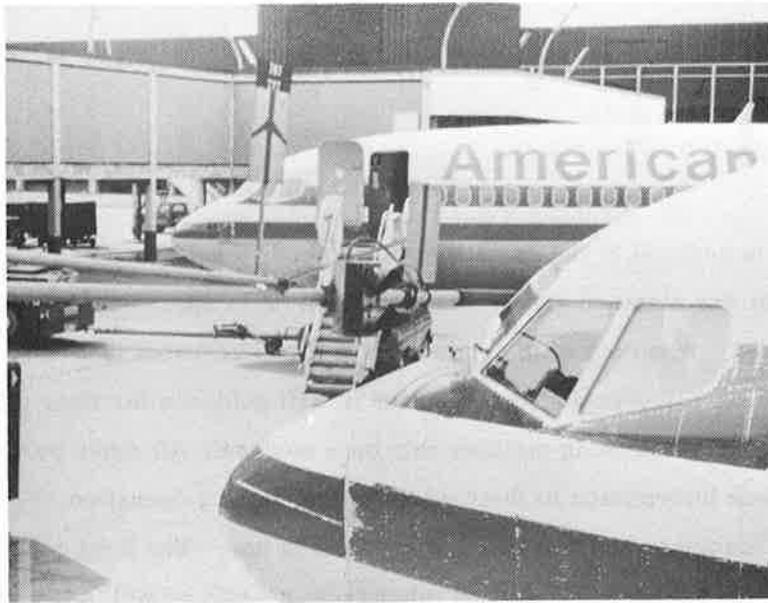
Figure 7-1. Docking Aid for 707 and 727 Aircraft at Gate K-2

American has two types of systems in use. The first consists of two painted panels displaced from each other both in depth as well as in actual elevation, depending on the particular combination of aircraft type and gate configuration. Figures 7-1 and 7-2 provide photographs of two installations at the same gate (K-2). In the first figure an aircraft has just about completed docking using the two panels mounted on a boom which extends from the jetway serving that gate. It may be noted that this set of panels is used for 707 as well as 727 aircraft as indicated on the rear panel.

The pilot steers his aircraft into the gate area by keeping the vertical lines (painted on both panels) in line with each other. This ensures the correct alignment of the aircraft. His forward progress is halted when the padded end portion of the boom rests against the front of the aircraft windshield. Note also the traffic light mounted on the boom which permits a mechanic to signal the pilot to halt in the event of a potential ground hazard not visible to the pilot. Once the plane has stopped, the jetway operator raises the boom to a vertical position and then proceeds to bring the jetway into position for emplaning/deplaning.

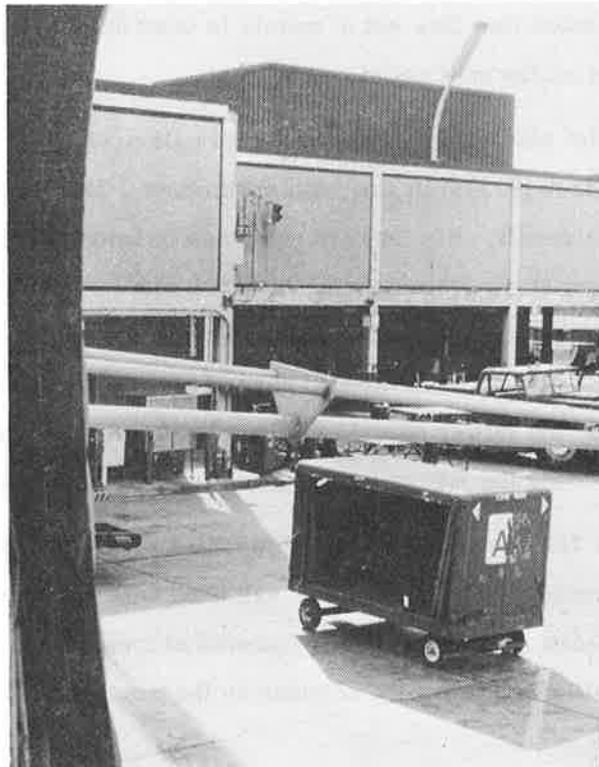
Figure 7-2. Docking Aid for DC-10 Aircraft at Gate K-2

Figure 7-2 shows the set of panels used when a DC-10 is to dock at that gate. Similar procedures to those above are used with the exception of the stopping procedure which is accomplished by means of a mechanic actuating the red portion of the traffic light mounted adjacent to the panels.

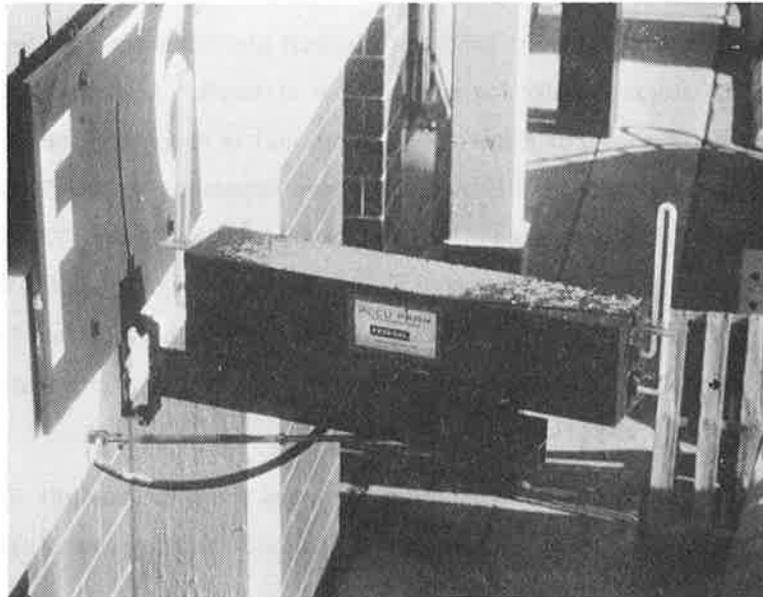
Figure 7-4. Directional Guidance Unit of the ACCU-PARK System Installed at Gate F-6

Figure 7-4 shows a close-up view of the directional guidance unit as installed at gate F-6. The neon tubes located near the building and at the opposite end (red and green, respectively) are to be kept superimposed on each other by the pilot as the aircraft enters the gate area. Figure 7-5 shows the approximate viewing angle for the pilot.

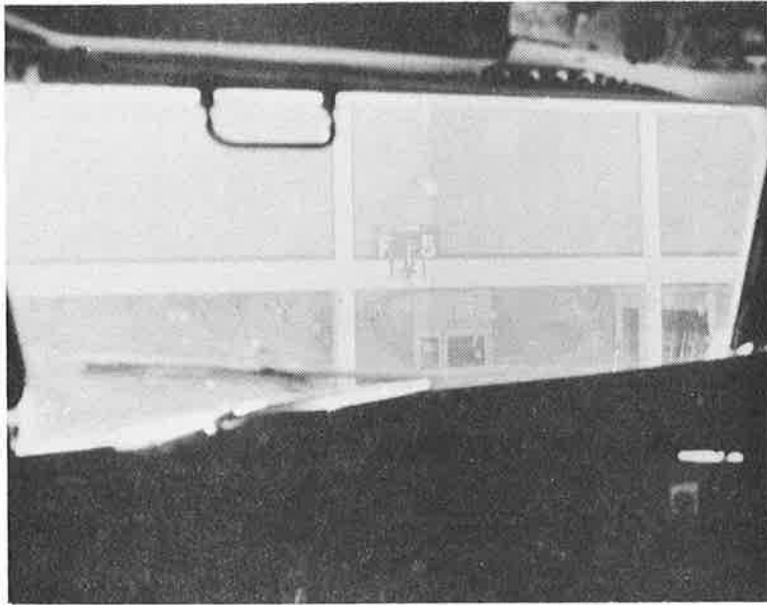
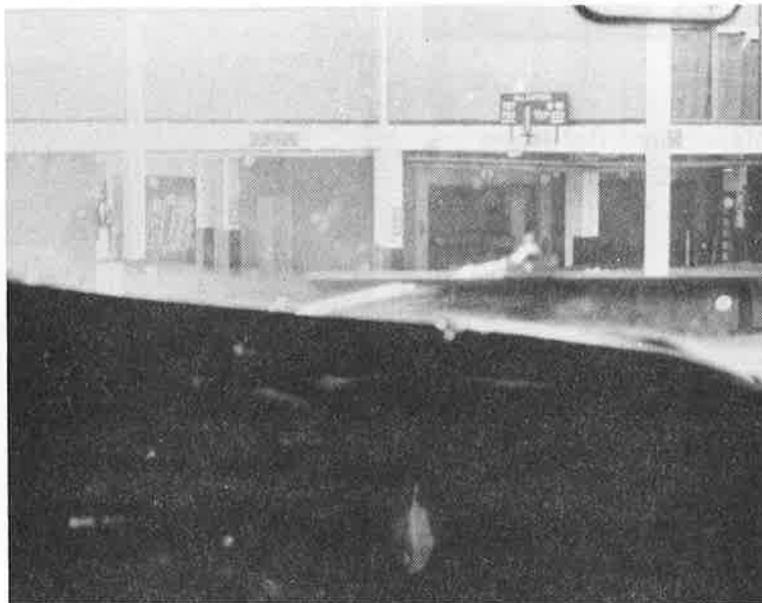
Figures 7-7 and 7-8 are photographs taken from the cockpit of a parked aircraft to indicate the relative view of the parking aids to the crew of the aircraft.
