**THREE-CABLE
MEDIAN BARRIER
FINAL REPORT**

#OR-RD-99-03

Brett Sposito, E.I.T.

Sam Johnston, P.E.

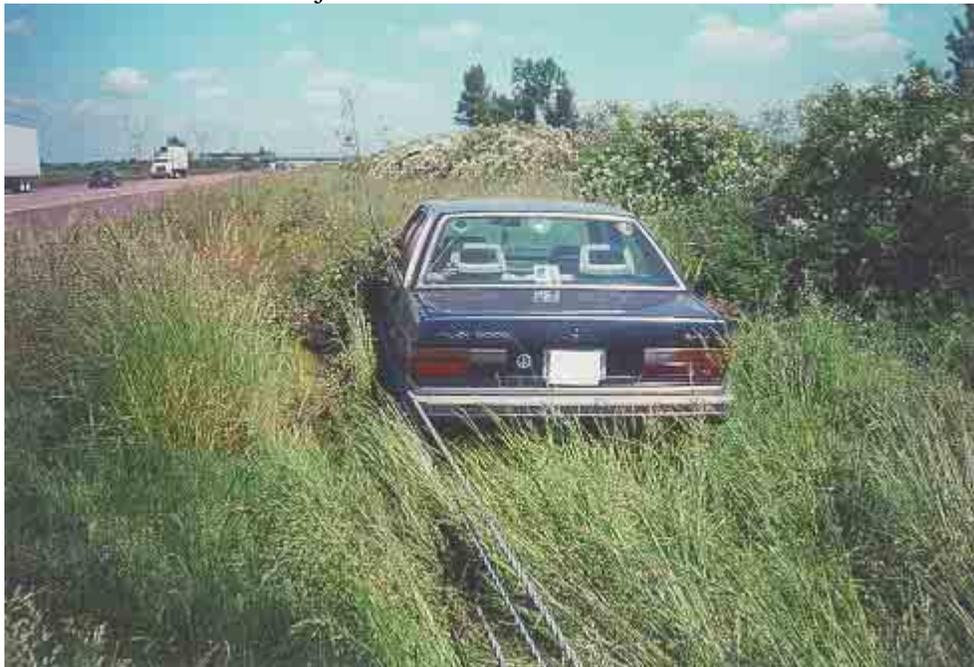
Time/Date: 0230; 6/6/97

V#1 was in the 'A' lane passing V#2. As V#1 was alongside V#2, V#2 started changing lanes from 'B' to 'A'. V#1 swerved to left to avoid V#2. V#1 then veered back to the right to avoid the median bushes, traveled into the 'B' lane in front of V#2, then swerved back to the left to avoid traffic. Ultimately V#1 went into the median at an angle and was stopped by the center median cables restraint system. Damage to approximately 60 feet of cable. ODOT notified of damage. It probably prevented a head-on collision. Due to conflicting statements by subjects involved and no independent non-partisan witnesses, no action was taken. No injuries.

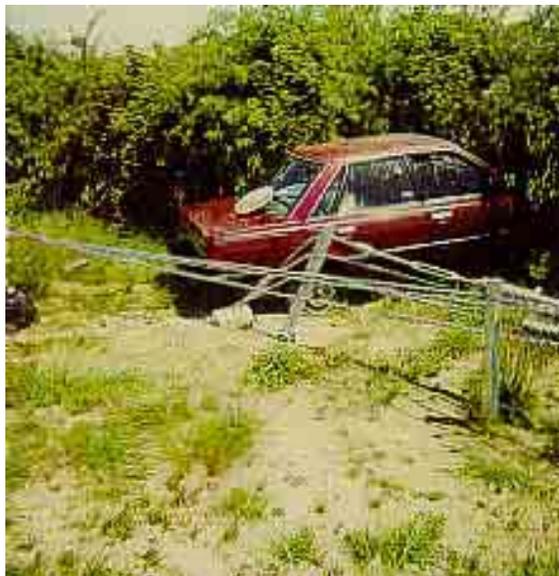
Time/Date: 2020; 7/17/97

V#1 was S lane 'B'. V#2 was S lane 'C'. OP #1 looked down for a second and when OP#1 looked up V#1 swerved a little, OP#1 overcorrected back, tapped V#2 causing minor damage to V#2. V#1 left roadway, struck 3-cable restraint system, passed through cables and stopped. Cables tore hood off V#1 and crushed windshield. V#1 stopped in median. Non-injury.

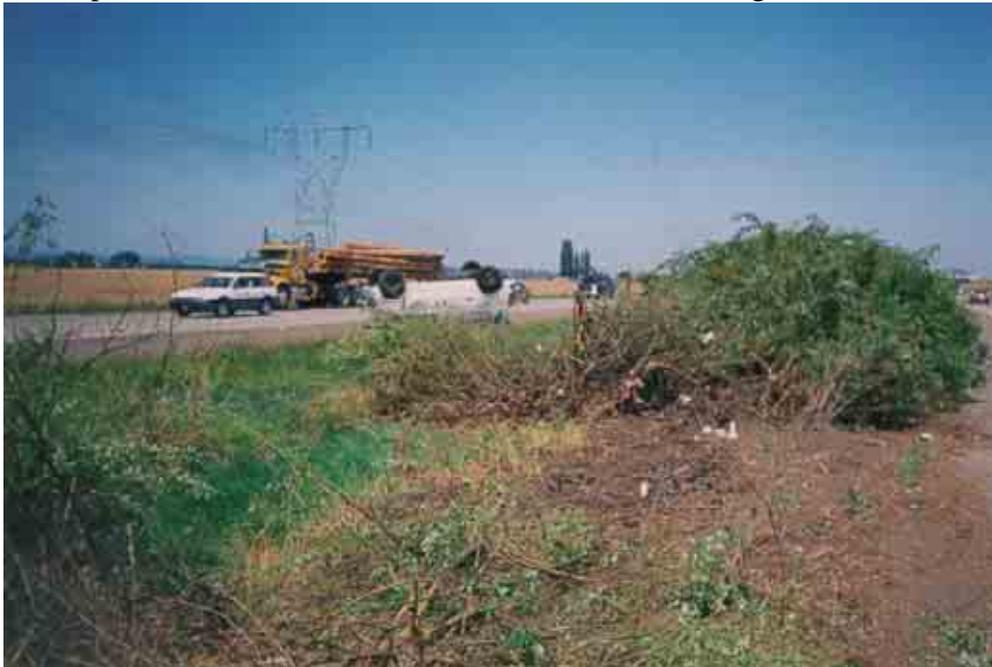
Time/Date: 0400; 7/24/97

V#1 was I-5 N at MP 268. Witnesses said V#1 was following too close. A vehicle in front braked. OP#1 slammed on the brakes and lost control. OP#1 hit the median 3-cable system and flipped. OP#1 received minor injuries and was treated and released from hospital. OP#1 was issued a citation for careless driving.

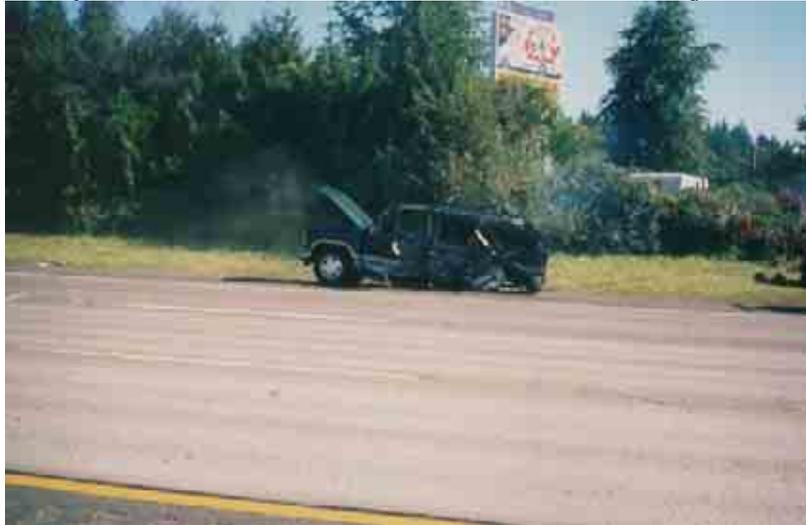
Time/Date: 1130; 9/24/97

Preliminary investigation indicates that OP#1 suffered a seizure. V#1 was S on I-5, crossed the median, broke through the cable barrier, struck V#2 and continued across the N lanes where it came to rest in a field. OP#2 received minor injuries/treated and released at hospital. V#2 totaled and towed. V#1 sustained major front-end damage.
