EXPERIMENTAL FEATURES CONSTRUCTION-REPORT

SERB GUARDRAIL
IN-SERVICE EVALUATION
OR 88-02

S. Ashland to California State Line
F.A.P. IR-5-1(113)00
Jackson County

OREGON STATE HIGHWAY DIVISION
Materials and Research Section
Salem, Or 97310

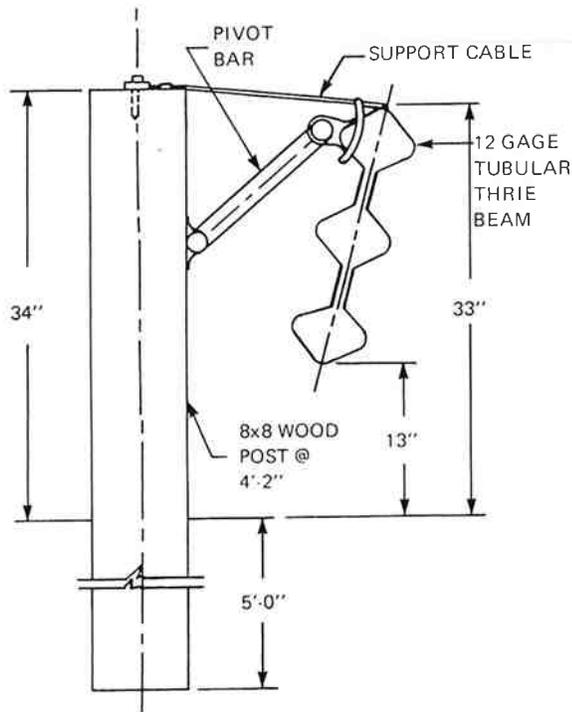
(Diagram 1, SERB Design)

The SERB guardrail is fabricated out of 12 gauge steel. It consists of two tubular thrie-beam sections connected back-to-back forming three hollow tubes. Diagram 1 is a design description of the rail used at this test installation. Photo 1 is of the SERB rail mounted in place.

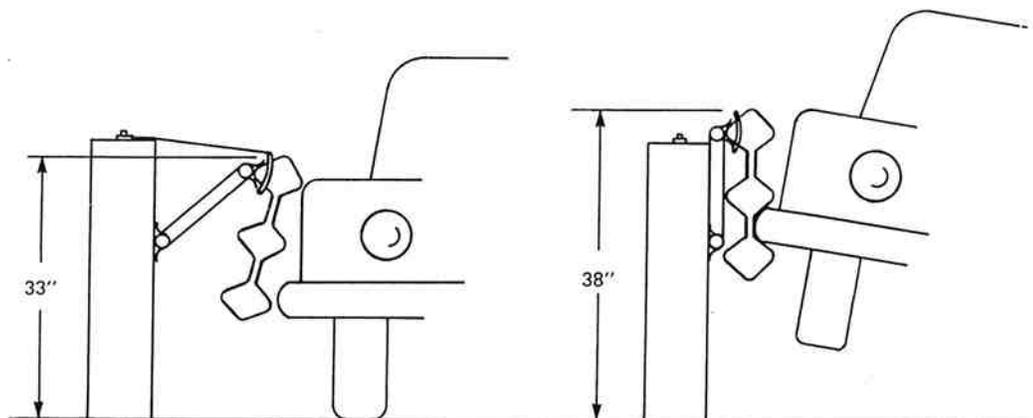
(Diagram 2, SERB Flex upward and backward)

Pivot bars and support cables (as shown in photo no. 2) attach the SERB rail to ground mounted wooden posts. The pivot bars and support cables allow the rail to deflect backward and upward, and then return to its original position. This allows the vehicle to follow the upward motion and provides for a smooth redirection as shown in diagram two.
