**GEOSYNTHETIC MATERIALS
IN REFLECTIVE CRACK
PREVENTION**

Final Report

SR 537

July 2007

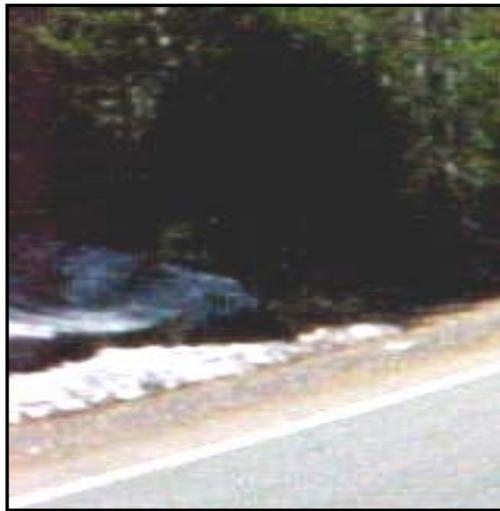
Precipitation in the project area typically occurs as snow or rain (Figure 2.1). The average annual precipitation for Chemult between 1998 and 2006 was 24.7 inches (in) (Table 2.2) (Hale 2007). The largest amount of precipitation fell in 1998, totaling close to 40in, while in 2000 and 2001 only 13.8in and 15.9in, respectively, were recorded.

Figure 2.1: Photograph showing accumulation of snow on shoulder of road

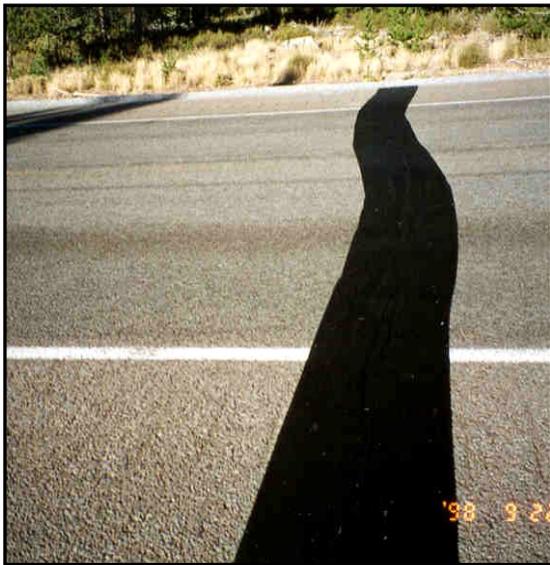
Geosynthetics were placed by the contractor from September 21st through the 24th, 1998 (Figure 4.1). The contractor swept both shoulders prior to placing the geosynthetics in order to have good adhesion with the pavement. The geosynthetics were not overlapped due to concern regarding the impacts on ride quality. Where the geosynthetic was placed in pieces, the edges were butted against each other, creating a seam. Geosynthetics were placed across both travel lanes in all cracks except 32 through 35 where Glasgrid 8502® was applied to the northbound lane only.

Figure 4.1: Geosynthetic on roadway

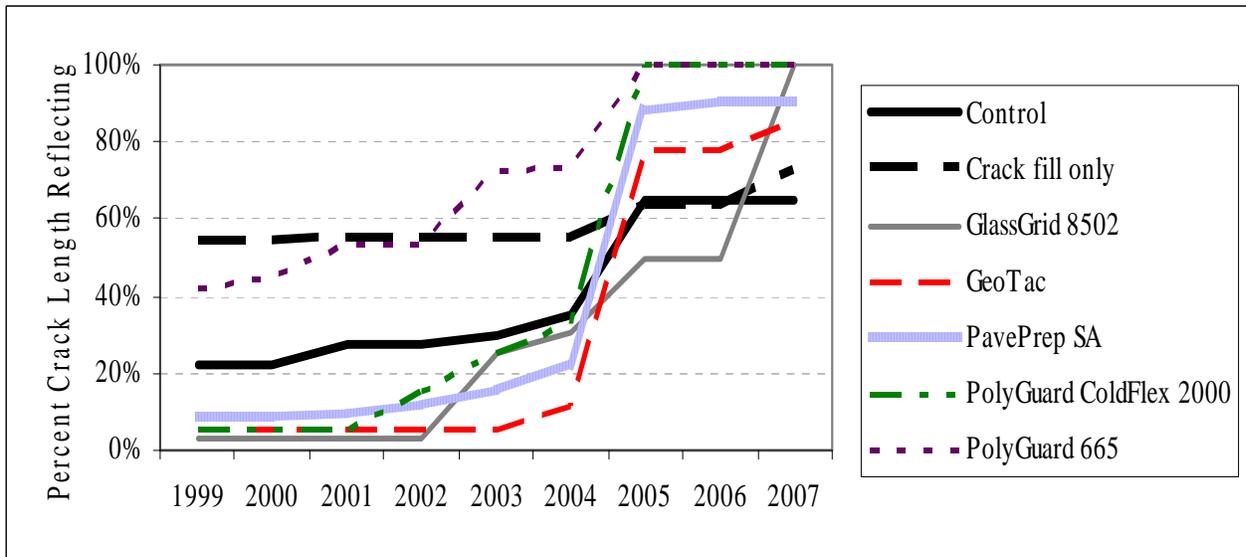
Figure 5.2: Chart showing the percentage of original crack length reflected from 1999 to 2007

A summary of field observations from 1999 to 2007 is recorded in Table 5.1. Two main factors were recorded every year: crack length and severity (calculated from crack width). Classification of cracks was subjective and depending on time of day or if the pavement was wet, crack visibility varied. The length of the reflecting crack was compared to the original crack to see how much had returned or reappeared. The comparison was calculated into a percentage value. The results of these calculations were imputed into a chart that shows the performance of each treatment type from 1999 to 2007 (Figure 5.2).

In 1999, a total of 33 low severity cracks reflected as did one medium severity crack from the control sample. In that same year 55 percent of the total crack length of crack fill only test sections reappeared and 42 percent of Polyguard 665™ reappeared. The three other geotextile test sections each had less than 10 percent crack length reflected. It was clear in the first year of observations that Polyguard 665™ was performing poorly.

In the next year, 2000, four new low severity cracks were observed and were located in the Polyguard 665™ test section. An additional medium severity crack was recorded in 2001 but was located in the crack fill only test sections. Between 2002 and 2003 nine more cracks were reflected totaling 52 cracks. Sixteen of the original 20 cracks in the Polyguard 665™ section were reflected, three of which were rated at medium severity. Over 70 percent of the original crack length of Polyguard 665™ was reflected in 2003, which was the worst of any of the treatment types, including control and crack fill only sections.

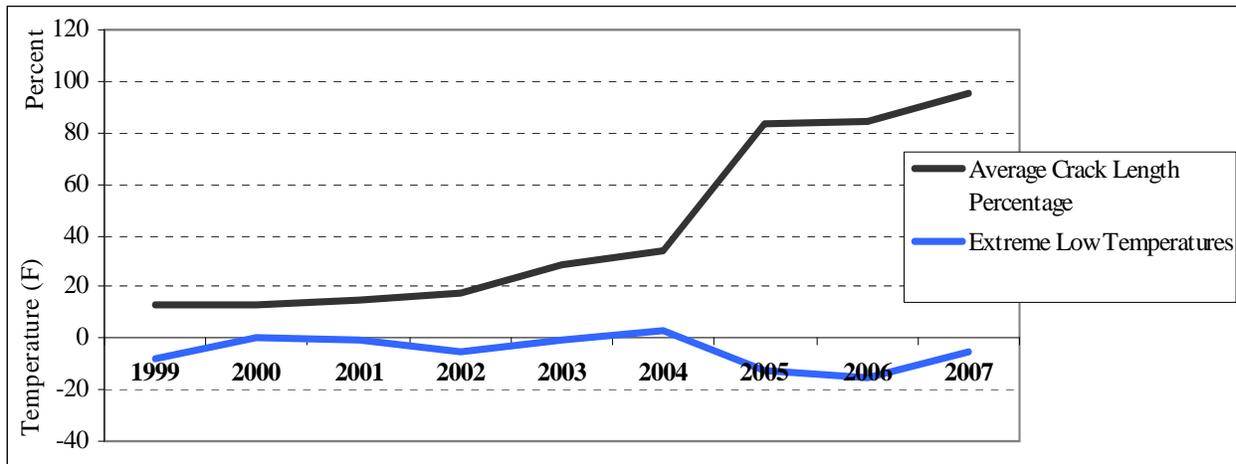
Figure 6.2: Chart showing the correlation of extreme low temperatures and percentage increases in average crack length of geosynthetic test sections

Overall the tested geosynthetic materials performed poorly in coldest years such as 1998, 1999, 2005 and 2006 (Figure 6.2). The trend lines for average crack length of geosynthetic materials and the extreme low temperature per year are almost inverse of one another. These trends show a good correlation between the drop in temperatures and the worsening of the effectiveness of each geotextile. In general this finding is consistent with other studies across the US that concluded geosynthetic materials performed best in warm and mild climates (Cleveland et al. 2002).

In the years 1998, 2005 and 2006 higher than average precipitation amounts were recorded at the nearest station to the test site, Chemult, OR. In those years the annual precipitation level was close to 30in, nearly 6in above the 1998-2006 total average. The increased precipitation in 1998, 2005 and 2006 may have also contributed to the worsening of the effectiveness of the geosynthetic materials.
