**STANDARDS FOR TIRE-BALE EROSION  
CONTROL AND BANK STABILIZATION  
PROJECTS: VALIDATION OF EXISTING  
PRACTICE AND IMPLEMENTATION**

Prepared by:  
New Mexico Institute of Mining & Technology  
Department of Mechanical Engineering  
Socorro, NM 87801

**Final Report NM08MNT-01**

SEPTEMBER, 2010

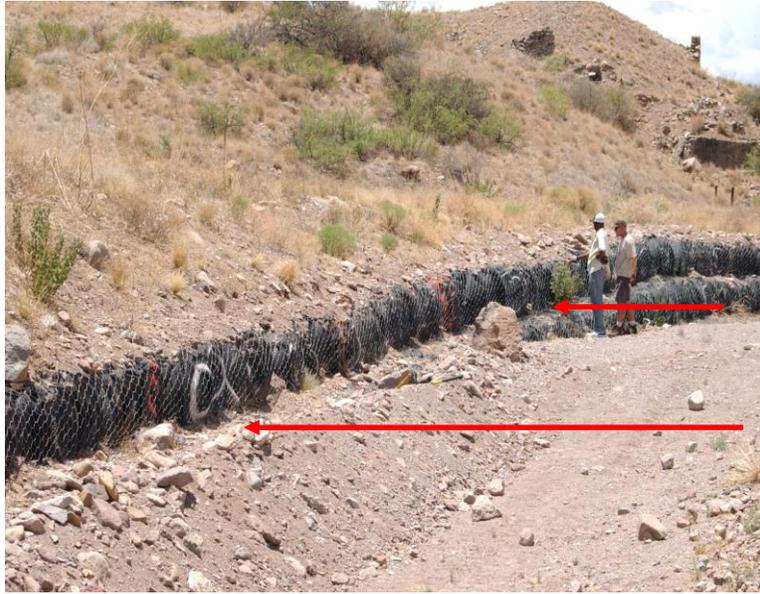
Fortunately, the visual observations of NM152 required little photo journalism or details regarding erosion features or patterns. The site appears unchanged to the observing eye. For the purpose of comparison and documentation two photos are shown below in Figures 12 and 13. The arrows indicate the same area in both figures. As a frame of reference the rock in Figure 12 is still present and in the same location in Figure 13. On the July 2008 in-field site visit there was some sediment displacement within the tire-bales accompanied by some voids. In the May 2010 visit it appears settlement of the sediment has slowed or ceased.

**FIGURE 12 July 3 2008 NM152**

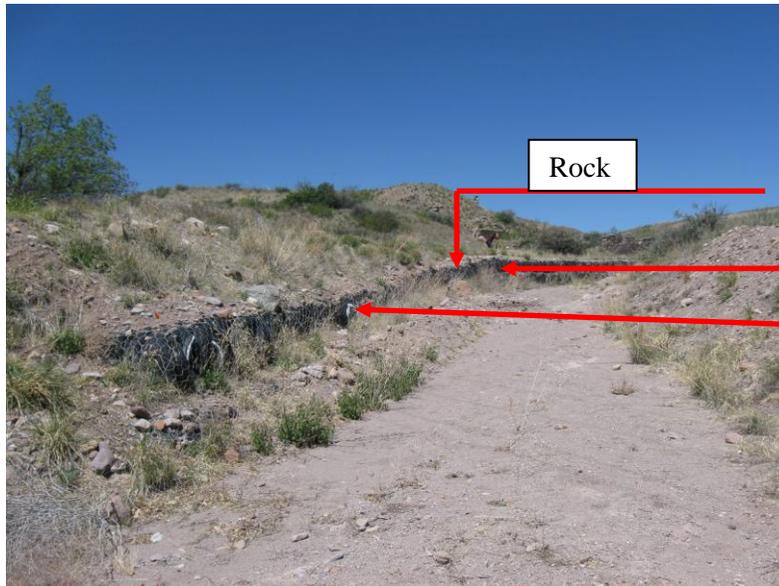
**FIGURE 13 May 4, 2010 NM152**

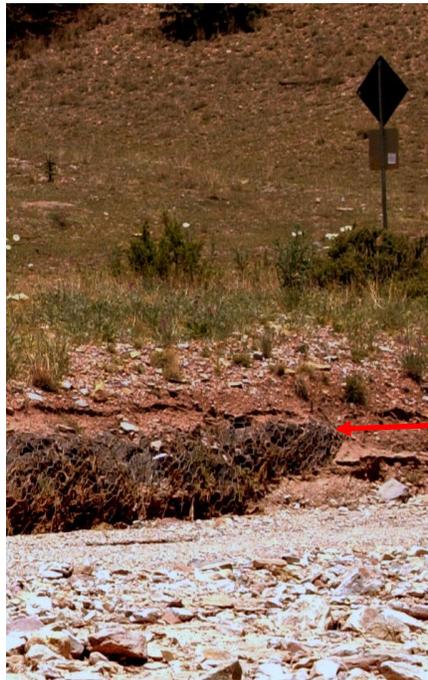
Beginning of tire-bale structure  
– no appearance for additional  
structure exposure

**FIGURE 15 Additional 5 feet (NM52 MP27.2)**

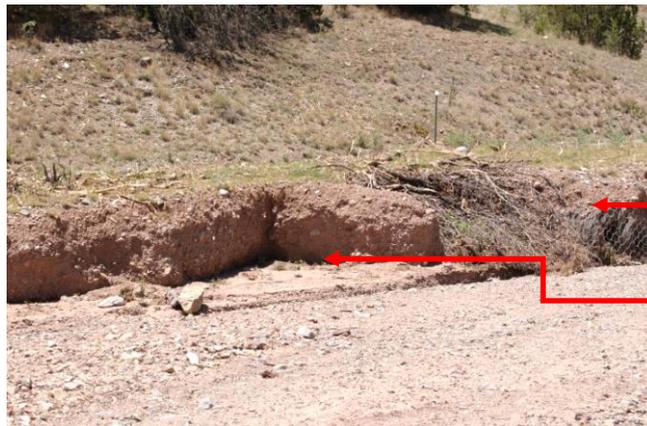
End of Structure  
Scour area

Increased Scour

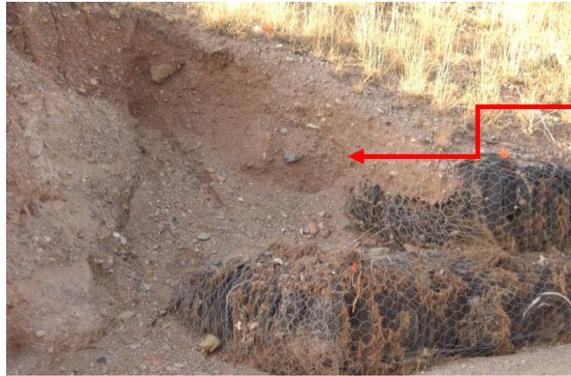
Scour measures 12 feet long and varies in width and depth

**FIGURE 20 Scour at End of the Structure Mile Post 26.7**

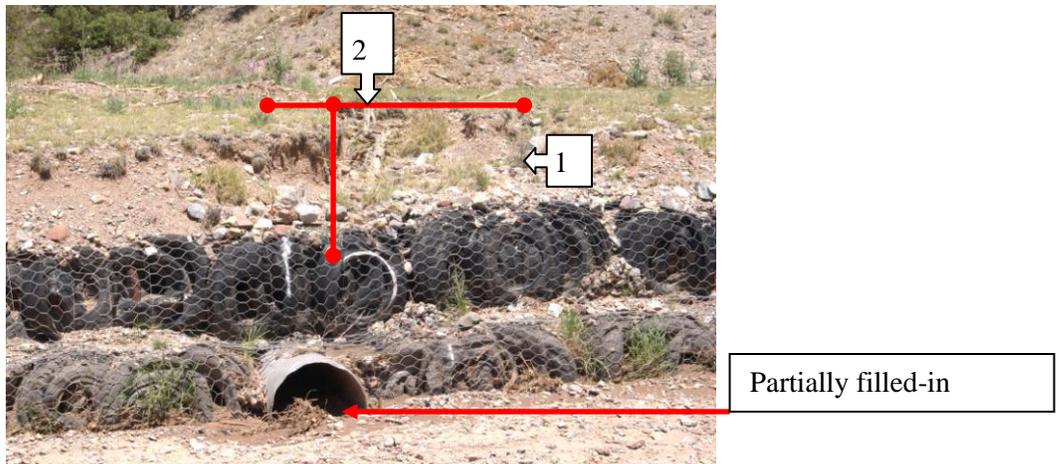
- On July 5, 2010 the culvert erosion appeared visually to have varied slightly. Figure 26 is an analytical representation of the culverts position on the upper level of the tire-bale structure. The erosion pattern measured 21 feet 6 inches by 16 feet (Figure 24). Again the measurements were taken with the Garmin so the accuracy is within limits, so it can be conclude that the culvert erosion was unchanged. It should be stated that latitude and longitude were not used in the analysis.

- Additionally, it was observed that the culvert is beginning to fill-in with sediment (Figure 24), a potential maintenance necessary for continued usefulness of the culvert.

**FIGURE 24 Culvert Upper Level Erosion - July 5, 2010 at MP 27.75**

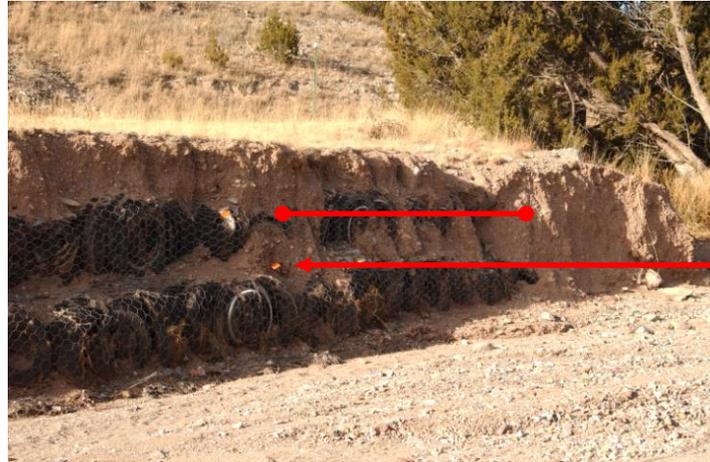
- An additional 21 feet of exposed tire-bales were visible at the beginning of the structure that was not exposed on the June/July 2008 visit and survey point placements (Figure 25).

Survey Flag Placed  
in June/July 2008

**FIGURE 25 21 Feet of Newly Exposed Tire-bales December 2008 MP 27.75**

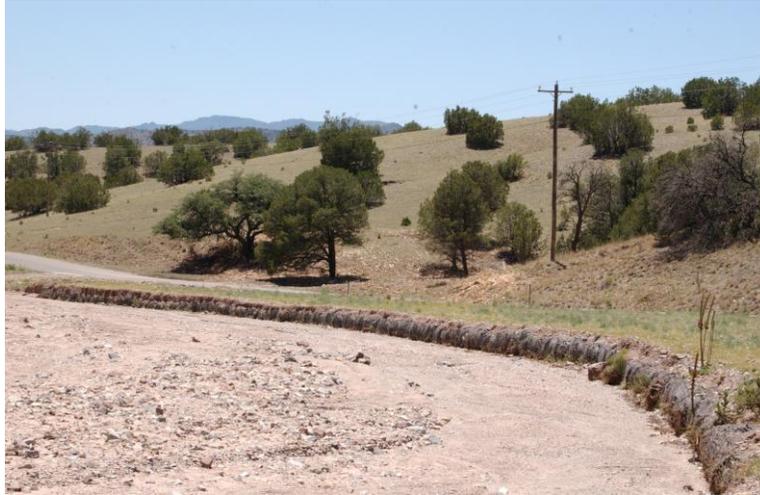
At NM52 milepost 27.2 the opposite observation occurred. The lower level tire-bales have complete soil retention, so much so that the survey team was only able to obtain two rows of readings in comparison to milepost 27.75 where all three rows were obtained. The difference between the two sites is milepost 27.2 has no incline (Figure 27).

**FIGURE 27 NM52 MP 27.2 Lower Level Covered**

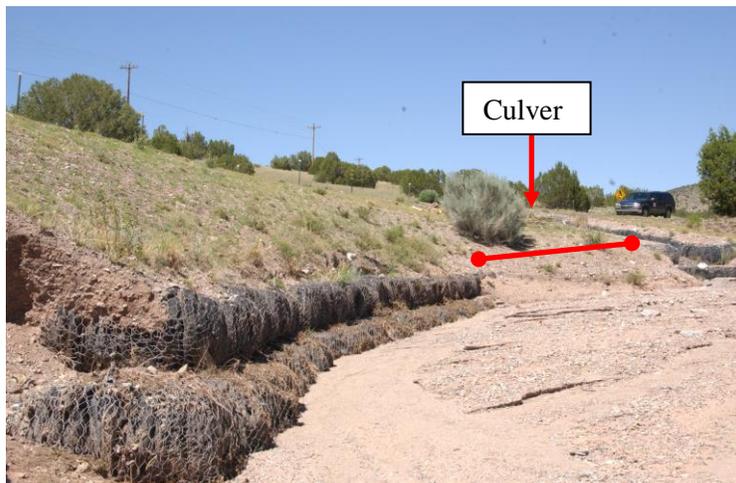
The NM52 milepost 26.7 appeared to have some soil retention at the beginning of the structure near the culvert outflow into the arroyo. While at the end and middle of the structure a decrease in soil retention seemed to occur. Similar to NM52 milepost 27.75, milepost 26.2 is on an incline although milepost 26.2 is a less steep incline. So the soil retention accumulated at the upstream end of the structure. The configuration of milepost 26.7 site makes it difficult to get the entire structure in the photographic frame. However, the area of soil retention is located on the south end of the culvert (indicated by the arrow in Figure 28). The distance is unknown since there was no precise information or data to determine the location of the tire-bales. Parts of the structure were not surveyed since the tire-bales were not visible during survey point placement.

**FIGURE 28 NM52 MP 26.7 Soil Retention**

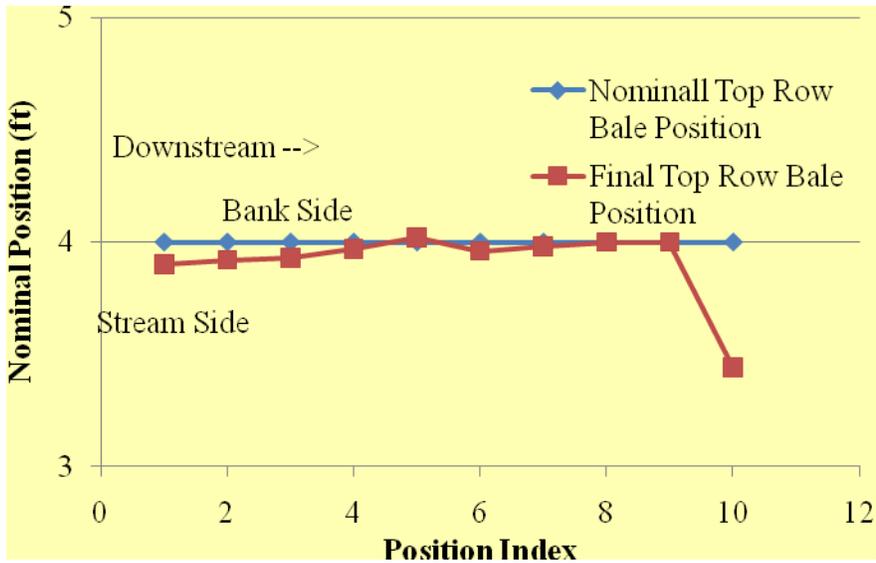
**FIGURE 39 NM 52 MM 26.7: Horizontal displacement of top-row tire-bales over time**

Figure 39 indicates that the top-row bales moved toward the streambed in the upstream portion of the structure, but that this displacement approached zero at the downstream end. (The last data point is clearly an outlier.)

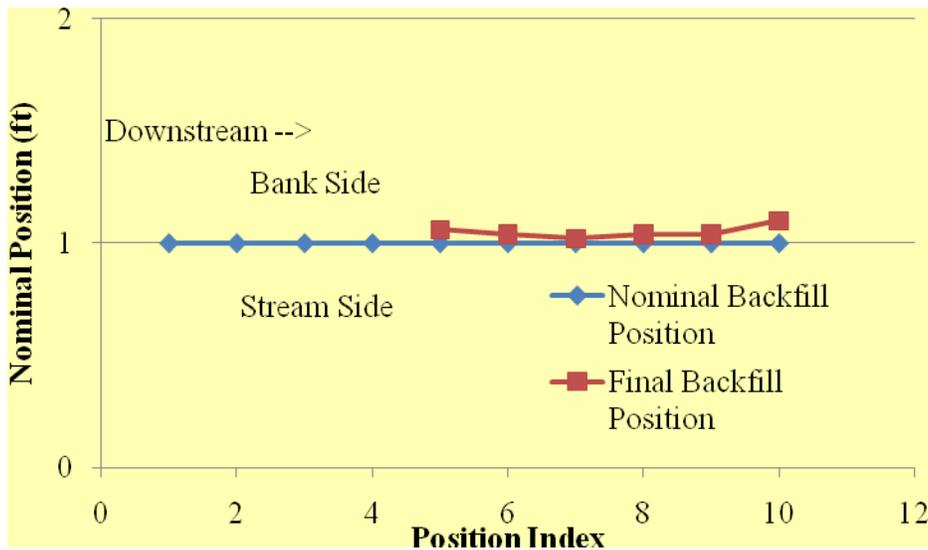
**FIGURE 40 NM 52 MM 26.7: Horizontal displacement of backfill survey points over time**

Figure 40 shows the lateral movement of survey points in the backfill, downstream from the culvert outflow channel (the presence of which is why the coverage is not complete). This data indicates that there was a slight movement of the backfill material away from the streambed, as would be expected as the backfill consolidated over time. This indicates that more thorough of the backfill was needed after the tire-bale structure was built.

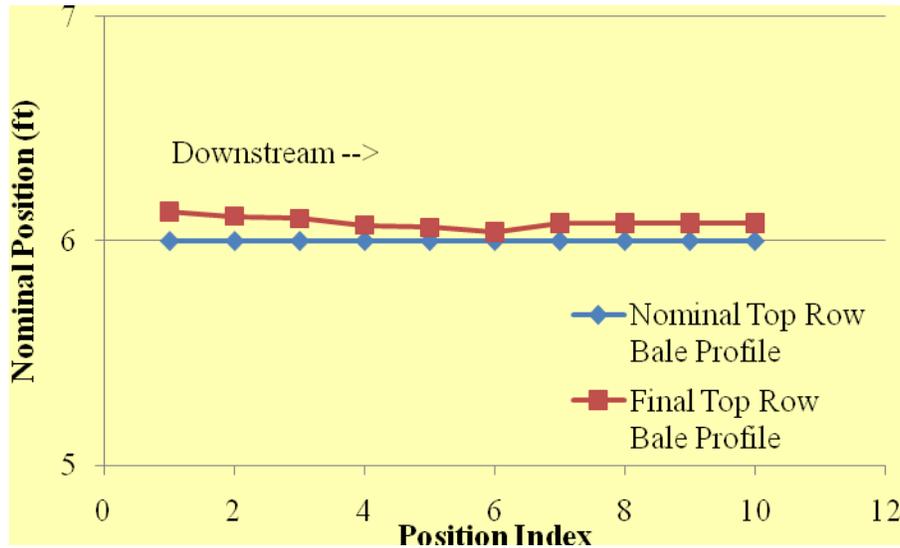
FIGURE 41 NM 52 MM 26.7: Vertical displacement profile of the top-row tire-bales

The vertical displacements of the top row bales (Figure 41) are consistently positive, and indicate that there was some soil swelling beneath the structure. A possible cause for this is that the backfill material below the structure had a higher proportion of native clay, which had expanded at the time of the surveys. Figure 42 shows that the vertical displacement of the backfill was very slight, and for all intents and purposes nonexistent.

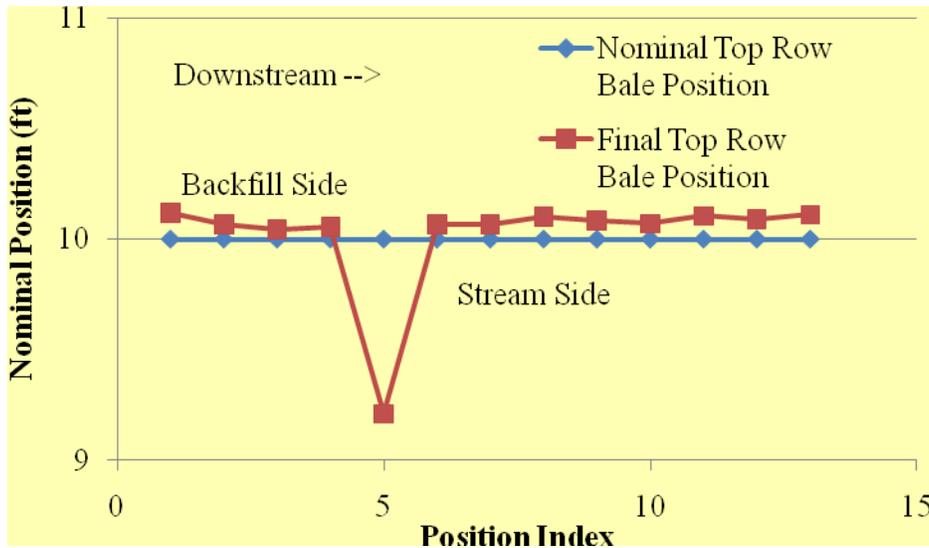
FIGURE 43 NM 52 MM 27.2: Horizontal displacement of top-row tire-bales over time

Figure 43 indicates (but for the presence of an obvious outlier) that the top row of bales has consistently shifted away from the stream bed, toward the backfill. The displacements are small but definite, and they follow a clear trend.

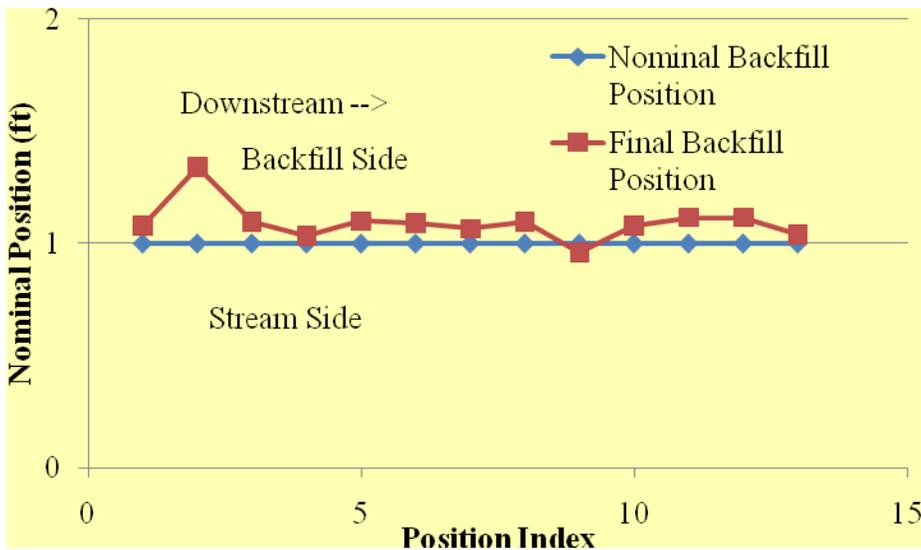
FIGURE 44 NM 52 MM 27.2: Horizontal displacement of backfill survey points over time

Figure 44 shows a similar trend, but for the presence of two probable outliers. These two data sets clearly indicate that the structure has experienced post-construction and stream-flow-induced displacement.

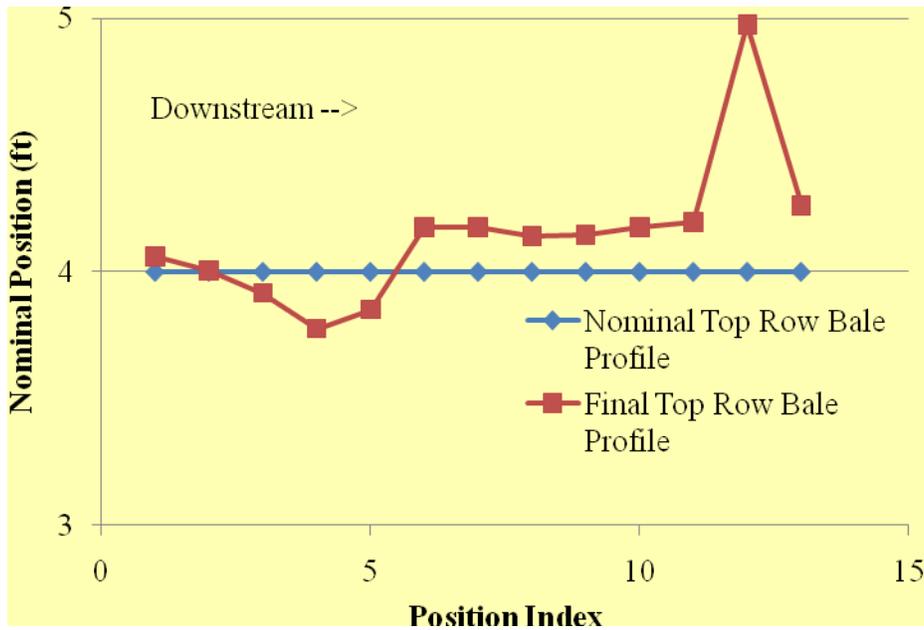
**FIGURE 45 NM 52 MM 26.7: Vertical displacement profile of the top-row tire-bales**

The data presented in Figures 45 and 46 is not as clearly defined. Figure 45, showing the vertical displacement of the top-row bales, indicates that the upstream bales have settled, while the downstream bales have risen (there is one obvious outlier).

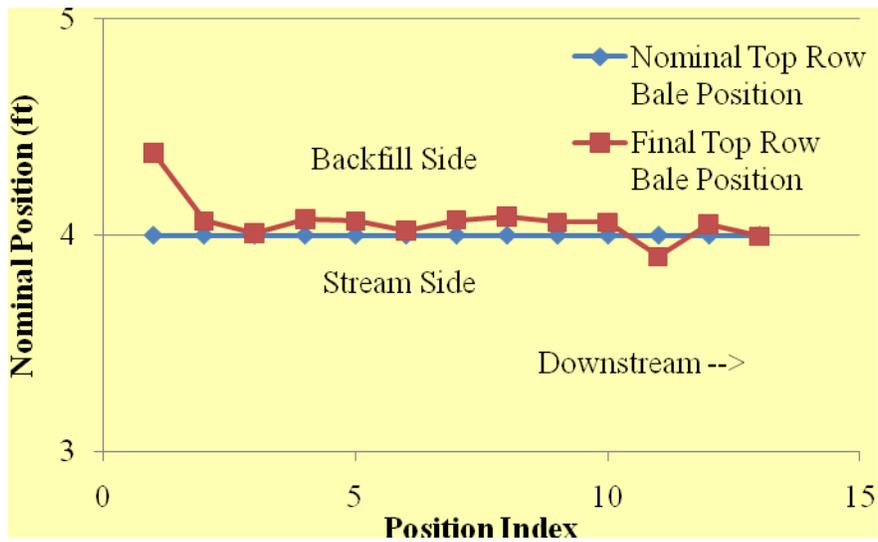
**FIGURE 47 NM 52 MM 27.75: Horizontal displacement of top-row tire-bales over time**

Figure 47 shows lateral movement of the top row of tire bales. The first data point (on the left) is probably an outlier, as is the third-from last point on the right. These two measurements aside, this figure (and Figure 48 which follows) indicate that there has been a definite shift in the structure's position over time; consolidation of the backfill and apparent hydrodynamic pressure from ephemeral water flow have served to 'push' the structure a small distance away from the stream bed. It must be emphasized that the displacements are very small, and nearly within the range of measurement error. (It should also be stated that deflections of this magnitude are to be expected for any structure, as soil consolidation takes place in the first few months-to-years after construction.)

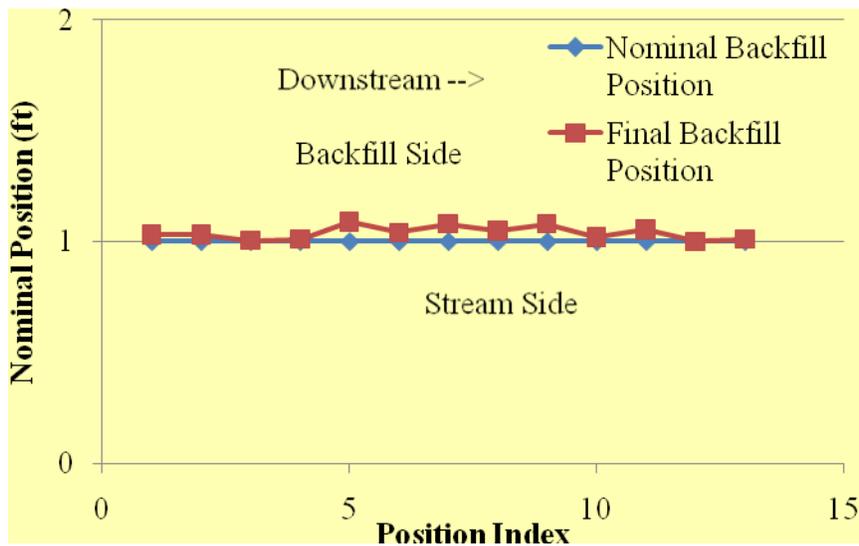
**FIGURE 48 NM 52 MM 27.75: Horizontal displacement of backfill survey points**

Figure 48 shows lateral deformation in the backfill as a function of position along the length of the tire-bale structure. The results shown in Figure 39 are echoed here, though at a smaller magnitude. The displacement is away from the stream bed, again consistent with consolidation of the backfill and the influence of ephemeral-stream hydrodynamic pressure on the front of the structure.

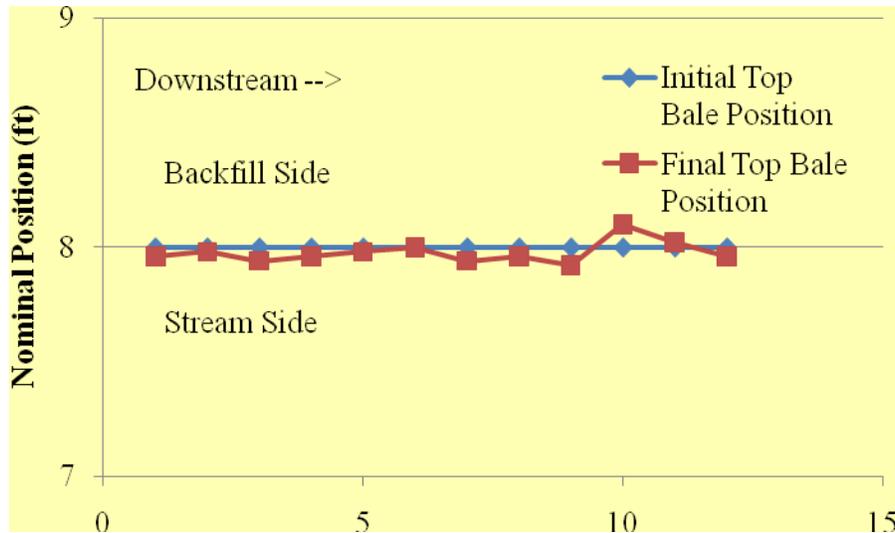
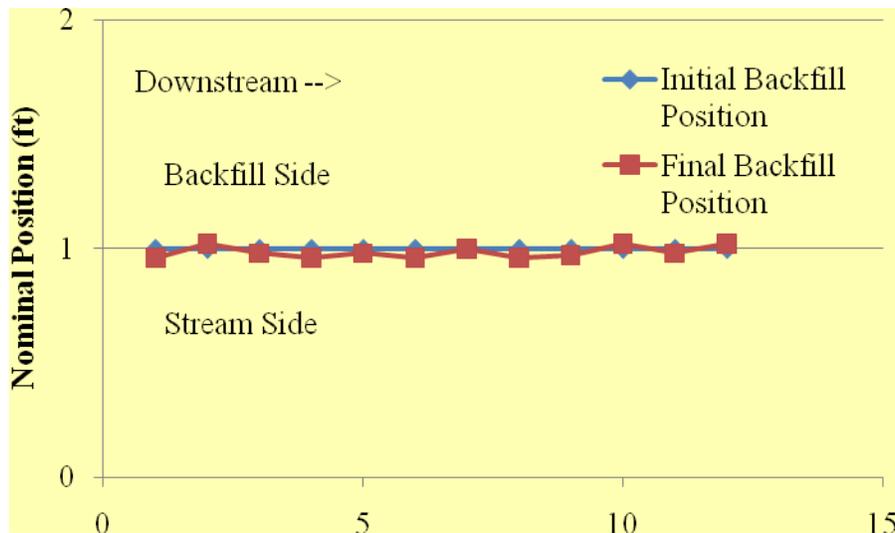
Our hypothesis is that this has resulted in slightly greater soil pressures from the backfill as it consolidates, pushing the structure outward toward the stream bed.

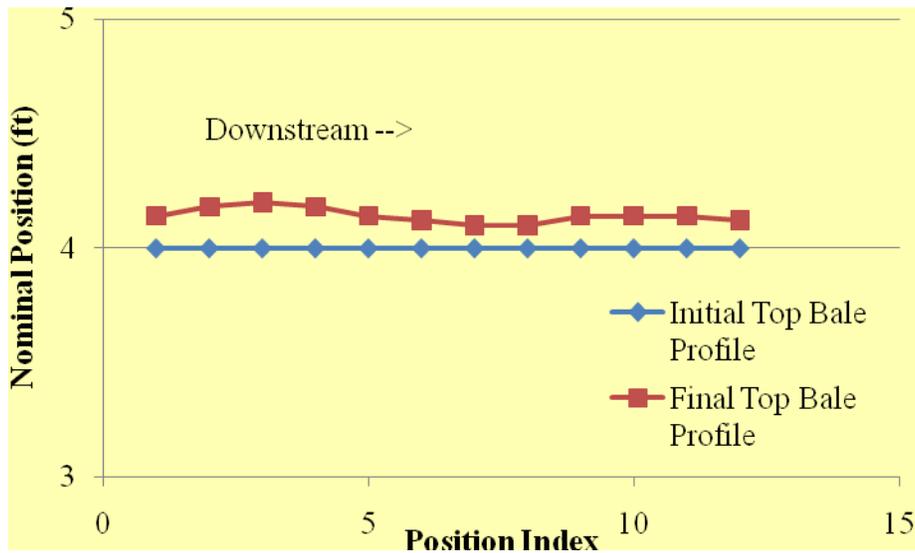
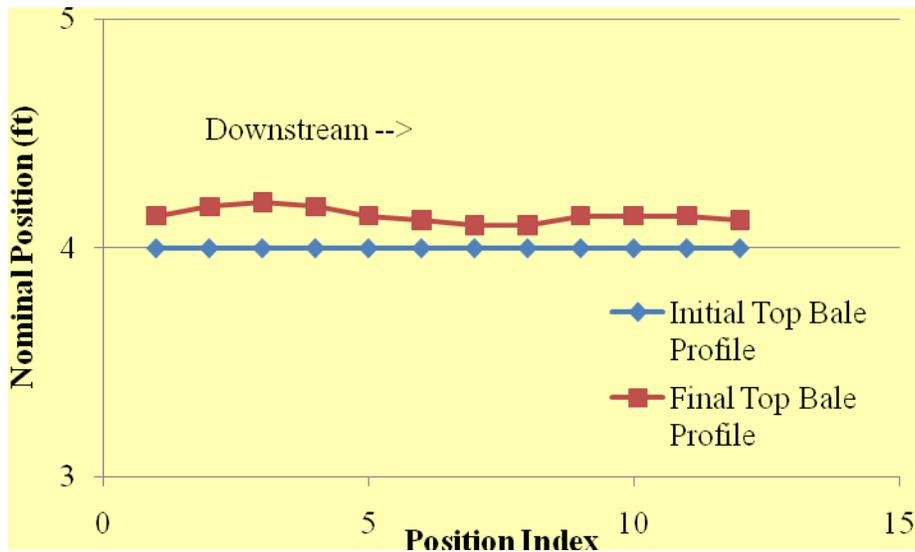
Figures 53 and 54 show the vertical deformation of the top-row tire-bales and the backfill survey markers, respectively, as a function of position along the tire-bale structure. Both Figures show a definite increase in elevation, which should be consistent with the assumption that backfill consolidation in this unique configuration has increased the soil pressure behind the tire-bale structure.

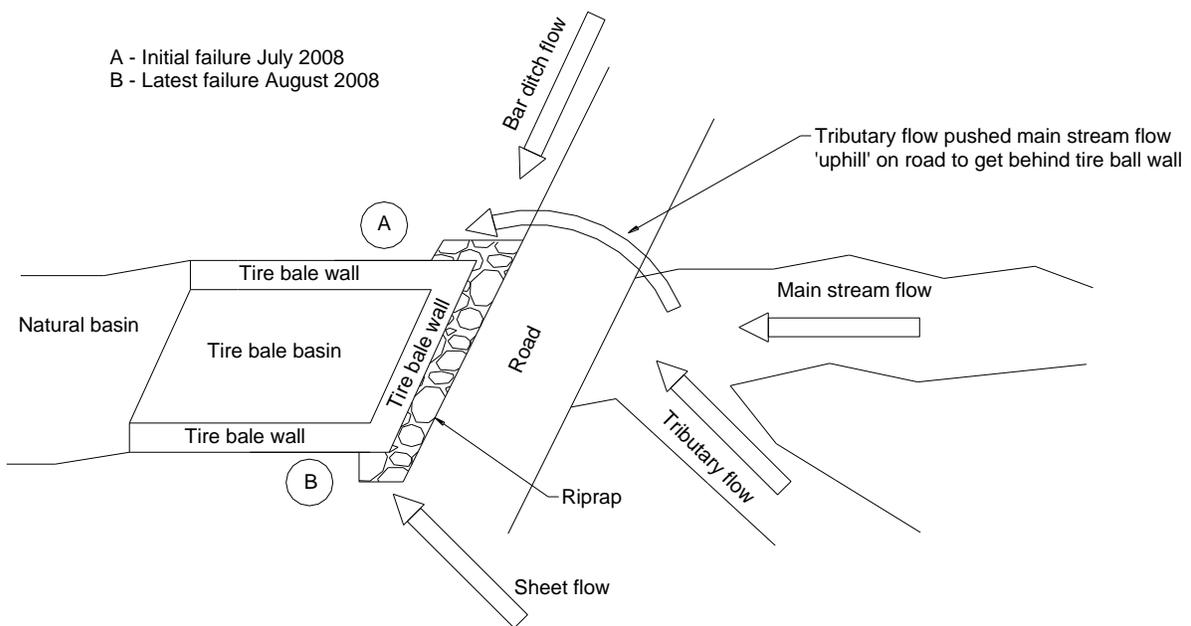
**FIGURE 55 NM 143 Site Layout**

At the end of July, 2008, a failure occurred at the NM-143 site, near Deming, approximately two months after installation. Figure 55, below, shows a schematic of the site. The original road design called for periodic arroyo flows to go over the road and into the natural basin on the other side. Recent increased development in the area had increased the water flow in the arroyo, leading to soil erosion on the north side of the road. The tire-bale structure was intended to stop the encroachment of the arroyo basin into the shoulder area of the north side of the road. The failure of the tire-bale structure at NM-143 was due to stream water from three directions flowing across the top of the structure and exploiting the contact between the native soil and the fill on the east side at point A on Figure 55.

The original drainage pattern as determined by the geometry of the road, riprap, and tire-bale structure. The hydrostatic forces acting behind the tire-bale structure and the buoyant forces from the bales themselves acted on the bales (within their 'net' of gabion wire) in the form of an outward pressure (i.e., away from the bank and into the channel). The steel cable and anchor system held the base of the tire-bale 'wall', but they acted as a pin connection; they did not provide appreciable moment resistance to resist the combination of hydrostatic pressure and buoyant forces, and the 'wall' rotated about them and overturned into the channel. The main resistance against overturning actually came from the gabion wire covering the structure, and was at its maximum at the reentrant corner where the channel wall

met the head structure adjacent to the road. This is a critical failure mode for a tire-bale structure, and points to a clear requirement for lateral anchors (i.e., deadmen) to connect the structure to the backfill with horizontal tension members such as cables.

The lesson of the failure of the NM 143 structure is that lateral anchors are a necessity for tire-bale structures used in erosion control applications. They cannot be built with sufficient moment resistance to resist hydrostatic pressure behind the structure, and there is no way to ensure the permanent exclusion of water through the life of the structure.

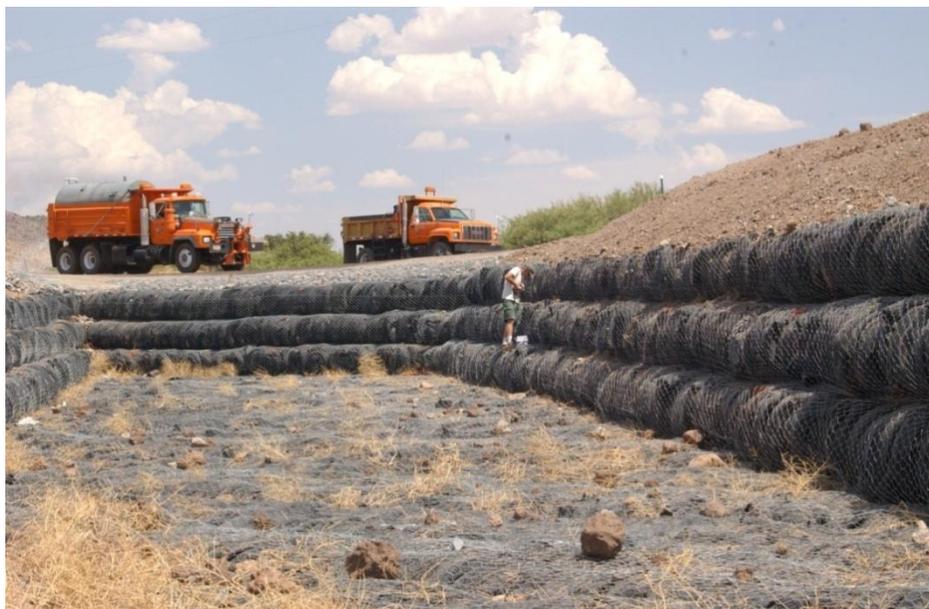
**FIGURE 56 NM-143 tire-bale structure as pictured on June 26, 2008**

Figure 56, below, shows the structure as of June 26, 2008. It appeared to be virtually brand-new, as the bottom “bed” of tire-bales was clearly visible. This was most likely the condition of the structure when the damage occurred. The original design may have called for shotcreting some areas of the structure, but this had not been completed when the damage occurred.

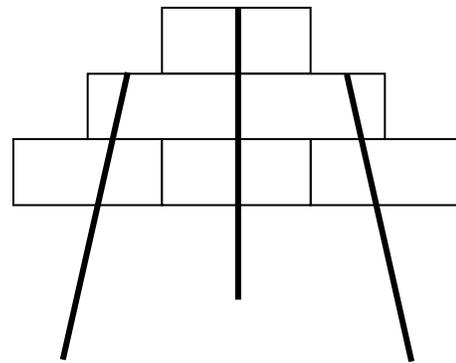
**FIGURE 80 Difference Between Specified and Constructed Pile Configuration for Head-cutting Structure**

A meeting was held with both the research and the construction teams after the construction of both structures was nearly completed, so that the construction team could share their experiences, offer their recommendations, as well as point out the challenges faced during construction, and the differences between the design drawings and the actual structures built. One of the main differences was the manner used to anchor the tire-bales to the ground using cables and driven piles on either side of the structure. Because tying only the first layer with the cables was causing the tire-bales to rotate, lifting their inside edges, as shown in Figure 77, the construction crew decided to anchor the second layer instead, securing the bottom two layers of tire-bales at the same time. For this reason, two cables were used one on the near end and the second on the far ends of the second layer of tire-bales. A third cable was used to hold the top layer (Figure 78). Although L5"x5"x1/2" (12' long) angle iron was used for the piles, bending often occurred due to the slenderness of the piles and the lack of an appropriate piece of equipment. For this reason, although more expensive, solid bars, would have probably been more practical. For ease of construction, on the head-cutting structure, the piles were driven at an angle opposite to that of the design drawings, that is, instead of the outside piles being slanted under the structure towards each other, they were angled away from the structure and away from each other (Figure 78). This was rectified for the side structure, where piles were driven as specified.

- the use of thicker (1/2") cable to allow the construction crew to apply tension without worrying about cable failure;
- the use of solid bars instead of angle iron for the piles to prevent bending or the use of better pile driving equipment.

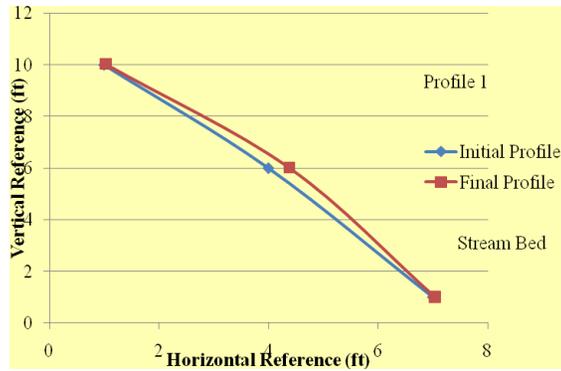
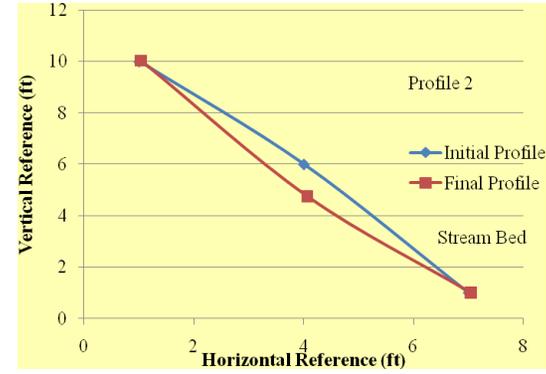
Displacement profiles 1 and 2 (Figures E1 and E2) represent an area in which significant scour was observed at the upstream end of this structure.
