# Investigation of Early Distress in Wisconsin Rubblized Pavements

Investigation of Early Distress in  
Wisconsin Rubblized Pavements  
Research Study # WI-10-02

Report # WI-02-11

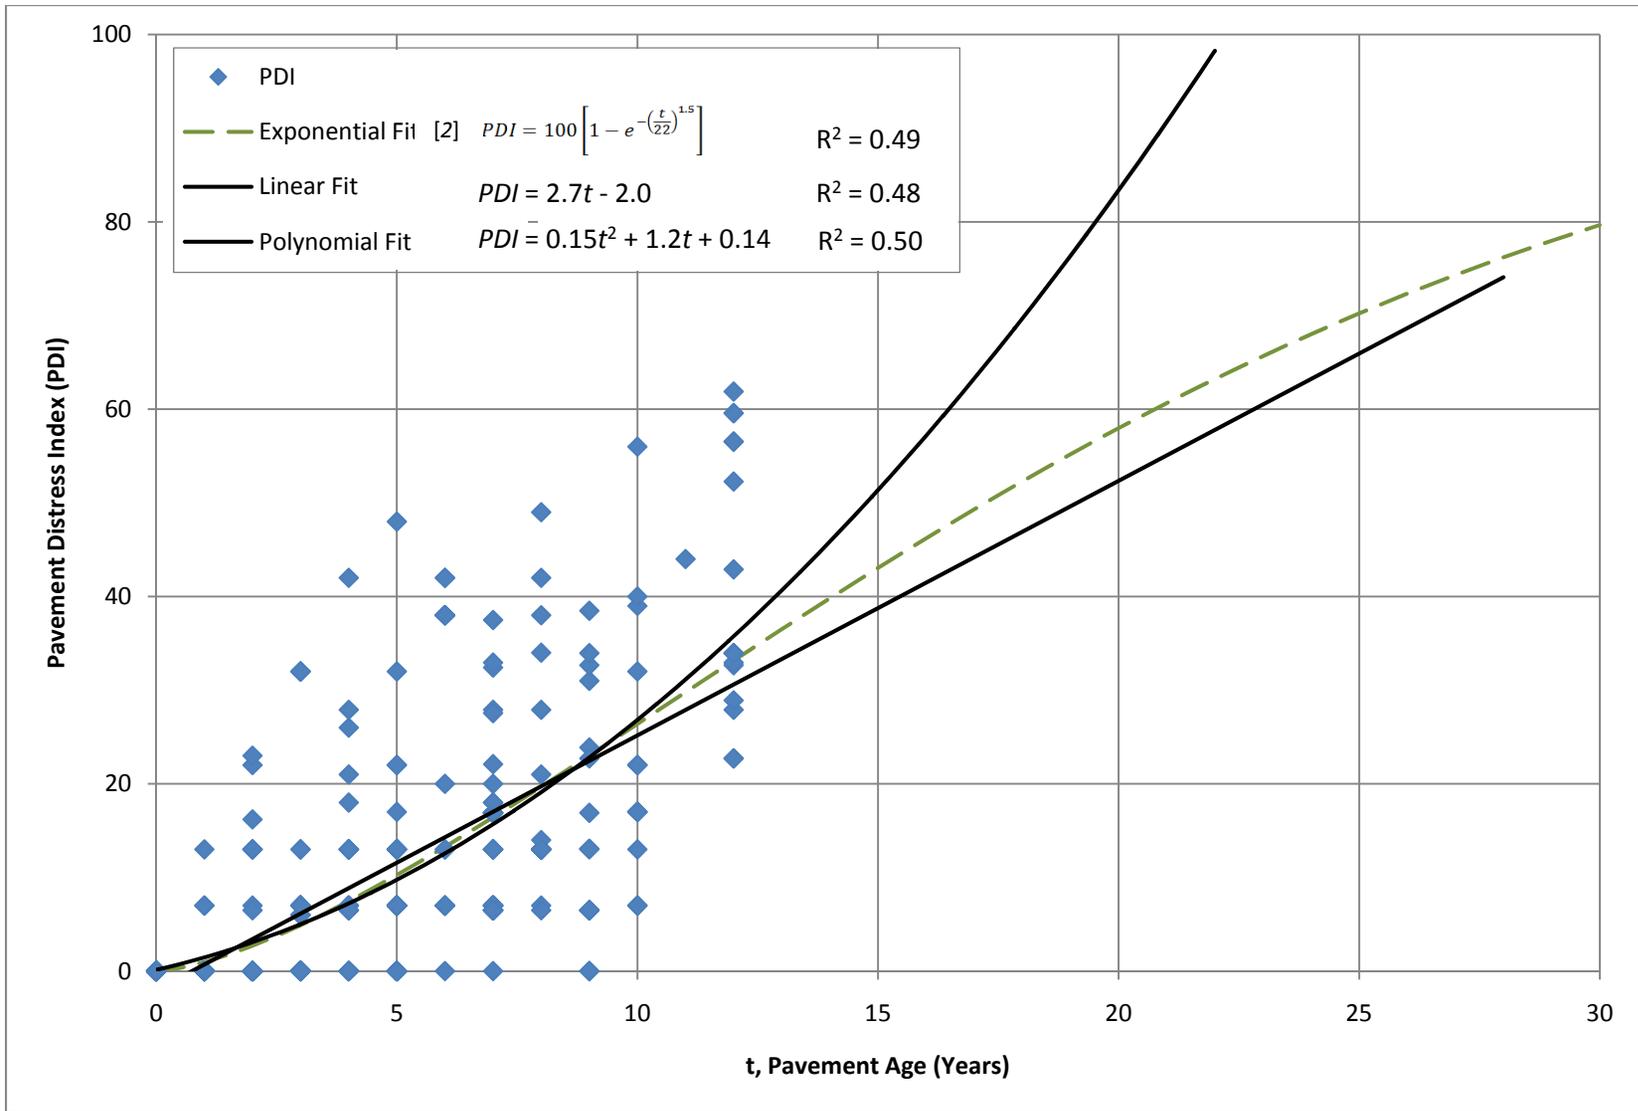
Figure 6. Pavement distress prediction, "good" performance category pavements

Based on the PDI threshold of 65 and the trends shown in Figure 6, the initial service life of rubblized pavement systems with good performance ranges from 17 to 25 years. Pavements in the "poor" performance category may only be serviceable for 13 to 15 years (Figure 7). The 17 to 25 year estimate for good-performing pavements is on par with the previous service life prediction for Wisconsin pavements of 21 years by Von Quintus, et al. [2] Current WisDOT design values of 22 years for HMA over rubblized pavement and 18 years for traditional HMA pavements fall within the 17 to 25 year range. [29]

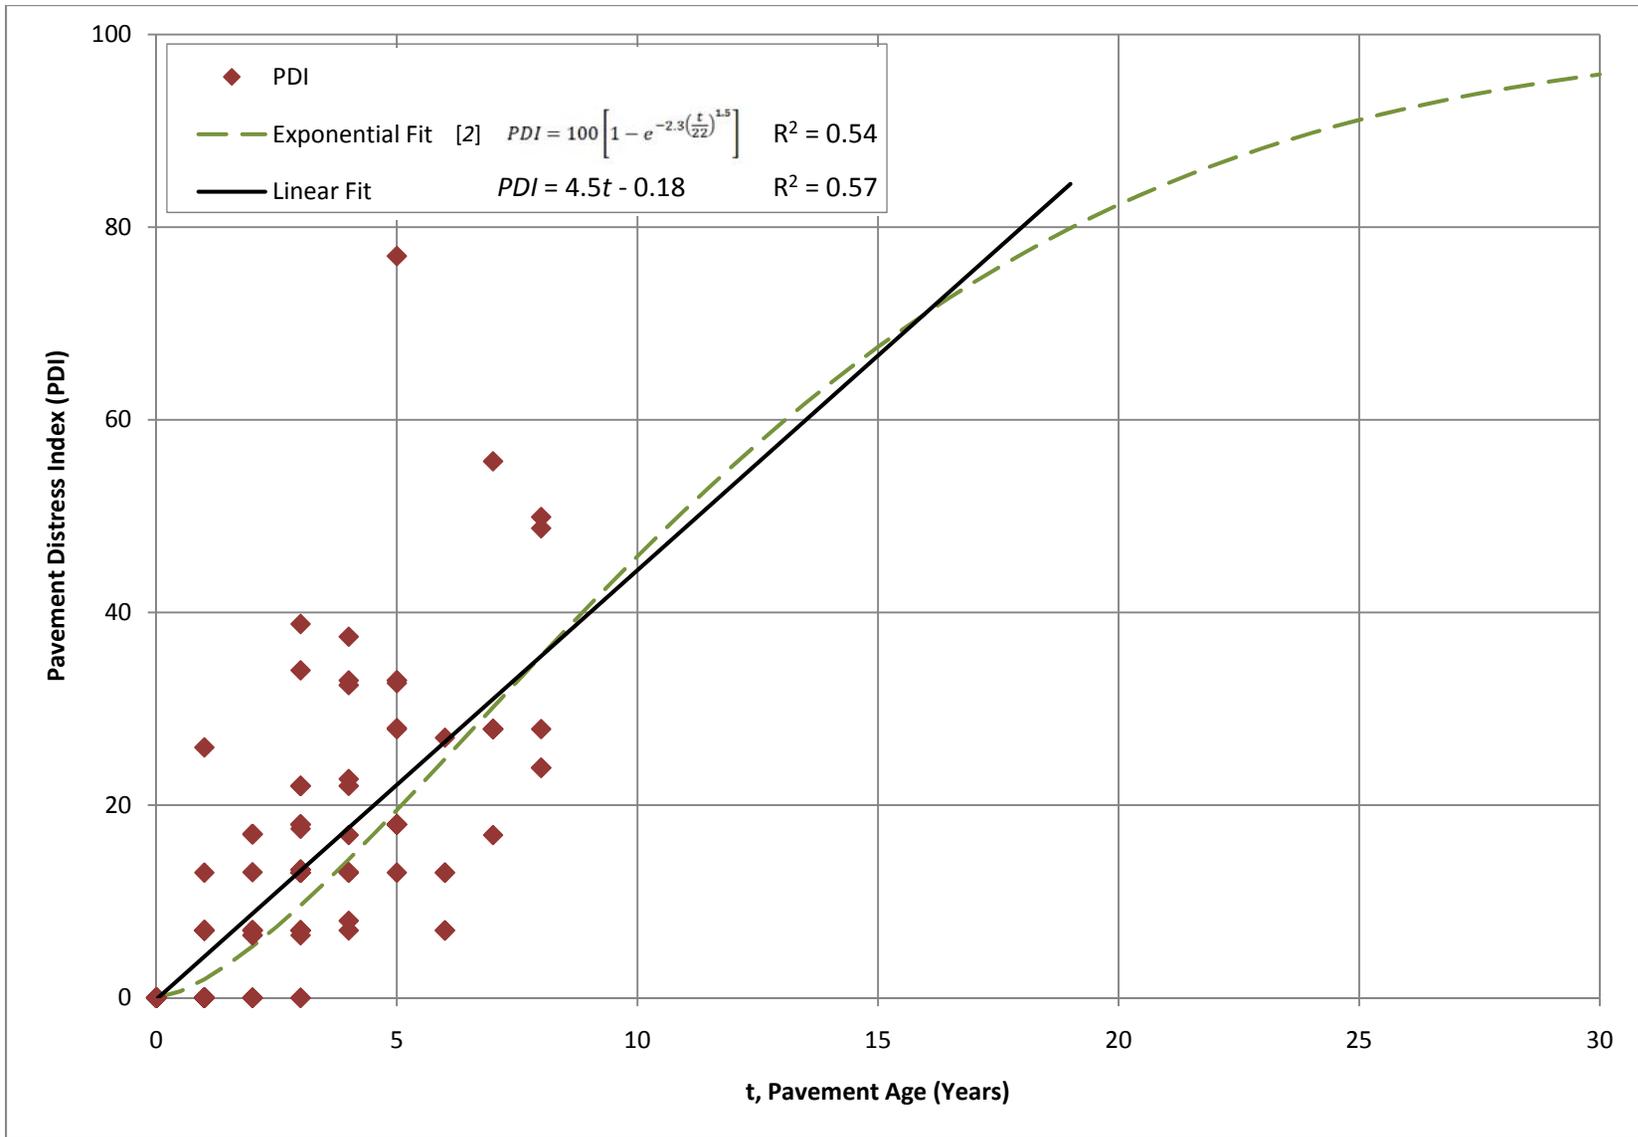
Figure 7. Pavement distress prediction, "poor" performance category pavements

For this evaluation, a PDI threshold of 65 was defined as the point at which a pavement is at the end of its initial service life. This PDI value would be reached with the presence of 11 or more severe transverse cracks per tenth-mile survey segment in the HMA pavement, which was the prevalent distress noted in the "poor" performance category projects.

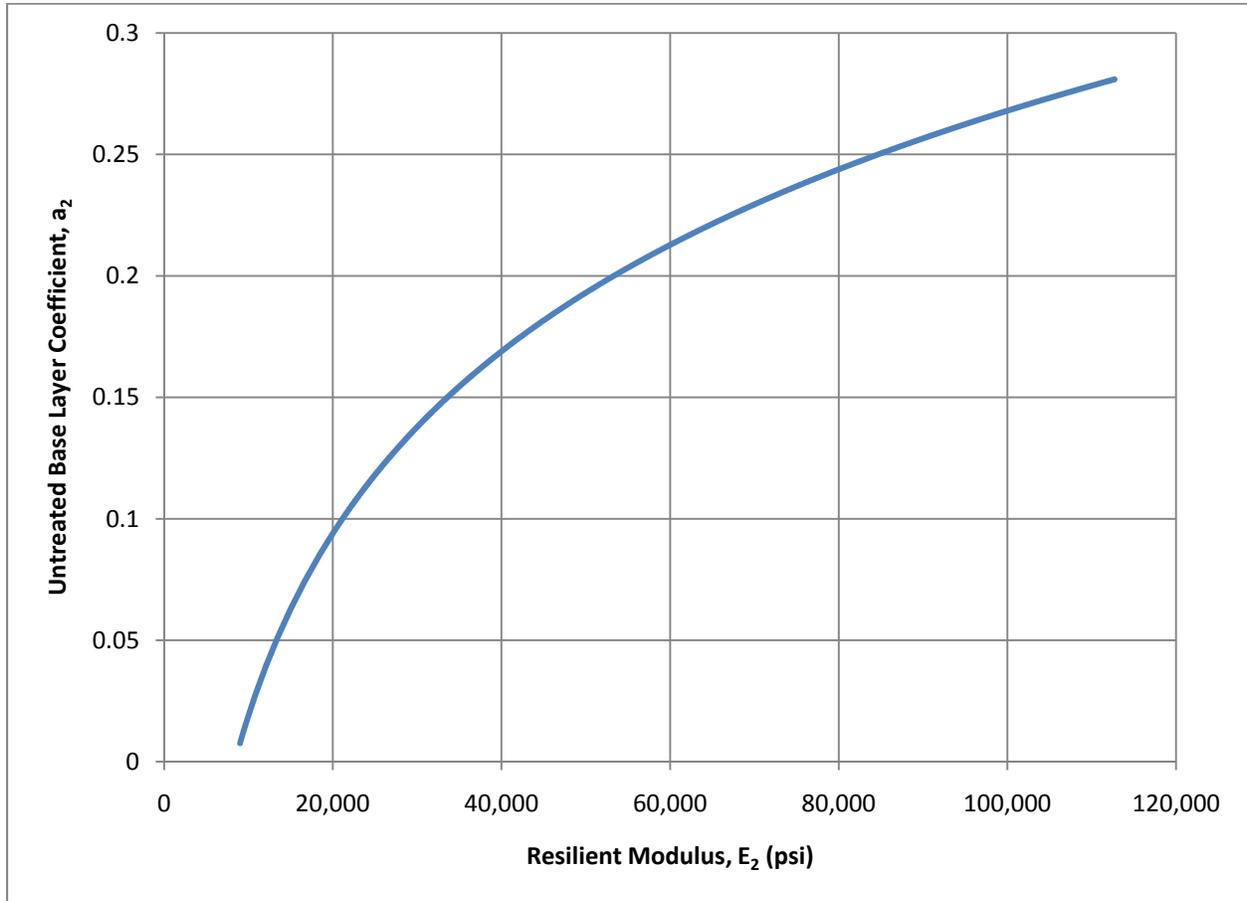
Figure 8. Relationship between structural layer coefficient and resilient modulus for untreated base.

This relationship is plotted in Figure 8. Current WisDOT design practices stipulate an  $a_2$  value of 0.20 to 0.24 for rubblized pavements, which correlates with a modulus of approximately 55 to 80 ksi. The layer coefficient specified for crushed stone is 0.14; this correlates with  $E_2$  equal to approximately 30 ksi.

Concern has been expressed by Wisconsin pavement designers that the current layer coefficients used for rubblized pavement design are high; this results in thin HMA pavement design, leading to premature distress. This study did not find HMA pavement thickness to be a direct cause of rubblized pavement failure, and therefore current layer coefficient values can be assumed to be valid. However, it would be worthwhile to use actual field testing of Wisconsin's rubblized pavements to further refine the rubblized layer coefficient used for pavement design.
