# **Final Report**

## **Non-Destructive Bridge Testing With Advanced Micro-II Digital AE system**

### BRIDGE ON COAST GUARD BOULEVARD

The test bridge (Virginia Structure # 1809, Federal Structure ID # 21212), located on Route 164, falls on the stretch between the Cedar Lane and the Norfolk Road. The bridge was built in 1991. It was originally planned to cross over the Coast Guard Boulevard. Due to change in plans it currently crosses over the W. Norfolk Road and N&W R/R.

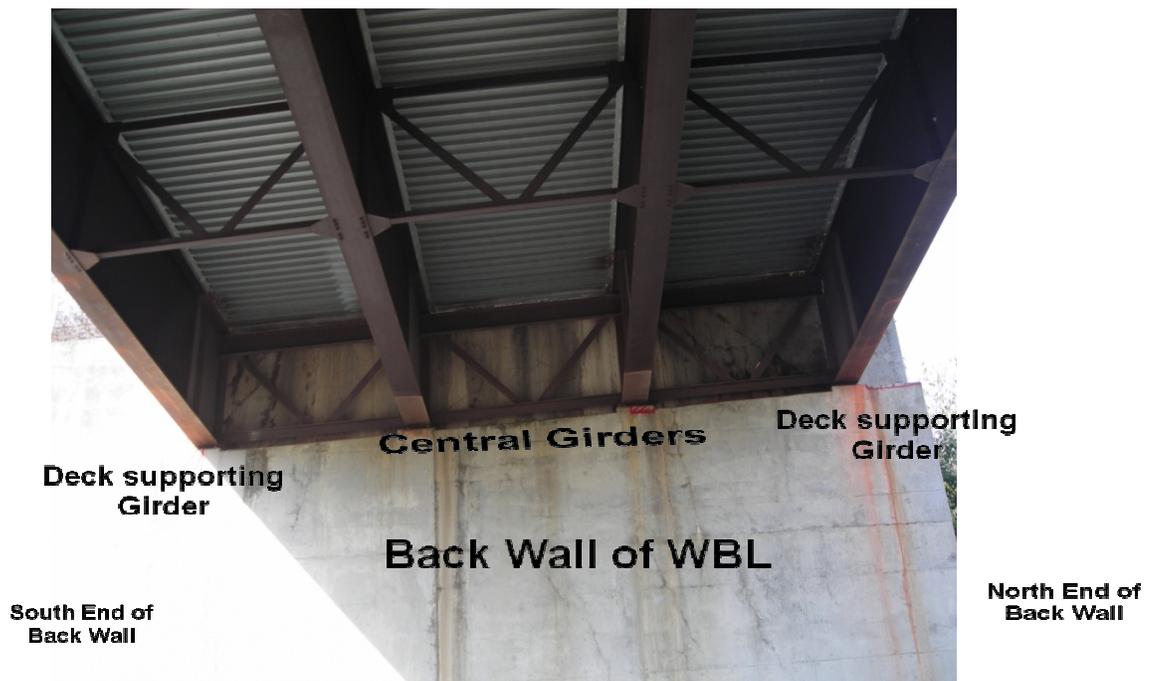
Figure 2. The West Bound Lane (WBL) supported by 4 steel girders

The WBL on the bridge is supported by 2 central steel girders and 2 deck supporting steel girders, as shown in Figure 2. The west ends of the steel girders are anchored to the concrete back wall (Figure 2). Because of the high truck volume on the bridge and a heavy freight transport by trains that run under the bridge, the concrete back wall is expected to be under high stress not only because of the traffic volumes on the bridge but also due to traffic that runs on the rail tracks (Figure 3). It was, therefore, decided to investigate the back wall using the NDE technique of Acoustic Emission (AE) in consultation with VDOT/VCTIR.

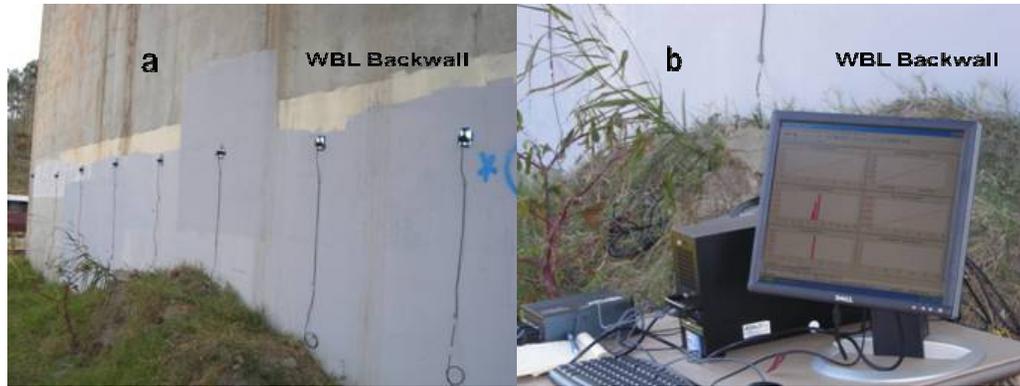
In Table 1, the vertical locations from the ground are 7.00 feet. The installed sensors are shown in Figure 4 (a). The data was recorded using the Micro-II Digital DAQ system of Figure 4(b).

Figure 4. (a) 8 AE sensors installed on the WBL back wall at locations given in Table 1; and (b) The micro-II Digital AE DAQ system acquiring data

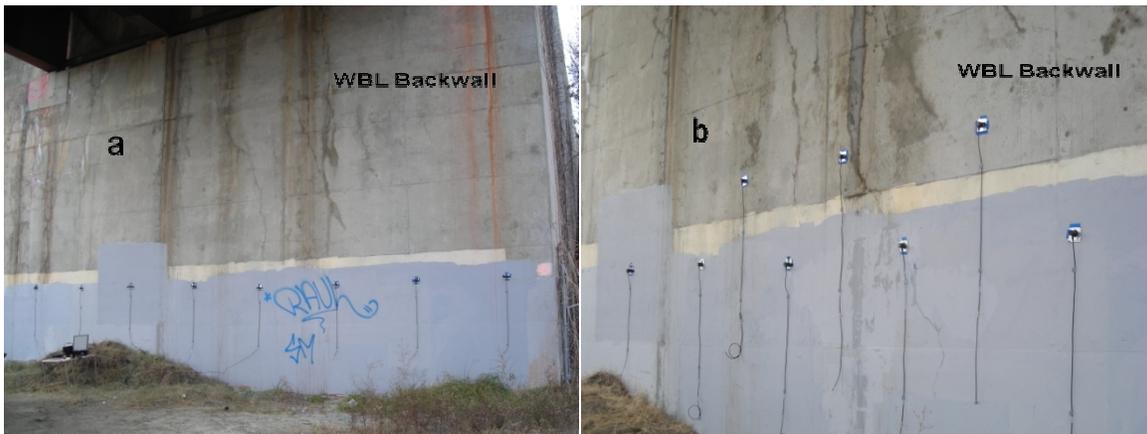
Figure 8: The AE sensors relocated to cover: (a) the entire width of the back wall; and (b) the most active areas

Figure 8 (a) shows installations of the relocated sensors (see Table 2 for locations) to cover the wall area between 16 feet – 51 feet. Considering the width of the back wall of the bridge as 54.5 feet, this relocation covers the entire width of the wall at 7.75 feet from the ground. The responses from sensors 5-8 in this configuration acquired on December 22, 2010 are demonstrated in Figure 9 in the absence of any freight movement under the bridge. However, when the freight train arrived on the same day, the data showed a significant change in AE activity shown in Figure 10. Figure 9 shows responses from sensors 5 – 8 for locations given in Table 2 for the traffic situation in item 1 above where AE events have been plotted against the sensor locations. Figure 10 shows the cluster of events in the wall stretch between sensors 5 - 6 and between 6 -7 are from locations falling around the central steel girders in Figure 2. The situation in Figure 10 corresponds to the condition of item 2 above where there is also the presence of train freight apart from the normal traffic on the bridge. These AE events are resulted from the existing cracks in these regions as well as generation/expansion of new cracks. Comparison of Figures 9 and 10 clearly demonstrates the effect of freight train movement on the AE activity in the wall. The effect is significant as indicated by a large number of recorded hits, specifically in the sensor 6 - 7 stretch and in the vicinity of sensor 7 towards sensor 8.
