Evaluation of Effects of Super-Heavy Loading on the US 41 Bridge Over the White River

EVALUATION OF EFFECTS OF SUPER-HEAVY LOADING ON THE US-41 BRIDGE OVER THE WHITE RIVER

Report Number: FHWA/IN/JTRP-2011/15

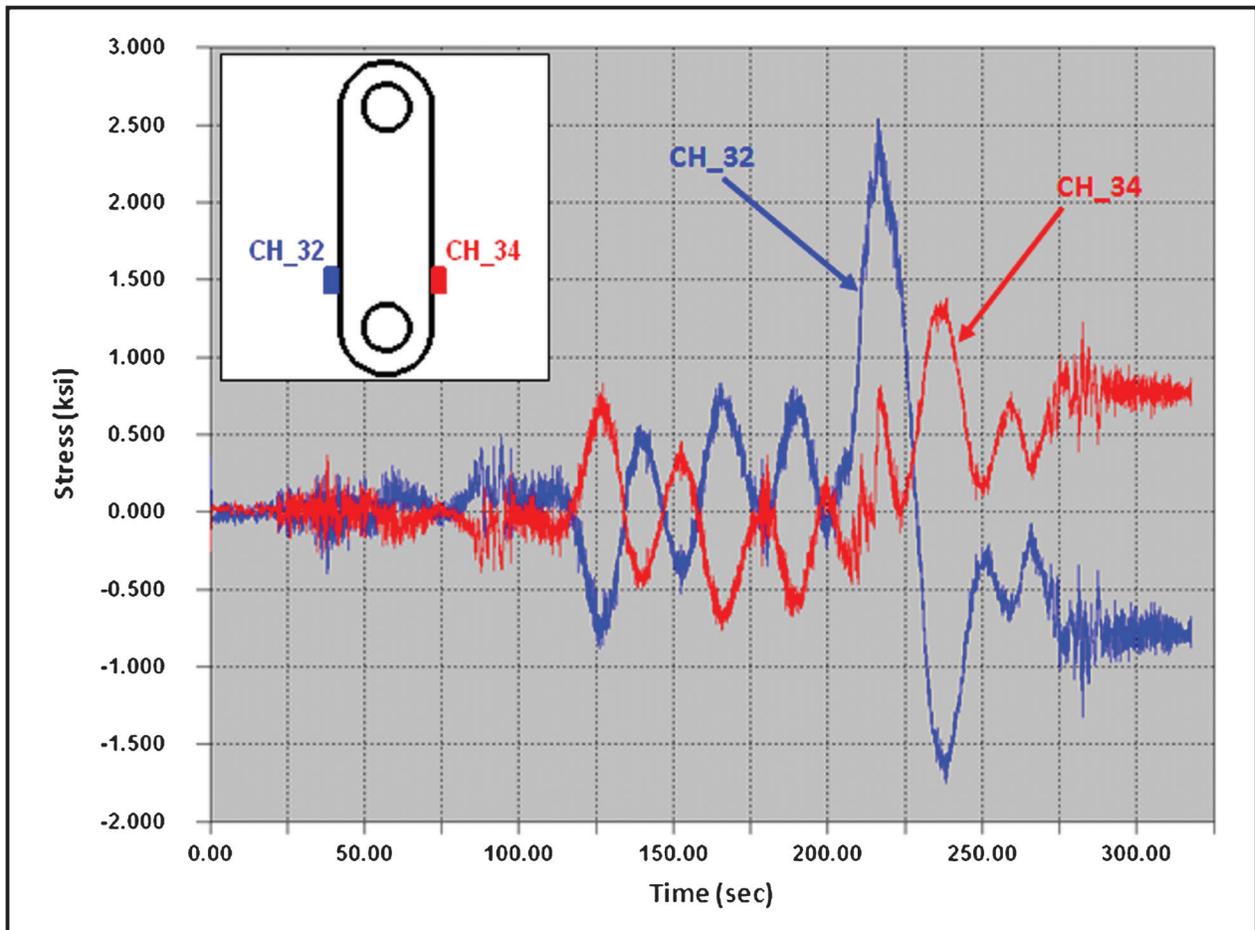
Figure 4.32: Maximum response from side-by-side crawl test at Girder G2 east hanger

The plot indicates that some minor bending is occurring in the hanger. Bending is signified by the opposite response of the strain gages (i.e., one is in tension while the other is compression). This is seen in every span. As discussed above, for a continuous structure a strain gage will alternate between tension and compression as a load moves through successive spans. Such a response is noted at the Girder G2 east hanger for the side-by-side crawl test. The way in which the hanger is bending is as predicted. When the trucks

trucks exit the bridge, a displacement has resulted. A permanent displacement in the pin and hangers would be of concern; however, what is shown in the plot is not permanent. Based on data recorded longer than the above plot, the pin and hanger assemblies exhibit some minor temporary displacement after a heavy loading. Over time the pin and hangers slowly vibrate back to their original position. This behavior is not uncommon with pin and hanger assemblies and, therefore, is of little concern. Based on the data presented above, the Girder G2 east hanger is not moving completely freely because bending is occurring; however, since the hanger does return to its original position there is not a large concern with the functionality of this element.

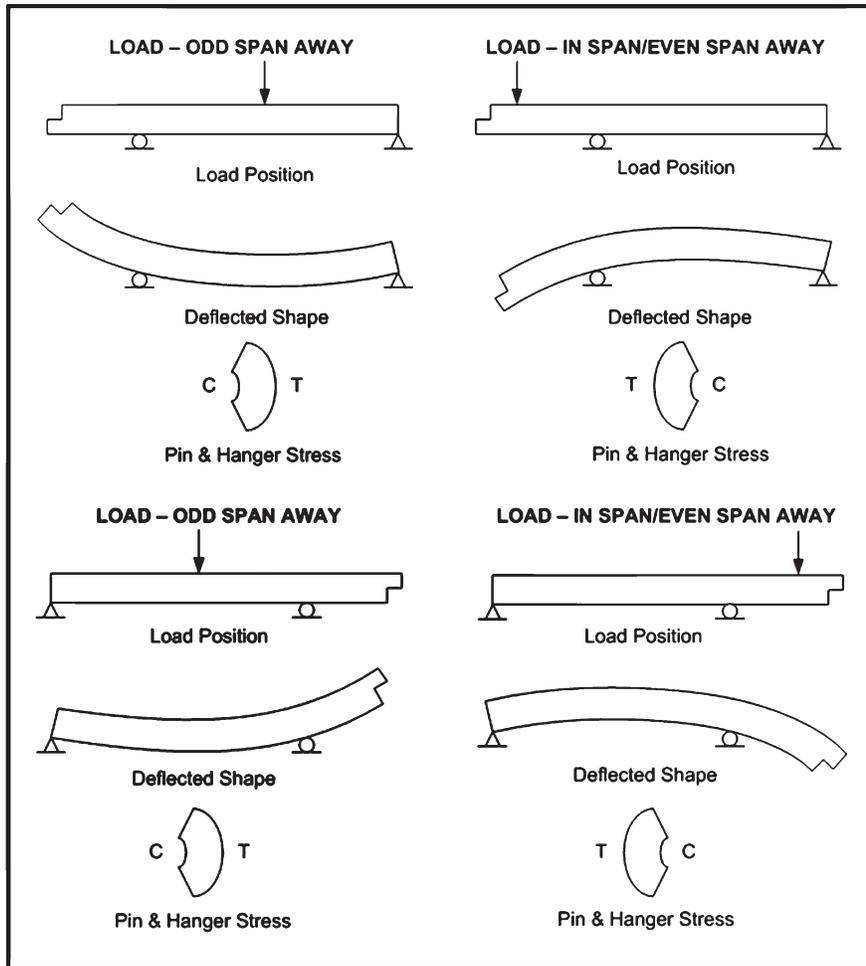
Figure 4.33 is an illustration showing how the pin and hanger is bending as a load moves across the bridge. The sketch illustrates the predominant tension or compression stress induced in the hanger as a result of the deformation caused by the applied truck load. The direction of the bending is related to the resistance provided by the hanger to the relative displacement.

Figure 4.33: Hanger bending

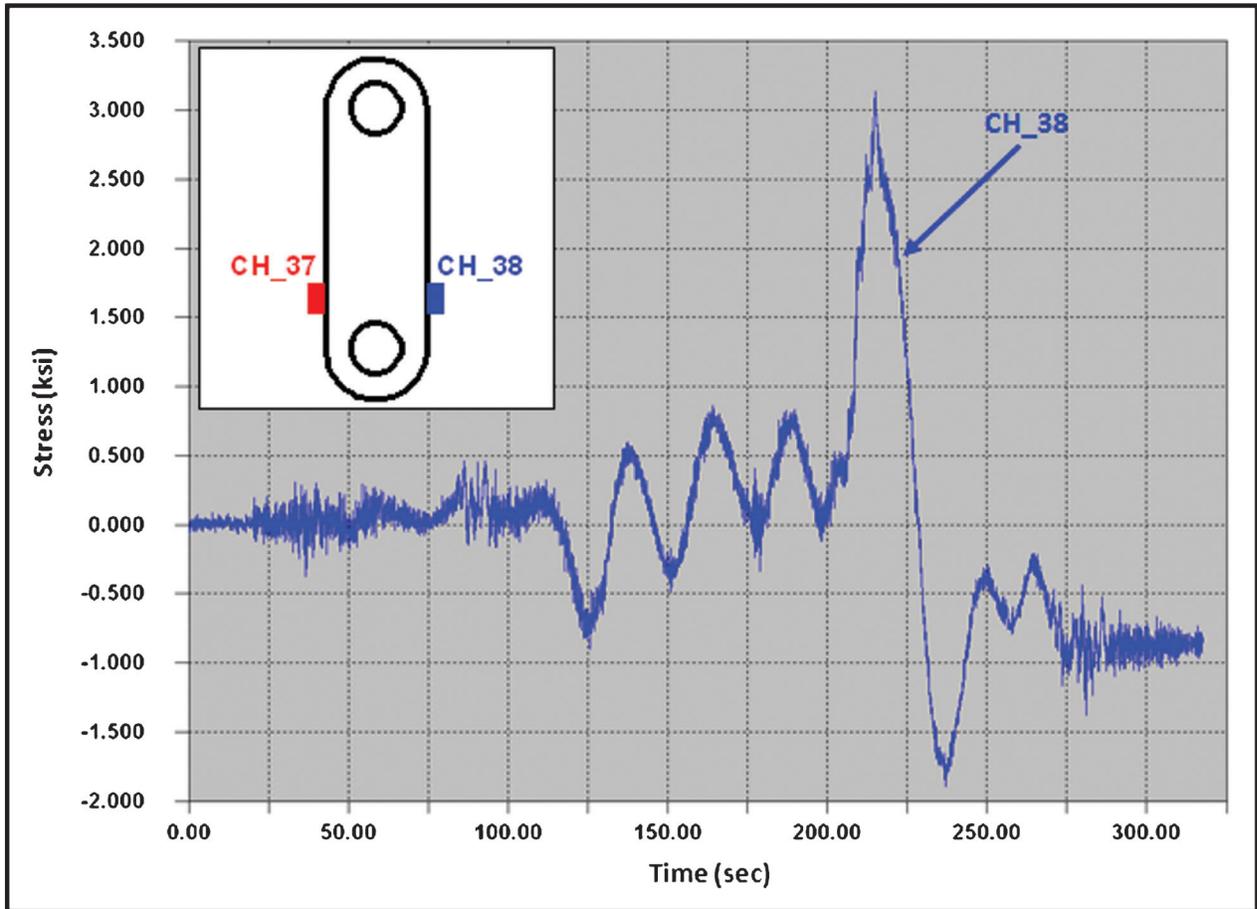
Comparing the plot of CH_38 with the corresponding strain gage on the adjacent hanger, CH_32, similarities are found. Both plots have the same general shape. The hanger experienced bending as the trucks crossed through the adjacent spans. Comparing the two hangers, Girder G2 west hanger has a larger overall response. The maximum tensile stress in Girder G2 west hanger was 0.6 ksi greater than that of Girder G2 east hanger. On the other hand, the compressive response was only 0.1 ksi different. One other notable feature is observed; the stress did not return to zero when the trucks exited the bridge. All three functional strain gages had readings of approximately 0.7 ksi when the trucks exited. It was found that over a period of time the hangers slowly vibrated back to their original position. Thus, the temporary displacement caused by the passage of the trucks was not of great concern. Based on the data presented above, the Girder G2 west hanger is not moving completely freely; however, since the hanger does return to its original position there is not a large concern with the functionality of this element.

Figure 4.34: Response from side-by-side crawl test at Girder G2 west hanger

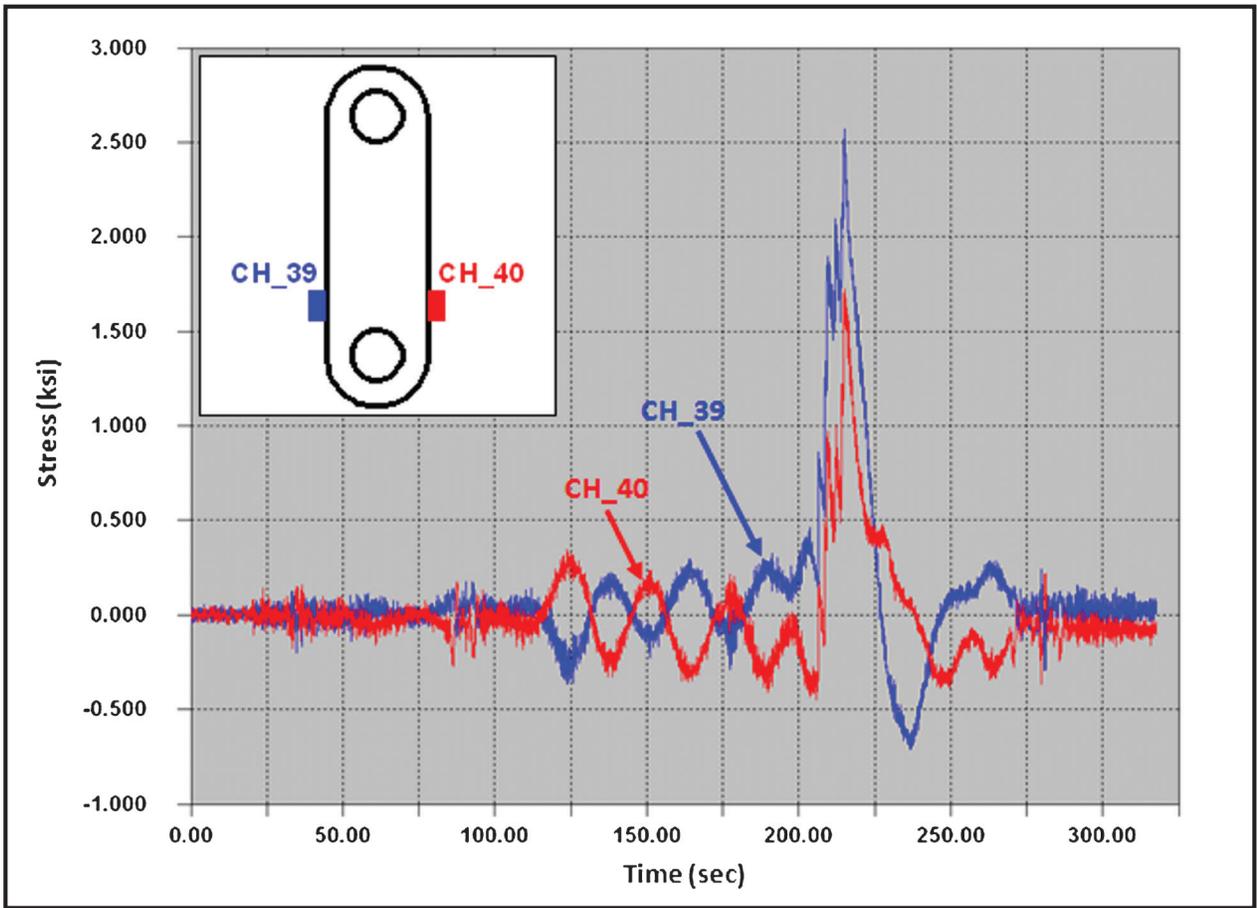
Figure 4.35 Response from side-by-side crawl test at Girder G1 east hanger

did not return perfectly to zero. Based on the data presented above, the Girder G1 east hanger is moving relatively freely and mostly acting as designed.

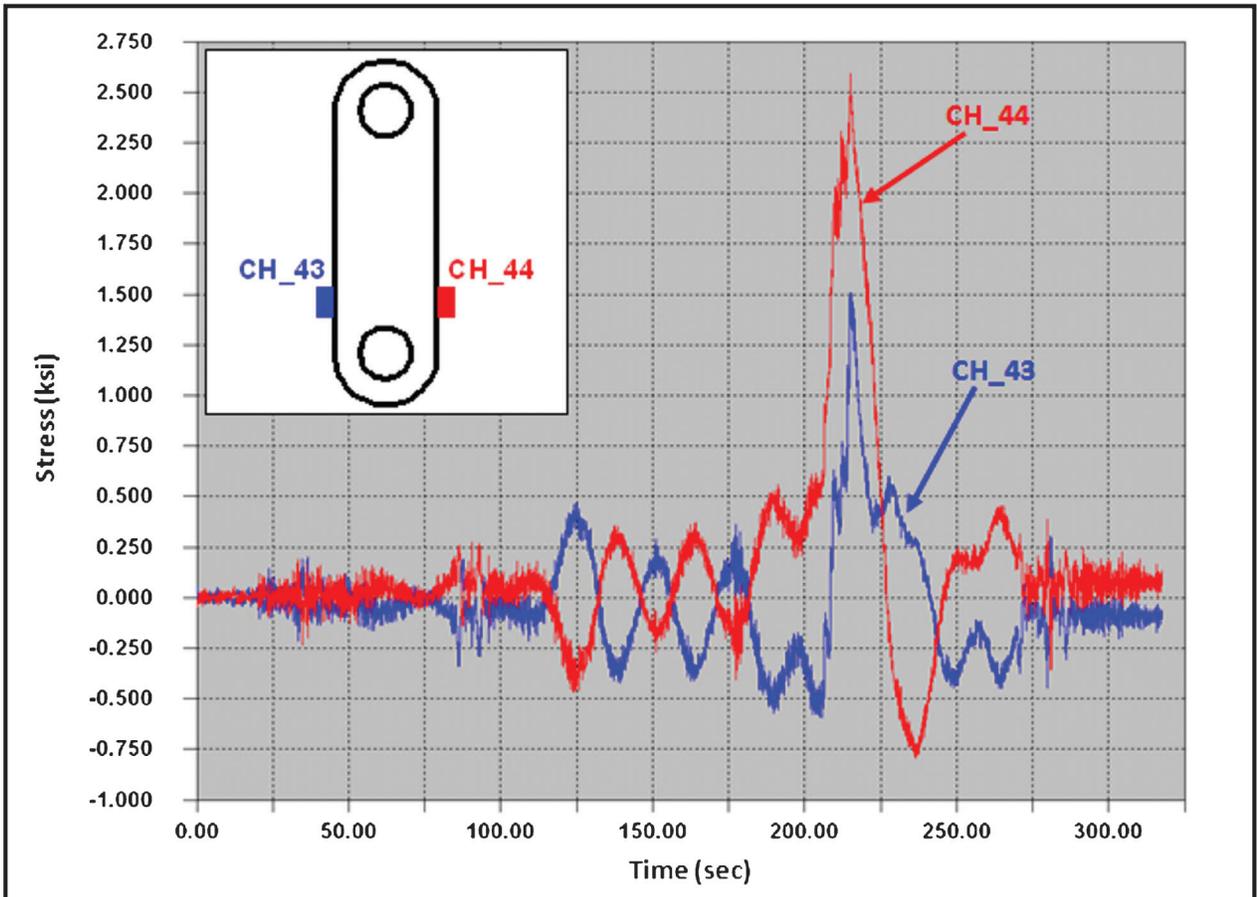
Girder G1 west hanger exhibited some minor bending during the controlled load testing. This is noted by the opposite stress response in the strain gages shown in the plot of the data recorded during the side-by-side crawl test. This response is very similar to that of Girder G1 east hanger. Again, a tensile response was recorded for both hangers as the truck crossed into the hung span. Upon exiting the hung span; however, the response switched back to conflicting stresses. Lastly, the Girder G1 west hanger had some, but very little, final displacement at the end of the event as the stress

Figure 4.36: Response from side-by-side crawl test at Girder G1 west hanger

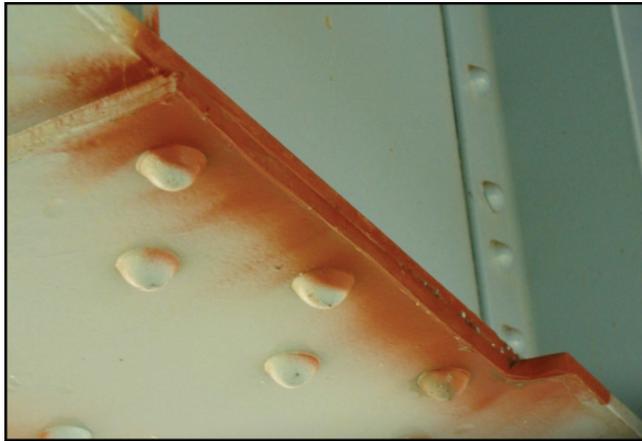
INDOT extracted the samples from the bridge under the direction of the Purdue Research Team. The specimens were taken from areas of low stress (e.g., at the end of a member) with the consideration of the difficulty of removal. To remove each sample, a hole was first drilled at the corner of the specimen. This was done to create a smooth transition to the removed section for improved fatigue resistance. Likewise, after each sample was removed the cut surface was ground smooth to improve the fatigue resistance. Finally, all bare surfaces were painted to reduce the effects of corrosion. Figure 6.2 is an example location where a material specimen was removed from the US-41 White River Bridge. The area in the photo is at a cover plate termination.

Figure 6.2: Example location of removed material sample

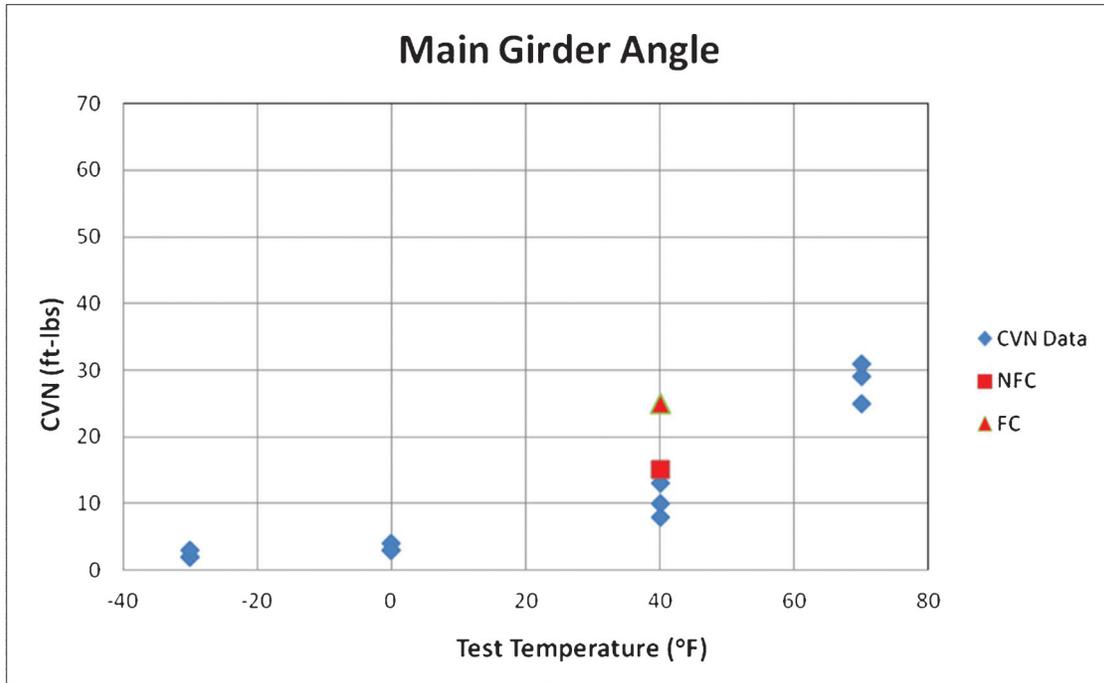
As can be observed in the plots of the test results, the impact toughness for all three elements is extremely poor. The CVN values for the US-41 White River Bridge do not meet the current requirements for a fracture critical bridge. Furthermore, of all nine specimens tested at 40 °F only one of the floor beam specimens exceeded the non-fracture critical requirement. It should be noted that the US-41 White River

Figure 6.4: Main girder angle plot of CVN data

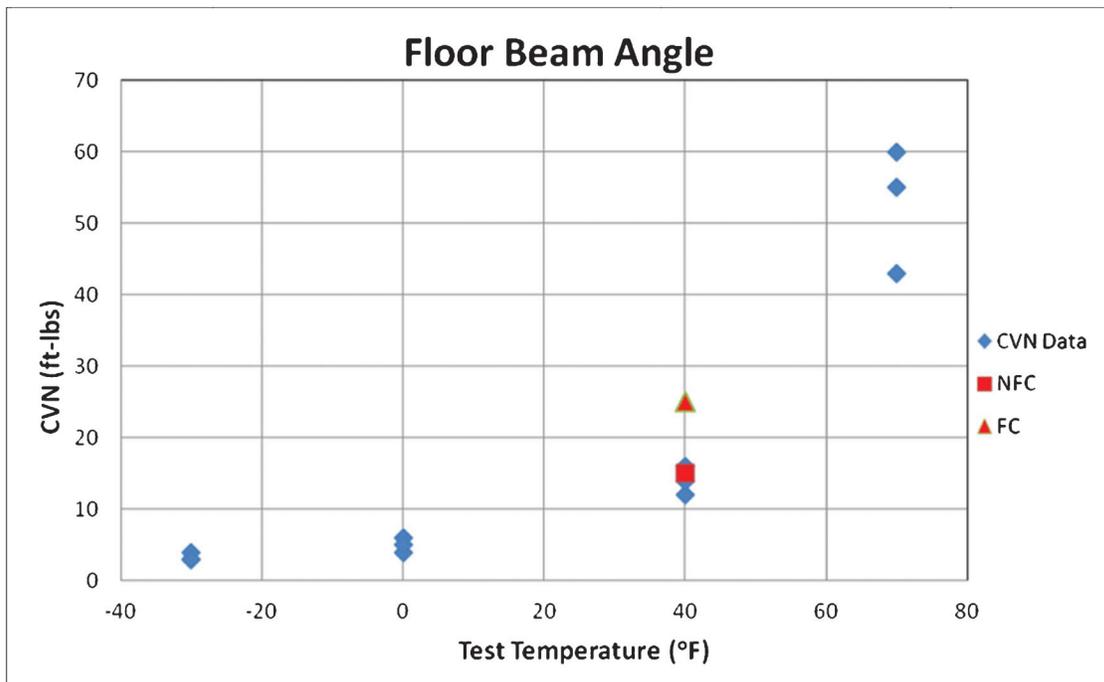
Figure 6.5: Floor beam angle plot of CVN data

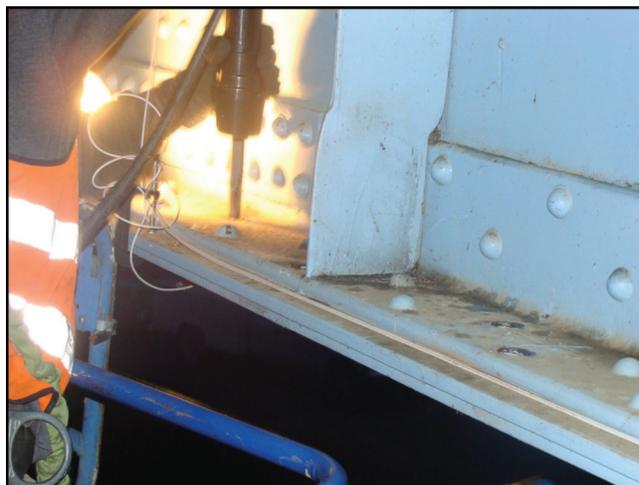
A total of 214 rivets were removed from several spans in the northern half of the northbound and southbound bridge superstructures (exact locations of all rivets removed can be found in the rivet removal plan attached to this report in Appendix B). The rivets were removed by shearing off the top rivet head and then driving the rivet out of the hole with a pneumatic chisel. All 214 rivet holes were inspected both visually and with magnetic particle testing. No cracks or defects were found in any of the 214 inspected holes. Once the inspection was complete and the condition documented the rivet was replaced with a fully pretensioned high-strength bolt. If the area around the rivet hole or the rivet hole itself was damaged at all during the removal process it was properly ground smooth as to not negatively impact the fatigue performance of the member. Lastly, all the new bolts were painted to reduce the potential for corrosion. All rivet removal and inspection work was performed by Wiss, Janney and Elstner, Inc. (WJE) from Northbrook, IL between December 14 and 16, 2009. Photographs taken during the rivet removal and inspection work can be seen in Figure 6.8 through Figure 6.10. (It should be noted

Figure 6.9: Driving the rivet out

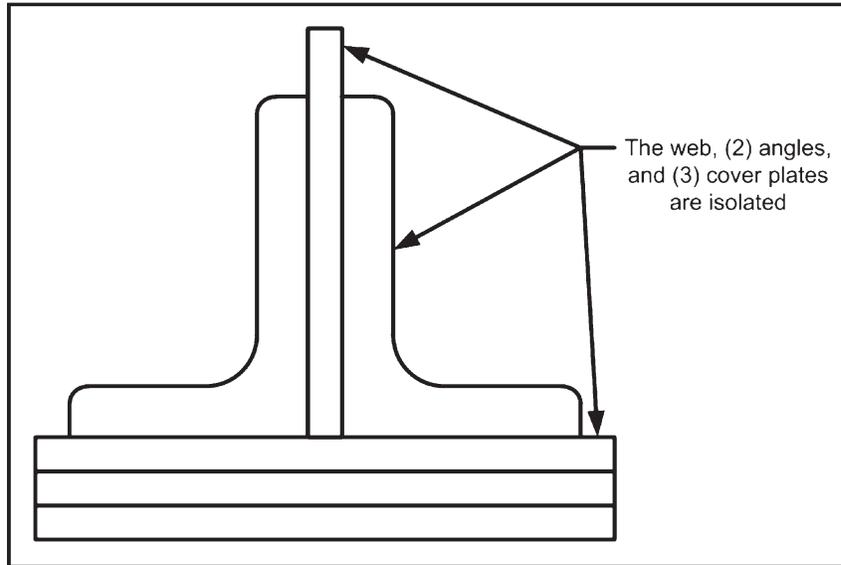
Figure 6.11: Example of redundancy in a built-up member

crack in one element has no direct path into another. This is not the case with welded built-up members in which fractures can propagate directly from a flange into a web (see Figure 6.11). There are many examples found in literature where individual components of riveted members have failed, while the overall integrity of the member was maintained. The redundancy analysis to follow did not attempt to determine the cause of the fracture, it simply assumes a fracture occurred.

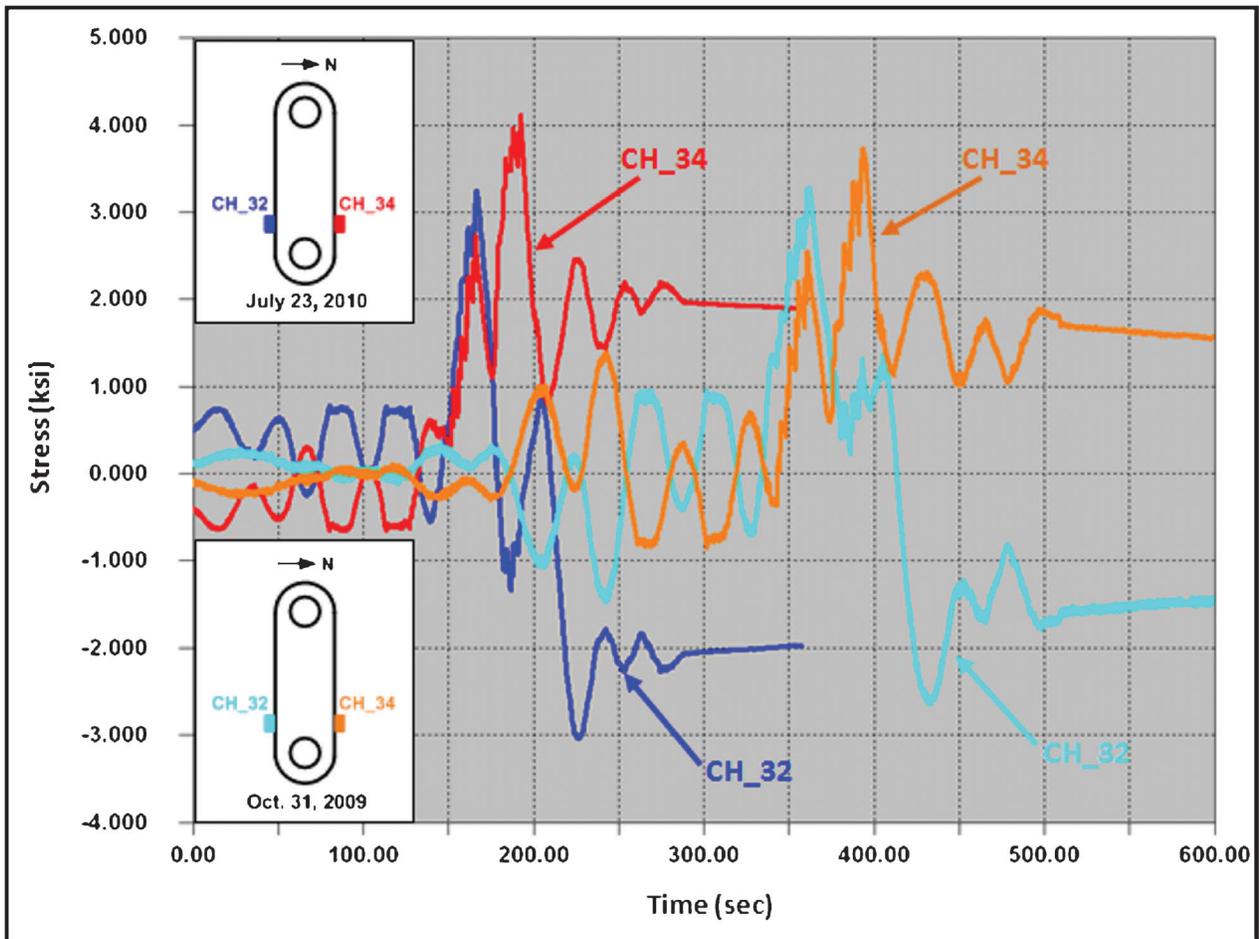
Figure 7.15: Girder G2 east hanger superload comparison

Four of the seven remaining strain gages were installed on Girder G2 east hanger. This specific hanger was the most heavily instrumented of all the hangers. During the controlled load testing some minor bending was observed when looking at CH_32 and CH_34. Thus, the data measured during the October 31, 2009 and July 23, 2010 moves is plotted in Figure 7.15 to evaluate any changes in the behavior of the hanger.

It can be seen that during both the October 31, 2009 move and the July 23, 2010 move bending occurs. This is signified by the alternating stresses as the load moves through successive spans. As can be seen in the plot, neither one of the moves clearly demonstrates more bending than the other. Additionally, the maximum responses, both tensile and compressive, are less than 0.5 ksi different between moves. However, one difference worth noting is the temporary displacement. The July 23, 2010 crossing has a greater remaining stress than the October 31, 2009 crossing. Approximately an additional 0.5 ksi remained after the superload exited the bridge. The remaining stress signifies some sort of displacement has occurred. From data collected over longer monitoring periods, it was observed that the pin and hangers vibrate back to their original position (i.e., zero stress) over time. Nevertheless, the remaining stress indicates that the pin and hanger movement is restricted to some degree.

2009 and July 23, 2010 moves, it is the belief of the Research Team that the pin and hangers sustained no noticeable negative long-term effects from the passage of the multiple super-heavy loads. However, it is suggested that all pin and hangers should be lubricated to allow them to move more freely. This in turn should help reduce the bi-axial bending measured during long-term monitoring.

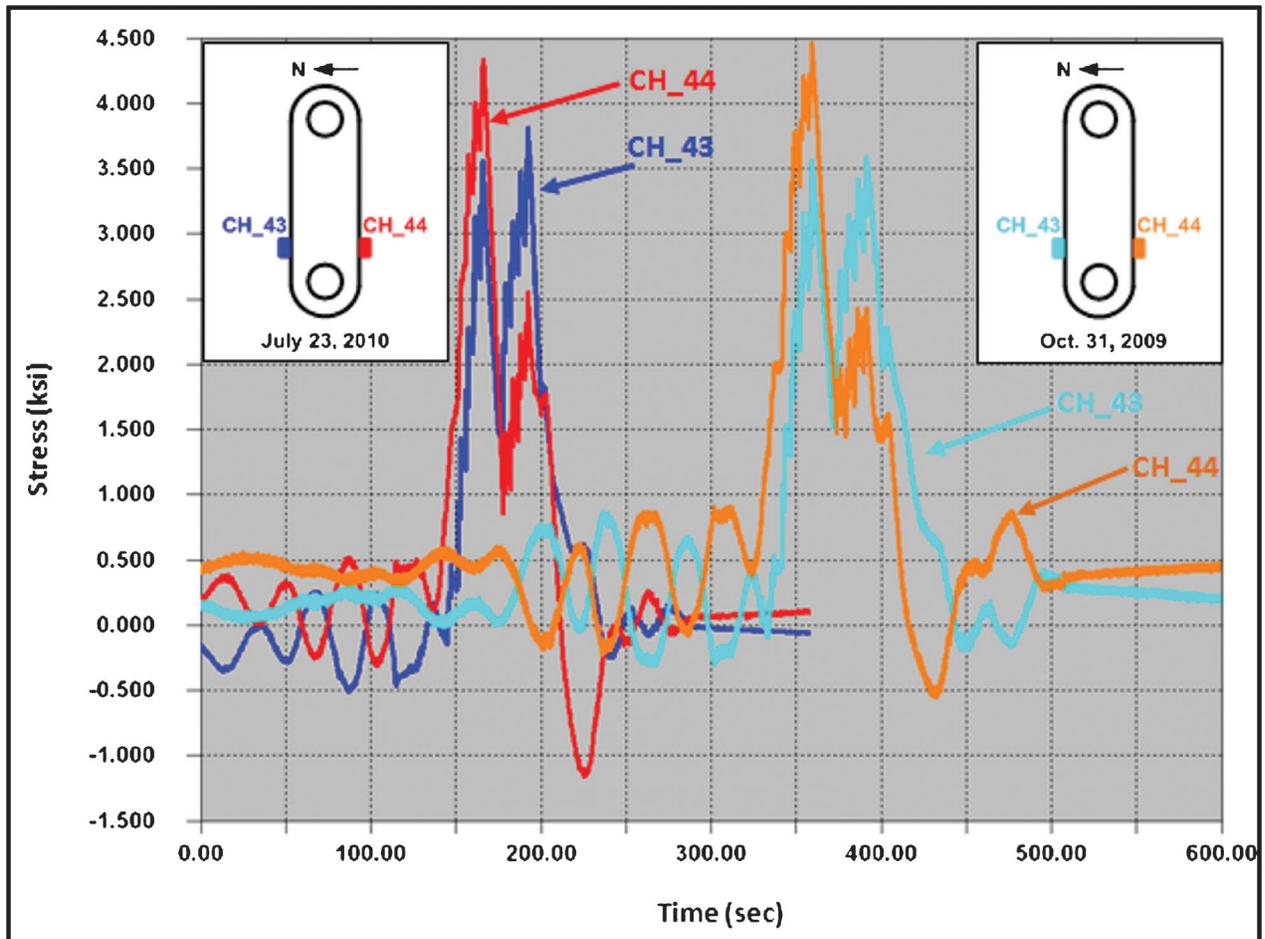
Figure 7.16: Girder G1 west hanger superload comparison

Less bending was measured in the Girder G1 west hanger than Girder G2 east hanger for both superload passages. This was also the case during the controlled load testing. A plot of CH_43 and CH_44 for the October 31, 2009 and July 23, 2010 moves can be found in Figure 7.16. As can be seen in the plot, neither one of

the crossings clearly exhibits more bending than the other. However, the July 23, 2010 stress ranges are greater than the October 31, 2009 stress ranges by approximately 0.5 ksi. Such a minor difference is of little concern; especially, considering all the data presented above shows the later move producing larger stresses.

A final observation taken from Figure 7.16 is the stress remaining in the hangers after the superloads have exited the bridge. Less than 0.25 ksi remains in the Girder G1 west hanger after both moves. It should be noted that when looking at the CH_44 plot of the October 31, 2009 haul (orange trace) has a stress of 0.5 ksi; however, this trace as well as CH_43 from the same event (teal trace) should be shifted downward and centered at zero. Regardless, the amount of stress remaining in the Girder G1 west hanger after the passage is over 1.0 ksi less than Girder G2 east hanger. This indicates that the Girder G1 west hanger is moving much more freely than the Girder G2 east hanger.

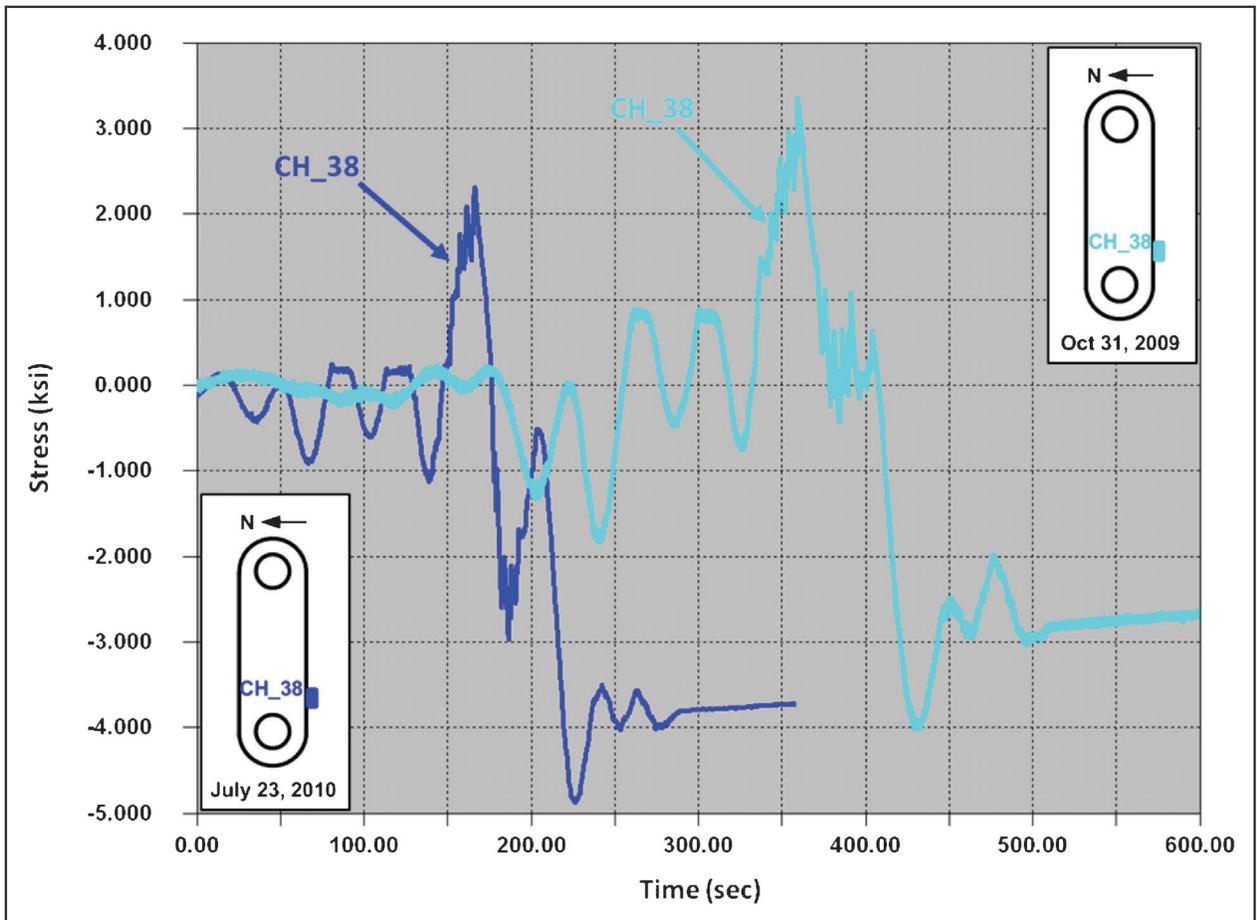
Figure 7.17: Girder G2 west hanger superload comparison

Conversely, a stress of approximately 3.7 ksi remained after the July 23, 2010 crossing. Figure 7.17 plots the measurements taken during each event. The remaining stress indicates that this pin and hanger is experiencing resistance to movement. Unfortunately, the opposite strain gage to CH_38 (CH_37) was not included in the long-term monitoring. Thus, it is difficult to determine the amount of bending that occurred during both crossings. However, based on the cycling stress, the hanger experienced some amount of bending during the hauls. One other interesting point to note is that CH_38 had the greatest stress range of all pin and hanger strain gages included in the long-term monitoring.

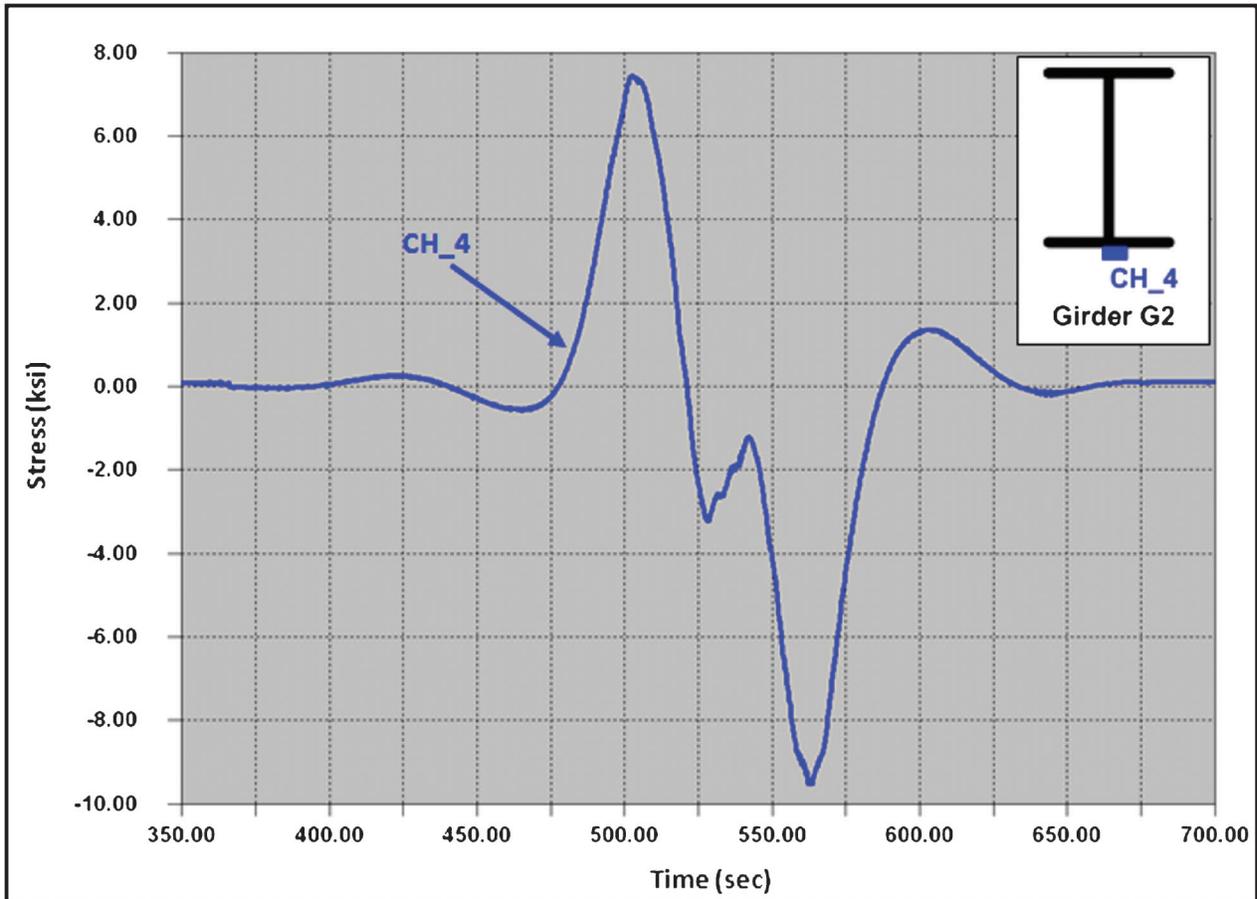
Figure 7.18: Response from heaviest superload at dead load inflection point

Figure 7.18 is a plot of the response from CH_4 at the inflection point strain gage location as the heaviest superload crossed the US-41 White River Bridge. As can be seen in the figure, the general response is typical for this location; however, the magnitude of the response is larger than normal. A large tensile response is first measured, followed by a large compressive response. Similar behavior was observed at this location during the controlled load testing and during both superloads used in the comparison.

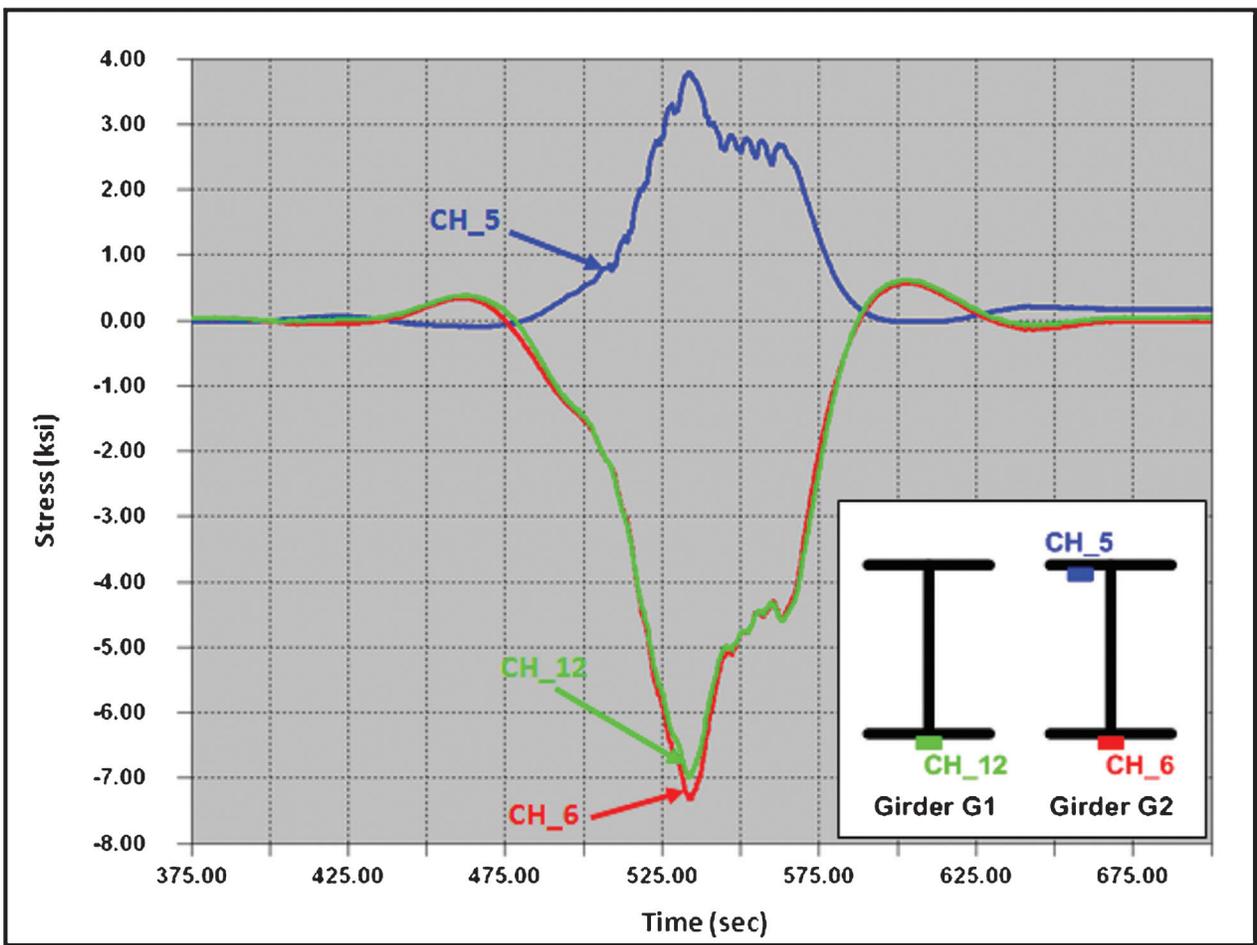
Figure 7.19: Response from heaviest superload at Pier 13

The Pier 13 strain gage location is an excellent one to examine when evaluating the effects of a given loading. This location has strain gages installed on both main girders; thus, the load distribution between the two girders can be examined. Additionally, Girder G2 has strain gages on both the top and bottom flanges; therefore, the effects of composite action can be analyzed. The Pier 13 strain gage location is the only main girder strain gage location with both the top and bottom flange stresses recorded for the long-term monitoring. This location was selected to have both strain gages recorded because if composite action was to be lost it would most likely to be here where the concrete would be put into tension. Figure 7.19 is a plot of the response from the three main girder strain gages to the heaviest superload.

The first thing observed in the figure is the nearly identical responses of the two bottom flange strain gages (CH_6 and CH_12). Both of these strain gages have a tensile response of approximately 0.6 ksi before and after the primary compressive response. The compressive response of both strain gages is very similar as well. A difference of only 0.3 ksi is measured (-7.3 for CH_6 and -7.0 for CH_12). Similar results

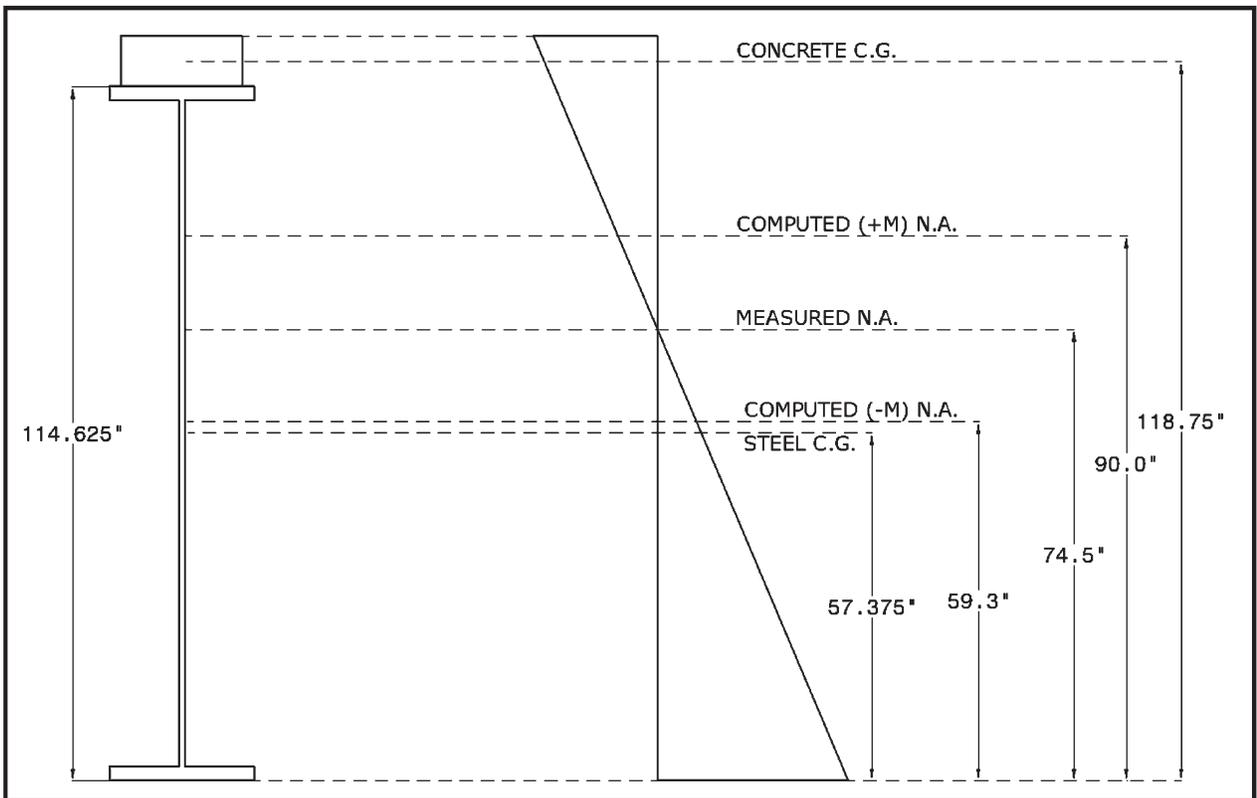
Figure 7.20: Neutral axis comparison for the heaviest superload at Pier 13 Girder G2

There also appears to be a downward shift in the measured neutral axis during the heaviest superload. The shift is noted when comparing Figure 7.20 of the heaviest superload to Figure 4.10 of the controlled load testing. Regardless, full composite action is still

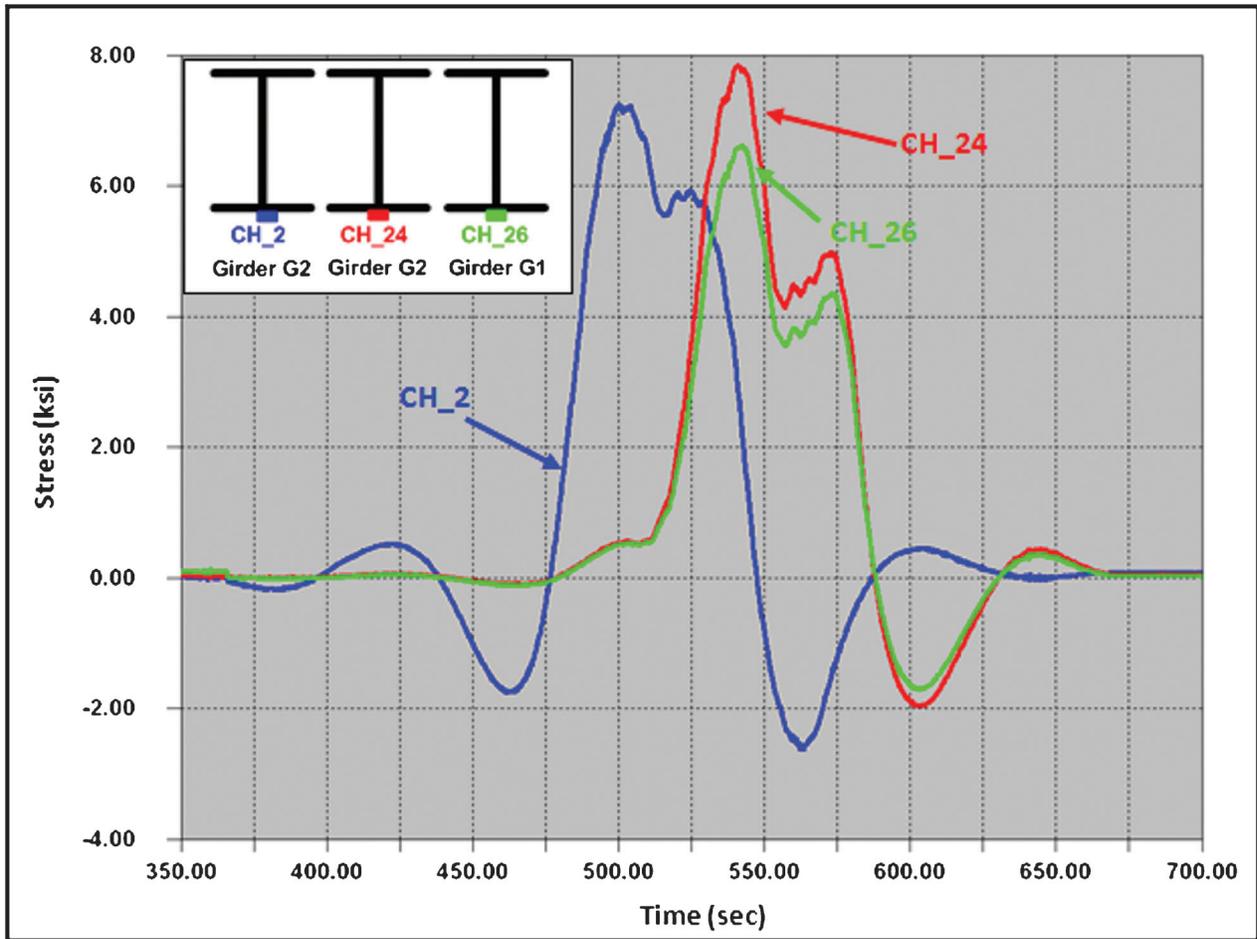
Figure 7.21: Response from heaviest superload at positive moment locations

and Girder G1, respectively. Figure 7.21 is a plot of the response of CH_2 (blue trace), CH_24 (red trace), and CH_26 (green trace) during the heaviest superload. As expected, the general response of all three strain gages was very similar. This response was also similar to the response measured during the side-by-side crawl controlled load test with one exception. Due to the length of the superload, there are two peaks in the stress of the superload data. Conversely, the controlled load test only had a single peak. Nevertheless, the overall general response of the structure is the same between the two data sets.

Load distribution between the two primary girders can also be evaluated in Figure 7.21. At the midspan of Span P both primary girders are instrumented. Comparing the strain gage measurements at these two locations will give an indication of the load distribution. As can be seen in figure, Girder G2 (CH_24) carries slightly more load than Girder G1 (CH_26). This is signified by the measured stress in each girder. Similar load distribution was observed during the controlled load testing; likely, this is due to the transverse location of the superload. Based on the data, the truck is favoring the east side of the bridge. Thus, as expected, the increased weight of the superload has little effect on the

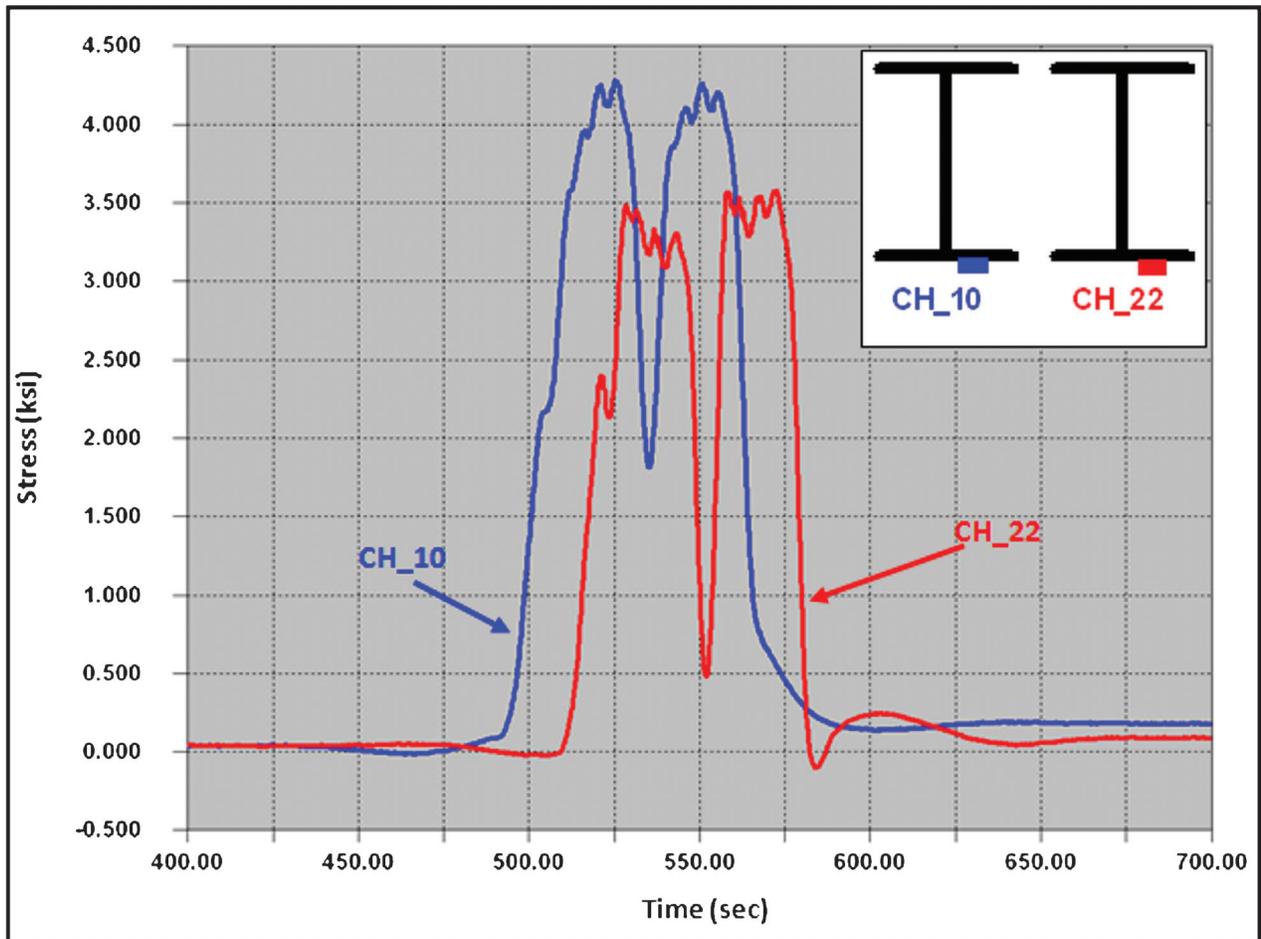
Figure 7.22: Floor beam response to heaviest superload

Two floor beam strain gages remained after the controlled load testing. Both of these were located at the position of maximum positive moment. The maximum and minimum stresses measured from both floor beam strain gages during the heaviest superload were recorded. Additionally, the resulting stress range for each strain gage was tabulated. All of these values can be found in Table 7.6. Also found in the table is a brief description of where these two floor beam strain gages are located. The response of the floor beam strain gages as the truck crossed the US-41 White River Bridge was plotted and can be seen in Figure 7.22.

‘smoother’ having only two defined peaks in stress. On the other hand, Figure 7.22 has multiple smaller stress spikes making up the two large peaks in stress. These smaller stress spikes are the direct result of individual axle lines crossing over the floor beams. Both superloads used for the comparison had similar stress spikes.
