Evaluation of Effects of Super-Heavy Loading on the US 41 Bridge Over the White River

EVALUATION OF EFFECTS OF SUPER-HEAVY LOADING ON THE US-41 BRIDGE OVER THE WHITE RIVER

Report Number: FHWA/IN/JTRP-2011/15

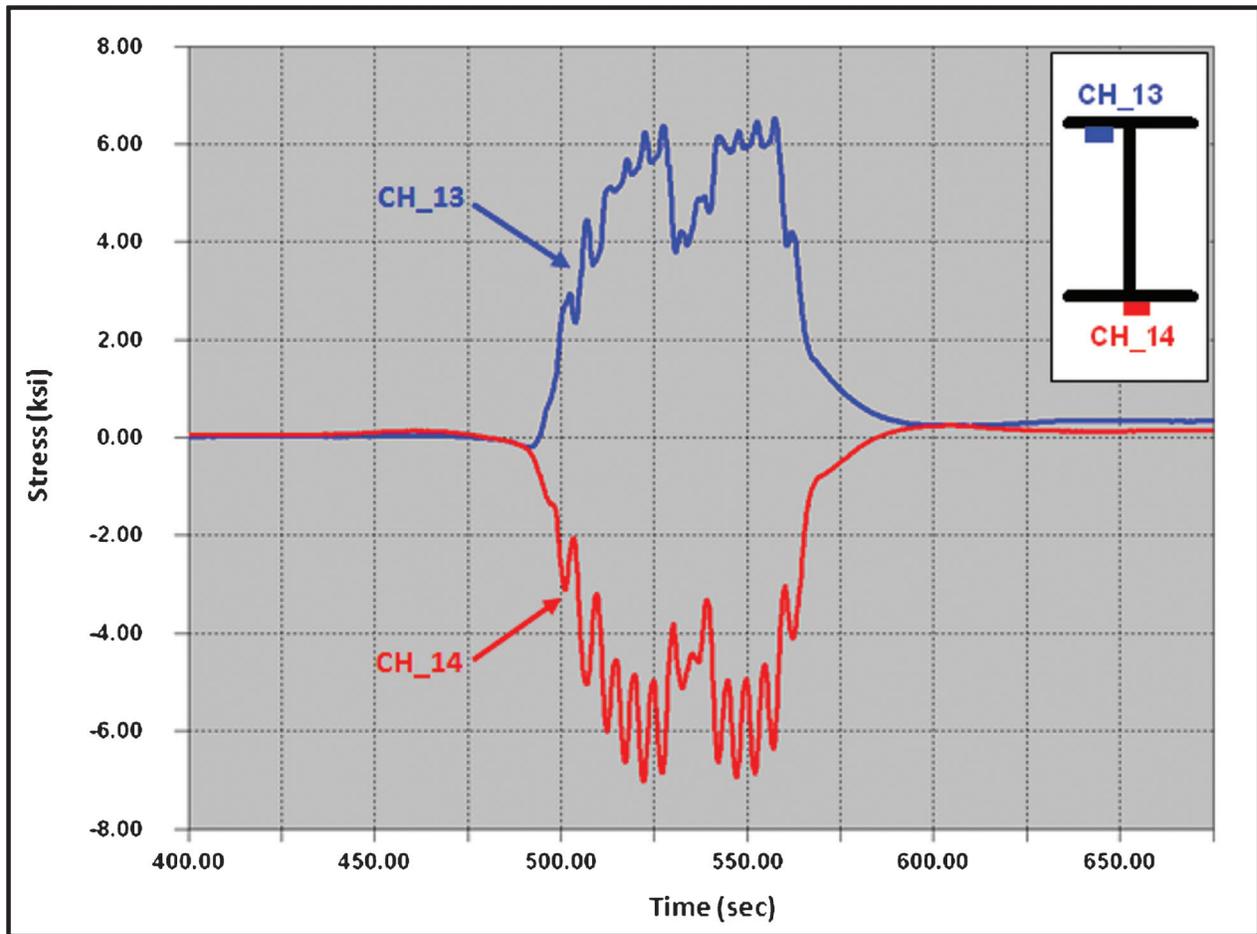
Figure 7.23: Stringer of Pier 13 response to heaviest superload

plot of the CH_13 and CH_14 data during the heaviest superload is presented in Figure 7.23.

Another observation displayed extremely well in Figure 7.23 is the local bending effect as each individual axle crosses over the strain gage location. Since the stringers are in direct contact with the deck, local bending effects are often captured at the stringer strain gage locations. Local bending effects similar to those found in this plot were measured during the controlled load testing and superload comparison as well. Thus, such effects are completely normal for a stringer and were expected during the passage of the heaviest superload.

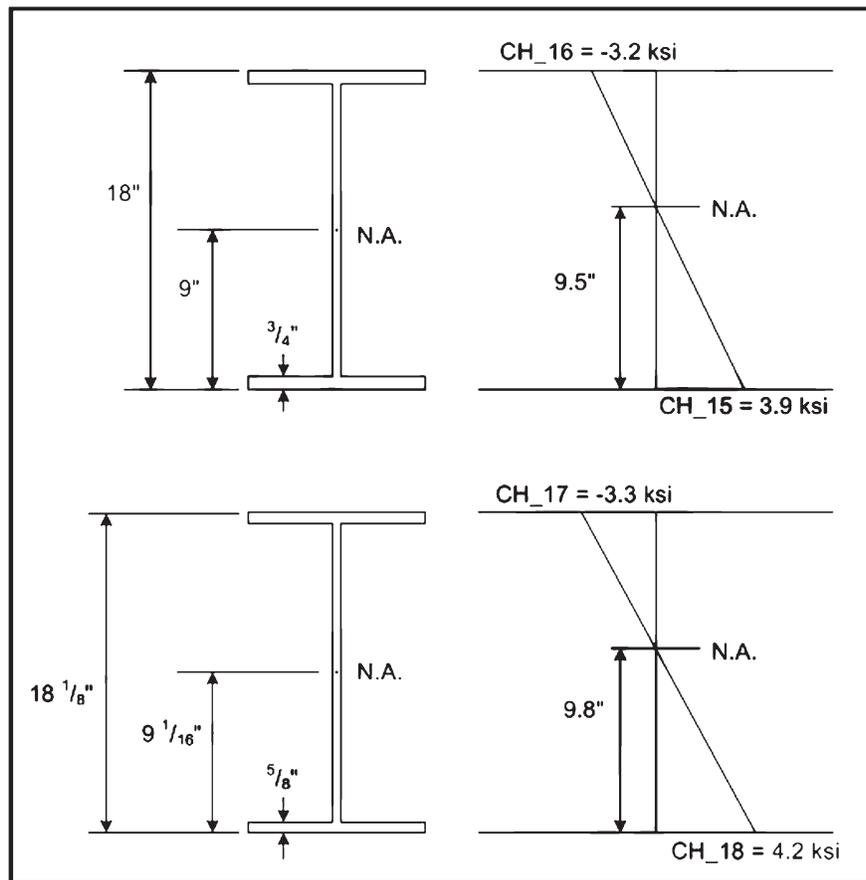
Figure 7.26: Neutral axis for positive moment region stringer locations from heaviest superload

Using the maximum field measured stress values the neutral axis was computed and compared to the neutral axis of the steel section alone. A plot of the resulting values is shown in Figure 7.26. As can be seen in the figure, the neutral axis resulting from the strain gage measurements is slightly greater than the neutral axis of the steel stringer alone. This confirms that some composite action is being developed between the concrete deck and steel stringer. Comparing the locations of the neutral axis from the heaviest superload to those calculated from the controlled load test it is found that more slip has occurred. The additional slip is signified by the lower neutral axis for the superload than the controlled load tests. Thus, as in the case of the controlled load test, some minor composite action is developed between the concrete deck and steel stringers; however, it is not great enough or consistent enough to rely on in the analysis of the bridge.

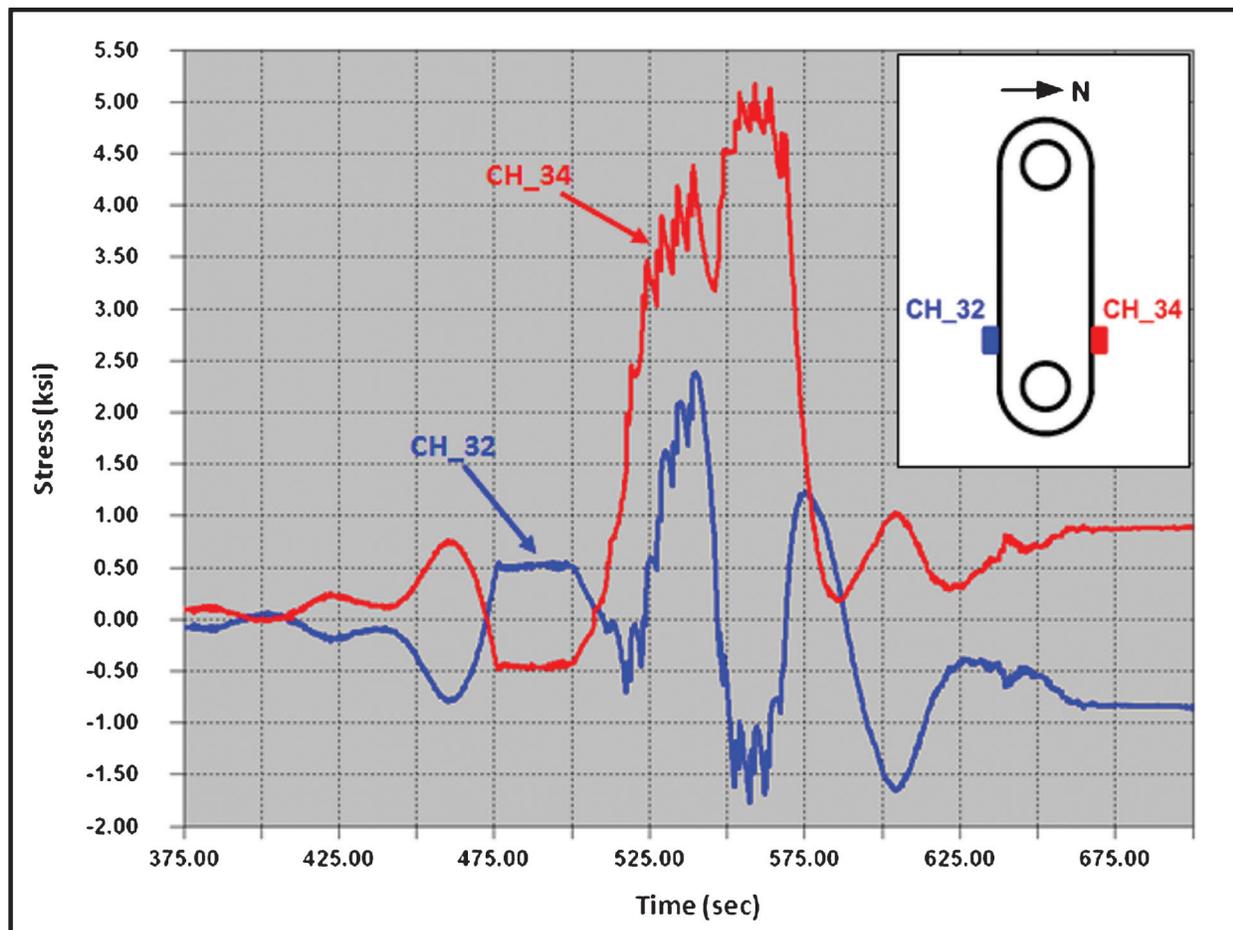
Figure 7.27: Girder G2 east hanger response to heaviest superload

The east hanger on Girder G2 had the most instrumentation of all the hangers monitored. Originally, eight strain gages were installed on this hanger. During the long-term monitoring four strain gages remained. The response of two of these strain gages (CH_32 and CH_34) is plotted in Figure 7.27. CH_32 and CH_34 were used to evaluate any bending that might be occurring in the hangers during the side-by-side controlled load tests and during the superload comparison.

During both the controlled load tests and superload comparison, bi-axial bending regularly occurred as the vehicle(s) crossed through successive spans. Bending was signified by the alternating equal and opposite stresses measured by the strain gages. A similar behavior can be observed in Figure 7.27. It should be noted that the amount of bending occurring in the hanger prior to the load crossing the assembly appears to be less during the side-by-side controlled load tests. This is likely due to the length of the superload spreading the load out over many spans. Thus, the

forces causing bending counteract each other as continuous spans are loaded. Conversely, once the superload crossed the pin and hanger assembly and began exiting the bridge, significantly more bending occurred than did during the side-by-side controlled load test. This increased bending is best noted in Figure 7.27 between 550 and 575 seconds.

The heaviest two superloads crossed the US-41 White River Bridge on May 23, 2010 and June 3, 2010 and had a GVW of 1,117,000 lbs. Fifteen other superloads of nearly one million pounds also crossed the bridge during the construction period. Based on the analyzed long-term monitoring data of all bridge elements, the Purdue Research Team believes that no negative long-term effects were sustained due to the series of super-heavy loads. Nevertheless, as noted earlier, it is recommended that all pin and hanger assemblies be lubricated to help ensure free rotation and minimize bending effects.

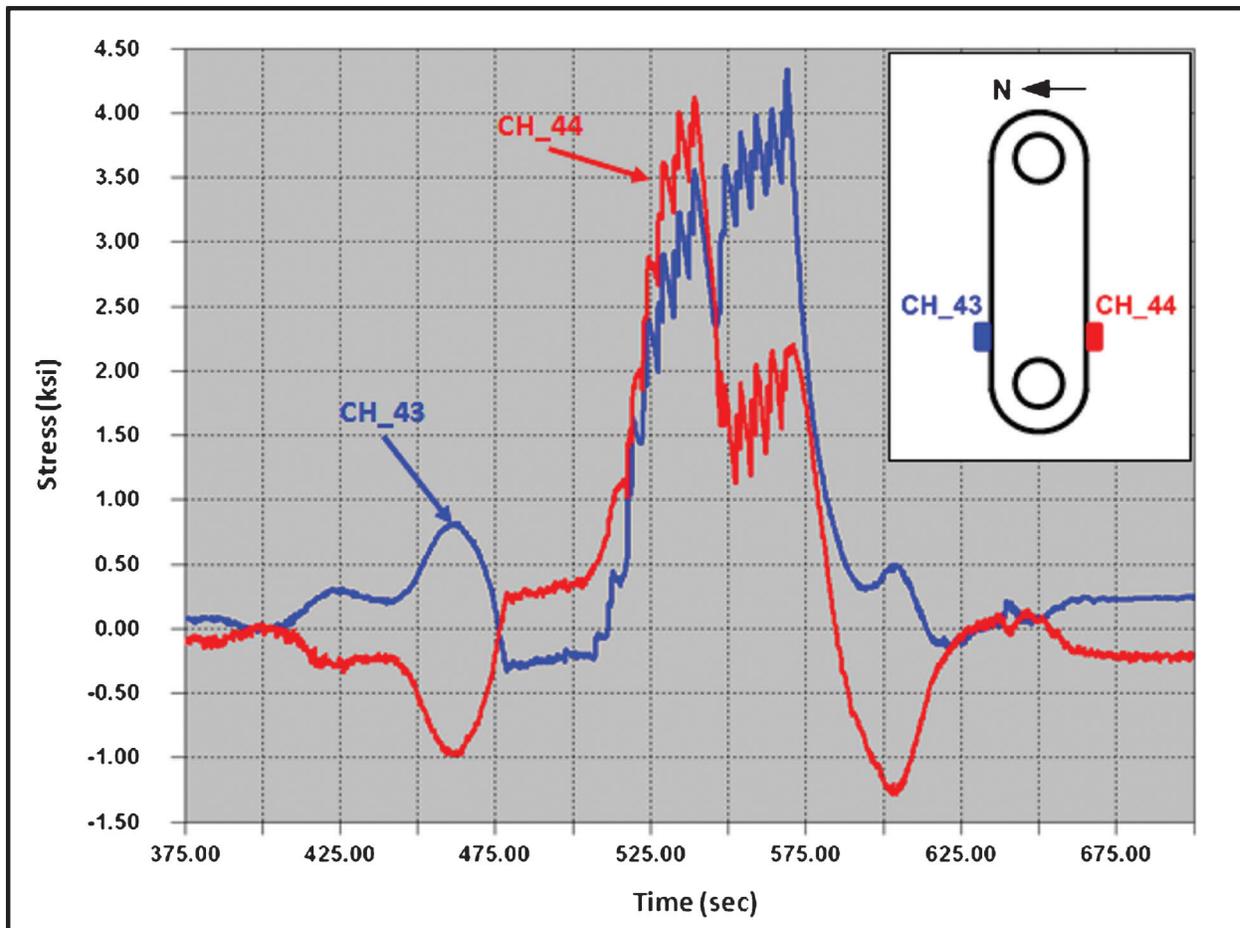
Figure 7.28: Girder G1 west hanger response to heaviest superload

controlled load test to determine if any bi-axial bending was occurring in the hanger. Plotted in Figure 7.28 is the response of CH_43 and CH_44 to the heaviest superload.

Girder G1 west hanger exhibits very minor bending as shown in Figure 7.28. However, like in the case for the controlled load test and superload comparison, much less bending is occurring in this hanger than Girder G2 east hanger. Very minor opposite alternating stresses are observed before and after the superload crosses the pin and hanger assembly. As is typical for a hanger, when the load crossed into the hung span a large tensile response is measured by both strain gages. One final indication that less bending is occurring at this hanger is the amount of stress remaining at the strain gages after the truck has exited the bridge. This stress is an indication of how much temporary displacement remains after the crossing. Less stress suggests that the pin and hangers were moving much more freely; hence, bending less.
