1. Report No. FHWA/TX-12/0-6080-1		2. Government Accession No.		3. Recipient's Catalog No.	
4. Title and Subtitle PERFORMANCE MONITORING PAVEMENTS WITH THERMAL SEGREGATION IN TEXAS				5. Report Date January 2012 Published: April 2012

# **PERFORMANCE MONITORING PAVEMENTS WITH THERMAL SEGREGATION IN TEXAS**

Report 0-6080-1

Project Title: Performance Histories of Thermally Segregated HMA

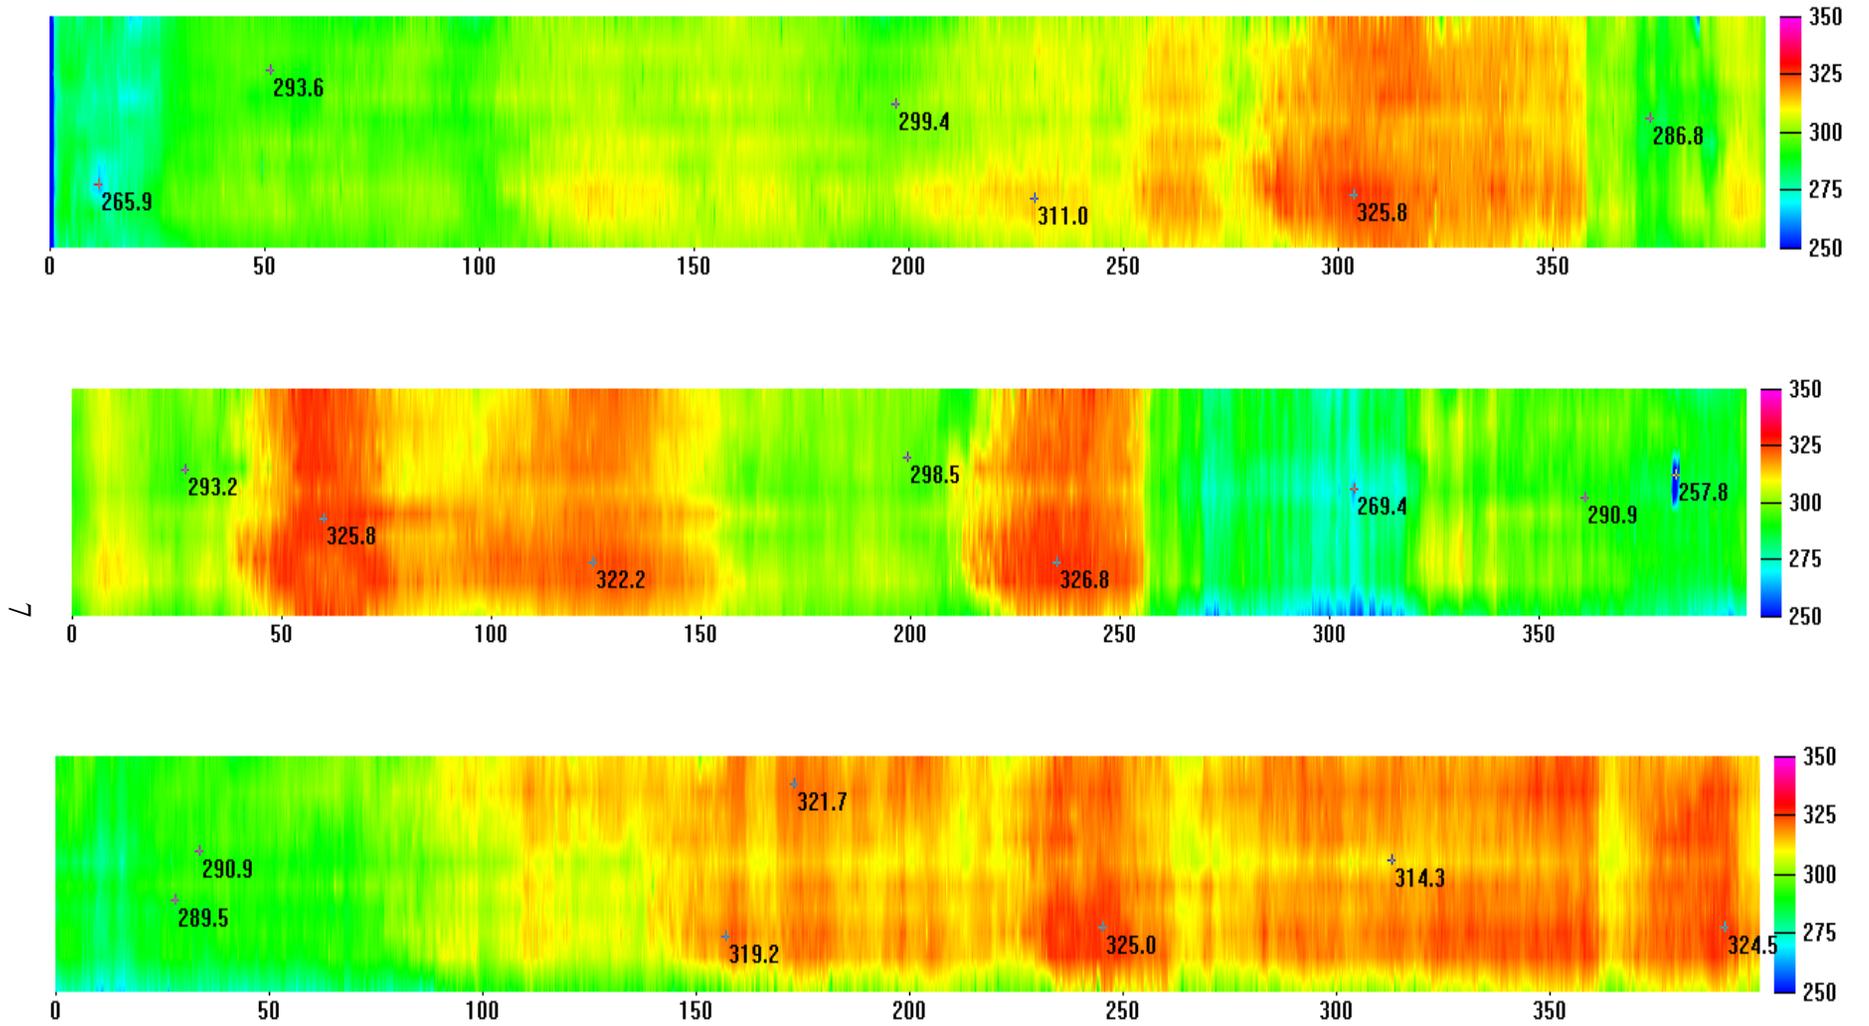
- There is some noticeable variability in temperatures between trucks, but overall temperature uniformity is good. Temperatures across each transverse scan are very uniform, typically ranging less than 15°F from the min. to max. temperature. Recommendations from prior work suggest temperature uniformity should be within 25°F.
- The 257.8°F cold spot at 780 ft (380 ft into middle plot) is not due to segregation, but resulted from cold water spilling onto the mat when a worker got water from a cooler.

Figure 2. Infrared Data on IH 20 Starting at Station 578 -29.

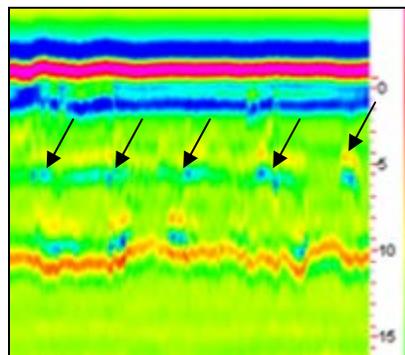
In late 2009, TxDOT reported that this project had some leveling work performed by maintenance forces due to rutting. In 2011, TTI conducted a radar survey over the section; Figure 6 presents an example from these radar data. The data show the surface mix appears good; however, the GPR indicates possible localized problem areas in the subsurface mixture. These areas may be cyclical segregation that could result in distress occurring over time.

**Figure 6. Example GPR on IH 20 after Seven Years of Service.**

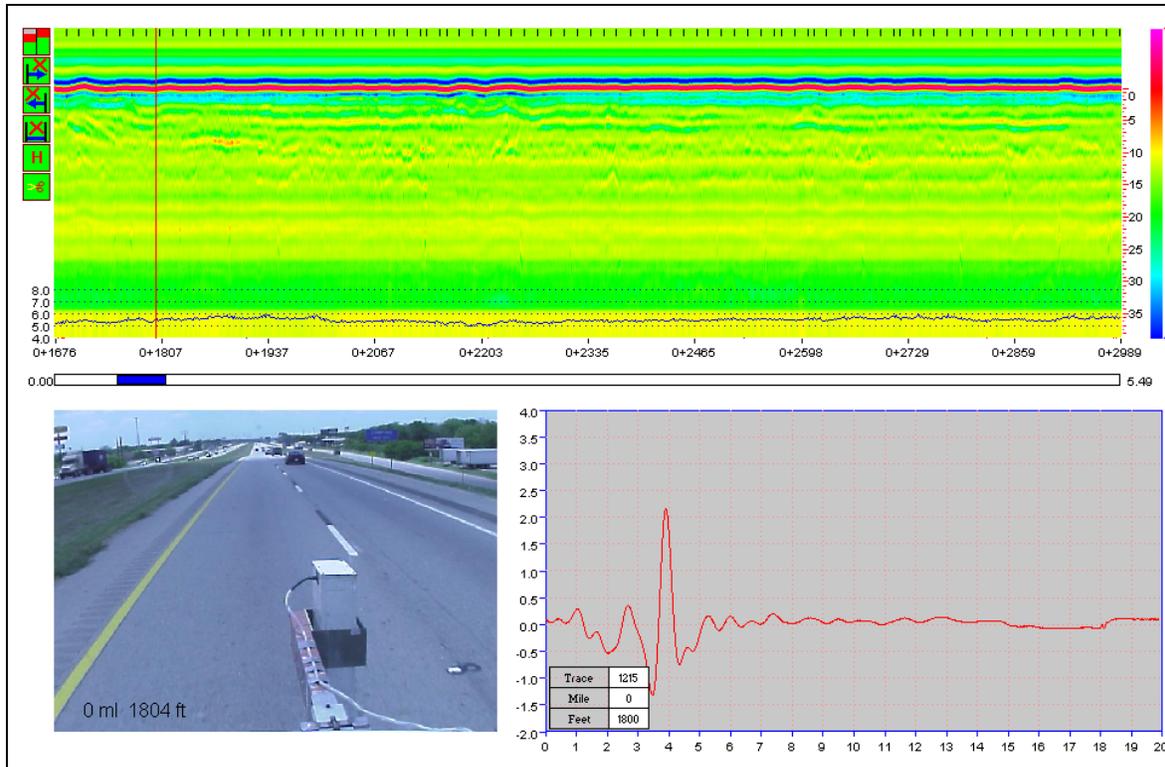
In July 2011, TTI conducted a visual and GPR survey of this project. The only distresses noted were occasional transverse cracks, as Figure 8 illustrates, and occasional longitudinal cracking on the shoulder. The longitudinal cracking was likely due to the subgrade and dry weather pattern that existed at the time of the survey. The GPR survey did not reveal any items of concern, with clean, uniform traces and uniform surface dielectric values. Figure 9 presents an example excerpt from the GPR data collected over the westbound inside lane.

**Figure 9. Example GPR on IH 10 in July 2011.**

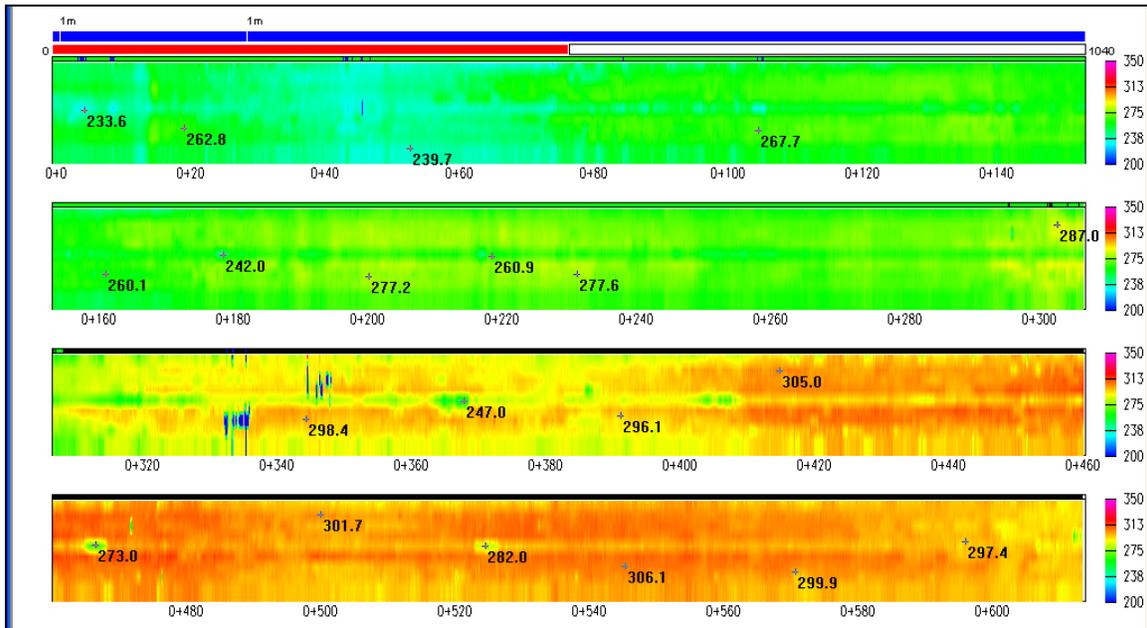
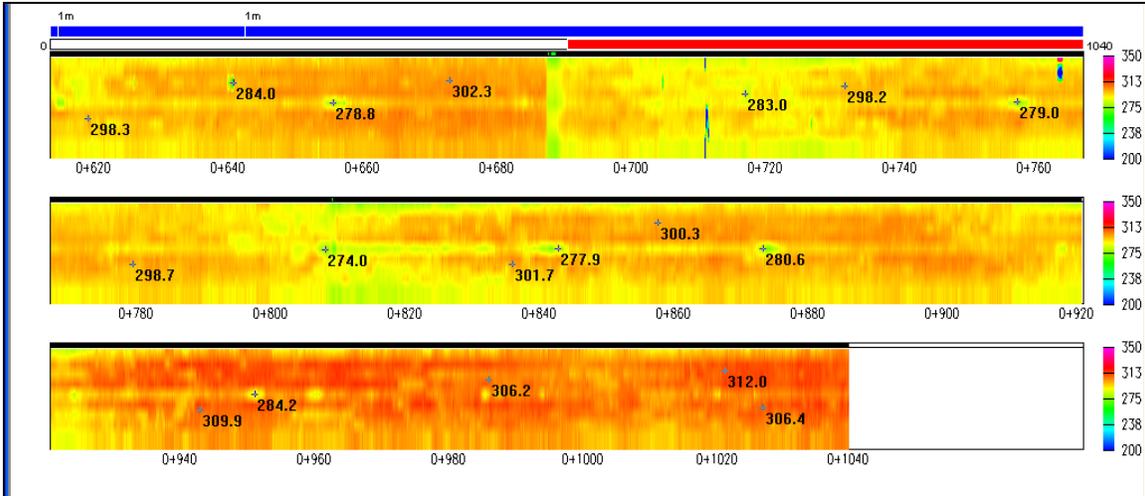
Figure 11 shows a Pave-IR system collecting project data on US 75. In the thermal survey, the “zero” distance point is approximately 15 ft north of the northern end of the bridge deck over Center Road. Figure 12 shows the IR data collected on the first approximately 1000 ft of paving. The data show that the first two truckloads of mix were somewhat cooler than the rest of the loads, with placement temperatures between approximately 230 and 275°F. After those first initial truckloads, the mix placement temperatures appeared to stabilize within a narrow temperature window of approximately 280° to 310°F. Although the thermal profile also shows recurring thermal differentials at approximately 40-ft intervals in the lane centerline, after the first two truckloads the magnitude of these differentials was only between approximately 20° and 30°F, which should not cause concern.

**Figure 12. Thermal Profile at Start of US 75 Paving on 12-3-08.**

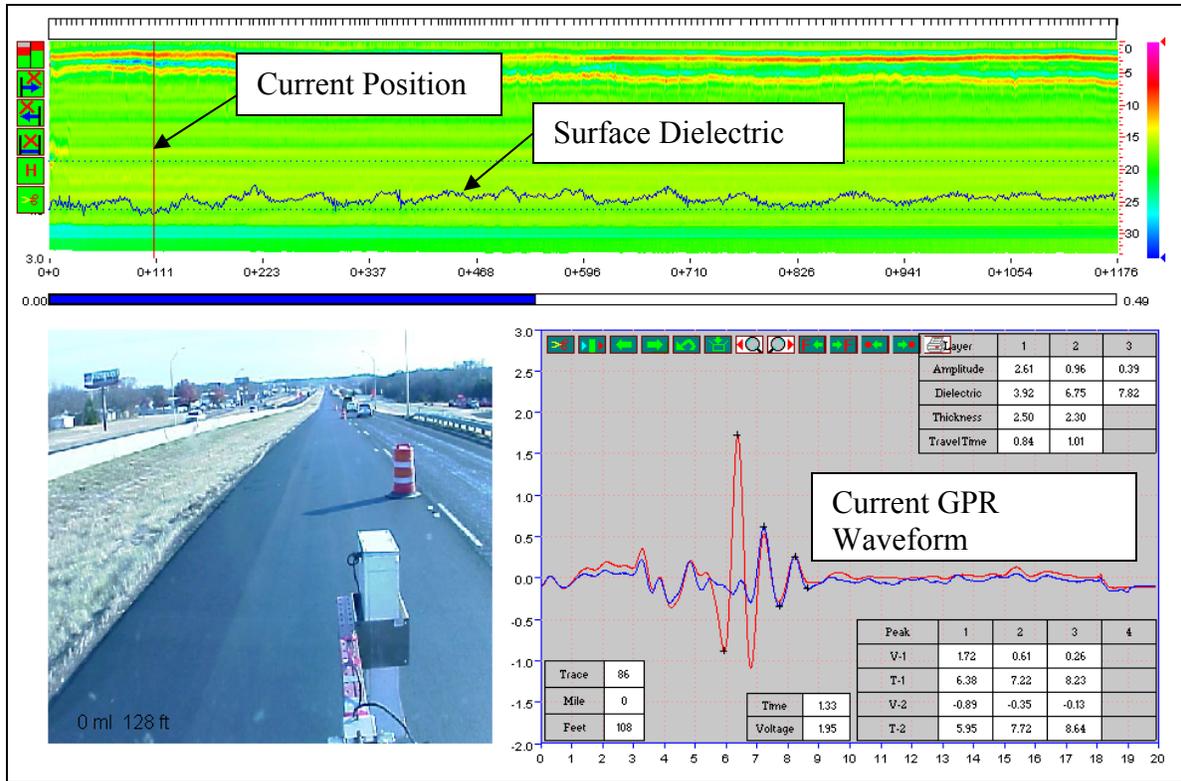
Figure 17 shows an excerpt from one of the GPR runs. At the location shown, the surface dielectric is rather low compared to the rest of the data. Based upon data review in the field, TTI selected four core locations to calibrate the GPR to density. TxDOT collected and tested the cores for air void content. Table 3 shows these data, and Figure 18 shows the calibration between the GPR data and HMA density. Although the air voids are typically predicted from the dielectric value using an exponential function, with this data set a much better fit exists by using a linear function.

**Figure 17. Excerpt from GPR Survey on US 75.**

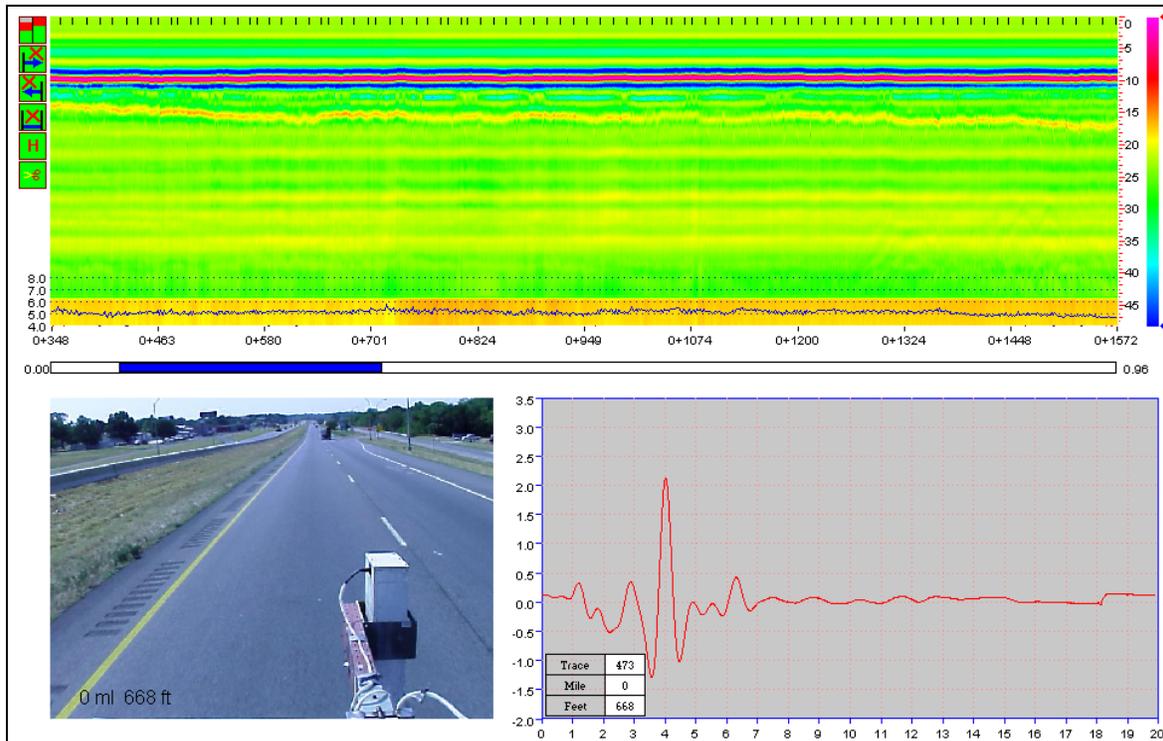
In August 2011, TTI conducted a visual and GPR survey of this US 75 project and noted no distresses. The GPR data similarly look good, with no odd reflections and a uniform surface dielectric. Figure 21 presents an excerpt of the GPR data from the section.

**Figure 21. Example GPR Data on US 75 in August 2011.**

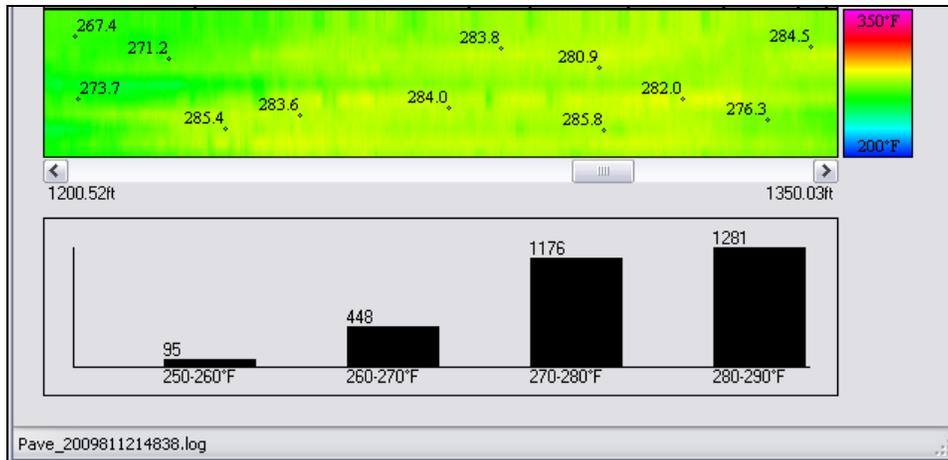
**Figure 25. Increase in Mean Arrival Temperature Resulting in Increased Temperature Differential within 150 Ft Segment on IH 40 Type C HMA.**

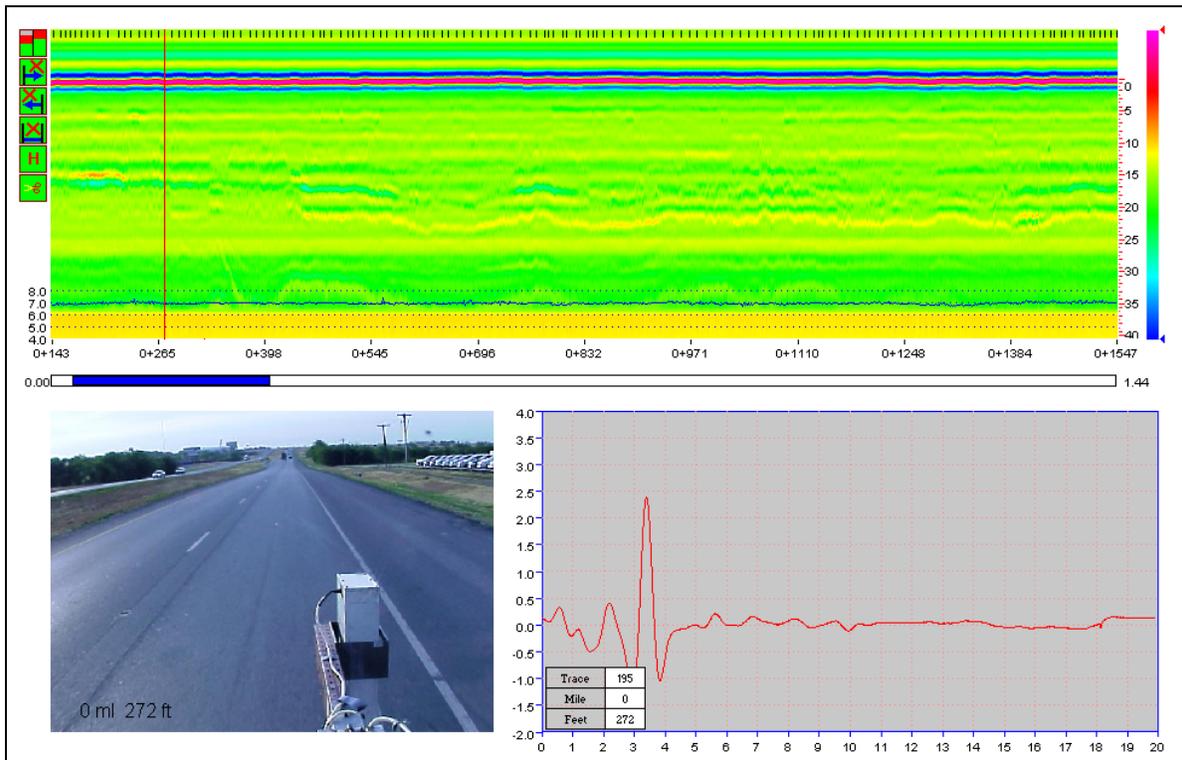
Figure 36 shows example radar data from the section. The radar data are clean with very uniform surface dielectric, and no odd radar traces exist at the locations with the distress. A review of the thermal profiles also did not reveal any anomalies at the locations. Additionally, the problem areas observed were almost in the centerline, as Figure 35 shows. Due to these observations, researchers ruled out segregation as a potential cause for the observed distress.

**Figure 36. Example GPR Data from US 81.**

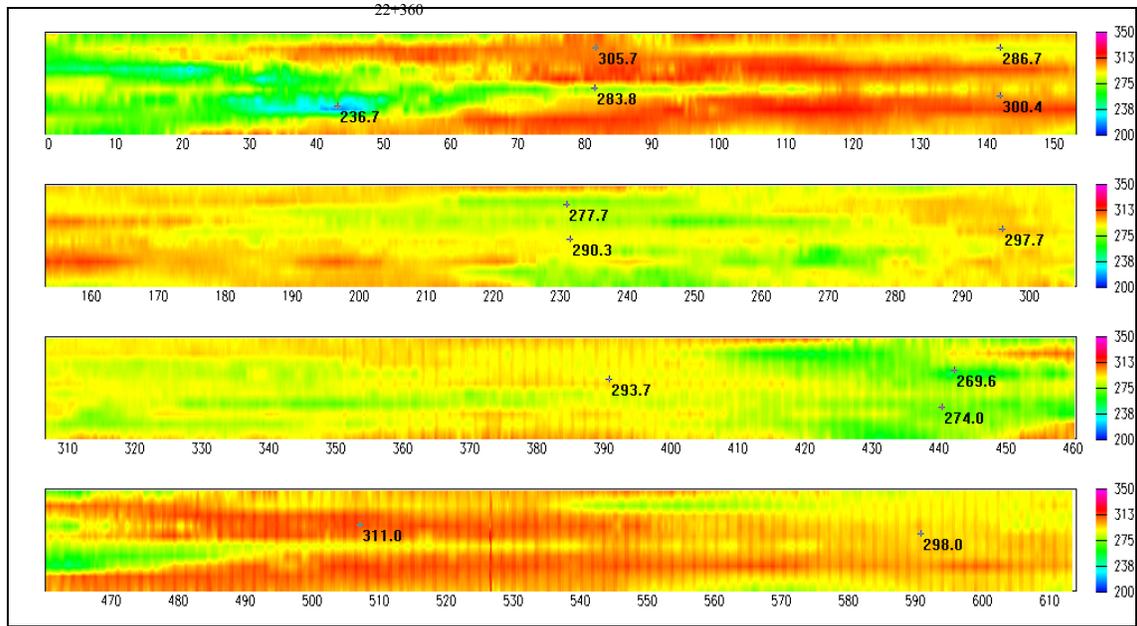
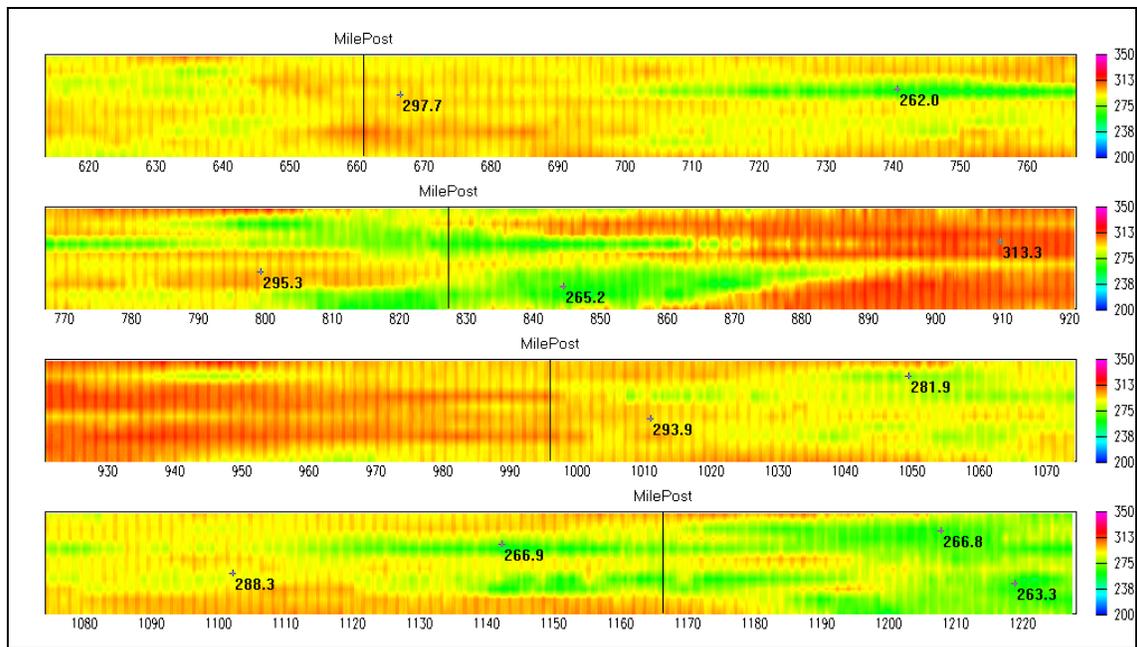
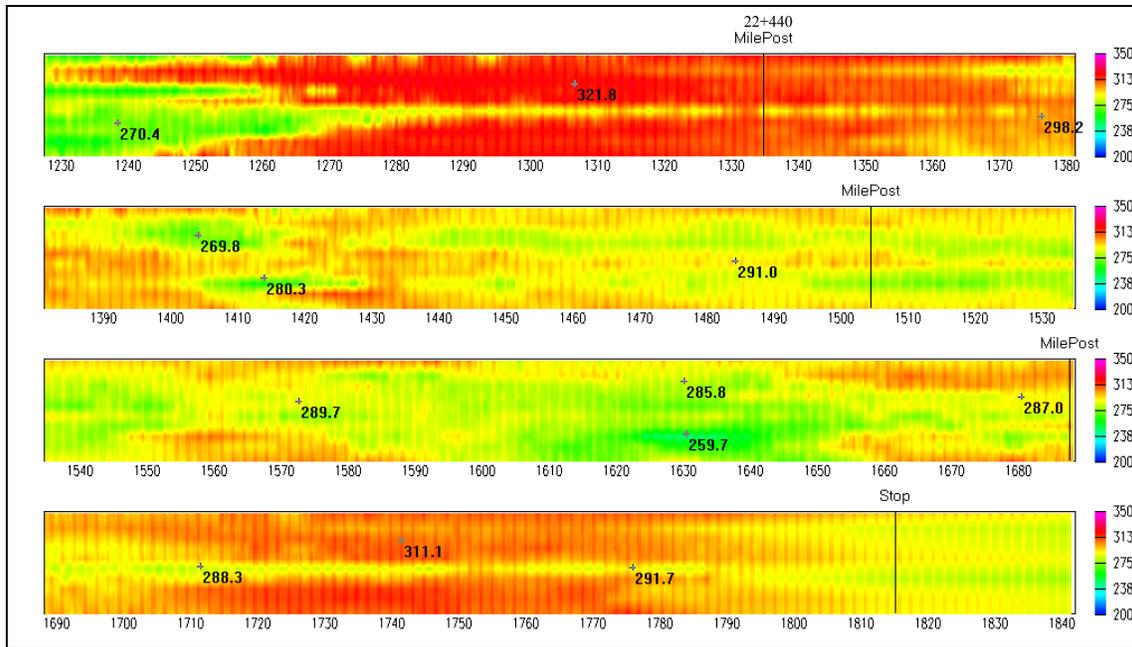
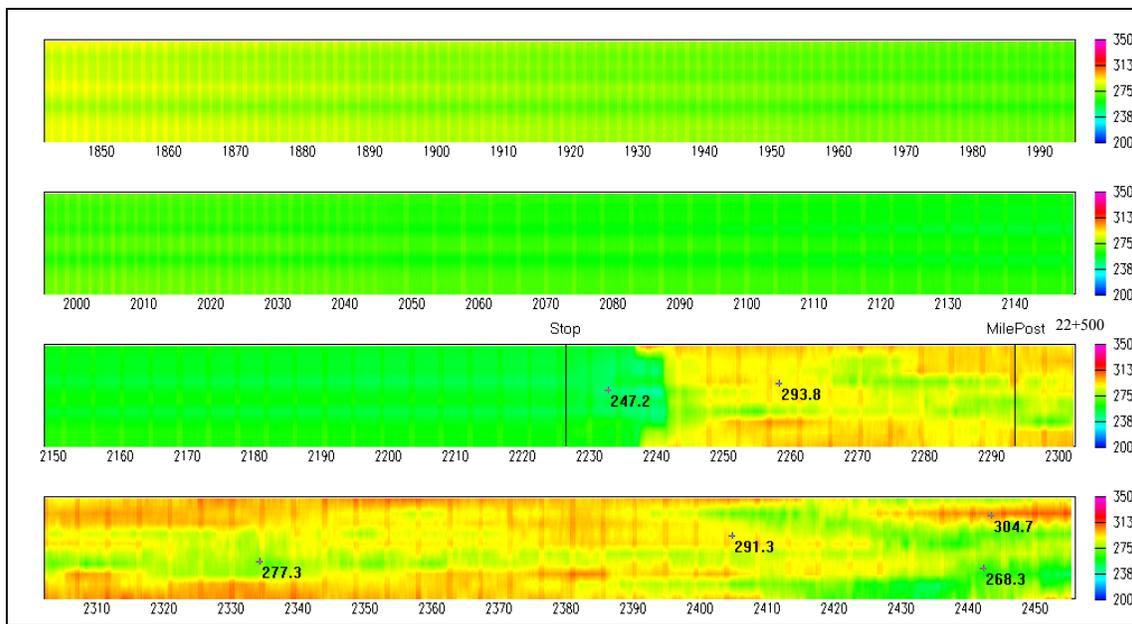
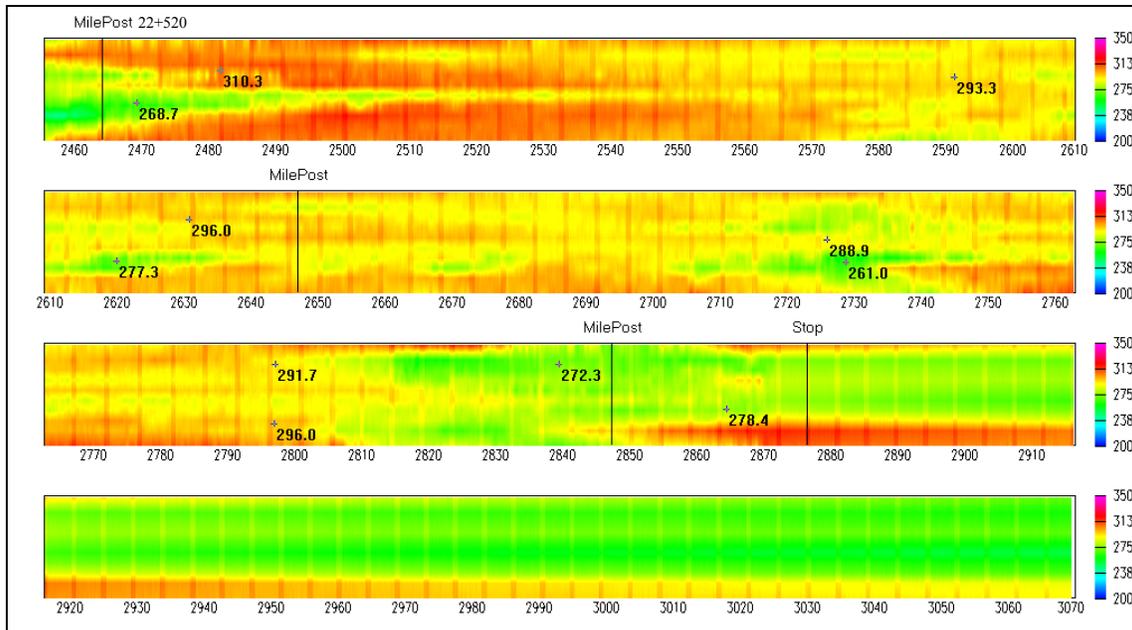
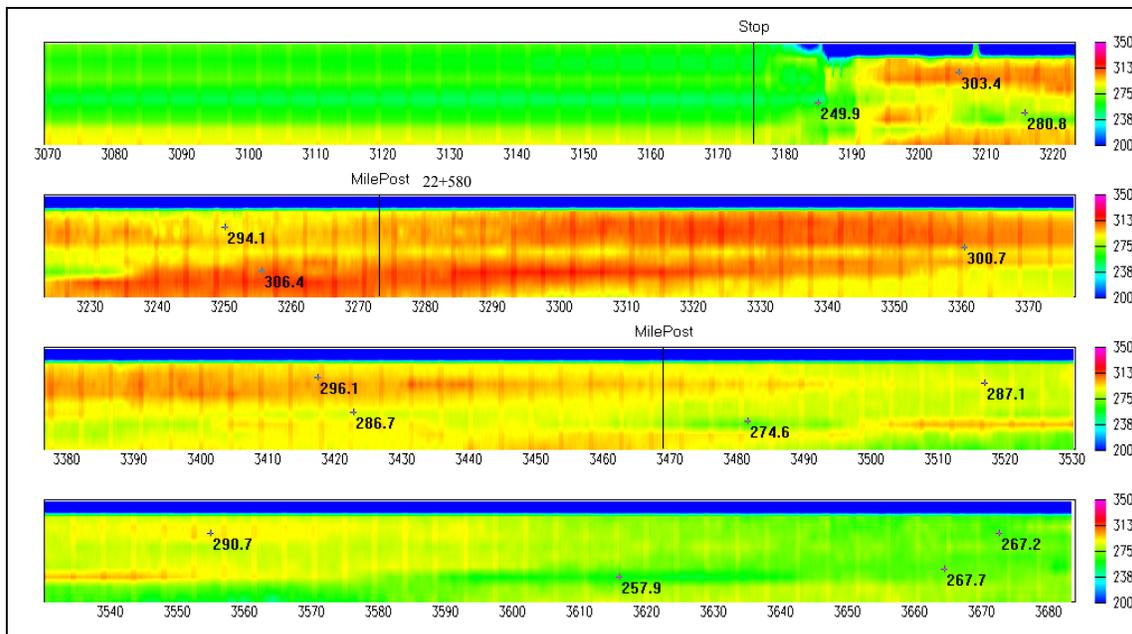
**Figure 47. Thermal Plot of US 77.**

Figure 47 shows the thermal plot for the project. Due to problems with the distance measuring device, the thermal data were collected in the time mode. To reference the data to the project, markers were inserted in the data at the stations. Additionally, locations of paver stops and starts were denoted by a marker labeled “stop.” Examination of the thermal data show:

- Thermal uniformity of the mix within each truckload was very good.
- Truck arrival temperatures were consistent, with placement temperatures (excluding truck-end cold spots) typically between 280° and 310°F.
- Clear patterns of truck-end temperature differentials exist from STA 22+360 to STA 22+560. The temperature differentials at these truck-end locations were typically between 25° and 40°F. It is unknown if these trucks were insulated or not.

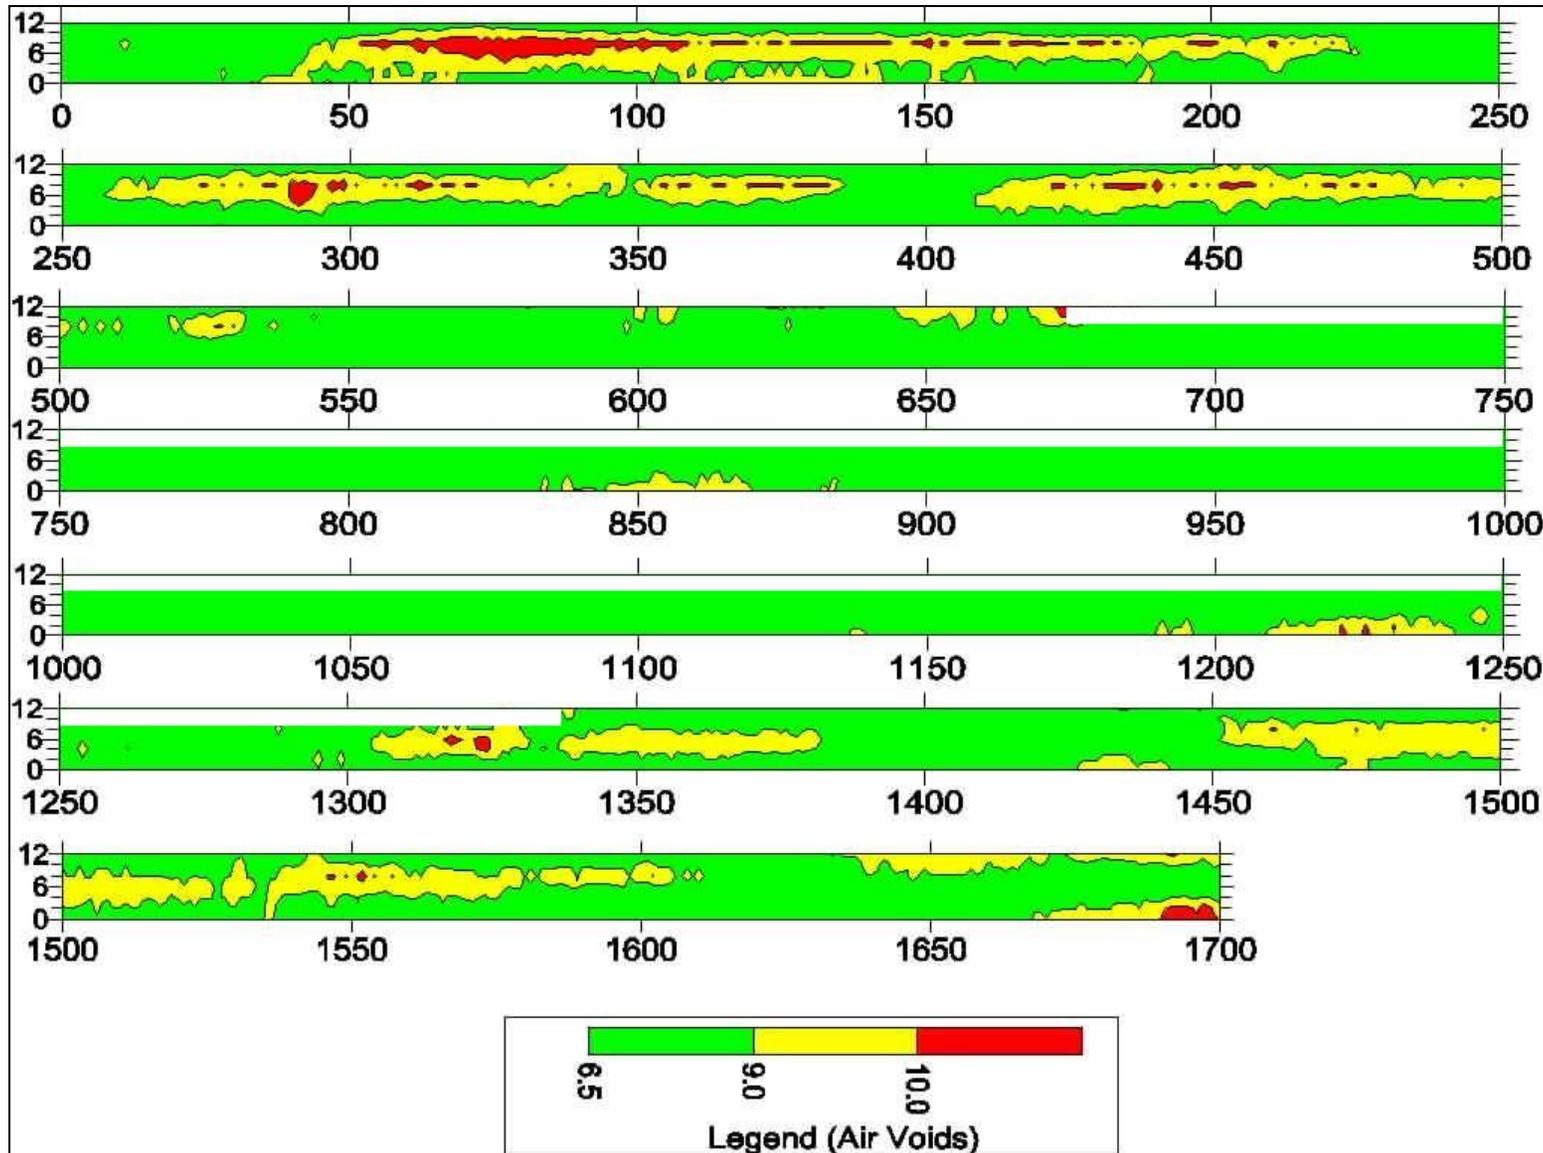
Figure 50 shows another product from the GPR survey: the surface plot of expected in-place air voids. This figure is generated from the calibrated relationship between dielectric and air voids and the known transverse spacing of each of the five GPR passes.

Figure 50. Surface Plot of Expected In-Place Air Voids on US 77 Northbound Test Section.

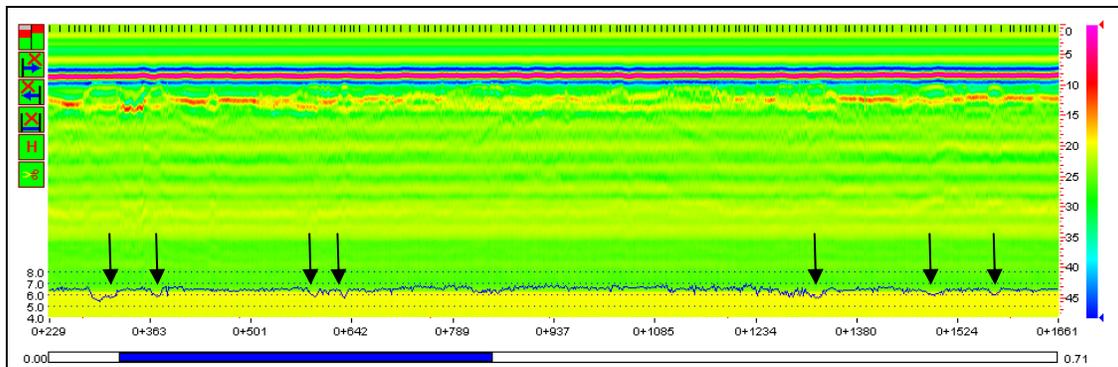
**Figure 52. GPR on US 77 after Five Years of Service.**

TTI conducted a visual and GPR survey on this section of US 77 in July 2011, approximately five years after construction. The pavement exhibited some longitudinal and transverse cracking, as Figure 51 illustrates. Additionally, the visual and GPR survey shows clear signs of truck-end segregation. Figure 52 presents the GPR data, which show cyclical dips in the surface dielectric value. Many of these cyclical dips correspond to locations of high air voids shown in Figure 49 identified at the time of construction.

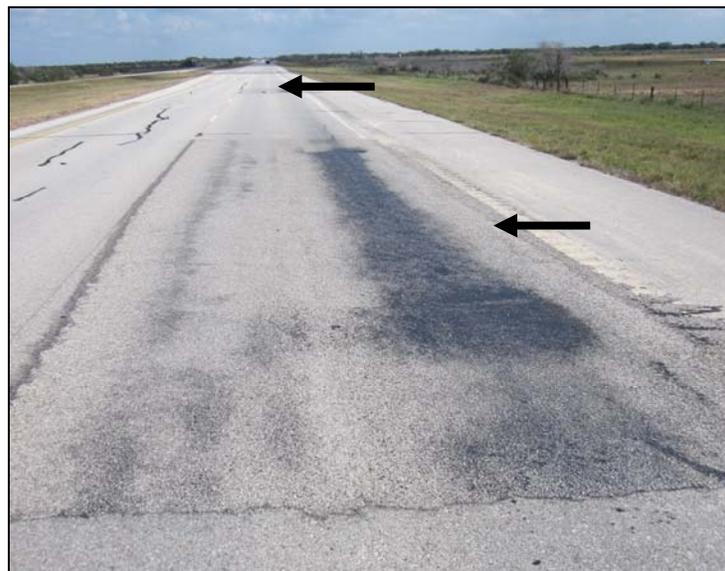
**Figure 55. Patching on US 77.**

Elsewhere on the US 77 project, other locations of segregation were observed, as Figure 54 illustrates. Although these locations were not surveyed at the time of construction, Figure 54 illustrates classic cases of cyclical segregation, exhibiting a coarser surface texture, raveling, and cracking. Additionally, some locations of patching exist on the project, and at one location, these patches were centered about 150 ft apart, typically the distance between truckloads. Figure 55 shows this location.

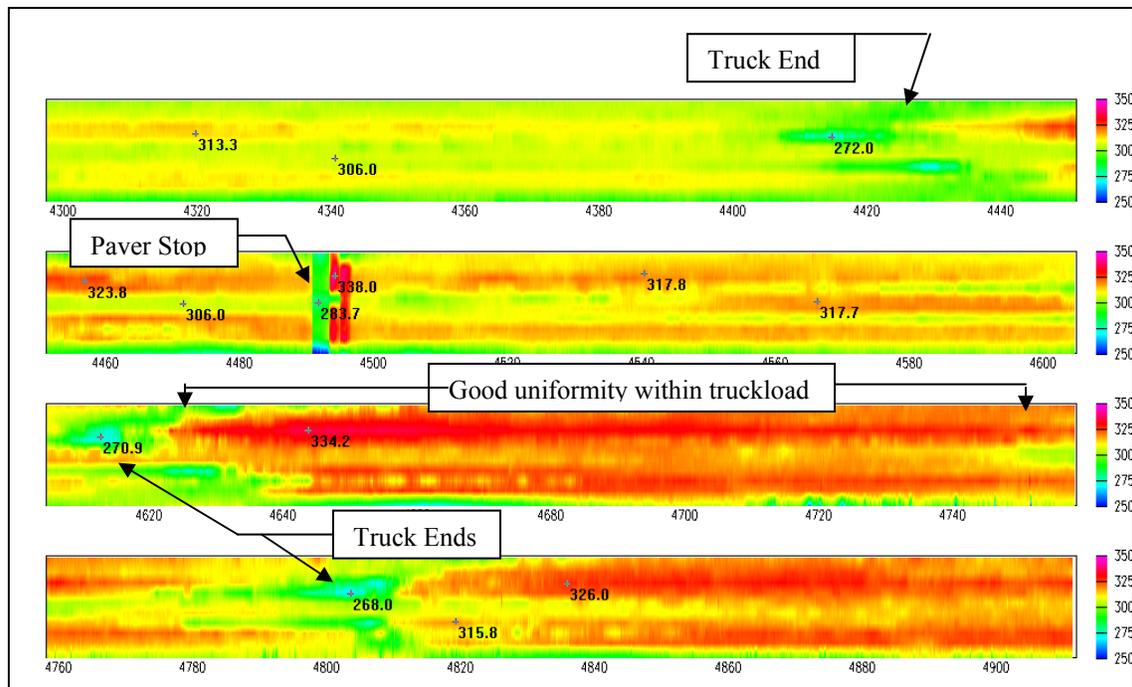
**Figure 58. Representative Temperature Surface Plot.**

Figure 58 shows a representative surface plot of mat placement temperatures and illustrates good uniformity within truckloads, a location where the paver stopped, and locations of truck-end thermal segregation. Figure 58 shows a hot spot immediately following the location of a paver stop. This pattern is due to burners on the paver operating while the paving train was stationary.

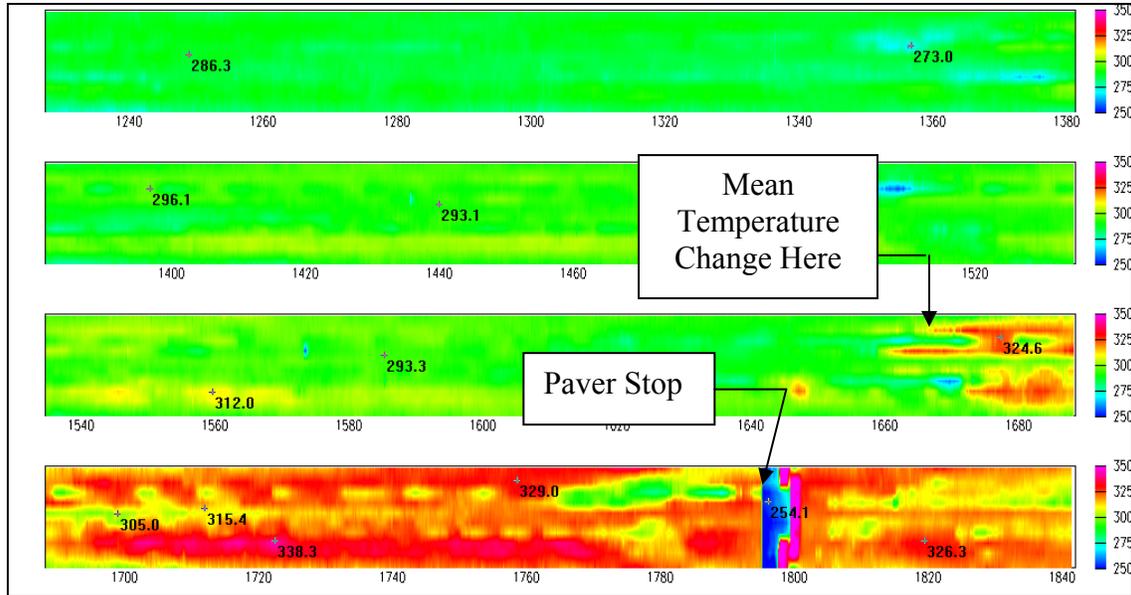
Figure 59 illustrates a location where a shift in the mean truckload temperatures occurred. The green areas are in the range 280° to 300°F, whereas in the last segments the temperatures are

generally above 320°F. This figure also shows a location of a paver stop; the short blue area represents cooling mix under the paver; the adjacent strong red strips across the mat probably represent the area beneath the burners.

**Figure 59. Transition Point in Mean Truckload Temperatures.**  
*Note: data from Lot 1.*

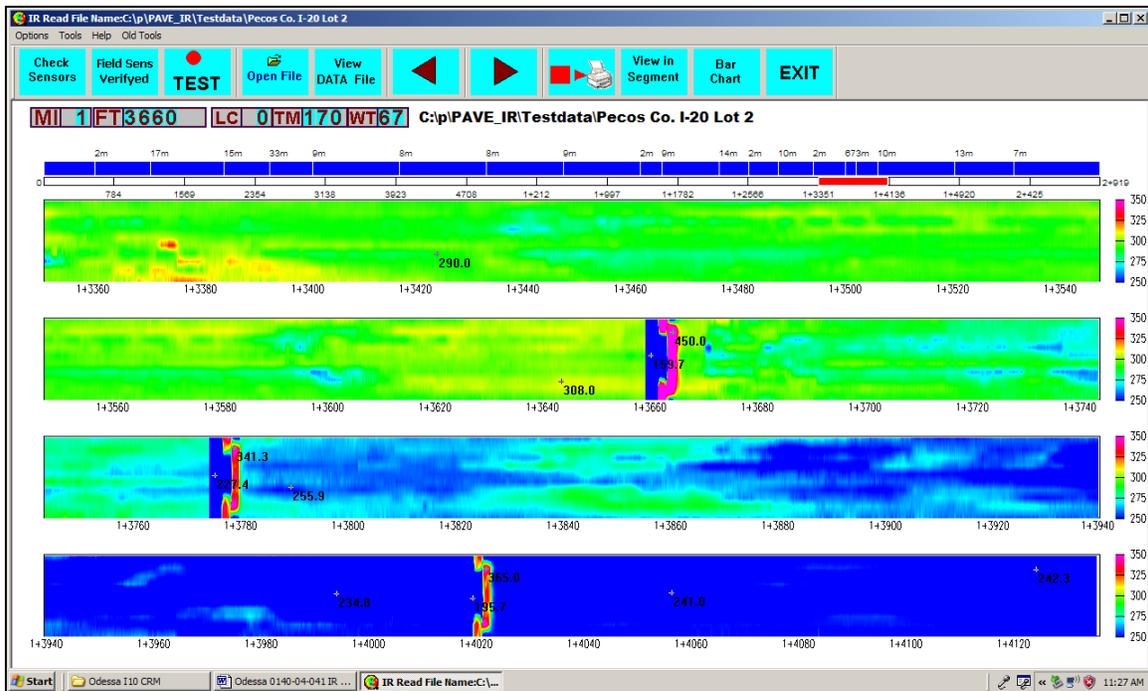
Figure 61. Potential Problem Area in Lot 2 on IH 10 CRM.

For Lot 2, the total paving length was measured as 2 miles and 919 ft. In that lot, the paver stopped 19 times, with eight of the stops equal to or longer than 10 minutes. In one instance (at 1 mi. and 3660 ft) that paver stopped for 66 minutes. After this paver stop, the pavement segment from 1 mi. + 3660 ft to 1 mi. + 5220 ft seemed to have been placed at an average temperature of between 220 to 250°F, well below the target temperature range.

Figures 61 and 62 show examples of the temperature profile from the possible problem locations. In Figure 61, the paver stop at 1 mi. + 3660 ft, and the surface temperature of the mat when the paving train resumed was 159°F, while under the burners that surface temperature was 450°F.

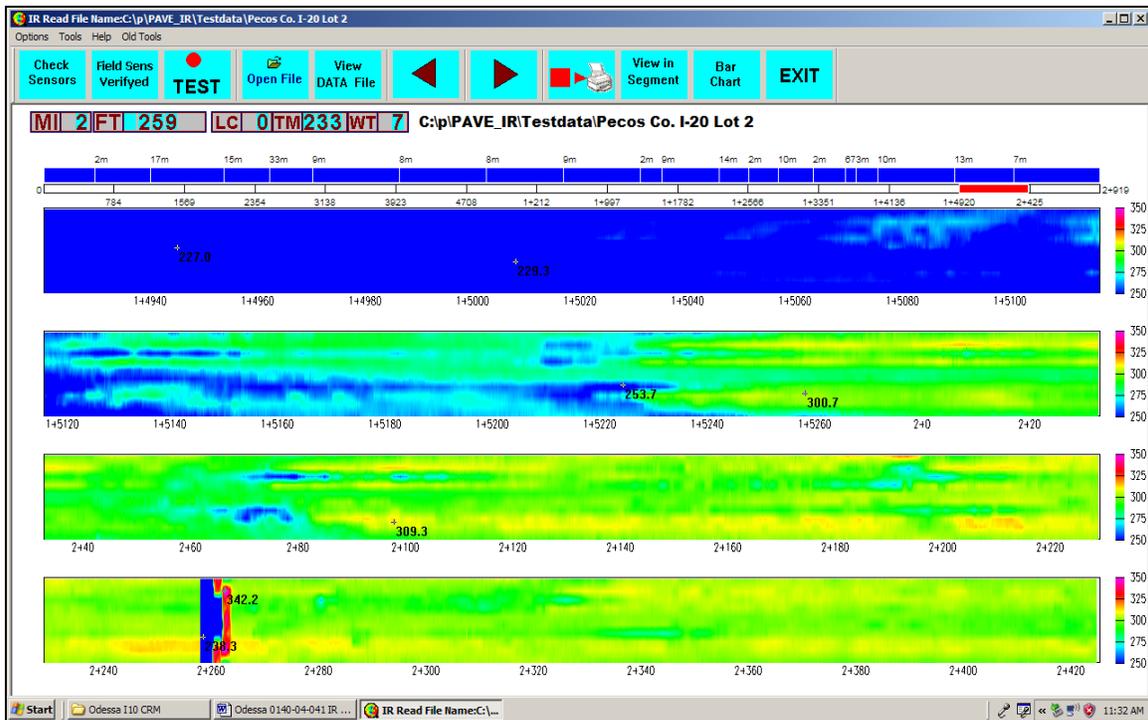
**Figure 62. End of Cold Truckloads in Lot 2 on IH 10 CRM.**

Figure 62 shows the end of the cold section where normal surface temperatures were restored after 1 mi. and 5220 ft. Lot 2 was by far the most extreme lot from all the data collected. Most of the other lots showed reasonably uniform placement temperatures. The most obvious temperature issue with the other lots was caused by frequent paver stops.

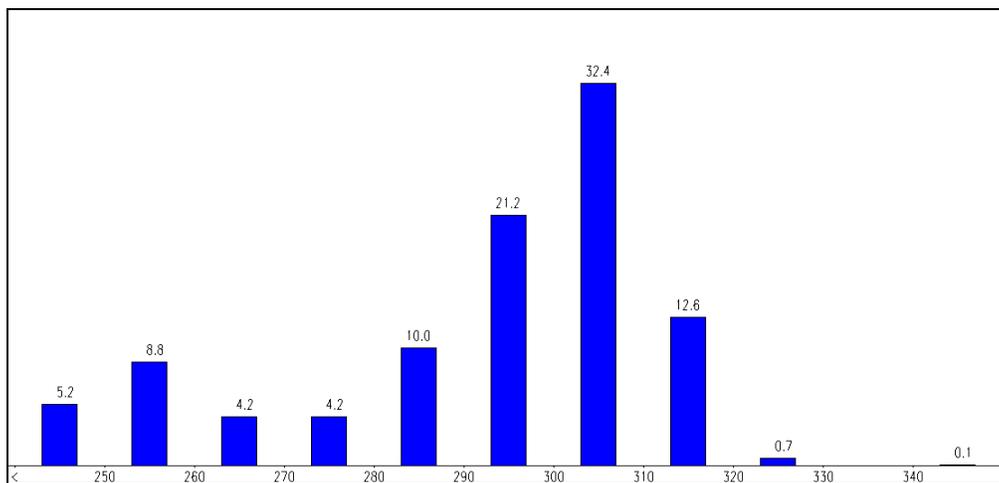
**Figure 63. Histogram of IH 10 CRM Lot 2 Placement Temperatures.**

Figure 63 shows the distribution of temperature for the entire Lot 2. This distribution is considerably different from the distribution for Lot 1 shown earlier in Figure 60. In Lot 1, only 2 percent of the mat was less than 280°F; in Lot 2, over 22 percent of the mat was placed at less than 280°F.

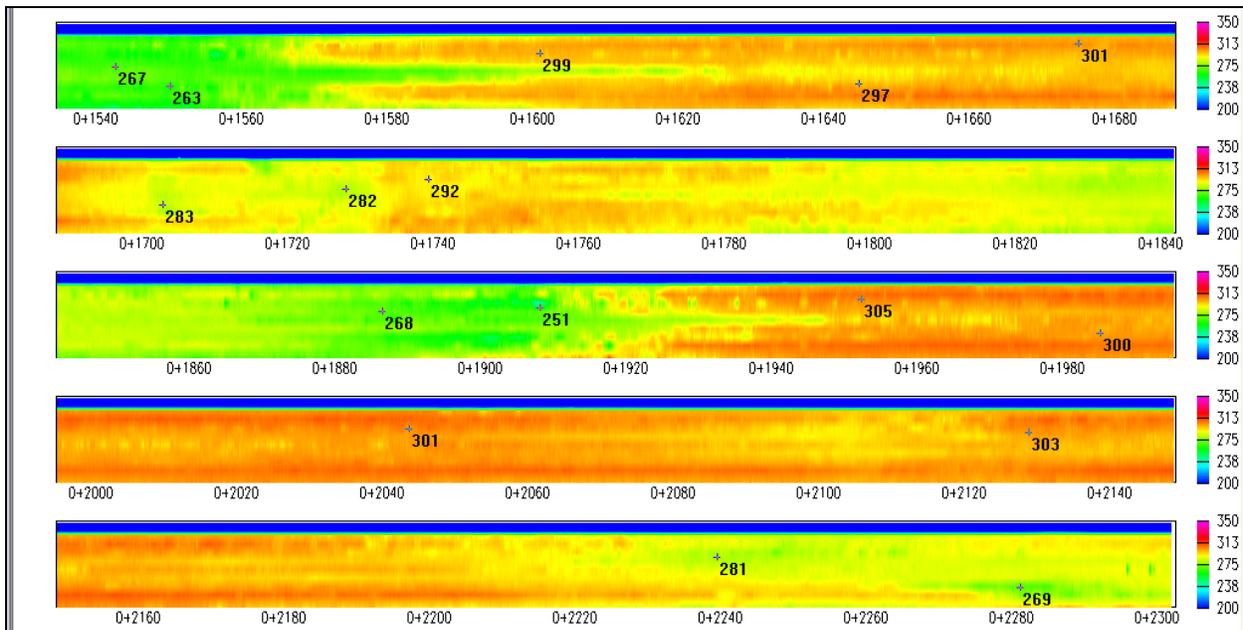
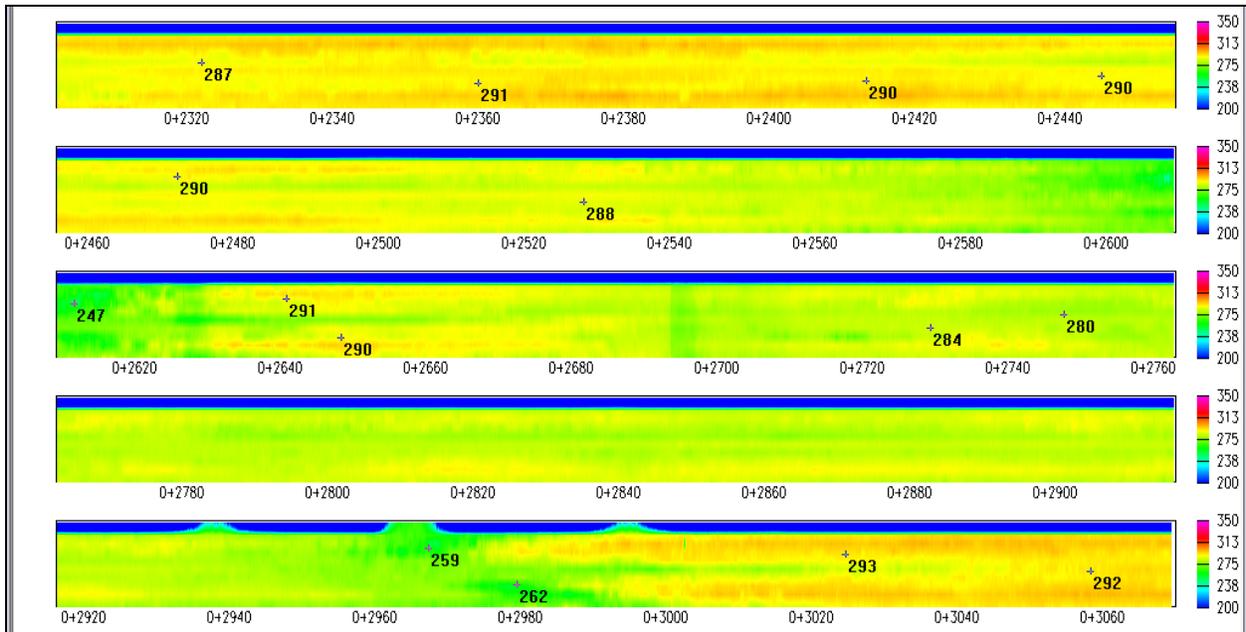
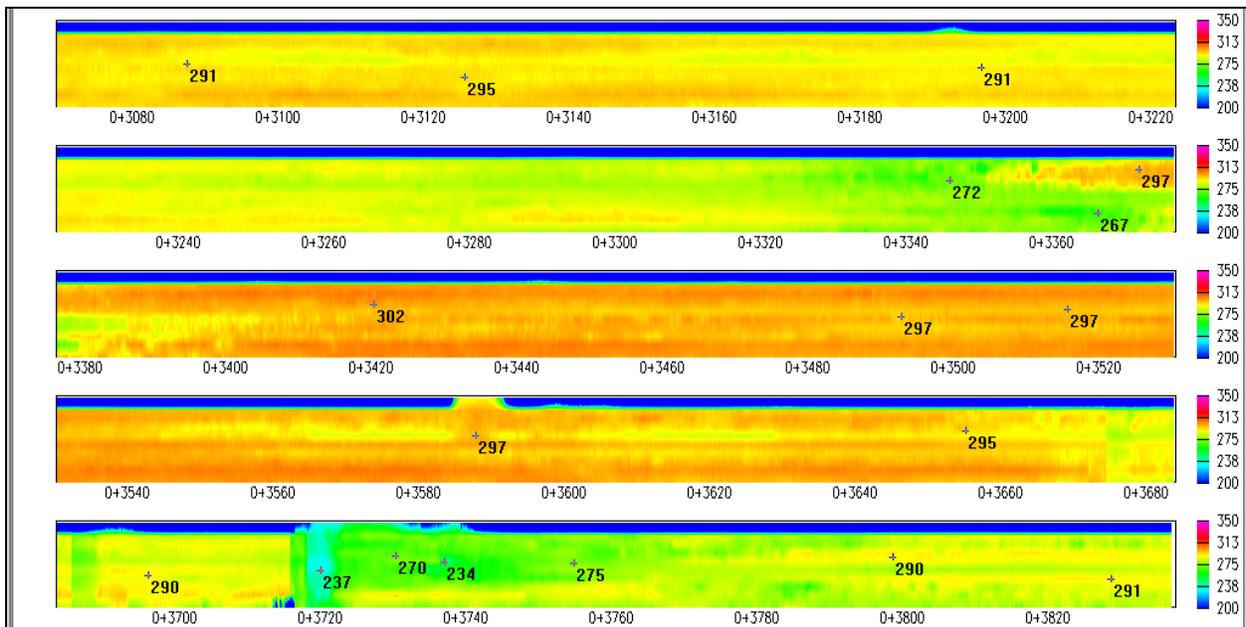
**Figure 66. Thermal Profile of CAM on US 59 Southbound Inside Lane.**

TTI performed a thermal survey on the southbound inside lane, beginning at the northern project limit and continuing to station 45+09. Figure 66 shows excerpts from the thermal profile, which revealed good uniformity within truckloads, some variations in the mean placement temperature from individual trucks, and some truck-end thermal differentials typically around 30°F.
