1. Report No. FHWA/TX-12/0-6080-1		2. Government Accession No.		3. Recipient's Catalog No.	
4. Title and Subtitle PERFORMANCE MONITORING PAVEMENTS WITH THERMAL SEGREGATION IN TEXAS				5. Report Date January 2012 Published: April 2012

# **PERFORMANCE MONITORING PAVEMENTS WITH THERMAL SEGREGATION IN TEXAS**

Report 0-6080-1

Project Title: Performance Histories of Thermally Segregated HMA

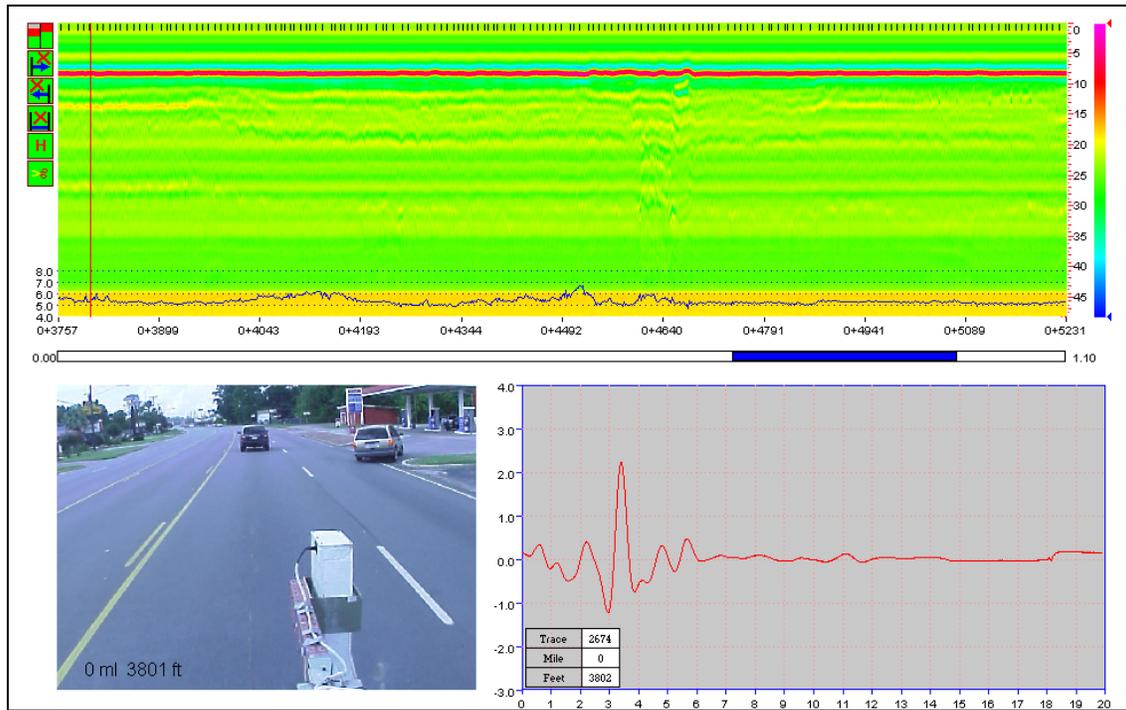
**Figure 68. GPR Data on BU 59 after Five Years of Service.**

Figure 68 shows example GPR data from the section. The GPR data are clean and have some notable variations in the surface dielectric. However, no distress appears apparent at these locations, and the locations of corrugations in the pavement do not seem to consistently match any changes in the dielectric from the GPR.

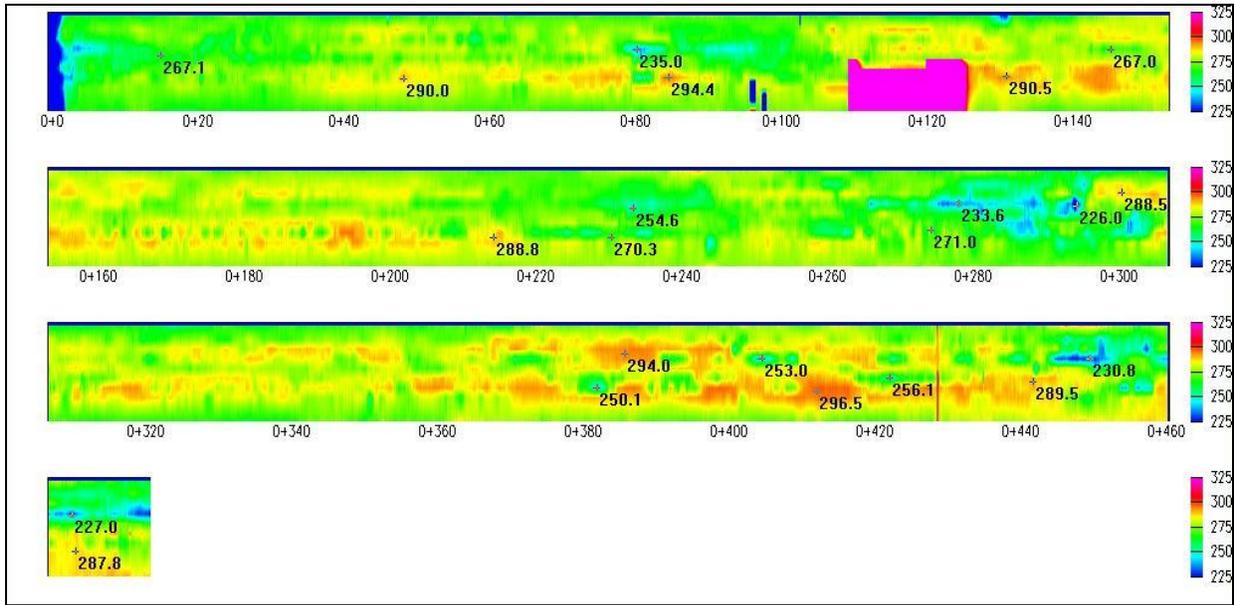
**Figure 70. Thermal Profile from US 90 CAM.**

TTI collected a thermal profile beginning at N 29 12.820, W 99 55.612; and ending at N 29 12.751, W 99 55.425. On this project, numerous locations of thermal segregation were observed with temperature differentials around 50°F. Figures 70 and 71 show the thermal profile. Oftentimes these cold locations were also visibly evident, as Figure 72 illustrates.

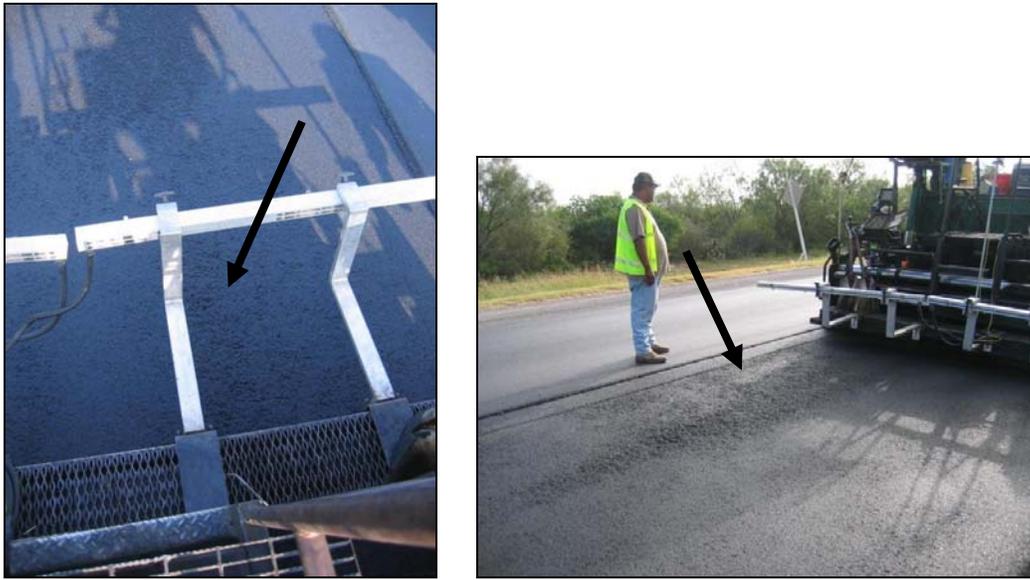
**Figure 72. View of Cold Spot on US 90 CAM.**  
*Note: corresponds with 520 ft in Figure 57.*

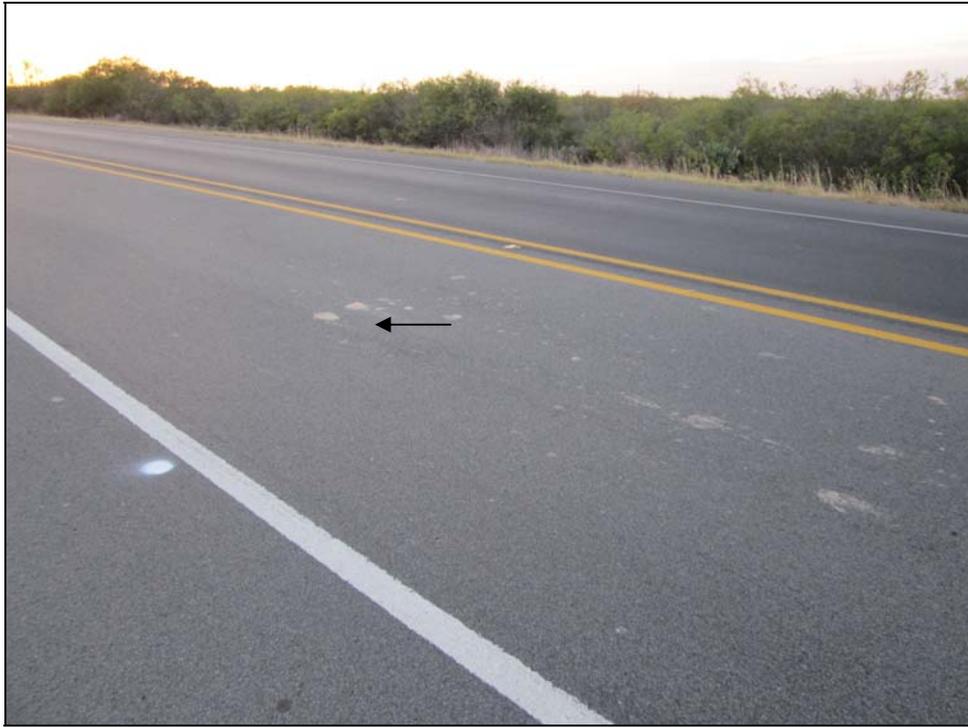
**Figure 74. US 90 Thermally Segregated Locations.**  
*Note: corresponds to ~450 ft in Figure 70.*

In July 2011, TTI conducted a follow-up visual and GPR survey. Figure 73 shows the GPR data, which show a significant drop in the dielectric in the middle and at the end of the evaluated section. Visually, some locations of coarser surface texture, and some corrugations, were observed. Figures 74 and 75 show the thermally segregated locations selected for coring.

In addition to the cores selected from the thermally segregated areas, coring also was performed at a normal location corresponding with approximately 355 ft in Figure 70. Table 10 presents these core results. The core results show some significant changes in density at the most severely thermally segregated location, but poor performance in all cases in the overlay test.

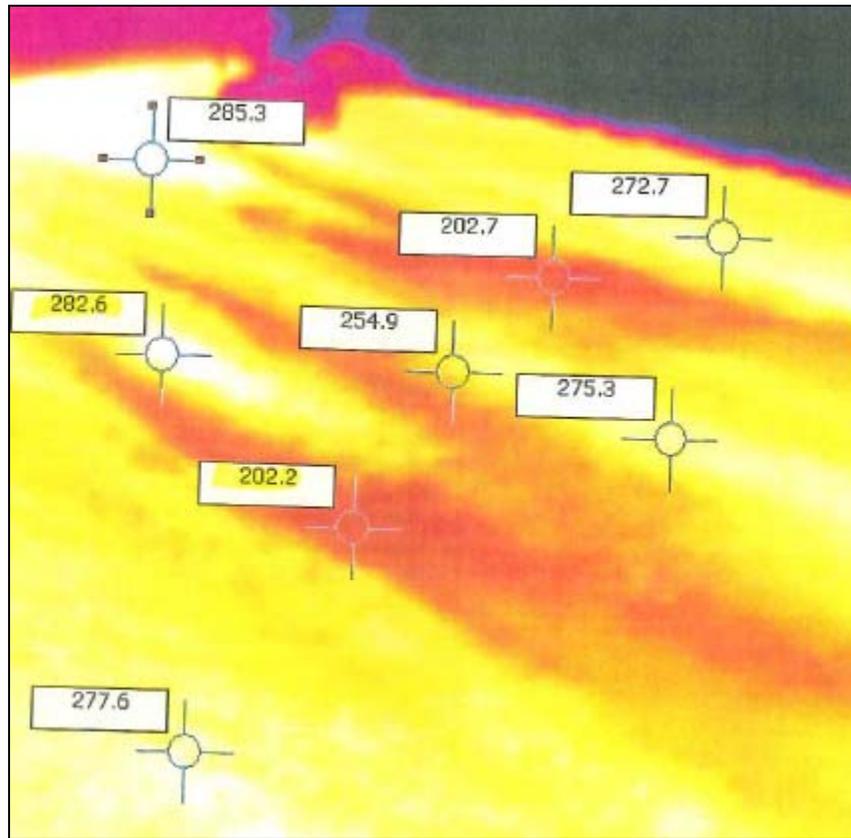
**Figure 76. Example Thermal Picture on FM 2440.**

TxDOT's Austin District staff performed thermal profiling on this project with an infrared camera. The results indicating thermal segregation and failing density profiles prompted a request for follow-up radar and coring surveys. Figure 76 shows an example thermal picture from the project.

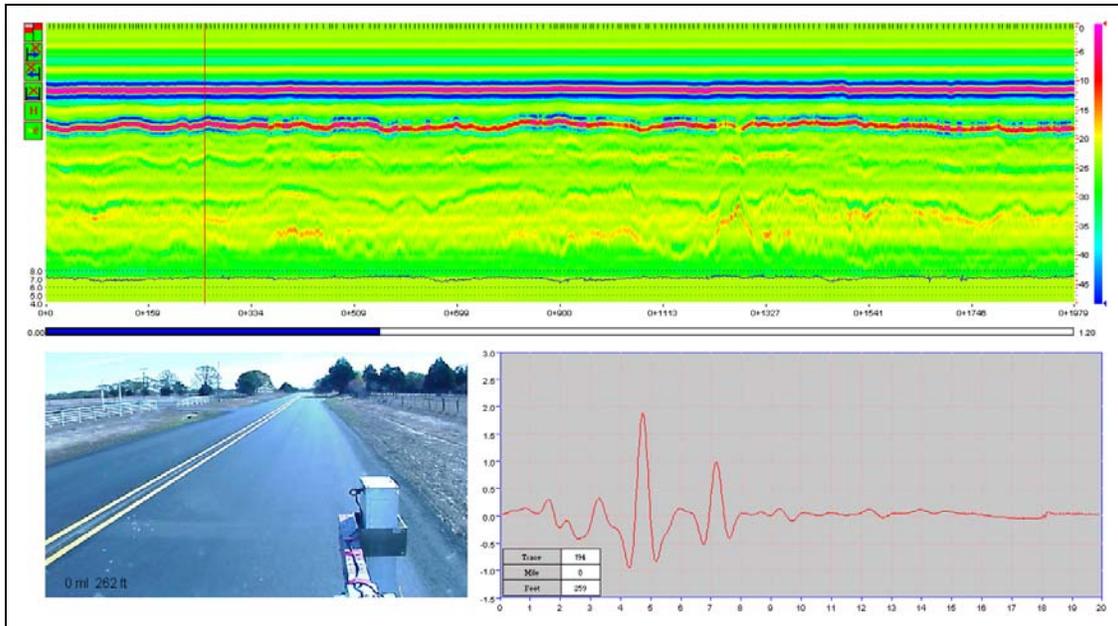
**Figure 77. Example GPR on FM 2440 Shortly after Construction.**

The GPR survey employed four passes each at a different transverse offset on a section approximately 1.2 miles long. The beginning and ending GPS coordinates were 30.20290495 N -96.96591655 W, and 30.19522483 N -96.94862899 W, respectively. The survey covered approximately from station 237 to 299. Figure 77 presents an excerpt of the GPR survey data.

Based upon the results, core locations were selected and tested, as shown in Table 11. In selecting core locations, TTI made efforts to specifically select cores representing a range from the worst to best compacted locations in the area surveyed.

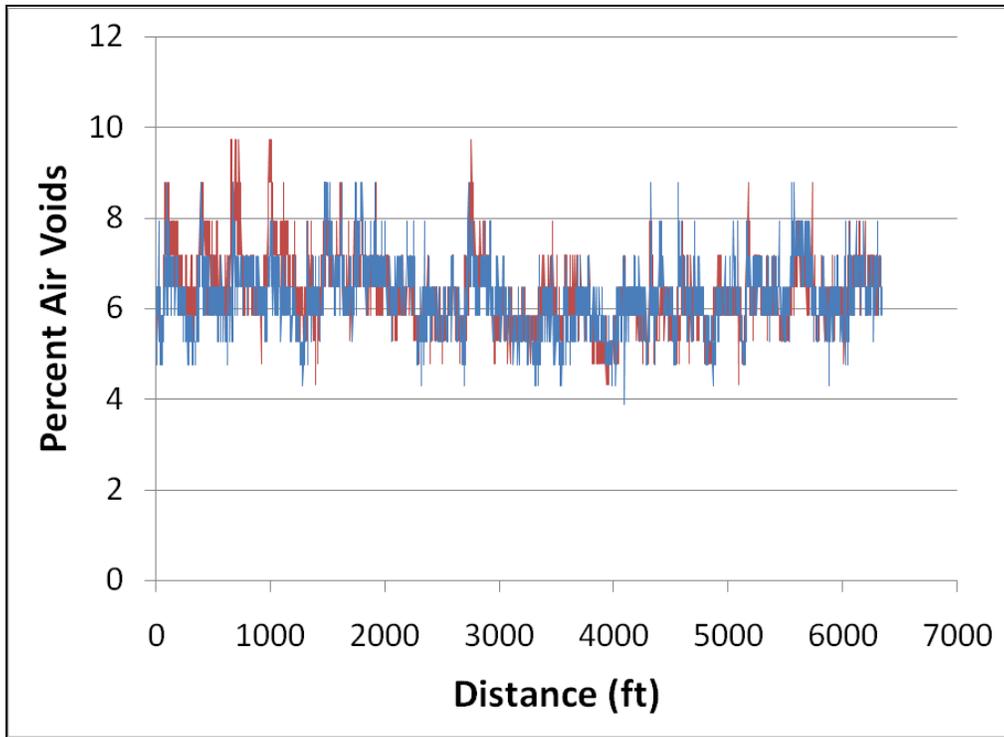
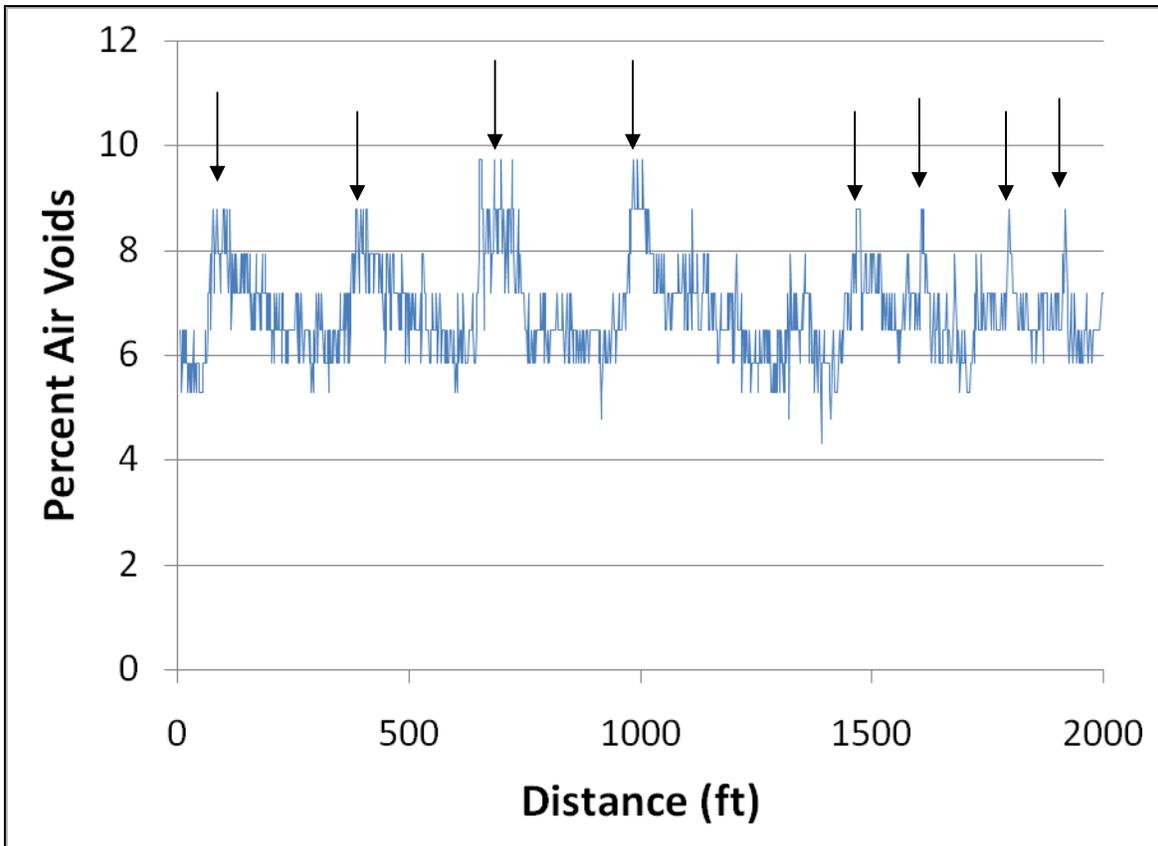
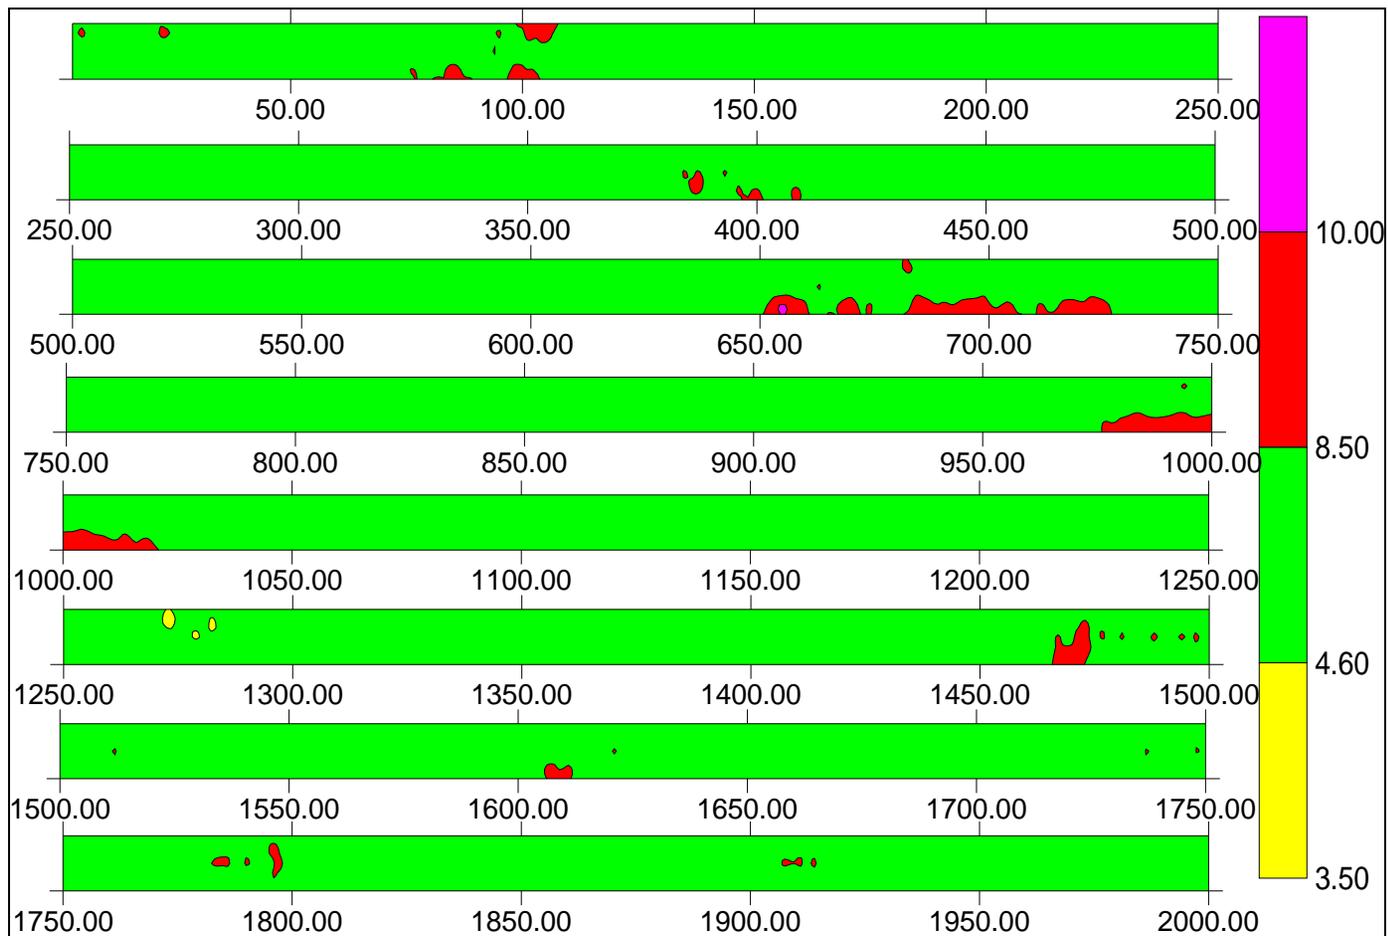
Although the expected distribution of air voids shown in Figure 78 does not raise many concerns, visual localized segregation was observed at many locations throughout the project, as Figure 80 shows. Although these cyclic segregated areas will not make up a large portion of the mat area, they can result in maintenance headaches for TxDOT due to the early failure that may occur at these locations. Therefore, the GPR data were further examined for evidence of cyclic spikes in air void content. The GPR data do show noticeable patterns. For example, Figure 81 graphs predicted air void content with distance for both the second and third GPR runs. Noticeable peaks in air void content exist at approximately 300-ft intervals over the first 1000 ft, then at an average spacing of 150 ft from 1450 to 2000 ft. Figure 82 zooms in on the first 2000 ft and further illustrates these patterns using data from the second GPR run. Also, Figure 82 combines the information from all the GPR runs into a surface contour plot of the predicted in-place air void content with thresholds in the color scale chosen from critical points in the Item 341 Placement Pay Adjustment Factors table. Figure 83 illustrates the cyclical low-density areas spatially on the pavement mat from station 237 to 257.

Figure 81. Predicted Air Voids with Distance for GPR Runs 2 and 3 on FM 2440.

Figure 82. Cyclic Peaks in Air Voids with Distance in Second GPR Pass on FM 2440.

**Figure 83. Surface Plot of Predicted In-Place Air Voids on FM 2440.**

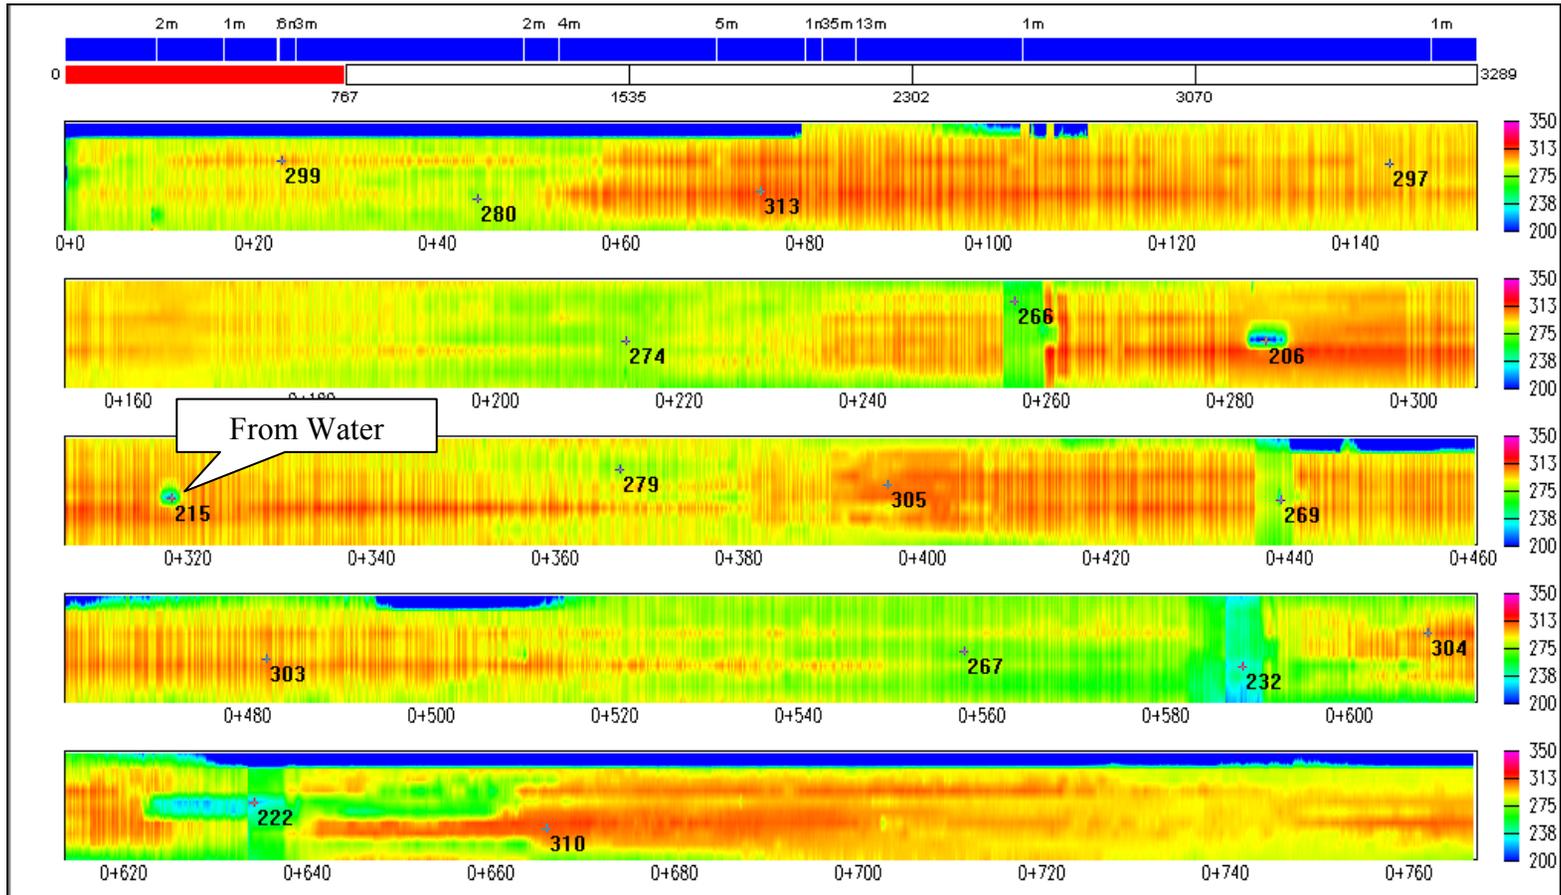
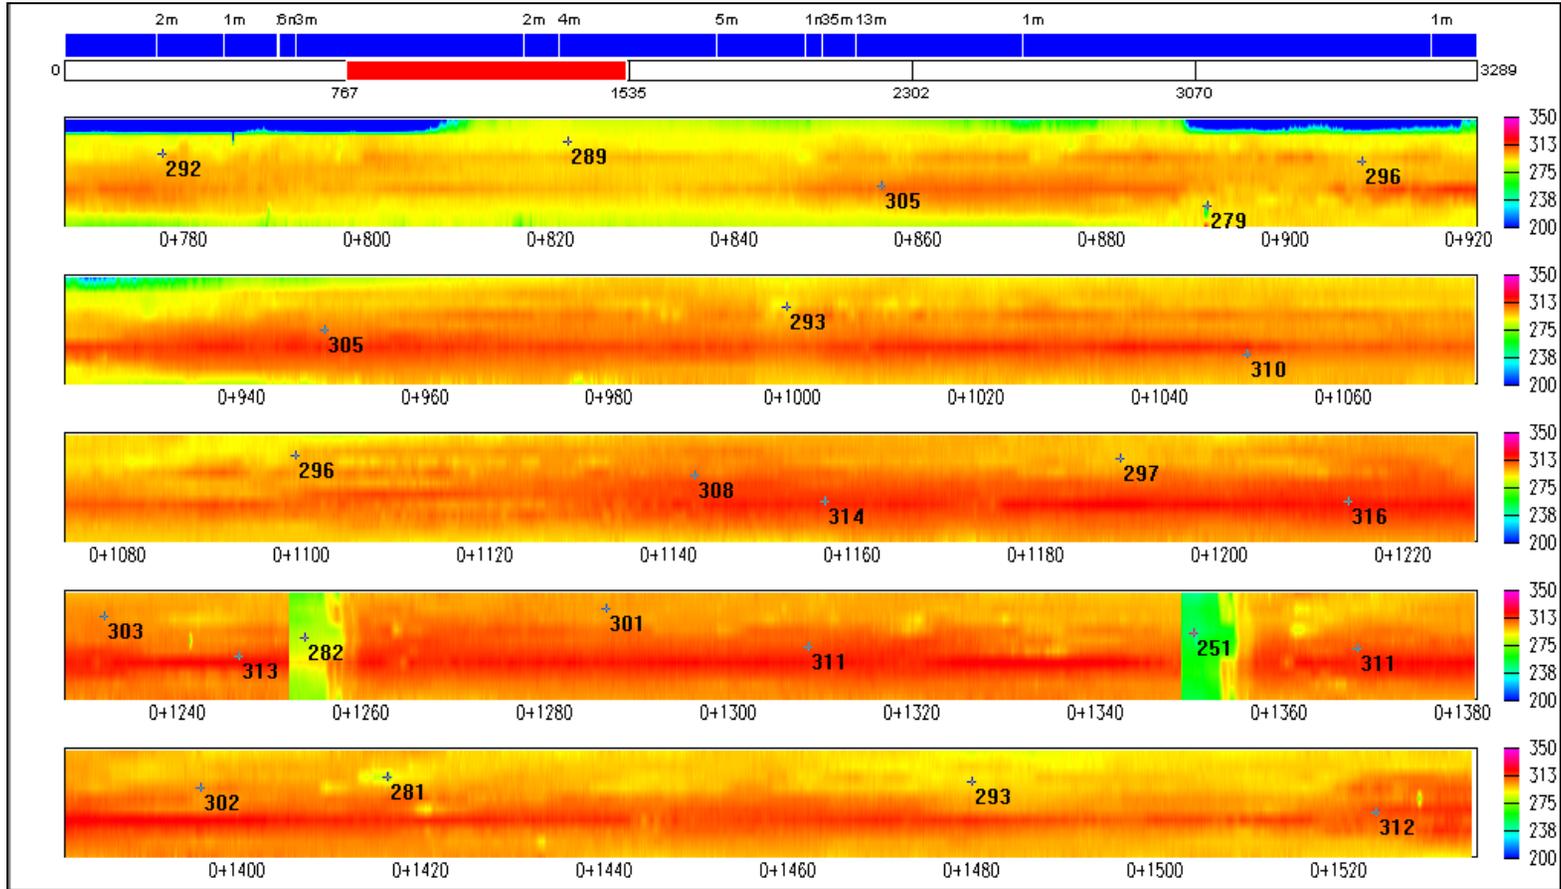
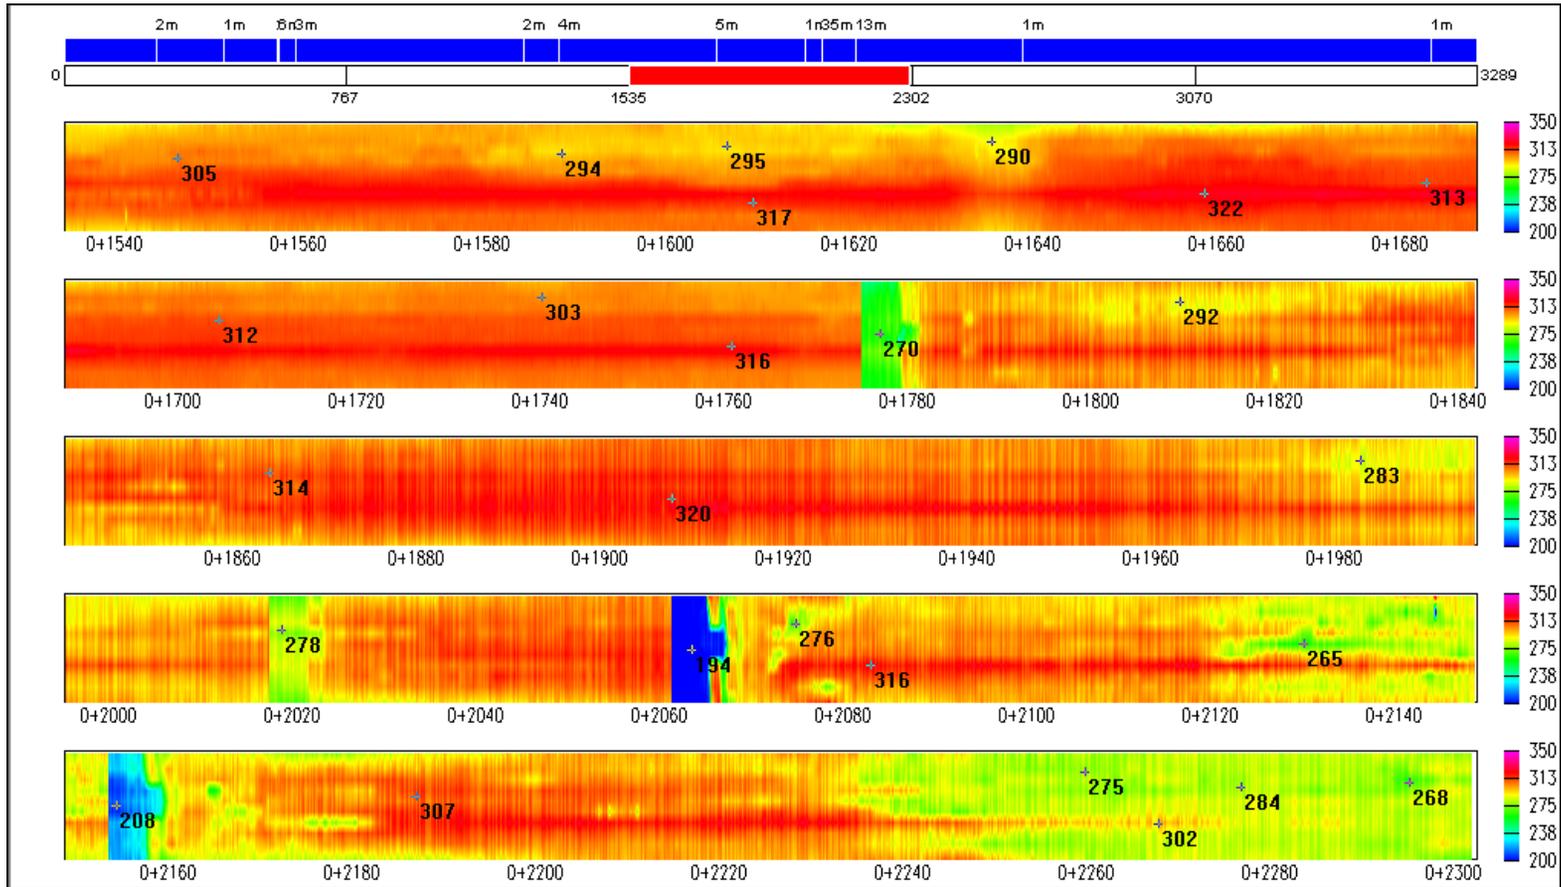
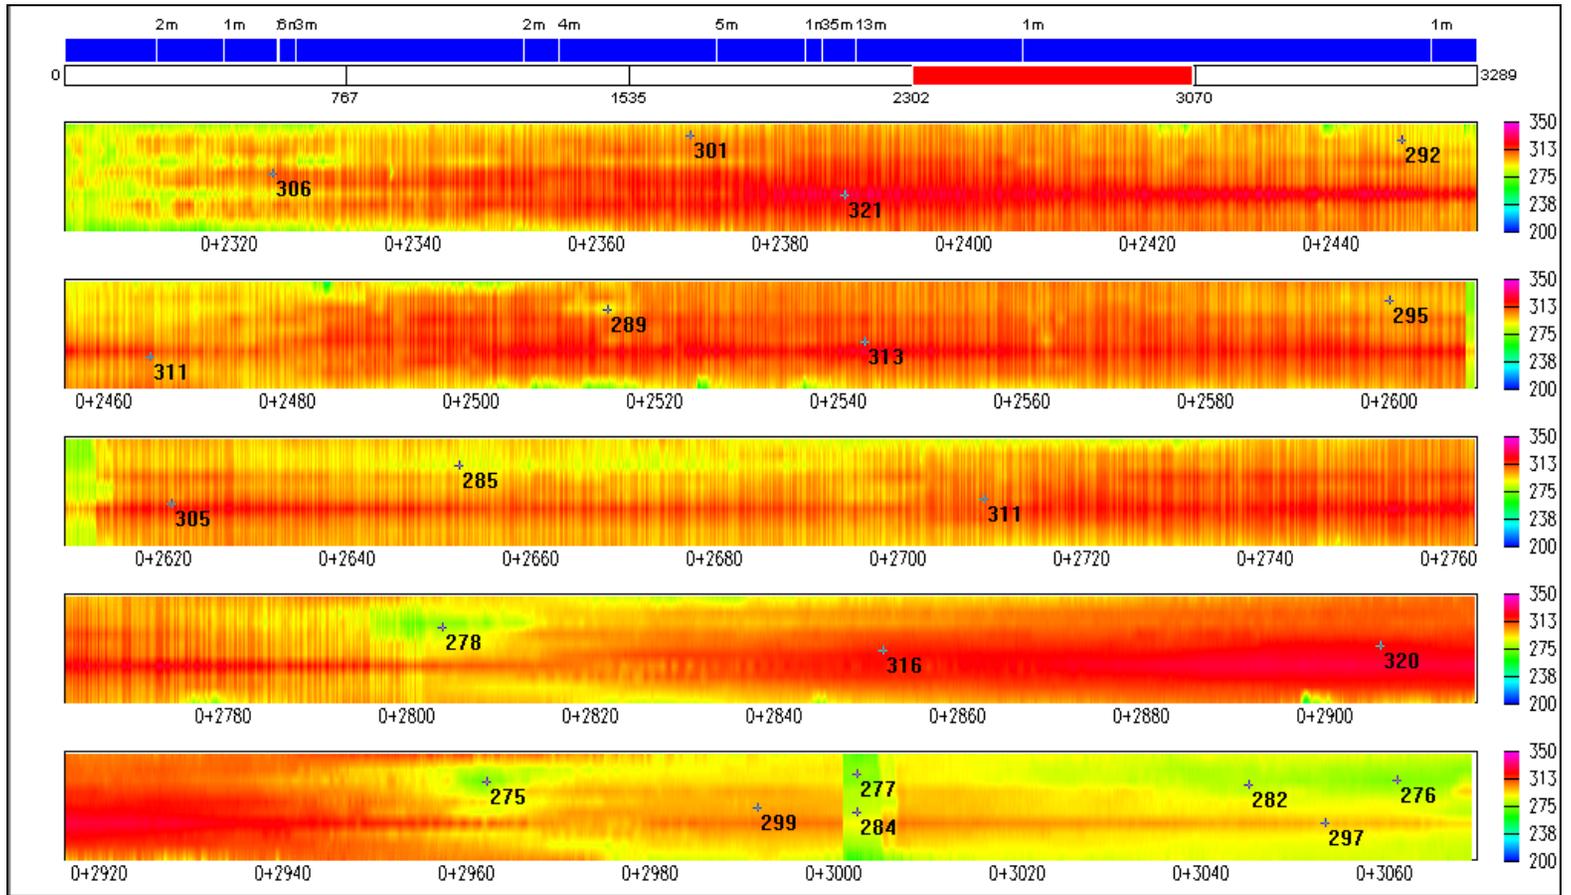
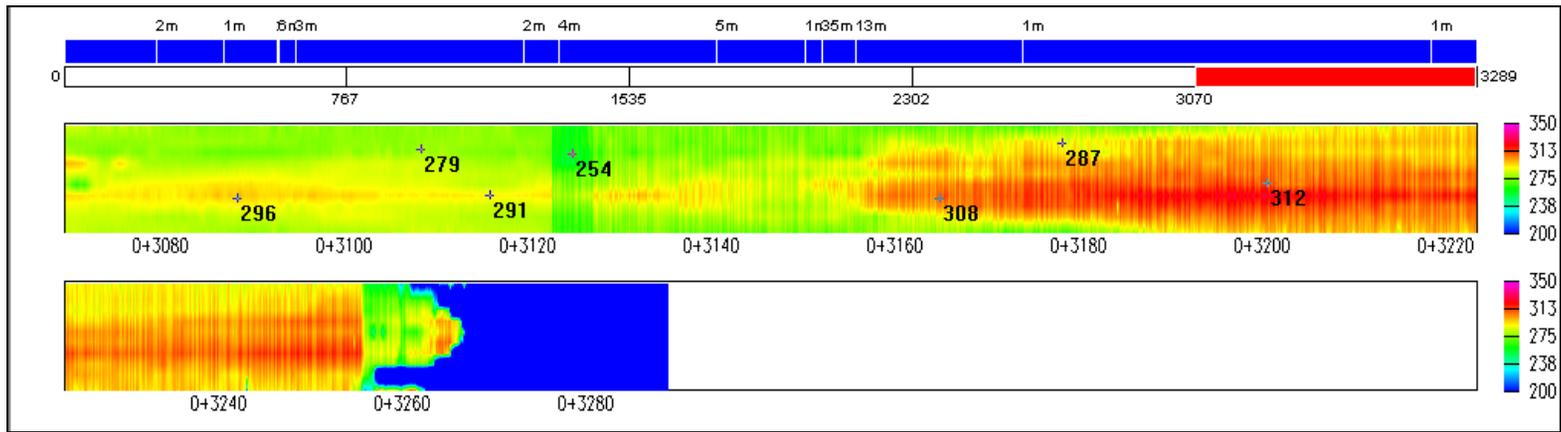
Figure 86. Thermal Profile on Parmer Lane.

The thermal survey began at 30.42574588 N, -97.71588790 W, and ended at 30.42156534 N, -97.70664239 W. The section was the eastbound left lane on Parmer Lane. Figure 86 shows the thermal profile, and Figure 87 shows a histogram of all the measured temperatures. Some observations and comments from the profile data include:

- Noise exists in the data when the computer was plugged into the paver generator. The impact of the noise on the profile can be seen by comparing the first 770 ft in Figure 86 to the data from 770–1530 ft.

- With the exception of locations of paver stops and a few other anomalous spots, temperature differentials in the longitudinal direction are typically around 30°F or less.

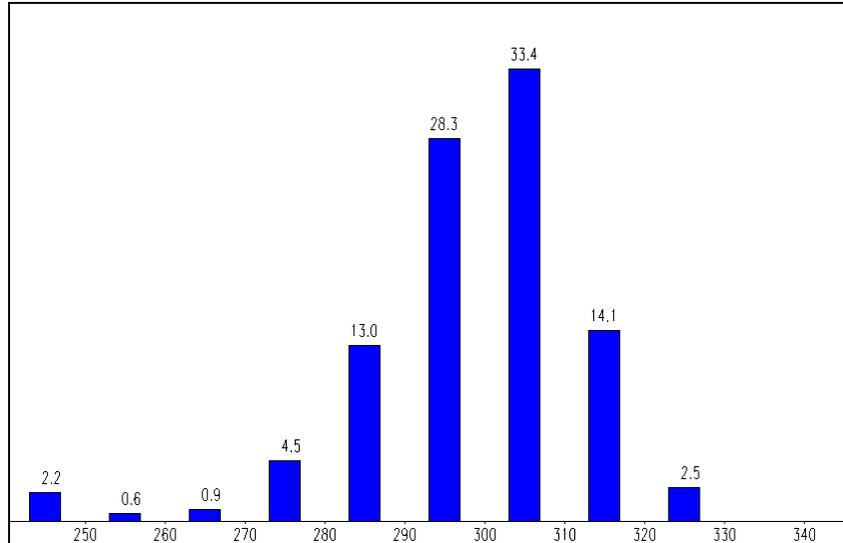
**Figure 87. Histogram of Measured Temperatures on Parmer Lane.**

- Approximately 95 percent of the mat surveyed had placement temperatures between 270° and 320°F, as Figure 87 shows. However, the noise in the data from the method of powering the laptop likely inflated this range; the actual 95 percent interval of placement temperatures is more likely within a 40°F range.

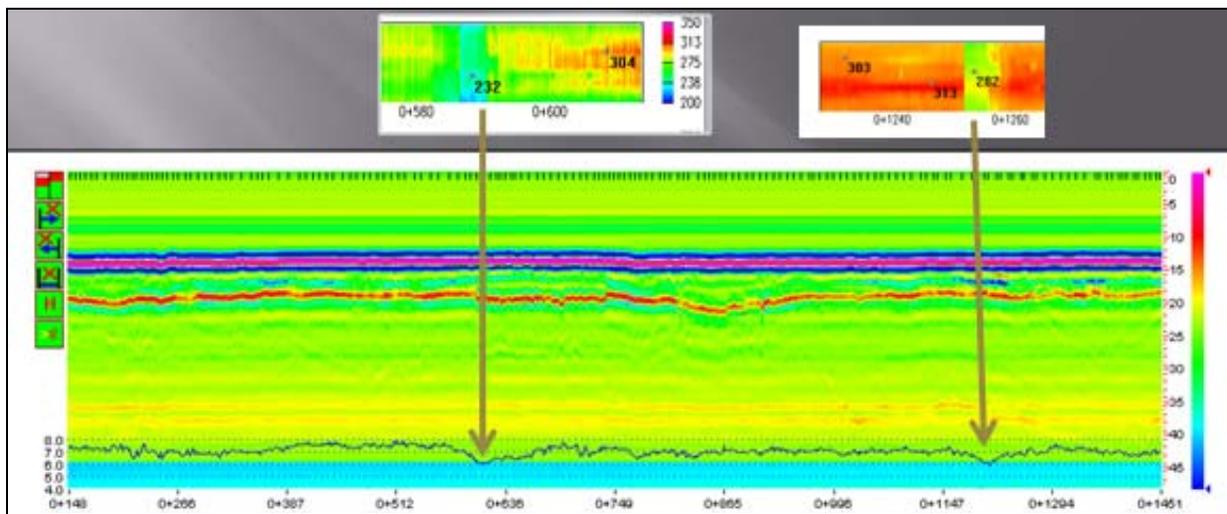
**Figure 88. Low Dielectric Locations at Paver Stops on Parmer Lane.**

On April 23, 2009, TTI collected GPR over the section. An initial review of the data showed some sizeable dips in the GPR-measure surface dielectric value. Some of these low dielectric locations occurred at locations of paver stops. However, not all paver stops showed up in the GPR data as low dielectric locations. Figure 88 shows an example of two paver stops and corresponding low surface dielectric values.

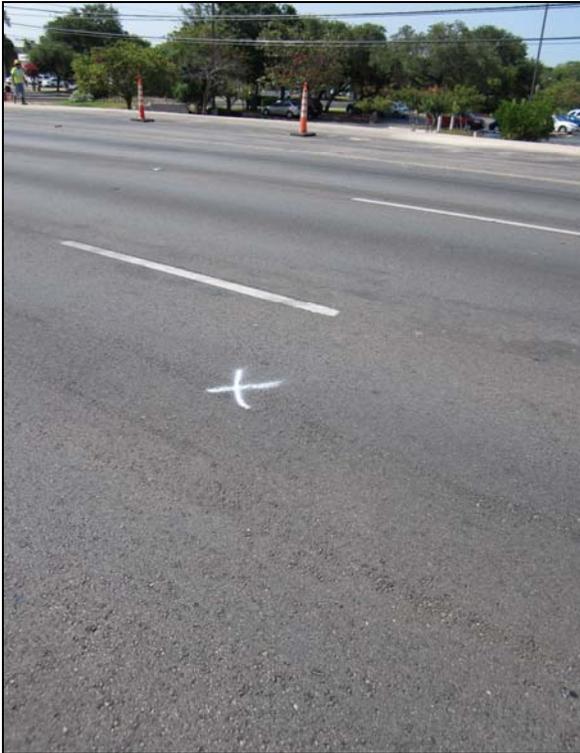
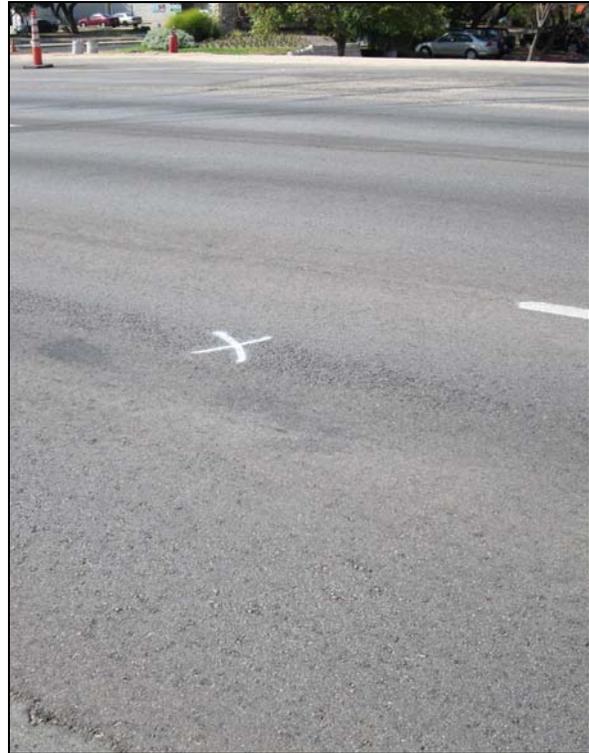
**Figure 89. Streak on Parmer Lane after Two Years of Service.**

In July 2011, TTI performed a follow-up visual and GPR survey on the section. The section appears in good condition with no distress noted. The only observations noted were locations of coarser surface texture between 625 and 680 ft. The location at 625 ft matches the centerline thermal streak in Figure 86. Patterns of paver stops at 2060 and 2154 ft also were observed and match paver stops observed in the thermal profile. Figures 89 and 90 show these

streak and paver stop locations. At the streaks, only a coarser surface texture was noted. At the locations of the paver stops, the outline of the paver bull plate was still visible in the pavement.

To evaluate in the lab the performance measures of the anomalous locations against a normal location, the spots marked in Figures 89 and 90 were cored for laboratory density, overlay, and Hamburg tests. Two additional cores at 1079 and 1779 ft into the pull were cored. The location at 1079 represents a normal location, and the location at 1779 ft was another paver stop region. Table 12 presents the results from these cores. In general, the locations observed as thermally segregated at the time of construction had higher air voids. All the samples passed the

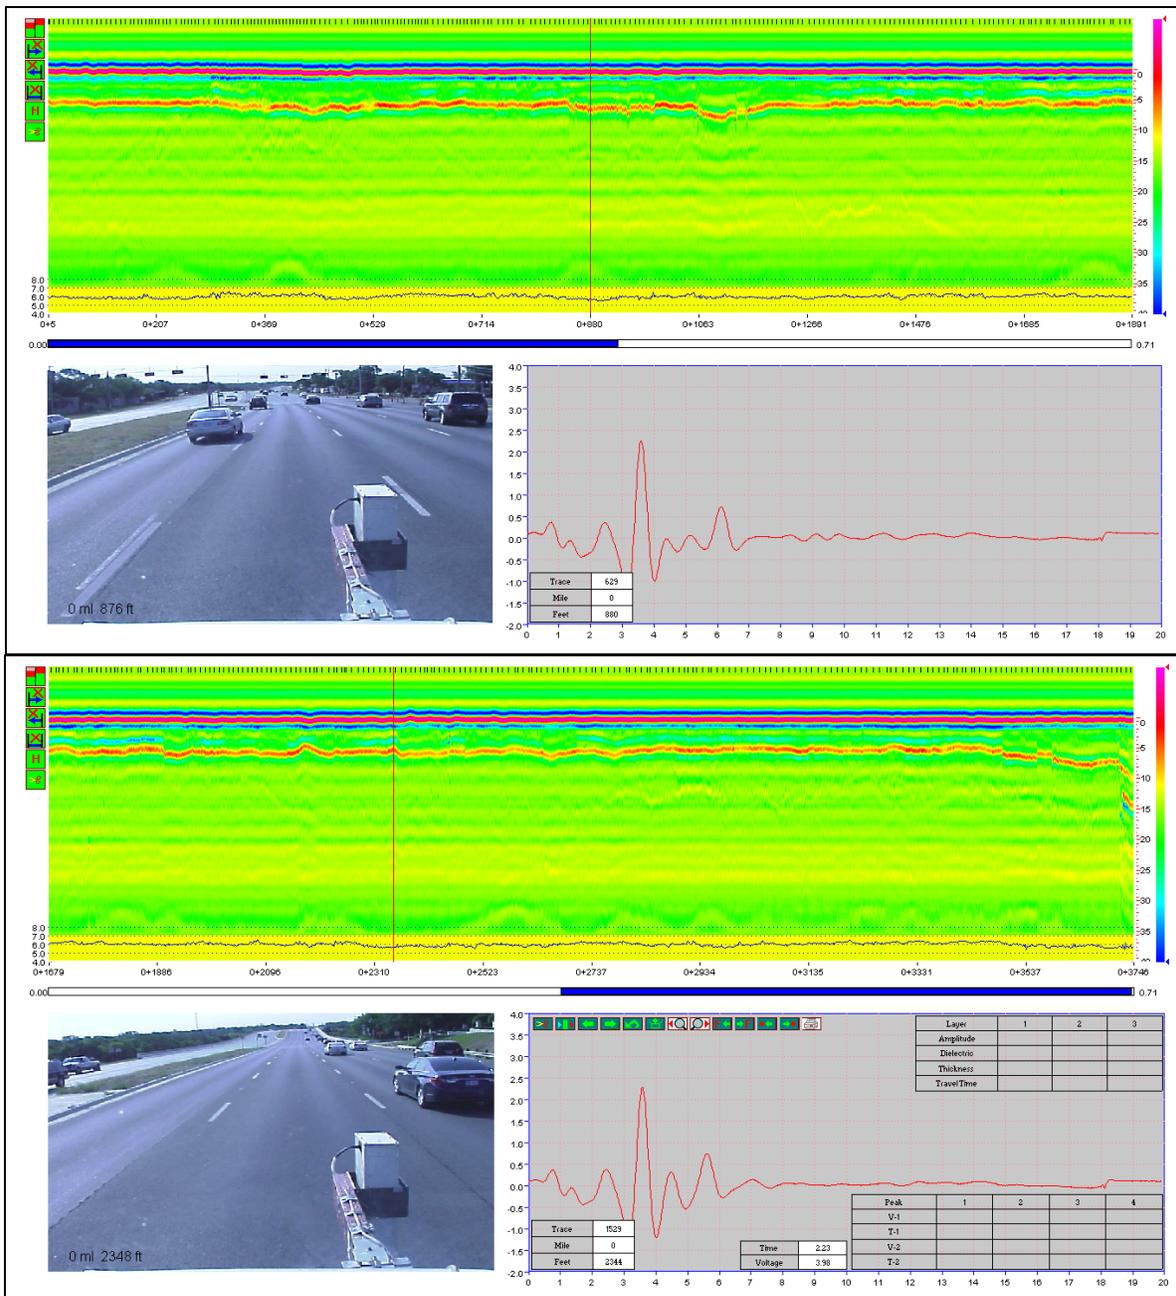
**Figure 91. GPR on Parmer Lane after Two Years of Service.**  
*Note: start of pull is at 292 ft in this GPR file.*

Figure 91 shows GPR data on Parmer Lane after two years of service. As compared to Figure 77, the surface dielectric does not vary as much as was observed immediately after construction.

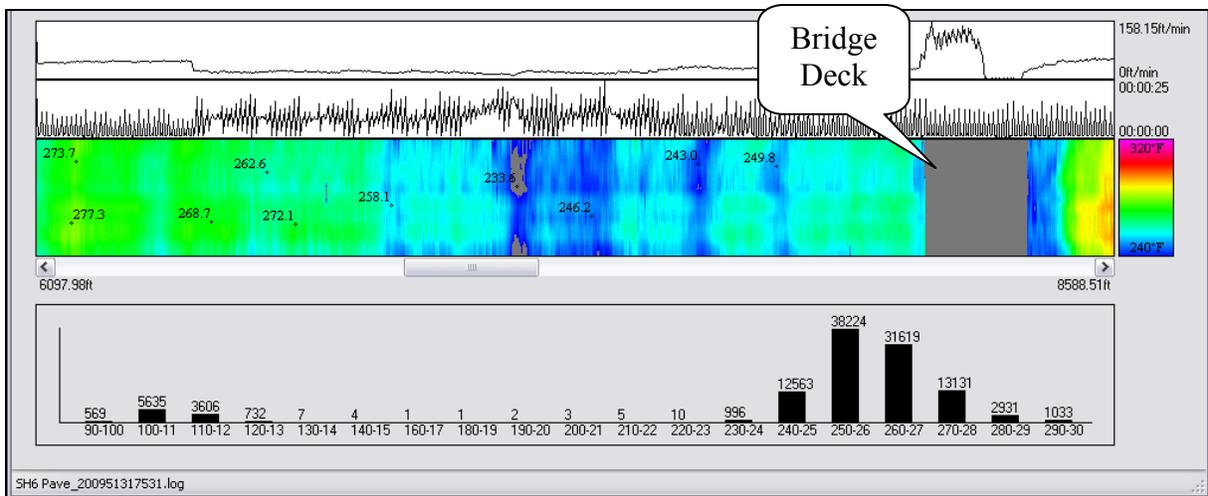
Figure 97. SH 6 Thermal Problems as Approaching First Bridge Deck.

The most anomalous location occurred as the paving train approached the first (northernmost) bridge deck. Figure 97 shows these data. Reportedly, the plant experienced some problems that resulted in this anomalous location. Figure 97 shows mix from approximately 1047 ft north of the bridge deck to the bridge deck not meeting the minimum desired placement temperature of 260°F. This location was from approximately Station 488.86 to the bridge deck. Additionally, the first approximately 67 ft south of the bridge deck did not exceed 260°F.

Although TxDOT does not currently apply thermal profiling to PFC mixtures, TTI performed a follow-up survey in July 2011. In particular, this survey focused on examining whether any problems existed at the location shown in Figure 97 with the thermal irregularities. Figure 98 contrasts the current GPR data from a representative portion of the project with the section of thermal irregularity at the time of placement. No visual or GPR indicators exist to suggest the zone with the thermal irregularity is substantially different than the normal section. Visually, no distress was observed, and the GPR shows no difference in surface dielectrics between the two zones.

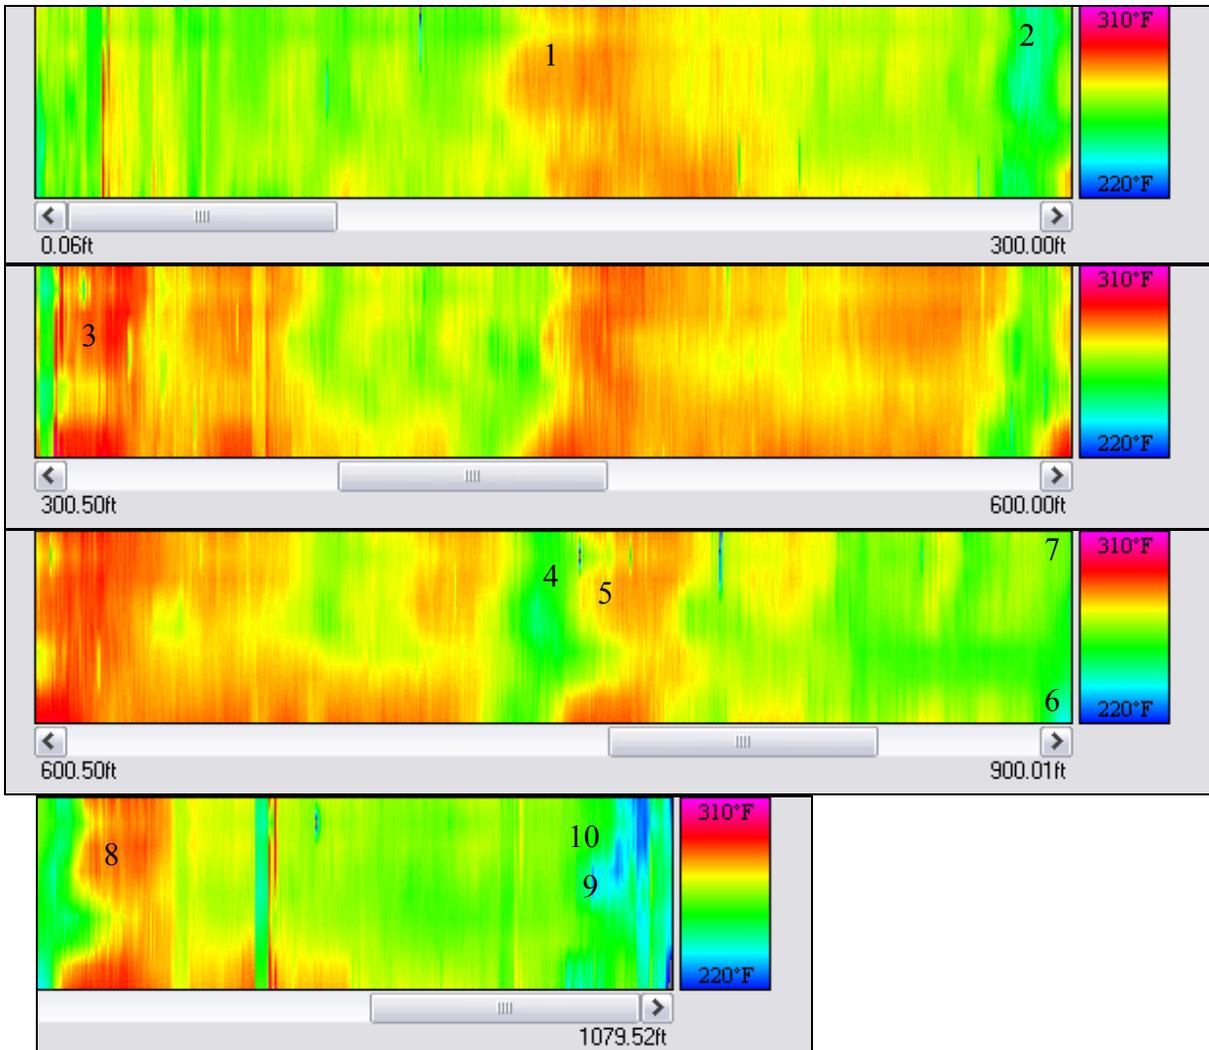
**Figure 100. US 190 Thermal Profile.**

Figure 100 shows the thermal profiles from the project. The thermal data show reduced temperatures at the truck ends with temperature differentials typically around 30°F. Ten locations were marked for further investigation, as annotated in Figure 100.

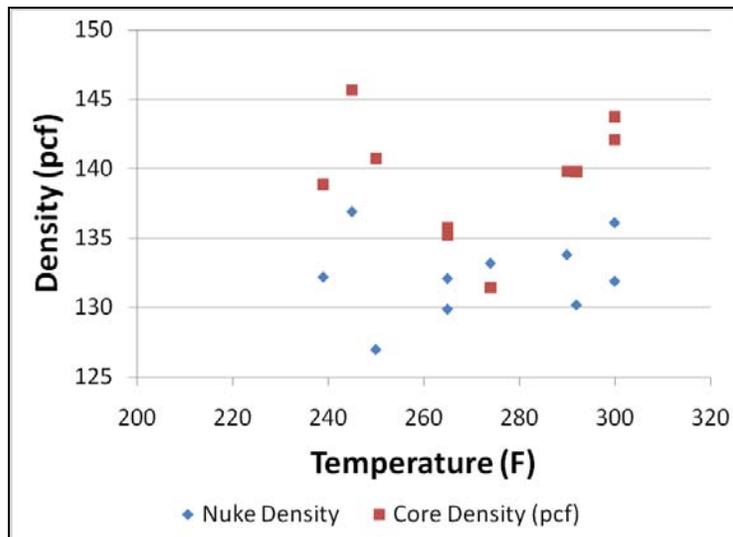
**Figure 102. Lack of Correlation between Temperature and Density on US 190.**

With the core data complete, researchers analyzed the IR and GPR data in conjunction with the core results to investigate the significance of the NDT readings. Historically, thermal cold spots typically show up as low density locations in the mat. However, Figure 102 illustrates that on this project the temperature data did not correlate to the in-place density.

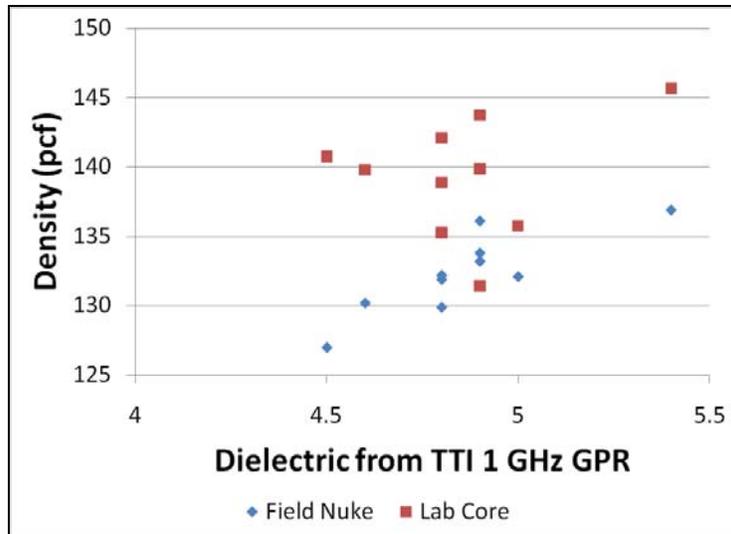
Figure 103. Lack of Correlation between GPR and Lab Density on US 190.

Figure 103 illustrates that on this project, although the GPR-measured surface dielectric correlated well with field nuclear density readings, neither the GPR nor the nuclear gauge correlated with the laboratory-measured core densities. More research needs to be conducted to determine why the GPR did not correlate with the lab densities. It is unknown if the mix type, the presence of fibers, or the rain at the plant contributed to the lack of tracking between the GPR and core densities.
