1. Report No. FHWA/TX-12/0-6080-1		2. Government Accession No.		3. Recipient's Catalog No.	
4. Title and Subtitle PERFORMANCE MONITORING PAVEMENTS WITH THERMAL SEGREGATION IN TEXAS				5. Report Date January 2012 Published: April 2012

# **PERFORMANCE MONITORING PAVEMENTS WITH THERMAL SEGREGATION IN TEXAS**

Report 0-6080-1

Project Title: Performance Histories of Thermally Segregated HMA

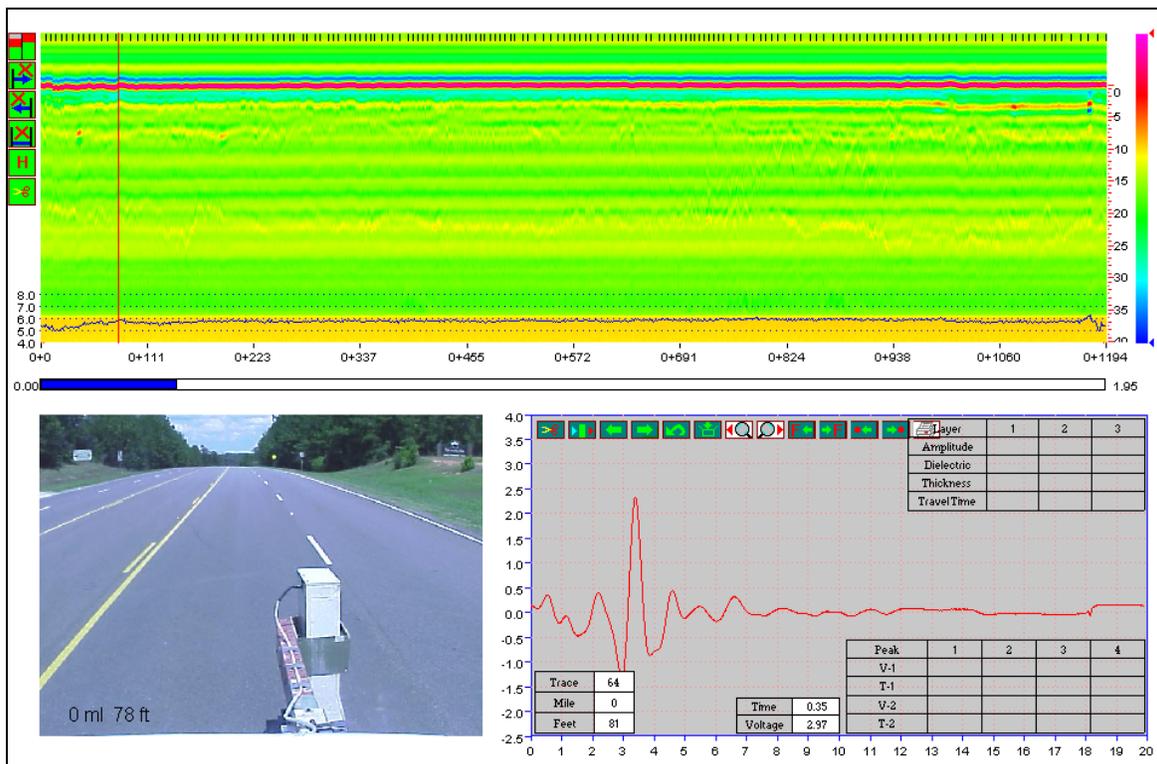
Figure 104. US 190 GPR after Two Years of Service.

In July 2011, TTI conducted a follow-up visual and GPR survey on this section. Visually, no distress was noted. Figure 104 presents the GPR data over the section approximately two years after construction. With the exception of the first 70 ft, and the location in the immediate vicinity of the construction joint at the end of the pull, the GPR data are uniform with no indication of concerns.

On this project, although at the time of construction some moderate thermal segregation was observed with temperature differentials typically around 30°F, after two years of service no evidence of concerns exists on the project. The section does not have any distress, and current radar data indicate a uniform surface mix.

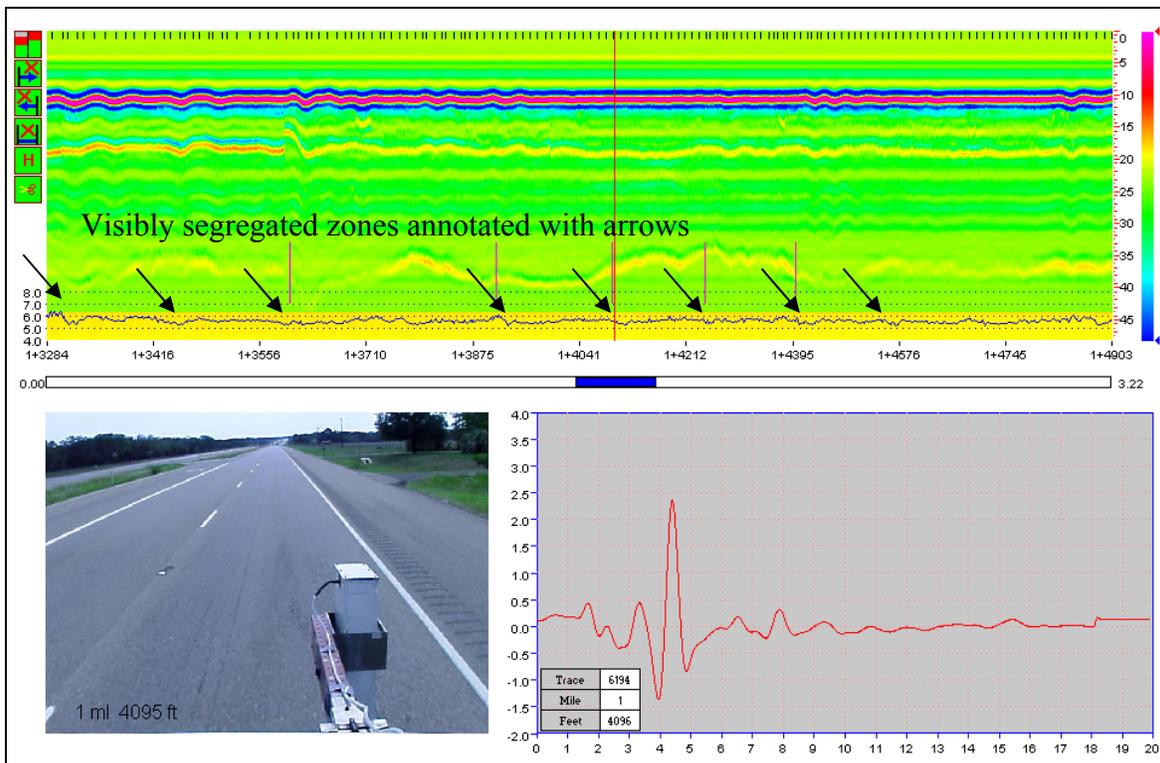
**Figure 109. Example GPR on SH 21 with Cyclical Distress.**

Figure 109 shows example GPR from this SH 21 project. The radar data show systematic drops in the surface layer dielectric corresponding to the segregated zones. These are the zones experiencing early failure. Had the construction been completed without segregation, the pavement condition would not have deteriorated as rapidly.

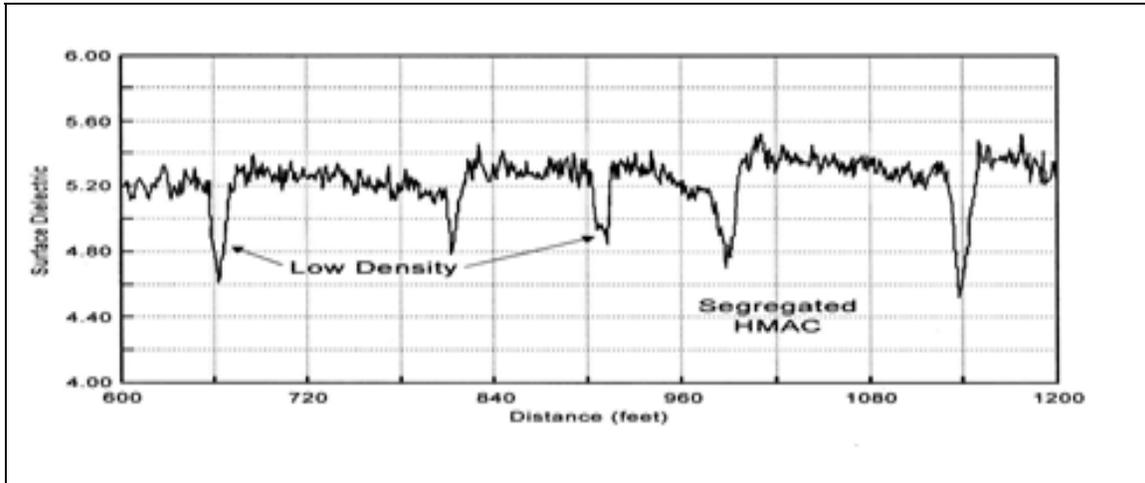
**Figure 113. Surface Dielectric for a Section of HMA Base Material on IH 20.**

One of the first demonstrations using GPR to identify thermal segregation was on a section of asphalt base material on IH 20 west of Odessa in 2002. Figure 113 shows the surface dielectric from the GPR data, clearly showing cyclical zones of low density in the mat.

At the time of construction, the segregated layer was not an immediate concern since it was to be overlaid with at least 4 inches of additional HMA. This section of highway has performed well for 10 years, and it was resurveyed in 2011 as part of the IH 20 corridor analysis that TTI conducted. Currently, this section has periodic transverse cracking and some longitudinal cracking. Figure 114 presents example GPR data from the section, which show some periodic negative reflections from mid-depth in the HMA layer. In most cases, the surface cracks coincided with the defects observed in the GPR data at mid-depth in the HMA layer.

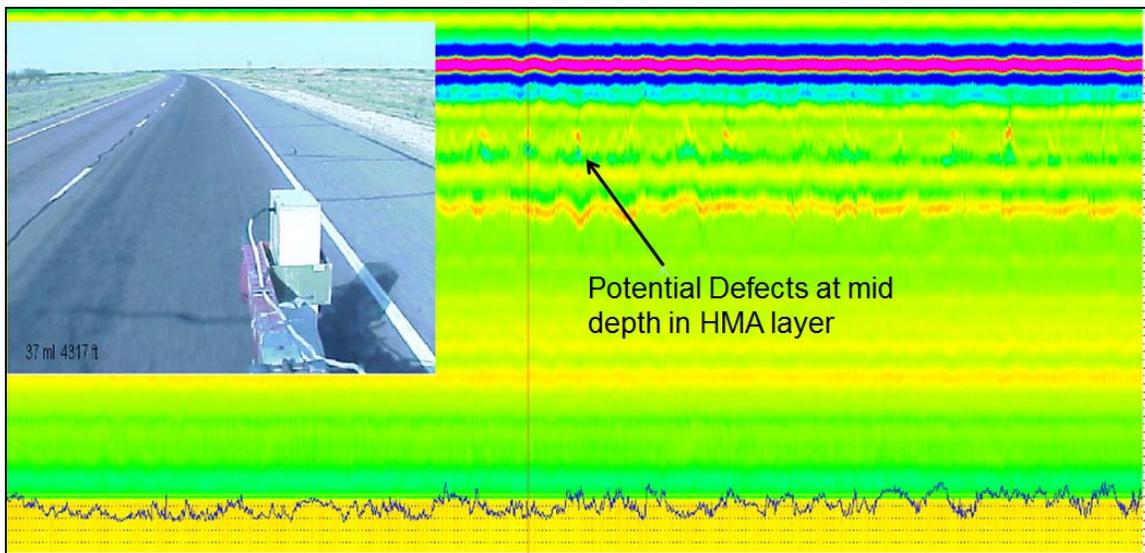
**Figure 114. GPR Data from IH 20 near Reference Marker 87.**

The GPR signature shown in Figure 114 was also observed in other locations of IH 20. Figure 116 shows an excerpt of radar data from TRM 148 to 159, which also exhibited periodic areas with a similar GPR display. This section has received a seal and a PFC surfacing, but as Figure 116 shows, localized suspect areas at mid depth exist in the HMA layer about 6 inches below the surface.

Based on these observations, field performance of these pavements suggests that buried thermal segregation may be a more significant problem than originally thought. With time and the probable ingress of moisture, these areas could continue to deteriorate. These localized

failure zones will become a major maintenance problem, since repairs to only the upper surface layers will not address the defect buried at mid-depth in the HMA layer. In the worst-case scenario, the problem in the lower HMA layers could continue to deteriorate to such a stage that rehabilitation of the section will require the complete replacement of all the HMA layers.
