# LTPP Pavement Maintenance Materials: PCC Partial-Depth Spall Repair Experiment, Final Report

PUBLICATION NO. FHWA-RD-99-153

OCTOBER 1999

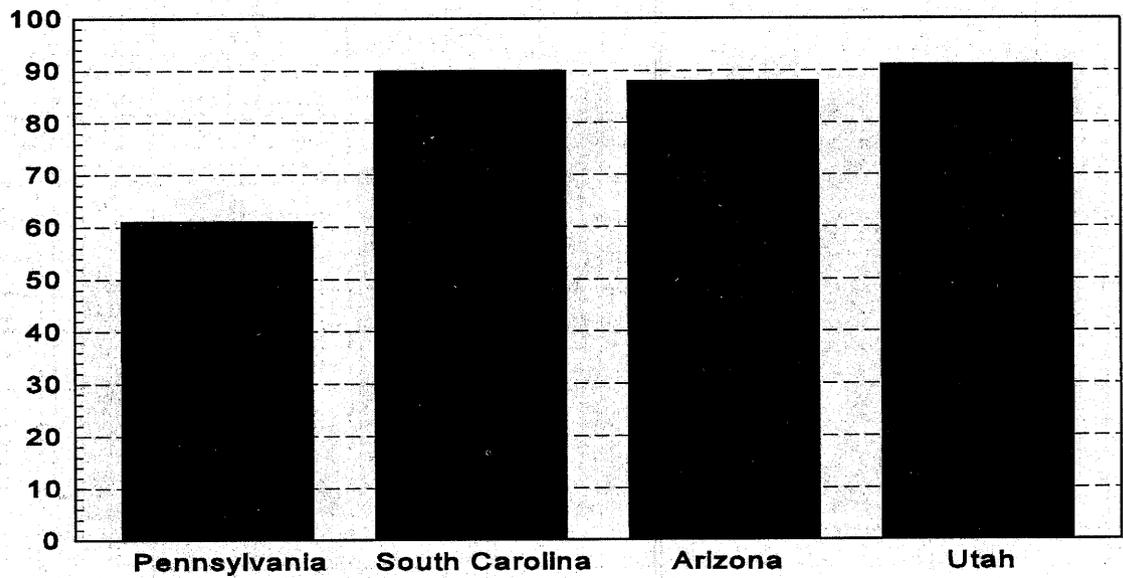
Figure 21. Percentage of surviving patches by test site.

Conceptually, a patch is considered failed if it can no longer service traffic safely. As seen in figure 21, as of the final evaluations, 39 percent of the patches were failed at the Pennsylvania test site, 12 percent were failed at the Arizona test site, 10 percent were failed at the South Carolina test site, and 9 percent were failed at the Utah test site.

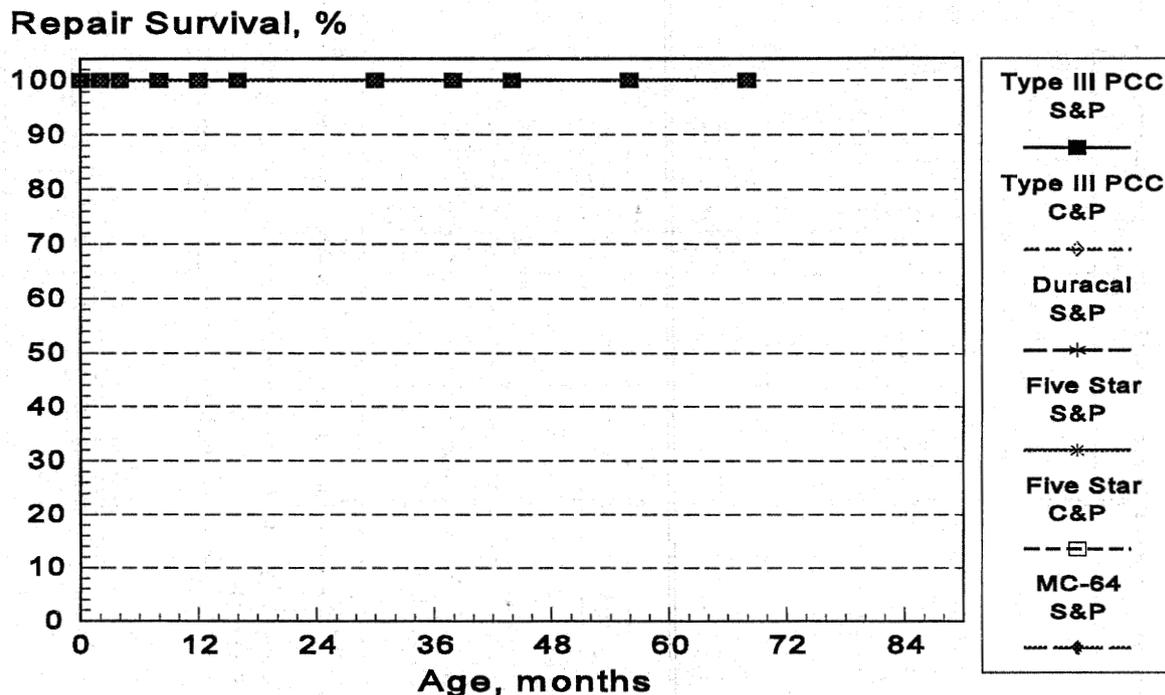
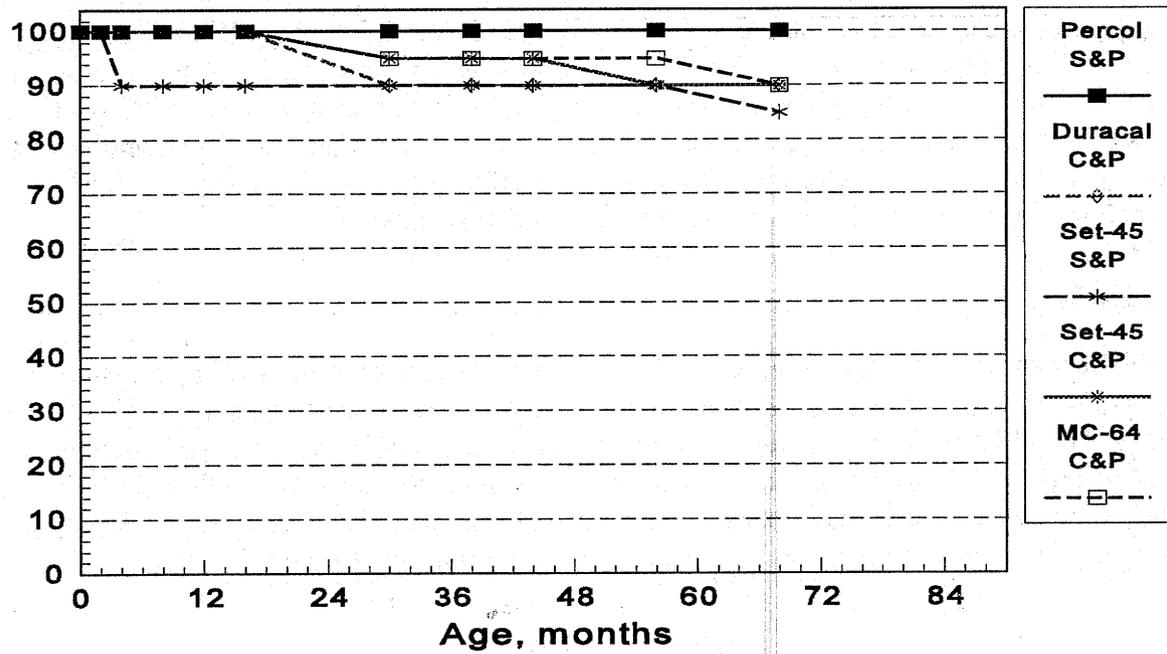
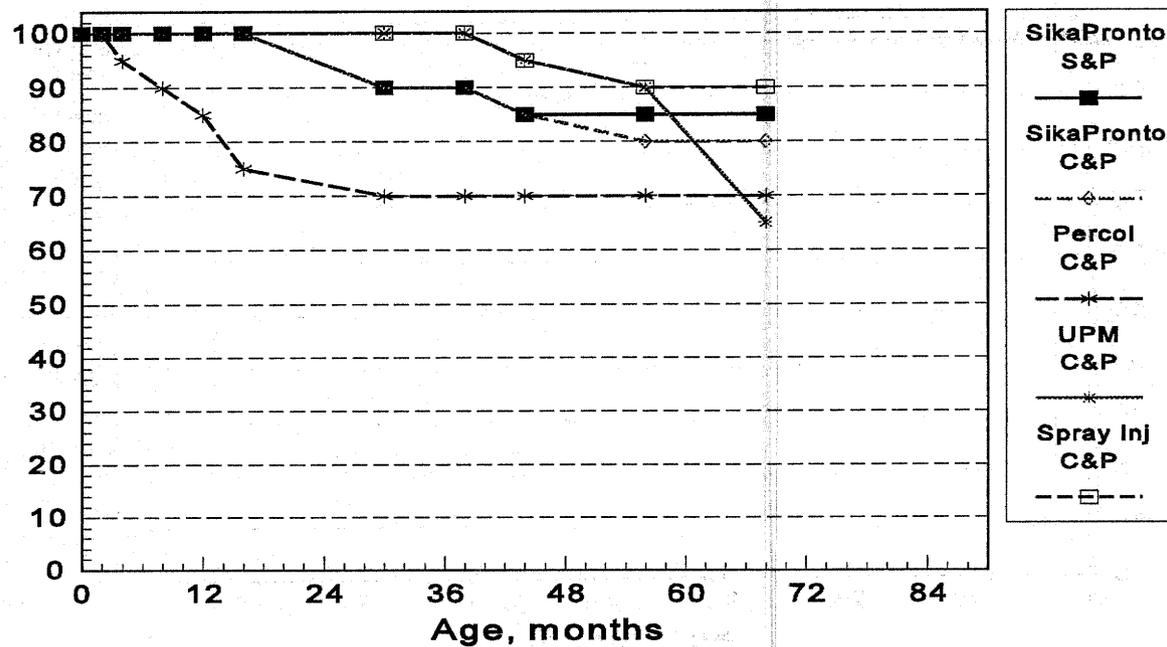
Figure 24. Spall repair survival at South Carolina test site.

Figures 24 through 27 show the survival trends of the various repair types placed at each of the four test sites. These figures indicate that the percentage of repairs surviving after 4 to 7 years is quite variable for the Pennsylvania and Arizona test sites, whereas all but three repair types experienced no failure over 7 years of observation at the Utah test site. The fact that the repairs were all in the passing lane and not subjected to the majority of the truck traffic was one of the factors contributing to the good performance observed at the Utah site. The overall good condition of the pavement, which was better than any of the other spall repair test sites, also provided the repairs with a better opportunity for good performance.
