PERFORMANCE EVALUATION OF IOWA BRIDGE DECKS CONSTRUCTED WITH EPOXY-COATED REINFORCING BARS

Final Report
August 19, 2011
WJE No. 2010.0868

Prepared for:
Iowa Department of Transportation
Office of Bridges and Structures
800 Lincoln Way
Ames, Iowa 50010

Prepared by:
Wiss, Janney, Elstner Associates, Inc.
330 Pfingsten Road
Northbrook, Illinois 60062
847.272.7400 tel | 847.291.4813 fax

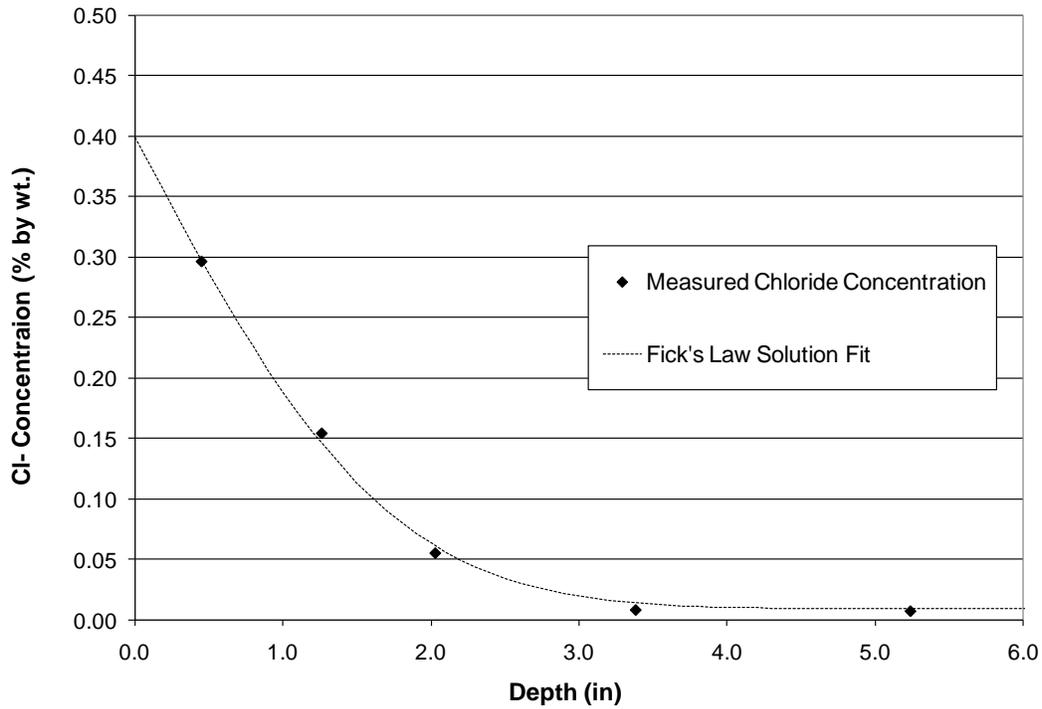
Figure 29. Measured chloride concentration and fitted solution to Fick's Law

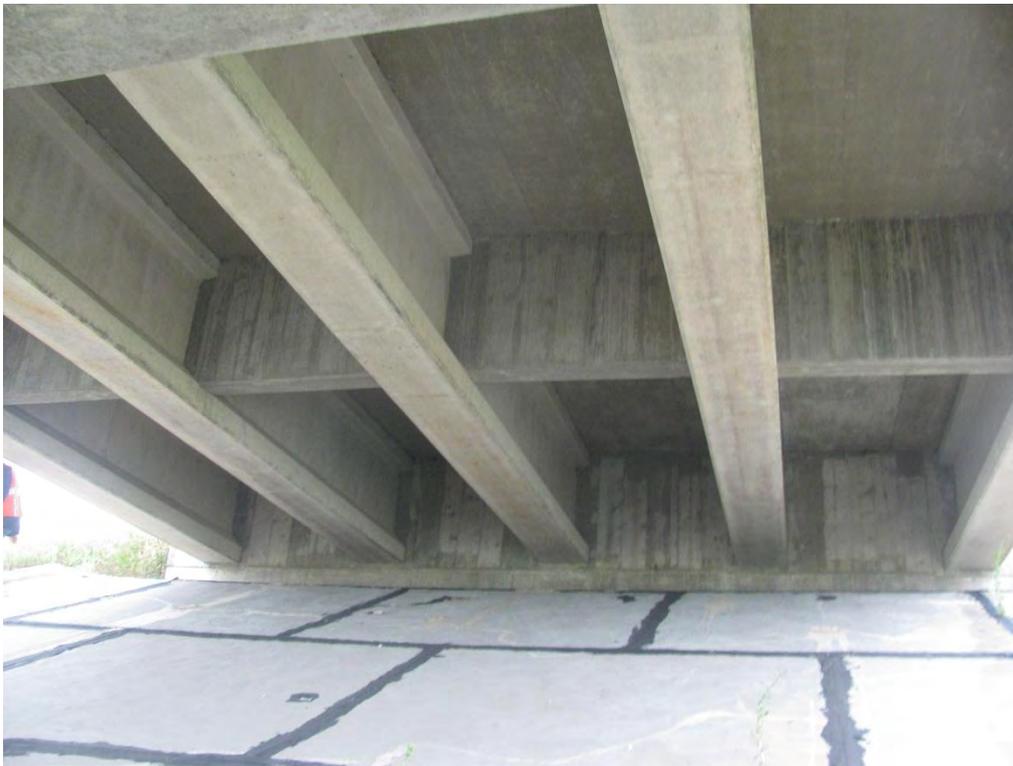
Figure 30. Typical view of IA 17 deck underside

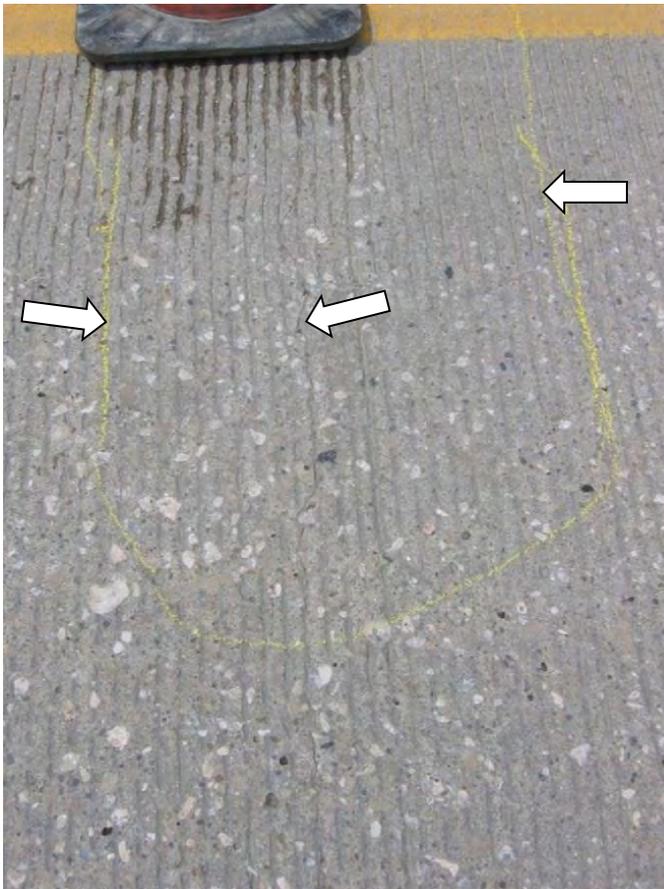
Figure 32. Area of delaminated concrete (outlined in yellow) at a transverse crack in the IA 150 bridge deck.

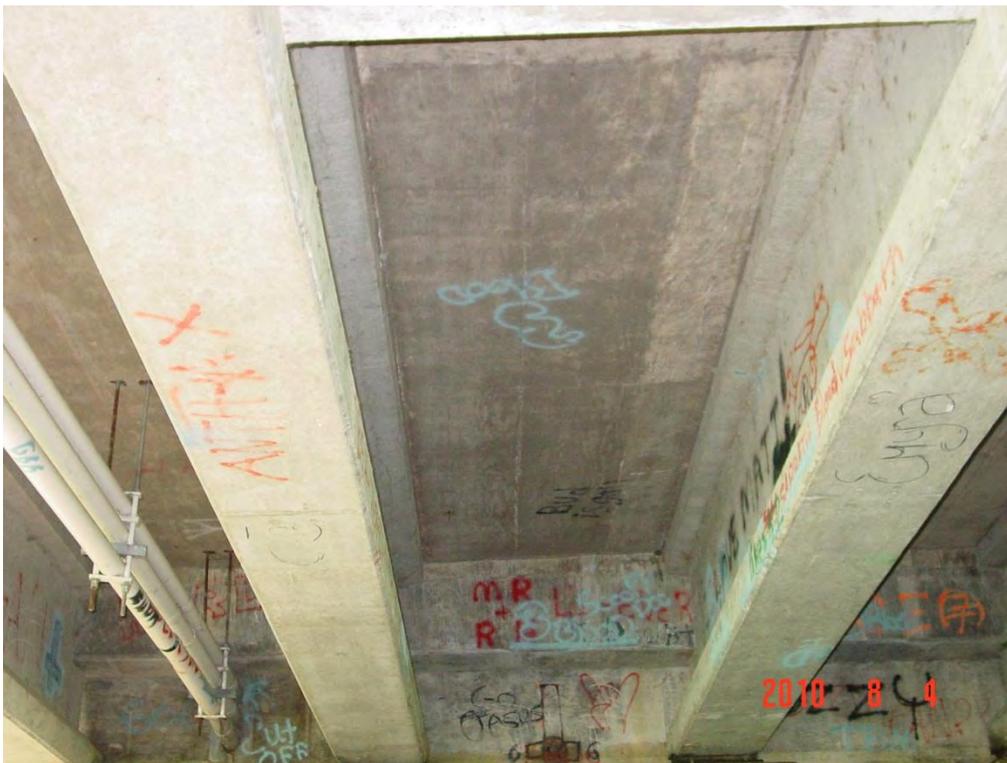
Figure 34. View of underside of IA 150 deck adjacent to the north abutment.

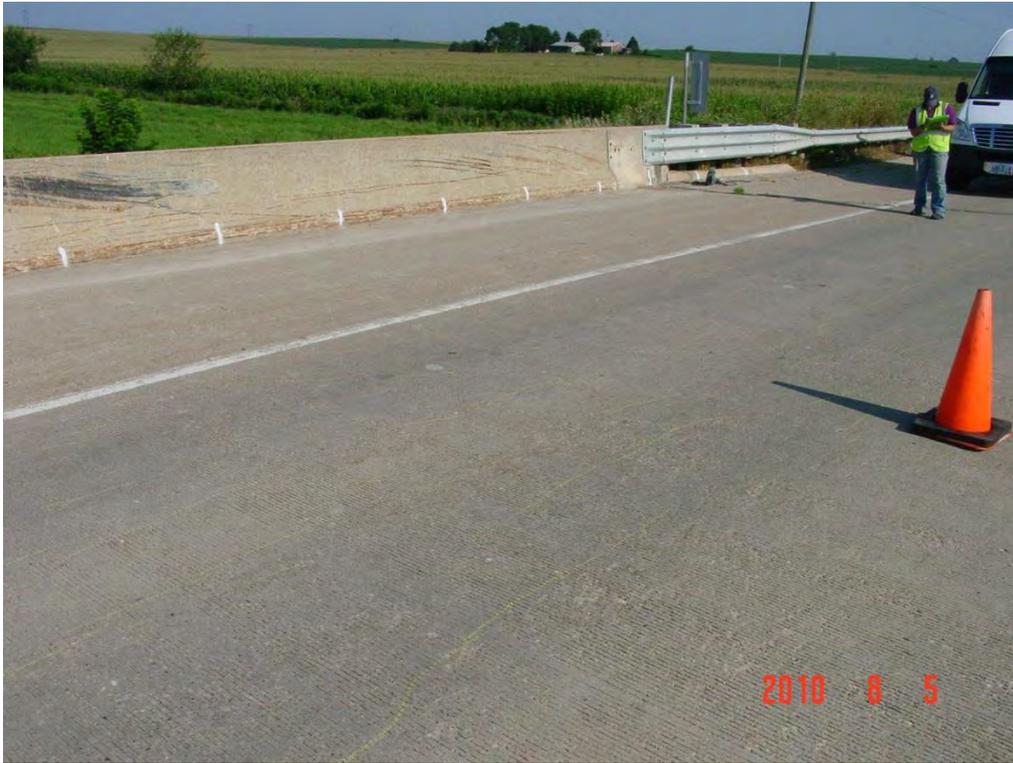
Figure 35. Typical view of top surface of the Southbound Iowa 13 bridge deck.

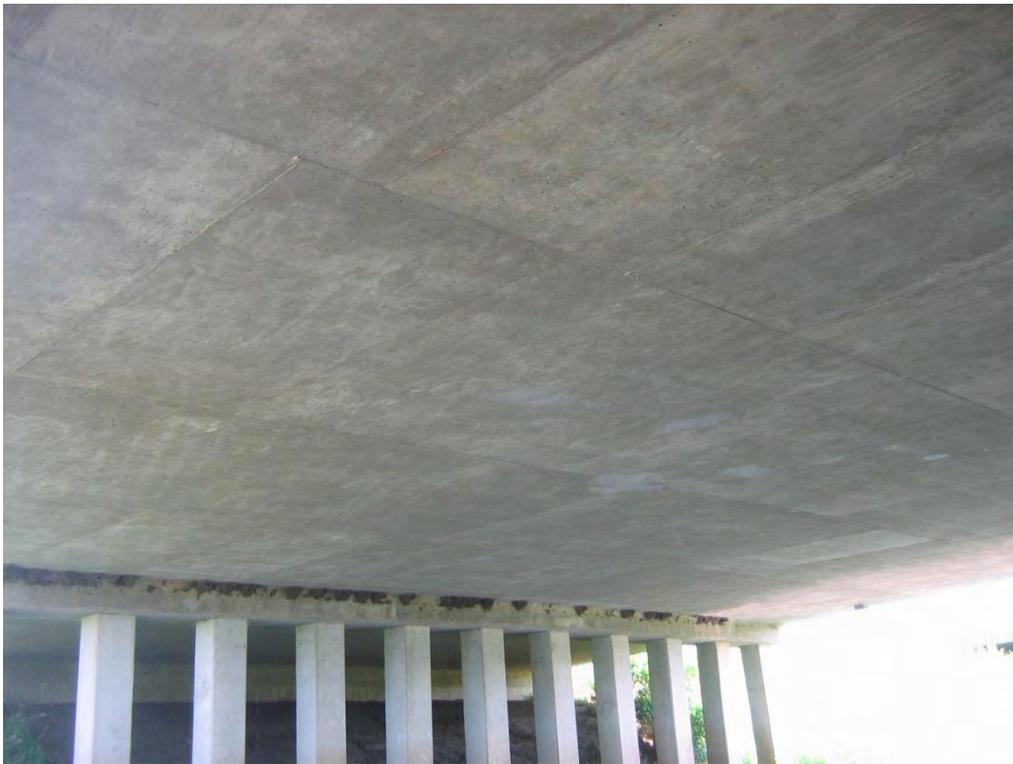
Figure 36. Typical view of the underside of the Southbound Iowa 13 bridge deck.

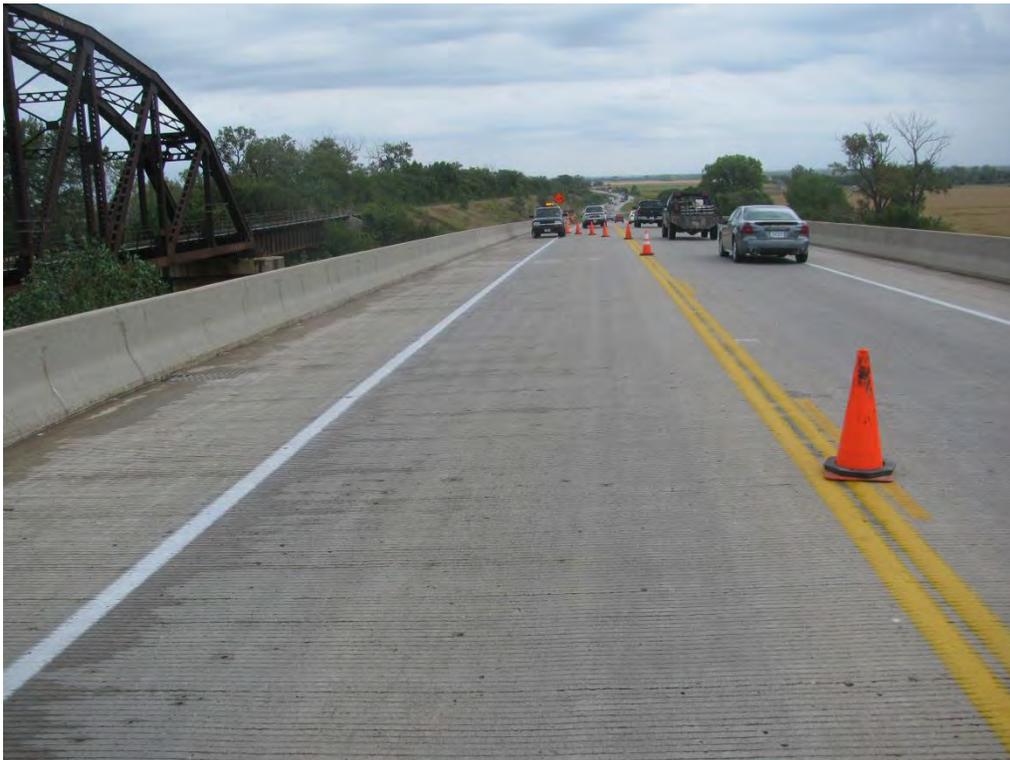
Figure 38. Typical view of US 30 bridge deck in east approach spans.

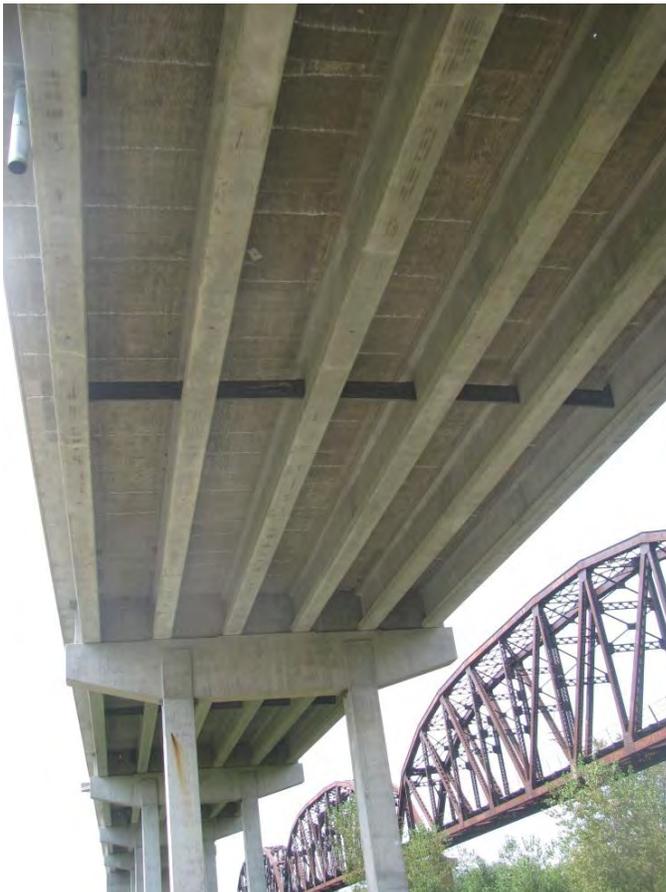
Figure 40. Regular through deck transverse cracks highlighted by efflorescence on the underside of east approach spans for the US 30 bridge deck

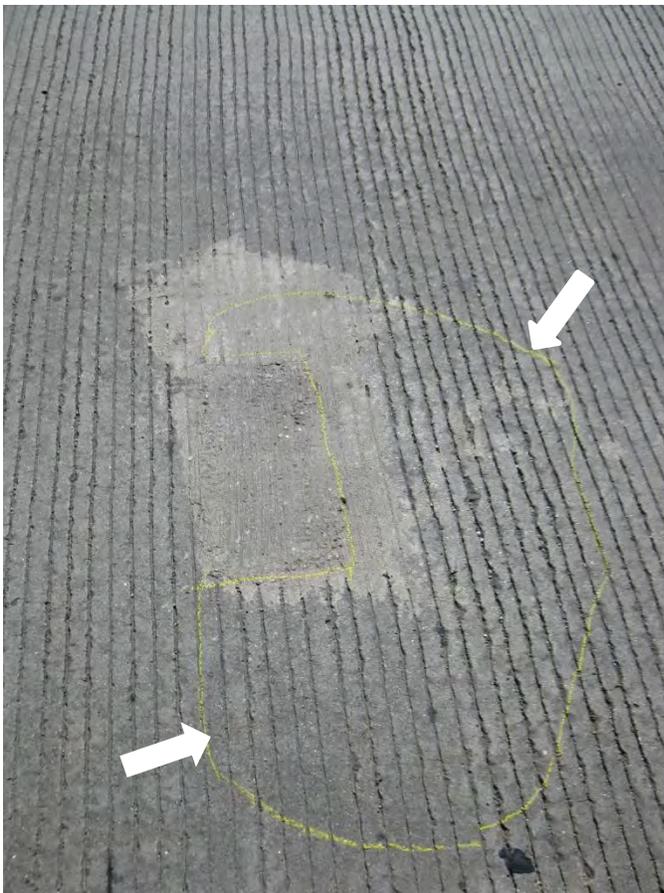
Figure 42. Area of delaminated concrete (outlined in yellow) immediately adjacent to an existing patch on the west approach spans of the US 30 bridge

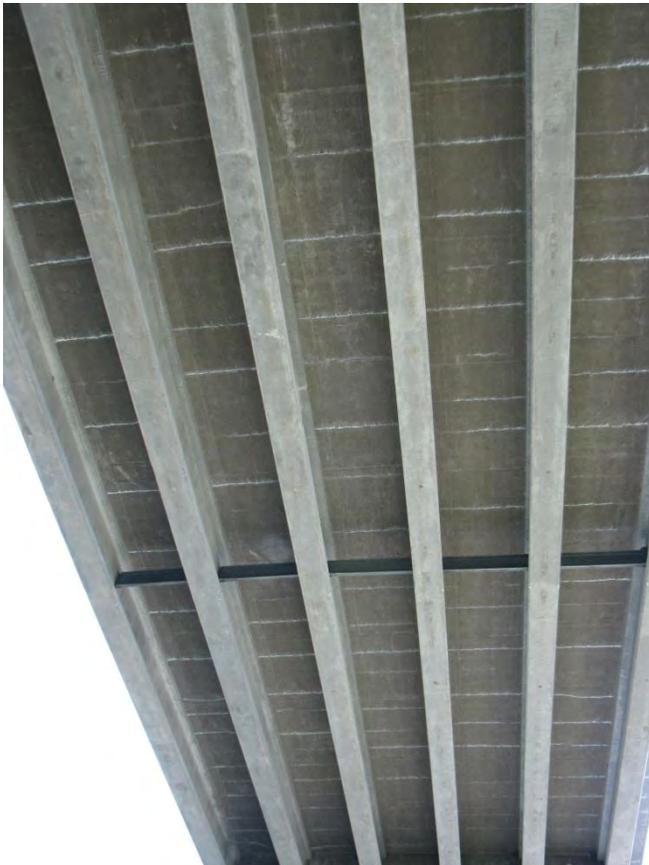
Figure 44. Area of typical transverse cracking with efflorescence at underside of west approach spans for the US 30 bridge.

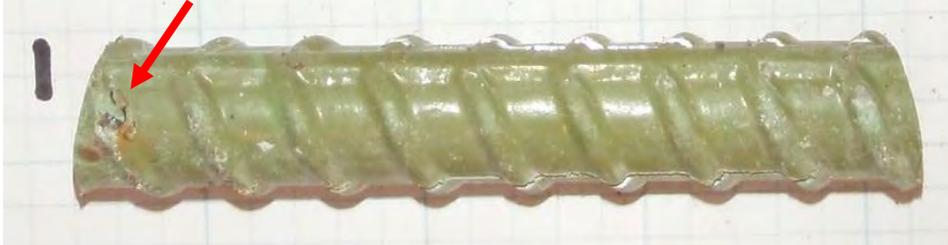
Figure 45. Pre-existing damage to coating of actively corroding bar in Core #2 from US 30 bridge deck (location of damage indicated by red arrow).

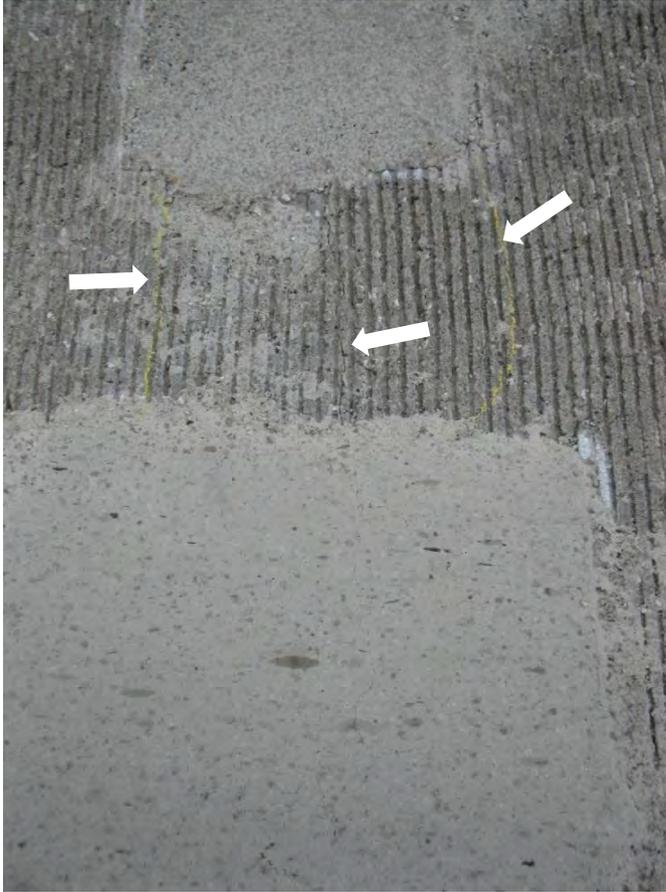
Figure 49. Area of delaminated concrete outlined in yellow between two patches and along a transverse crack in the Southbound US 65 bridge deck.

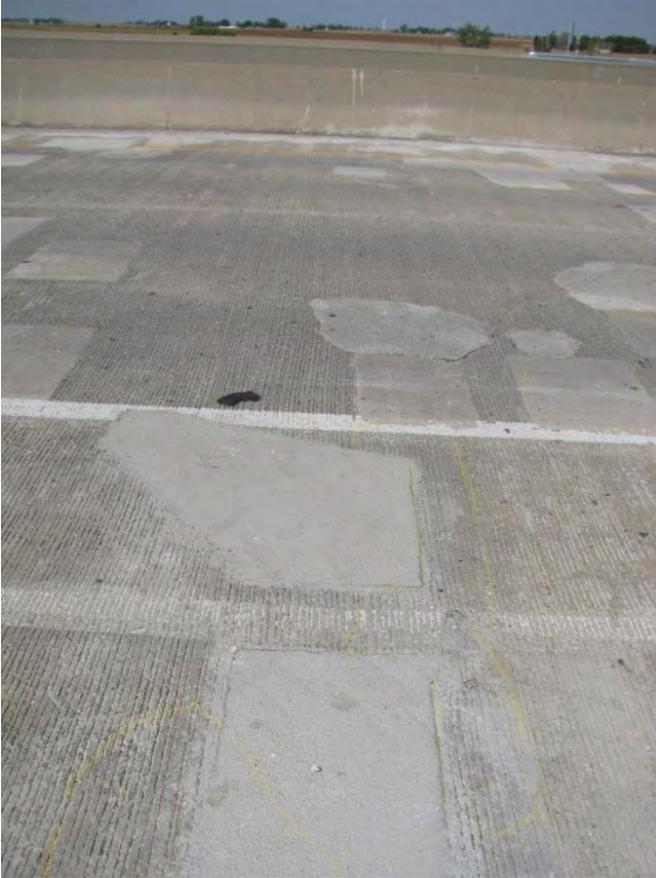
Figure 53. Area of extensive patching on Northbound US 65 bridge deck.

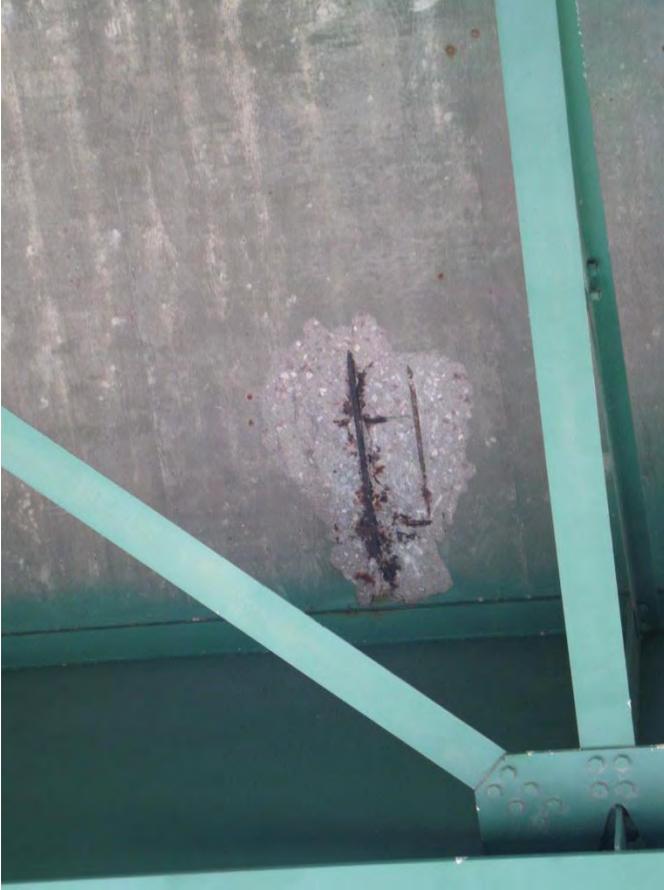
Figure 55. Area of spalled concrete on underside of Northbound US 65 deck.

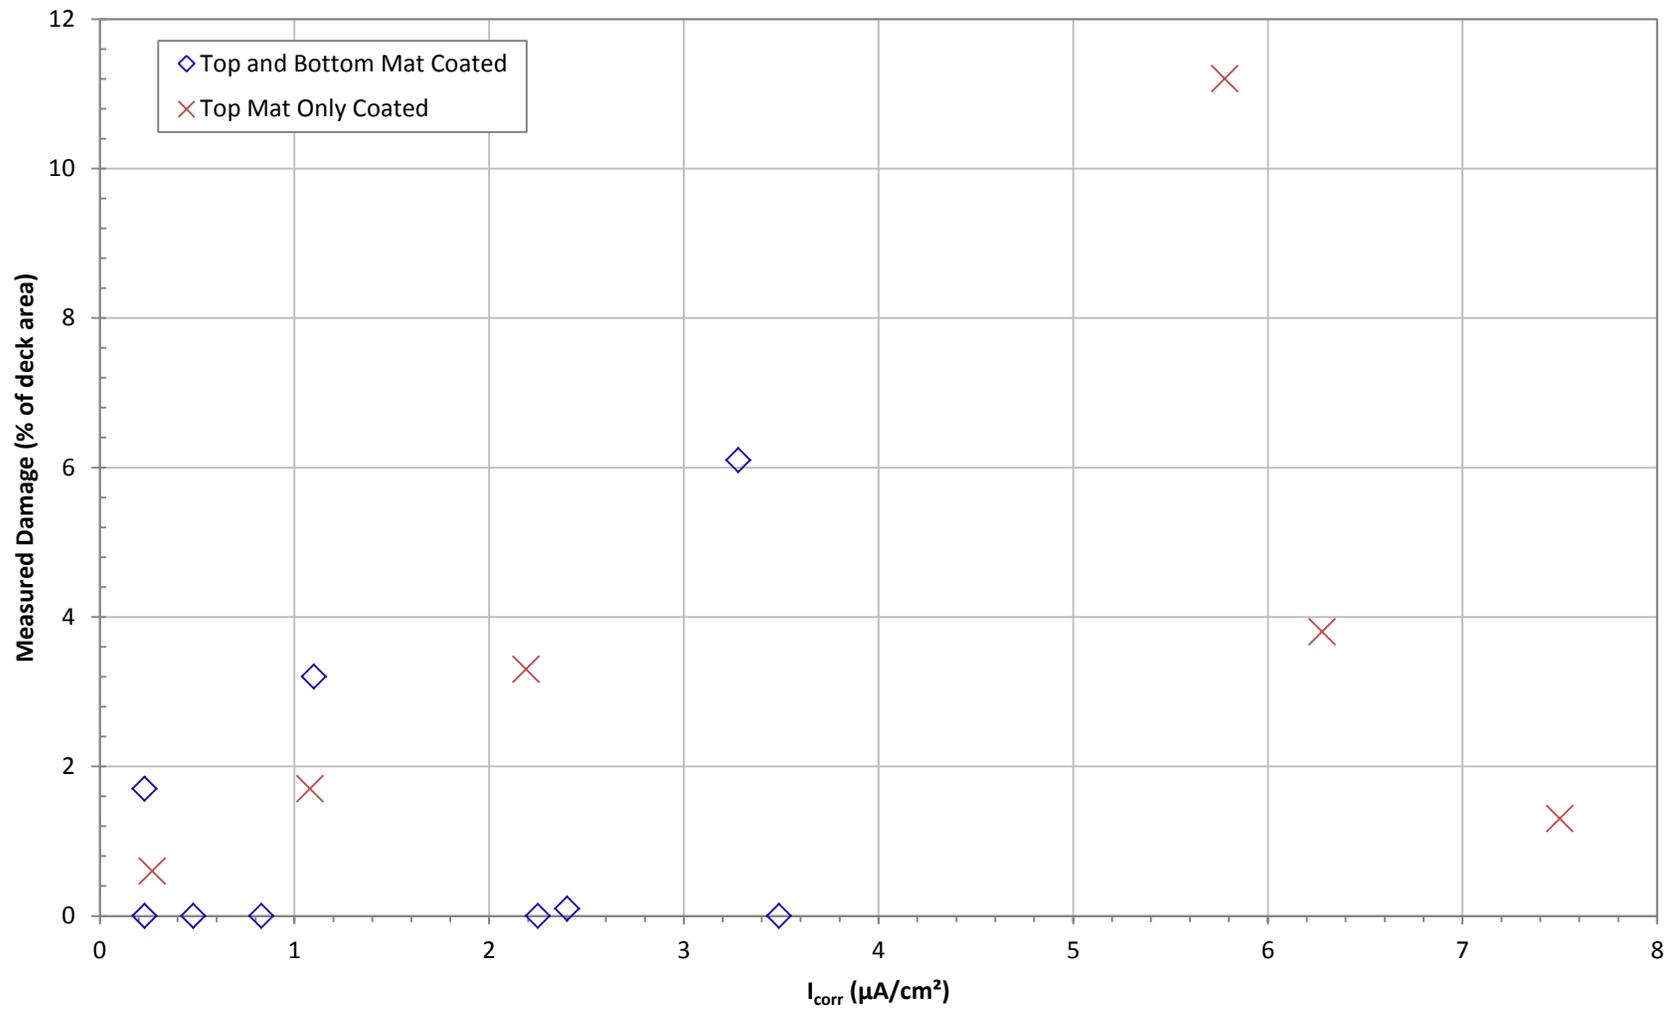
Figure 57. Measured damage to deck (delaminations, spalls, and repairs) compared to average instantaneous corrosion rate (I_{corr}) measured for all deck sections surveyed.

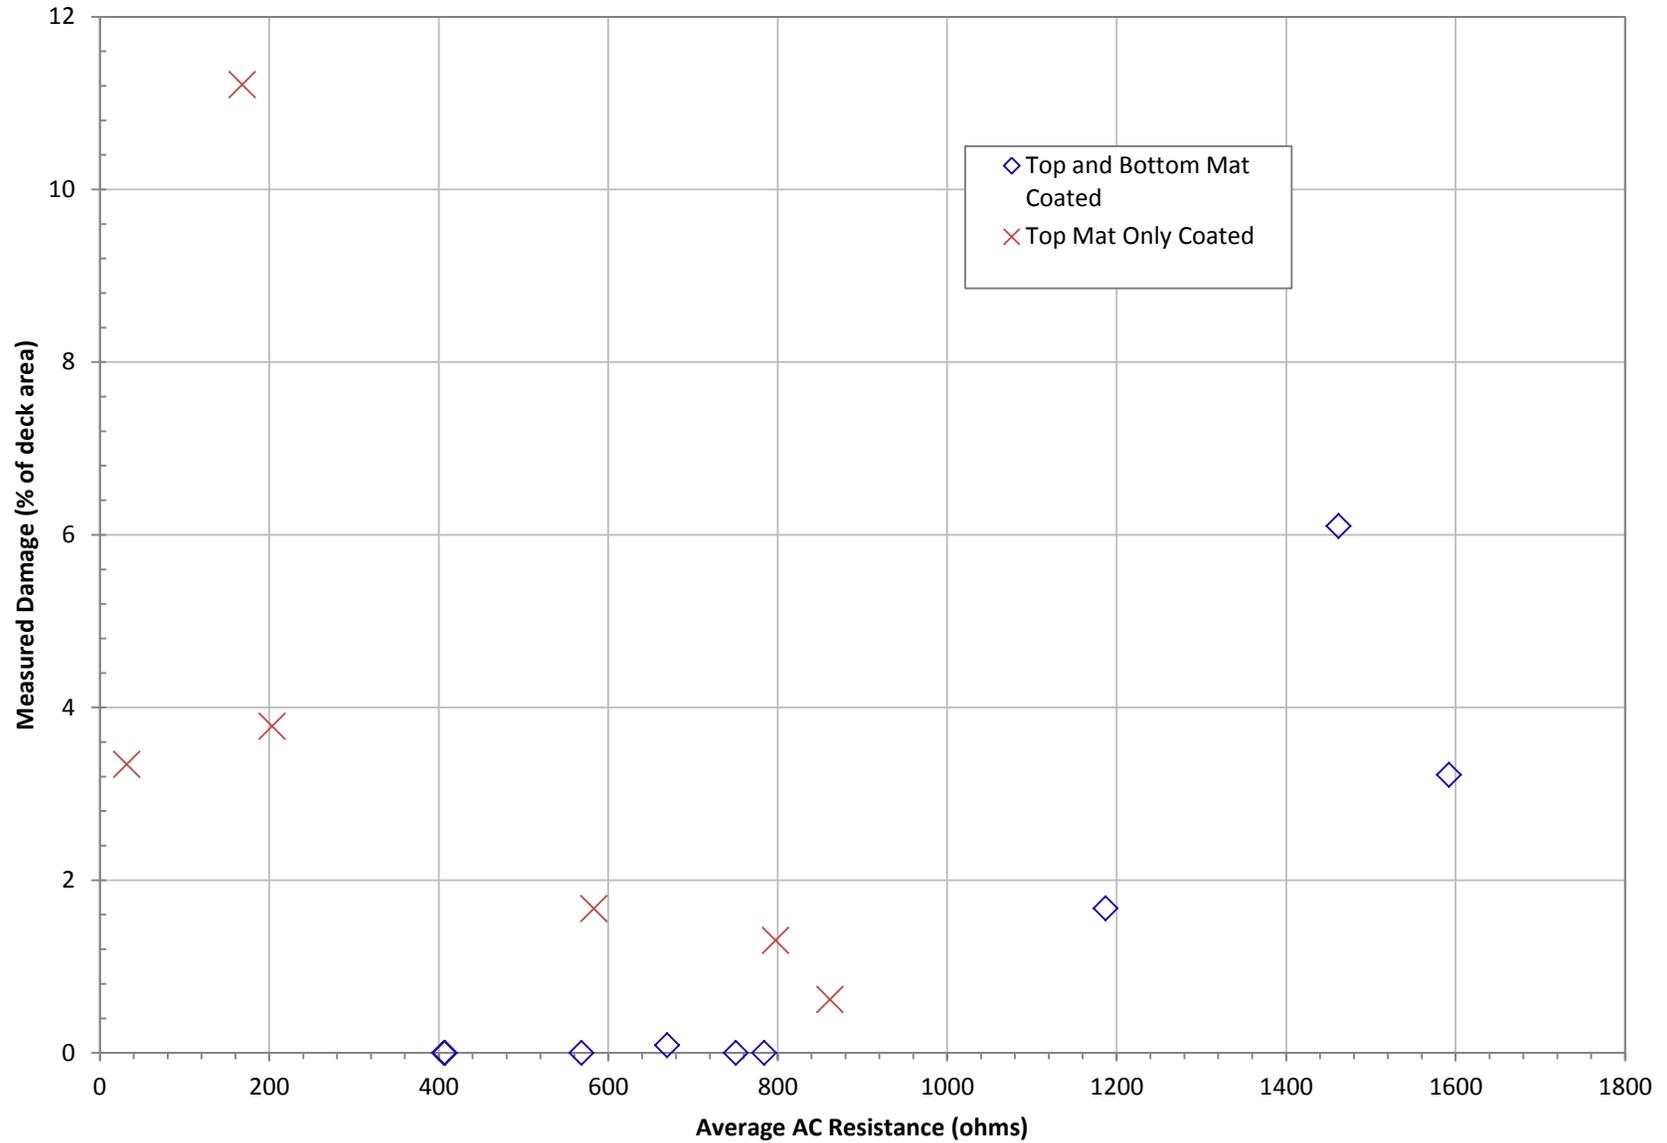
Figure 58. Measured damage to deck (delaminations, spalls and repairs) compared to average AC resistance for all deck sections surveyed.

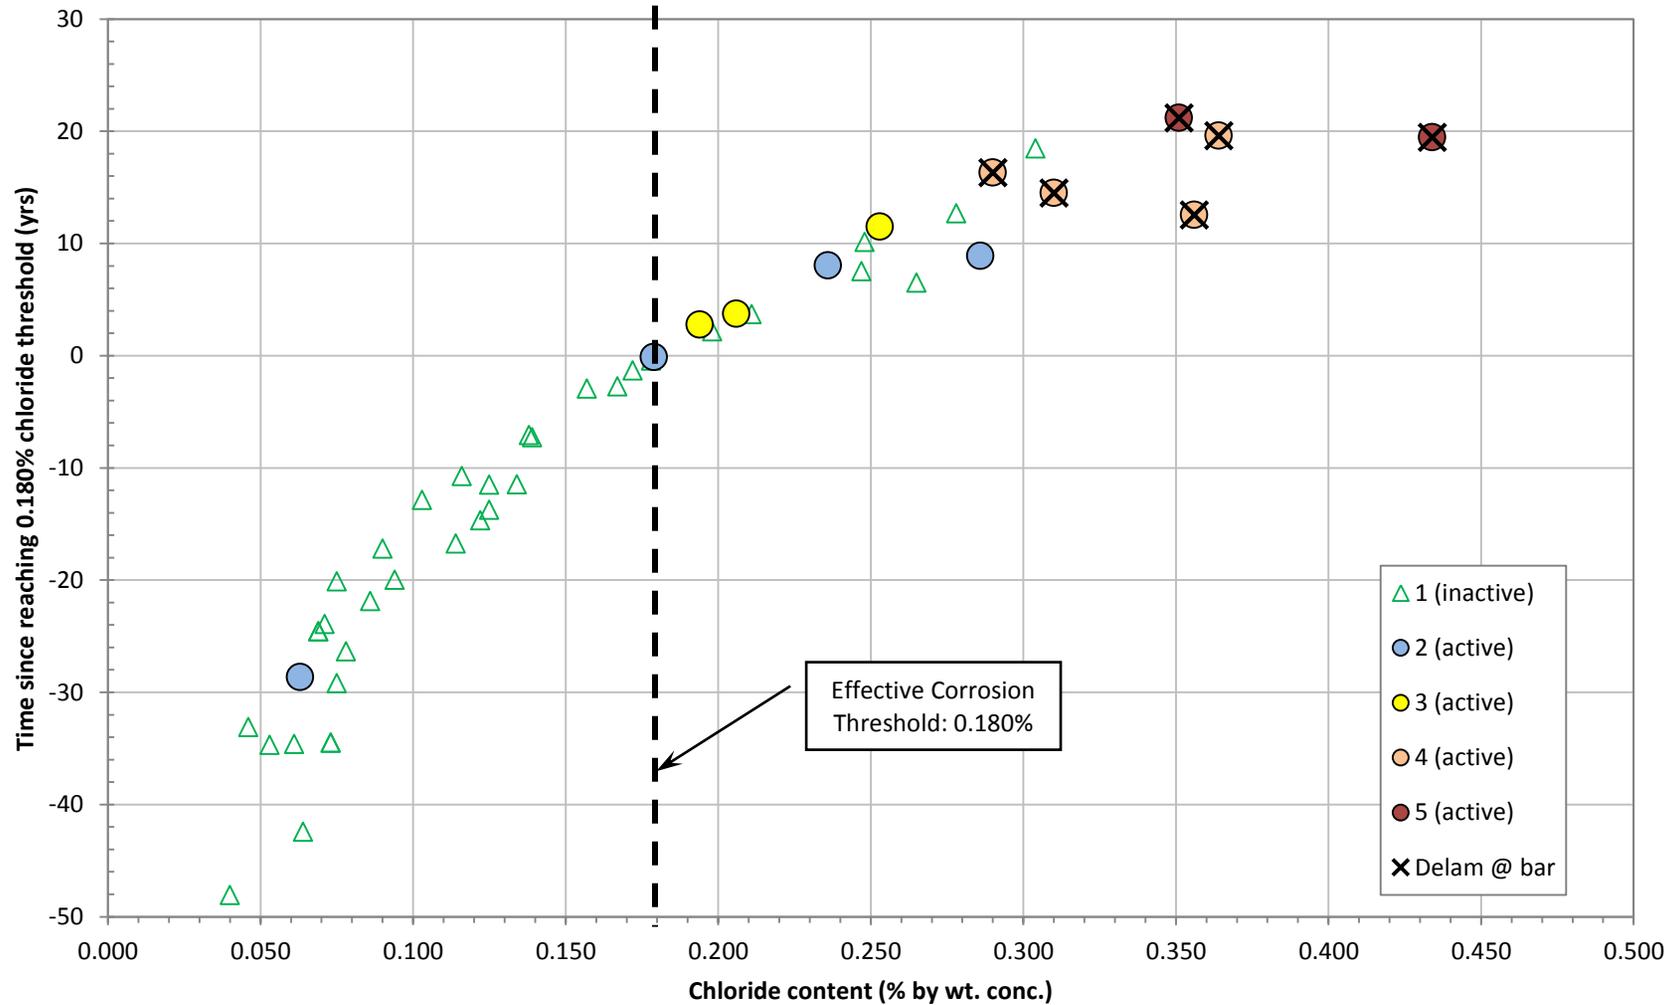
In the data shown in Figure 63, more severe corrosion was observed in those bars exposed to high chloride concentrations for longer periods of time. Concrete delamination was observed only at bars that exceeded the effective threshold of 0.180 percent by weight of concrete more than 12 years ago. This suggests that it may take at least 10 years for corrosion to propagate on coated bars before sufficient stresses are generated to crack and delaminate the concrete. The data shown in Figure 63 includes

Figure 63. Time since reaching 0.180% by wt. chloride content at bar depth vs. chloride content at bar depth, categorized by corrosion rating. Positive numbers indicate the length of time since reaching the specified threshold. Negative numbers indicate that the chloride content at the bar has not yet reached 0.180 % by wt.

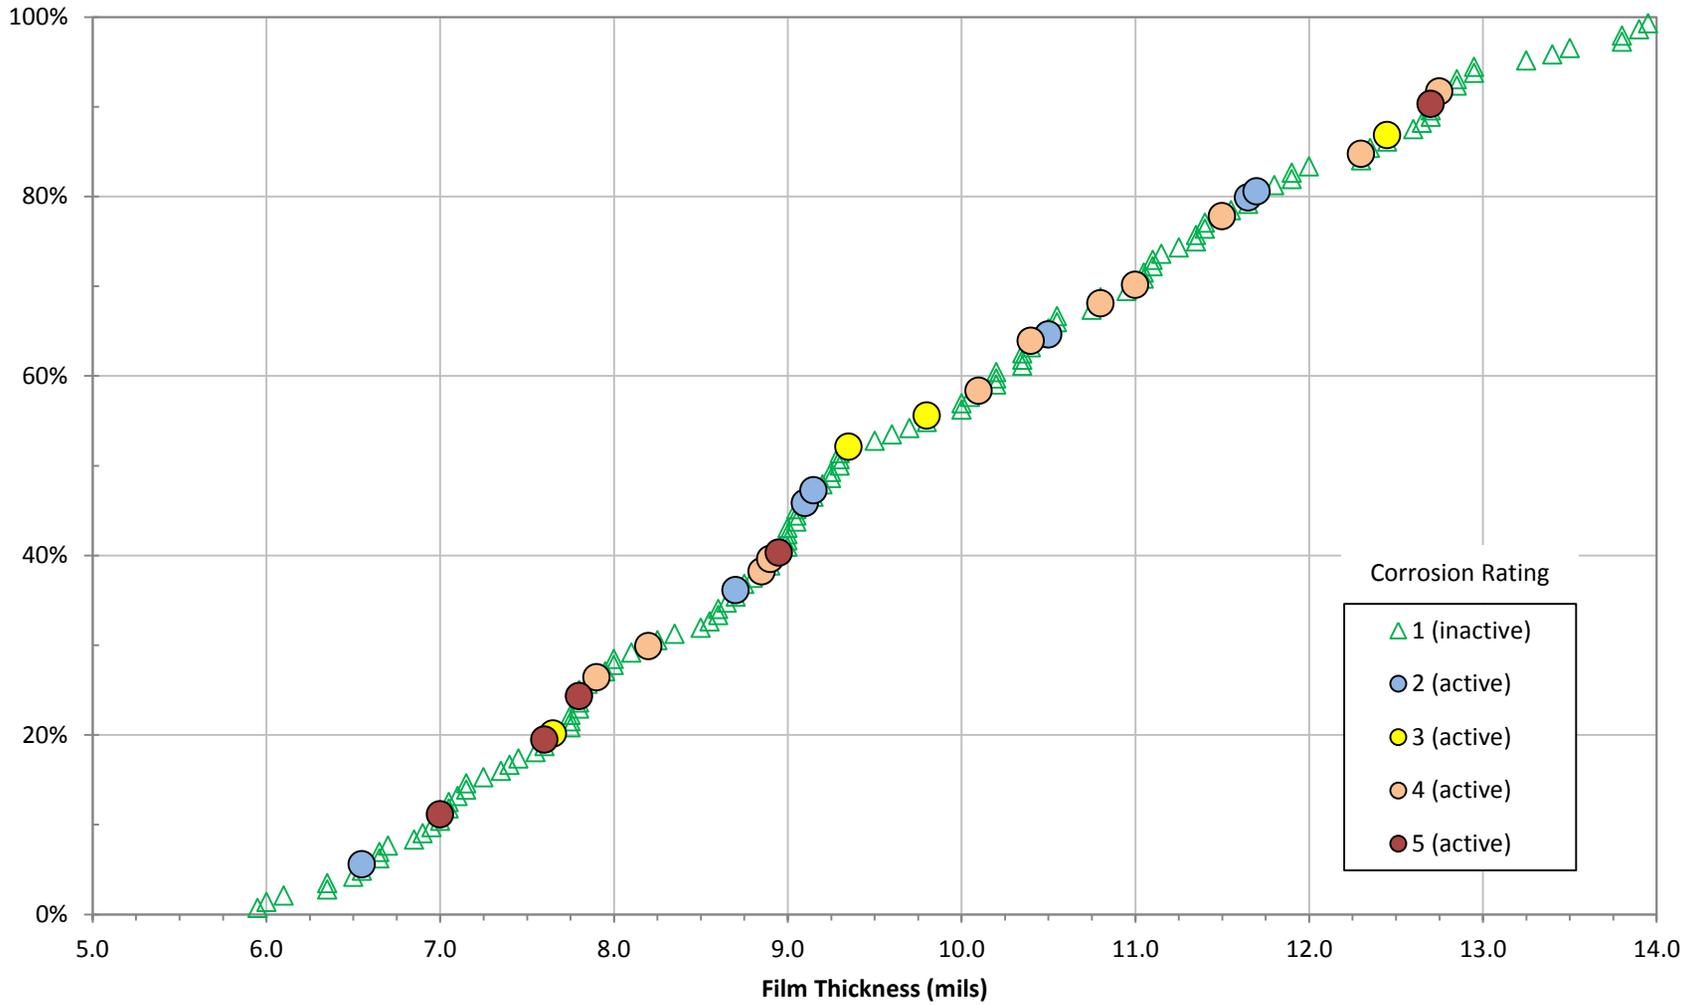
In Figure 64, the distribution of measured coating thickness is shown. The coating thickness on the extracted bar segments ranged from 6 to 14 mils. An increased frequency of coating holidays or other defects is known to be associated with thinner coatings, and such defects would be expected to produce a more rapid onset of corrosion (Pfeifer, Landgren, & Krauss, 1992). However, for this sample set, this property was not strongly correlated to corrosion, with bar segments judged to be experiencing active corrosion having coating thicknesses ranging from 6.5 to 12.5 mils.

Figure 64. Cumulative distribution of epoxy film thickness, categorized by corrosion activity.

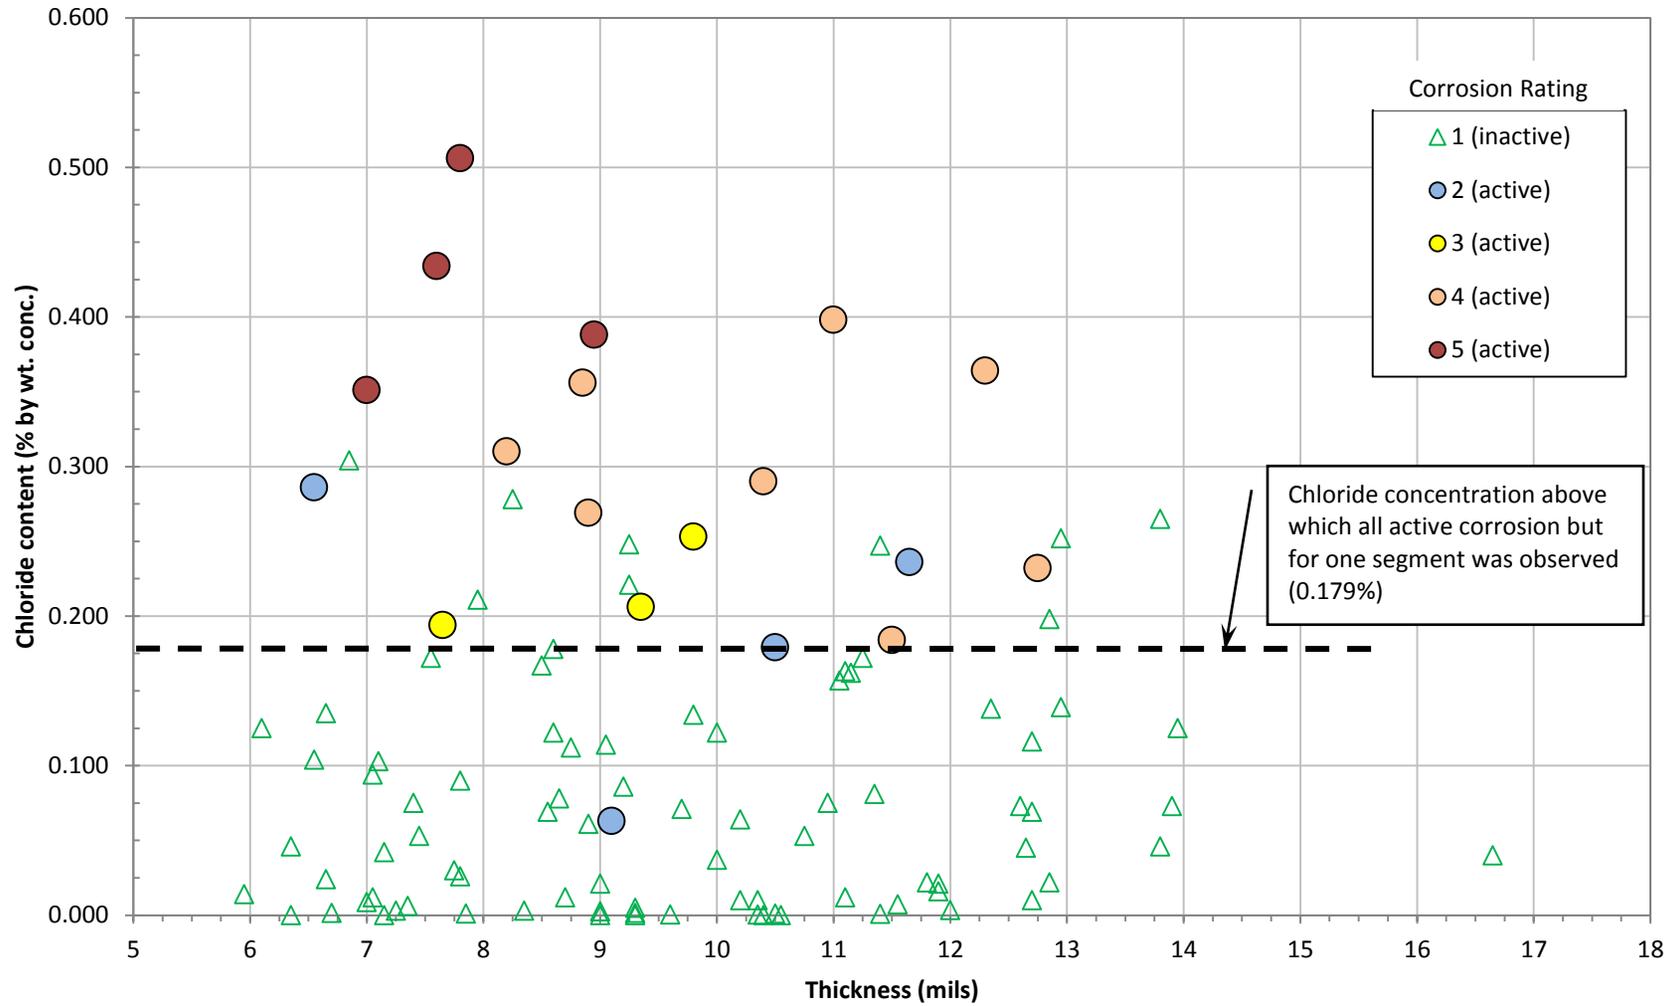
To evaluate whether a combined effect of chloride concentration and coating thickness influenced corrosion, the corrosion condition as indicated by the corrosion rating was plotted versus chloride at bar depth and coating thickness in Figure 65. With the one exception previously discussed (Core No. 2 of US 30), active corrosion did not occur where the chloride concentration at bar depth is less than 0.179 percent by weight of concrete. Above this chloride concentration where corrosion was observed, there was little correlation between corrosion condition and coating thickness. However, the bars with most active corrosion tended to have the highest chloride content and thinner coatings (7 to 9 mils).

Figure 65. Net chloride content at bar depth versus epoxy film thickness, categorized by corrosion rating.

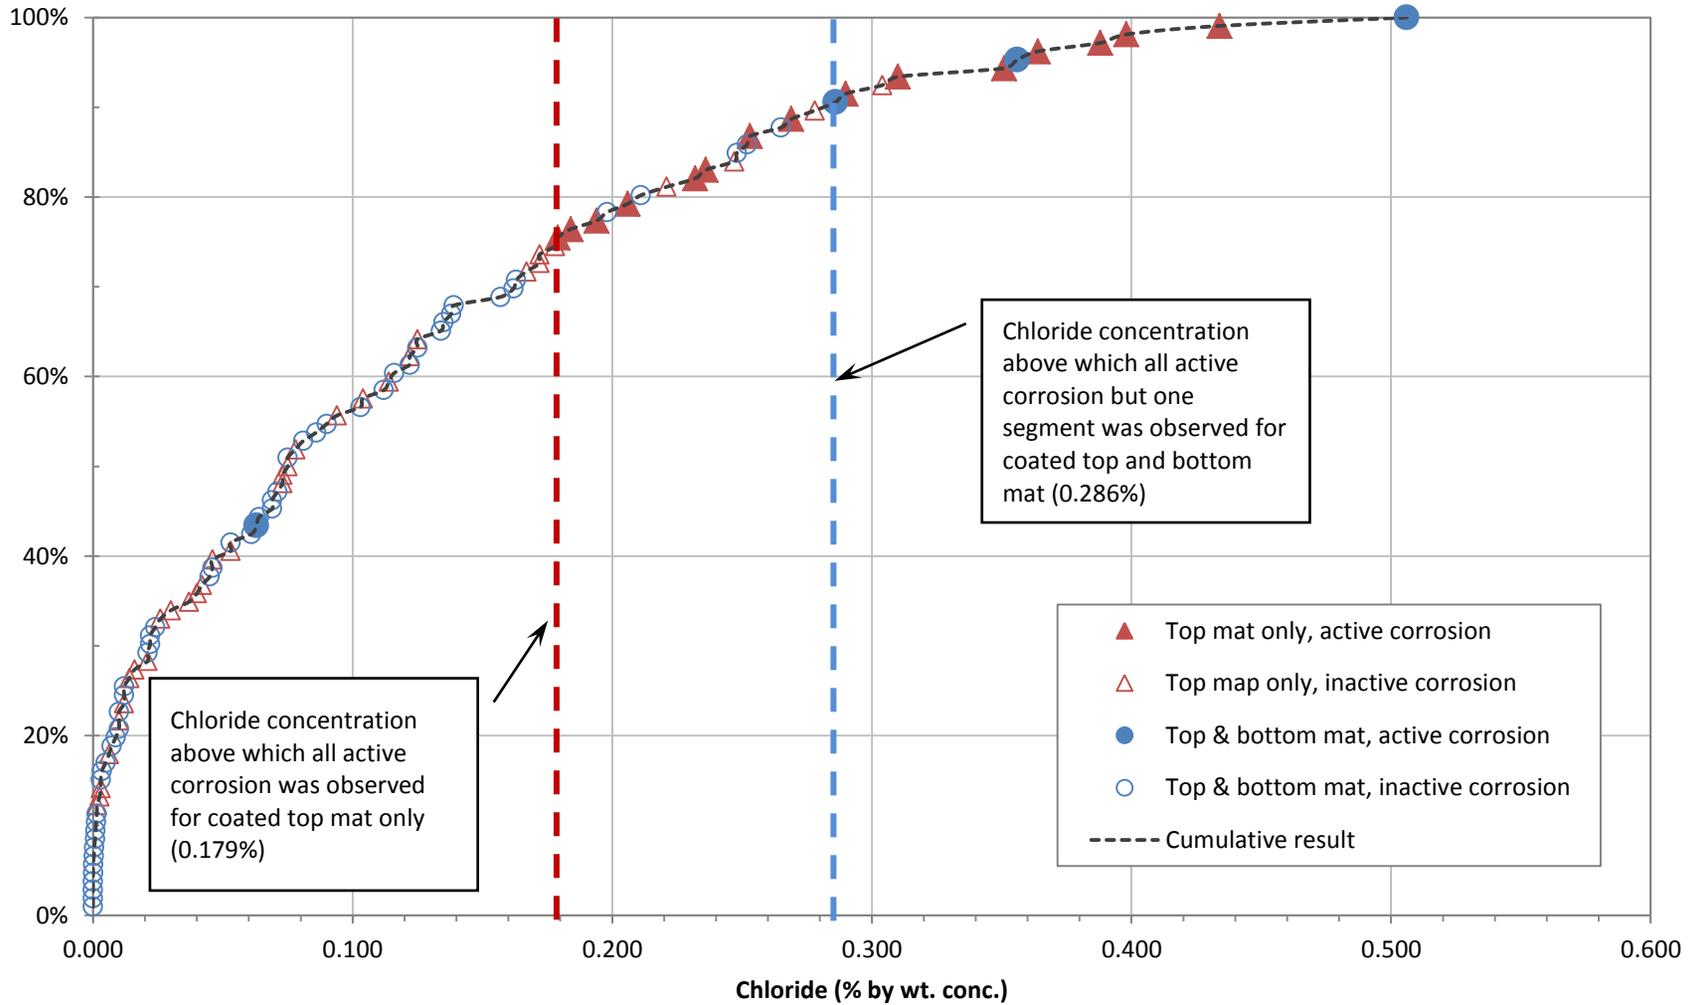
To examine the consequences of constructing bridges with only coated reinforcing bars in the top mat compared to coated bars in both top and bottom mats, the data shown in Figure 62 has been reproduced in Figure 66, with cores from these two groups of bridges separated by color. Relatively few bars from the

Figure 66. Cumulative distribution of net chloride content at bar depth, categorized by deck construction and corrosion activity.

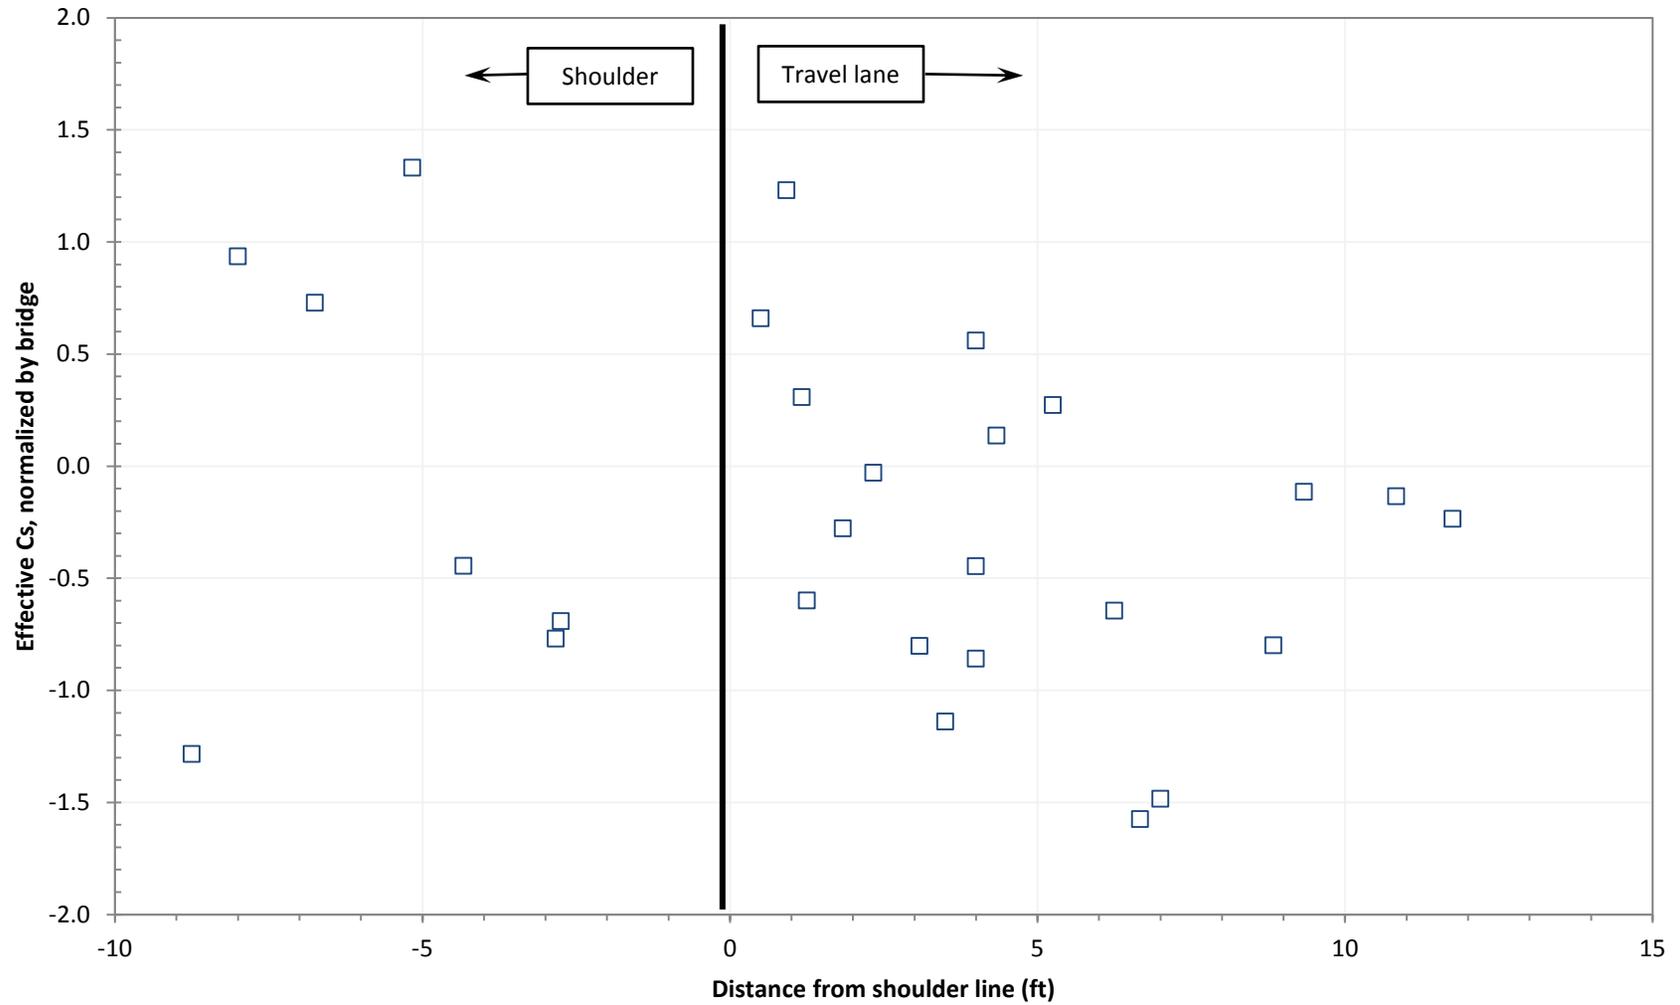
The effective surface concentration (surface chloride concentration minus background chloride) conceptually represents the severity of chloride exposure. As shown in Figure 67, the surface concentration is mostly scattered, but appears to decrease slightly moving toward the center of the deck. This may reflect the tendency for snow to be plowed to the shoulder and for deicing runoff and rainwater to drain away from the crown of the deck.

Figure 67. Effective surface chloride concentration versus distance from shoulder line. Positive values in distance indicate that the sample was obtained in the travel lane, and negative values indicate the sample was obtained from the shoulder.
