PERFORMANCE EVALUATION OF IOWA BRIDGE DECKS CONSTRUCTED WITH EPOXY-COATED REINFORCING BARS

Final Report
August 19, 2011
WJE No. 2010.0868

Prepared for:
Iowa Department of Transportation
Office of Bridges and Structures
800 Lincoln Way
Ames, Iowa 50010

Prepared by:
Wiss, Janney, Elstner Associates, Inc.
330 Pfingsten Road
Northbrook, Illinois 60062
847.272.7400 tel | 847.291.4813 fax

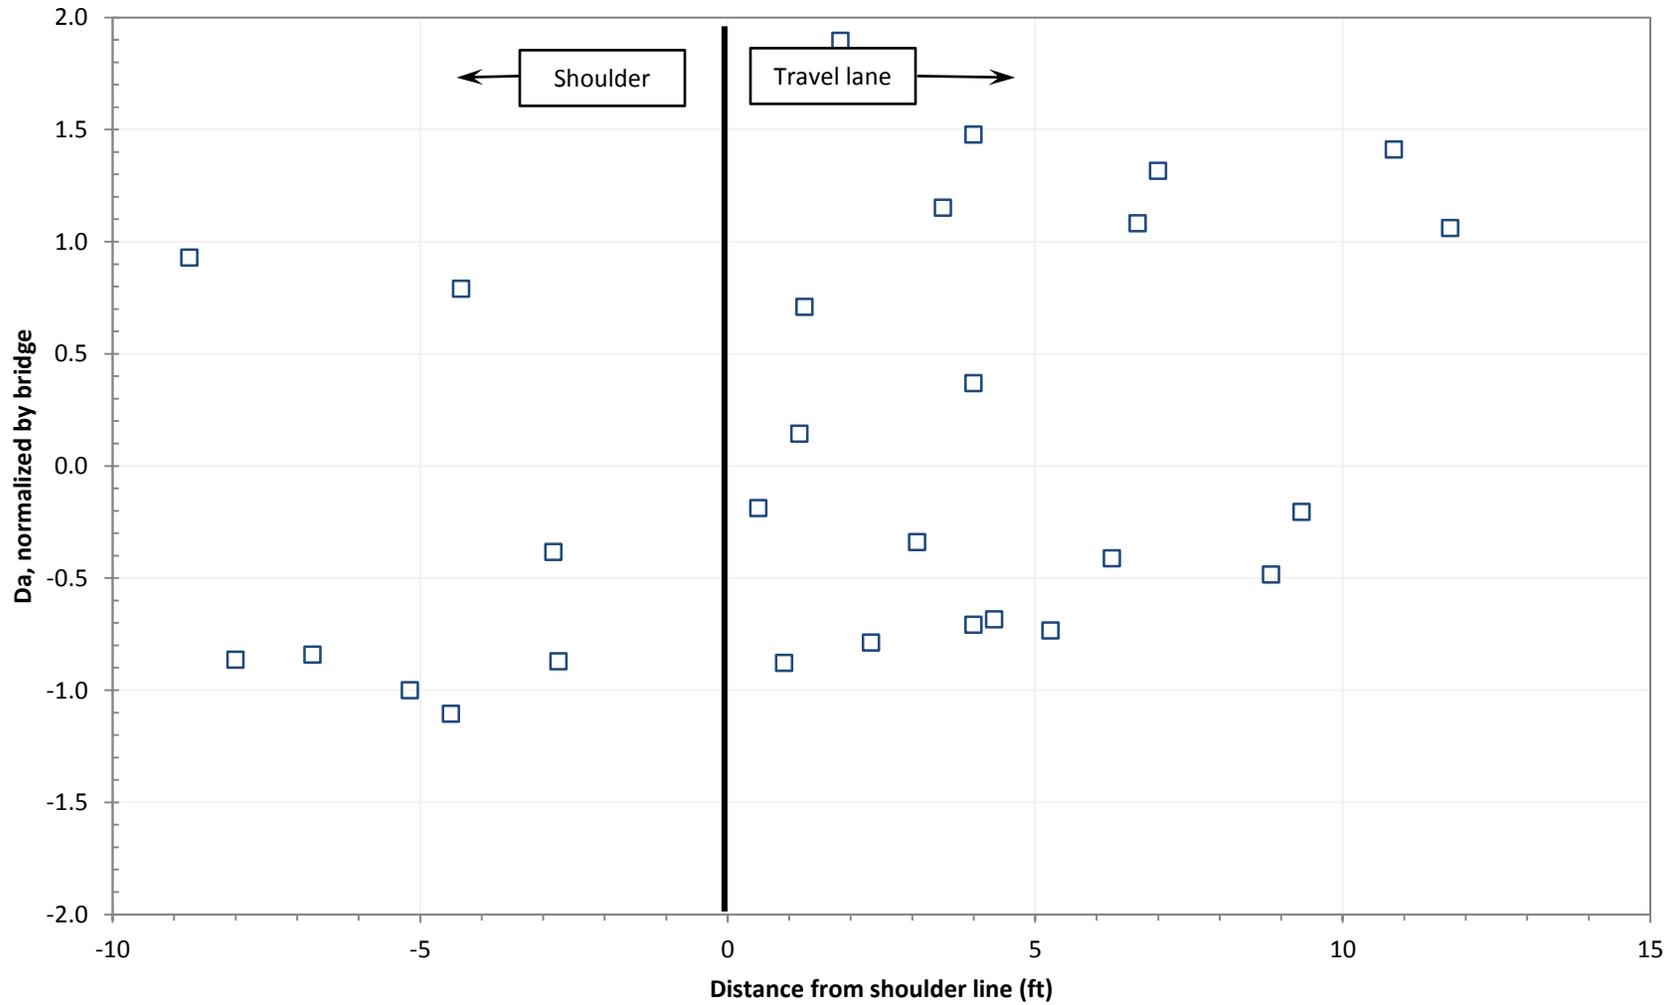
The apparent diffusion coefficient represents the resistance of the concrete to chloride ingress. In the plot of apparent diffusion coefficient versus location from the edge of the traffic lane shown in Figure 68, the apparent diffusion coefficients vary widely in relation to their relative location, but those in the travel lane appear to be slightly higher than those from the shoulder. The mechanism responsible for this is unclear, but may be due to more frequent wetting and drying cycles or increased pressure gradients caused by vehicular traffic.

Figure 68. Apparent diffusion coefficient, D_a , versus distance from shoulder line. Positive values in distance indicate that the sample was obtained in the travel lane, and negative values indicate the sample was obtained from the shoulder.

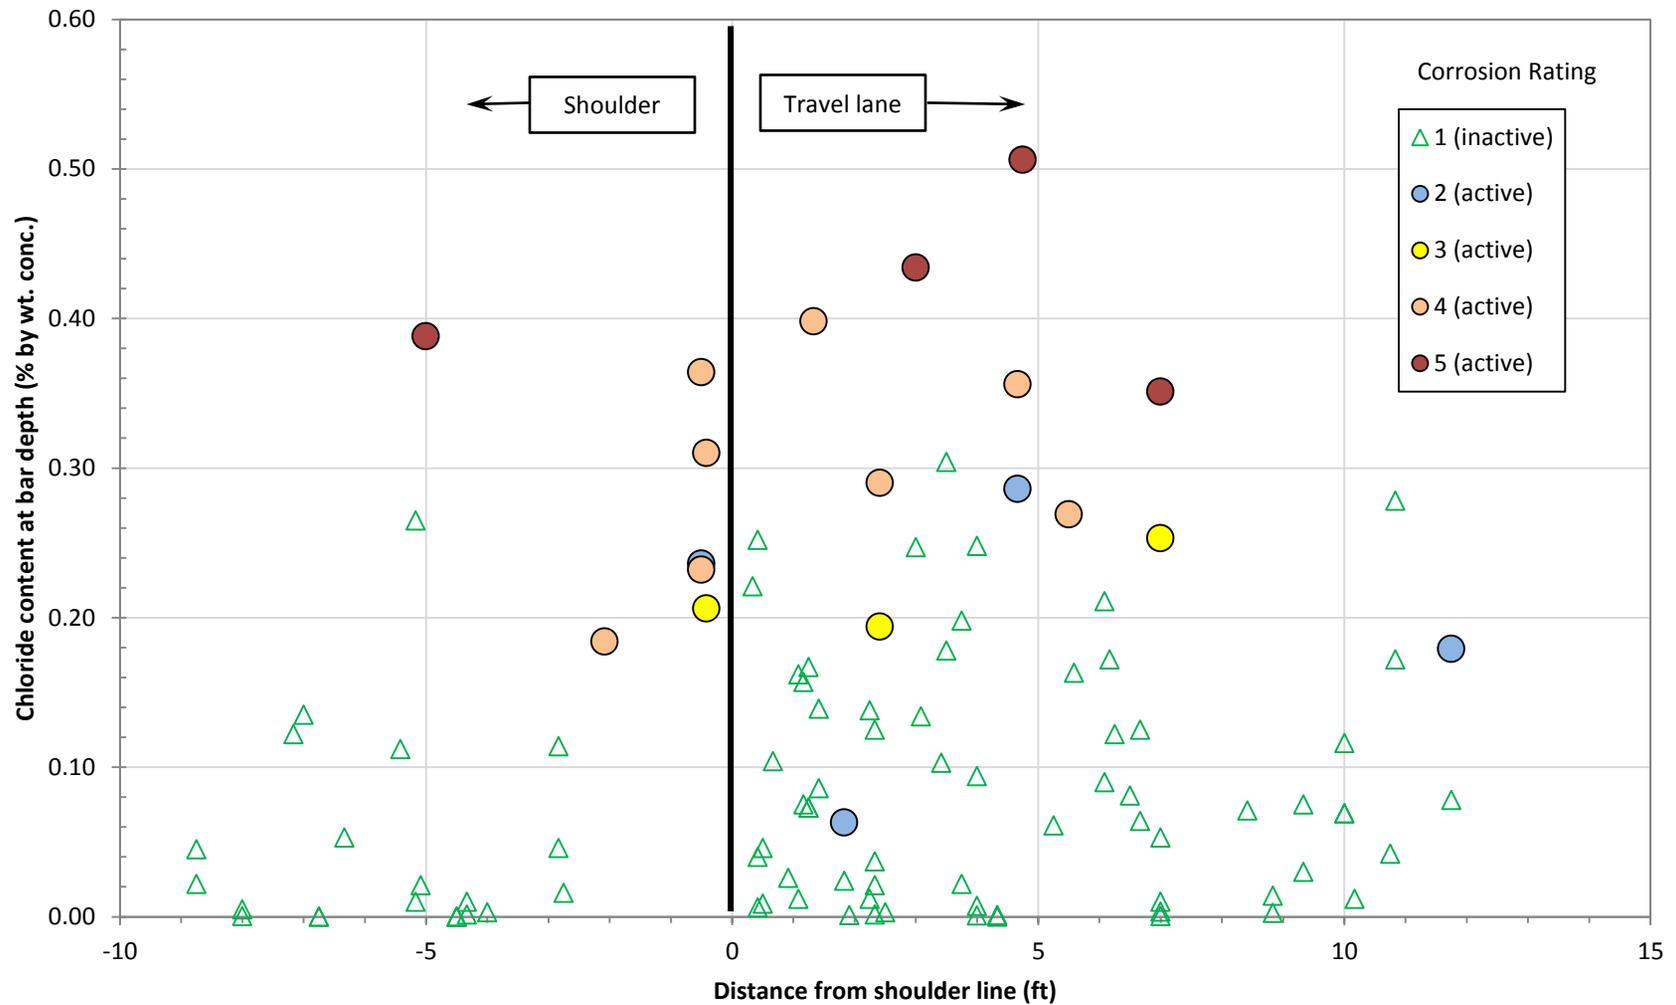
The effective chloride concentration at the bar depth, which is a function of both effective surface concentration and apparent diffusion coefficient, was relatively independent of location, as shown in Figure 69. Chloride at the bar depth is also dependent on concrete cover, and a clear influence of location on the deck to concrete cover was not observed.

Figure 69. Effective chloride content at bar depth versus distance from shoulder line. Positive values in distance indicate that the sample was obtained in the travel lane, and negative values indicate the sample was obtained from the shoulder.

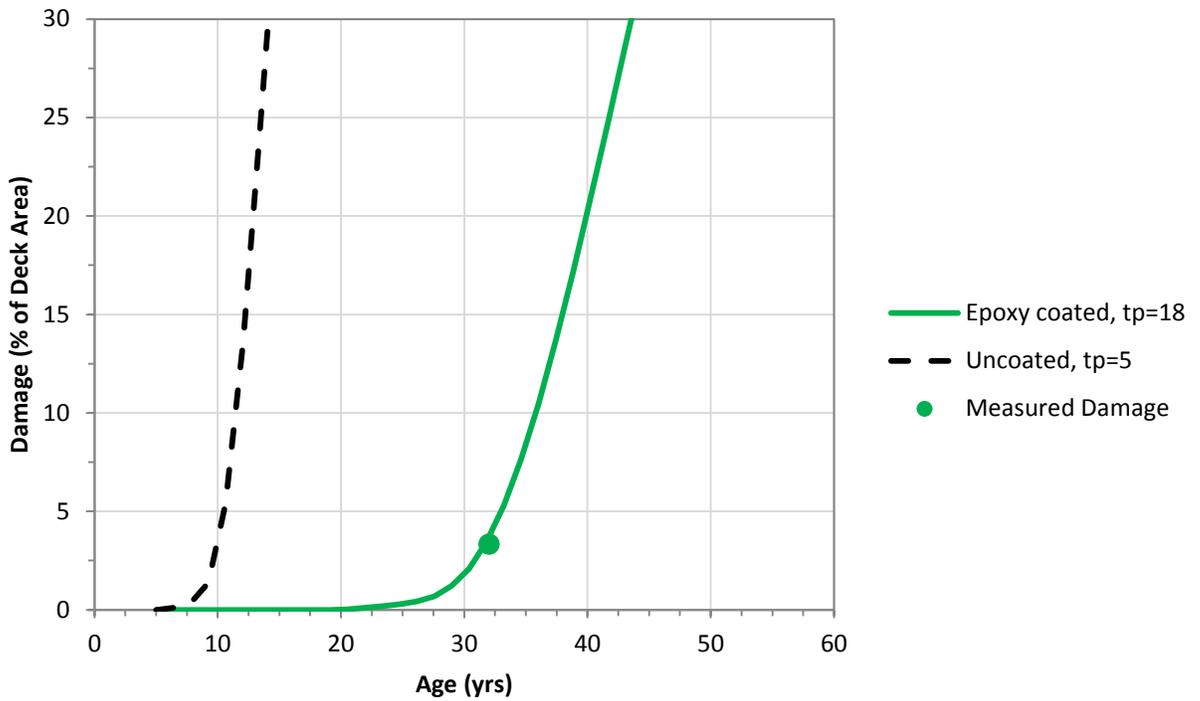
To compare bridge deck performance, the service life model was used to project expected service life before rehabilitation. For this discussion, the limit of damage allowed before rehabilitation was defined as 10 percent of the deck area. The current bridge age, projected rehabilitation age, and measured damage for each section is provided in Table 17. The predicted damage given in terms of percent of delaminated deck area versus time for all bridge sections is also shown in Figure 71 through 78. These figures also show the amount of damage observed on the individual bridges during this survey and during previous surveys by WJE (Lee & Krauss, 2003) and Iowa State University (Fanous, Wu, & Pape, 2000), where available.

Figure 71. Projected damage development for Iowa 17.

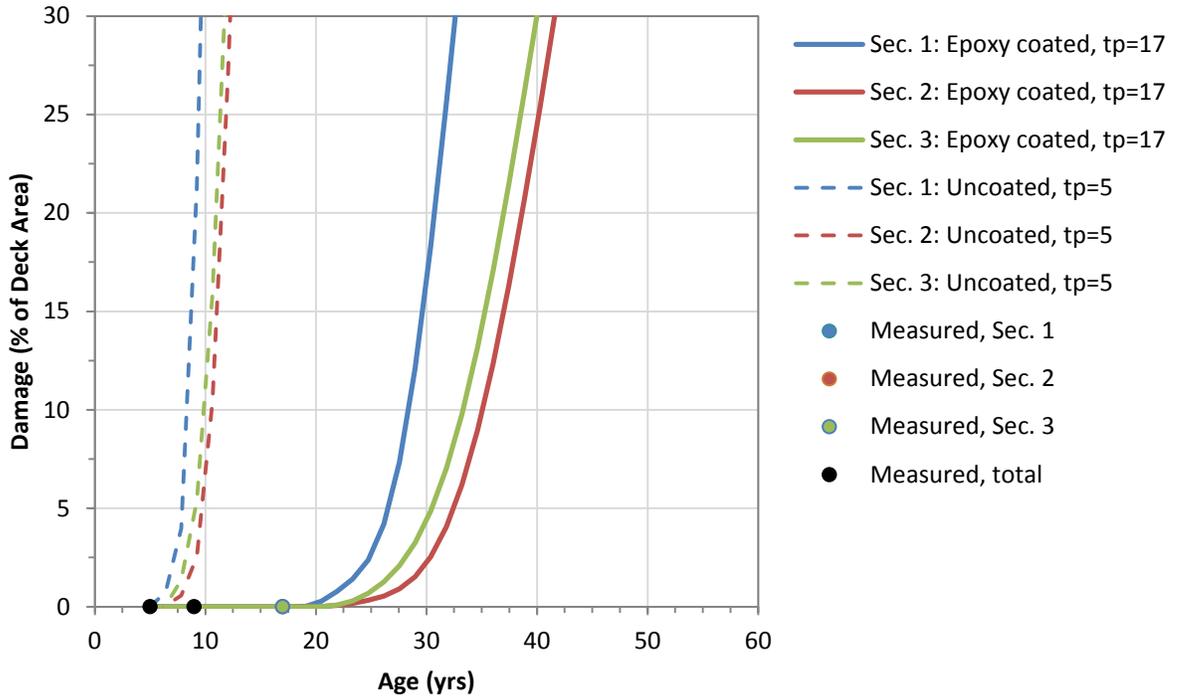
Figure 72. Projected damage development for US 218 (includes previous surveys by WJE and others).

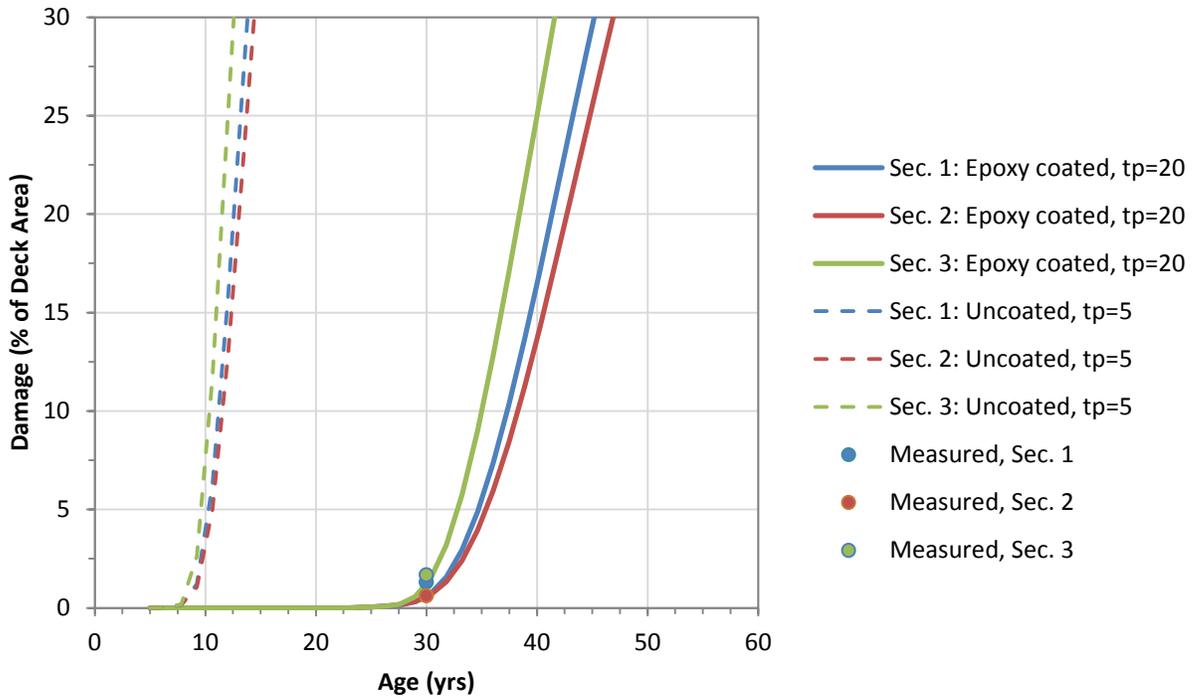
Figure 73. Projected damage development for Iowa 150.

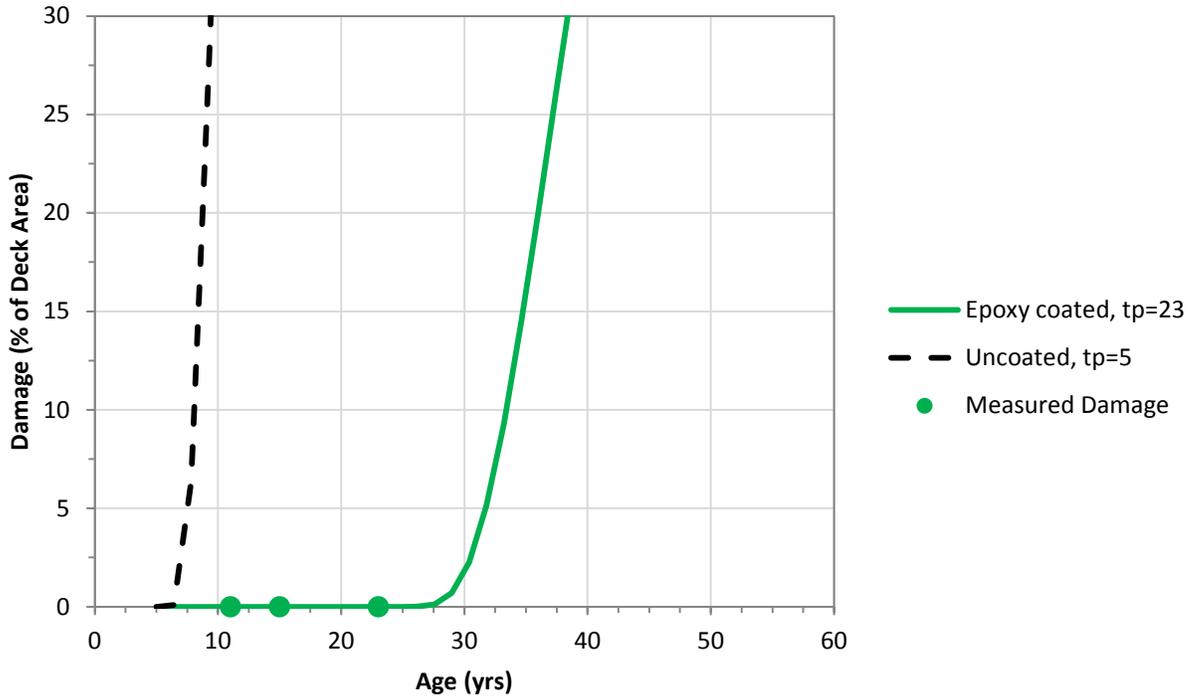
Figure 74. Projected damage development for Iowa 13 (includes previous surveys by WJE and others).

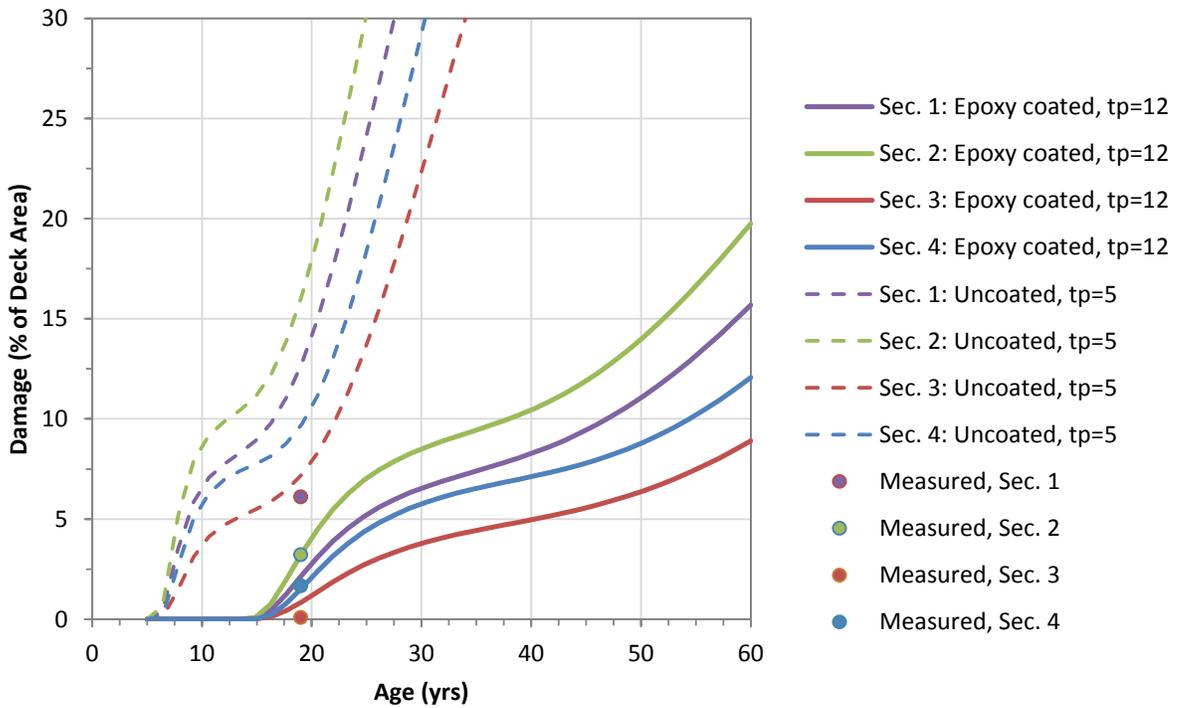
Figure 75. Projected damage development for US 30.

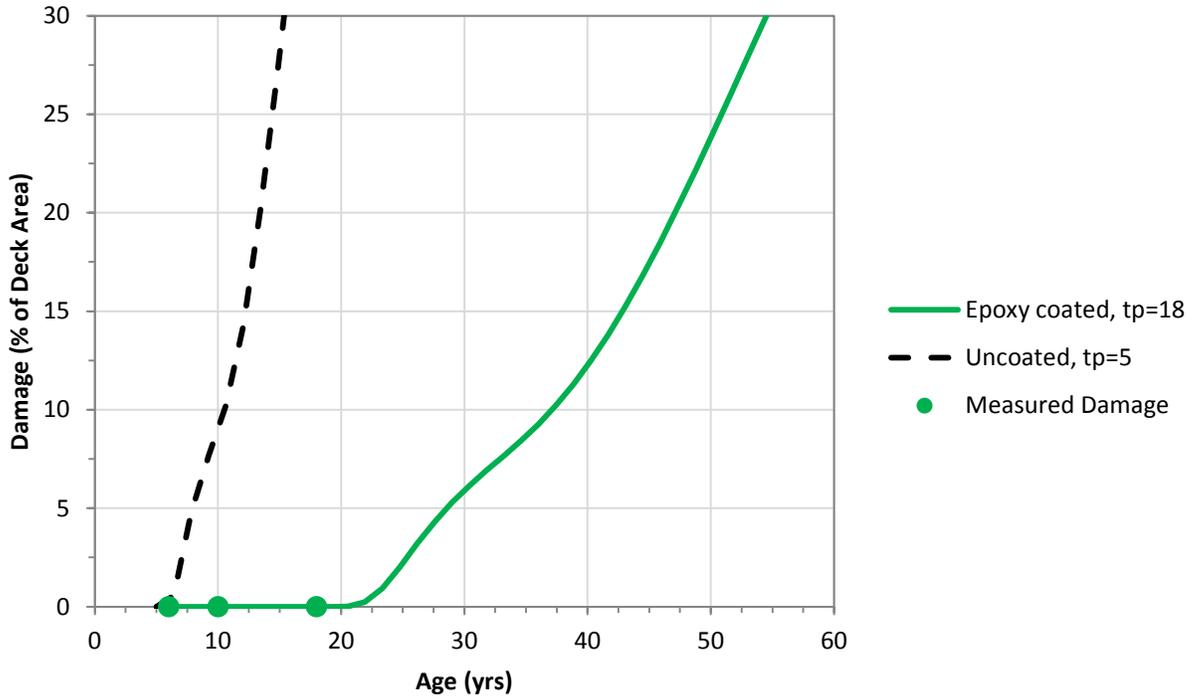
Figure 76. Projected damage development for US 18 (includes previous surveys by WJE and others).

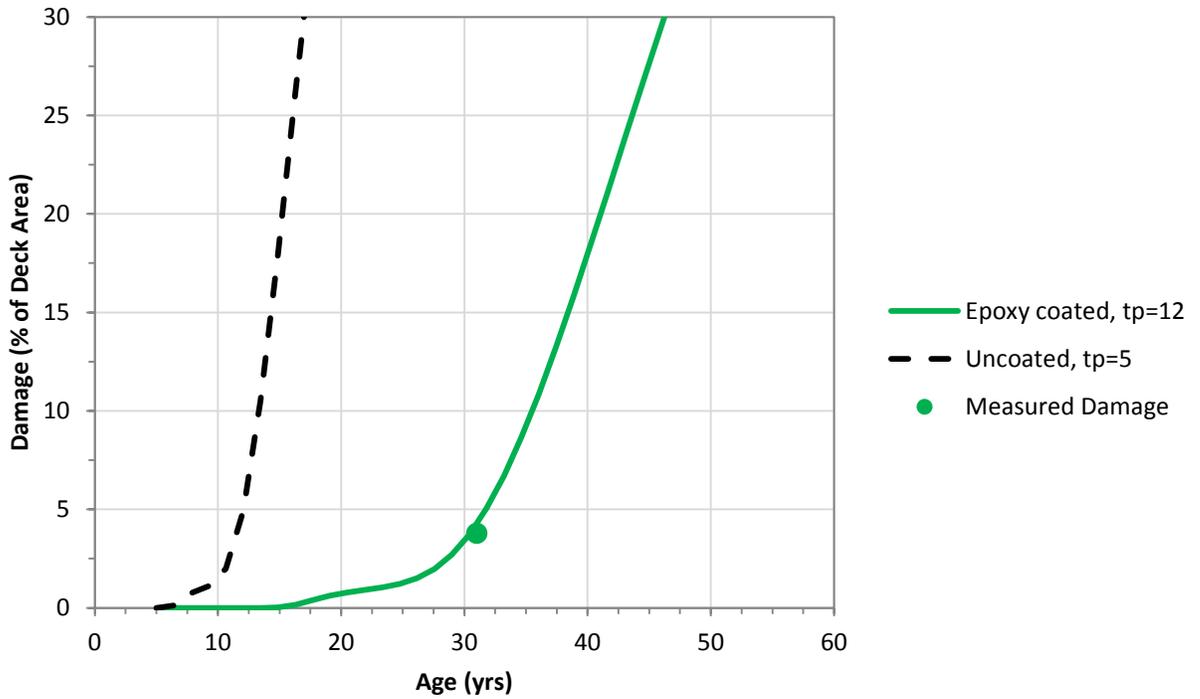
Figure 77. Projected damage development for Southbound US 65.

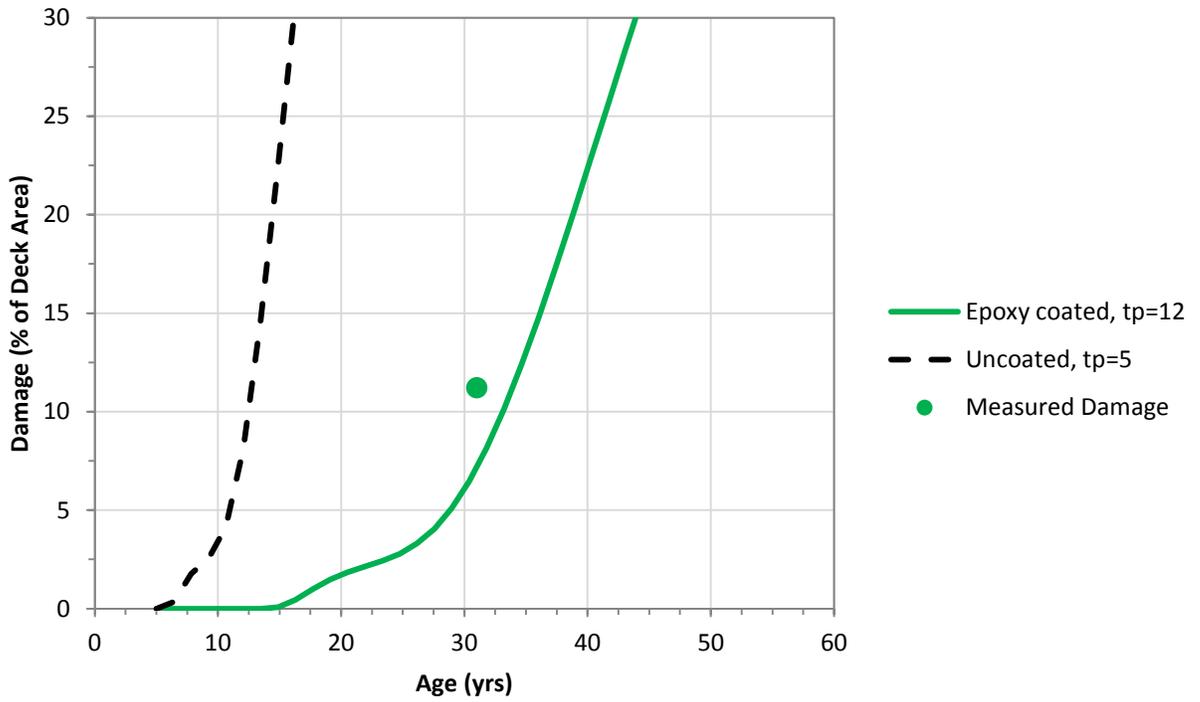
Figure 78. Projected damage development for Northbound US 65.

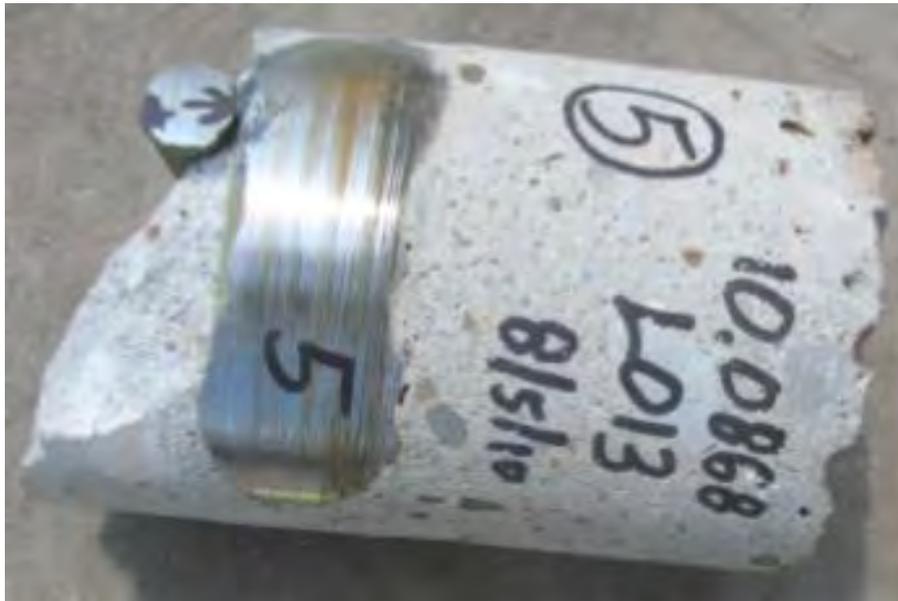
Figure 1. The site photo of the side of Core IA 13 SB #5.

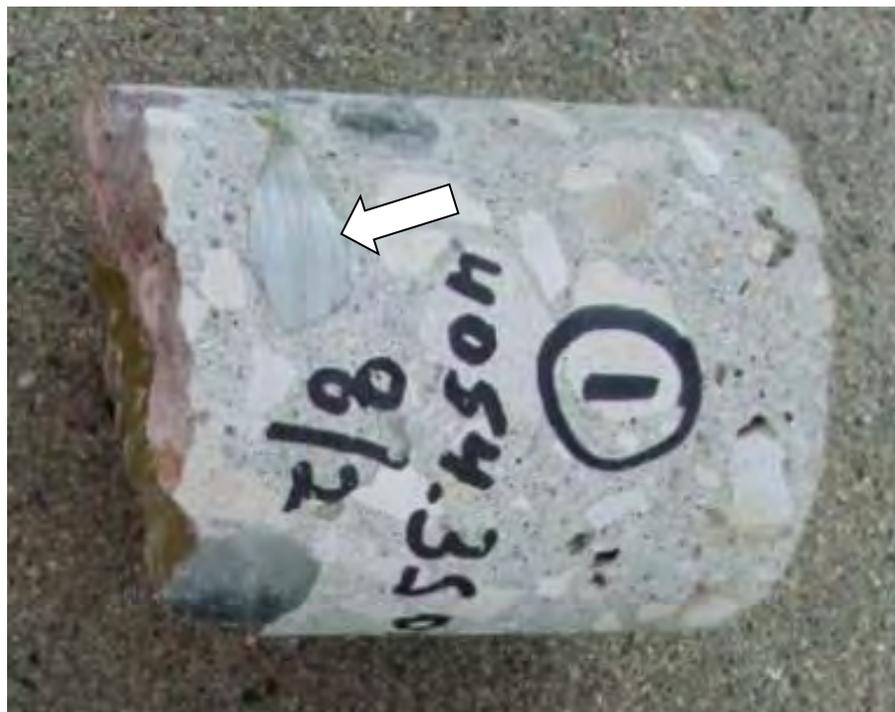
Figure 4. The site photo of the side of Core IA 17 #1 (reinforcing bar identified by arrow).

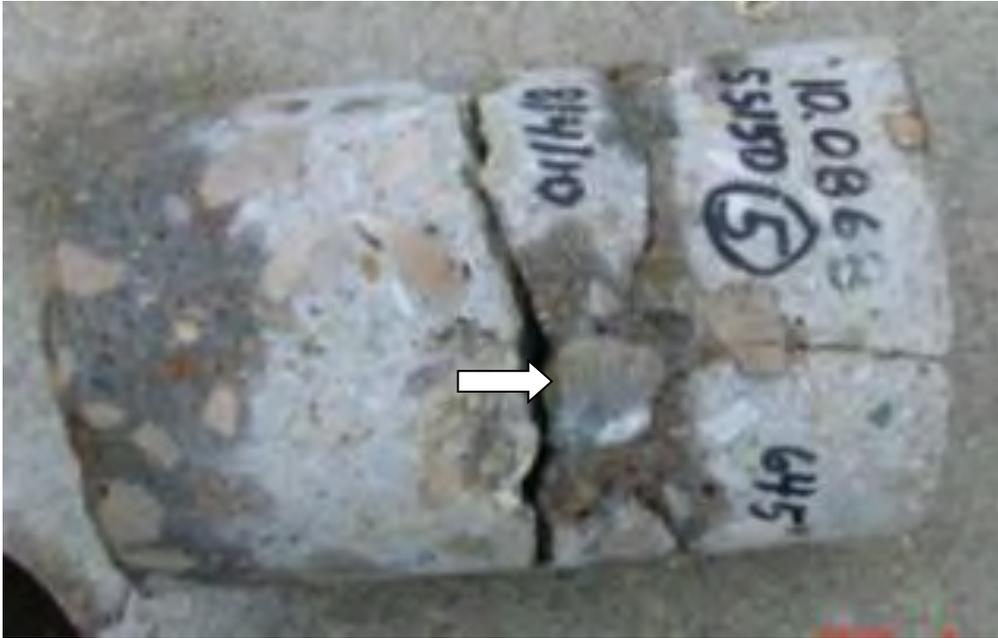
Figure 7. The site photo of the side of Core IA 150 #5. The rebar (arrow) was subsequently removed in the laboratory for examination.

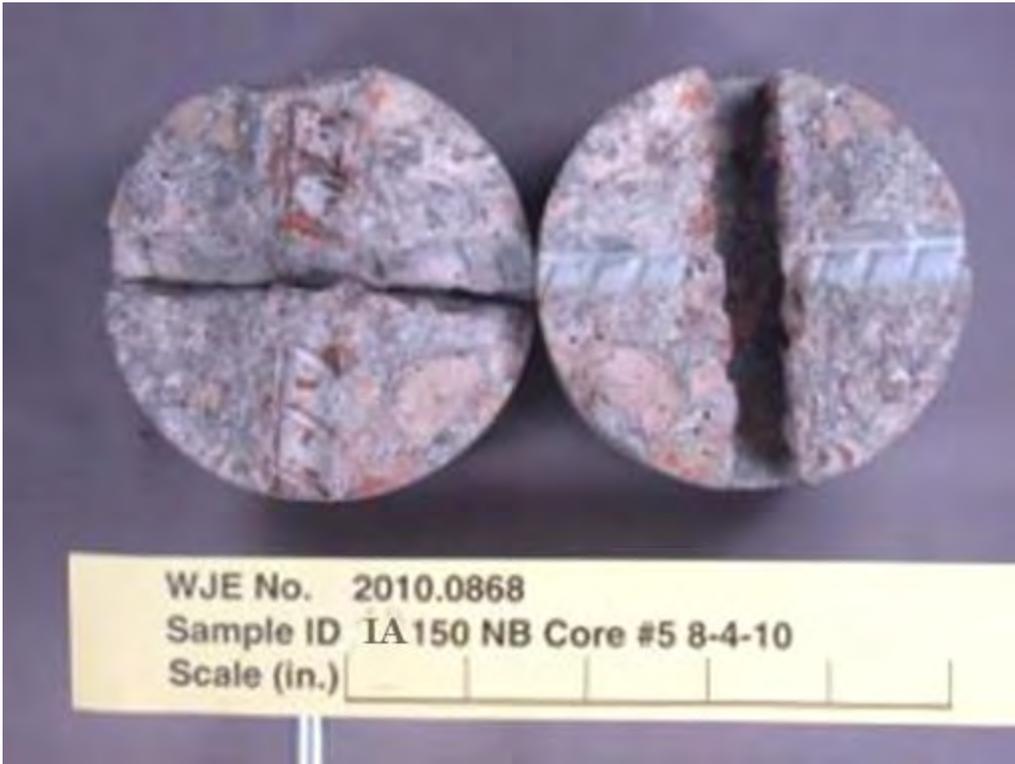
Figure 9. The as-received appearance of the inner fracture surfaces of Core IA 150 #5.

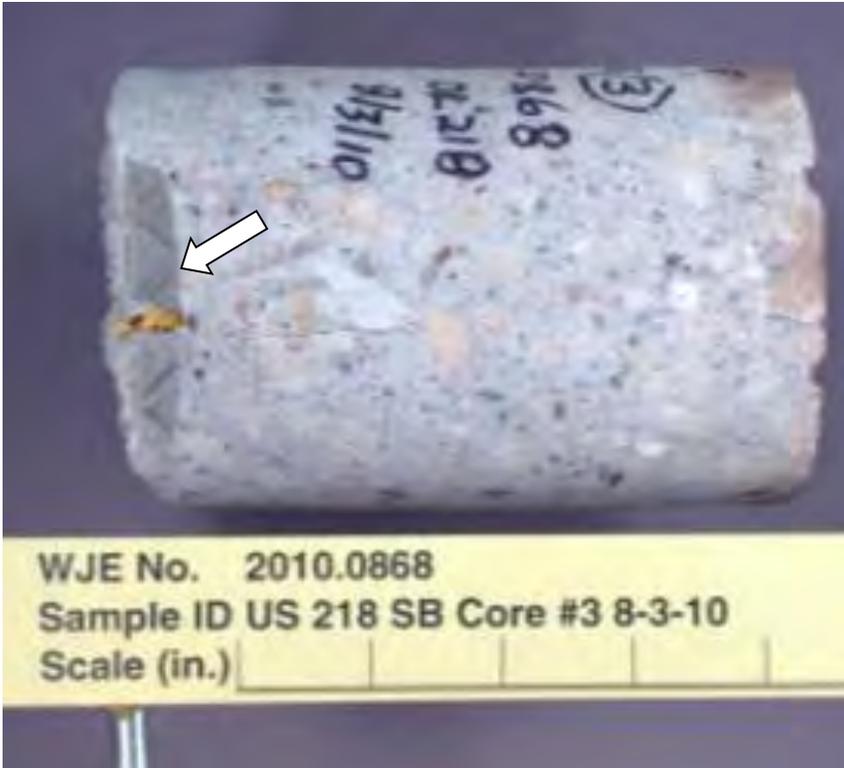
Figure 11. The as-received appearance of the side of Core US 218 SB #3. Note imprint of reinforcing bar at bottom of core (arrow).

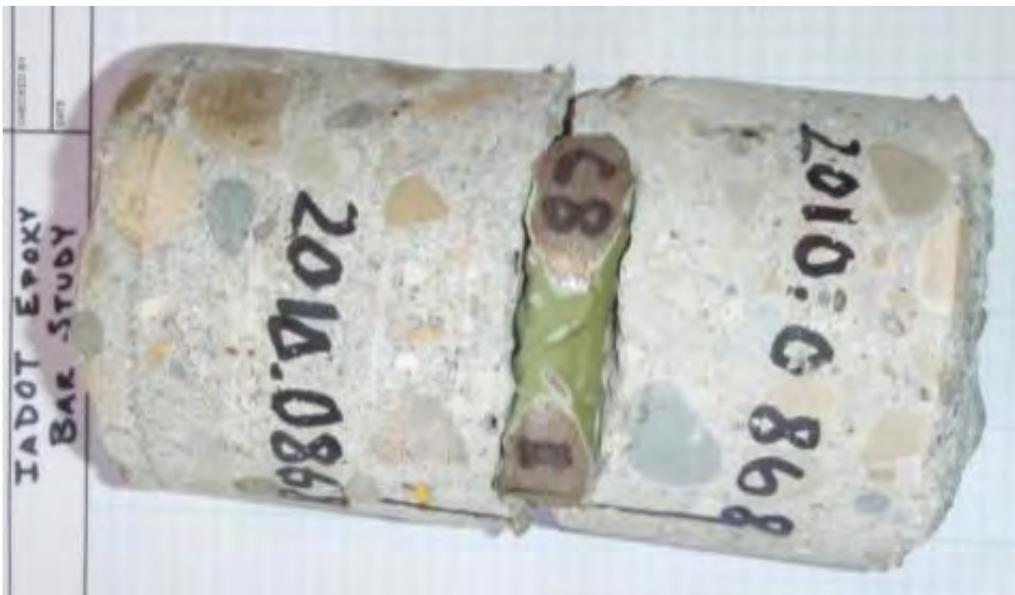
Figure 14. The site photo of the side of Core US 18 #8. The rebar was subsequently removed in the laboratory for examination.

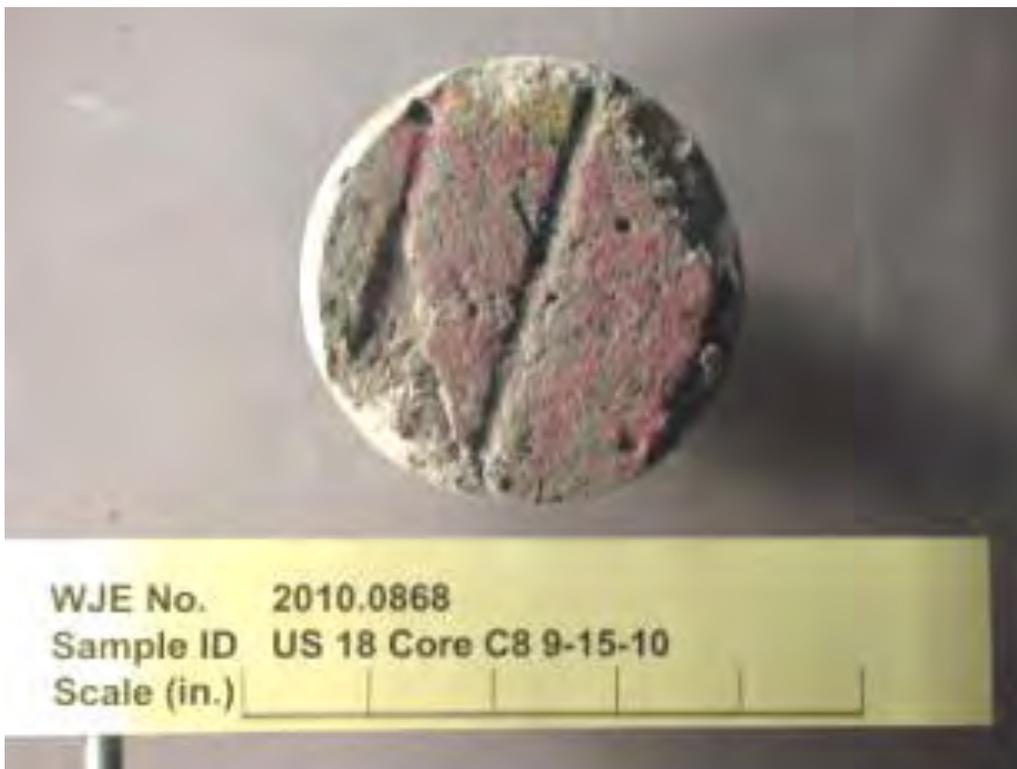
Figure 15. The as-received appearance of the top of Core US 18 #8.

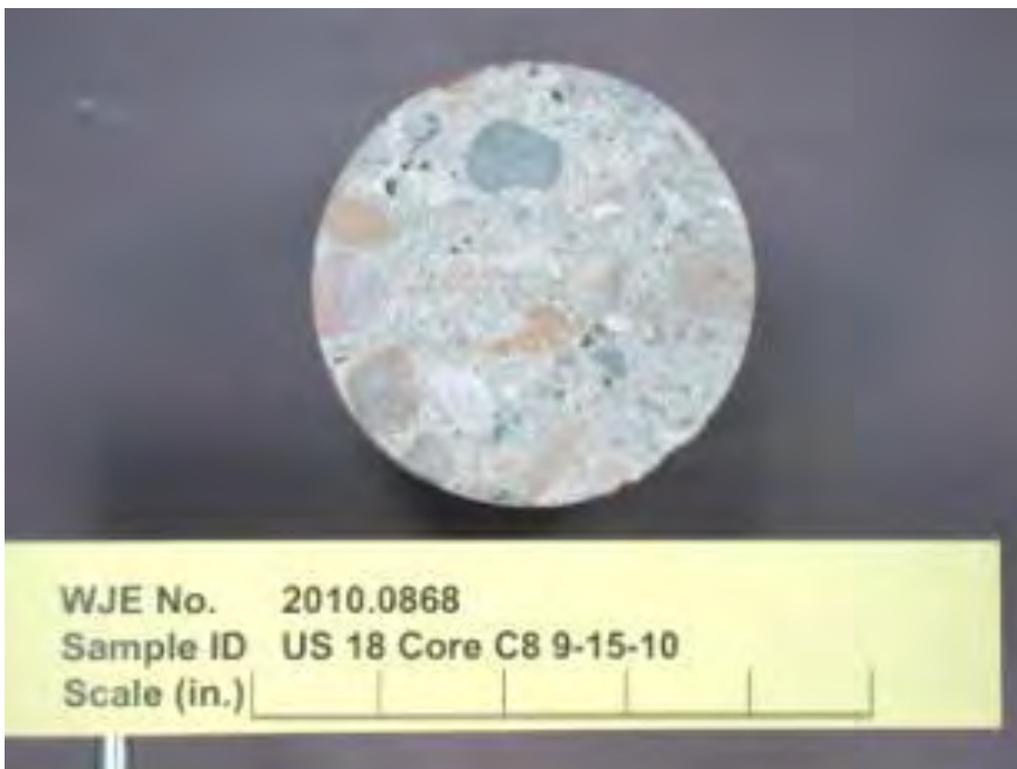
Figure 16. The as-received appearance of the bottom of the top section of Core US 18 #8.

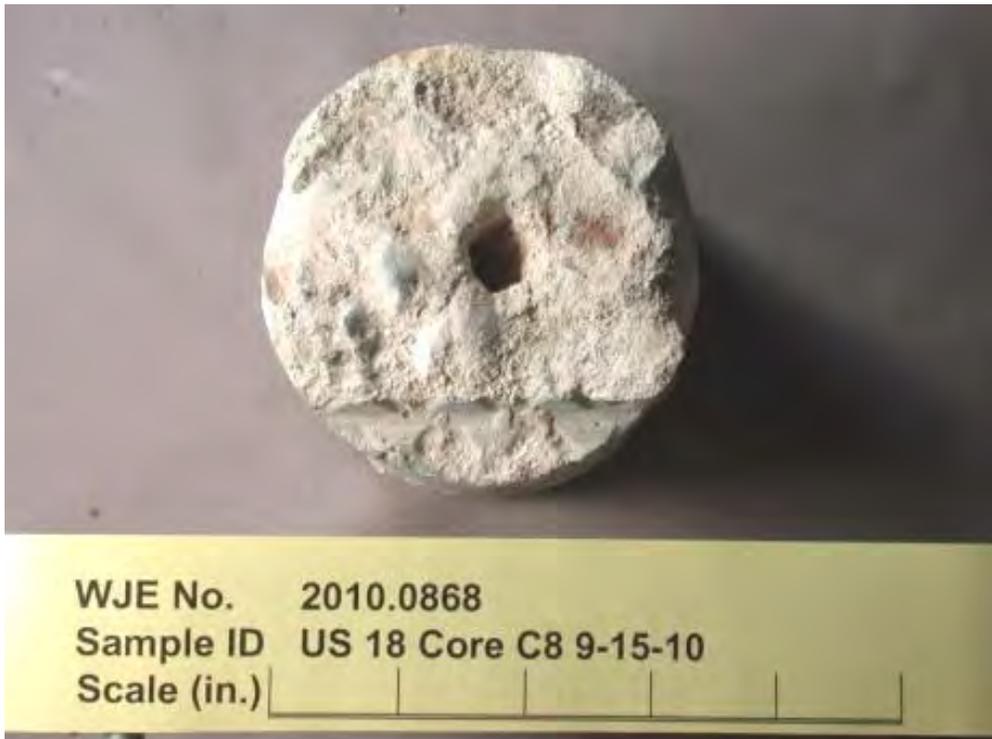
Figure 17. The as-received appearance of the top of the bottom section of Core US 18 #8 using low angle lighting.

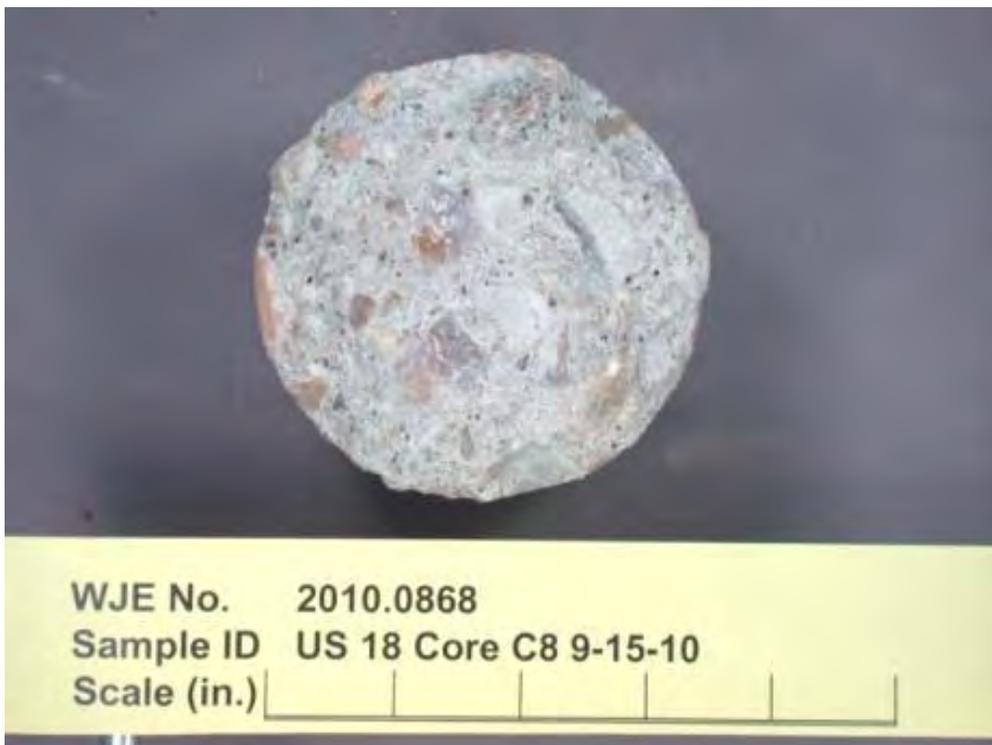
Figure 18. The as-received appearance of the bottom of Core US 18 #8.

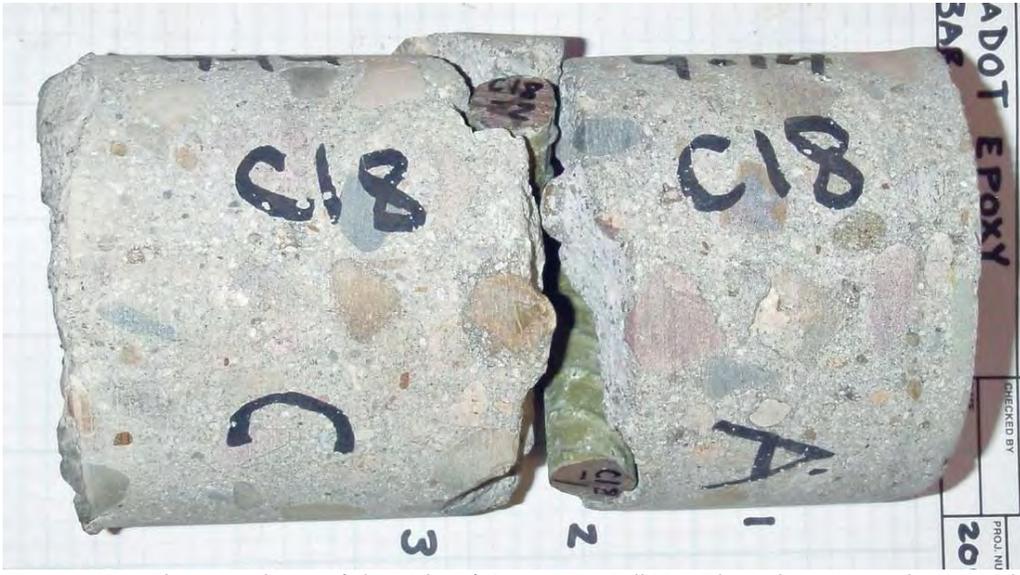
Figure 19. The site photo of the side of Core US 30 #18. The rebar was subsequently removed in the laboratory for examination.

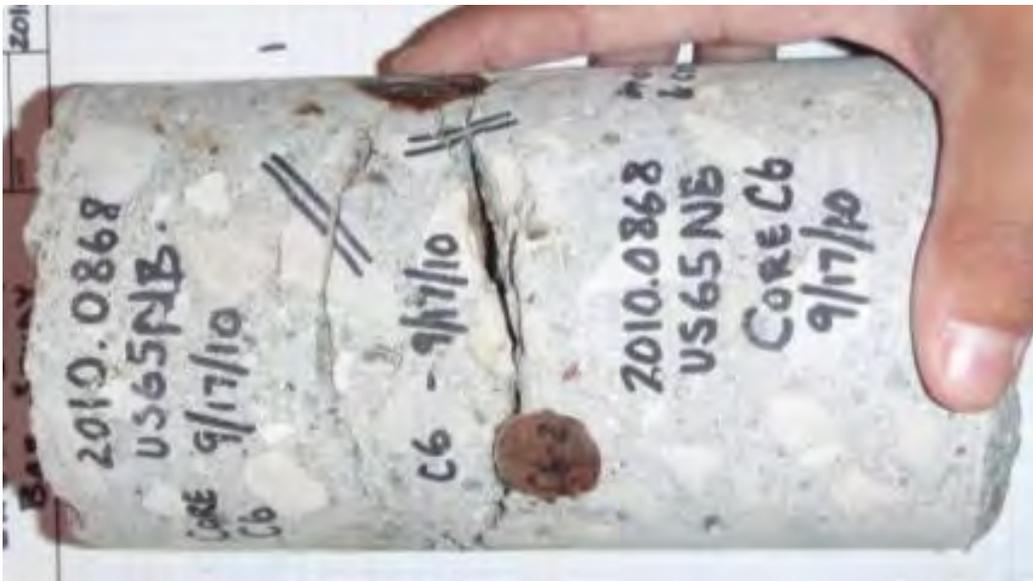
⁷ Multiple cracks associated with embedded steel reinforcement. See Figures 24 and 27.

Figure 24. The site photo of the side of Core US 65 NB #6. The rebar was subsequently removed in the laboratory for examination.

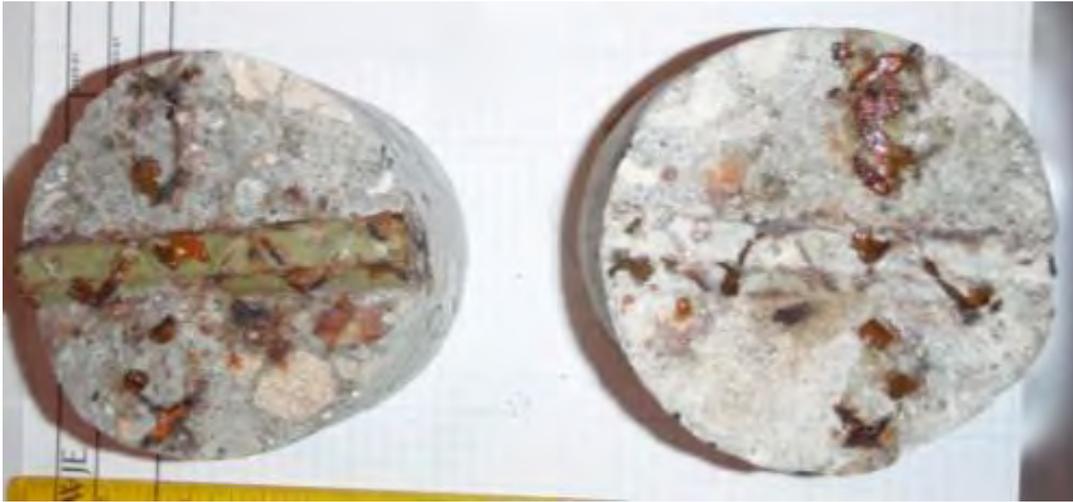
Figure 25. The inner crack faces of the horizontal delamination plane in Core US 65 NB #6.

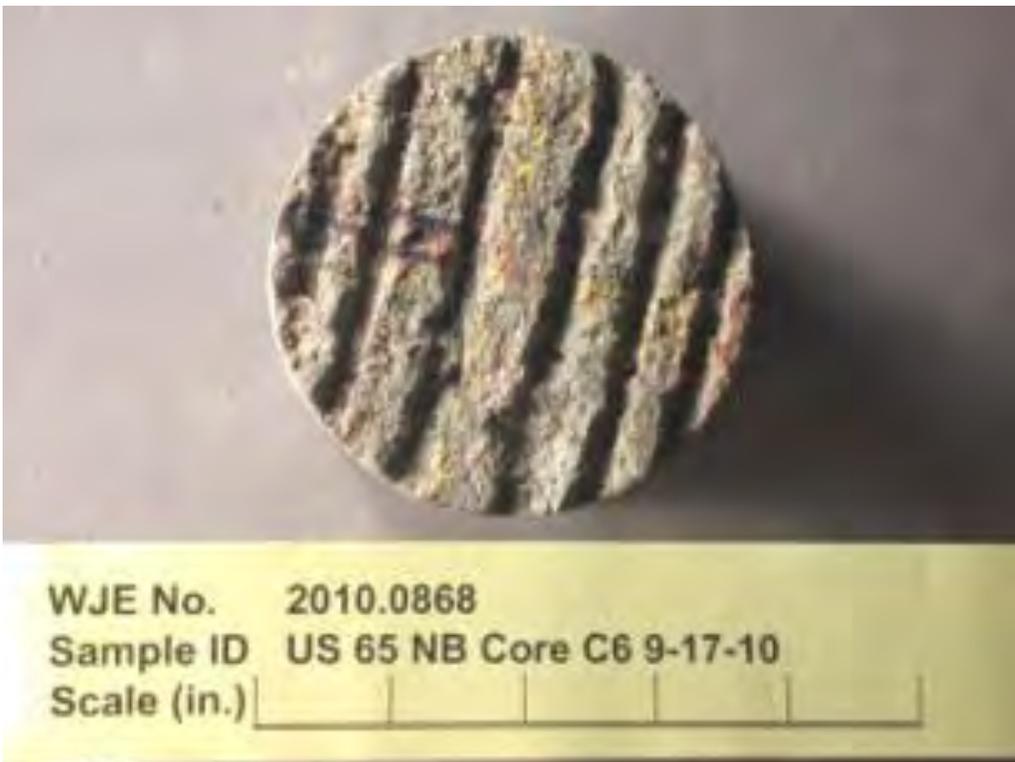
Figure 26. The as-received appearance of the top of Core US 65 NB #6 using low angle lighting to emphasize rake finish of top deck surface.

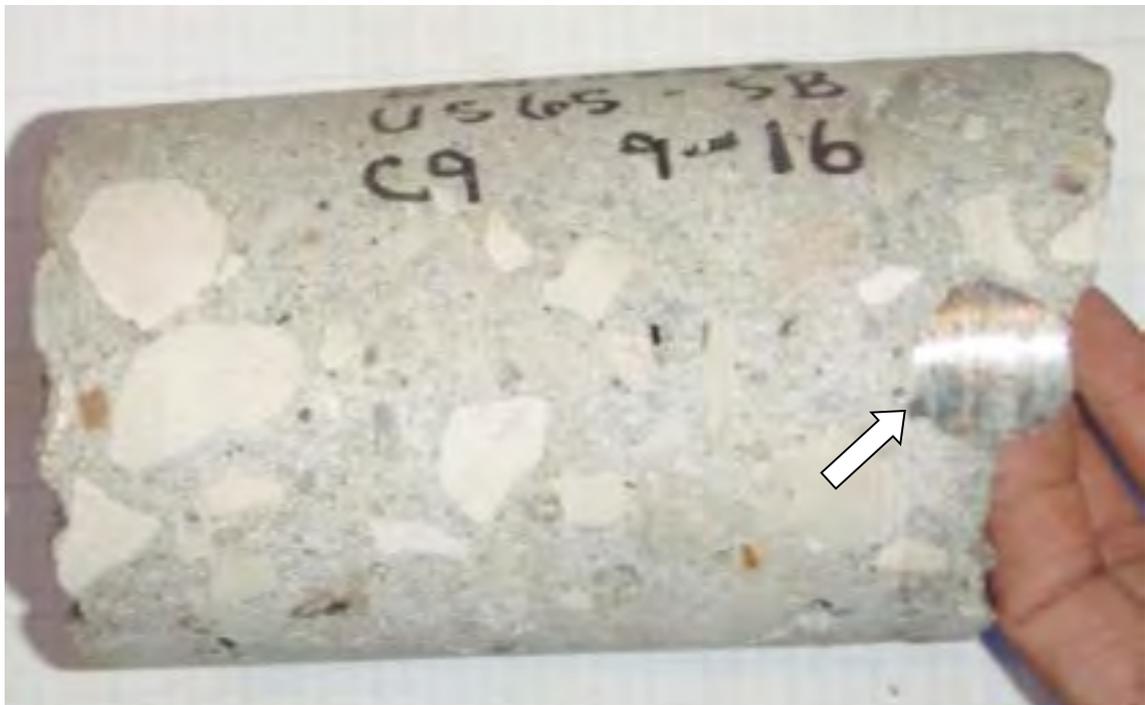
Figure 30. The site photo of the side of Core US 65 SB #9. The reinforcing bar (arrow) was subsequently removed in the laboratory for examination.

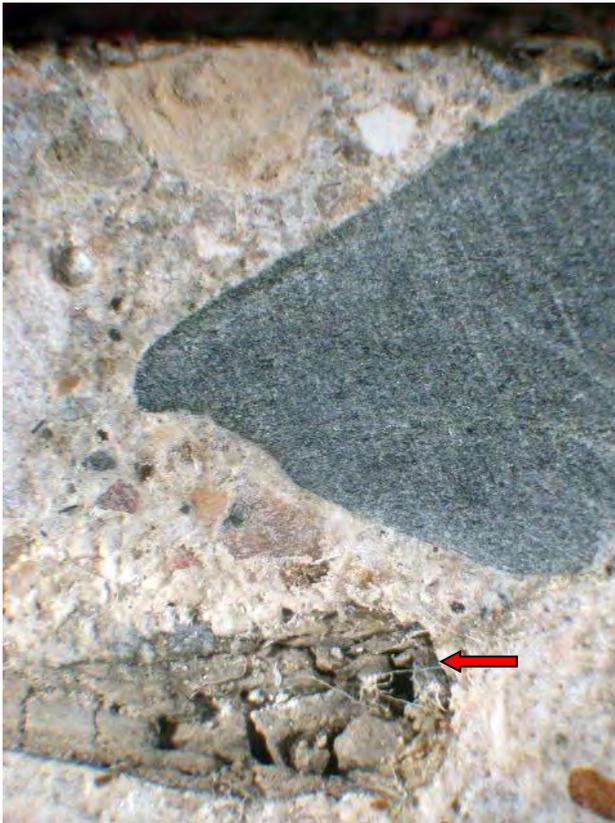
Figure 41. A non-durable shale particle that is embedded near the surface of Core US 18 #8 is marked with an arrow. The particle is intersected by a fracture that is oriented approximately horizontally. The height of the field of view is 0.5 inch in this photo.

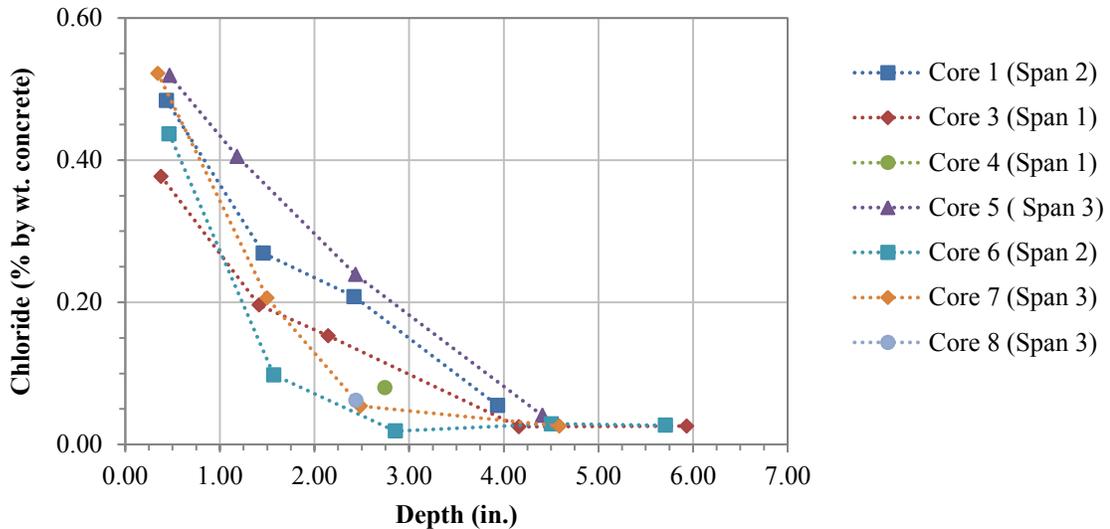
Core Number	Location	Cracking		Diffusion Coefficients		Acid-soluble Chloride Contents	
		Vertical (Depth, In.)	Horizontal (Depth, In.)	C _s (% by wt. conc.)	D (in. ² /yr.)	Average Depth (in.)	Chloride (% by wt. conc.)
1	Span 2	Full	-	0.556	0.140	0.44	0.484
						1.46	0.269
						2.42	0.208
						3.94	0.055
3	Span 1	-	-	0.438	0.099	0.38	0.377
						1.42	0.196
						2.15	0.153
						4.16	0.025
5.94	0.026 / 0.002 [1]						
4	Span 1	-	-			2.75	0.080
5	Span 3	Full	-	0.615	0.173	0.47	0.519
						1.19	0.405
						2.44	0.239
						4.41	0.041
6	Span 2	-	-	0.674	0.027	0.47	0.437
						1.57	0.098
						2.86	0.019
						4.51	0.029
5.71	0.027						
7	Span 3	-	-	0.648	0.052	0.35	0.522
						1.50	0.206
						2.49	0.054
4.59	0.026						
8	Span 3	-	3.3 - at bar			2.44	0.062
