PERFORMANCE EVALUATION OF IOWA BRIDGE DECKS CONSTRUCTED WITH EPOXY-COATED REINFORCING BARS

Final Report
August 19, 2011
WJE No. 2010.0868

Prepared for:
Iowa Department of Transportation
Office of Bridges and Structures
800 Lincoln Way
Ames, Iowa 50010

Prepared by:
Wiss, Janney, Elstner Associates, Inc.
330 Pfingsten Road
Northbrook, Illinois 60062
847.272.7400 tel | 847.291.4813 fax

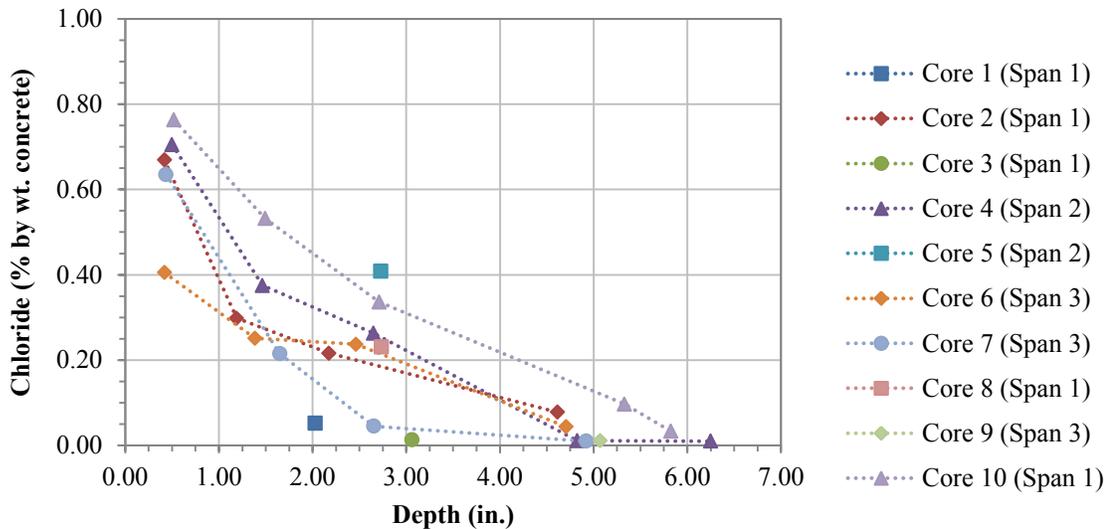
Core Number	Location	Cracking		Diffusion Coefficients		Acid-soluble Chloride Contents	
		Vertical (Depth, In.)	Horizontal (Depth, In.)	C _s (% by wt. conc.)	D (in. ² /yr.)	Average Depth (in.)	Chloride (% by wt. conc.)
1	Span 1	-	-			2.03	0.052
2	Span 1	-	1.0 - not at bar	0.794	0.044	0.42	0.669

1.19	0.298
						2.18	0.216
						4.62	0.078
3	Span 1	-	-			3.06	0.013
4	Span 2	2.0	-	0.825	0.083	0.50	0.705
						1.47	0.375
						2.65	0.263
						4.83	0.011
5	Span 2	Full	2.7 - at bar 3.7 - at bar			2.73	0.408
6	Span 3	Full	2.4 - at bar	Patch material in top portion of core - no diffusion coefficients calculated		0.42	0.405

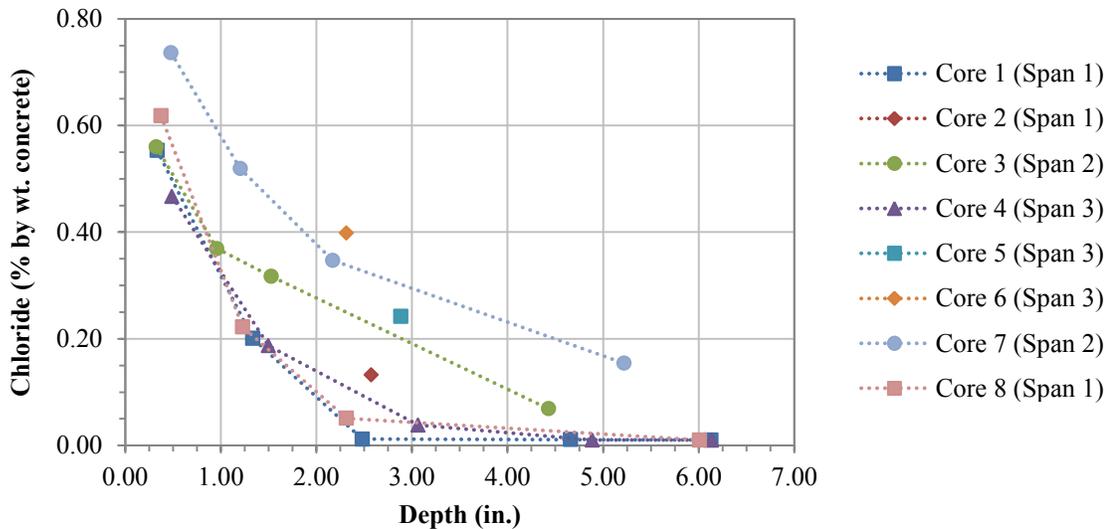
Core Number	Location	Cracking		Diffusion Coefficients		Acid-soluble Chloride Contents	
		Vertical (Depth, In.)	Horizontal (Depth, In.)	C _s (% by wt. conc.)	D (in. ² /yr.)	Average Depth (in.)	Chloride (% by wt. conc.)
1	Span 1	-	-	0.712	0.022	0.34	0.553
						1.34	0.201
						2.48	0.012
						4.66	0.011
						6.13	0.010
2	Span 1	-	-			2.58	0.132
3	Span 2	-	-	0.601	0.086	0.33	0.560
						0.96	0.369
						1.53	0.317
						4.43	0.069
4	Span 3	-	-	0.635	0.032	0.49	0.467
						1.50	0.187
						3.07	0.038
						4.89	0.010
5	Span 3	Full	2.9 - at bar			2.89	0.242
6	Span 3	2.4	2.4 - at bar 3.4 - at bar			2.32	0.398
7	Span 2	Full	2.3 - at bar	0.787	0.158	0.48	0.736
						1.21	0.519
						2.17	0.347
						5.22	0.154
8	Span 1	-	-	0.838	0.019	0.38	0.618
						1.23	0.222
						2.32	0.051
						6.01	0.010
