Use of H2Ri Wicking Fabric to Prevent Frost Boils in the Dalton Highway Beaver Slide Area, Alaska Final Report

December 2012

INE/AUTC 12.23

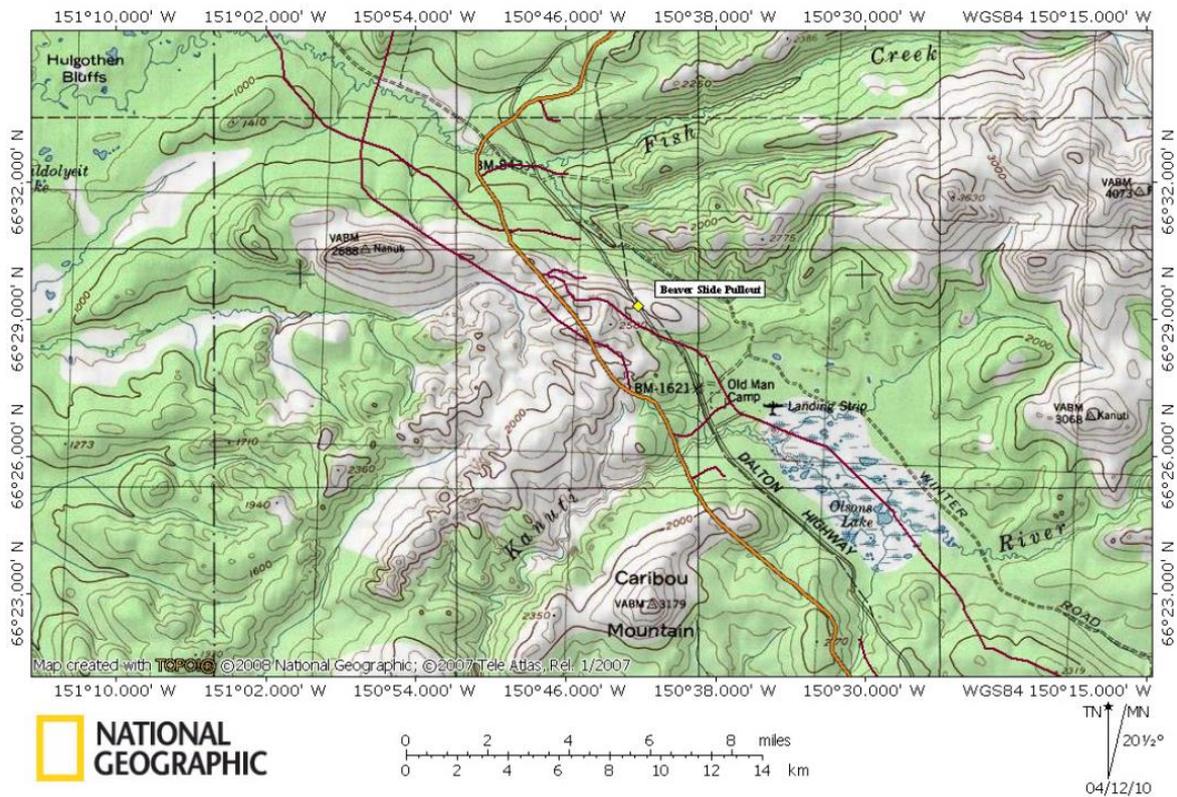
Figure 1. Dalton Highway Beaver Slide study site general area map

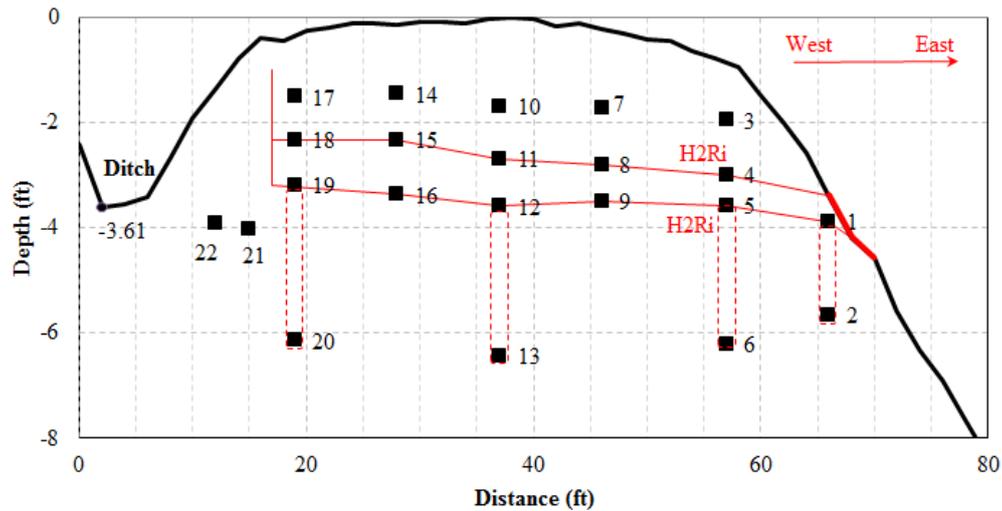
Figure 19. Final configuration of the test section (looking north)

The H2Ri wicking fabric is an excellent material for transporting water from the road structure. As shown in Figure 19, the H2Ri wicking fabric was purposely sloped during installation. The slope helps drain water only when the soils are saturated. Note that when the soils are unsaturated, the H2Ri wicking fabric relies on the suction gradient generated by evaporation to drain water from the road embankment. Figure 124 shows the suction in the air at the Beaver Slide, which is calculated using hourly air temperature and relative humidity in the air.

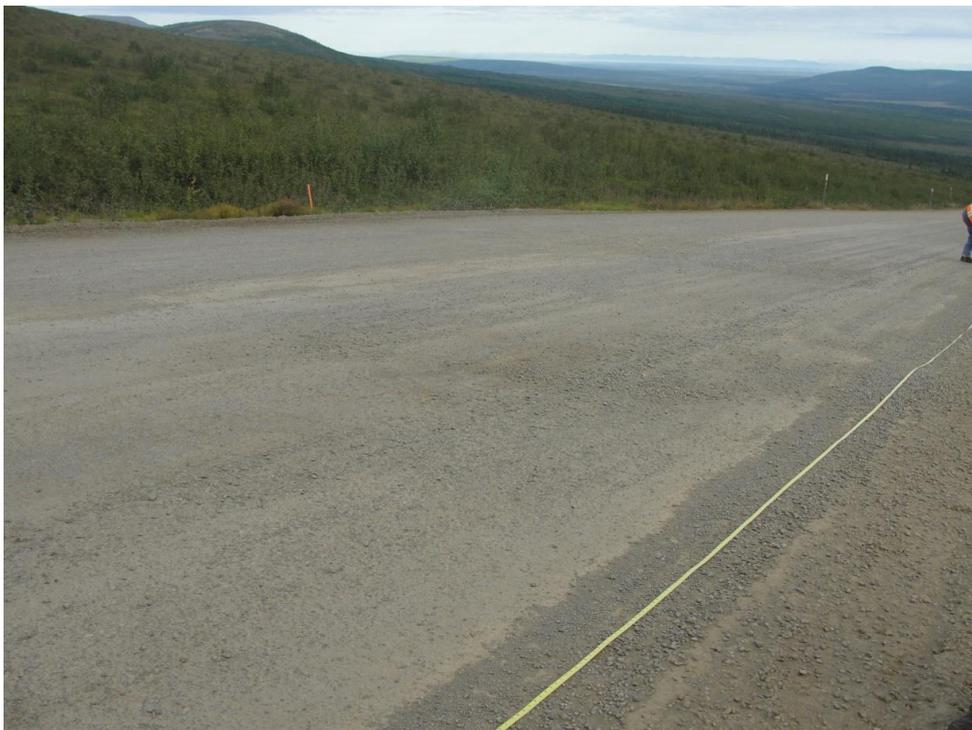
The construction of the test section started on August 3, 2010. A 60 feet long road section that had the most frost boils was selected for testing (Figure 20). First, the eastbound half of the existing road was excavated to a depth of 3.5 feet (Figure 21), and the bottom of the excavation was graded using a bobcat (Figure 22). The soils were generally brown to yellow sand with gravel, according to visual classification. The first 4 in. of soil was cemented and dense, most likely due to heavy traffic. Next, three pits were dug—at the center of the road, at the edge of the original road (20 feet to the center), and approximately at the edge of excavation (29 feet to the center of the road)—for installation of sensors 13, 6, and 2, respectively (see Figure 19).

Figure 20. Selection of test section (looking north)

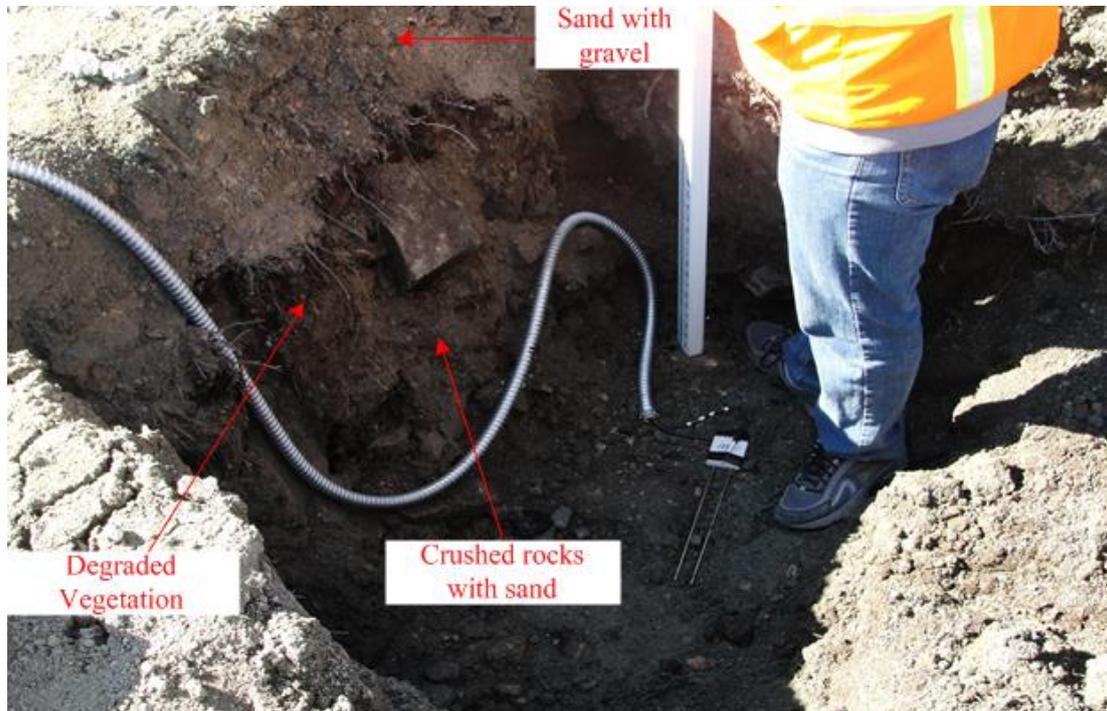
The excavation pits were about 1.5 feet by 1.5 feet large and 3 feet deep, as shown in Figure 23. In the excavation pit for sensor 13 (Figure 23), a 4 in. thick degraded, dark brown

vegetation layer was encountered 4 feet below the original road surface (0.5–1.0 feet below the excavation bottom). Sand with gravel was on top of the degraded vegetation layer. Under the degraded vegetation layer were crushed rocks with sand. The soils excavated from pits at sensor locations 2 and 6 were generally sand with gravel, the same as soils excavated from the first 3.5 feet of soils. No degraded vegetation layer was found in these two excavation pits.

Figure 23. Excavation pit at the center of the road for sensor 13

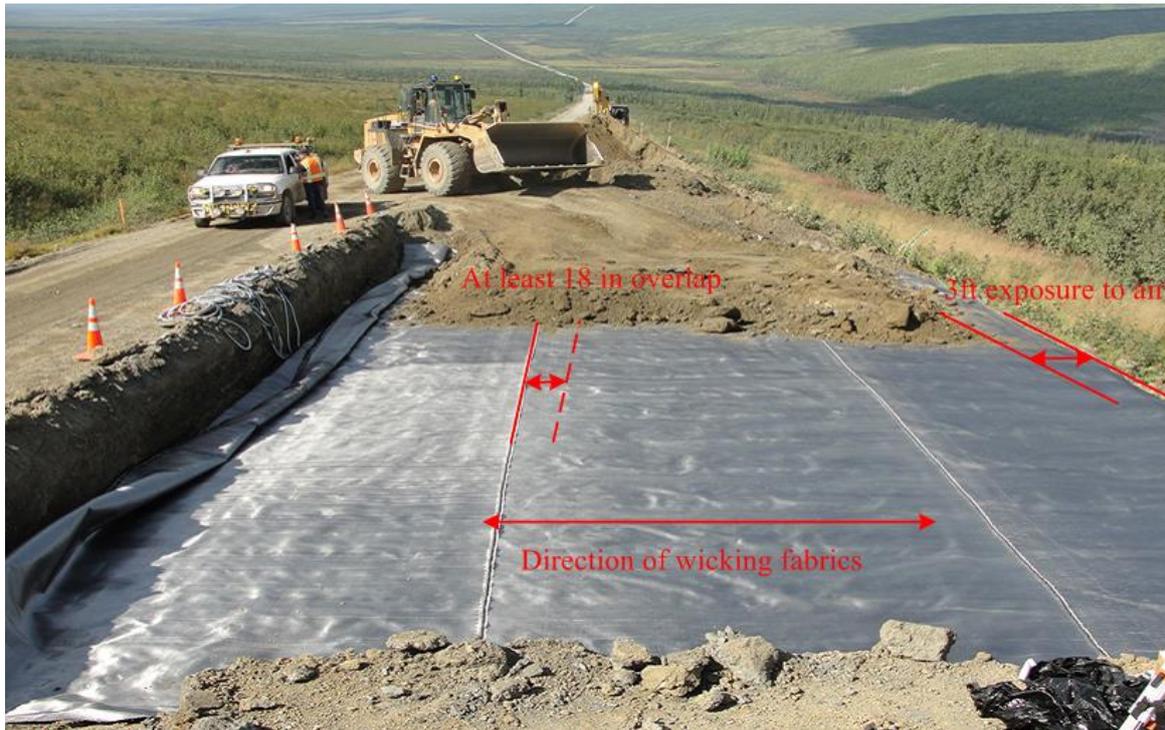
Figure 27. Wicking fabric installation after placement

Next, the wicking fabric was installed about 3.5 feet below the original road surface, as shown in Figure 26 and Figure 27. During the wicking fabric installation, a roll of wicking fabric was brought to the south (high) end of the excavation section (Figure 26). The wicking fabric was placed on the ground by pushing the roll downslope to the other end. The fabric was then cut at the lower end to the proper length, which covered the whole excavation range. Since the wicking fabric is directional, care was taken to make sure the direction of the wicking fabric was along the transverse direction of the road section so that water was transported out of the road structure horizontally to the road shoulder as shown in Figure 27.

The excavation in the east lane was about 60 feet long and 36 feet wide. Each roll of the wicking fabric was 300 feet long and 15 feet wide. In addition, according to the original design, at least 3 feet of wicking fabric was exposed to air at the shoulder. Thus, three passes were needed to cover the whole excavation area. The additional two passes of wicking fabric were placed in the same way as that for the first pass. To make sure the water would be transported from one layer of wicking fabric to another layer, a 3 ft overlap was used (see Figure 27).

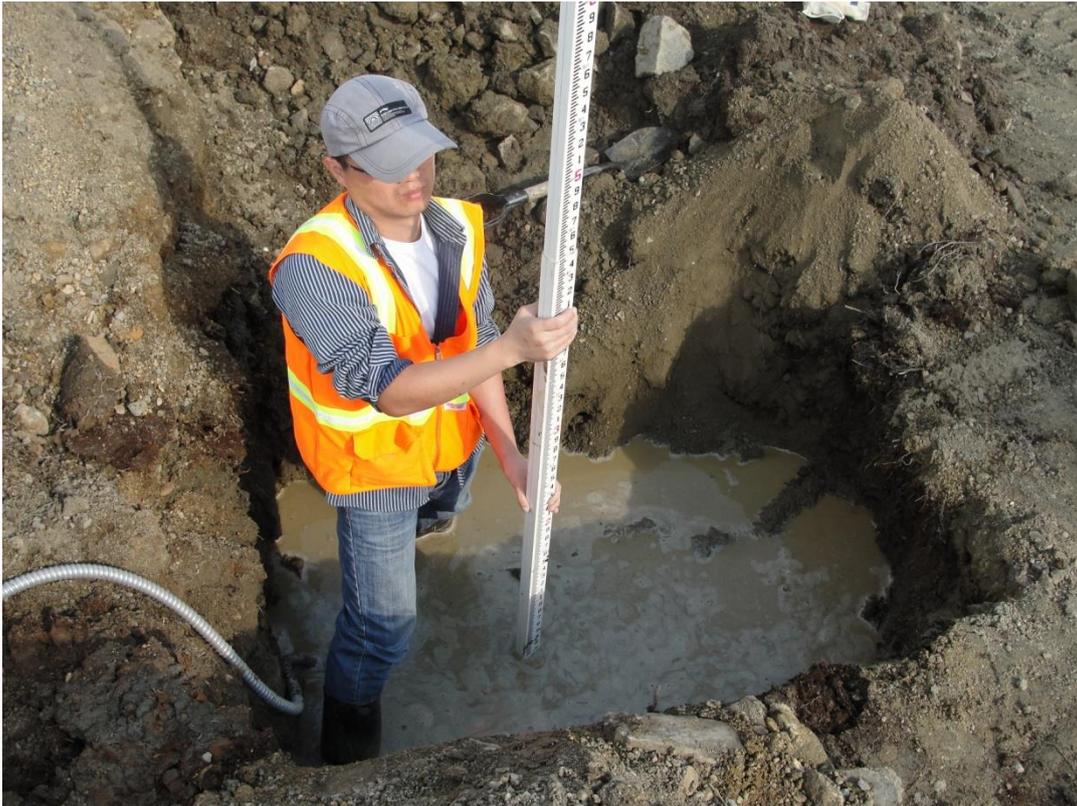
Figure 34. Installation of sensor 20

After the bottom of the excavation was graded, a pit was excavated at about 18 ft from the center of the road to install sensor 20, as shown in Figure 34 (please also refer to Figure 19). The pit was about 1.5 feet by 1.5 feet, with a depth 3 feet. During this process, groundwater was encountered at a depth of 2.5 feet (total about 6 feet below the original road surface). The soil was crushed rock with sand and silt and had high permeability. After the soils were excavated, water quickly migrated to the pit and in less than 1 hour, the bottom of the excavation pit was filled with water. As a result, sensor 20 was installed under the water, and then the pit was backfilled with soils excavated from the pit.

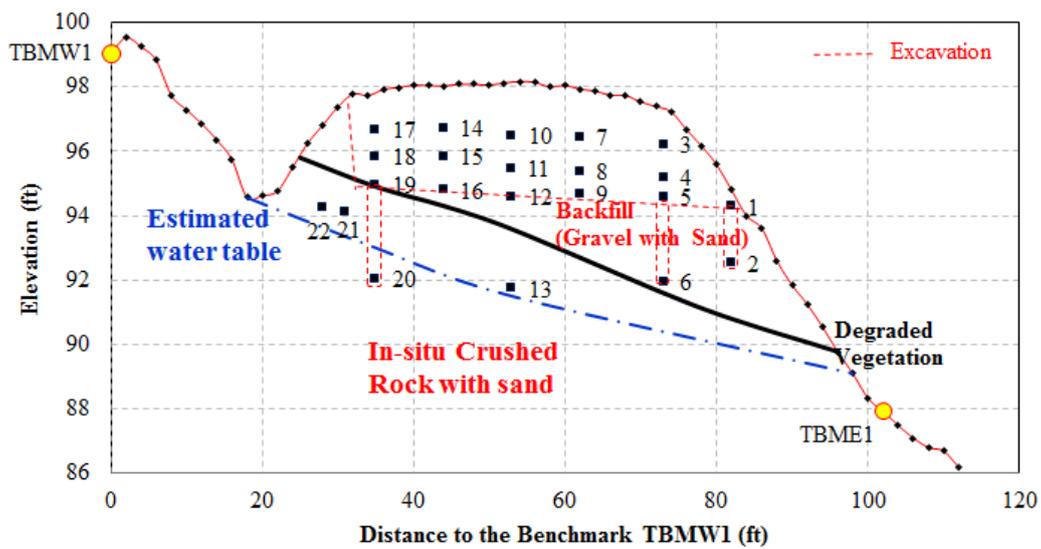
Figure 50. Soil stratigraphy at the test section

Construction of the test section required excavation of the whole road at the site, and the excavation provided information for the geotechnical site investigation. Figure 50 shows the soil stratigraphy for the test section based on observations made during the construction process. It was found that the road section was built directly on the original tundra of the hill using degraded granite, which can be classified as silt with gravel according to USCS classifications. The original tundra was about 3 feet below the surface at the west edge of the road, 4.5 feet below the centerline of the road section. It was about 9 feet lower than the road surface when it extended to tree line at the west shoulder of the road. The buried vegetation had degraded to a dark yellow layer 1 to 2 in, thick. Below the degraded vegetation was in situ crushed rocks with sand.

ditch to bury the sensor cables, we found that water seeped out of the soil surface once the tundra was removed. Additionally, water was found during the construction process in the existing ditch along the east side of the road. Figure 52 shows water in the ditch after the data collection box was installed on August 5, 2010. On the west side of the road, water was found along the tree line sporadically, as shown in Figure 53. Groundwater was also found when installing sensor 20 (see Figure 34). Figure 50 shows the approximate groundwater table based on the above observations.

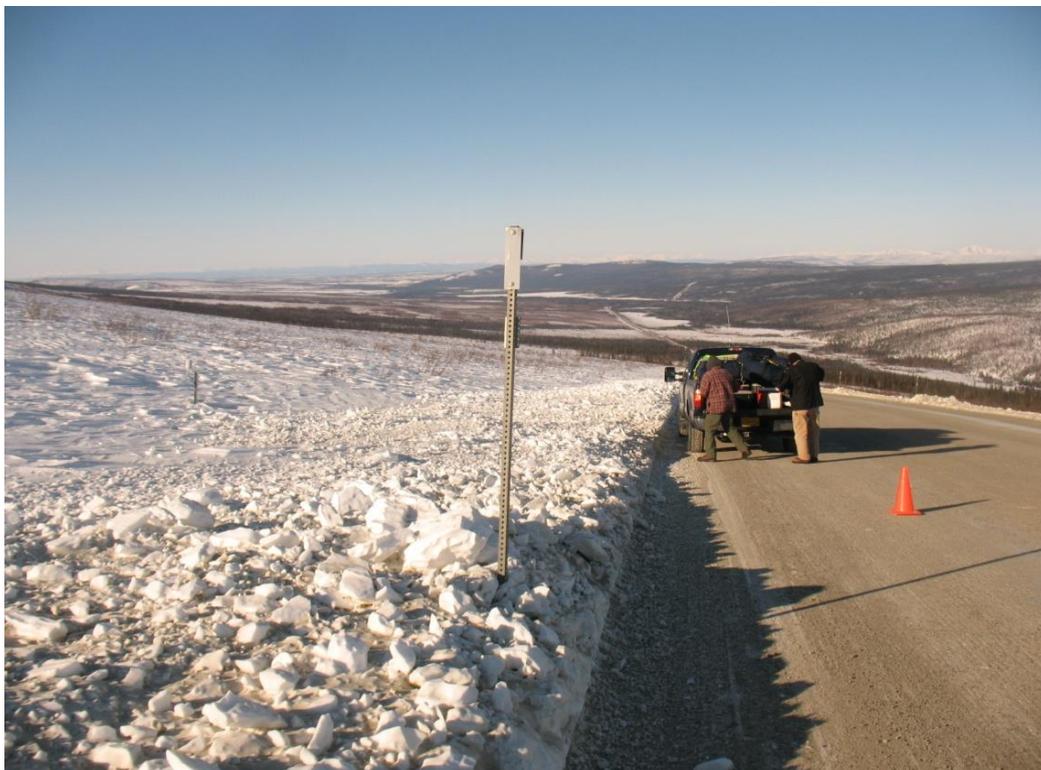
Figure 54. Site conditions on March 12, 2011, before installation of the solar panel

Figure 67 shows the temperature changes for sensors 1, 2, and 22 at the shoulders of the road section. The figure indicates that during the summer months, soil temperatures follow changes in air temperature. During the winter months, the temperature changes were small and not closely related to air temperature changes, mainly due to the insulation effect of thick snow at the shoulder (see Figure 54).

Figure 91 shows the temperature and moisture content contours for the road section on March 12, 2011, when the whole road section was completely frozen during the field trip (Figure 54). The moisture content was not above 10% anywhere.

for the datalogger decreased from 12.5 volts to 12.2 volts in two months. Although the CR1000 would have run correctly until the battery voltage reached about 10 volts, there was concern about whether the battery could survive the harsh winter in Alaska. It was decided that it might be better to add a solar panel as a backup source of power for the datalogger. A second trip was made to the test site on March 12, 2011, to download the data and install the solar panel. Figure 54 shows the test site conditions on March 12, 2011, before installation of the solar panel. The data collection box was completely covered by snow. Figure 55 shows the data collection box after installation of the solar panel. Another visit was made on March 30, 2012, and the site conditions that day are shown in Figure 56. The solar panel was exposed to the air. Figure 57 shows the changes in battery voltage over the past two years. The data indicated that battery voltage was high enough to maintain the functionality of the datalogger.

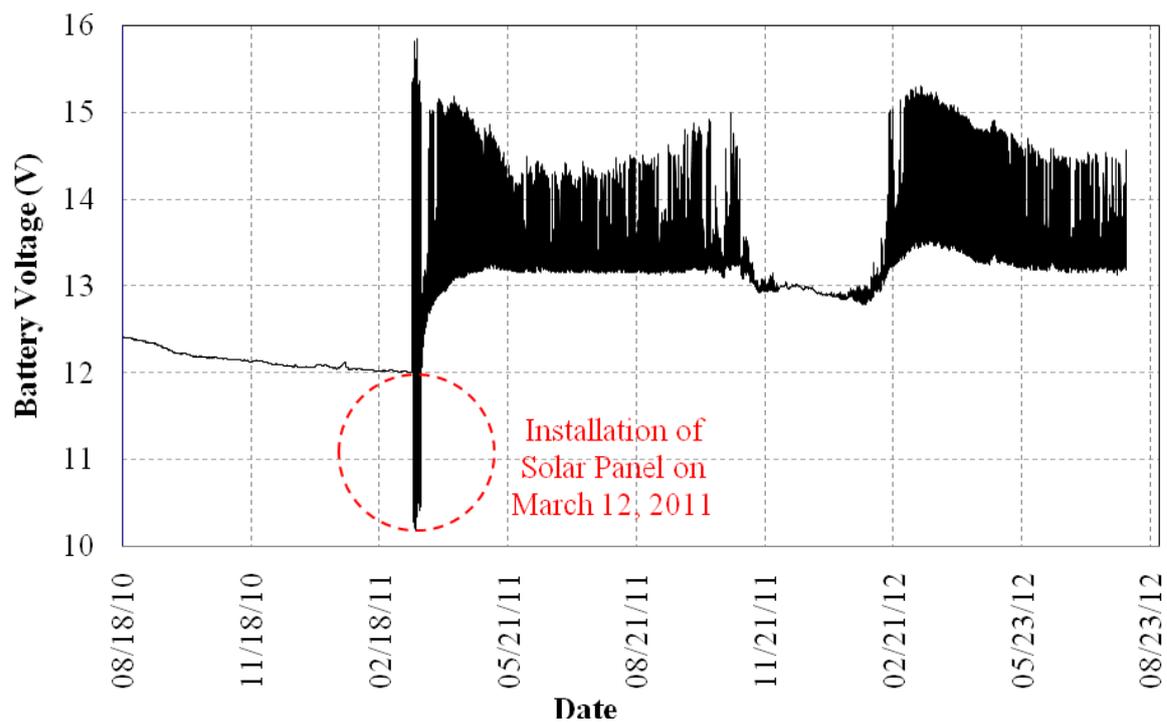
Figure 57. Battery voltage versus time curve

The first site visit to the test section was on October 16, 2010. The preliminary test results indicated that all sensors were functioning well. However, the voltage of the battery

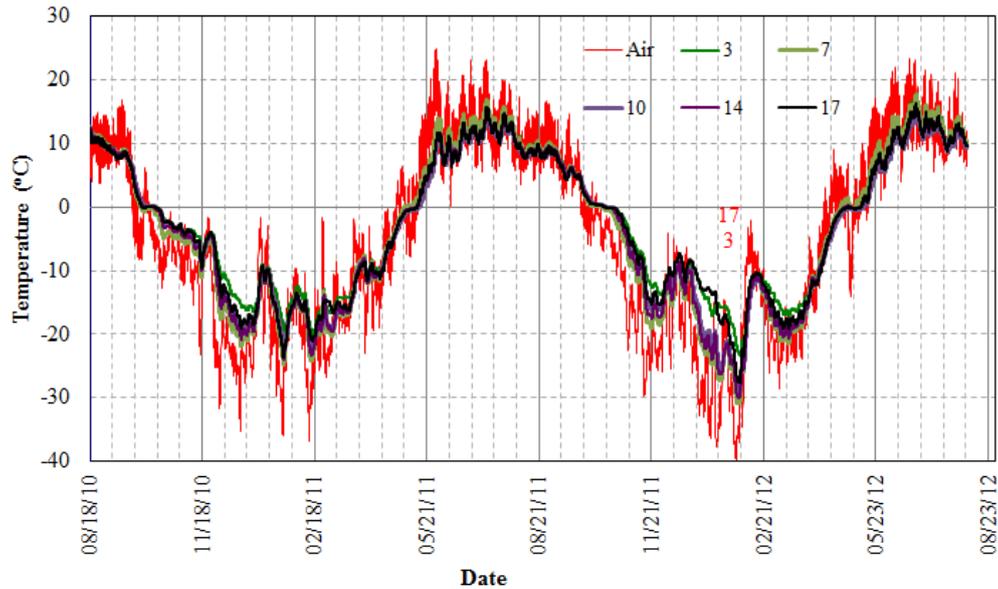
Figure 62. Temperature changes at 1.5 feet below the road surface

Figure 62 shows the temperature changes for sensors at 1.5 ft below the road surface during the two-year study period. Generally, changes in soil temperature follow changes in air temperature, but soil temperature changes are much less dramatic than air temperature changes, mainly due to the insulating effect of soil. Figure 62 indicates that changes in soil temperature followed changes in air temperature more closely in the summer months, from late April to early September, than in the winter months from September to April.

Soil temperatures are close to the average daily air temperature during the summer months and 5–10° warmer during the winter months, likely due to the insulation effect of snow cover. Because snow has low density and high voids, which trap a lot of air, it is good insulation and keeps the shoulders of roads relatively warm. In the winter, the soils (for example at sensors 7 and 10) at the center of the road are colder than the soils at the edges (for example at sensor 3 eastbound and sensor 10 westbound). The difference can be as much as 10°. This difference is mainly related to DOT&PF’s snow removal process; during the winter, its M&O crew often pulls snow from the road surface to the two shoulders and piles it at the shoulders (please see Figure 54 for reference). The center of the road, on the other hand, is exposed to air directly and is usually colder. Except for the road lanes, all other ground surface is covered by snow, which makes the overall soil temperature in the winter higher than the ambient air temperature. Figure 62 indicates that soil temperature first dropped to 0°C on October 10, 2010, and rose to above 0°C on May 15, 2011. In 2011, soil temperature first dropped to 0°C on October 14, and rose to above 0°C on May 12, 2012.

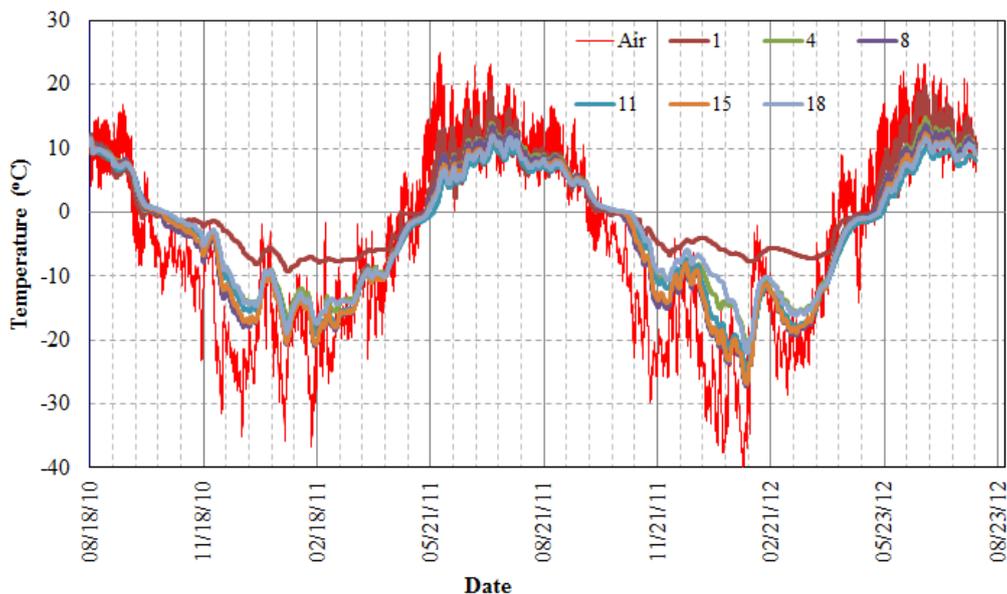
Figure 63. Temperature changes at 2.5 feet below the road surface

Figure 63 shows temperature changes for sensors at about 2.5 feet below the road surface. While sensors 4, 8, 11, 15, and 18 are in the road section and covered by 2.5 feet of soils, sensor 1 is at the shoulder just 1 foot below the ground surface. Temperature changes at sensor locations 4, 8, 11, 15, and 18 followed a pattern similar to the air temperature changes, but the soil temperatures were warmer in the winter and colder in the summer due to the insulation effect of the soils. Generally, soil temperatures in the center of the road were colder than those at the edge of the road.

Soil temperatures at the sensor 1 location followed air temperature changes during the summer months and were relatively constant at -7°C during the winter months. This pattern occurred because in the summer when all the snow was gone, sensor 1 was very close to the ground surface, and in the winter, it was covered by thick snow that had been removed from

the road surface. The differences between the air temperature and the temperature at sensor 1 were due to the evaporation of water at the soil surface, which absorbs a lot of heat energy. As a result, soil temperatures were always lower than air temperatures. Figure 63 indicates that soil temperature at sensor 11 first dropped to 0°C on October 17, 2010, and rose to above 0°C on May 23, 2011. In 2011, soil temperature first dropped to 0°C on October 23, and rose to above 0°C on May 22, 2012.

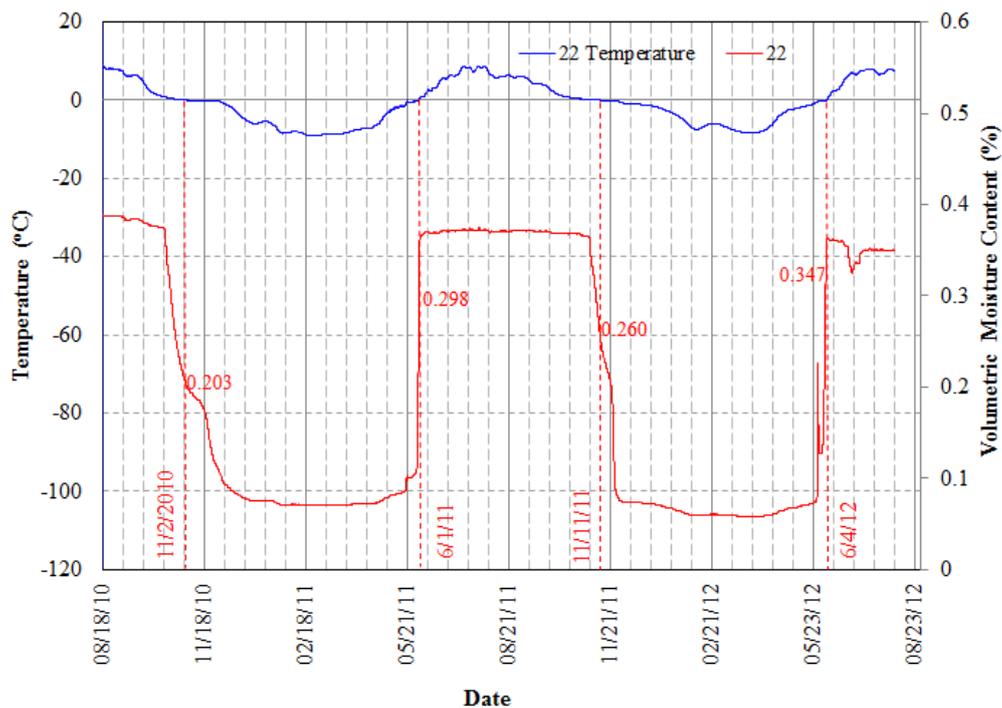
Figure 68. Temperature and volumetric moisture content changes at the location of sensor 22

The CS616-L moisture probes measure unfrozen volumetric water content of the soil. At the west side of the road is a ditch line, designed to drain away the melted mountain water. It was observed that water flows in the ditch during the summer months. The bottom of the ditch is about 3.6 feet below the road surface. Of all the sensor pairs, sensor 22 was the closest to the ditch, about 3.9 feet below the road surface. Figure 68 shows the temperature and volumetric moisture content changes at the location of sensor 22.

It was found that the volumetric water content of the soil during the 2011 summer months was constant at 37.2% when the soil was unfrozen. During the summers of 2010 and 2012, the volumetric water content of the soil at sensor location 22 was also relatively constant. It is considered, therefore, that soils at the location of sensor 22 are always saturated during the summer months. If the soils at the test sections were relatively uniform, then their saturated volumetric water content was close to 37.2%. Consequently, sensor 22 can be used as a reference to evaluate moisture content at other locations. Figure 68 also indicates that soil volumetric water content decreased before the soil temperature dropped to 0°C. It was found that when soils at the location of sensor 22 were completely frozen, the unfrozen moisture content of the soil varied from 5.9% to 7%.

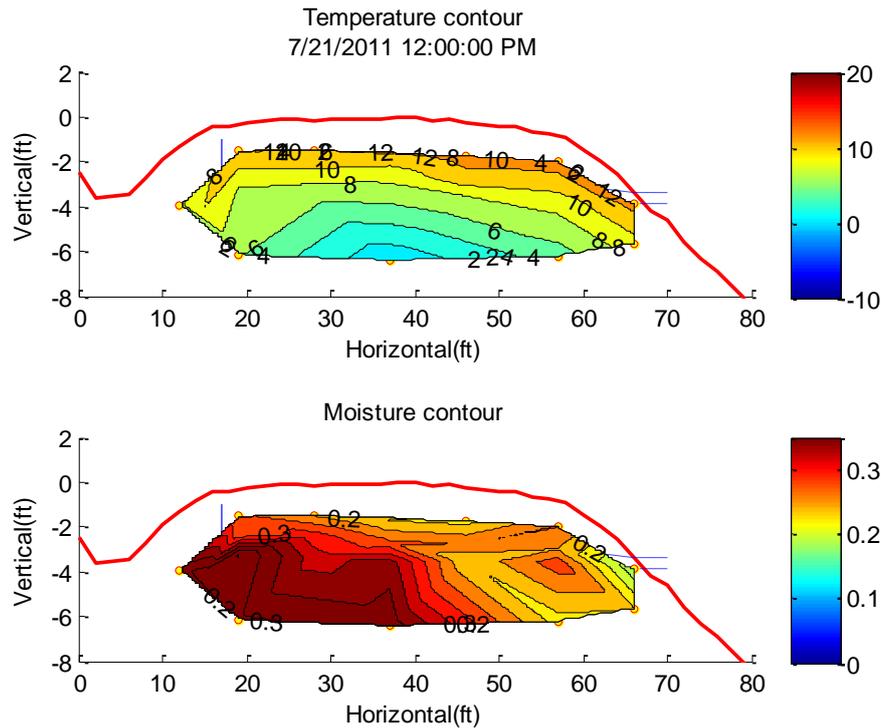
Figure 101. Temperature and moisture content contours at noon on July 21, 2011

Figure 101 shows the temperature and moisture content contours at noon on July 21, 2011, when the road section was completely thawed. The soils at 6 feet below the center of the road became saturated. The moisture content contour was similar but not identical to the ones in Figure 75, Figure 77, and Figure 85 for the previous year. The difference might imply that the freeze-thaw cycle changed the soil structure in the road section. Specifically, it seemed that the soils at the west lane of the road between sensor locations 13 and 22 had been loosened and had higher moisture content compared with the previous year. The soils at the east lane of the road were significantly drier than soils at the west lane.

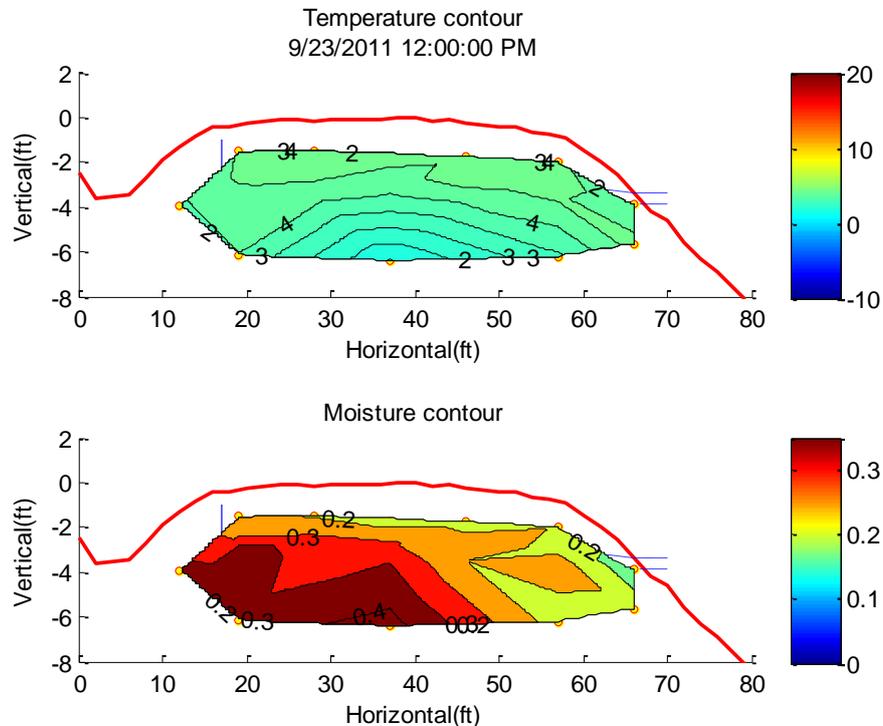
Figure 106. Temperature and moisture content contours at noon on September 23, 2011

In 2011, the air temperature dropped to zero on September 23. The corresponding temperature and water content contours are shown in Figure 106. Before the soil froze, water

had drained out, and the moisture content in most of the road section was low, especially in the first 3.5 feet below the road surface, where the soil moisture content was generally less than 20%, corresponding to a degree of saturation less than 50%. Because the soils were relatively dry, frost heave was not expected to occur in the first 3.5 feet of soils.

It seems that H2Ri wicking fabric successfully eliminated the frost heave problem at the Beaver Slide test section. The potential mechanism involves draining water out of the road embankment and forming a capillary barrier, as discussed in the Literature Review. Figure 86 and Figure 106 show that before the soils were frozen, moisture content in the test section was low, especially in the east lane, where the volumetric moisture content was lower than 20% for most soils, corresponding to a degree of saturation of 54%. For soils with such a low degree of saturation, the unsaturated permeability of the soils is normally very low. Consequently, when heat loss occurs at the road surface with subsequent freezing downward, the water supply from the lower soils is not sufficient to sustain ice crystal growth in the freezing front. Thus, most of the ice in the frozen soils comes from freezing of in situ water in the unsaturated soils. Table 3 shows a slight increase in water content for soils 1.5 ft below the road surface after the thaw in 2011. However, the increased water content did not cause the soil to reach saturation. As mentioned in the Literature Review, frost heaving requires substantially more water than is naturally available in soil pores (Taber 1929). By draining water out of the road embankment and keeping the top soils dry, the H2Ri wicking fabric worked as a capillary barrier and eliminated frost heave in the test section, as suggested by Henry and Holtz (2001).

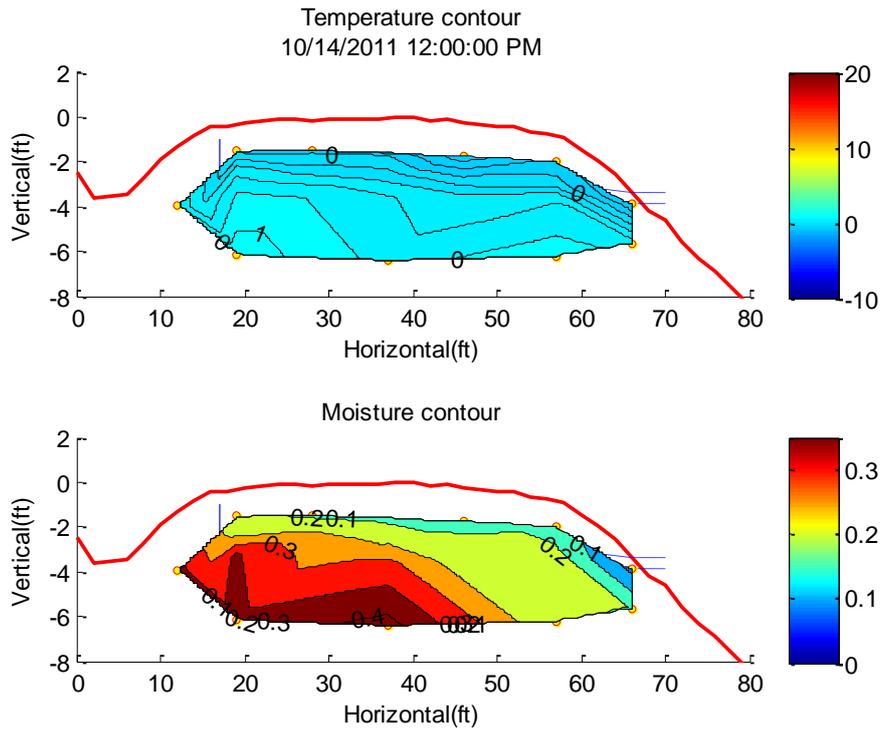
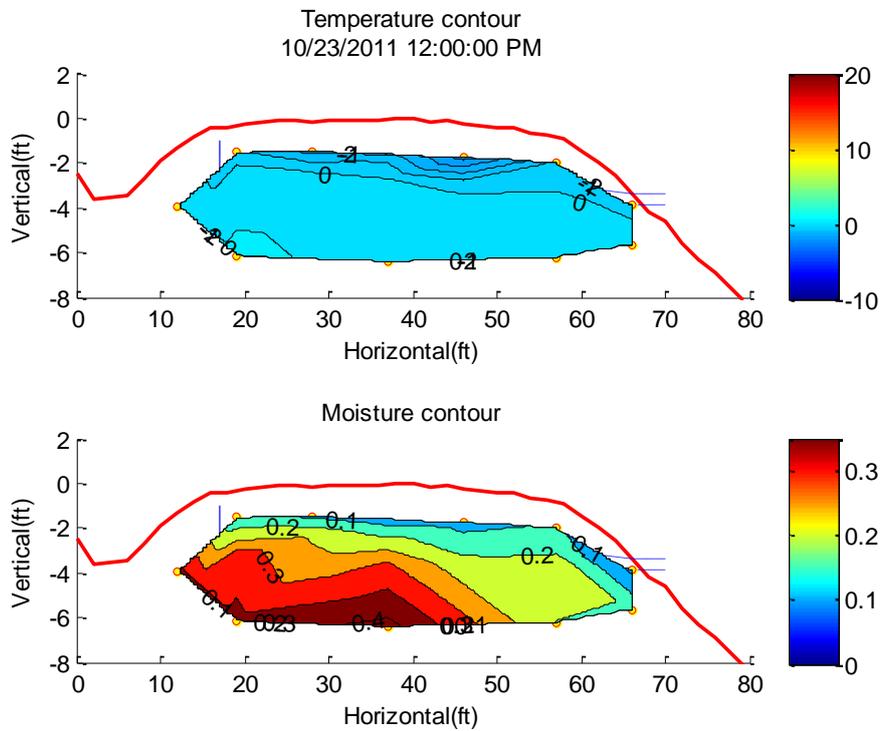
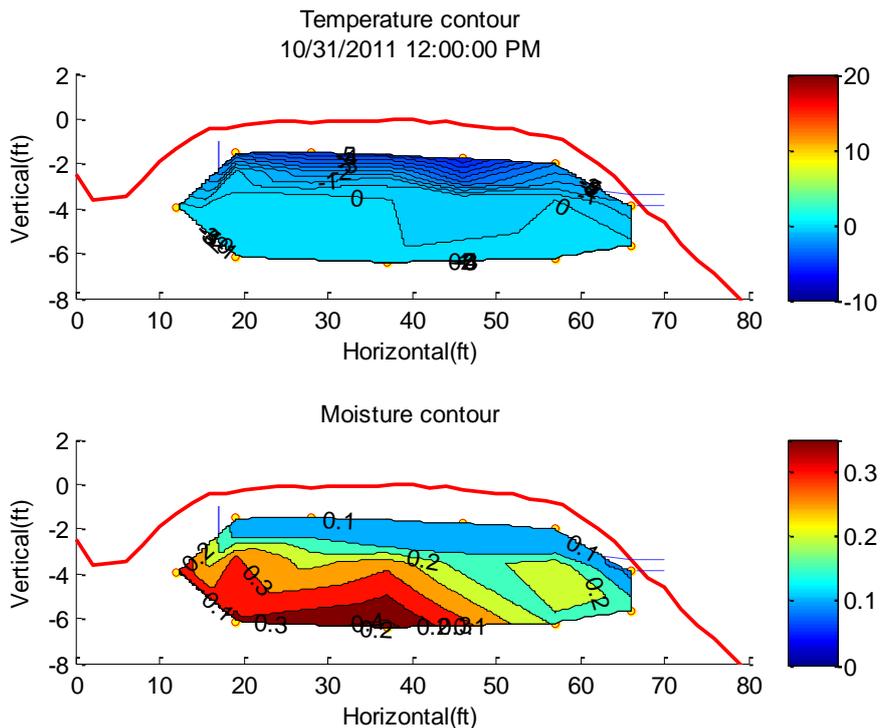
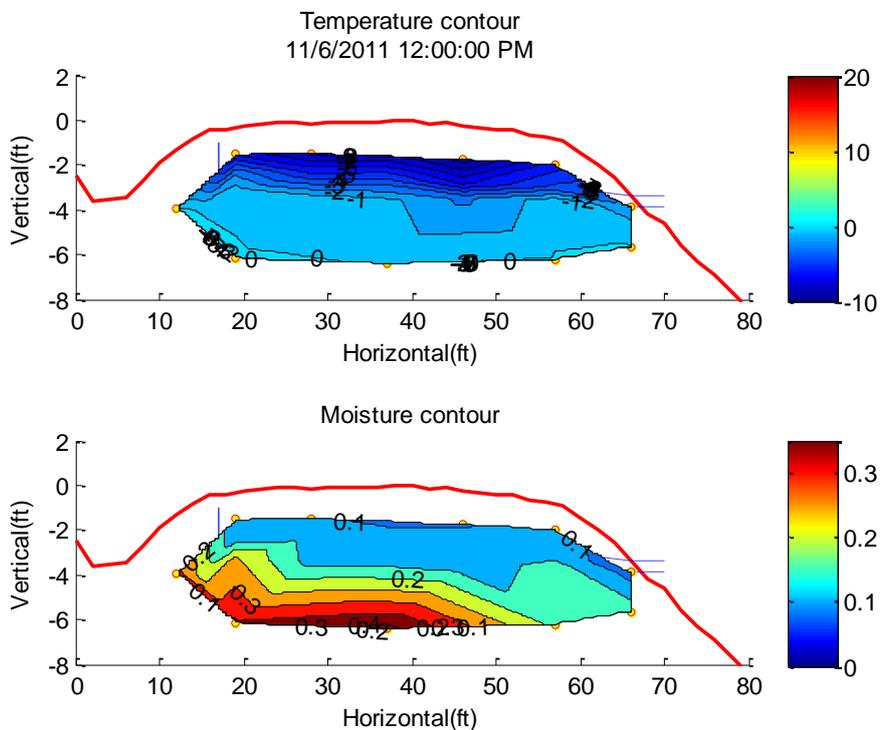
Figure 107, Figure 108, Figure 109, and Figure 110 show the temperature and moisture contours when the freezing front penetrated to 1.5 ft, 2.5 ft, 3.5 ft, and 6 feet below the road surface, respectively. There was concern that the wicking fabric would lose function when the exit at the edge froze. Such a scenario seemed not to happen. Once the air temperature dropped to zero and the soils started freezing, the water supply from the uphill slope was reduced. Consequently, the soil water content in the road section was reduced during the freezing process, as shown in Figure 107–Figure 110. Figure 111 shows the temperature and moisture contours when the road section was completely frozen. The unfrozen moisture content in the whole road section dropped to 10% or less.

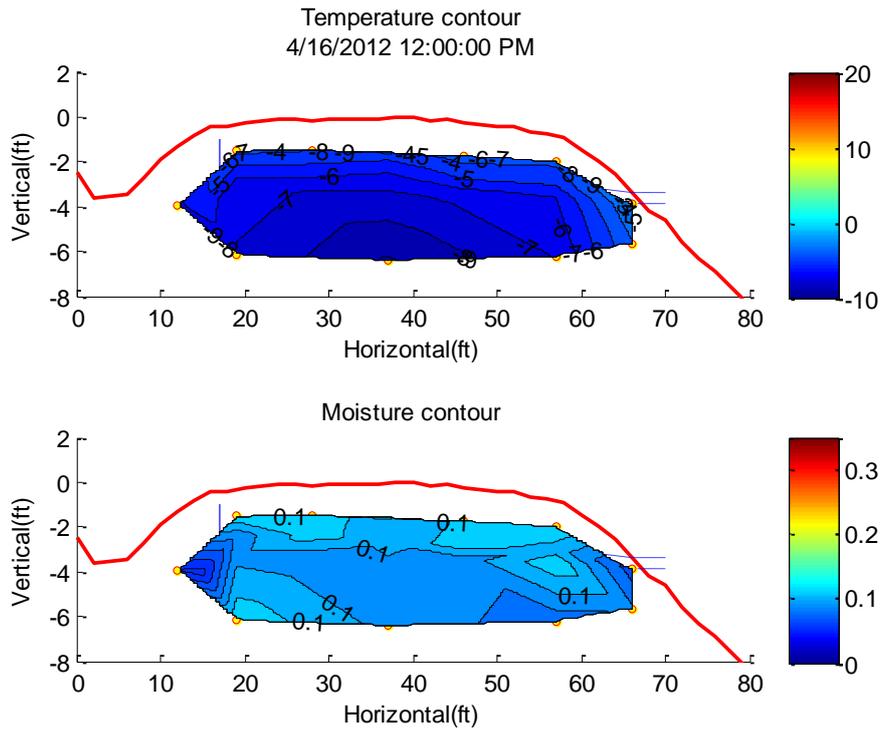
Figure 112. Temperature and moisture content contours at noon on April 16, 2012

Figure 112 shows the temperature and moisture contours when the air temperature first rose to above zero in 2012. It was found that the road section was completely frozen and the unfrozen moisture content was at 10% or less. Figure 113 and Figure 114 show the temperature and moisture contours when the thawing front penetrated to 1.5 feet and 2.5 feet below the road surface on May 12 and 22, 2012, respectively. This period corresponded to frost boils in early spring. The moisture contours during this period did not indicate any saturated soil zone, which was an indication of no frost heave in the previous year. Figure 115 shows the temperature and moisture contours when the thawing front penetrated to 3.5 feet below the road surface on May 29, 2012. Soils at sensor locations 19 and 21 near the ditch were saturated, while soils at other locations were below saturation. Similar to 2011, a frozen soil core was present at the bottom center of the road. The moisture content contour indicates that water was flowing from the ditch to the east edge along the wicking fabric.

Employees with DOT&PF M&O reported that frost boils occur from the end of April until mid-May each spring. As shown in Figure 112–Figure 114, soils remained frozen at 3 feet below the road surface until the end of May. Thus, the water that causes frost boils/soft spots is unlikely to be coming from the drainage ditch, which is 3.6 ft below the road surface. Instead, the water has to come from thawing of in situ water in the road structure. To form soft spots (shown in Figure 2), the soils must first be fully saturated, and excess water must be available. The excess water can only come from thawing ice lenses in the road structure. In other words, frost heave must have occurred the previous winter. For this reason, we conclude that frost boils that occur in early spring are due to frost heave and subsequent thaw weakening (see Figure 123a).

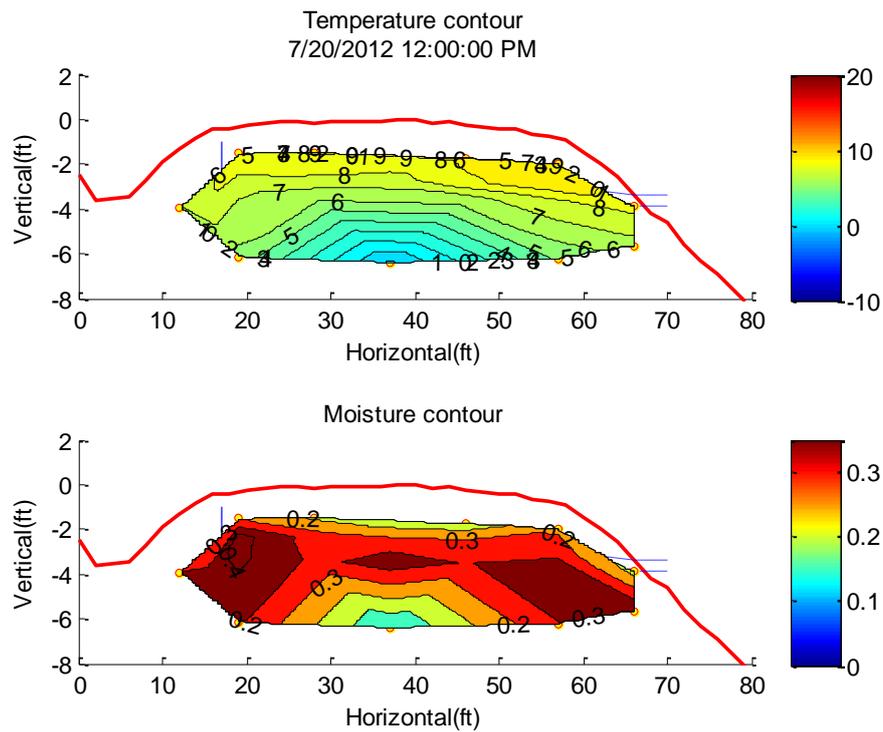
Figure 116. Temperature and moisture content contours at noon on July 20, 2012

Figure 116 shows the temperature and moisture contours on July 20, 2012, after a rainfall event. The moisture content in the road section significantly increased in comparison

with the previous days. There were three discontinuous saturated soil zones similar to those in Figure 98 on July 1, 2011, which demonstrates the non-uniform thawing of the soils and the associated ponding of water. The moisture contours in the following days (as shown in Appendix I) indicate that the ponding water drained out of the road structure along the direction of the installed wicking fabric. Figure 117 shows the temperature and moisture contours when the test section was completely thawed on July 30, 2012. The frozen soil core, as shown in Figure 116, was completely gone and the soils at the same area were saturated. In the east lane of the road, the moisture content between the two layers of wicking fabric was higher than the surrounding area, indicating the water was draining along the wicking fabric.

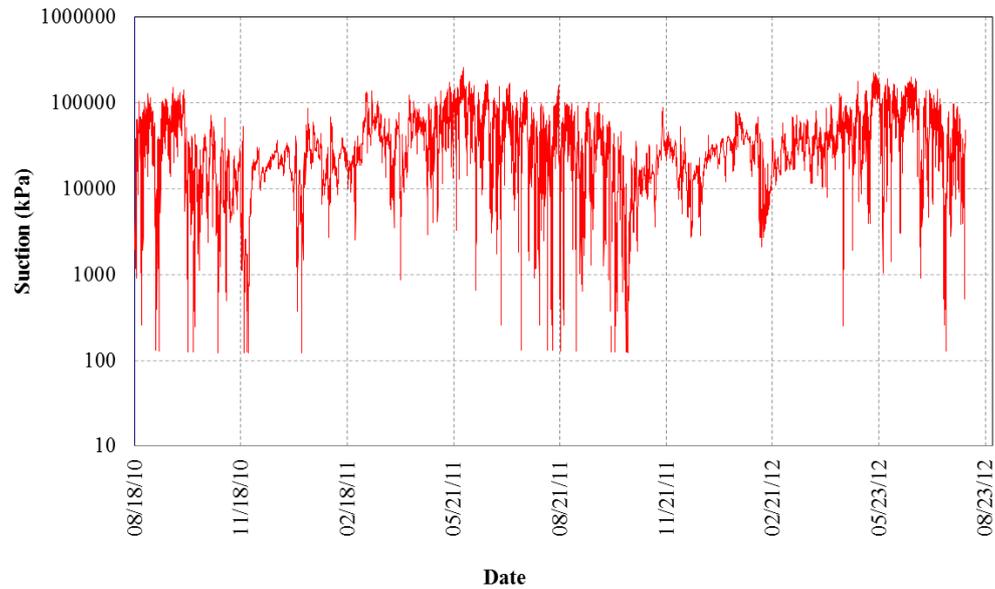
Figure 124. Suction in the Air at the Beaver Slide

Compared with thousands of kilopascal of suction in the air, the unsaturated soils in the pavement structure have suction values normally less than 1,000 kPa. The difference in suction is the driving force of H2Ri in moving water out of the road section, which is why it is important to have at least 3 feet of the H2Ri wicking fabric exposed to the air (see Figure 19).
