DEVELOPING COUNTY BRIDGE REPAIR AND RETROFIT TECHNIQUES

OTCREOS11.1-24-F

| 4. TITLE AND SUBTITLE Developing County Bridge Repair and Retrofit Techniques | | 5. REPORT DATE August 2013 | |

OTCREOS11.1-24 Developing County Bridge Repair and Retrofit Techniques

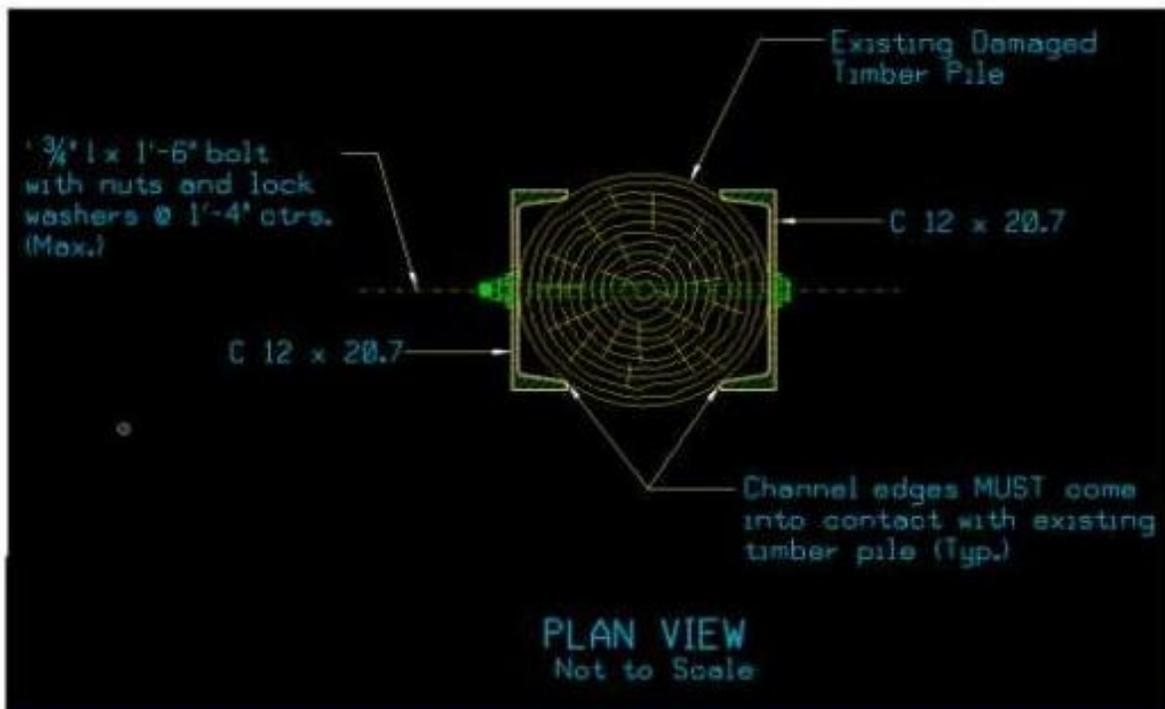
Figure 2. Plan View of C-Channel Jacket

C-Channel Jacket: Suggestions from Roe Enchayan, P.E., Nebraska Department of Roads, were presented at the Midwest AASHTO Bridge Preservation Conference in 2010. One of his suggestions involves two C-Channel shapes forming a jacket around a damaged timber pile, as shown in figures 2 and 3. These shapes are held together by a series of bolts that run through the pile. When tightened, the C-Channel's compress the pile around the longitudinal axis, strengthening any axial loads applied to the timber [4]. This repair is inexpensive, but is not as effective as a complete pile replacement.

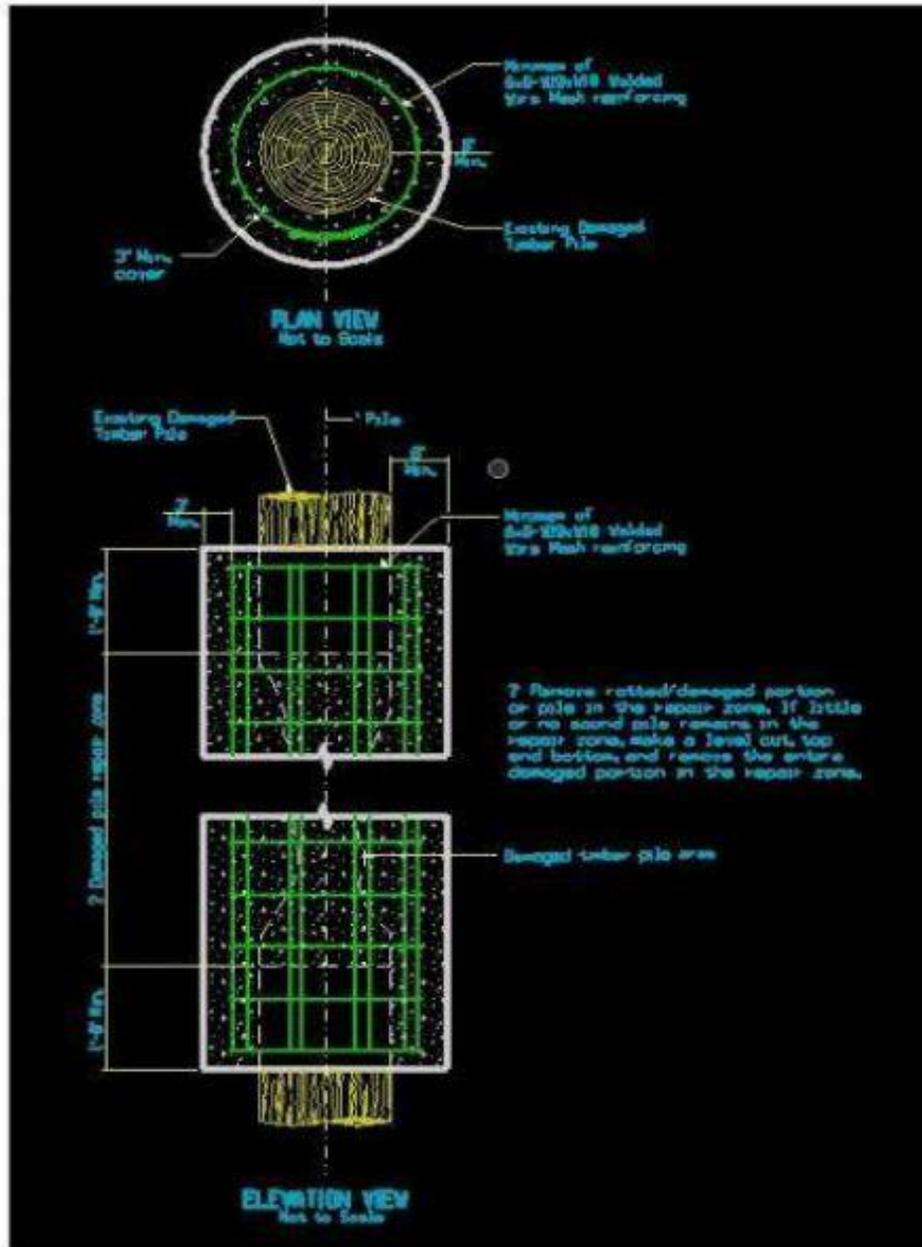
Figure 4.1 Elevation View of Concrete Jacket

Concrete Casing: Another repair suggested by Enchayan is a concrete casing, illustrated in figure 4. Similar to the C-Channel design, a cast-in-place concrete form is poured around the outside of the damaged timber pile. This repair protects the damaged timber from the elements and adds strength to the pile. However, forming and pouring concrete can be an expensive, labor intensive process.

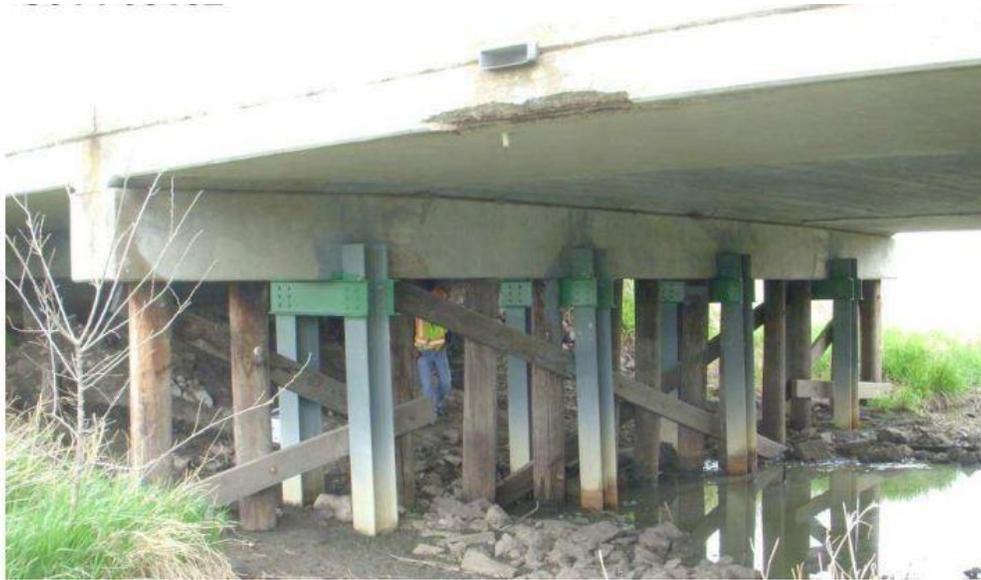
Figure 5. Example of Additional Piles as Repair

Additional Piles: Another simple solution to timber pile decay is to install additional piles as shown in figure 5. This repair requires a large amount of material and labor, especially due to the need for the new piles to be driven. This solution provides an alternate load path, which may be necessary depending on the condition of the existing timber piles.

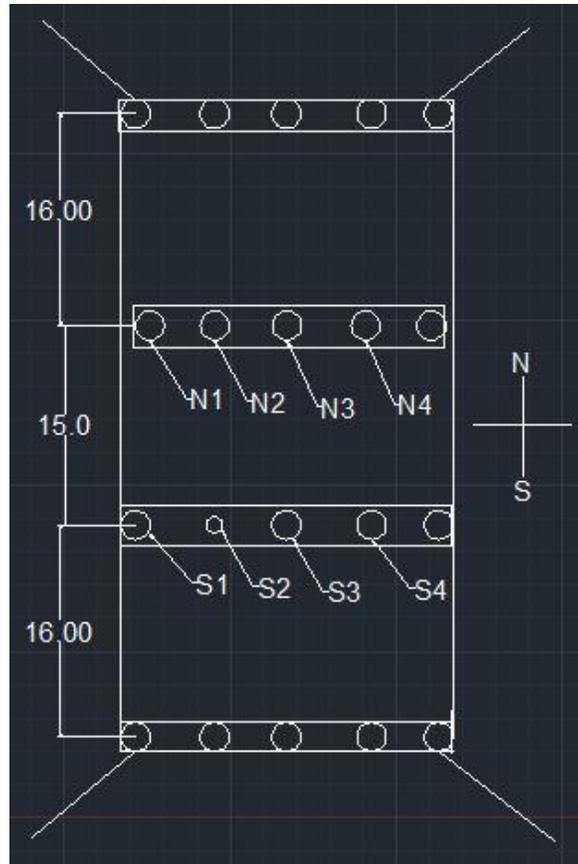
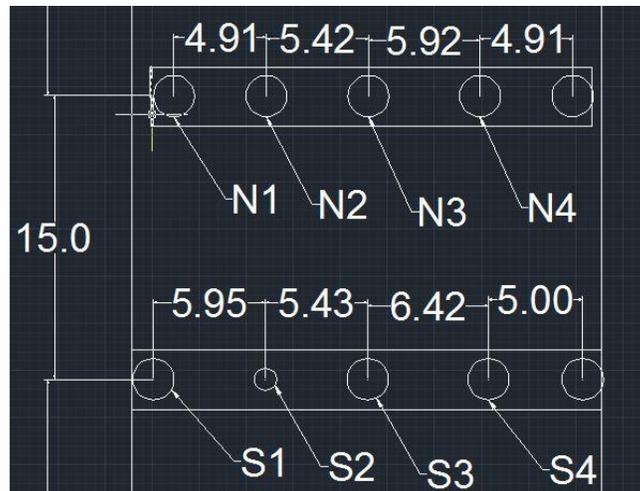
Figure 18. Plan View of Grant County Bridge Piles

feet. There are five piles under each bent cap, spaced from 59" to 77" apart, center to center. The pile configuration is illustrated in figures 18 and 19.

The splice repair was installed on the south bent cap, designated as S2 (shown in figures 18 and 19). According to past inspections the replaced timber pile had undergone more than 50% section loss and severe splitting. The replacement pipe is illustrated in figure 21.

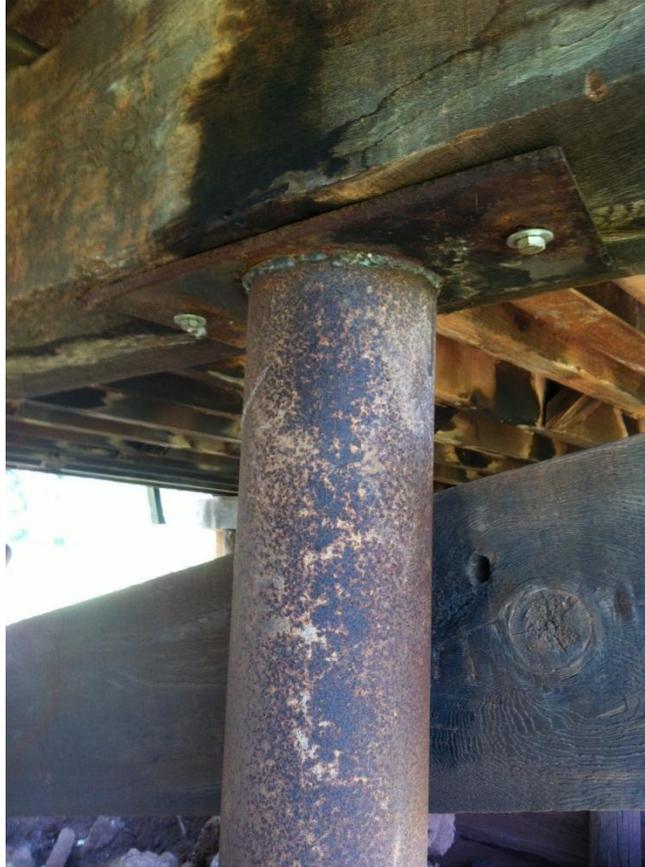
Figure 22. Top Connection

The pipe which replaced the timber pile was 7 5/8 inches in outside diameter and had a wall thickness of 0.450 inches. The grade of the steel is unknown, but was assumed to be grade 50. The pipes connection to the bent cap is shown in figure 22.

As illustrated, the pipe is welded to a plate, which is bolted to the bent cap. The bottom of the pipe is welded to the sleeve, underground.

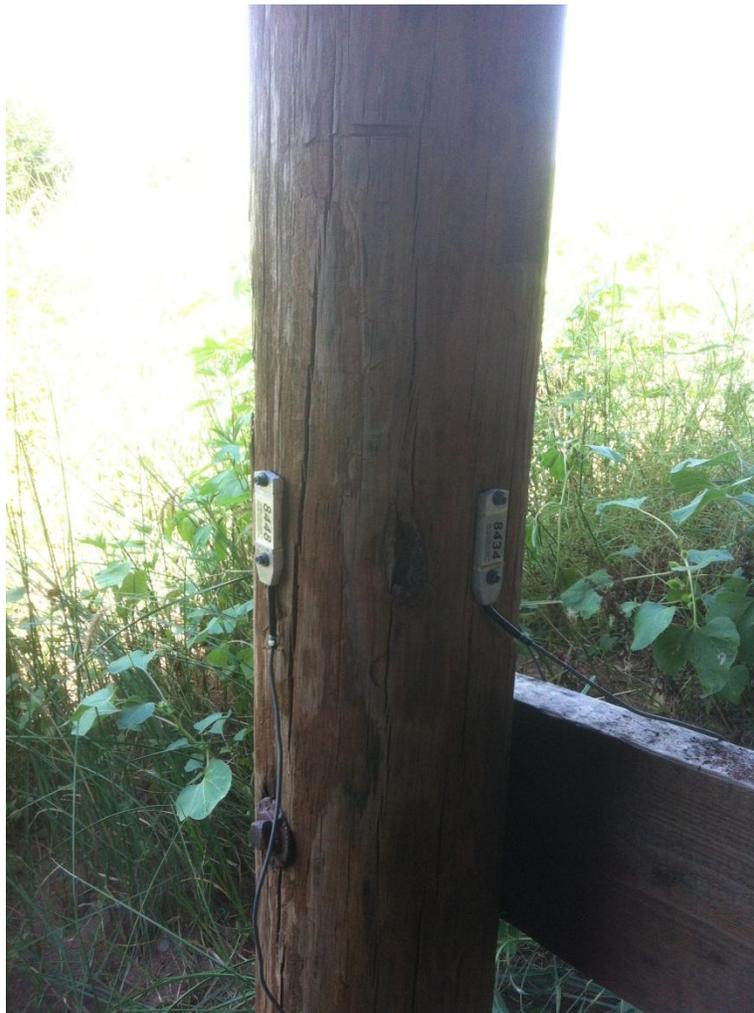
Figure 27. Pile N1 and Attached Strain Sensors

were chosen because they would theoretically be taking the most load when the load was driving across the bridge. 4 sensors were put on piles N1, N2, N3, S1, and S3. 2 sensors were installed on N4 and S4. 6 sensors were installed on S2. This distribution of sensors was chosen based on the importance of accuracy involved with different piles and the number of sensors available. N4 and S4, although important, were not as high of a priority to calculate an accurate strain value as S2, which had 6 sensors installed. The sensors were installed onto the timber piles with roofing screws on opposite sides of the pile. This is illustrated in figure 27, a picture of pile N1.

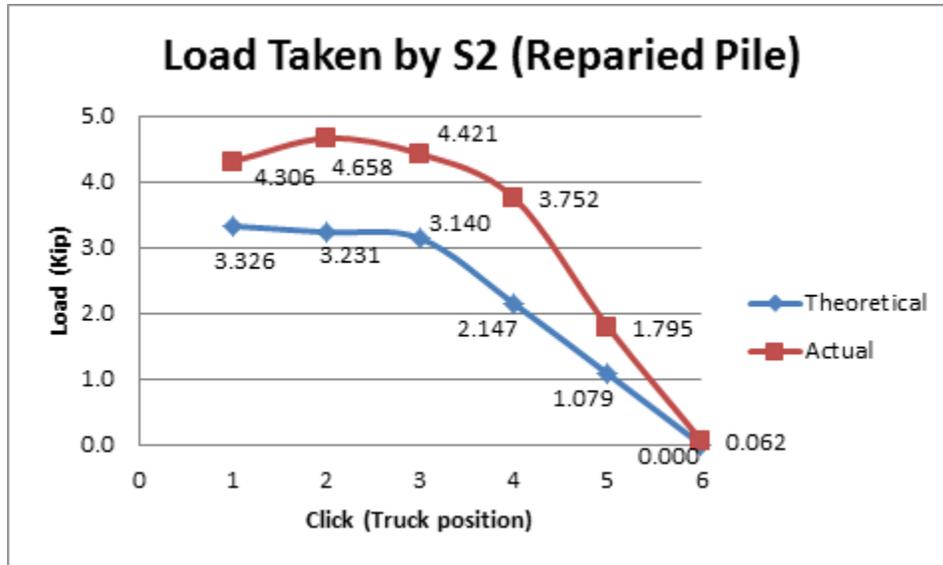
Figure 42. Load Taken by S2 (Repaired Pile)

While the location of the repaired pile does affect the amount of load it will take, this is another example of how stiff the repaired pile actually is.

Figures on the following pages illustrate the actual load registered in each pile, measured from the field test, compared to the theoretical load the pile should see based on structural analysis. It should be noted that in indeterminate structures like a pile system, load is distributed by stiffness. Therefore, if an element of a structure is undergoing a high load, then that element is stiff and provides strength to the system. Recall the location of each pile, illustrated in figure 40, and that the truck was traveling from South to North during the testing runs. Figures 41 through 46 show the comparisons between theoretically modeled loads and experimentally determined loads carried by piles S1, S2, S3, N1, N2, and N3. Pile S2 is the pile that was repaired with a steel replacement. It is also the only pile that actually carried more load than what was theoretically predicted via structural modeling.
