**ENGINEERING STUDIES ON JOINT BAR INTEGRITY, PART I: FIELD SURVEYS  
AND OBSERVED FAILURE MODES**

This paper is the first of a two-part series describing a research project, sponsored by the Federal Railroad Administration (FRA), to study the structural integrity of joint bars. In Part I of this series, observations from field surveys conducted on revenue service track are presented. Automated and visual inspections of rail joints were conducted to identify defective joint bars. Detailed information and measurements were collected at various joint locations.

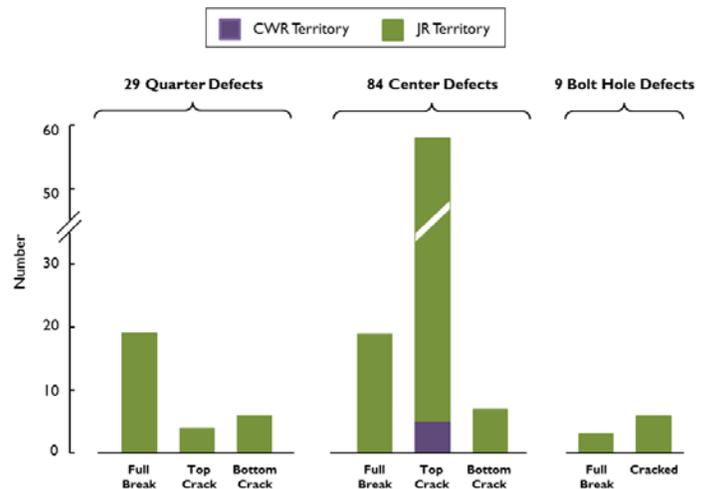
**Figure 9: Defect Type Distribution in Field Surveys (Total of 122 Defects)**

A total of 122 defects were found in 121 failed or defective bars (i.e. one bar contained more than one defect) at 107 joint locations during the six field surveys. These defects were grouped into three types: (1) quarter defects, (2) center defects, and (3) bolt hole defects. Within each type, the defects were divided into sub-categories: either fully broken through or cracked. For quarter cracks and center cracks, the origin of the cracking, either from the top or the bottom of the bar, was documented. Table 3 lists the number of each different type of defect found during the field surveys in CWR and JR territory. Figure 9 is a graphical representation of the data in the table. A majority of the defects, 84 out of 122 (or 69 percent of the total), were center defects (either cracked or fully broken bars).

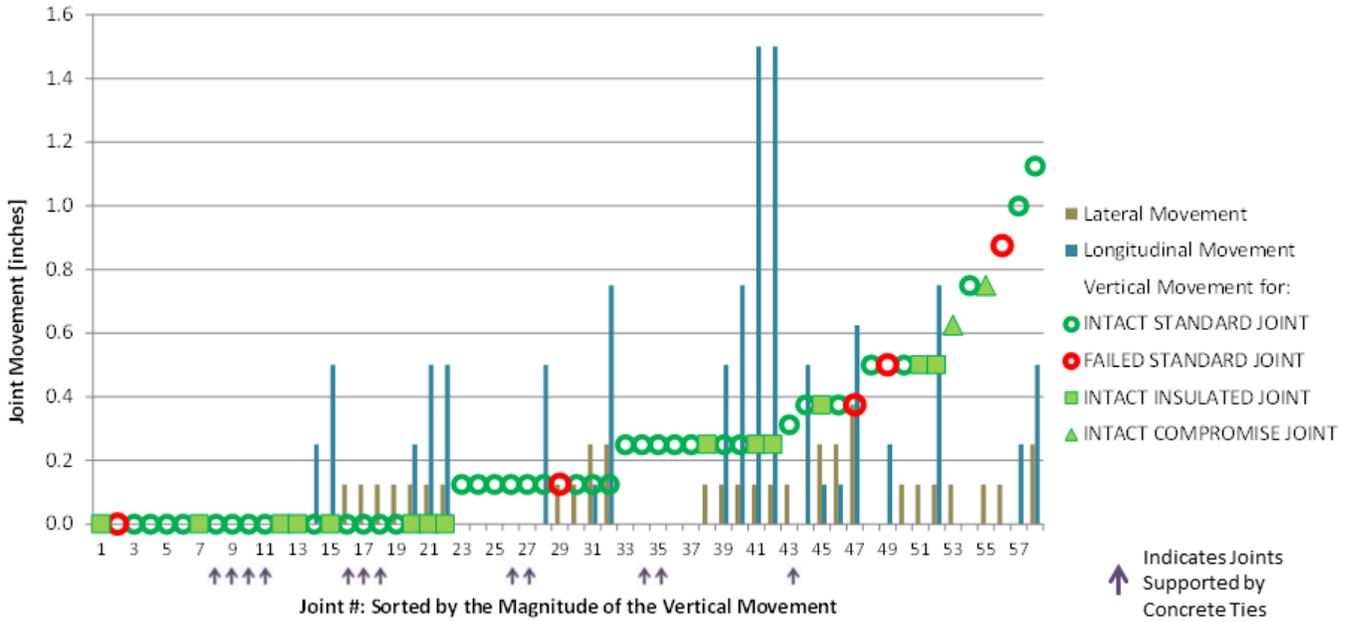
Figure 10: Overview of Joint Movements in CWR Territory

Figure 10 shows an overview of joint movements recorded at each of the joint locations in CWR territory. The horizontal axis in the plot is joint location sorted by increasing magnitude of vertical movement. The figure shows that the three failed joint locations have vertical movements of 0.375 inch or greater. The figure also shows that 12 joint locations were supported by concrete ties, which appear to have better support conditions than standard temporary joints. Similarly insulated joints appear to have better support conditions than standard temporary joints. However, it should be noted that several of the joints surveyed in CWR territory had been installed recently relative to the field evaluation date, and therefore did not have significant tonnage accumulation.

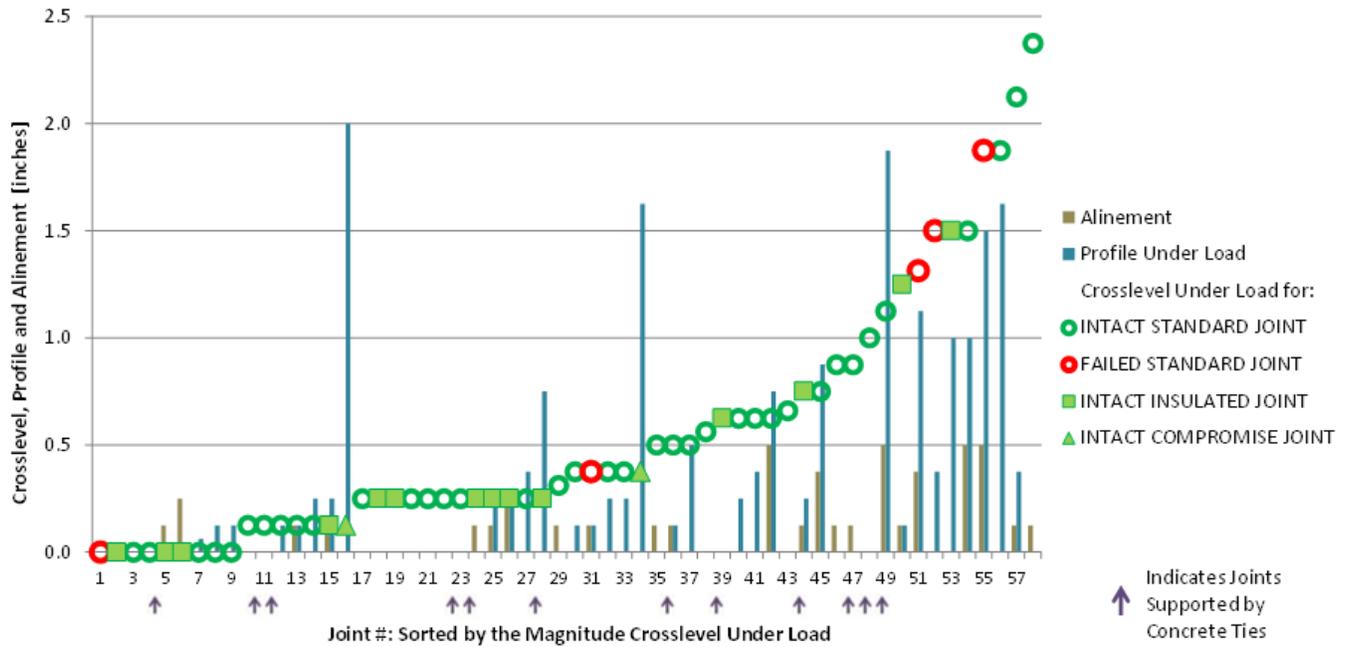
Figure 11: Overview of Geometry Measurements in CWR Territory

Figure 11 shows a similar overview of geometry measurements for cross level, alinement, and profile. In this figure, the horizontal axis is joint location sorted by ascending order of cross level under load. Three failed joint locations coincide with locations with adverse geometry conditions. The two other failed locations may be considered as statistical outliers; one was located at a switch where maintenance had recently been conducted relative to the survey date.

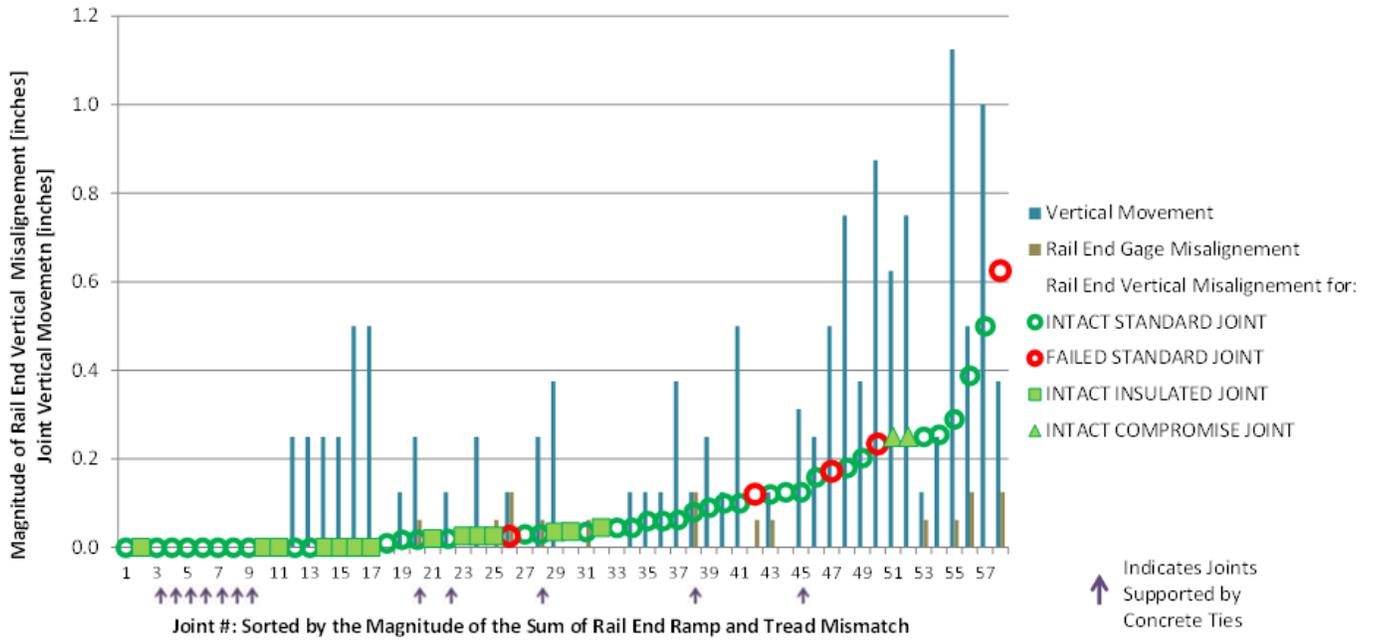
Figure 12: Overview of Rail End Batter in CWR Territory

Figure 12 summarizes the rail end batter measurements in terms of rail end ramp and tread mismatch. Significant tread mismatch or abrupt ramps were measured at four of the five failed locations. A possible explanation may be due to the fact that failed joints in CWR territory are temporary joints where rail breaks or defects are replaced with rail plugs on which the head wear may not match up with the wear on the main rail.

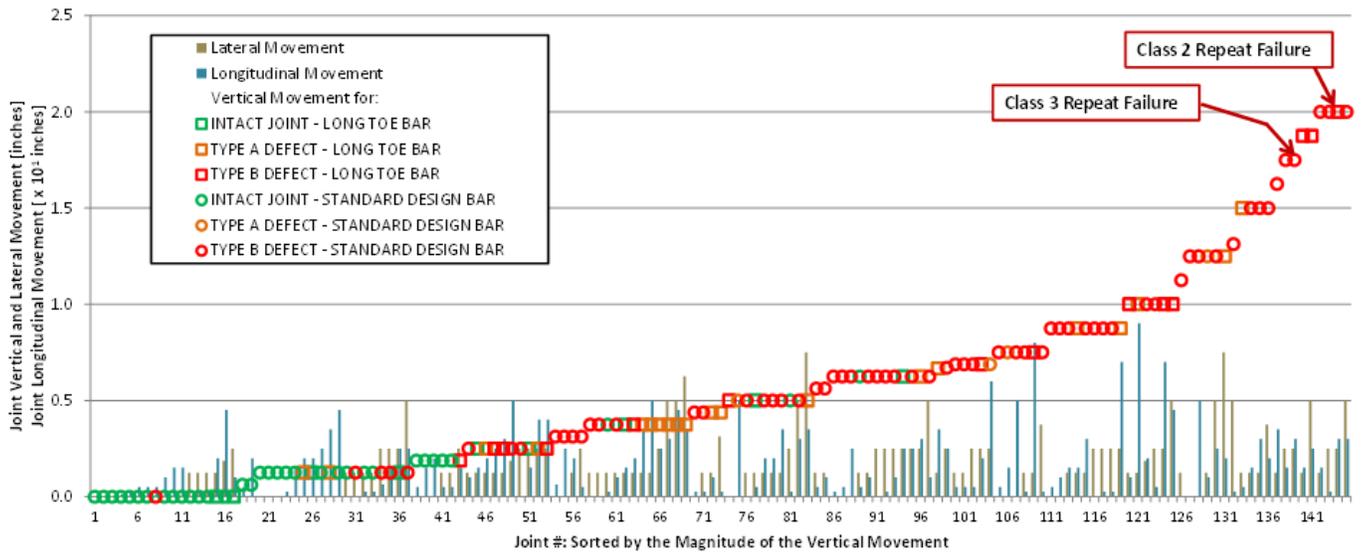
Figure 13: Overview of Joint Movements in JR Territory

Figure 13 shows an overview of joint movements in JR territory. Failed or defective joint locations tend to have larger vertical movements than intact joint locations. This observation is consistent with joint movements measured in CWR territory. The figure also points out two repeated locations with failed or defective joints, which were identified from looking at records from the JBIS vehicle when it inspected the test zone prior to the field survey. Significant vertical movements were measured at both locations with repeated failures.

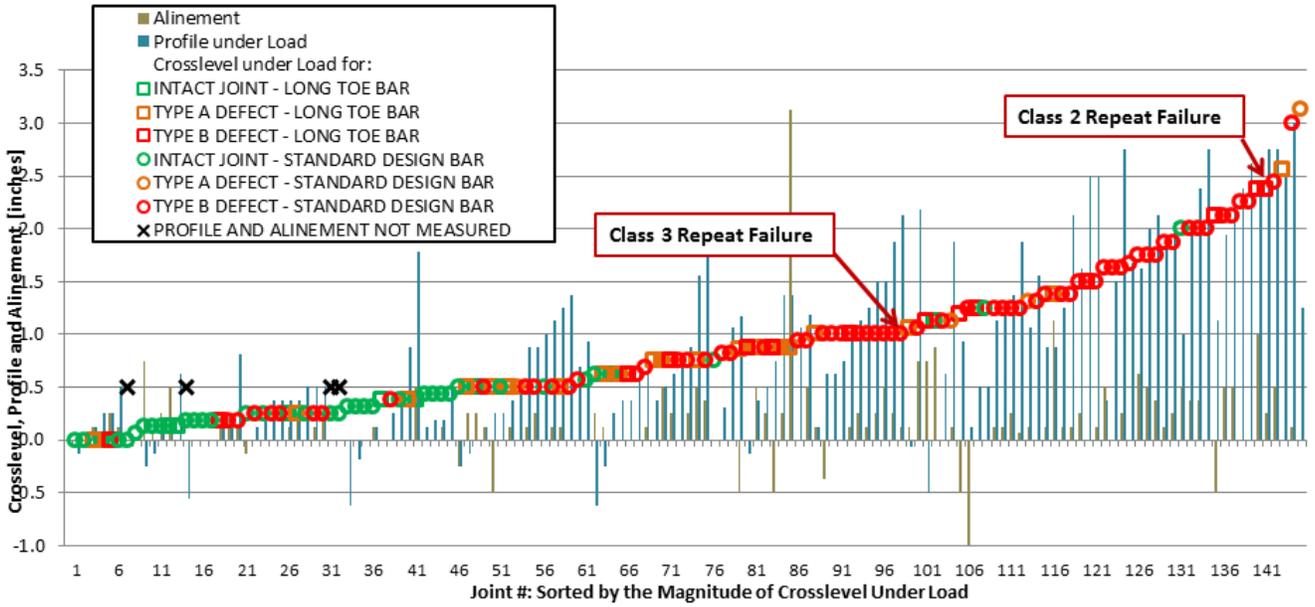
Figure 14: Overview of Geometry Measurements in JR Territory

An overview of the geometry measurements in JR territory is shown in Figure 14. Failed or defective joint locations have a significantly larger cross level under load and profile under load than the intact joint locations. The two joint locations with repeated failures are annotated in the figure.

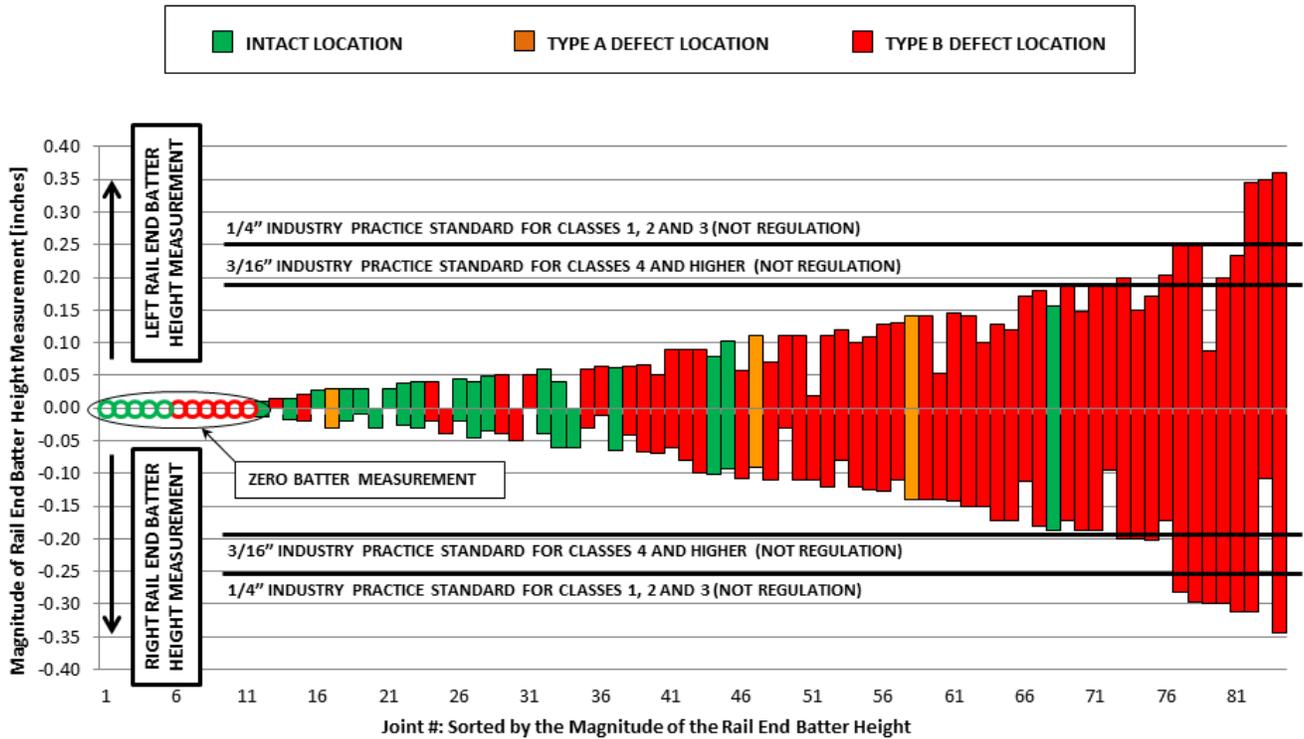
Figure 15: Overview of Rail End Batter in Class 3 JR Territory

A subset of the data collected on joints in JR territory was gathered to extract only joint locations in FRA Track Class 3. This subset was used to examine the possible effect of rail end batter on joint bar failure on main lines with relatively high tonnage and operating speeds. This subset consisted of 84 joint locations; 24 intact joints and 60 failed or defective joints. The horizontal axis in Figure 15 is joint location sorted by rail end batter height in ascending order. Positive values on the vertical axis refer to the left rail end batter, and negative values are the right rail end batter, which are reasonably consistent for the sample population. Moreover, the figure shows moderate to significant levels of rail end batter at failed or defective joint locations. The figure also shows that most of the rail end batter measurements are less than industry recommended limits. However, these trends with rail end batter at failed locations compared to intact locations were not observed on lower track classes (implying lower train speed) with low tonnages. That is, the measurements of rail end batter between failed and intact locations were not significantly different on lower track classes in JR territory.

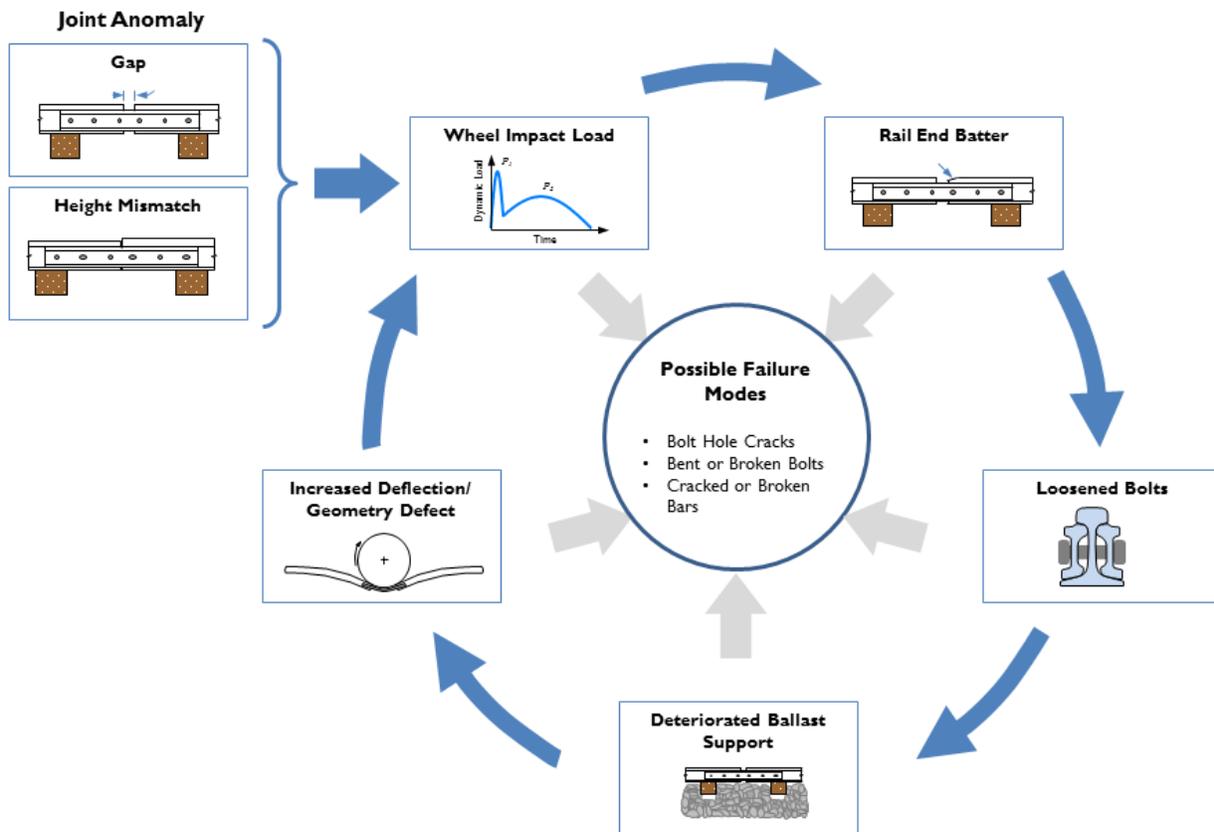
Figure 16: Cycle of Joint and Track Degradation Interacting with Wheel Impact Loads

structural performance of the joint. When a single wheel passes over the joint, the rail ends deflect downward one at a time, creating a small step and mismatch in rail heights. The size of the step varies depending on the original gap distance between rail ends. The step causes wear from repeated wheel passes, which is referred to as rail end batter. The structural performance of the rail joint also degrades as the bolts and the supporting ballast loosen. Eventually, increased deflections and joint anomalies (e.g. excessive gap between rail ends, end batter, loose or missing bolts, etc.) induce dynamic amplification of wheel loads at the joint, which accelerates wear. This vicious cycle of deteriorating track and joint conditions leading to and caused by high dynamic wheel impact loads is shown schematically in Figure 16. Failure of the joint (i.e. broken bar or rail) can occur anywhere within the cycle.
