JRC2014-3786

CONVENTIONAL FUEL TANK BLUNT IMPACT TESTS: TEST AND ANALYSIS RESULTS

Volpe National Transportation Systems Center
United States Department of Transportation
Cambridge, Massachusetts, USA

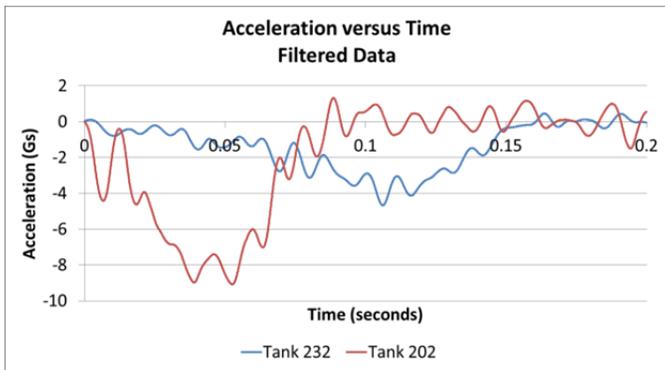
Figure 12. Acceleration-time History for Both Tanks

Acceleration data was collected for the impact cart during both tests. Figure 12 compares the longitudinal response of the both tanks to the test impacts. It is apparent from this figure that each tank responded to the impact differently. The response of each tank is discussed following the figure.

Impact with Tank 232 resulted in a longer-duration, lesser-magnitude deceleration of the impact cart. The change in slope that occurs between 0.05 and 0.1 seconds may be attributed to stiffening of the tank that occurs when the bottom (impacted) sheet closes the internal gap between it and the baffles. After slightly more than 0.1 seconds, the impact cart has stopped moving forward and is rebounding back as Tank 232 recovers its elastic energy.

As seen in this previous figure, Tank 202 behaved very differently than Tank 232. In Tank 202, there is an initial deceleration associated with buckling of the baffle directly beneath the impacted location. Following this buckling, the acceleration climbs at a high rate, as the load is being transmitted through the bottom sheet directly into the baffles in this tank. By approximately 0.05 seconds, the impact cart has come to a stop and is now being rebounded as the tank recovered its elastic energy. By approximately 0.1 seconds, the impact event had ended for Tank 202.

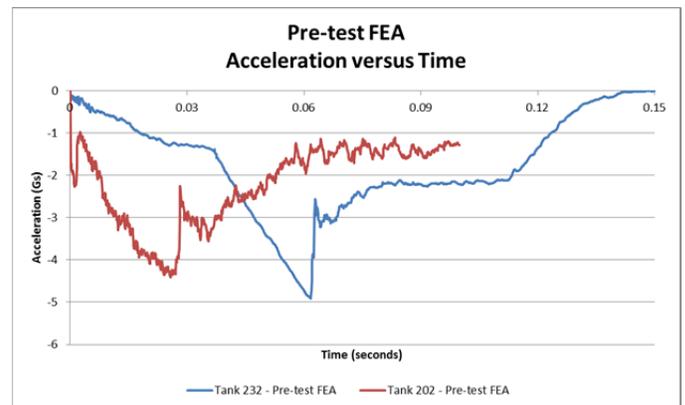
Figure 13. Acceleration versus Time for Both Tanks, Pre-test FEA

The acceleration-time histories from the pre-test models are shown in Figure 13 for both tanks. The pre-test models predicted very different qualitative behaviors from both tanks. The primary difference for this difference in behavior is a result of the internal baffle arrangement of each tank. In Tank 232, the baffles are arranged in such a way that a centered impact will strike the bottom sheet between baffles. Because there is a gap between the inside of the bottom sheet and the bottom of the baffle to permit fuel to flow, the impact response is initially soft. Once the gap has been closed, the impactor loads the baffles directly and the tank response becomes stiffer. Tank 202 features a baffle welded directly to the inside of the bottom sheet at the center of the tank. For a center impact on this tank, the baffle engages immediately and quickly buckles. The post-buckling response is still stiff compared to Tank 232, as the baffles of Tank 202 are attached directly to the bottom face sheet.

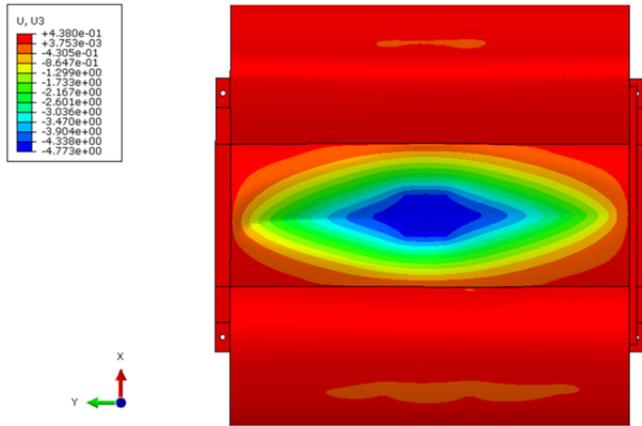
Figure 16. Residual Dent in Tank 232, Post-test FEA

The post-analysis deformed shape of Tank 232 is shown in Figure 16. Contours in this figure are of deformation in the

direction of impactor travel (i.e. the longitudinal direction) in inches. The deformed shape from the FEA resembles the post-test shape observed in Tank 232 and shown in Figure 9. In both the test and the post-test FEA, there is a clear impression of the 12x12 square impactor head at the location of the impact. The indentation in Tank 232 extends primarily across the width of the tank (i.e. in the y-direction as shown in Figure 16). The baffles in this direction are welded directly to the bottom of the tank, whereas the baffles in the perpendicular direction have an approximate 5-inch gap between the bottom of the tank and the bottom of the baffle. Therefore, it is easier for the tank to deform along this direction compared with the perpendicular direction. The result is a diamond-shaped indentation.

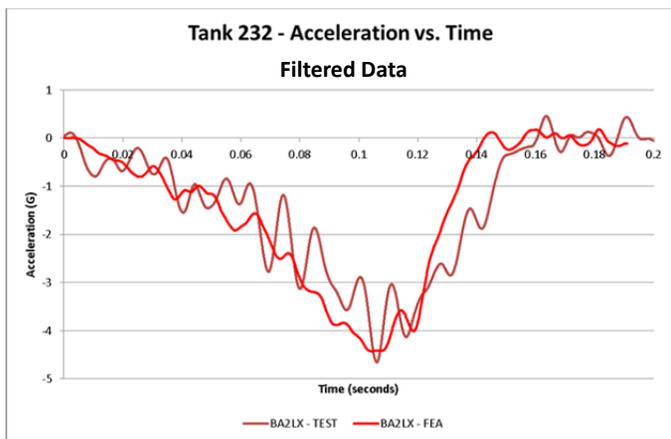
Figure 17. Acceleration versus Time, Tank 232 Test and FEA (Post-test)

The acceleration-versus-time history from the left side sill accelerometer, BA2LX, is compared between the test and the post-test FE model using the deformable cart in Figure 17. There is relatively good agreement between the two sets of results. Both the test data and the FE output have been filtered using the same filtering algorithm. As can be seen in this figure, some ringing remains in the data after this filtering. Both the qualitative behavior and the maximum deceleration are consistent between the test result and the FE model for Tank 232.

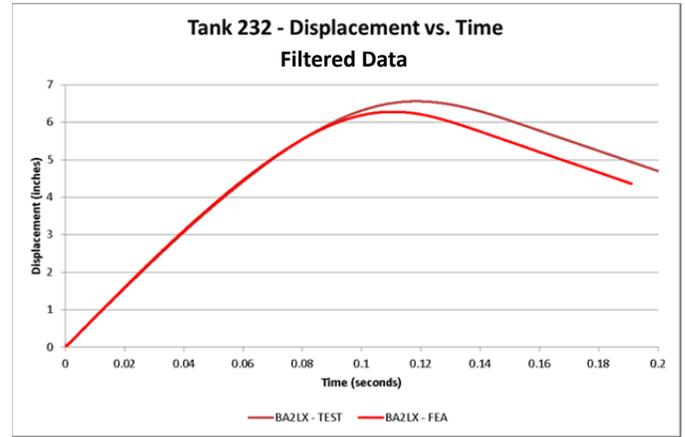
Figure 18. Displacement versus Time, Tank 232 Test and FEA (Post-test)

Figure 18 shows the displacement versus time data from the test plotted against the displacement versus time calculations from the FE model for the same accelerometer, BA2LX. There is good agreement between the two results. The maximum displacement in the test data is approximately 6.6 inches, and the maximum displacement calculated by the FE model is approximately 6.3 inches. This difference is within 5% of the measured value.

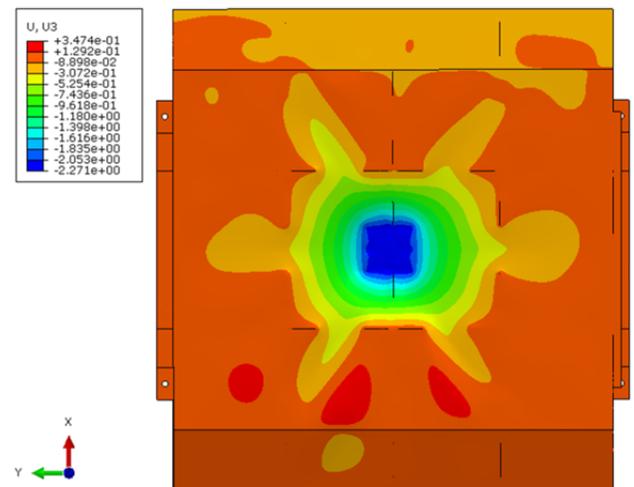
Figure 19. Residual Dent in Tank 202, Post-test FEA

The post-analysis deformed shape of Tank 202 is shown in Figure 19. Contours in this figure are of deformation in the direction of impactor travel (i.e. the longitudinal direction) in inches. The deformed shape resulting from the FEA resembles the post-test shape observed in Tank 202 and shown in Figure 11. In both the test and the post-test FEA, the dent roughly conforms to the square impactor shape in the area around the impact site. Outside of this immediate region, the dent is roughly X-shaped. This behavior can be attributed to the intermittent pattern of welds between the baffles and the bottom sheet of this tank. Where the bottom sheet is welded to the baffles the indentation is smaller, as the baffle provides increased stiffness at these locations.

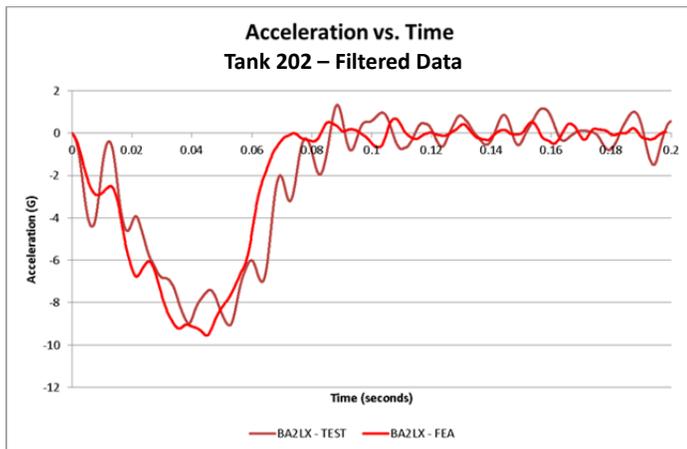
Figure 20. Acceleration versus Time, Tank 202 Test and FEA (Post-test)

The acceleration versus time history for Tank 202 is shown in Figure 20, both for the test and for the post-test FEA. The measurements were made by the left side sill accelerometer, BA2LX. There is relatively good agreement between the test and the FEA. In the test and the analysis the baffle beneath the impacted location buckles almost immediately upon contact. As the baffle directly beneath the impactor folds, the inside face of the bottom surface of the tank comes into contact with it, permitting the load to rise again. The accelerations measured during the impact test of Tank 202 are considerably higher than those measured for Tank 232. The impact event is also over in less time than the impact event of Tank 232.

Following the impact test, Tank 202 was cut open to permit examination of the internal deformations. The impactor struck this tank at the center of a baffle. The initial drop in load observed in both the test and FE accelerations prior to 0.01 seconds, shown in Figure 20, is associated with this baffle and its attachment brackets immediately folding up. Because the baffle remains in contact with the underside of the bottom sheet, the acceleration climbs as the tank offers increasing resistance to further indentation. This behavior was captured by the post-test FE model. The deformed shape of the baffle is shown for both the model and the actual tank in Figure 22.

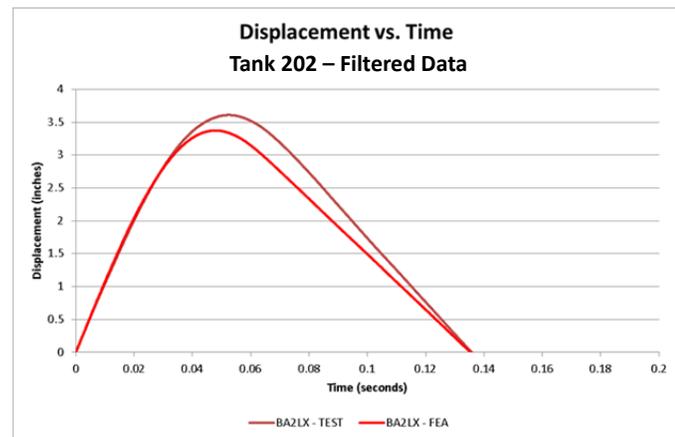
Figure 21. Displacement versus Time, Tank 202 Test and FEA (Post-test)

The displacement versus time history for the impact cart in both the analysis and the test is shown in Figure 21. The displacement data is obtained through double-integration of the left side sill accelerometer, BA2LX. In the test, the dent reached a maximum depth of approximately 3.6 inches before the cart began rebounding from the tank. In the post-test FE model, the maximum dent depth is approximately 3.4 inches before the cart is rebounded. The difference between test and FEA is approximately 5.5% of the measured value.
