Maine Department of  
Transportation  
**Transportation Research  
Division**

**Technical Report 99-11**  
*Innovative Solutions to Buried Portland  
Cement Concrete Roadways*  
*Final Report, March 2005*

## *Innovative Solutions to Buried Portland Cement Concrete Roadways*

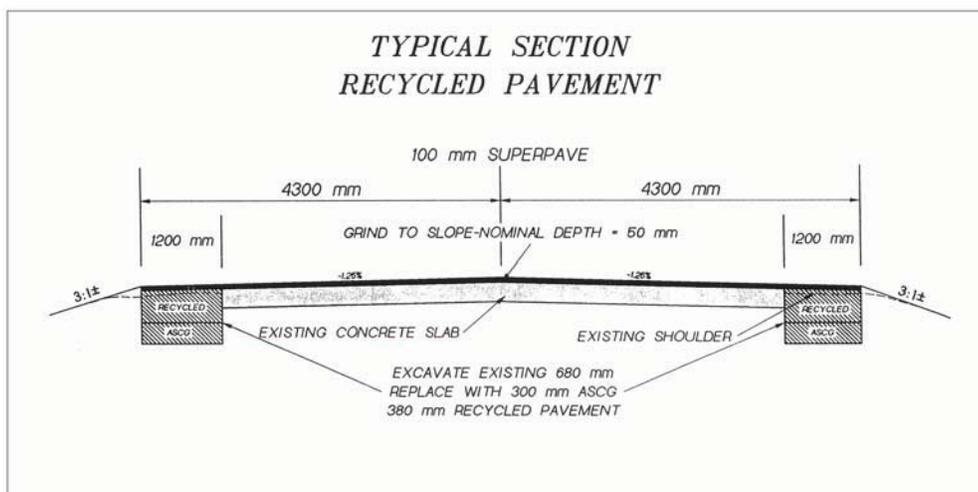
Fig. 2 Section 1

This section is located between station 1+000 and 1+500. Figure 2 contains a typical cross section. The existing pavement was ground to slope to a nominal depth of 50 mm (2 in). The shoulders were excavated adjacent to the existing PCC slab edge to a depth of 680 mm (27 in) and width of 1200 mm (47 in). The boxed shoulder was then filled with 300 mm (12 in) of Type D

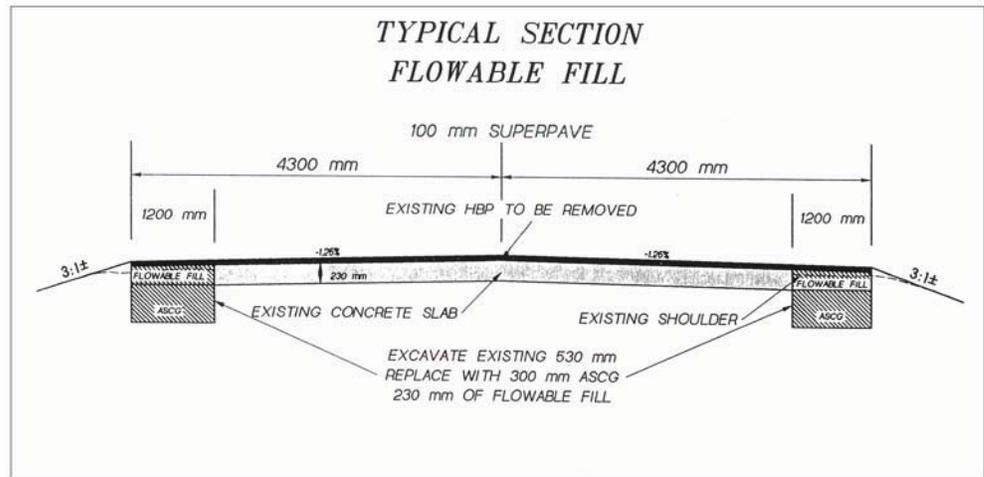
Fig. 3 Section 2A

There are two separate shoulder treatments within this section. Section 2A located between station 1+500 to 1+970 right and 1+500 to 2+000 left. This section has 300 mm (12 in) of ASCG and 230 mm (9 in) of Flowable Fill. Figure 3 contains a cross section of Section 2A.

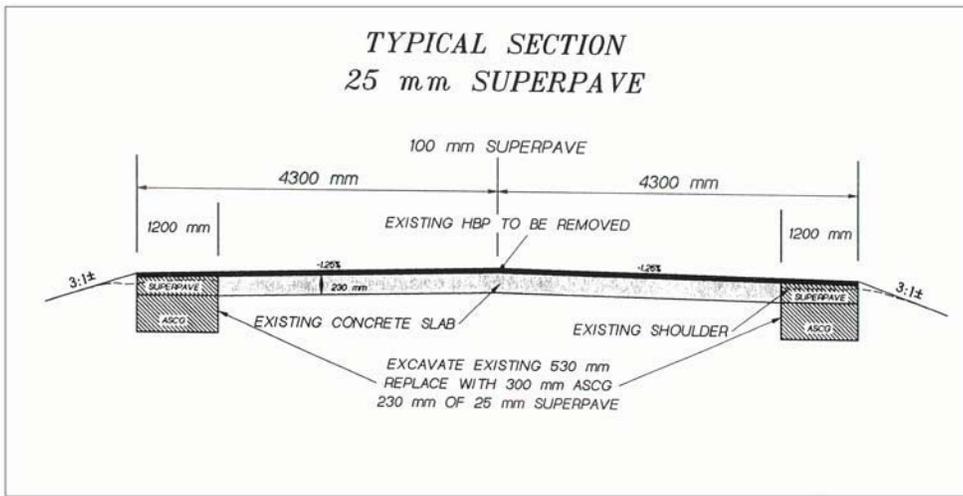
Fig. 4 Section 3

This section is located between station 2+000 and 2+500. The existing pavement was removed and shoulders were excavated beside the PCC slab to a depth of 530 mm (21 in) and width of 1200 mm (47 in). As with Section 2, the exposed PCC slab could not hold up to traffic and had to be shimmed with 9.5 mm (0.374 in) bituminous mix. A typical cross section of Section 3 is displayed in figure 4.

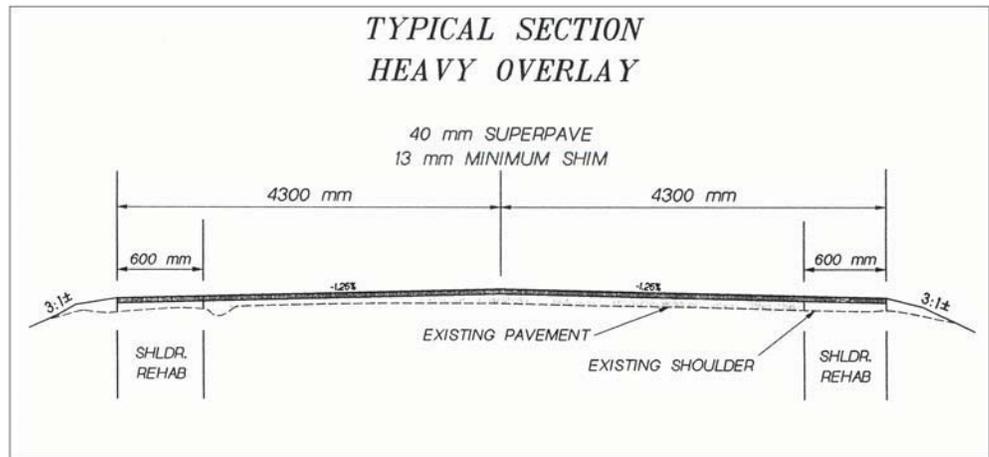
Fig. 5 Section 4

Section 4 is located between station 2+500 and 3+000. The existing shoulders were graded and compacted. All unsuitable material was removed and areas that were below grade were filled with ASCG and compacted to required grade. The roadway was then shimmed with a minimum of 13 mm (0.5 in) of 9.5 mm (0.374 in) bituminous mix. Then the roadway and shoulders were paved with 40 mm (1.6 in) of 12.5 mm (0.5 in) Superpave wearing coarse. A typical cross section of this treatment is displayed in figure 5.

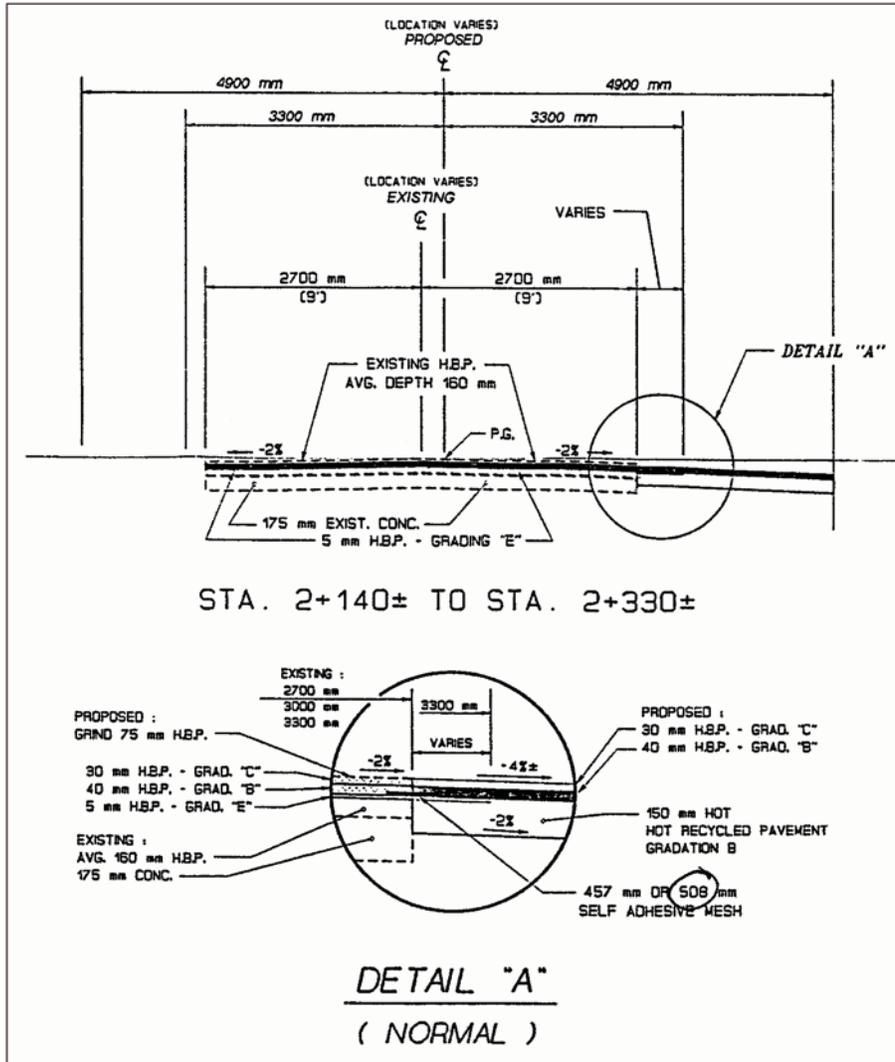
Fig. 6 Self-adhesive mesh

Figure 6 contains a cross section of the Self-Adhesive mesh section. This experimental area begins at station 2+140 and ends at 2+330. The project entails grinding 75 mm (3.0 in) of existing pavement then shimming with 5 mm (0.2 in) of 4.75 mm (0.187 in) bituminous mix.
