## **Repair of Earthquake-Damaged Bridge Columns with Interlocking Spirals and Fractured Bars**

**NUTC  
R298**

1. Report No. NUTC R298	2. Government Accession No.	3. Recipient's Catalog No.	
4. Title and Subtitle Repair of Earthquake-Damaged Bridge Columns with Interlocking Spirals and Fractured Bars		5. Report Date July 2014

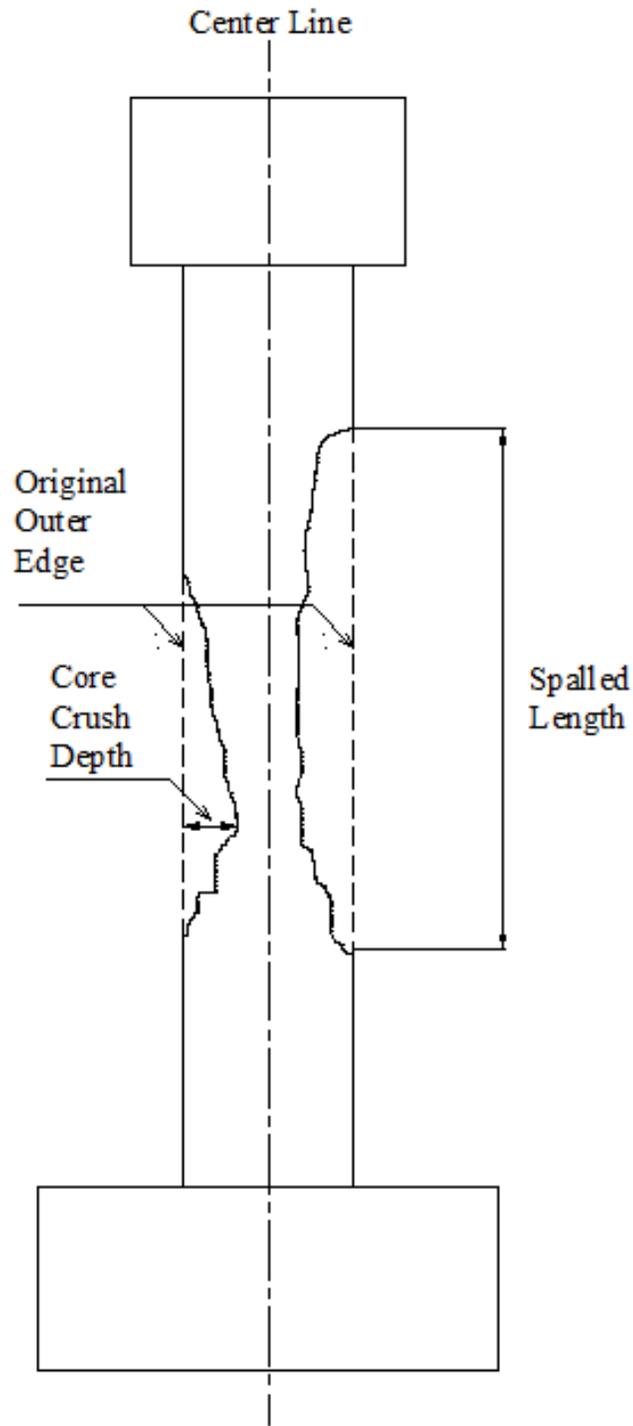
Figure 3-5 Definition of Spalled Length and Core Crushing Depth of Concrete

As shown in Figure 3-4b, for Calt-2 with T/M of 0.6, the cover concrete spalled from the column base to a height of 90 in. (2290 mm). Concrete near the column base crushed into the core with a depth of 12 in. (305 mm) (refer to Figure 3-5). No spirals swelled, and 14 of the 16

<sup>3</sup> The definition of spalled length and core crush depth are shown in Figure 3-5;

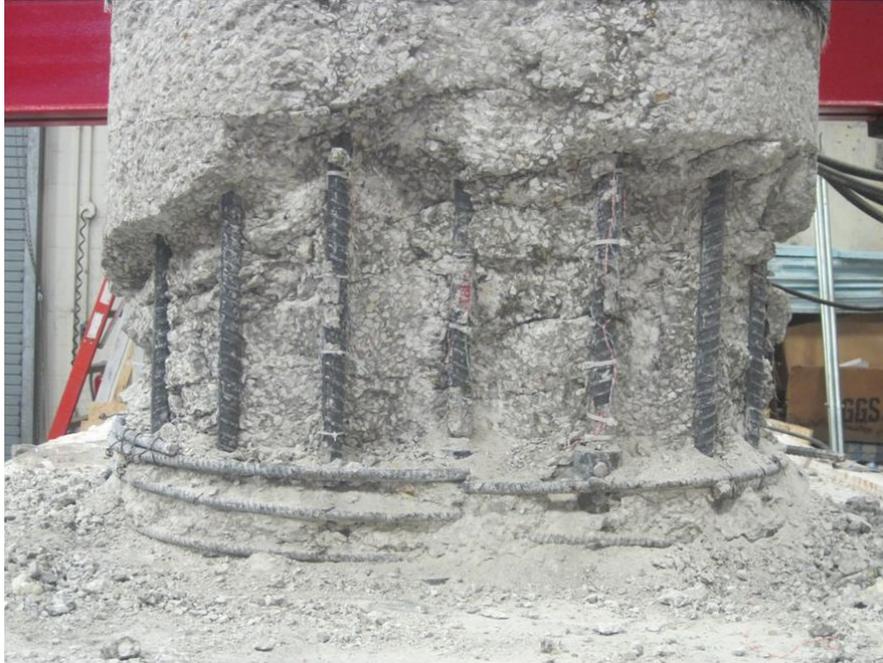
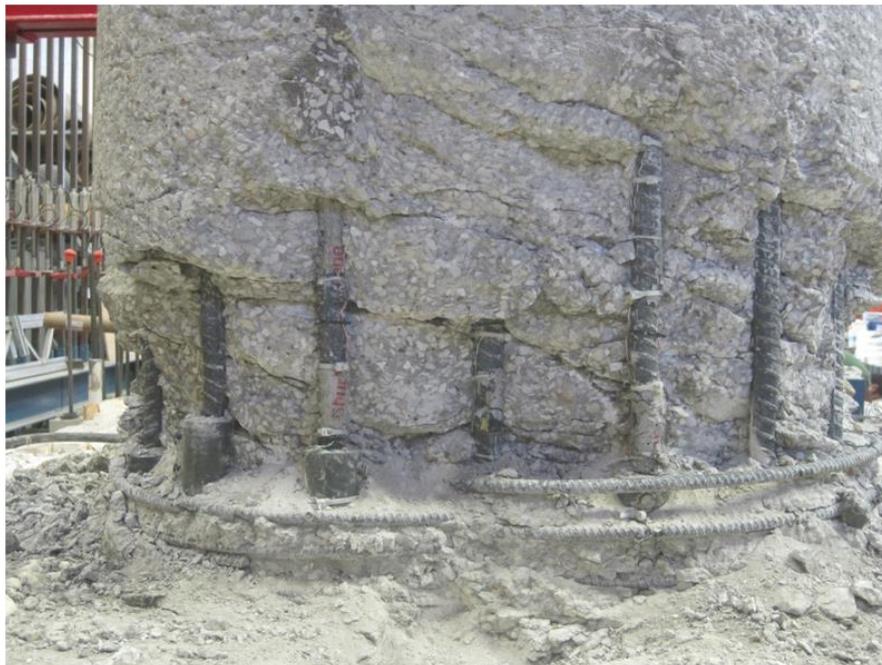
Figure 4-3 View of R-Calt-1 after Removal of CFRP Jacket

(a) South Face

(b) North Face

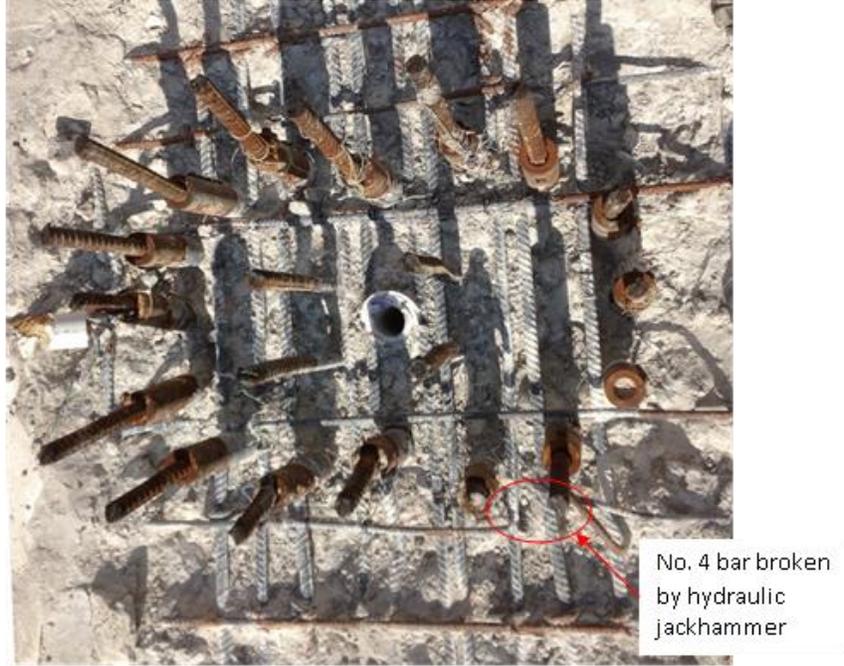
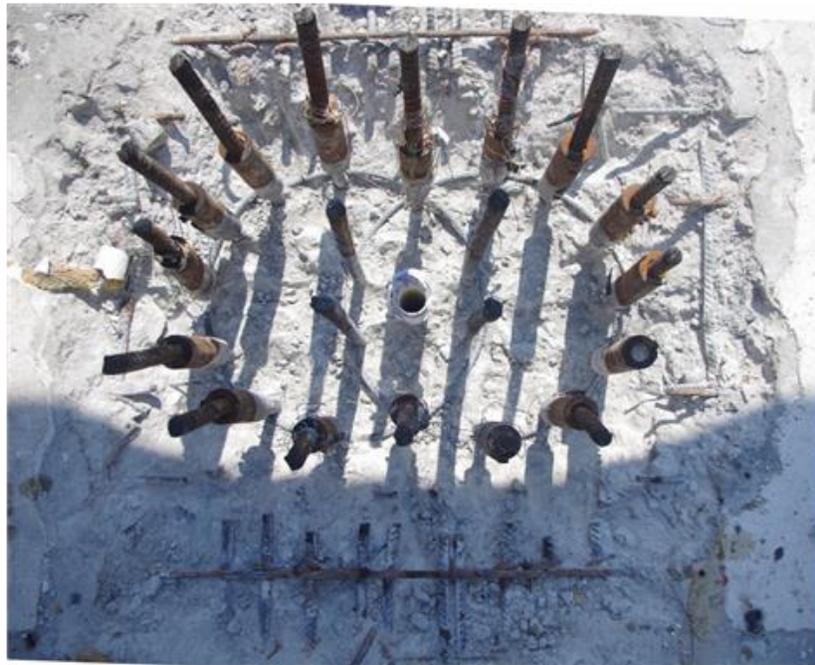
Figure 4-4 Plan View of Footing of R-Calt-1

(a) After Removal of Top Cover

(b) After Removal of First Layer of Footing Reinforcement and Core Concrete

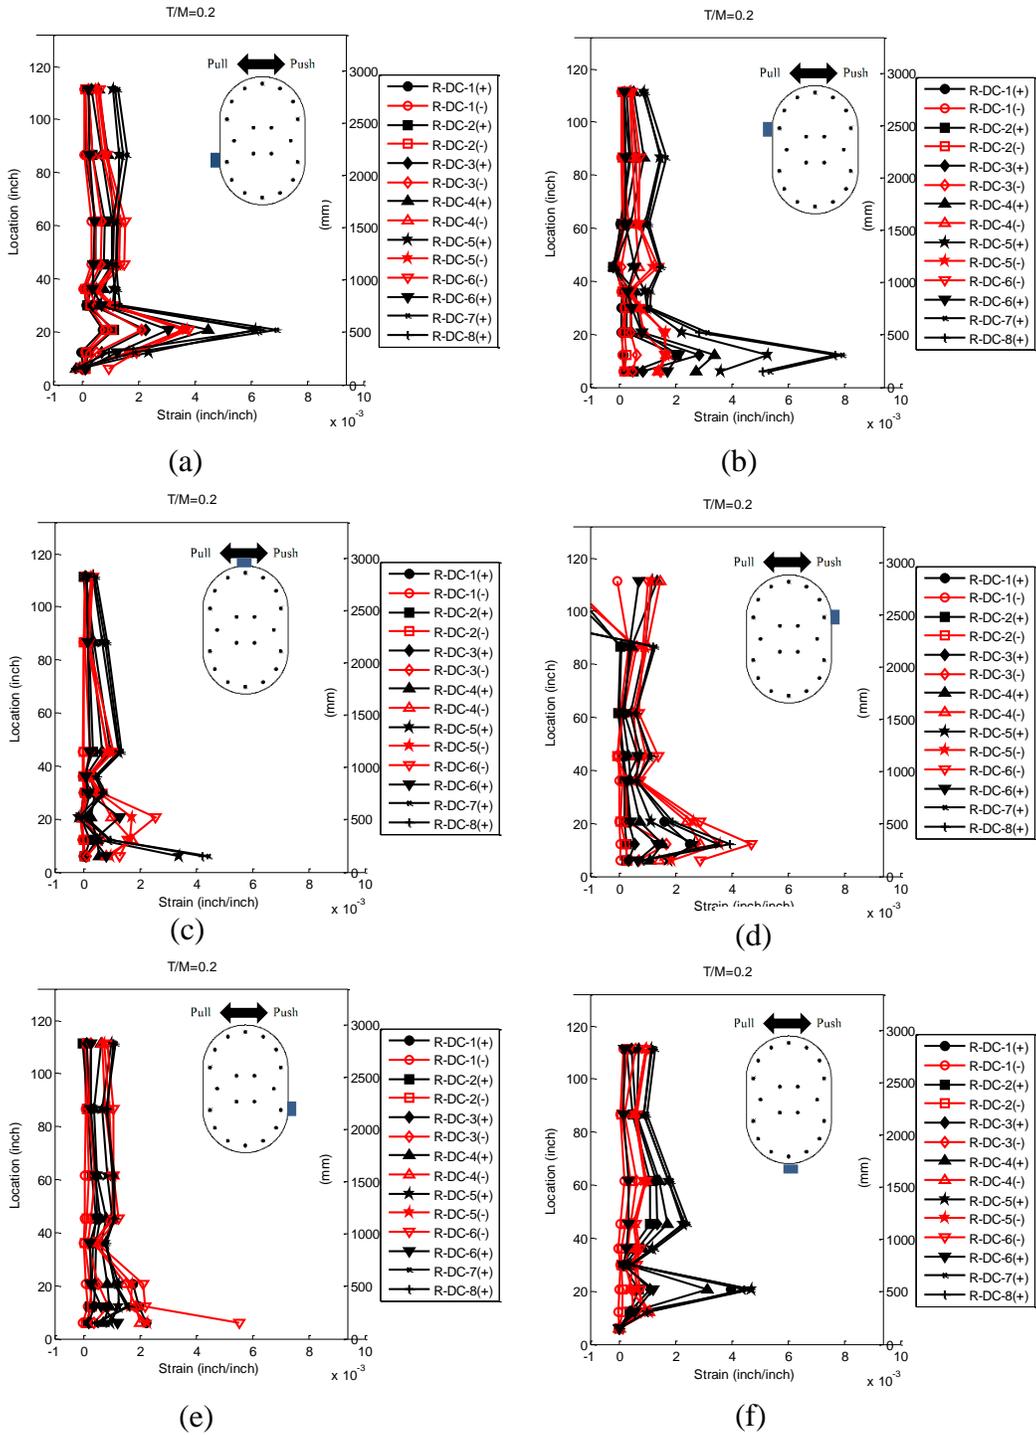
Figure 4-15 Measured CFRP Strain Distribution along Column Height of R-Calt-1

Figure 4-15 summarizes the CFRP hoop strain distribution along the column height for R-Calt-1. As shown in this figure, the maximum CFRP strain measured during testing was 0.008, which was close to the design rupture strain of the CFRP system provided by the manufacturer; however no CFRP rupture was observed during testing, which implies that the design strain was conservative. The maximum hoop strain in the direction perpendicular to the loading direction at each displacement control stage was measured 10 to 30 in. (250 to 750 mm) from the base of the column (Figure 4-15a, b, d, and e), while the maximum hoop strain parallel to the loading direction at each displacement control stage was measured 20 to 40 in. (500 to 1016 mm) from the base of the column (Figure 4-15c and f). This suggests that the CFRP would likely rupture in these locations with additional loading. As shown in Figure 4-15a, b, d, and e, the hoop strain perpendicular to the loading direction at a specific displacement control level was greater on the tension side than that on the compression side.

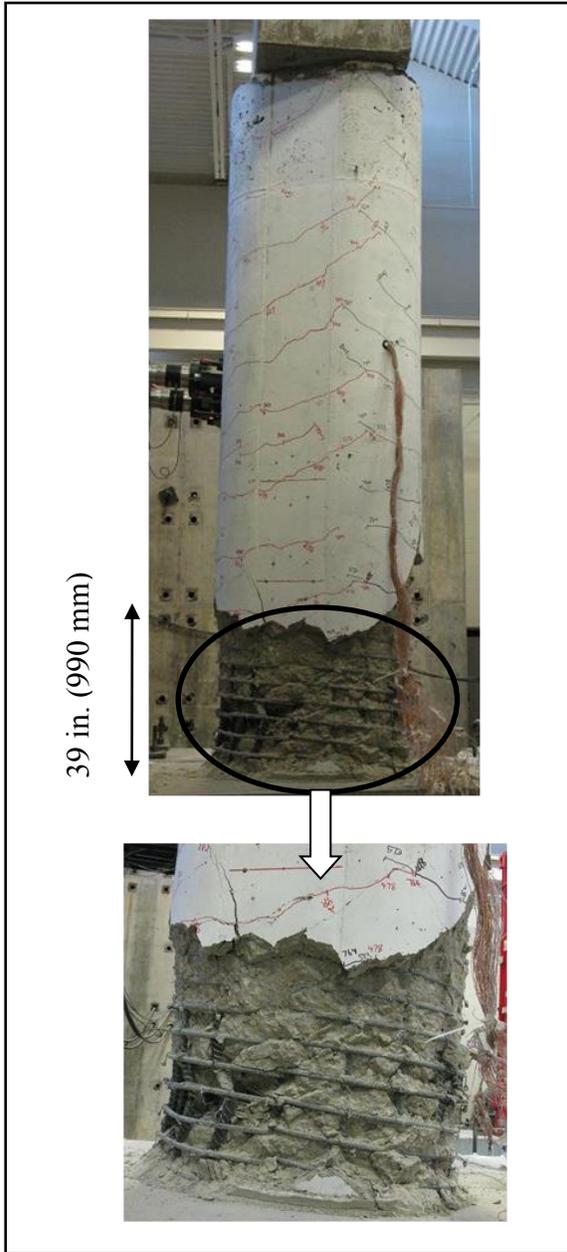
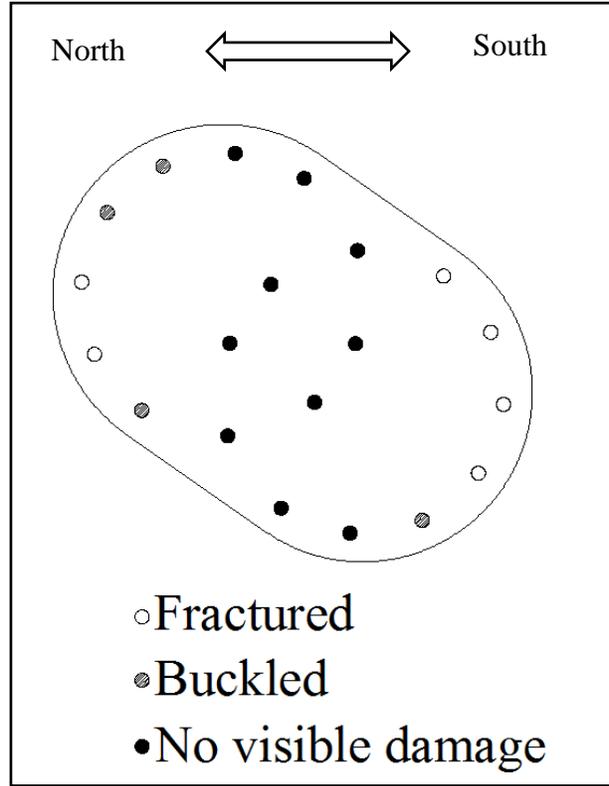
Figure 5-3 Visible Damage to Calt-3 after Original Test

As shown in Table 5-3 and Figure 5-3, for Calt-3 with T/M of 0.2, cover concrete spalled from the column base to a height of 39 in. (990 mm). Concrete near the column base crushed into the core with a depth of 5 in. (127 mm). The definition of the spalled length and core crushing depth of concrete is shown in Figure 3-5. No spirals swelled, four of the longitudinal bars buckled, and six of the longitudinal bars fractured (refer to Table 5-3). The fracture locations and buckled regions of longitudinal reinforcement are shown in Figure 5-4. Strain gages were applied at various locations along the length of the longitudinal reinforcing bars during the original testing, as shown in Figure 5-5. Typical longitudinal reinforcement strain history is shown in Figure 5-6, and typical transverse reinforcement strain history is shown in Figure 5-7. Based on analysis of the measured strain data, all of the longitudinal bars yielded. Yielding of the longitudinal bars was indicated by strain gages located in the region 4.0 in. to 61.75 in. (100 to 1568 mm) above

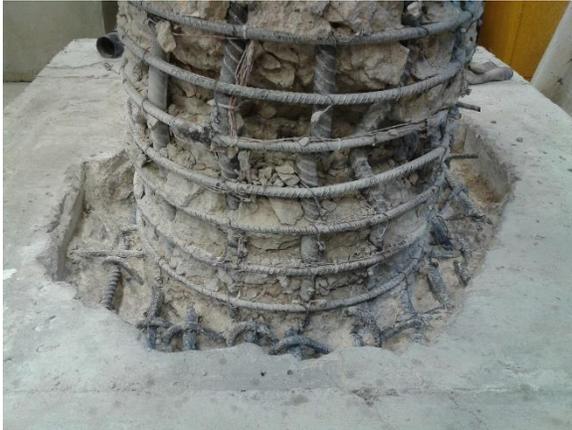
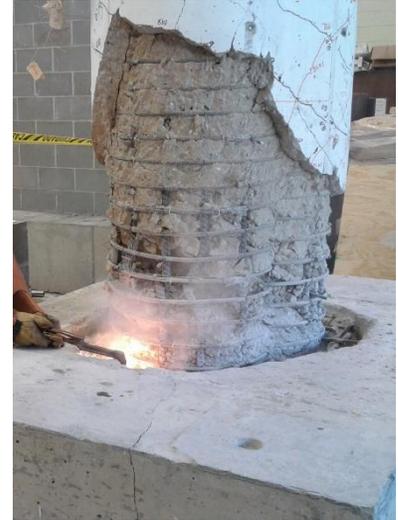
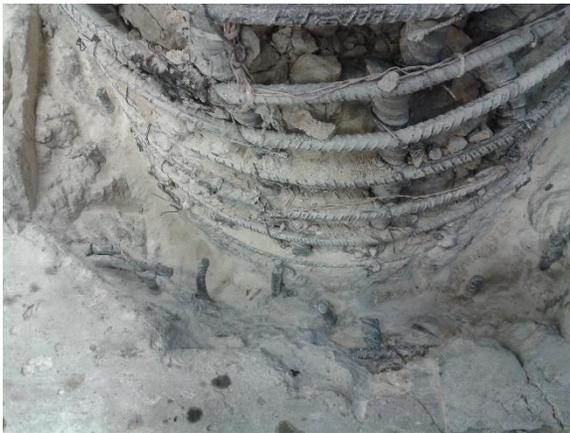
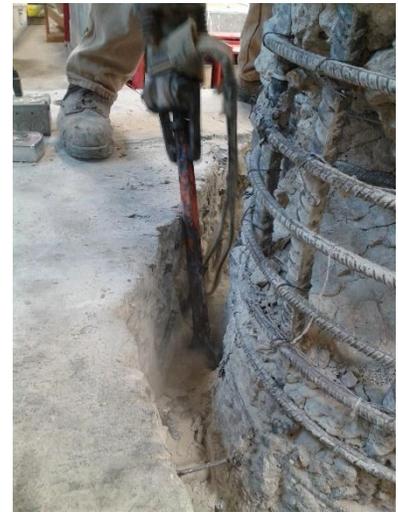
Figure 5-13 Footing Trenching Procedure for R-Calt-3

(a) Footing after removal of top cover concrete

(b) Cutting rebar with torch

(c) Trench after cutting rebar

(d) Deepening trench with jackhammer

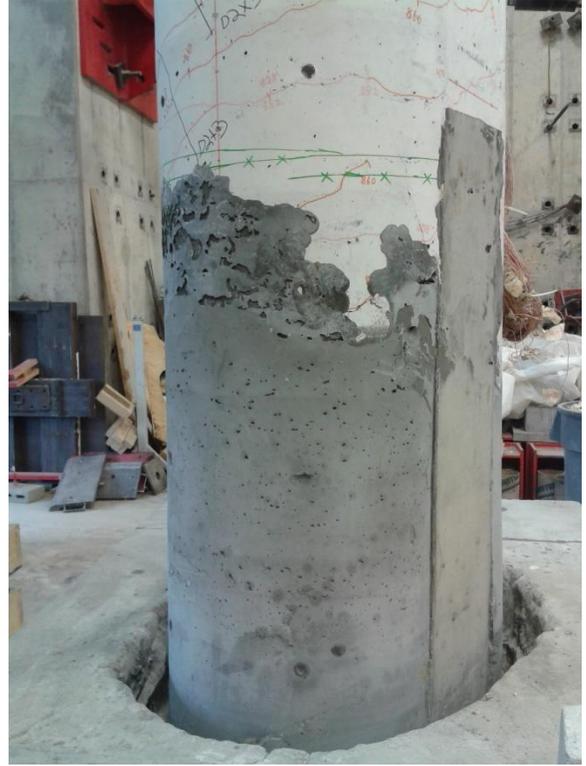
Figure 5-14 Column R-Calt-3 Before and After Grout Placement

(b) After grout placement

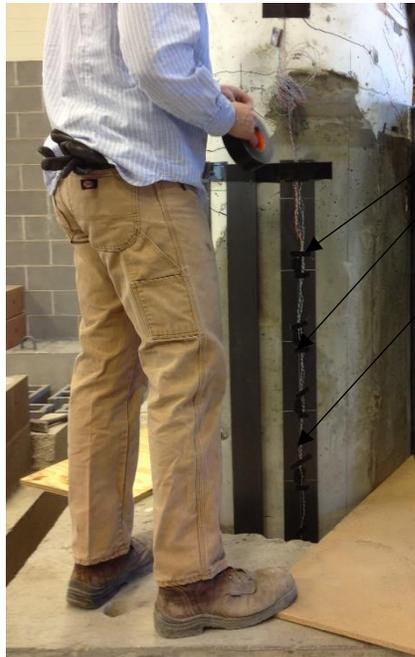
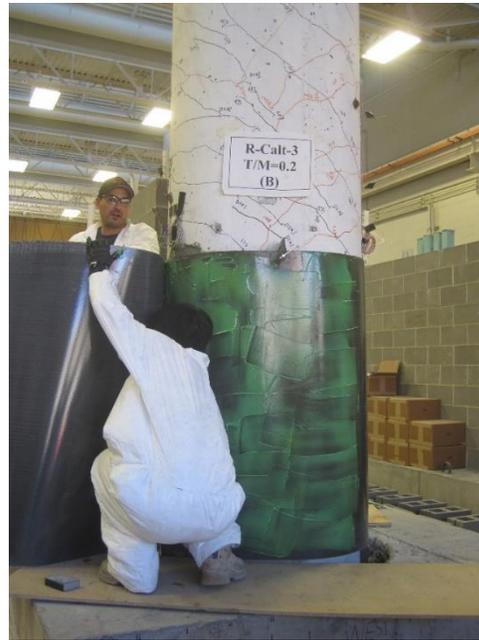
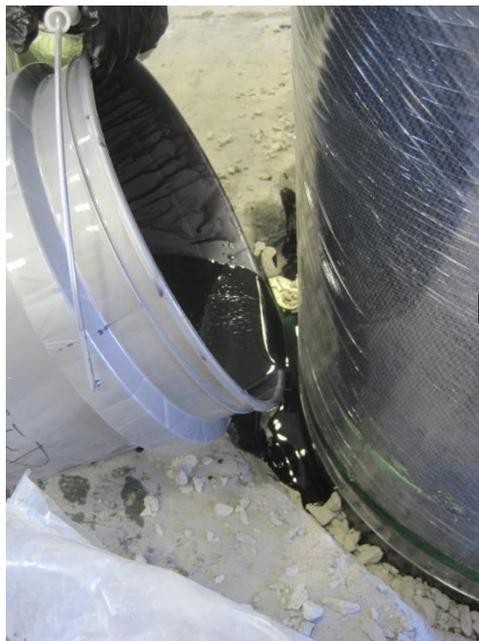
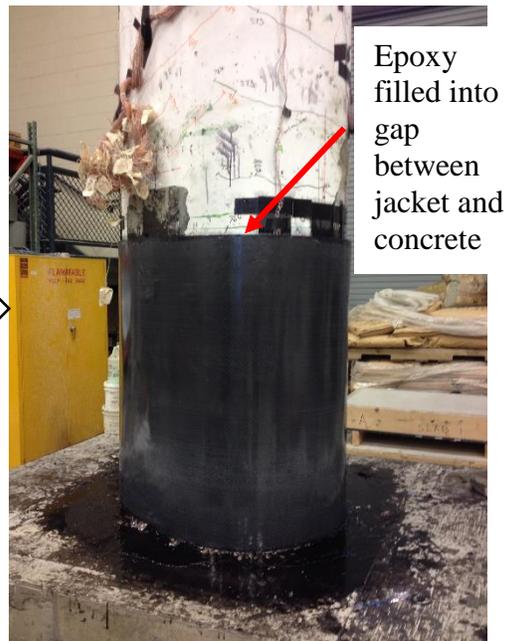
Figure 5-15 Installation of CFRP Strips and CFRP Jacket for R-Calt-3

(a) CFRP plate installation

(b) CFRP Jacket wrapping

Epoxy filled into gap between jacket and concrete

(c) Filling trench with epoxy and gravel

(d) Column after gap filling with epoxy

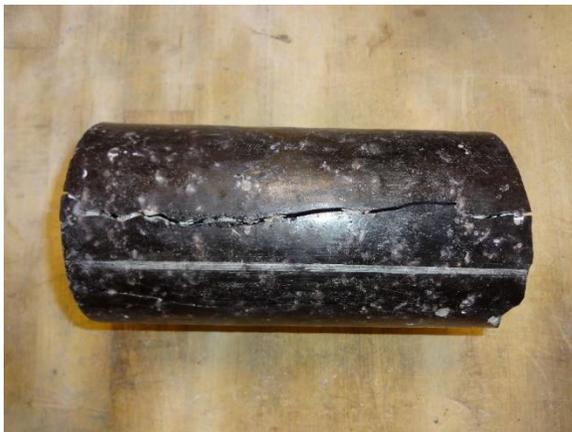
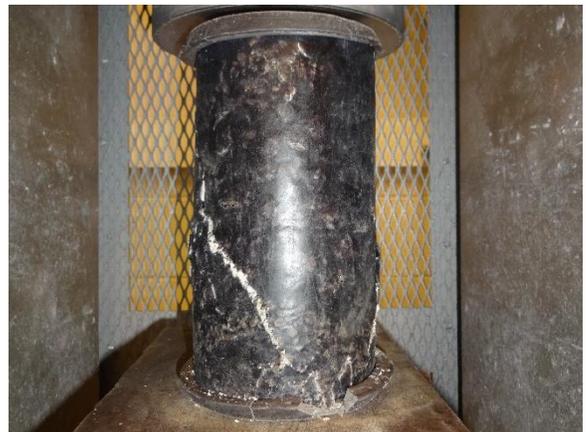
Figure 5-16 Material Testing Specimens of Epoxy with Gravel for R-Calt-3

(b) Splitting tensile failure

(c) Compression failure

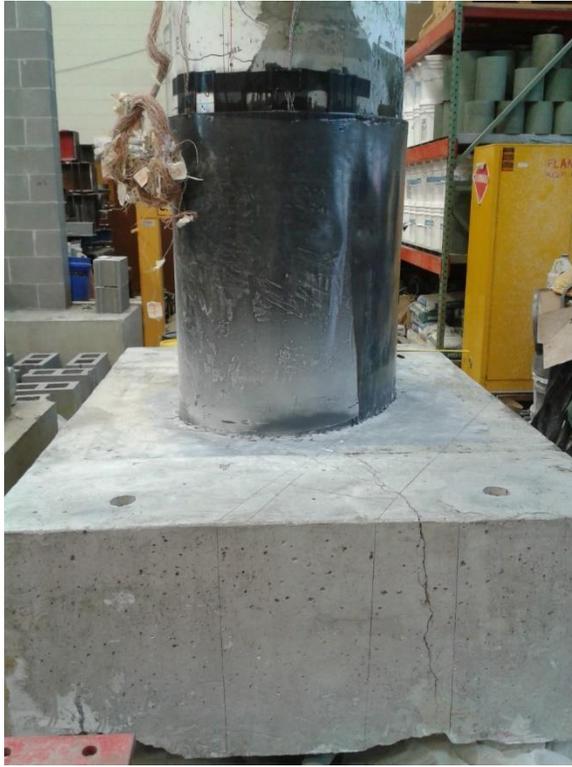
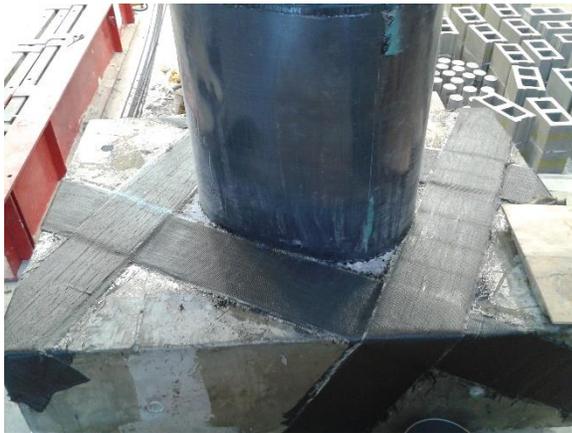
Figure 5-17 Column R-Calt-3 after Surface Preparation and CFRP Installation

(a) Column and footing after surface preparation

(b) Column and footing after CFRP installation

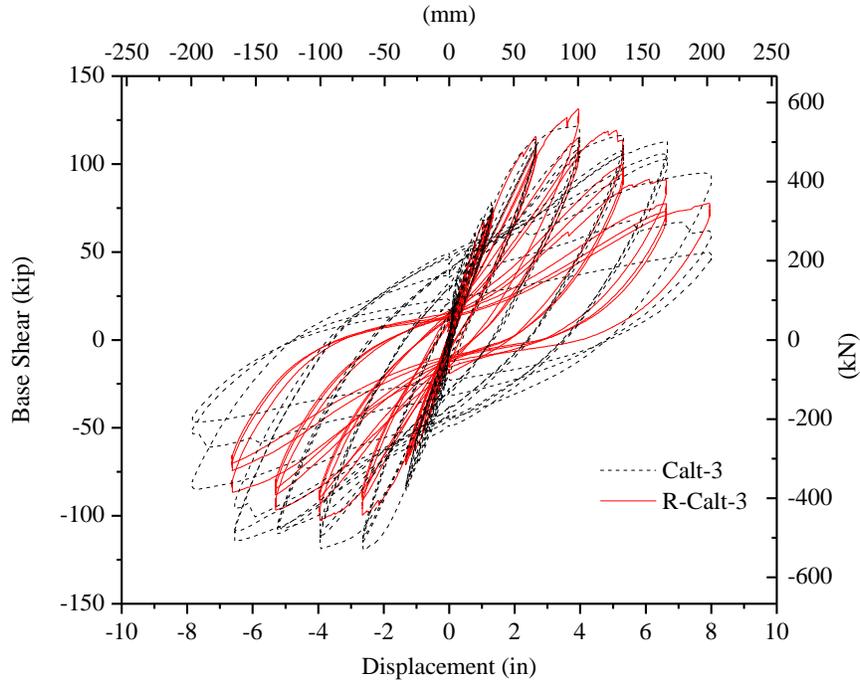
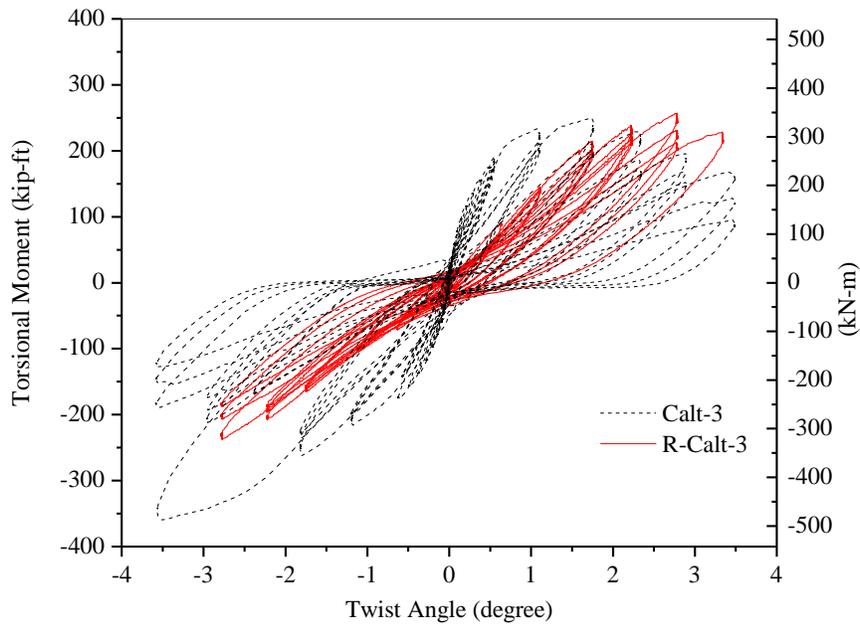
Figure 6-10 Load-Displacement Hysteresis Responses of Calt-3 and R-Calt-3

The base shear-lateral displacement hysteresis for R-Calt-3 and Calt-3 are compared in Figure 6-10a. The hysteretic behavior of R-Calt-3 was asymmetric with higher maximum base shear in the push direction than in the pull direction, while that of Calt-3 was more symmetric. This may be due to the fact that the rupture of CFRP jacket of R-Calt-3 in the positive cycle reduced the

Figure 6-10b shows the hysteresis of torsional moment and twist relations where clockwise torsion is defined as positive and counterclockwise torsion as negative. Degradation of the torsional strength of R-Calt-3 was observed at an angle of 2.5 degrees in the positive direction, while no degradation of the torsional strength of R-Calt-3 was observed in the negative direction. The torsional moment and twist envelopes are compared in Figure 6-b. As shown in this figure, the initial torsional stiffness of R-Calt-3 was much lower than that of Calt-3. This may be due to relative movement (slip) between the CFRP jacket and the column due to the low modulus of the epoxy filled in between them. The elasto-plastically idealized torsional moment and twist curves are shown in Figure 6-12c and Figure 6-12d, from which critical values were calculated and summarized in Table 6-2. As shown in this table, the equivalent yielding torsional moment of R-

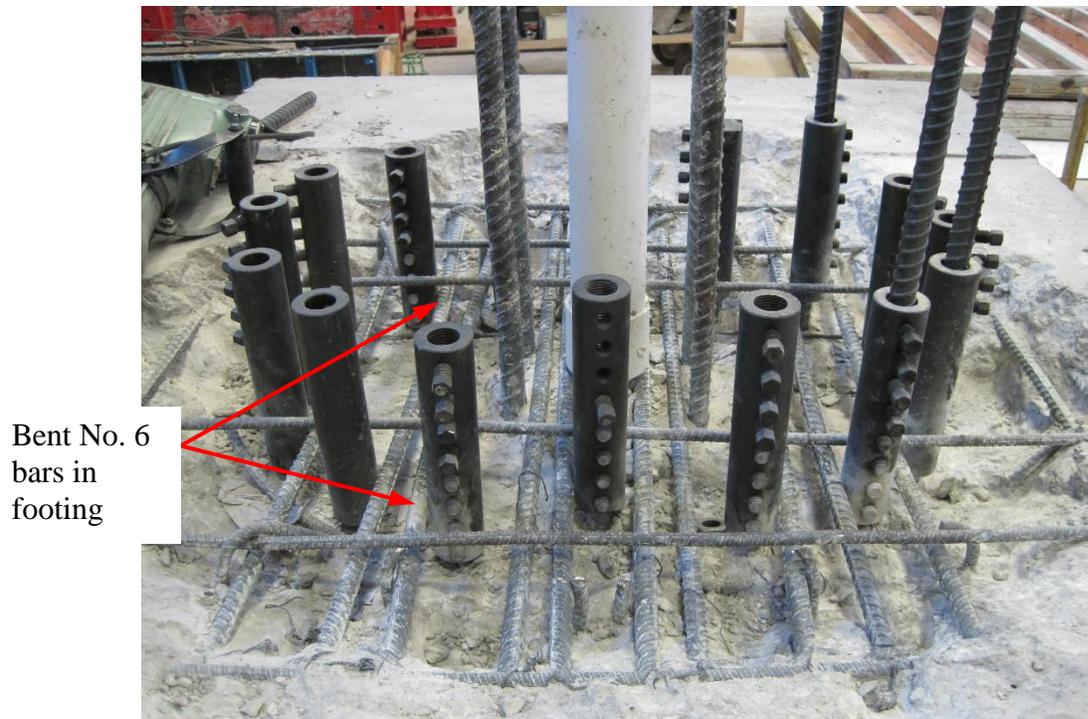
(a) Footing after coupler installation

For R-Calt-1, several No. 6 (19.1 mm dia.) bars in the footing were bent to make space for the bottom couplers as shown in Figure 7-1a. The heads of the coupler bolts were sheared off during installation using an impact torque wrench in most locations. The entire installation process took two workers approximately 40 hours due to the dense reinforcement in the footing, which required the use of a hand wrench. Three bar splices composed of the type of couplers used in R-Calt-1 and No. 8 (25.4 mm dia.) bar were tested to failure under pure tension as shown in Figure 7-1b. As shown in this figure, two of the splices failed with bar fracture within the couplers due to the stress concentration at the exterior bolt. Only one of the couplers failed with bar fracture away from the coupler after necking. However, these couplers performed well in restoring the ductility capacity of the repaired column, as discussed in Chapter 4.

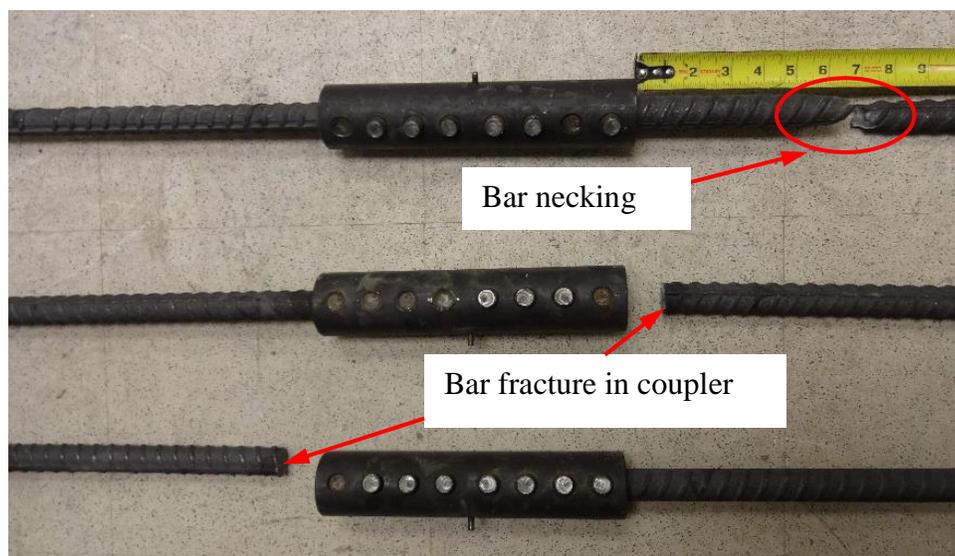
(b) Failure of splices under tensile test

unswaged region would reduce the capacity of the splice, one splice sample with a coupler that was not fully swaged was tested to failure under pure tension and compared to the results of three couplers that were fully swaged. The failure modes of the splices that were fully or not fully swaged are shown in Figure 7-2c. As shown in this figure, the splice with the coupler with a 1 in. (25 mm) long unswaged region developed a fracture in the bar at a location away from the coupler. The bar experienced necking before fracture, which was similar to the failure of splices with fully swaged couplers. The results indicated that couplers used in R-Calt-2 that were not fully swaged would also develop the desired failure mode. These couplers performed well in restoring the ductility capacity of the repaired column, as discussed in Chapter 4.

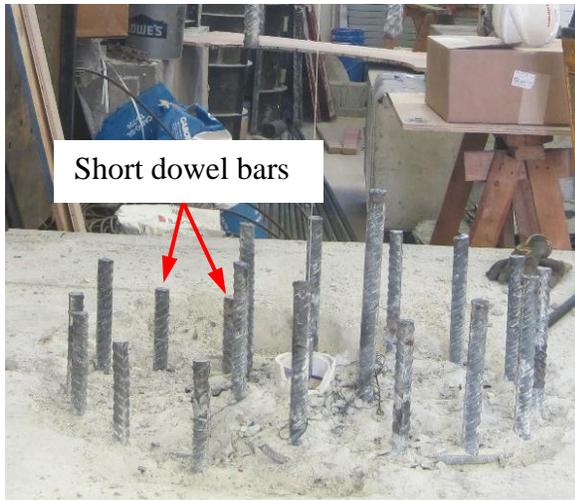
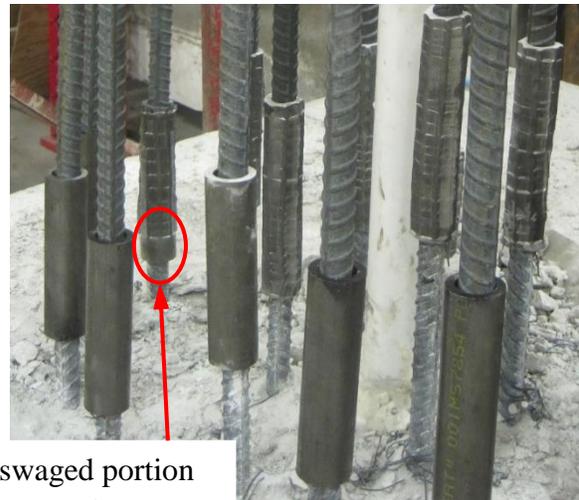
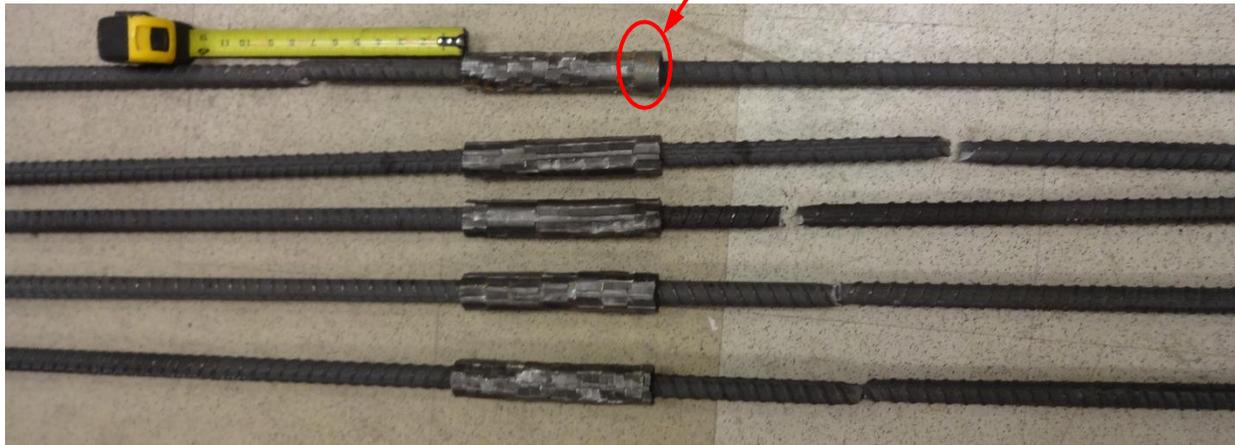
Figure 7-2 Installation and Failure of Bar Splice Tensile Tests of Swaged Couplers

For R-Calt-2, due to the higher T/M ratio than that of R-Calt-1 (0.6 and 0.2, respectively), the bent (i.e. buckled) portions of the damaged longitudinal bars were further from the footing than for the longitudinal bars of R-Calt-1; thus, after cutting the bars, the portion of the existing bars protruding from the footing was longer than that of the bars of R-Calt-1, and there was enough length available for the swaging machine to swage most of the couplers. Thus, the time required for the installation was approximately 16 hours with two workers, which was less than that of R-Calt-1. However, two of the protruding bars from the footing were too short to swage the couplers along the entire length (see Figure 7-2a). In this case, approximately a 1 in. (25 mm) length of the two couplers was not swaged as shown in Figure 7-2b. To investigate whether the

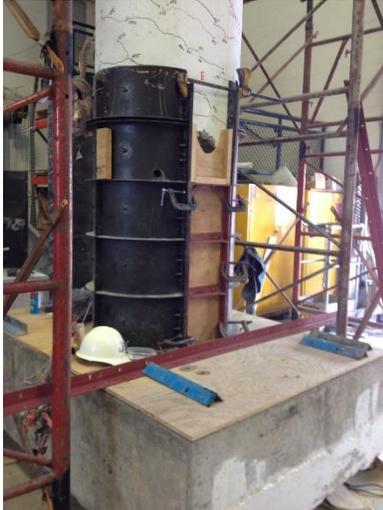
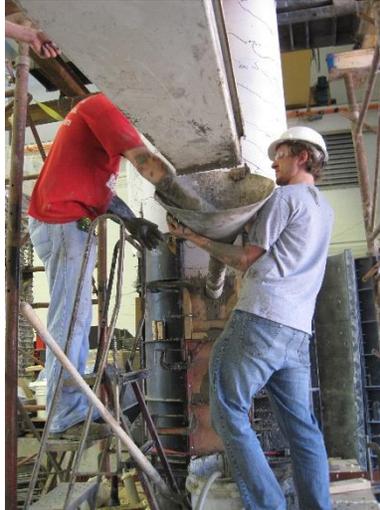
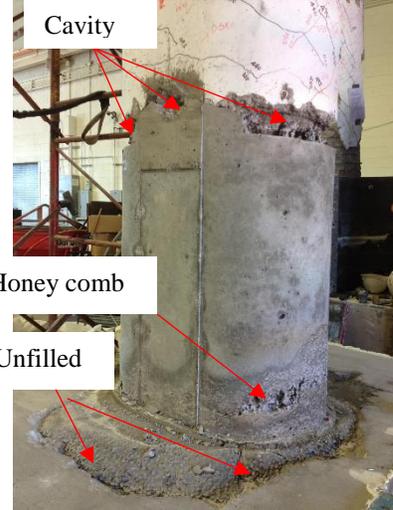
As shown in Figure 7-3a, the formwork for R-Calt-1 was composed of two semi-circular plastic shells and two stiffened wooden forms. The plastic shells were commercially available and were the same as those used to construct the original columns. Concrete was placed through a hole preserved at the top of the formwork (see Figure 7-3b). Concrete was consolidated by limited vibration. The column after concrete placement was shown in Figure 7-3c. As shown in this figure, the top level of the newly cast concrete did not reach the existing concrete and resulted in a 4 in. (100 mm) wide cavity. Honeycombing was also found near the bottom of the column due to limited vibration. The removed top cover of the footing was also not fully filled due to the low

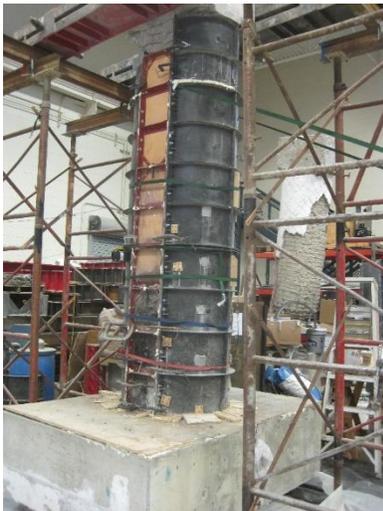
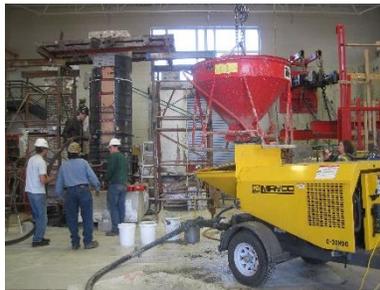
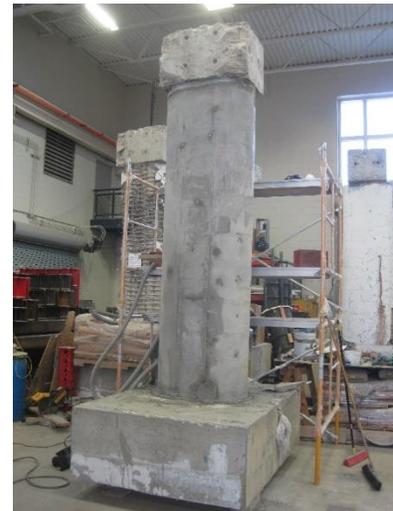
With the lesson learned from the concrete placement of R-Calt-1, a different method was used to place the concrete for R-Calt-2, which involved more flowable concrete and a pump to ensure better placement of the concrete. Formwork similar to that of R-Calt-1 was used as shown in Figure 7-3d. Highly-flowable concrete with design strength similar to that of the original column was pumped into the formwork (see Figure 7-3e). The column after placement of concrete was shown in Figure 7-3f, which shows that the placement method used for R-Calt-2 was improved compared to that used for R-Calt-1.

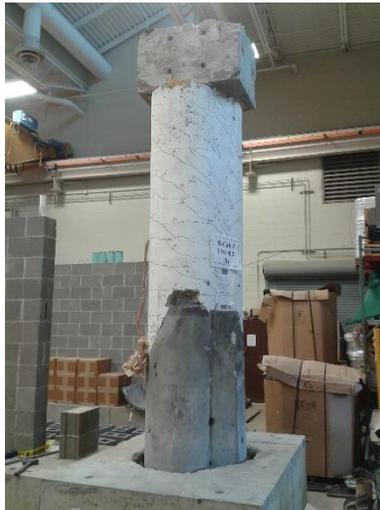
(g) R-Calt-3 after grout casting

For R-Calt-3, high-fluidly grout with design strength similar to that of the original column was cast to replace the damaged concrete. A pump was not used to place the grout. The formwork used for R-Calt-3 was similar to that described for R-Calt-1 and R-Calt-2. The column after grout placement is shown in Figure 7-3g, which also shows the success of the grout placement method used.

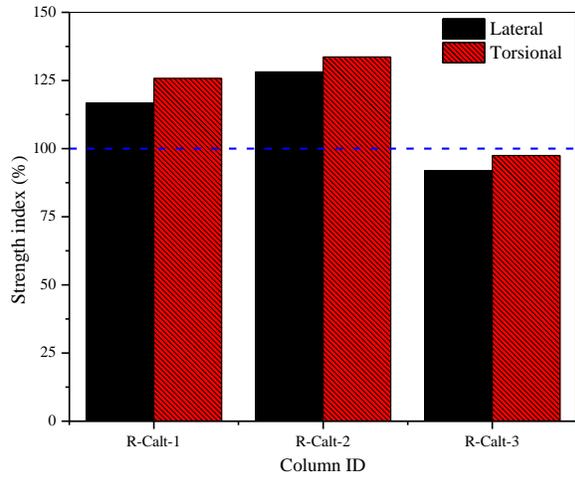
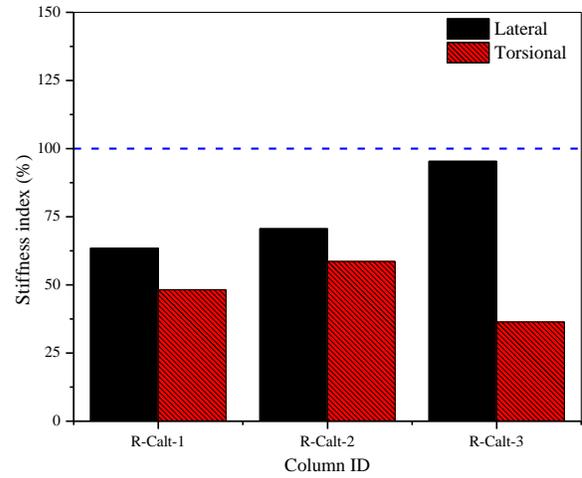
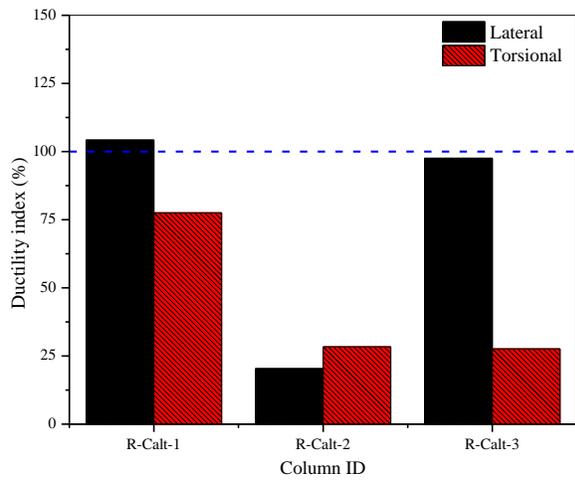
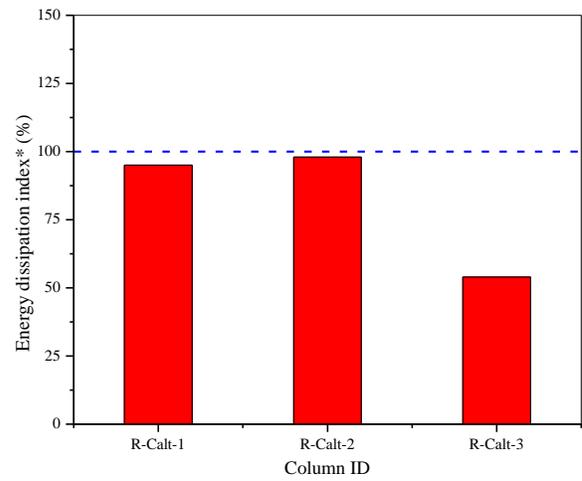
Figure 7-4 Restoration Indices of Repair Methods

Figure 7-4 shows the strength index for each column. As shown in this figure, the repair methods used for R-Calt-1 and R-Calt-2 enhanced both the lateral and torsional strength with strength indices over 110%. The repair method used for R-Calt-3 was successful in restoring both the lateral and torsional strength to over 90% of the original column. Thus, it can be concluded that both repair methods proposed were able to restore both the lateral and torsional strength.

Figure 7-4 shows the stiffness index for each repaired column. As shown in this figure, each of the repair methods resulted in lower lateral and torsional stiffness compared to that of the corresponding original columns. Both repair methods were more successful in restoring the lateral stiffness than the torsional stiffness. The repairs of R-Calt-1, R-Calt-2, and R-Calt-3 restored the lateral stiffness to 64%, 71%, and 95% of that of the original columns, respectively. However, the torsional stiffness was only restored to 48%, 59%, and 36% of that of the original columns, respectively. The restoration of stiffness for R-Calt-1 and R-Calt-2 was similar due to the similar repair procedure. The repair method for R-Calt-3 was successful in restoring the
