STRUCTURAL PERFORMANCE OF ULTRA-THIN WHITETOPPING ON ILLINOIS ROADWAYS AND PARKING LOTS

Research Report No. FHWA-ICT-14-018

A report of the findings of
ICT-R27-61
**Mechanistic-Empirical Design Implementation and Monitoring for Rigid
Pavements**

August 2014

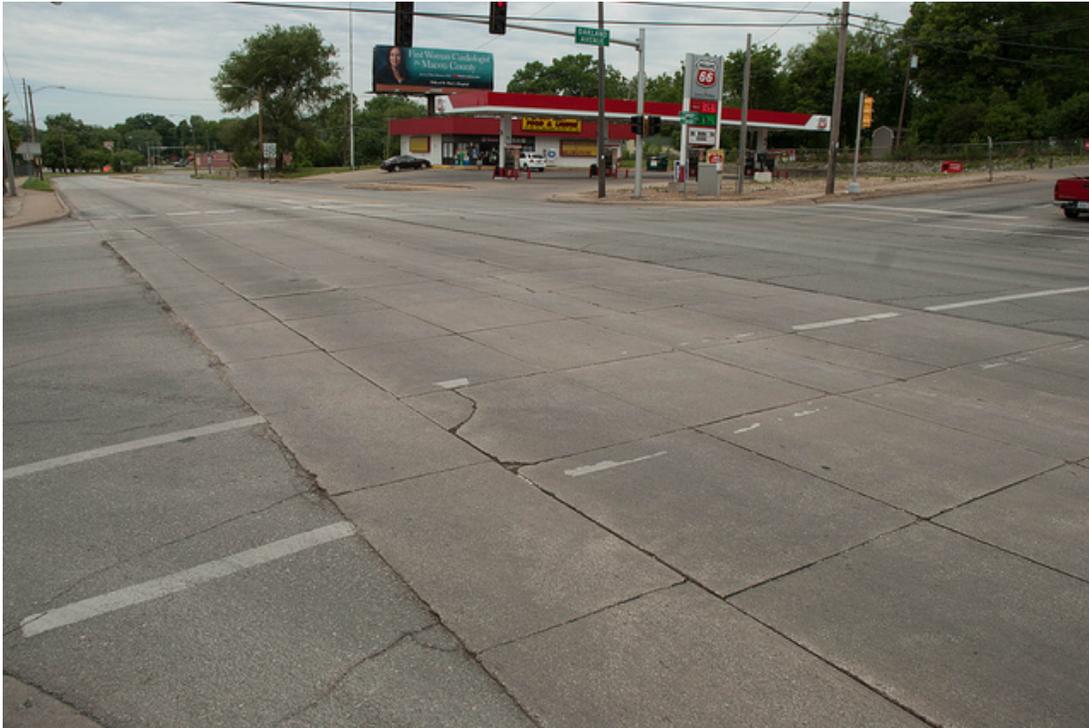
Figure 2.2. Overview of U.S. 36 and Oakland Avenue in Decatur (June 2012).

Overall, the project was in poor condition. As seen in Table 2.3, 35.8% of panels at this intersection featured cracking or were considered completely shattered slabs. Included in the number of panels with longitudinal cracks was a continuous longitudinal crack extending through 14 slabs. At 3 to 4 feet wide, the joints fell in the wheel path, likely contributing to the distresses. As noted in Table 2.4, the number of cracked slabs almost doubled between 2003 and 2012.

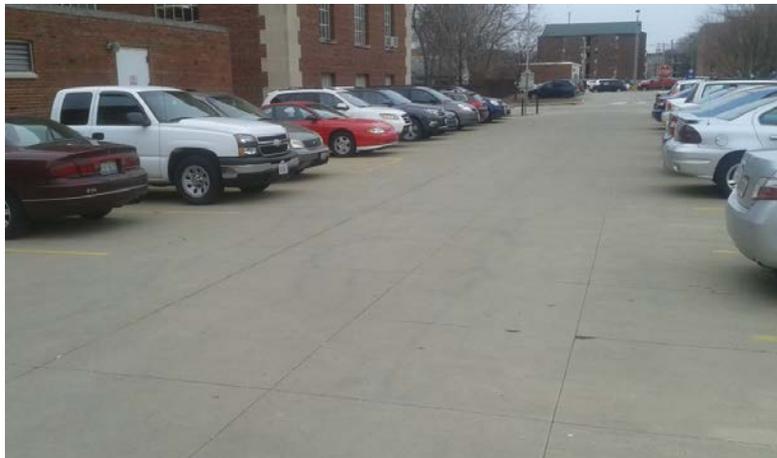
Figure 2.7. Overview of Talbot Lab parking lot (February 2013).

The lot was in good condition overall in 2012, especially considering its age. Although 22% of panels were cracked, as noted in Table 2.6, the majority of the distresses appeared to be the result of use of the lot as a staging area for heavy vehicles and equipment during renovation projects on Talbot Lab rather than repeated loading from parking lot traffic. Cracks were most prevalent near the entrance to the lot, as seen in Figure 2.9, but none exceeded medium severity. Spalling of cracks and joints was minimal, and there was no faulting. The pavement was still in good serviceable condition.

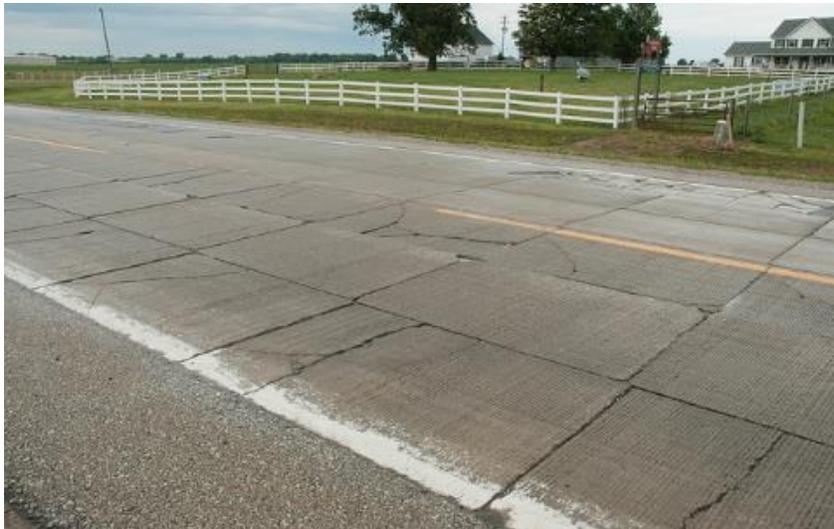
Figure 2.12. Overview of U.S. 36 in Tuscola (June 2012).

Overall, U.S. 36 was in very poor condition. As shown in Table 2.10, 20.8% of all panels were cracked, which was substantially more than had been found in surveys performed between 1999 and 2004 (Tables 2.11 and 2.12). Issues with the longitudinal joints were the primary cause of distress. The longitudinal joints fell in the wheel path in each section of the project. This problem, in conjunction with the fact that the joints had been saw-cut too wide during construction, left the longitudinal joints very susceptible to opening and spalling. In turn, extensive corner cracking (15.3% of all panels) developed along the longitudinal joints. Figure 2.14 shows the opened joints and corner cracking along a longitudinal joint. As seen in the figure, some of the corner cracks had been patched with asphalt. Use of a thinner saw blade would have reduced this opening and slowed the deterioration.

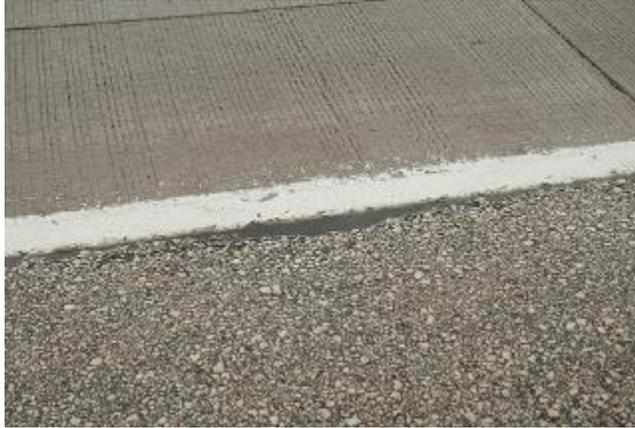
Figure 2.16. Water buildup between the shoulder and pavement edge (June 2012).

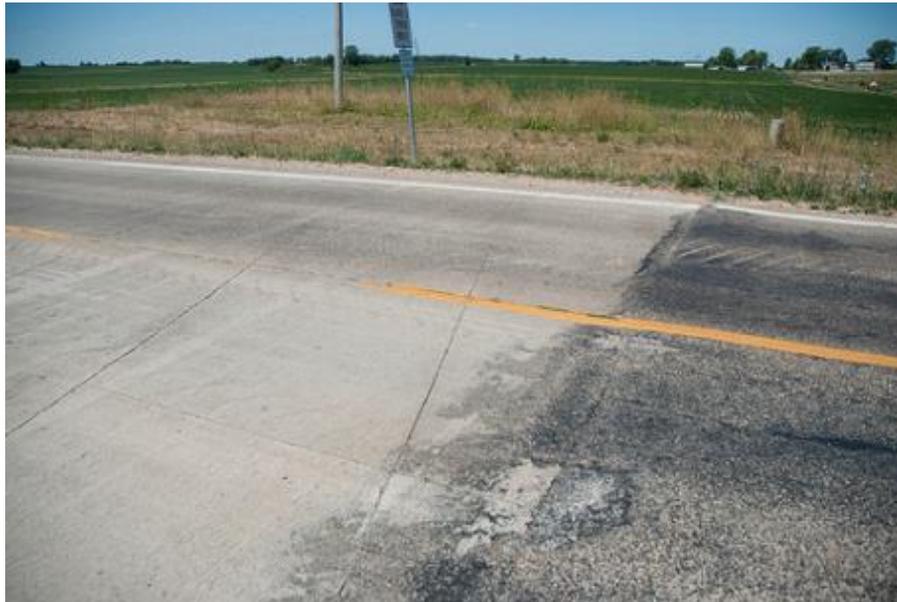
Figure 2.19. Overview of Cumberland County Highway 2 (June 2012).

County Highway 2 was in excellent condition. There were two transverse cracks that covered a total of four panels, as noted in Table 2.15, but they appeared to be just shrinkage cracks resulting from an uncracked transverse joint. Dominant joints were not apparent. There was some low-severity joint spalling scattered throughout the project, with the greatest approximately 4 inches.

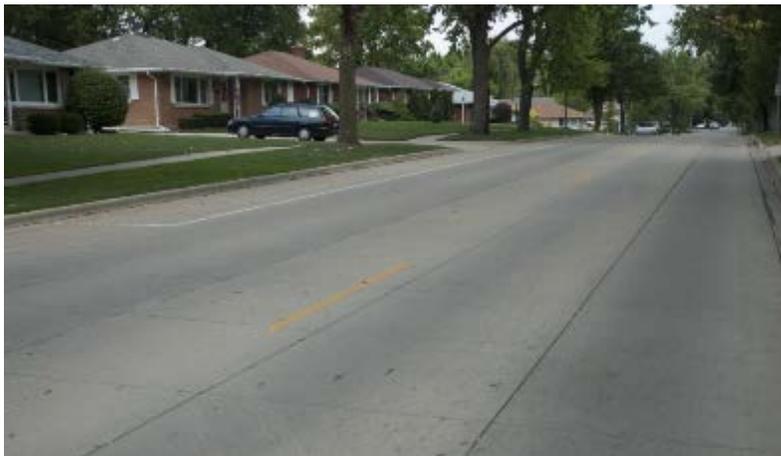
Figure 2.26. Overview of Grace Street (August 2012).

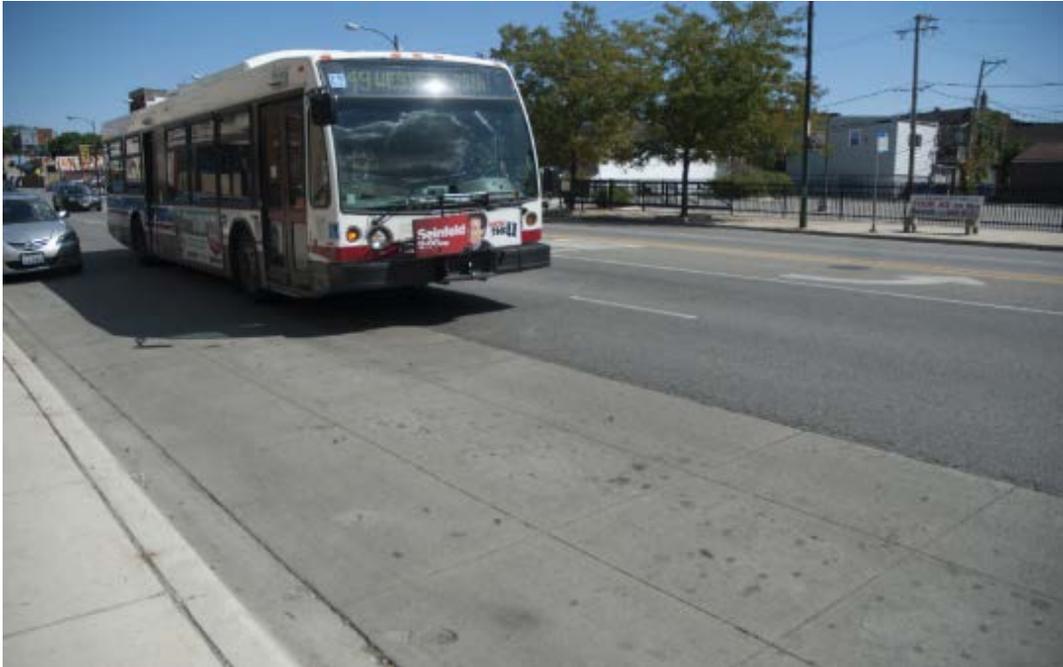
Figure 2.32. Typical UTW bus pad at Western and Iowa (August 2012).

Overall, the bus pads were in very good condition from a functional performance perspective. Although the pads had cracked panels, noted in Table 2.21, the joints and cracks appeared to have been kept tight by the fibers, and little faulting was observed. The main issue that likely led to cracking in many sections was a debonded interface between the concrete slabs and foundation, especially along the curb.

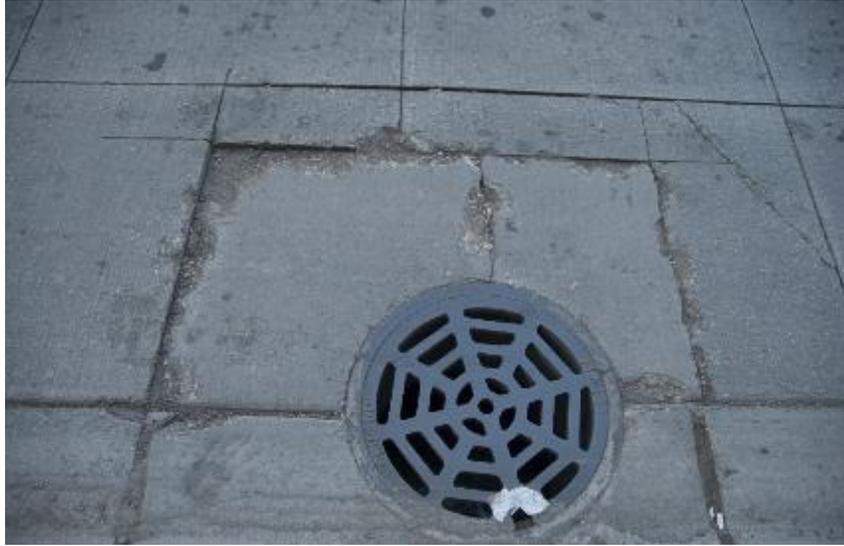
Certain observations unique to particular stops included faulting in a longitudinal joint at the beginning of the Washington stop that may have resulted from a distress in the adjacent asphalt, pictured in Figure 2.34; joint opening and faulting near a patch at a manhole at the Hubbard stop, pictured in Figure 2.35; and some minor slab migration on the approach panels of the Warren stop. The pad with the highest percentage of cracked panels, at Washington, was noted to have had the toughest construction conditions. Also at this bus stop, a geotextile had been placed between the concrete and base layers toward the beginning of the pad but had not led to any observable distresses.

Figure 2.35. Joint opening and faulting near a manhole patch at Western and Hubbard (August 2012).

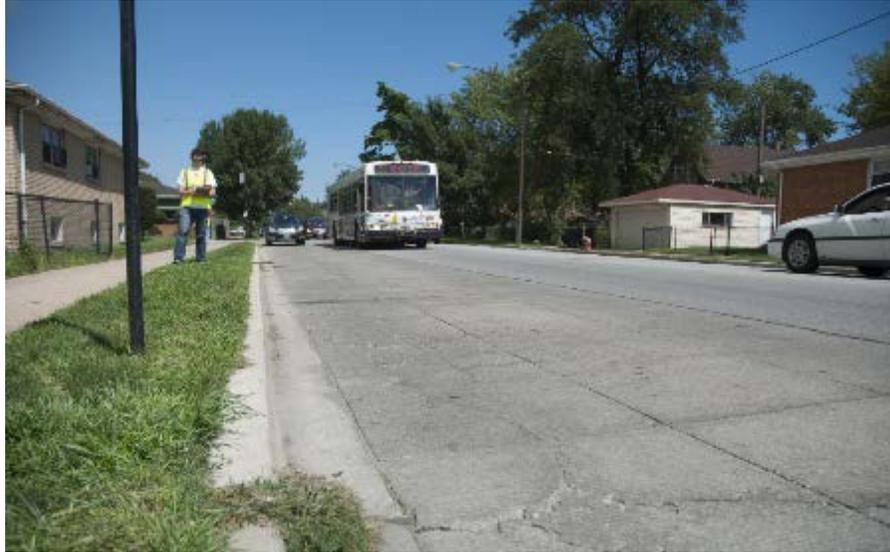
Figure 2.36. UTW bus pad at South Michigan and 124th Place (August 2012).

As seen in Table 2.23, the remaining pad experienced significant distresses. Although the other pads had been replaced, a 2007 report from the University of Illinois at Chicago detailed their early performance. The report indicated that all of the pads exhibited similar distresses to those observed at 124th Place and that the majority of the pads experienced early failure. It was concluded in the 2007 report that a lack of consideration of the underlying layer in design and poor quality control during construction were the main causes of distress (Issa 2007). Despite the extensive cracking in the last remaining pad, the cracks and joints were tight and the pavement was still in serviceable condition.

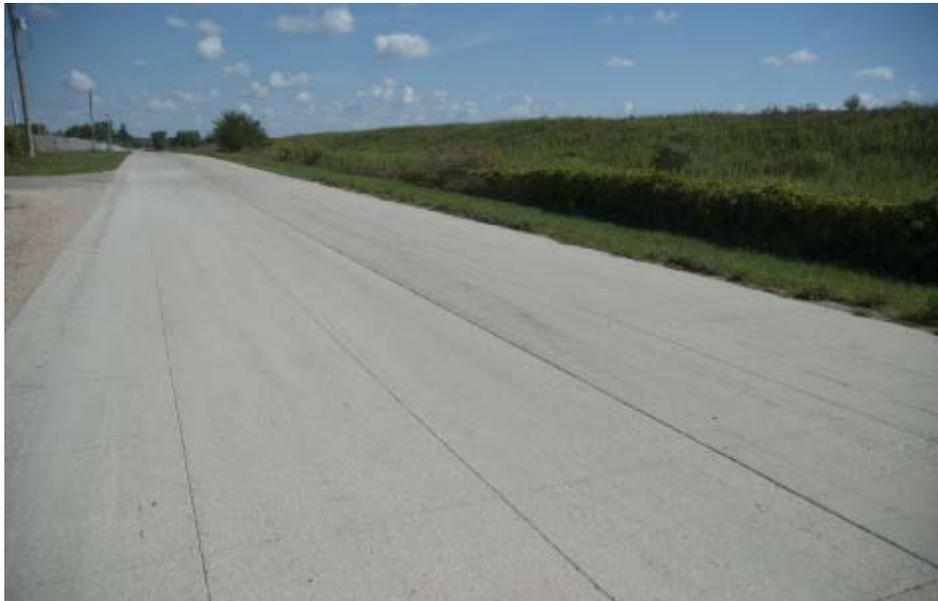
Figure 2.38. Overview of North Lorang Road (August 2012).

Overall, the project was in excellent condition. As noted in Table 2.25, there was a low percentage of cracked panels. The majority of the cracked slabs occurred on the widened east edge of the pavement on the south end of the project, which was adjacent to residential driveways. An example of this cracking is shown in Figure 2.40. Debonding was detected near the joints by these cracks. There were no driveways on the west pavement edge, and no similar distresses were observed on that side.

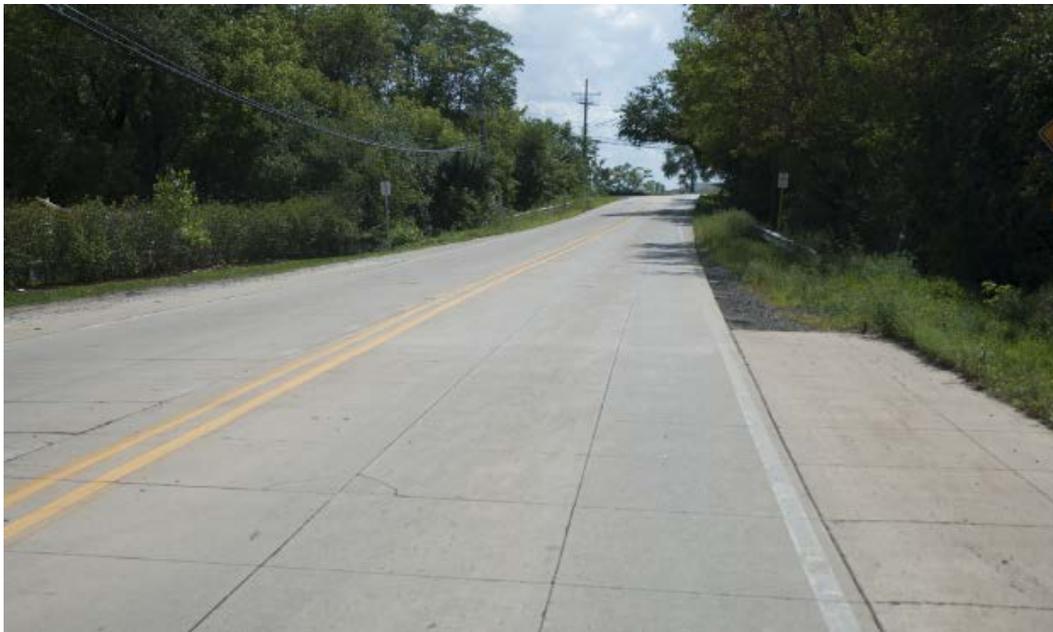
Figure 2.42. Overview of Schank Avenue (August 2012).

Overall, the project was in good condition, with roughly 8% of all slabs cracked, as seen in Table 2.27. However, serious support problems were developing. The main issue was in the middle of the roadway section, which lay on an embankment that appeared to be settling. A major loss of shoulder support at the edges of the pavement resulted from the settlement, causing the opening of the outermost longitudinal joints in both lanes and the rotation of the outside panels away from the rest of the pavement. Faulting, debonding, and low-severity slab migration (less than 5 mm) were all prevalent at these edge areas and may worsen as the embankment continues to settle. A location with obvious loss of shoulder support is shown in Figure 2.44, and examples of the resulting distresses are found in Figures 2.45 through 2.47.

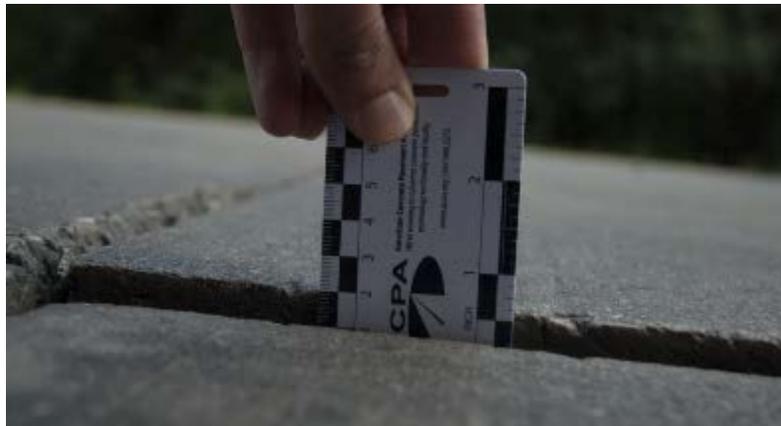
Figure 2.46 Close-up of faulting in the outside longitudinal joint (August 2012).

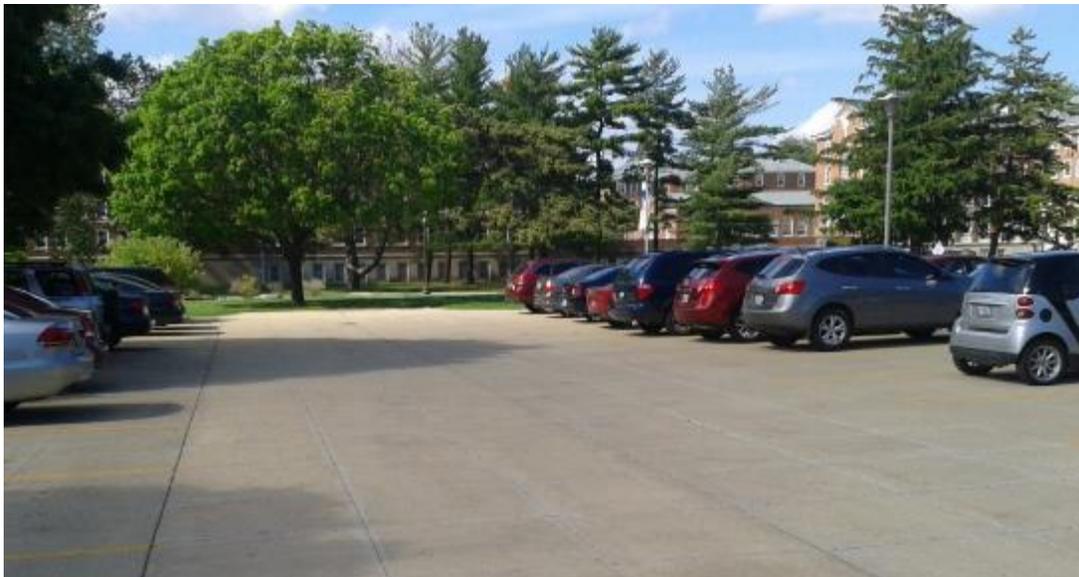
Figure 2.49. Overview of the McKinley parking lot (May 2013).

The McKinley parking lot was in excellent functional and structural condition overall. Less than 0.5% of all panels were cracked, as noted in Table 2.29. Of the longitudinal cracks found in the lot, the two in the northwest section propagated from a curb joint and the six in the northeast section propagated from a manhole. The corner breaks were graded low to medium severity.

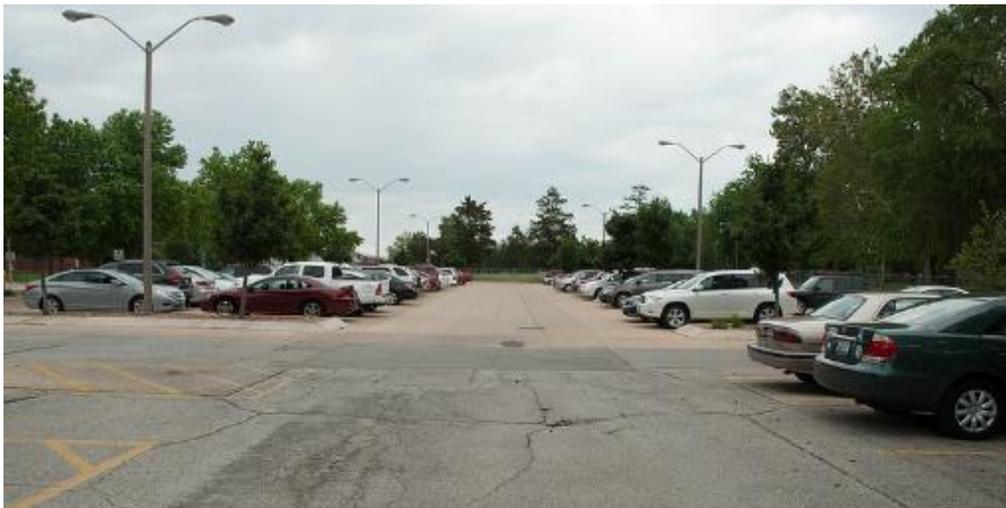
Figure 2.53. Overview of E-15 parking lot (June 2012).

Overall, the E-15 lot was in excellent condition. As shown in Table 2.31, just 0.25% of all panels were cracked. All of the cracking was graded as low severity. The corner breaks and diagonal cracks in Bays 1 and 2 were either near islands or propagated from drains, as shown in Figure 2.55.

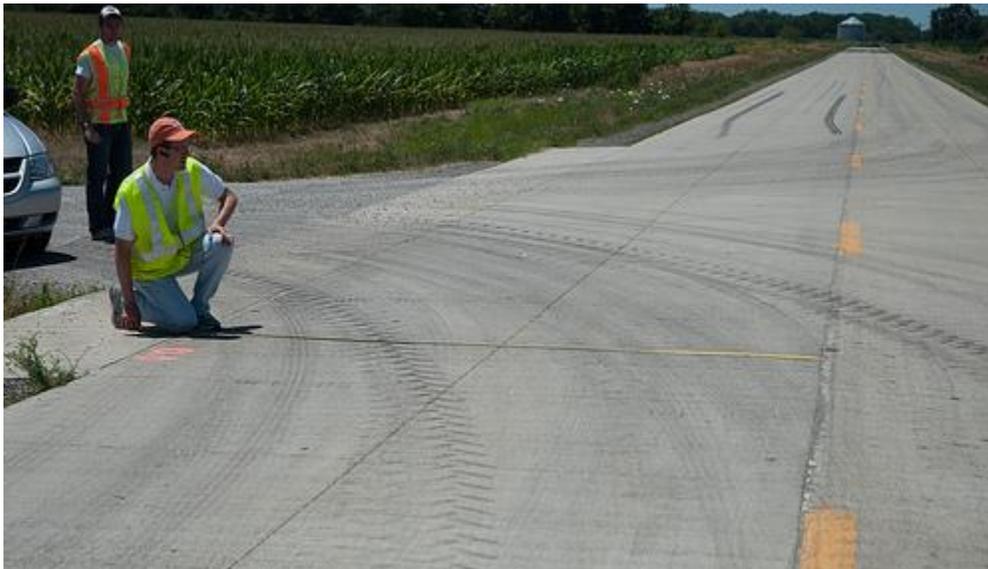
Figure 2.56. Overview of Bible Grove Road (June 2012).

Overall, the project was in good condition. There were few cracked slabs, as noted in Table 2.33, but there were a number of distresses that were likely caused by construction issues. In the 5.5 foot panel section, there were several instances of misalignment of transverse joints in the eastbound lane. In three cases, this irregularity led to transverse cracks across the adjacent panels in the westbound lane, as demonstrated in Figure 2.58. A panel had also been replaced at a misaligned joint.

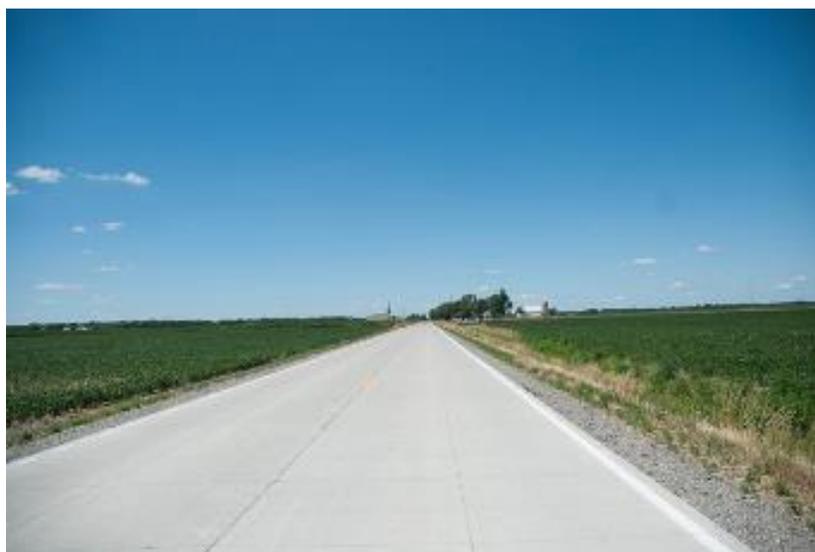
Figure 2.59. Overview of Richland County Highway 9 (June 2012).

Overall, the project was in excellent condition. There was no cracking in the slabs, as shown in Table 2.35. There were a few instances of joint spalling, which was likely due to saw-cutting. There was no fiber balling evident at the surface similar to what was observed in other pavements that featured macro-fibers.

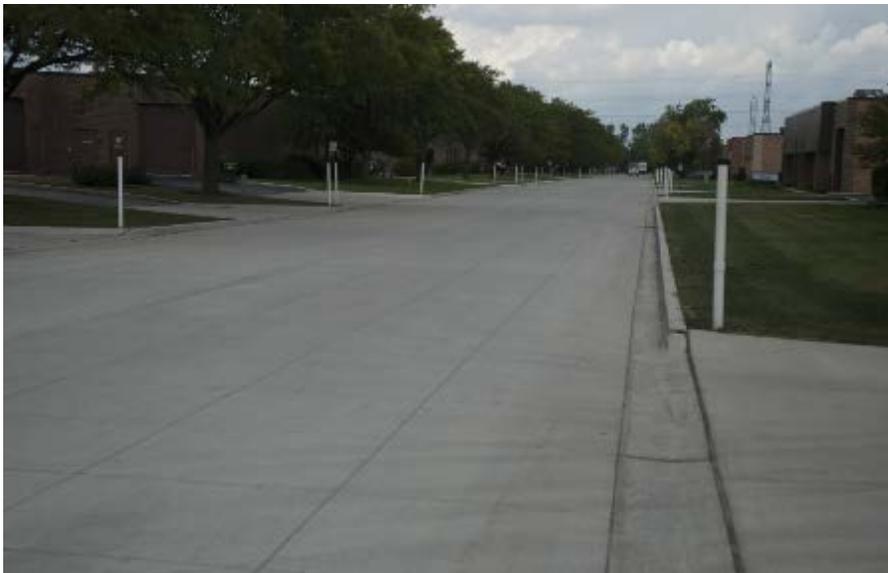
Figure 2.61. DuPage Avenue in the North Industrial Park project (August 2012).

No crack survey of the North Industrial Park project was performed because the project was relatively new and there were few instances of distress. Most of the distresses that were observed appeared to have resulted from construction, which was done on a cold day in November with highs around 40°F (Riley 2010).

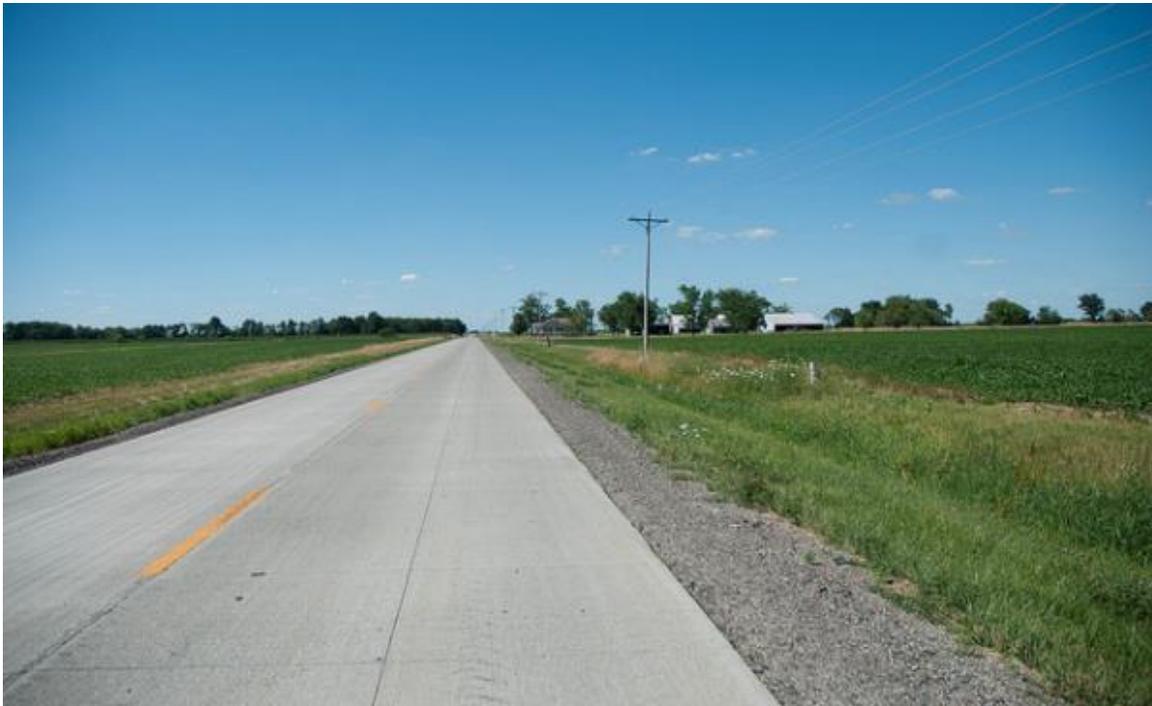
Figure 2.64. Overview of Xenia-Iola Road (June 2012).

Overall, the project was in excellent condition. There were few cracked panels, as noted in Table 2.38. The only major observed distresses were surface cracks that may have resulted from shrinkage or restraint. There was also slight deterioration of the edge of the northbound lane.

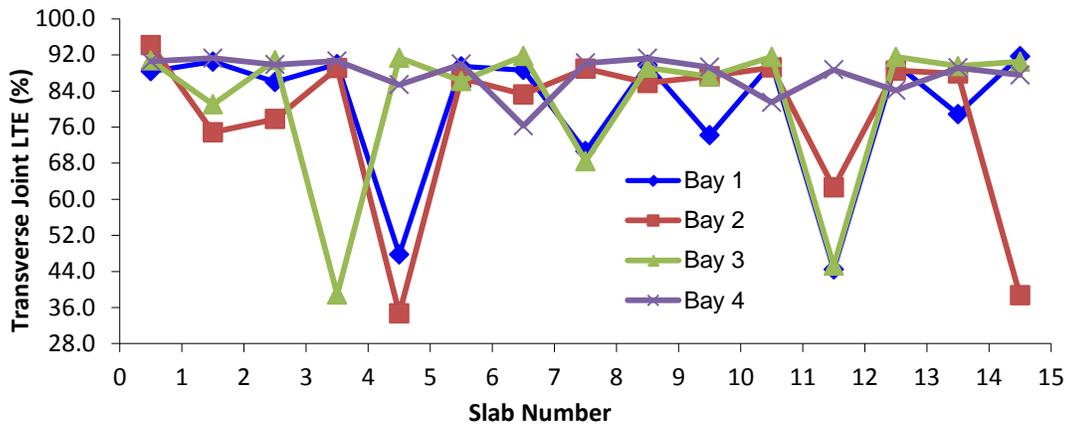
Figure 3.10. Variation in transverse joint LTE for consecutive slabs, E-15 lot 2012.

A common finding when plotting transverse joint load transfer efficiency as a function of distance was local variation in LTE from slab to slab. Numerous local reductions in transverse joint LTE are shown in Figures 3.10, 3.20, 3.27, and 3.28. These reductions are hypothesized as either dominant joints or locations where full-depth joint crack has propagated through both the concrete and asphalt layers (Cervantes et al. 2009). These reductions in joint LTE may have affected the backcalculated h_{eff} results in some cases, which will be discussed in the next section (3.3.2).

A comparison of the backcalculated h_{eff} of the newly completed section (Bay 4) of the E-15 lot with the sections that were six years old at the time of the 2012 testing is provided in Figures 3.10 and 3.21 for LTE and h_{eff} , respectively. The primary difference appears to be that there is not as much variation in both LTE and h_{eff} in Bay 4 compared with the older sections of the lot and no instances of local spikes or reductions. This uniform behavior may indicate that full-depth cracks did not occur, which may have been due to the weather during construction or to a combination of reasons, including a difference in the concrete material hydration and initial cooling.

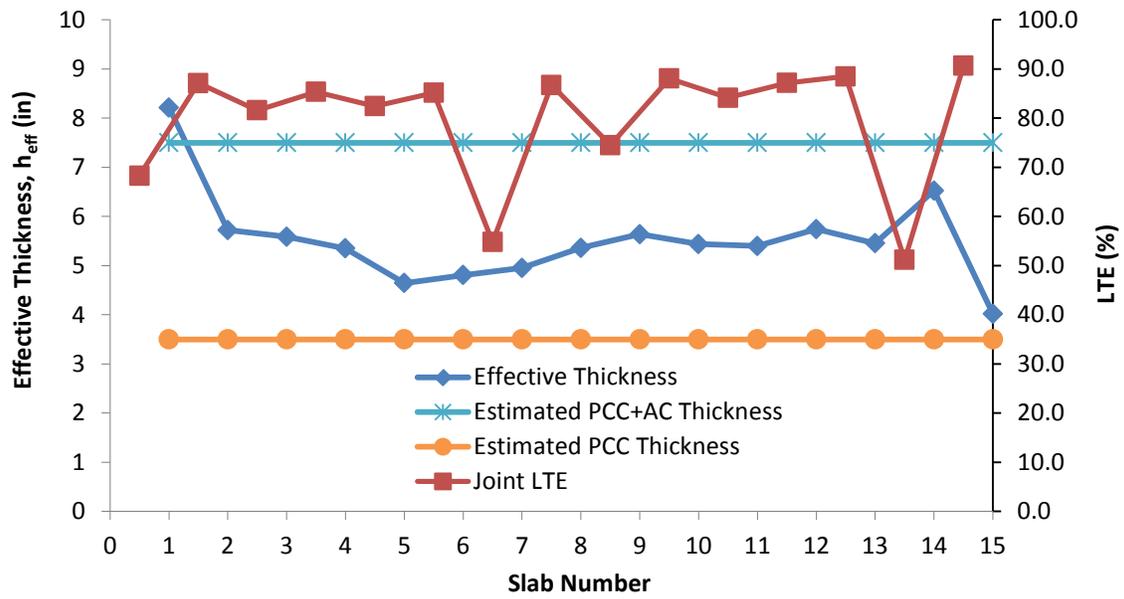
Figure 3.20. Comparison of local transverse joint LTE and effective slab thickness, northeast section, McKinley lot, 2012.

There were several other cases where spikes in h_{eff} corresponded to local reductions in LTE at the preceding transverse joint, including at slabs 1 and 14 in the northeast section of the McKinley lot (Figure 3.20) and at slab 2 on Richland County Highway 9 (Figure 3.28). To unravel the cause of this phenomenon, one of the transverse joints was assumed not to crack at the expected 4 foot interval, thus providing 100% moment and shear transfer, as seen in Figure 3.31. This resulted in a 4 by 8 foot concrete slab with the outer joints at 50% LTE. In the ILLI-SLAB analysis, the FWD plate was placed at the apparent center of a 4 by 4 foot slab to analyze the deflection behavior and compare it to the case where all joints were 50% LTE.

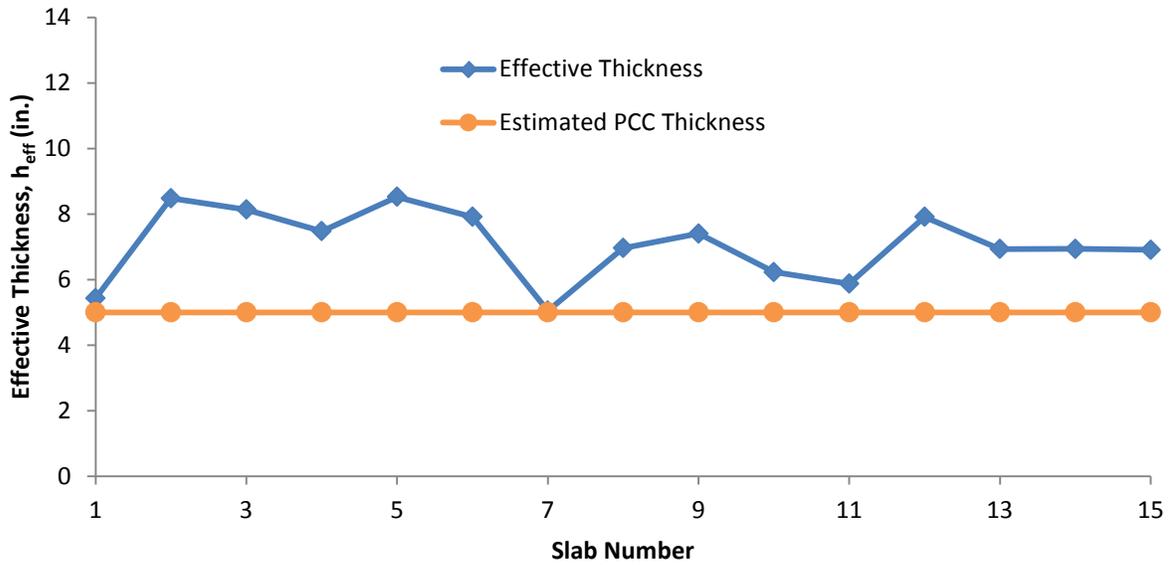
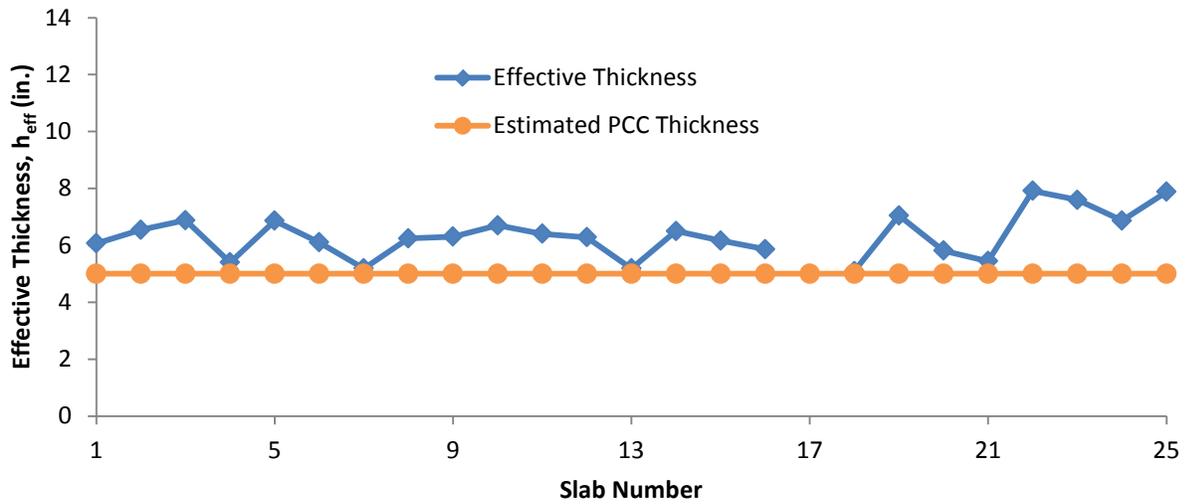
Figure 3.24. Effective thickness, intensive testing on 5.5 foot panels, Bible Grove Road, 2012.

Figure 3.25. Effective thickness, periodic testing on 5.5 foot panels, Bible Grove Road, 2012.

Effective thickness results for intensive and periodic testing of the 5.5 foot panel section of Bible Grove Road are presented in Figures 3.24 and 3.25. The h_{eff} values for the periodic testing were stable at each successive measurement and consistent with the h_{eff} values for the intensive testing, indicating that the structural conditions did not vary much across the section. Though the underlying HMA thickness of Bible Grove Road was unknown, the average h_{eff} values (Table 3.6) that were calculated were only about 1 to 2 inches thicker than the estimated PCC thickness, suggesting a relatively thin asphalt support layer.

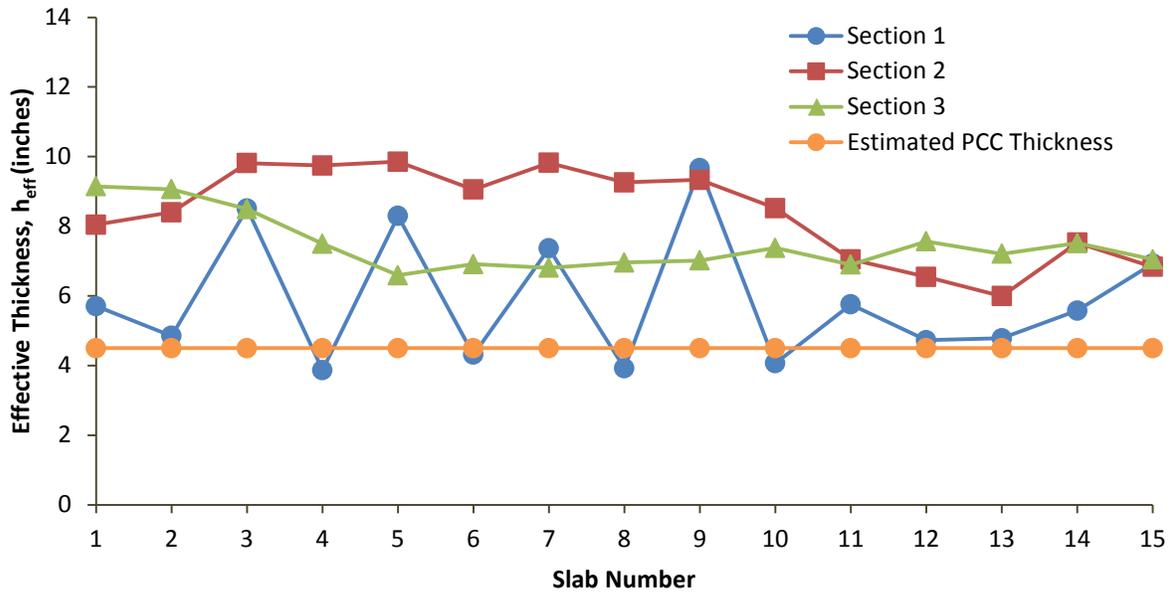
Figure 3.26. Effective thickness, North Lorang Road, 2013.

On North Lorang Road, the h_{eff} that was backcalculated in Section 1 (6.24 inches) was about 1 to 2 inches lower than the h_{eff} measured in Sections 2 (8.36 inches) and 3 (7.47 inches) (Figure 3.26, Table 3.6), and the difference was significant to a 90% confidence interval. These results seem to correspond with the findings of the visual distress survey because Section 1 of the FWD testing of North Lorang Road was the southernmost portion of the project. That section of the project experienced the greatest degree of distress and apparent loss of structural support in some areas, which would be expected to result in a lower h_{eff} . The backcalculated h_{eff} values in Section 1 were also significantly more volatile than in the other two sections, with spikes occurring at Slabs 3, 5, 7, and 9, shown in Figure 3.27. These spikes appeared to correspond to local reductions in LTE at the joint with the preceding slab (i.e., the spike in h_{eff} at Slab 3 corresponded with a local reduction in LTE at the joint between Slabs 2 and 3). As discussed in Section 3.3.1 of this paper, the local reductions in joint LTE may indicate dominant or cracked joints, and it appears that every other transverse joint in this location had cracked.

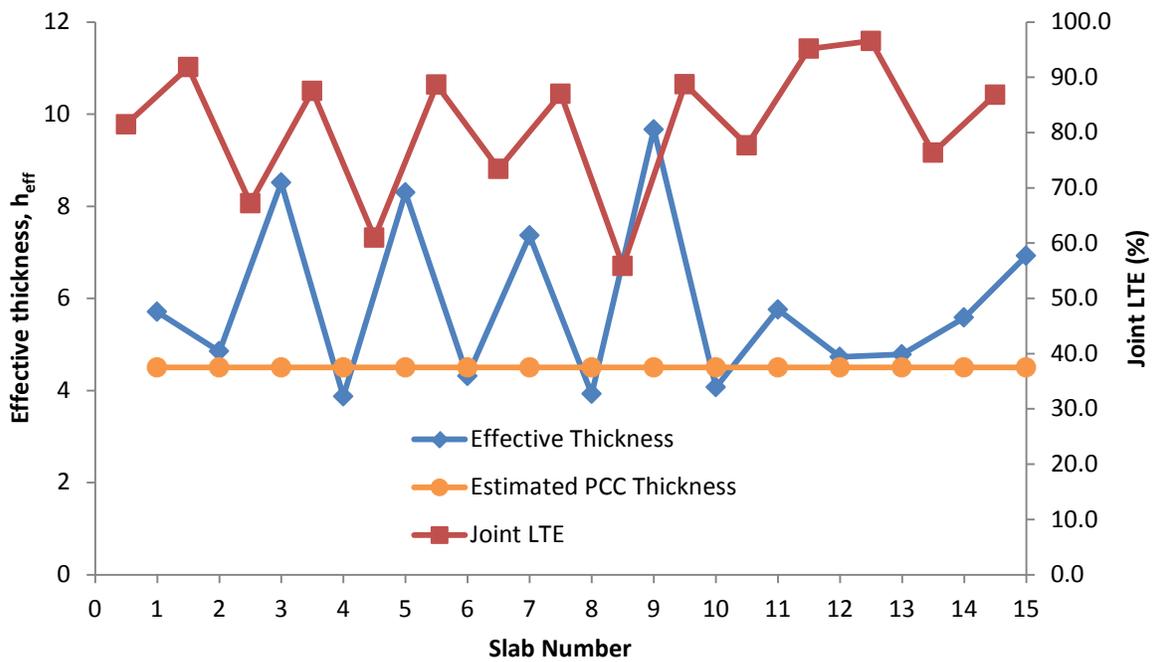
Figure 3.27. Comparison of local transverse joint LTE and effective slab thickness, Section 1, North Lorang Road, 2013.

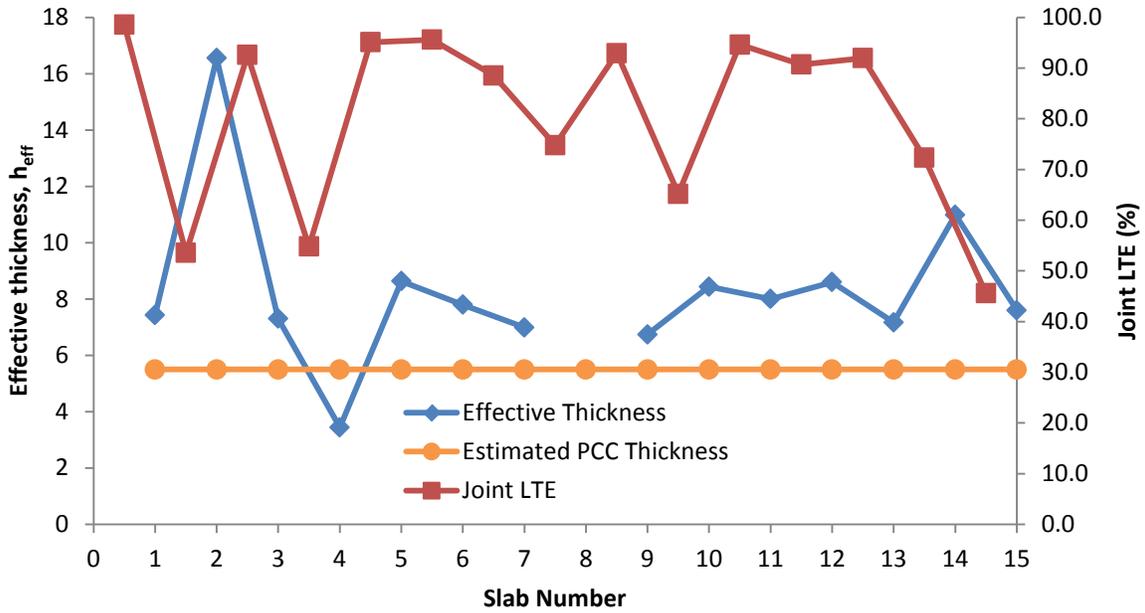
Figure 3.28. Comparison of local transverse joint LTE and effective slab thickness, intensive testing, Richland County Highway 9, 2012.

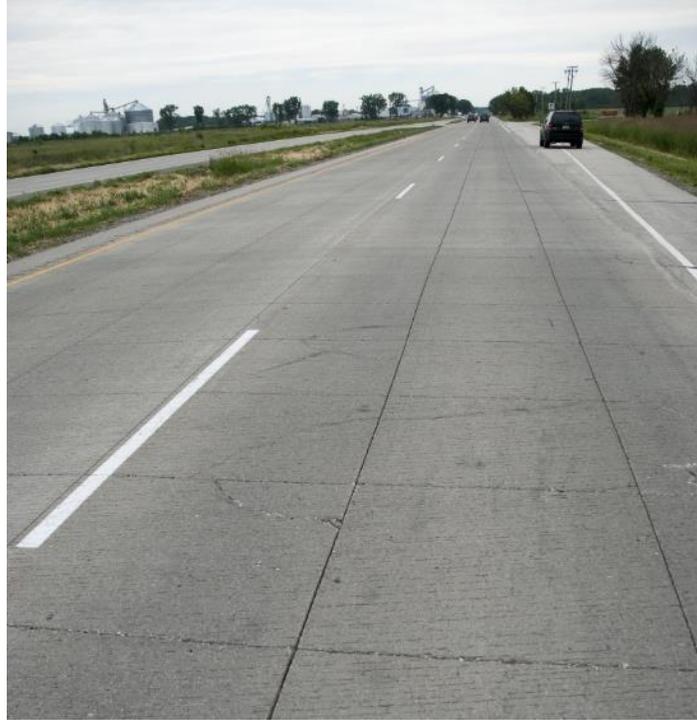
The UTW section on Illinois Route 53 in Will County is a four lane divided highway with two lanes each in the northbound and southbound directions, running approximately four miles from Arsenal Road at the south end to Hoff Road at the north end. There was a significant amount of truck traffic on this section due to nearby intermodal facilities. As of 2013, single-unit trucks accounted for 12.3% of all traffic, while multi-unit trucks accounted for 19.4% of all traffic. Project details are provided in Table 4.1, and an overview of the project is pictured in Figure 4.1.

Figure 4.1. Overview of Route 53 in Will County (June 2014).

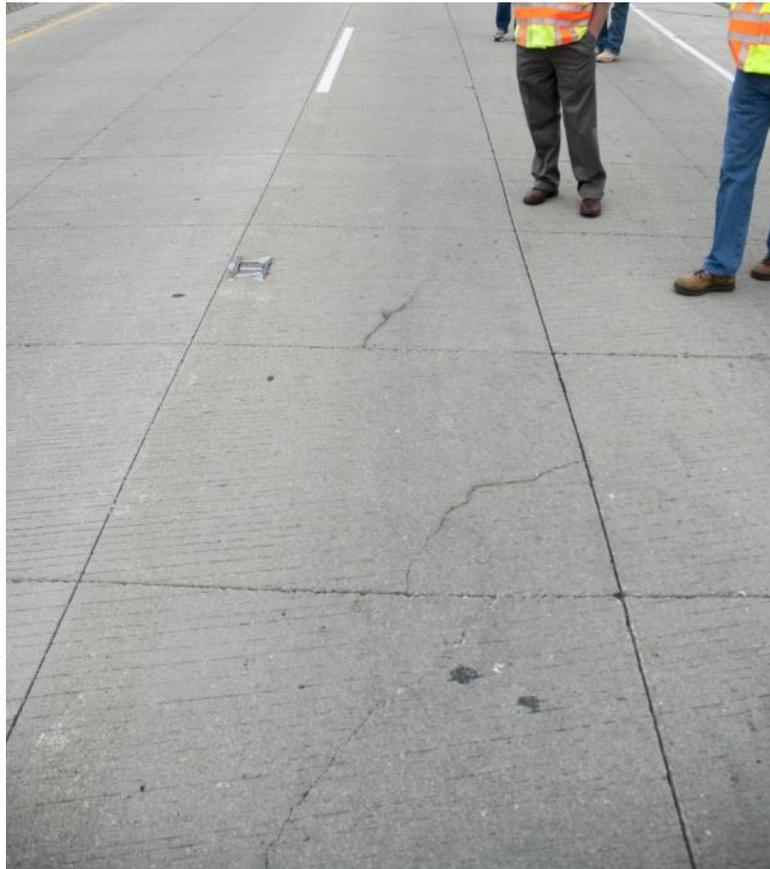
Although the percentage of total slabs cracked in the three section that were surveyed was not high, as seen in Table 4.3, distresses were more prevalent in the northbound lane than in the southbound lane and much more serious. There were particularly severe distresses along the lane-shoulder joint at various points throughout the northbound lane (not necessarily included in the distress survey), as shown in Figure 4.2, and inner wheel path of the right (driving) lane, seen in Figure 4.3. A number of panels in these areas also featured asphalt or concrete patching, indicating the same problems had occurred there. An example of asphalt patching surrounded by other local distresses is shown in Figure 4.4.

Figure 4.3. Distresses in the inner wheel path of the right lane in the northbound direction (June 2014).

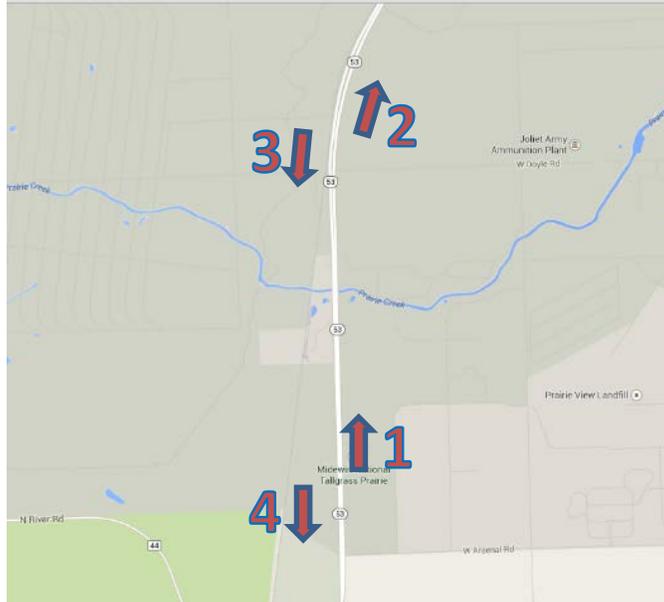
Intensive testing was conducted at four different sites along the project, which can be seen in Figure 4.7. Sites 1 and 2 are in the northbound lane, while Sites 3 and 4 are in the southbound lane. Testing at Sites 1 and 4 began at the entrance to Midewin National Tallgrass Prairie near the south end of the project. Testing at Site 1 proceeded northward in the northbound lane, while testing at Site 4 proceeded southward in the southbound lane. Testing at sites 2 and 3 began at an intersection with a road near a railroad crossing in the middle of the project just past the point where Route 53 curves toward the northeast. Testing at Site 3 proceeded northward in the northbound lane, while testing at Site 4 proceeded southward in the southbound lane.

Figure 4.7. Intensive testing sites on Route 53.

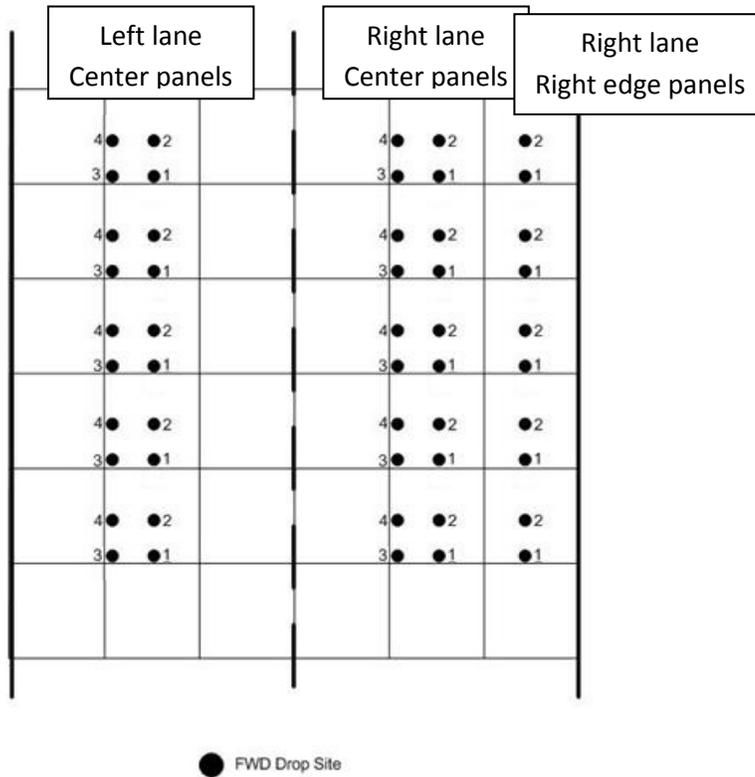
At each site, intensive testing was performed in passes over a series of 15 consecutive slabs in three different rows (left lane center, right lane center, and right lane right edge), for a total of 45 slabs tested at each site, and each slab featured two to four drop locations. The drop pattern provided in Figure 4.8 shows the slabs that were tested and locations on each slab for the intensive testing at each site.

Figure 4.8. FWD drop pattern, Intensive Testing, Route 53.

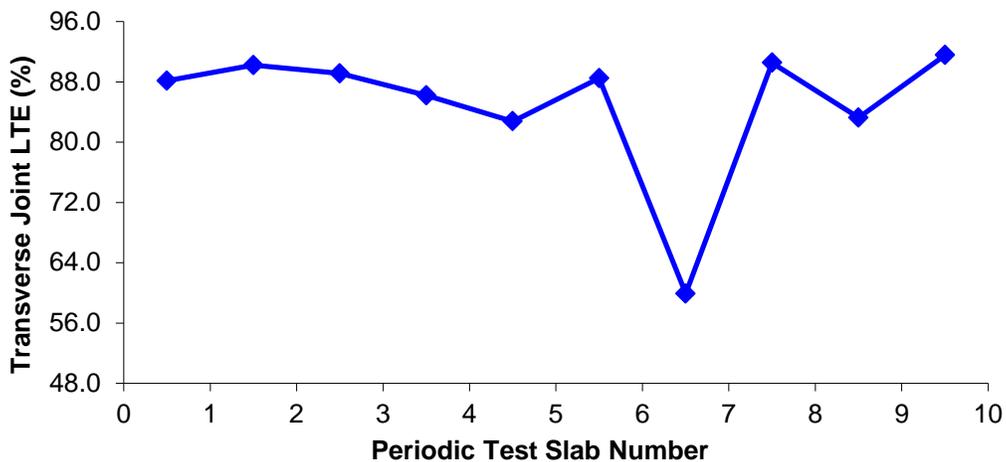
There were very few instances of local drops in transverse joint LTE, which have been found on a number of other UTW projects (Chapter 3) and may indicate dominant or cracked joints. Overall, this suggests that the support under the slab was continuous and likely thick. One of the few drops that was found with lower LTE in the project was during periodic testing of the southbound lane at Mile 3. The drop occurs at the joint just before periodic test slab 7 in the plot in Figure 4.9. Note that since these results are from periodic testing, the drop in Figure 4.9 does not represent a change in LTE between consecutive slabs, but rather between slabs 100 feet apart.

Figure 4.9. Variation in transverse joint LTE, Periodic Testing, Southbound, Mile 3.

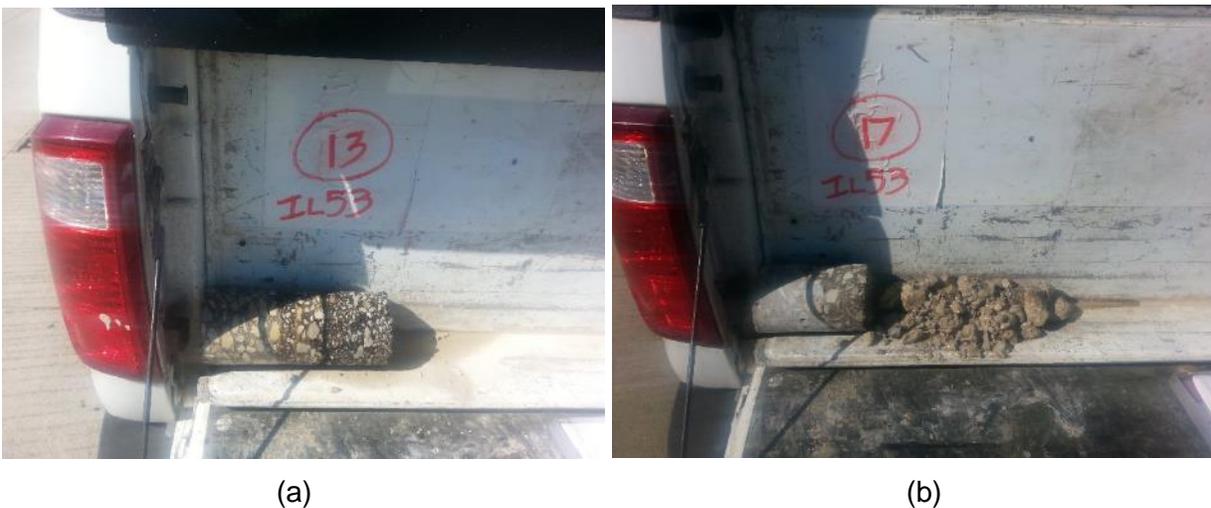
Sample pictures of the UTW cores are provided in Figure 4.10. The core pictured in Figure 4.10(a) shows the PCC inlay bonded to the milled asphalt surface, but there appears to be debonding within the asphalt layer about two inches down, perhaps marking the interface between the separate overlays placed in 1987 and 2000. This debonding may have only resulted from the coring process itself, but it was observed in several other cores as well, and may signal a diminished contribution of the asphalt layer to the structural capacity of the UTW pavement.

In the picture of the core in Figure 4.10(b), the old PCC pavement that was underneath the asphalt layer appears to have completely crumbled, which was seen in several of the cores. This finding indicates that the old PCC layer may be very weak and deteriorated throughout the project, which could possibly lead to a lower backcalculated k-value.

Figure 4.10. UTW Cores from Route 53 (IDOT photo).
