STRUCTURAL PERFORMANCE OF ULTRA-THIN WHITETOPPING ON ILLINOIS ROADWAYS AND PARKING LOTS

Research Report No. FHWA-ICT-14-018

A report of the findings of
ICT-R27-61
**Mechanistic-Empirical Design Implementation and Monitoring for Rigid
Pavements**

August 2014

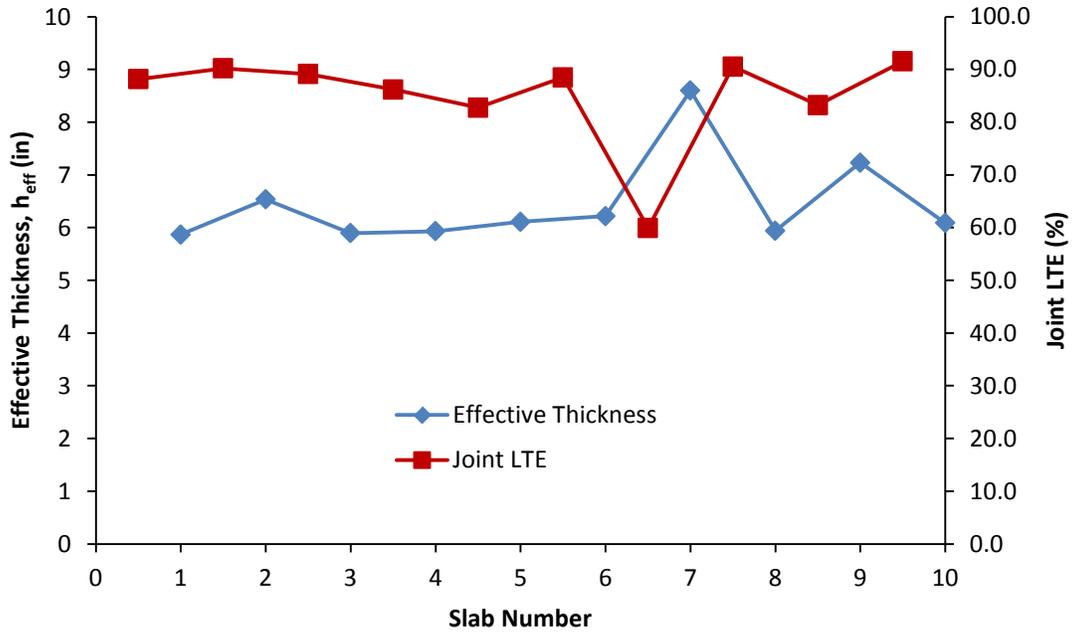
One phenomenon that has appeared in h_{eff} data in the past are large spikes that create significant variation between slabs. Two examples are provided in Figures 4.11 and 4.12. In Figure 4.11, there is one such spike at slab number 7. In Figure 4.12, these spikes occur at slabs 2, 6, and 10. As discussed previously (Chapter 3), the presence of an uncracked transverse joint can cause an over-estimation of h_{eff} at the next slab. Local drops in transverse joint LTE (as discussed in section 3.1) may indicate uncracked joints. In Figure 5, the spike in h_{eff} does appear to correspond to a drop in LTE at

Figure 4.11. Comparison of local transverse joint LTE and effective slab thickness, periodic testing, Southbound, Mile 3.

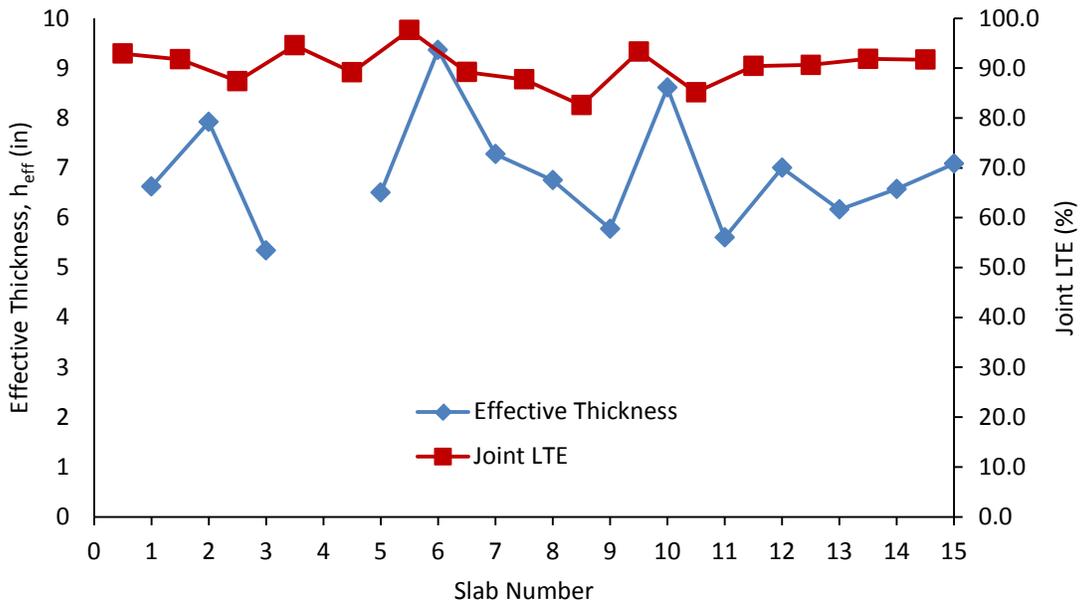
the preceding transverse joint. However, there are no such drops in LTE to explain the spikes in h_{eff} in Figure 6.

Figure 4.12. Comparison of local transverse joint LTE and effective slab thickness, intensive testing, Site 2, Left Lane, Center Panels
