Maine Department of
Transportation
**Transportation Research
Division**

Technical Report 99-11

*Innovative Solutions to Buried Portland
Cement Concrete Roadways – Rt. 100
Benton – Clinton & Rt. 2 Veazie*

Interim Report - Fourth Year, March 2004

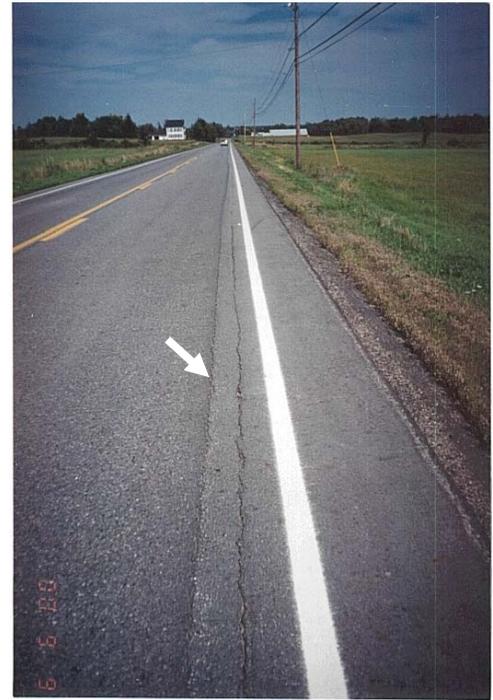
Photo 2. Section 3

Section 3 with Superpave continues to be very stable with an average shoulder deflection of 10.58 mils. This section also has a low amount of PCC related edge cracking.
