Technical Report 15-05

Bridge-in-a-Backpack™

*Task 7: Investigation of Damage and Repairs for
Concrete Filled FRP Tubular Arches*

Final Report – April 2015

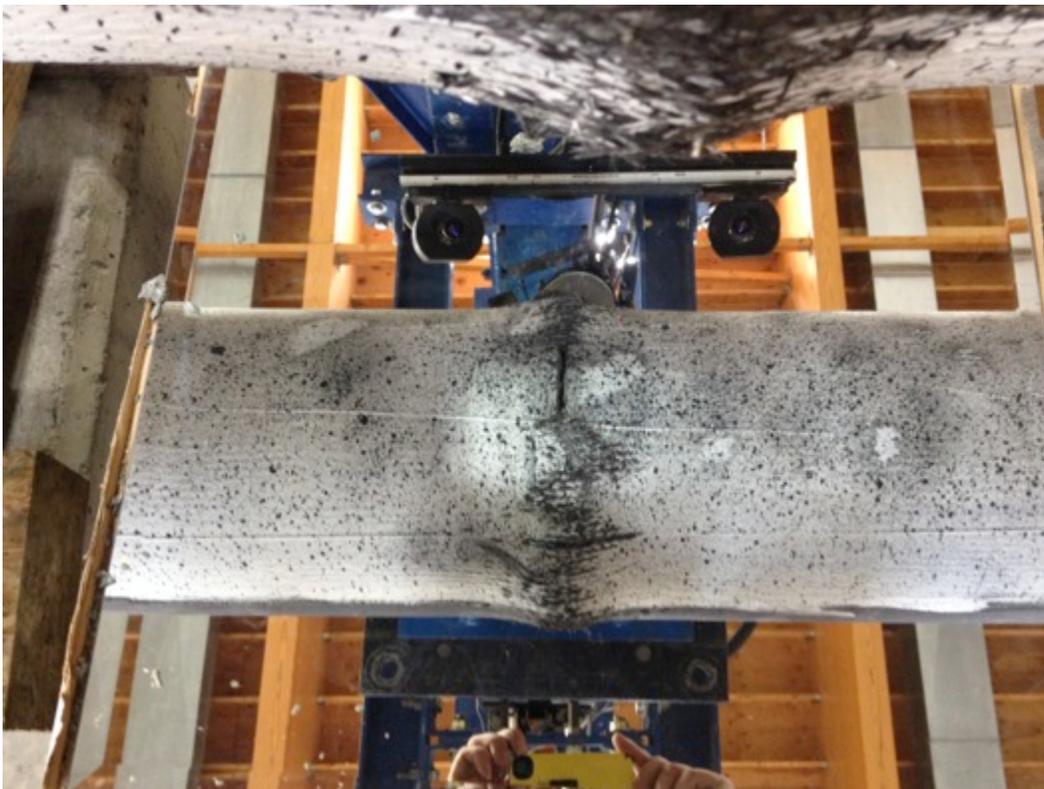
Figure 4. DIC cameras using mirror to collect image

All beams failed with rupture of the FRP in tension initiating at the precut section as seen in Figure 4.

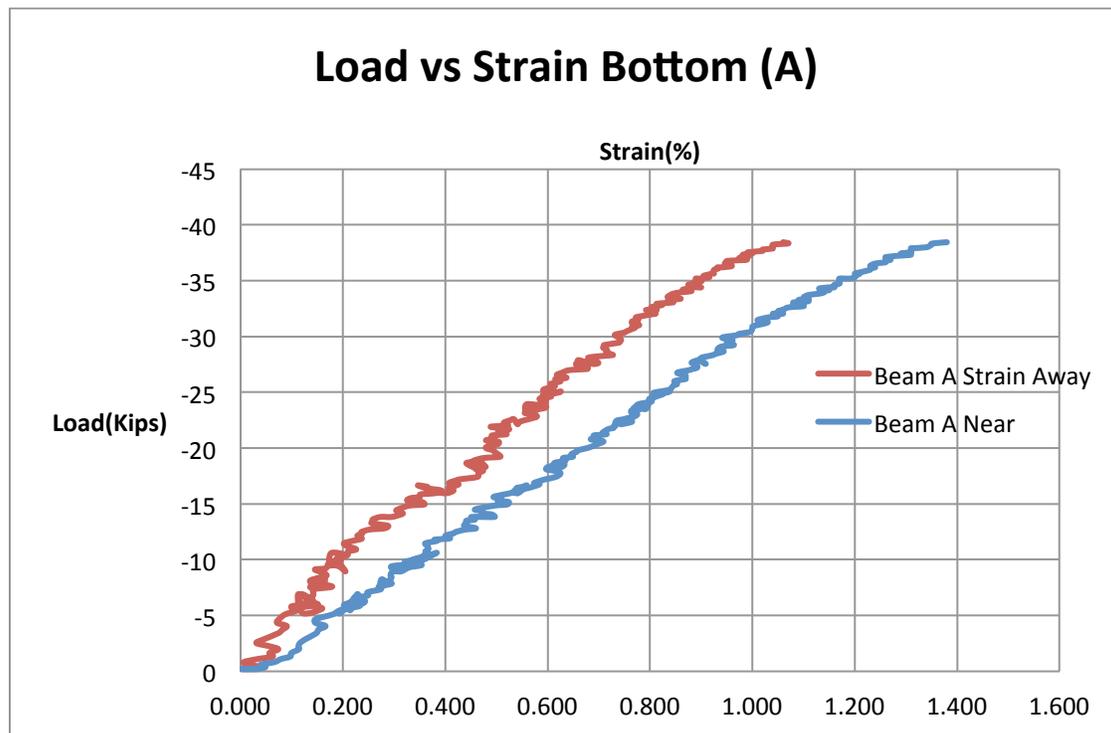
Figure 5. Strain in Beam A from DIC

A typical plot of strain versus load can be seen in Figure 5 where strains near the cut are higher than away from the cut.

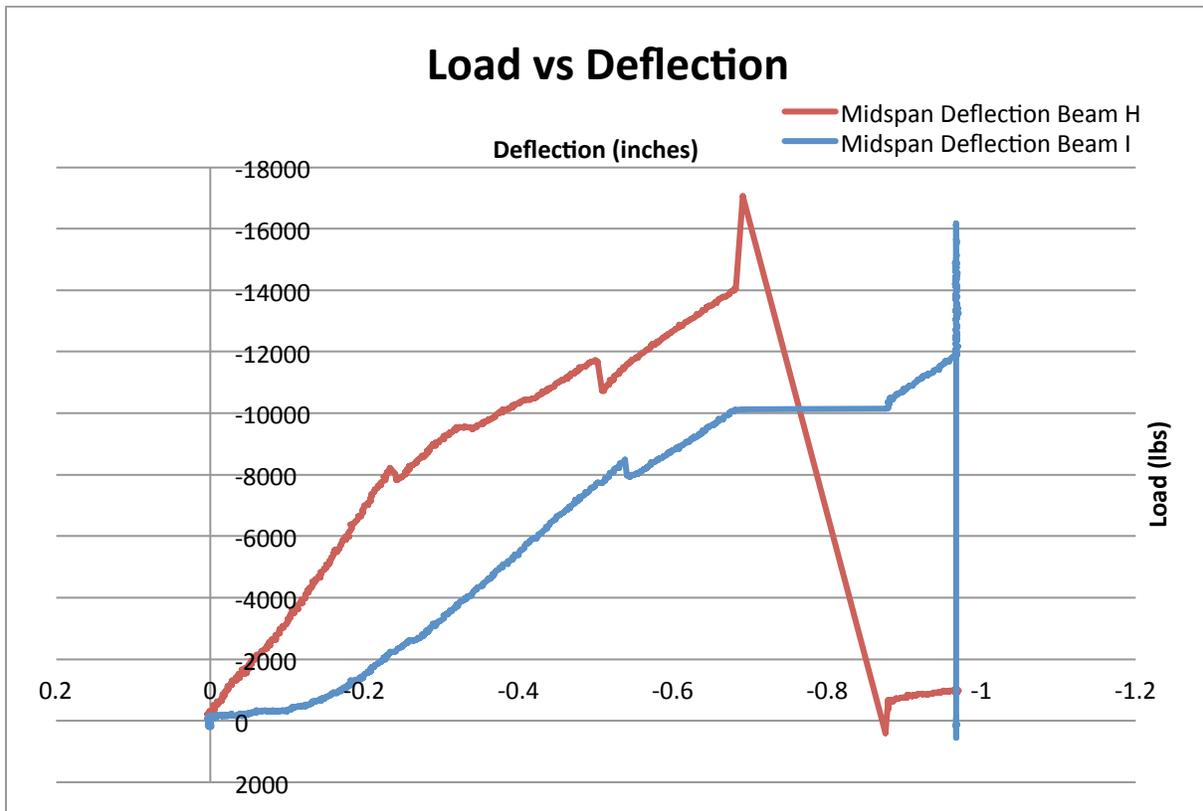
Figure 9. Load vs Deflection plot of repaired beams

Both beams failed at lower loads than they did in the damaged beam study (17.05 kip and 16.18 kip respectively for beam H & I). A failed beam can be seen in Figure 8 where the patch appeared to fail in or near the bondline. A summary of the resulting loading is given in Table 3.

Plots of load versus midspan deflection can be seen for both beams in Figure 9. It appears the string pots got hung up or bottomed out and did not move toward the end of the testing as shown by the vertical line for beam I. Capacities when comparing moments during the test were even lower than comparing the test loads.

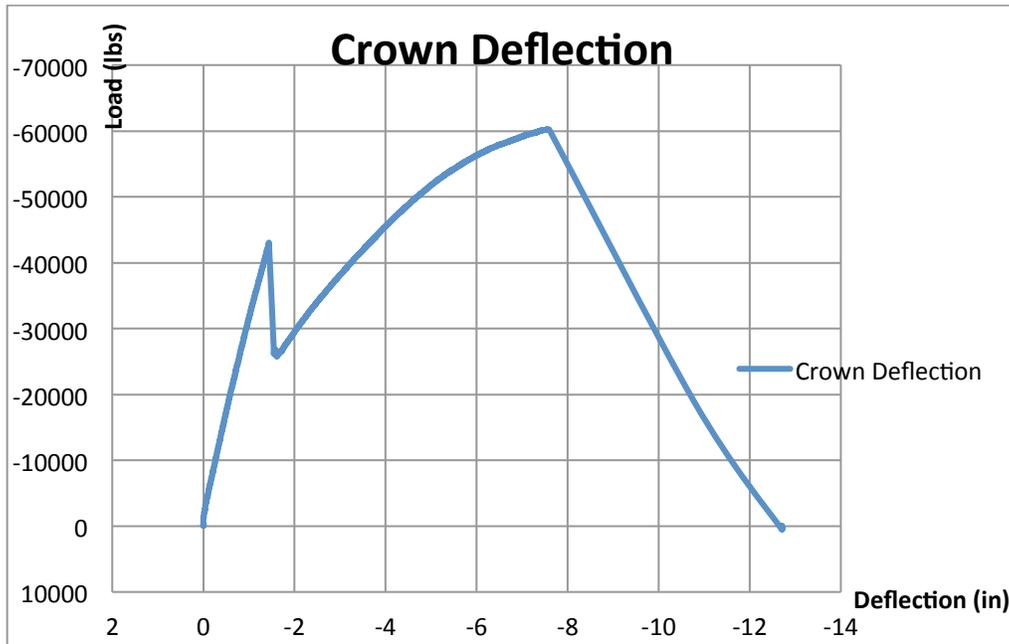
Figure 15. Plot of cross head load versus vertical deflection

The arch test reached a peak load of 43,041 pounds prior to the repair failure. An ultimate load of 60,321 lbs was seen when the arch shoulder ruptured. The repair failed in the bondline of the patch as seen in Figure 14. Load versus deflection at the crown of the arch can be seen in Figure 155.

The arch failed at a load lower than the original capacity of the member which was 62.3 kips (Nagy et al 2009). Additional bondline width or strength could be designed in future applications however it is expected that the moment gradients seen in this test with the single point load at the crown contributed to unrealistic peeling stresses for in-service bridges. Repair methods and professionals are available should there be a need for these services.

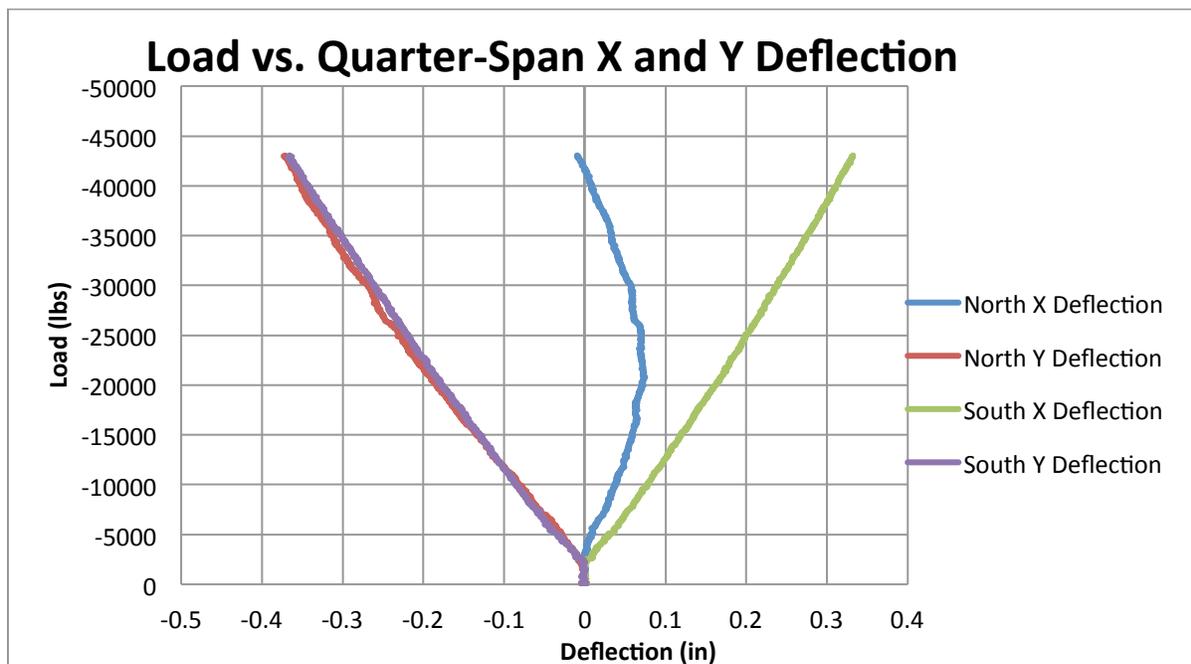
Figure 16. Plot of vertical and horizontal deflections at shoulders

Deflection of the shoulders in the vertical and horizontal directions is shown up until repair failure in Figure 166. As seen there, the vertical deflections on the shoulder on each side of the arch match up well but there appears to be some side sway as indicated by the difference in the X-direction deflections.

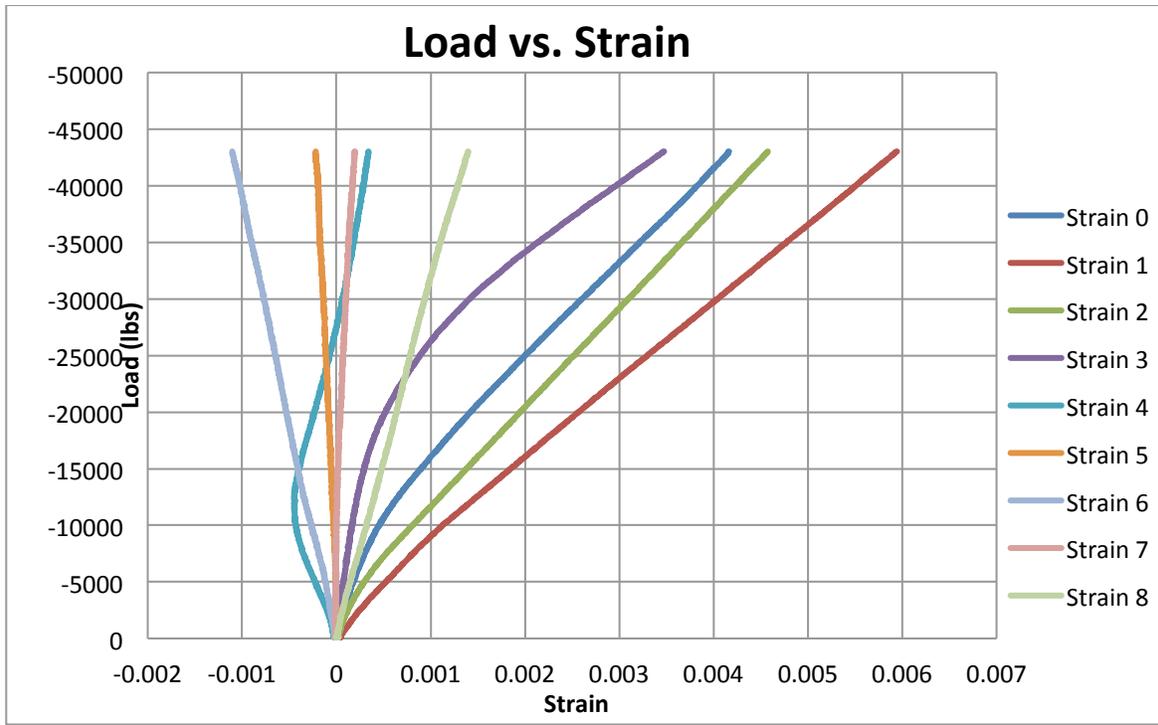
Figure 17. Plot of strain measurements from arch test

Strain is shown in Figure 17. Peak strains are shown with the gages under the load head at midspan (Strain 1) as expected where peak moments exist. Strain 0 and 2 are close as they should be in symmetric locations about midspan. Cross-sectional curvatures can be found using strains at the shoulder cross section and upper cross section by plotting each strain triplet (6,7,8 & 3,4,5) for each load value.
