Evaluation of Stay-in-Place Metal Forms

for the
Ohio Department of Transportation
Office of Research and Development

State Job Number 134155

Final Report
FHWA/OH – 2006/13
May 2006

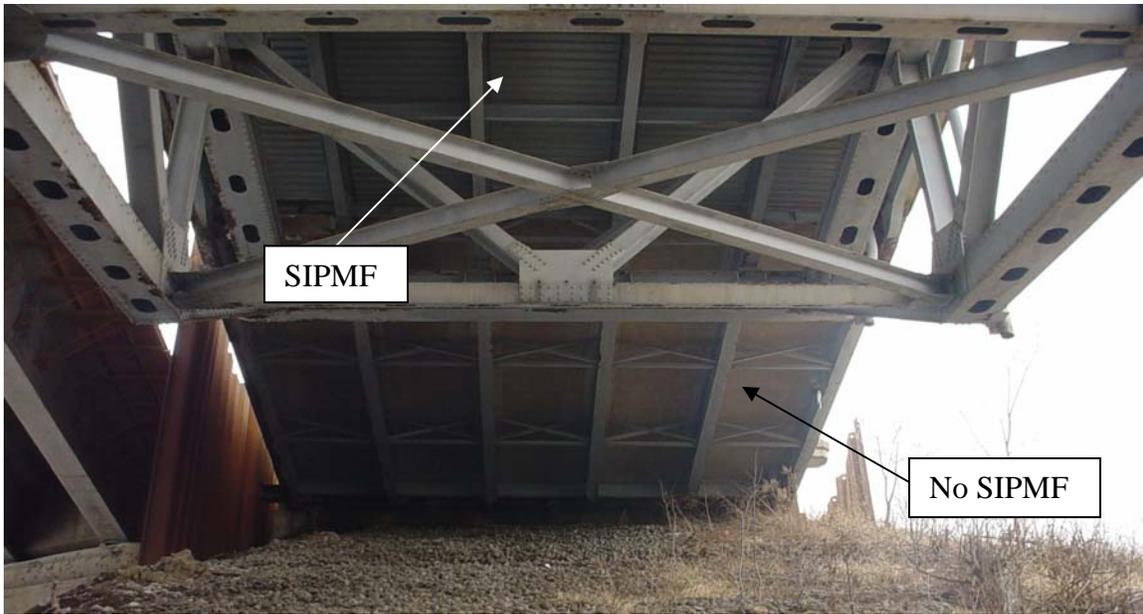
Figure 1.2. LOR-57-18.18 SIPMF and No SIPMF Areas

Since the bridge lies over a deep ravine it was built such that the deck from the approach slab to the first expansion joint was formed utilizing the conventional plywood forming method. The rest of the spans were constructed using SIPMF. Figure 1.2 illustrates this.

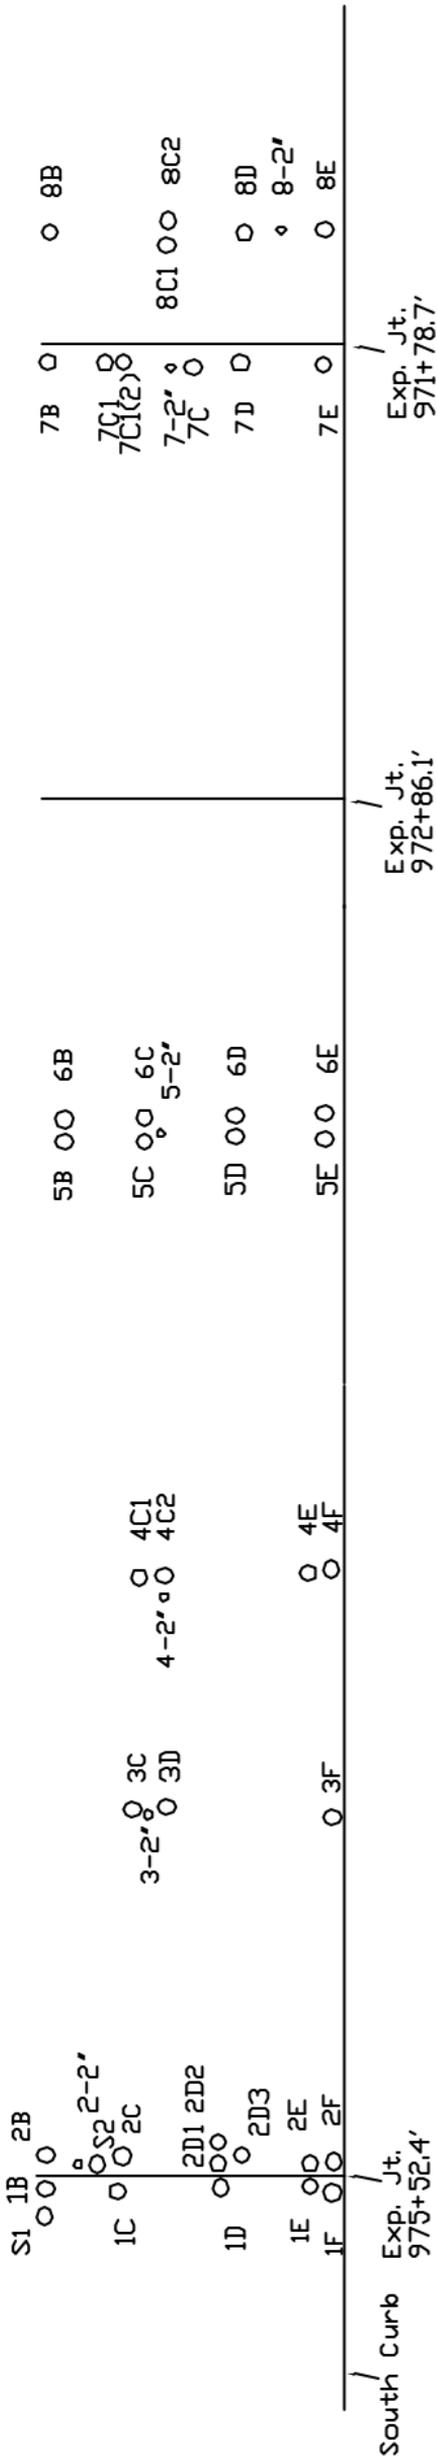
Figure 1.6

Map of Core Locations: LOR-57-18.18

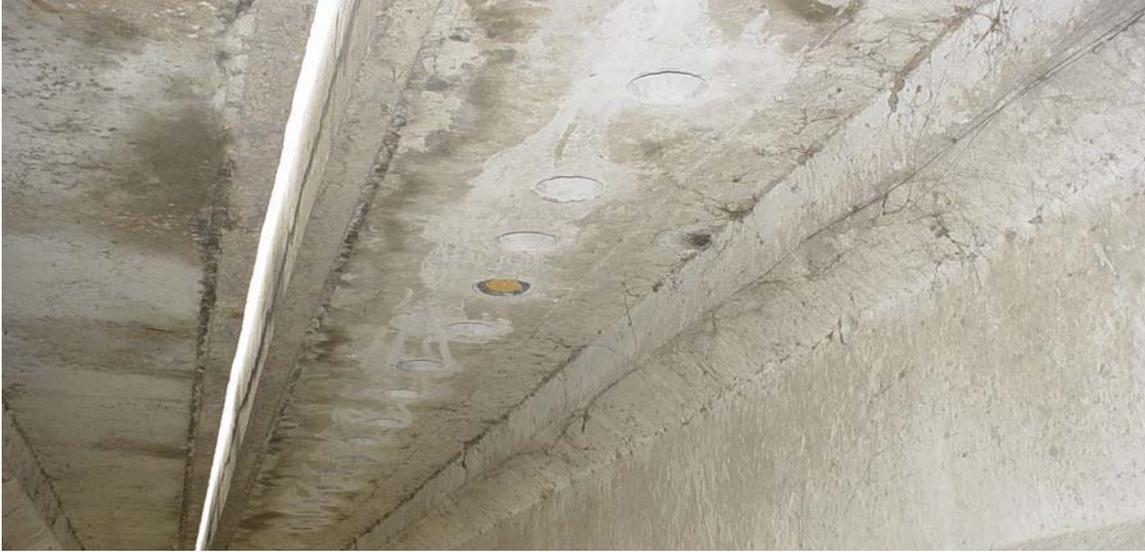
Figure 1.8. OTT-2-28.41 – No SIPMF Area

Because this bridge is located over Sandusky Bay access to the deck from below was very limited. Due to this limitation, the bridge was constructed such that the whole deck utilized SIPMF except for the area from the exterior girder to the edge of the deck. This area is shown in Figure 1.8.

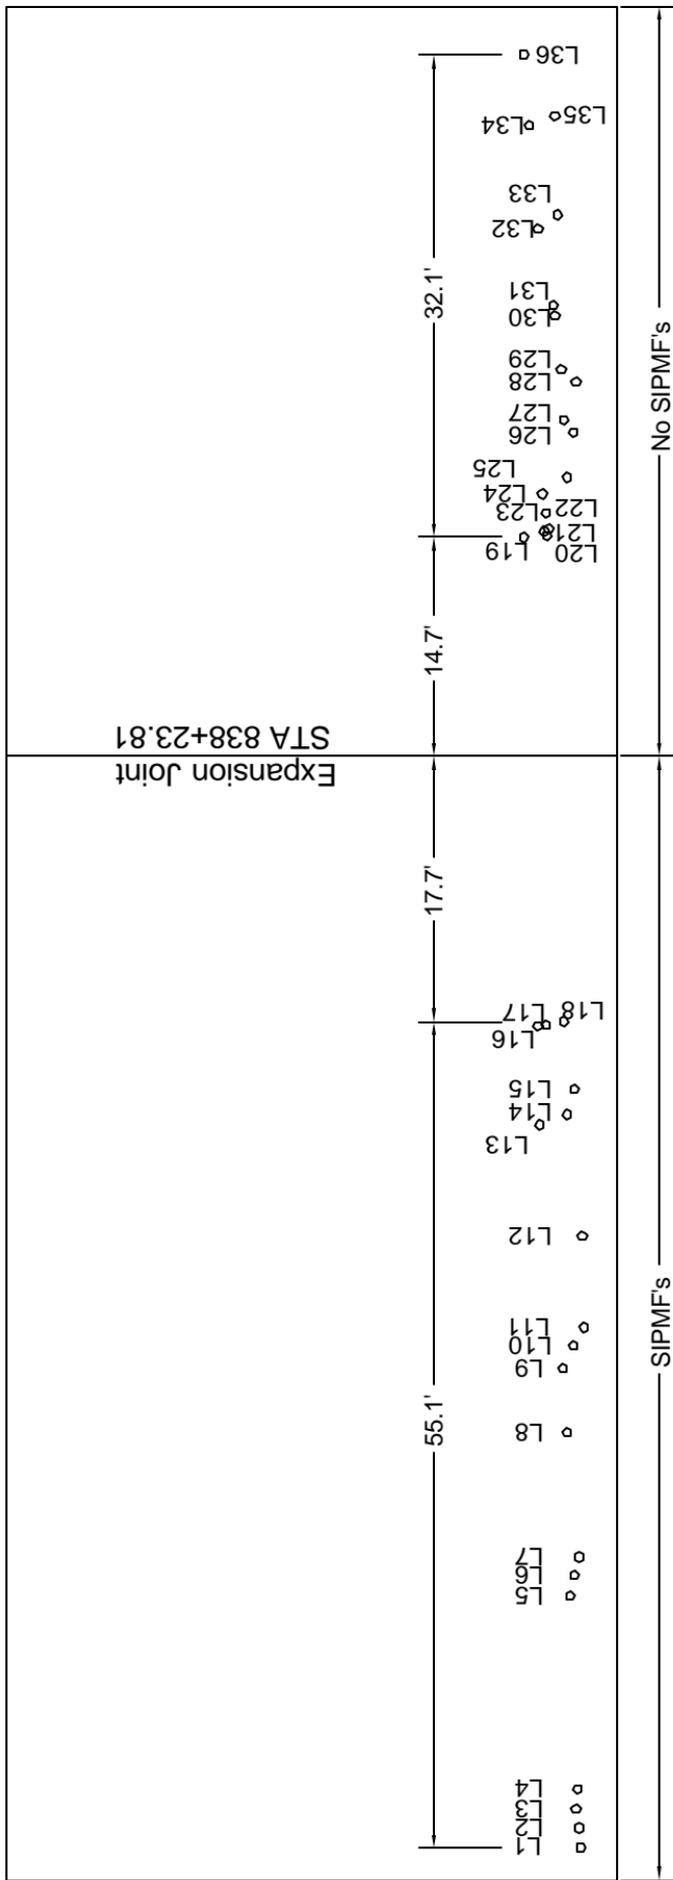
Figure 1.14

Map of Core Locations:LAK-0--23.42

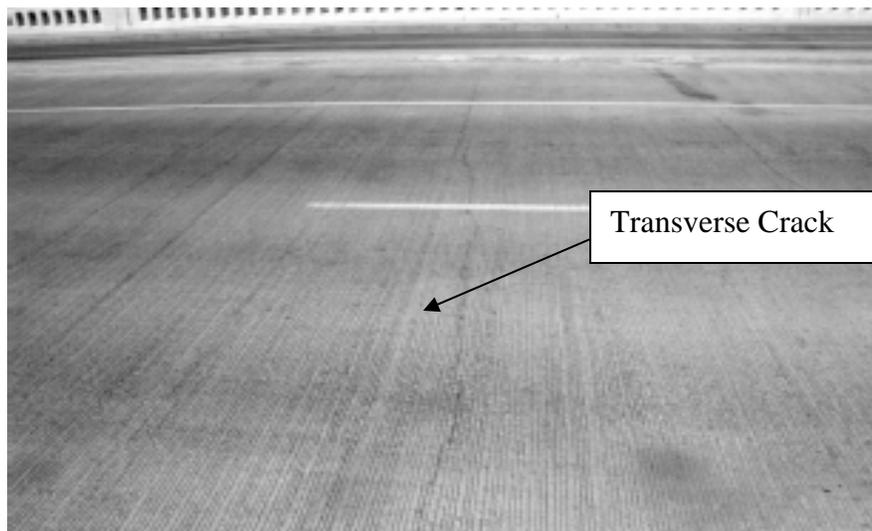
Frosch, Blackman, and Radabaugh (2003) have also noted that a major concern about the use of SIPMF lies in area of bridge deck cracking. They have noted that this is one of the major factors leading to bridge deterioration. The cracks provide a direct route for water and chlorides to enter the deck and damage the concrete and reinforcing steel. They have stated that cracks wider than 0.007 in (0.1778 mm) lead to bridge deck deterioration. Frosch et al (2003) have also concluded that more transverse cracks were noted on bridges where SIPMF were used rather than conventional plywood forms. The results of their study stated that six of the seven bridges that used SIPMF had transverse cracks in the bridge deck. A typical transverse crack from their study is shown in Figure 2.2.

Figure 2.2. Transverse Bridge Deck Crack (Frosch et al 2003)

These transverse cracks were attributed to the fact that the concrete on the bottom was more restrained than that on the top of the bridge deck. This in turn leads to an unsymmetrical shrinkage profile that is believed to initiate more transverse cracks. Another reason why SIPMF induce more transverse cracks can be attributed to the behavior known as curling. Curling will occur because the top surface is free to shrink, where as the bottom surface is restrained. This

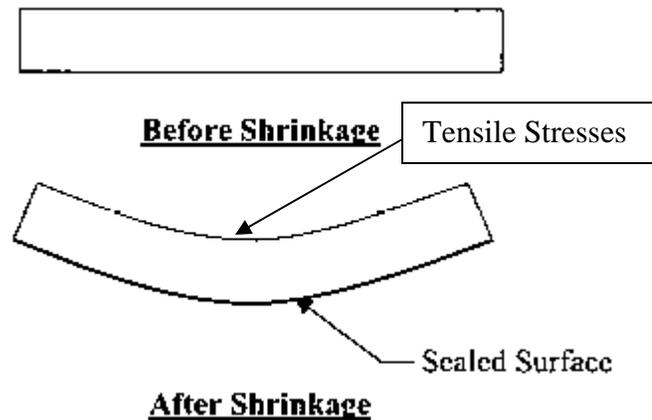
restriction of the bottom surface leads to the development of tensile stresses on the top surface. These stresses lead to transverse cracks. Figure 2.3 illustrates this behavior.

Figure 2.3. Curling (Frosch et al 2003)

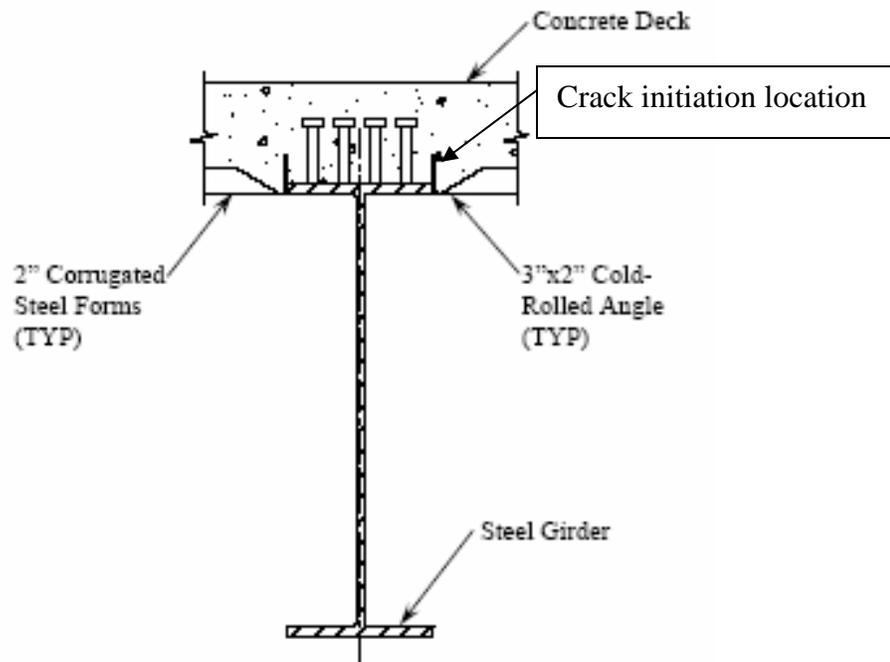
SIPMF also present a problem when it comes to attaching the form to the girder (Frosch et al, 2003). The typical approach of fastening the form to the girder implements the use of a 3-inch by 2-inch (76 x 50 mm) galvanized cold-rolled steel angle. This angle is attached to the flange of the girder by welding it directly to the top flange in the positive moment area or by welding it to a steel bar resting on the top flange in the negative moment area. The SIPMF are then attached to the angle by using self-tapping screws. Frosch et al noted from their inspection that the leg of the angle was usually turned upward into the deck. Since the leg of the angle was incorporated into the deck, it caused a discontinuity in the bridge deck. They stated that this may lead to a spot where cracks initiate, leading to longitudinal cracks. Figure 2.4 shows a typical detail in which the angle is turned upward into the deck.

Figure 2.4. Angle Turned Upward into Deck (Frosch et al, 2003)

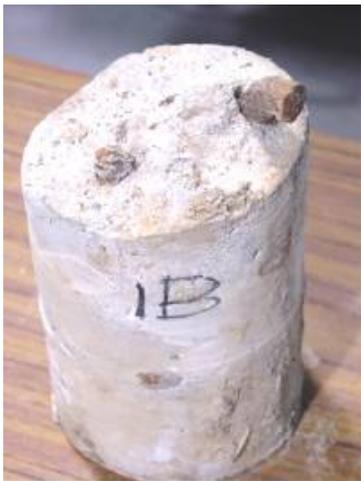
- 6.13 in. (155.7 mm) height, approximately 9 in. (228.6 mm) till the top of the broken region.
- Core is broken at the top, with re-bar protruding vertically.
- 2 reinforcement bars are located at 3.25 in. (82.55 mm) and 5.75 in. (146.1 mm) from the bottom surface.
- Exposed steel reinforcement showed slight signs of rust.

Figure 7.6. Core 1B shows rust in steel reinforcement

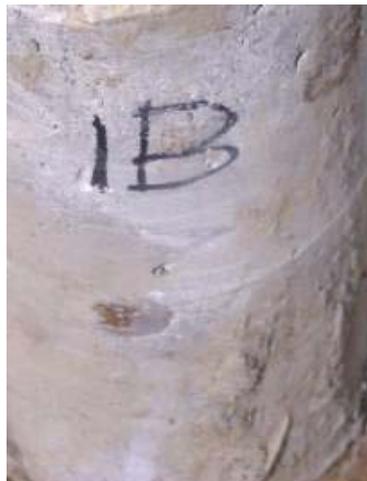
Figure 7.7. Core 1B shows small voids

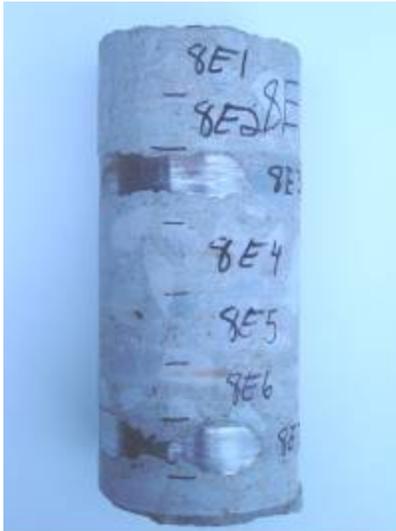
- 9 in. (228.6 mm) height.
- 2 reinforcement bars located at 2.5 in. (63.5 mm) and 7 in. (177.8 mm) from the top surface.
- Bars are not coated.
- Region of voids located approximately at 6 in. (152.4 mm) from the top surface.

Figure 7.8. Core 8E shows no epoxy coat for bars

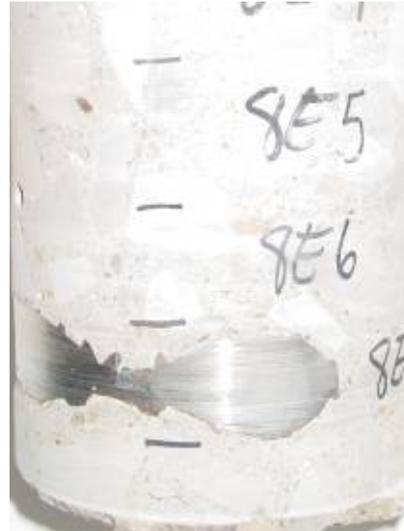
Figure 7.9. Core 8E shows small voids

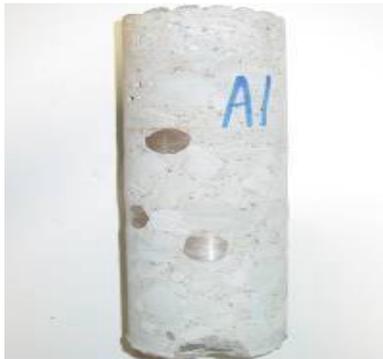
- 11 in. (279.4 mm) height.
- 3 reinforcement bars, non-epoxy coated located at 4 in. (101.6 mm), 6 in. (152.4 mm), and 7 in. (177.8 mm) from top surface.
- Some rust traces on bars.
- Small region of honeycombing located at 2.5 in. (63.5 mm) from top surface.

Figure 7.17. Core A1 shows rust traces

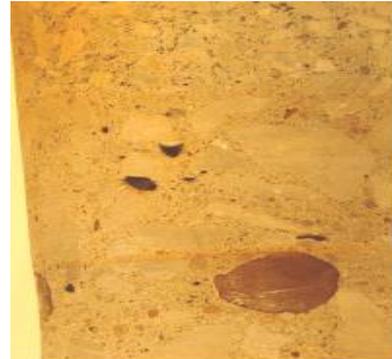
Figure 7.18. Honeycombing region

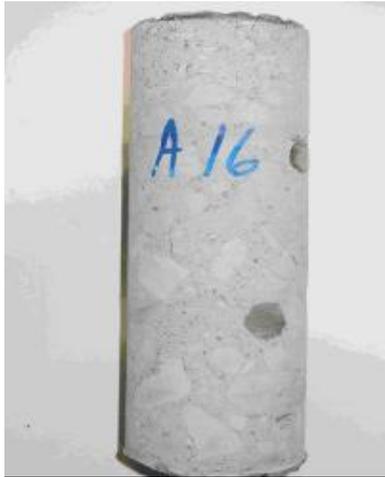
- 10.5 in. (266.7 mm) height.
- 2 reinforcement bars are located at 3.5 in. (88.9 mm) and 7 in. (177.8 mm) from the bottom surface.
- The upper bar shows severe rusting while the lower shows some rust traces.
- Region of honeycombing located at 6 in. (152.4 mm) from top.
- Region of large voids at the top-wearing surface.

Figure 7.21. Core A16 shows rust in steel reinforcement

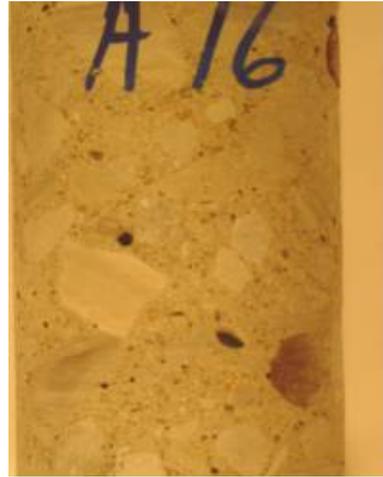
Figure 7.22. Core A16 shows region of honeycombing

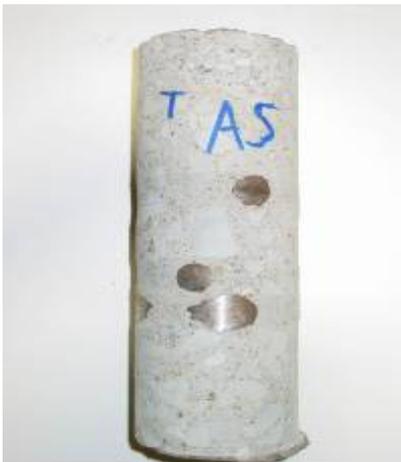
- 11 in. (279.4 mm) height.
- 3 reinforcement bars located at 4.5 in. (114.3 mm), 6.5 in. (165.1 mm) and 7.5 in. (190.5 mm) from the top surface.
- Bars are not coated and show some rust traces.
- Region of honeycombing at 2.5 in. (63.5 mm) and 6.5 in. (165.1 mm) from top.

Figure 7.23. Core A5 shows no epoxy coat on bars

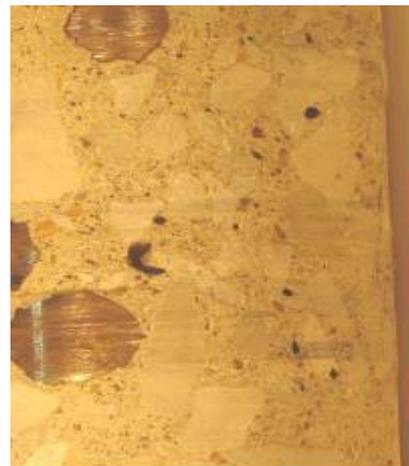
Figure 7.24. Rust traces and honeycombing

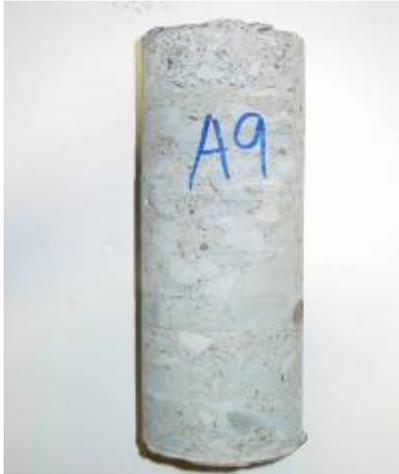
- 11 in. (279.4 mm) height.
- 2 reinforcement bars located at 3 in. (76.2 mm) and 7.5 in. (190.5 mm) from top surface.
- Bars are not coated and show severe rusting.
- Region of honeycombing at 4 in. (101.6 mm) from top.

Figure 7.25. Core A9 shows regions of honeycombing

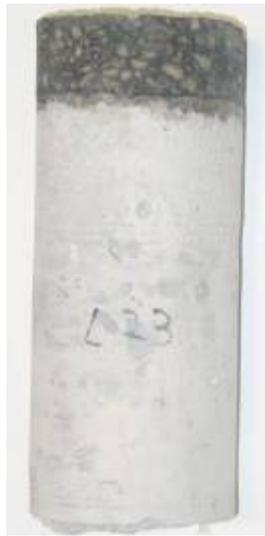
- 9.5 in. (241.3 mm) height. (10.03 without the wearing surface depth and with the 2 in. (50.8 mm) imaginary slice)
- 1 reinforcement bar located at 5 in. (127 mm) from the top surface.
- Bar is not coated and shows rust traces.
- 1.5 in. (38.1 mm) asphalt wearing surface existed at the top of the core.
- Two different concrete layers.
- The aggregate in the top concrete layer is fine, while it is coarse in the bottom layer.
- Region of moderate voids located at the upper concrete layer.

Figure 7.32. Core L23 with asphalt layer at top

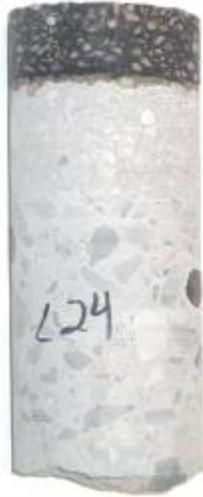
- 9.5 in. (241.3 mm) height. (9.97 without the wearing surface depth and with the 2 in. (50.8 mm) imaginary slice)
- 1.5 in. (38.1 mm) asphalt wearing surface existed at the top of the core.
- 2 reinforcement bars located at 5 in. (127 mm) and 6 in. (152.4 mm) from the top surface.
- Region of moderate voids at upper concrete layer.
- Brown rust traces on bars.

Figure 7.34. Core L24 with asphalt layer at top

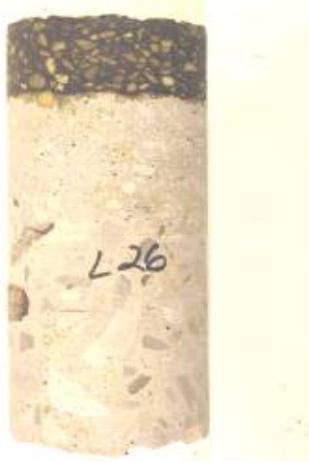
- 8.75 in. (222.3 mm) height. (8.97 without the wearing surface depth and with the 2 in. (50.8 mm) imaginary slice)
- 1.5 in. (38.1 mm) asphalt wearing surface existed at the top of the core.
- 2 reinforcement bars located at 5 in. (127 mm) and 6 in. (152.4 mm) from top surface.
- Some rust traces existed on bars.
- Region of large size honeycombing at top layer of concrete.

Figure 7.36. Core L26 with asphalt layer at top

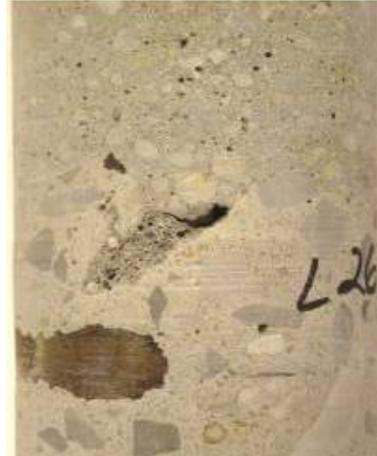
Figure 7.37. Rust and honeycombing regions

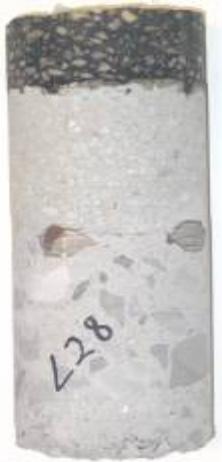
Figure 7.38. Core L28

- 10 in. (254 mm) height. (10.22 without the wearing surface depth and with the 2 in. (50.8 mm) imaginary slice)
- 1.5 in. (38.1 mm) asphalt wearing surface existed at the top of the core.
- 1 reinforcement bar located at 5 in. (127 mm) from top surface.
- Bar is not coated and shows some rust traces.
- Region of small to moderate voids at top concrete surface.

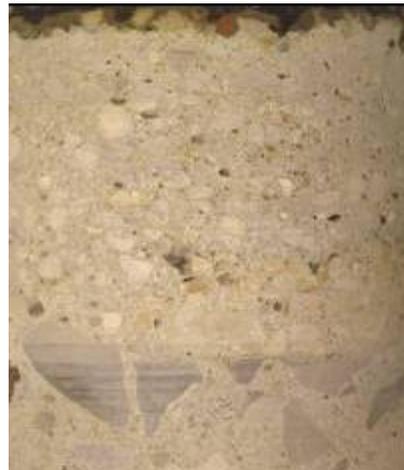
Figure 7.39 Honeycombing region

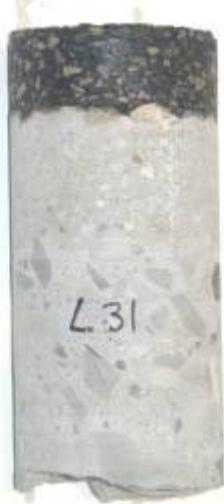
- 8.75 in. (222.3 mm) height. (9.15 in (232.4 mm) without the wearing surface depth and with the 2 in. (50.8 mm) imaginary slice)
- Region of small to moderate voids at top concrete surface.
- 1 reinforcement bar located at 5 in. (127 mm) from the top surface.
- Some rust at edges of reinforcement bars.
- Region of honeycombing.
- Region of small to moderate voids at upper concrete layer.

Figure 7.40. Core L31 with asphalt layer at top

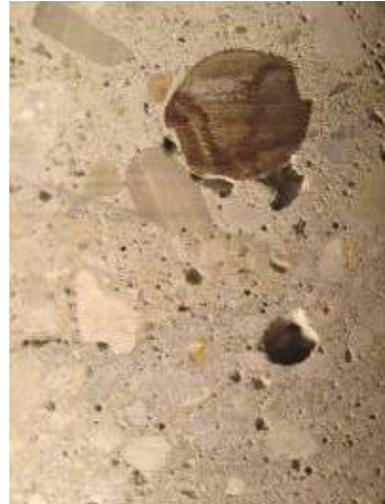
Figure 7.41. Honeycombing region

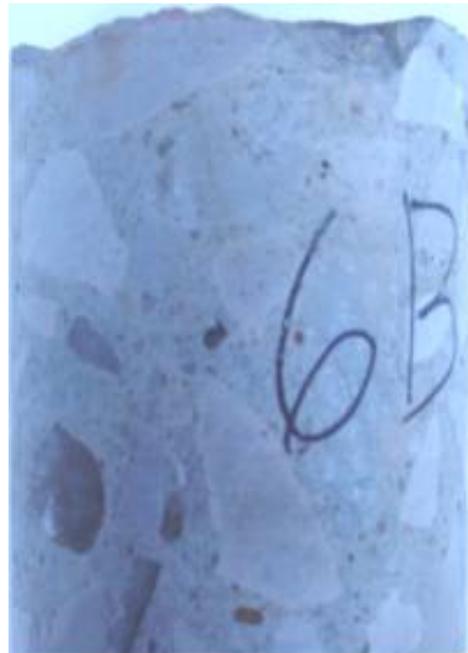
- 7.875 in. (200 mm) height (9.75 in. (247.7 mm) with the concrete in the region of the valley of the SIPMF).
- 2 reinforcement bars located at 3 in. (76.2 mm) and 7.5 in. (190.5 mm) from top.
- Bars are not coated and show some rust traces.
- Small region of honeycombing at 3 in. (76.2 mm) from the top surface.
- Concrete broken in region of SIPMF.

Figure 7.48. Core 6B shows small voids

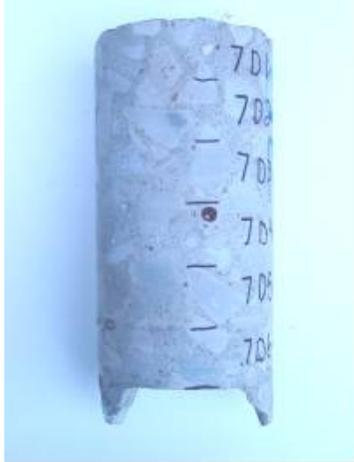
- 7.5 in (190.5 mm) height (9 in. (228.6 mm) with the concrete in the region of the valley of the SIPMF).
- Area of voids at 3.75 in. (95.25 mm) from top.
- Reinforcement bar located at 6 in. (152.4 mm) from bottom surface.
- Bars are not coated and show some rust.

Figure 7.51. Core 7D shows small void

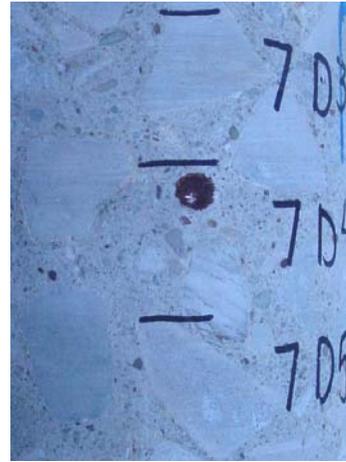
Figure 7.52. Core 7D shows rust in steel reinforcement

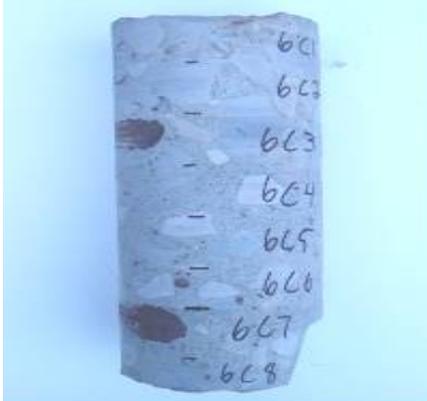
- 7.88 in. (200.2 mm) in height (9.875 in. (250.8 mm) with the concrete in the region of the valley of the SIPMF).
- 3 reinforcement bars located at 3 in. (76.2 mm), 4 in. (101.6 mm), and 7.5 in. (190.5 mm) from top surface.
- Bars are not coated and show traces of rusting.
- Areas of medium to large voids at 1 in. (25.4 mm), and 2.25 in. (57.15 mm) from top.

Figure 7.55. Core 6C shows rust in steel reinforcement

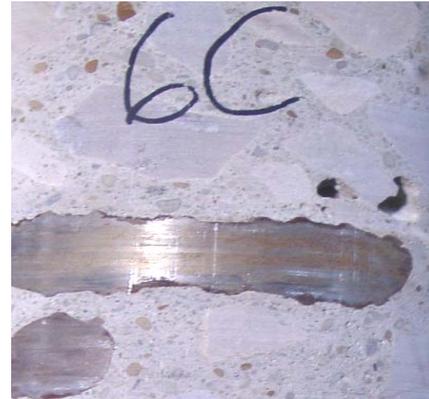
Figure 7.56. Core 6C shows large voids

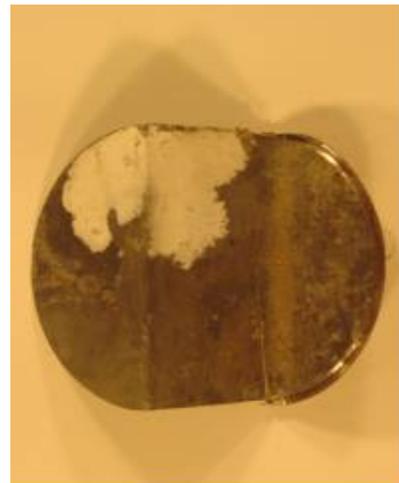
- 7 in. (177.8 mm) height (9 in. (228.6 mm) with the concrete in the region of the valley of the SIPMF).
- Regions of small voids.
- 2 reinforcing bars located at 1 in. (25.4 mm) and 3 in. (76.2 mm) from bottom surface, and show some rust traces.
- Brown and white traces on the SIPMF.
- Region of honeycombing at 6 in. (152.4 mm) from bottom.

Figure 7.65. White traces on SIPMF

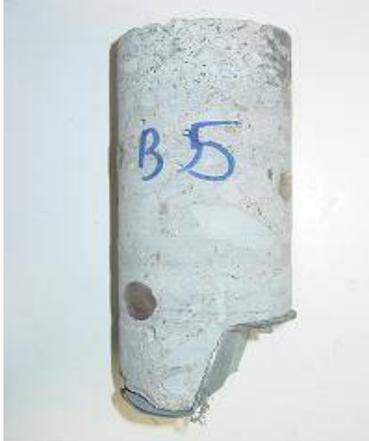
- 6.75 in. (171.5 mm) height (8.75 in. (222.3 mm) with the concrete in the region of the valley of the SIPMF).
- Area of voids at 3.75 in. (95.25 mm) from top.
- 2 reinforcing bars located at 3.75 in. (95.25 mm) and 5.5 in. (139.7 mm) from bottom surface, and show some rust traces.
- Brown and white traces on the SIPMF.

Figure 7.66. Core B5 shows small voids

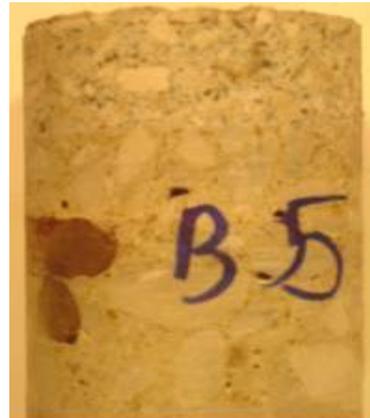
Figure 7.67. Core B5 shows no epoxy coat for bars

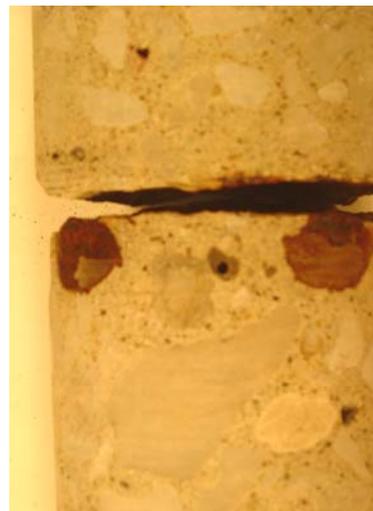
- 7.5 in (190.5 mm) height (9.5 in. (241.3 mm) with the concrete in the region of the valley of the SIPMF).
- Core is broken into two parts.
- 1 reinforcement bars located at 3.75 in. (95.25 mm) from bottom surface.
- Bar is not coated and shows severe rusting.
- Brown and white traces on the SIPMF.

Figure 7.69. Core C3 shows rust on steel reinforcement

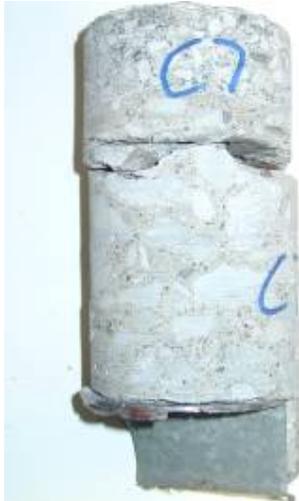
- 7 in. height (8.7 in. with the concrete in the region of the valley of the SIPMF).
- Core is broken into two parts.
- 1 reinforcement bar located at 5.5 in. (139.7 mm) from bottom surface.
- Bar is not coated and shows some rust traces.
- White traces on the SIPMF.
- Region of small to moderate voids.

Figure 7.70. Core C7 shows rust in steel reinforcement

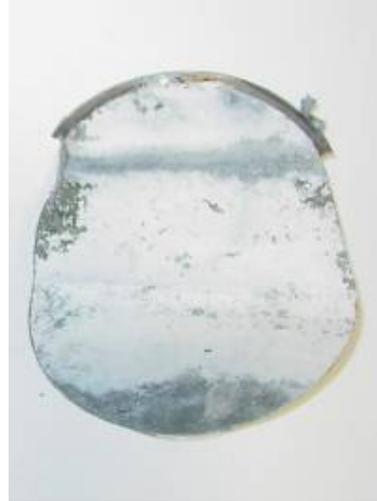
Figure 7.71. White traces on SIPMF

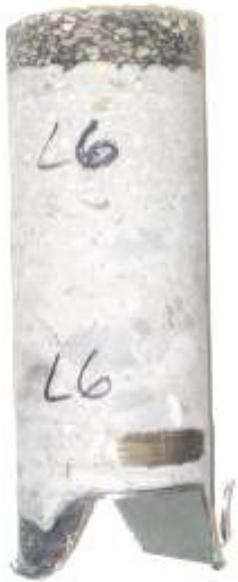
- 10.25 in. (260.4 mm) height (11.75 in. (298.5 mm) with the concrete in the region of the valley of the SIPMF).
- 1 reinforcement bar located at 9.5 in. (241.3 mm) from the top surface.
- Rust traces on the bar.
- Region of small to moderate voids at the top layer of concrete.
- Region of honeycombing at the bottom layer of concrete.

Figure 7.79. Core L6 with asphalt wearing surface

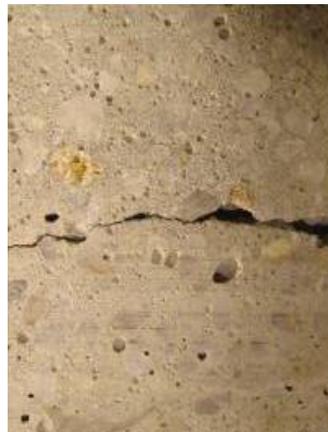
- 10.25 in. (260.4 mm) height (11.75 in. (298.5 mm) with the concrete in the region of the valley of the SIPMF).
- 1 reinforcement bar located at 9.5 in. (241.3mm) from the top surface.
- The bar is not coated and shows some rust traces.
- Region of small to moderate voids at upper layer of concrete.
- Core is broken approximately in the middle.

Figure 7.84. Core is broken into two pieces

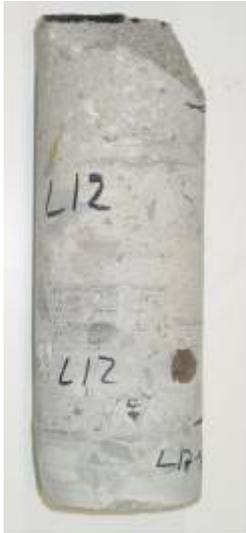
- 9.5 in. (241.3 mm) height (11.5 in. (292.1 mm) with the concrete in the region of the valley of the SIPMF).
- 1 reinforcement bar located at 9.0 in. (228.6 mm) from the top surface.
- Some rust traces on the bar.
- Region of small voids.
- Core is broken at top.
- White traces on SIPMF.

Figure 7.85. Core L12 shows rust traces on steel reinforcement

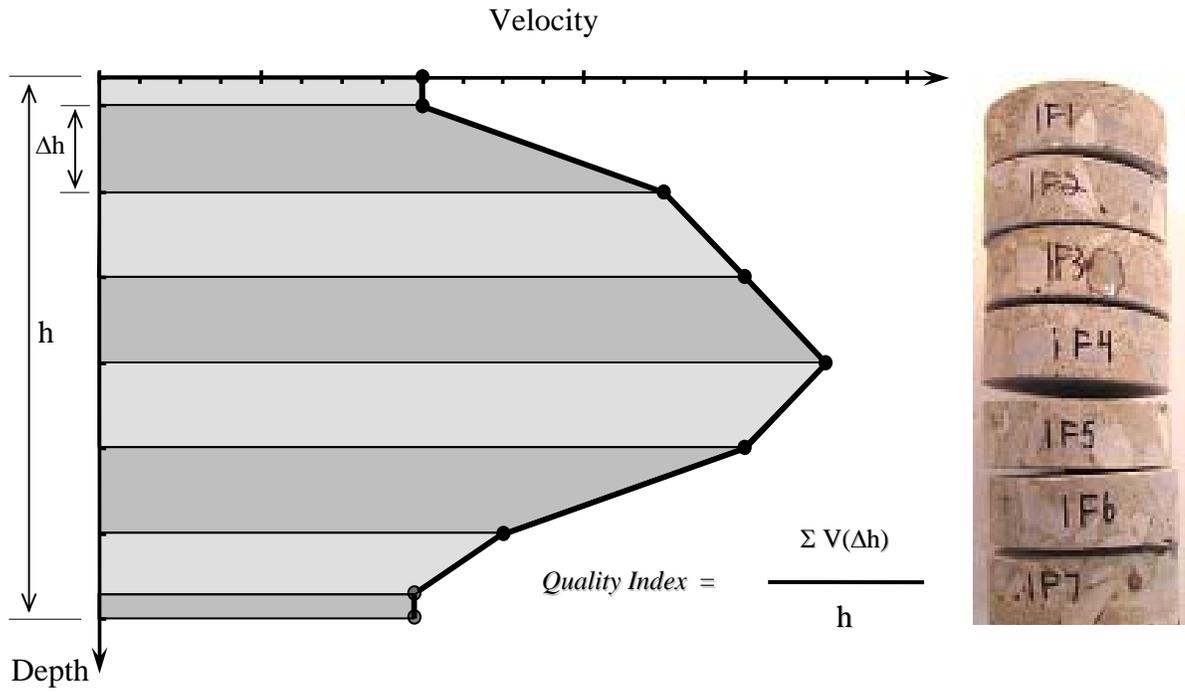
Figure 7.102. Quality Index(QI) calculation.

To better quantify the results of this analysis, a parameter termed Quality Index (QI) was introduced. The profile of wave velocity with depth can be quantified by taking the product of incremental wave velocity (for a given slice) and length of that particular slice. This is effectively represented as area contained by the velocity vs. length (along a core depth) plot. This area, considered alone, would bias results of longer cores. Therefore, a normalization of the quantity was achieved by dividing this summed area by total length of the core. The normalized value, QI , had units consistent with velocity (ft/s) and represented a weighted average of the wave velocity with depth over the entire profile (Figure 7.102). This parameter provided an effective means for comparison of the integrity of concrete between different cores. The results of this analysis for each core are presented in Tables 7.3-7.11. The QI representing all bridge deck cores without SIPMF (calculated for the total length of all analyzed cores from bridge decks without SIPMF) was 12,984 ft/s (Table 7.12). The QI representing all bridge deck cores with SIPMF (calculated for the total length of all analyzed cores from bridge decks with SIPMF) was 13,663 ft/s (Table 7.14). Even though the QI for bridge decks with SIPMF was greater than QI for bridge decks without SIPMF, the difference in QI between the two bridge deck systems was considered negligible (5.0%). Results from the through-transmission ultrasonic measurements demonstrated the similarity of the integrity of the concrete in the two bridge deck systems.

The normalized value, QI , has units consistent with velocity (ft/s) ($1\text{ft/s} = 0.3048\text{ m/s}$) and represented a weighted average of the wave velocity with depth over the entire profile (Figure 7.102). This parameter provided an effective means for comparison of the quality of concrete between different cores. The results of this analysis are presented in Tables 9.6-9.8. The QI representing all bridge deck cores (calculated for the total length of all analyzed cores) was 13,918 ft/s (4242.206 m/s) (Table 9.9). It should be mentioned that even though the QI for the OTT-2-28.41 deck was greater than QI (Chapter 7), the difference in QI between two bridge deck systems was considered negligible (5.0%).

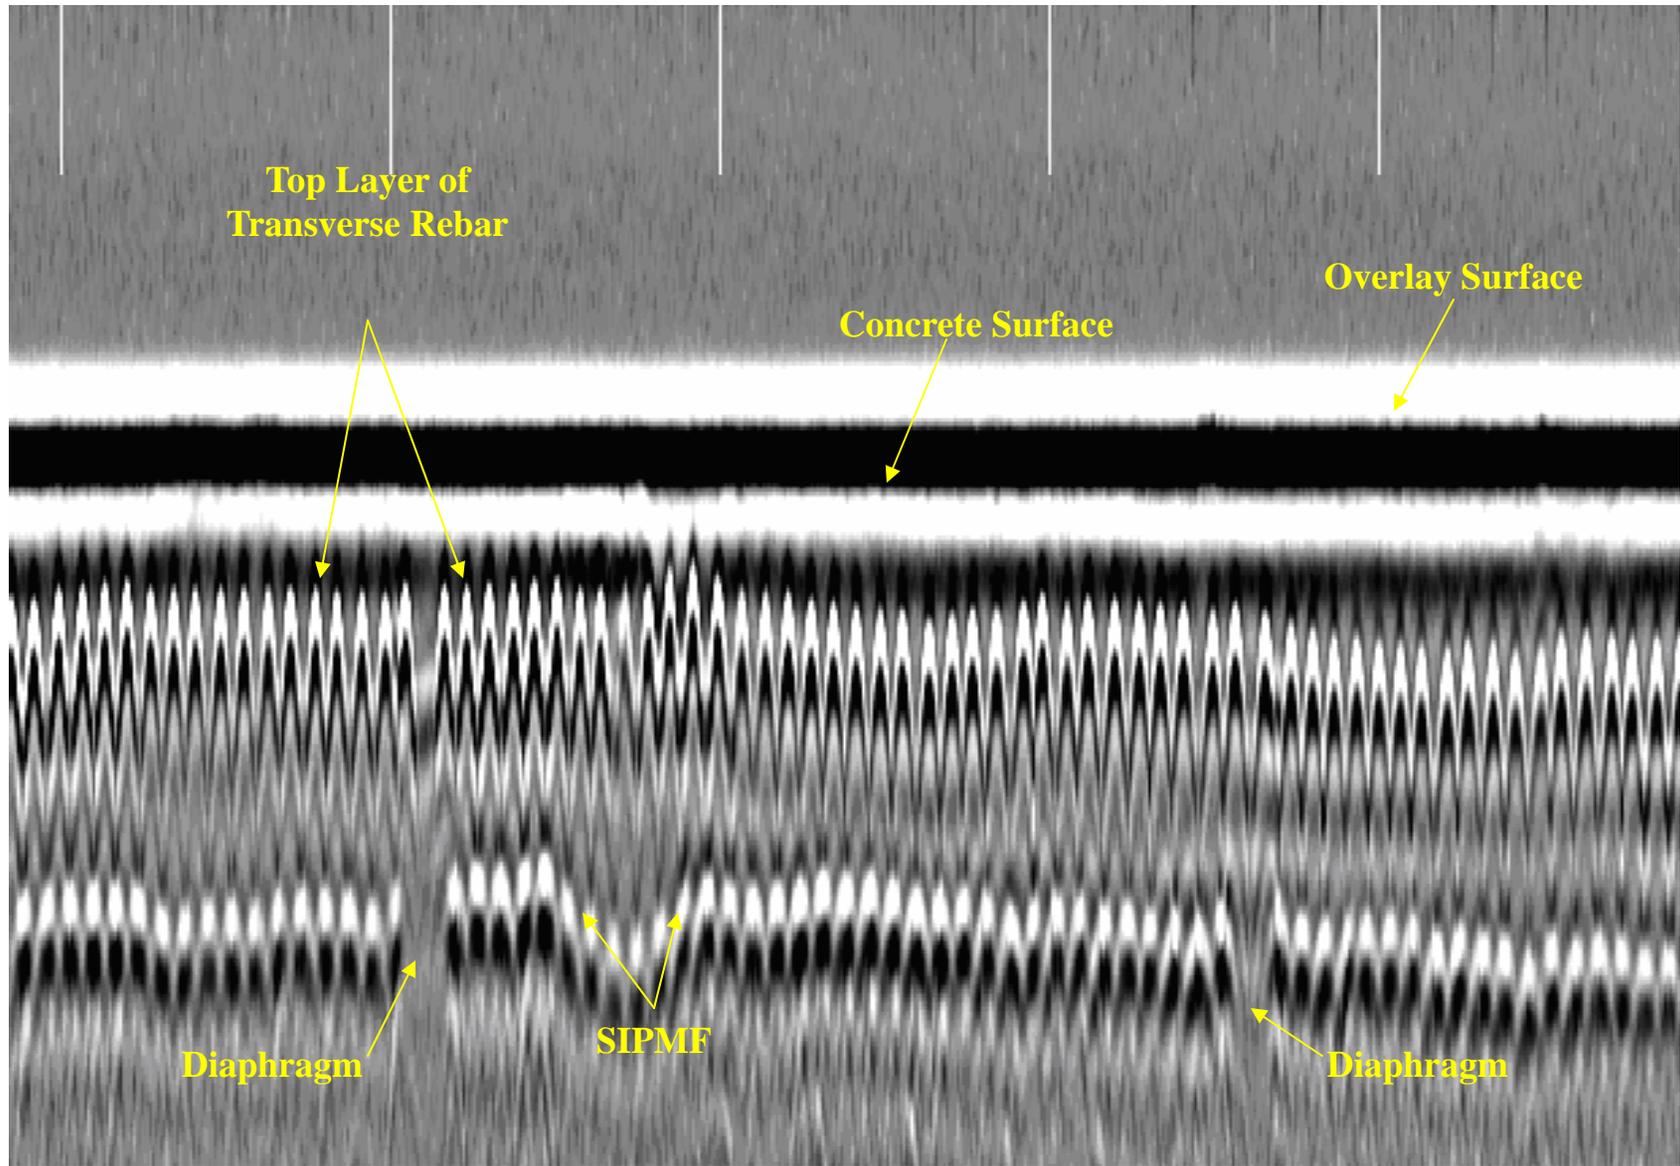
Figure 9.2. Ground Coupled Radar Results

The raw data from the survey was then compiled by Resource International, Incorporated (Rii). The Rii report is included as the appendix to this chapter. It was found that GPR gives a reflection from the transverse rebar in the upper layer of the bridge deck and from the SIPMF. The lower layer of transverse rebar, which is located directly below the upper layer, lies in the shadow of the upper transverse rebar as shown in Figure 9.1. Therefore, there is no reflection from the transverse rebar at the bottom of the bridge deck. The radar results for a section of bridge deck are shown in Figures 9.2 and 9.3 on the following pages. The ground-coupled results are shown in Figure 9.2 and the air-launched results are shown in Figure 9.3.

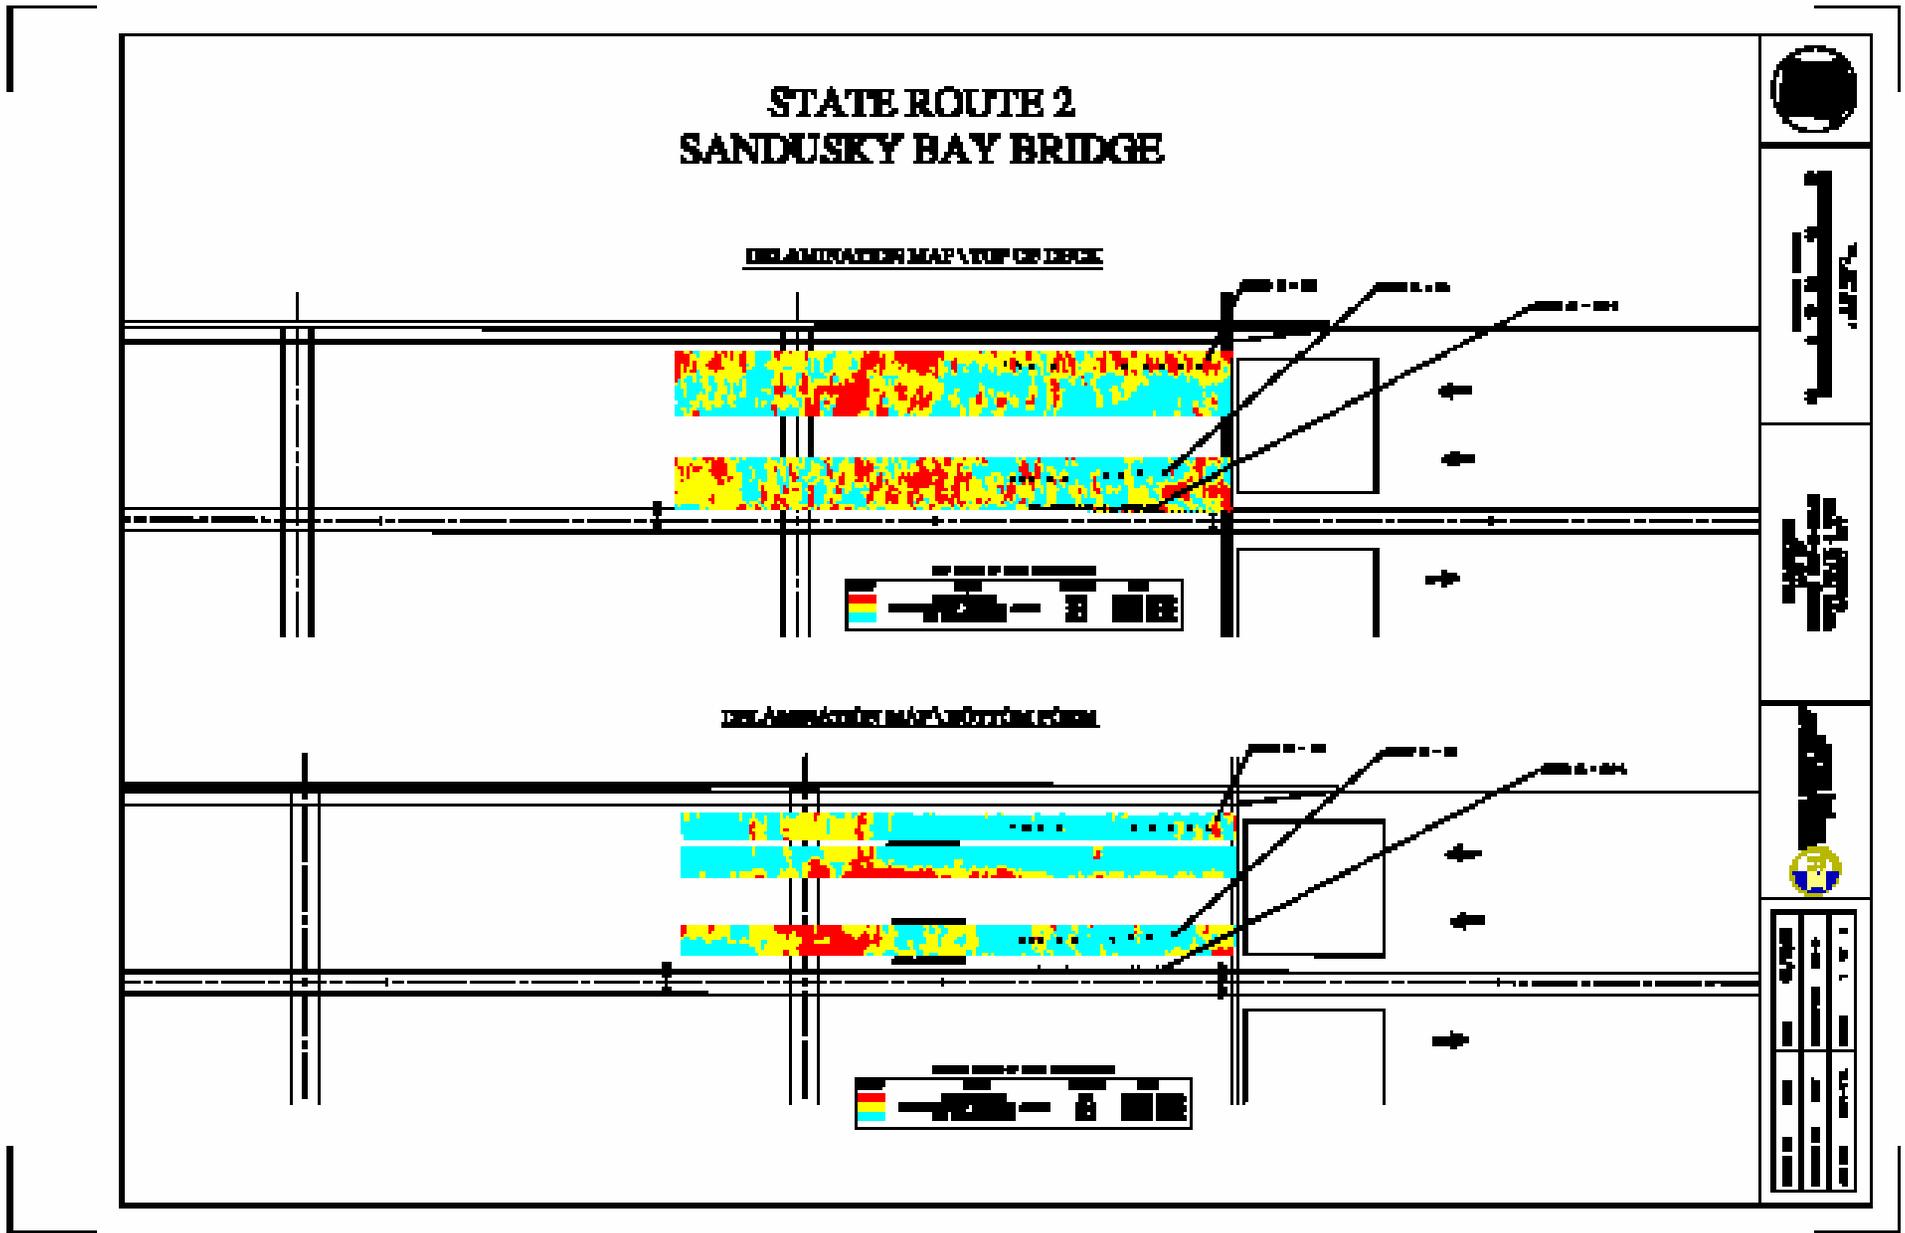
Figure 9.4. GPR Delamination Map of Existing Core Locations

Rii compiled maps of the strength of the reflected radar signal from the top layer of rebar and from the SIPMF over the region the original cores were taken from and the entire length of the bridge. Delaminations are one of the principle causes of high attenuation. Therefore, it was hypothesized that high attenuation indicated areas with delaminations. It was found that areas of high attenuation, indicating potential delaminations, existed over the entire length of the structure. Figure 9.4 is the delamination map over the region the existing cores were taken from. Figure 9.5 is the delamination map over the entire length of the bridge. If an area had low attenuation of the radar signal, it is blue on the delamination map. If the area had high attenuation, it is red on the map. Areas of intermediate attenuation are yellow.

There were three limitations to using the GPR data from the existing cores to reach broad conclusions about the efficacy of GPR. The existing cores covered a very small portion of the bridge, the existing cores were not located in areas where the GPR predicted severe delamination, and the cavities left by the core extraction reduce the accuracy of the GPR in the local region of the cores. Therefore, it was decided to harvest additional verification cores.

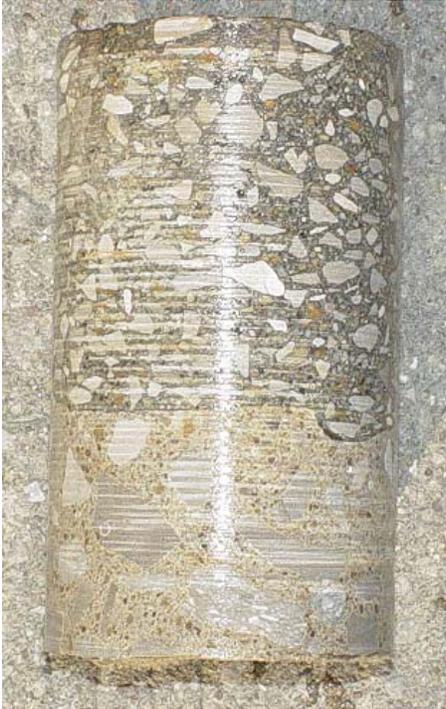
Figure 9.6. Core GT-1A

Station location 113+00.3 and 4.9 feet (1.494 m) from the face of the curb on the west side of the bridge.

- Core height 7 inches (177.8 mm) with 4.25 inch (108 mm) overlay.
- Some rust present on bottom of core.
- Numerous air voids present.

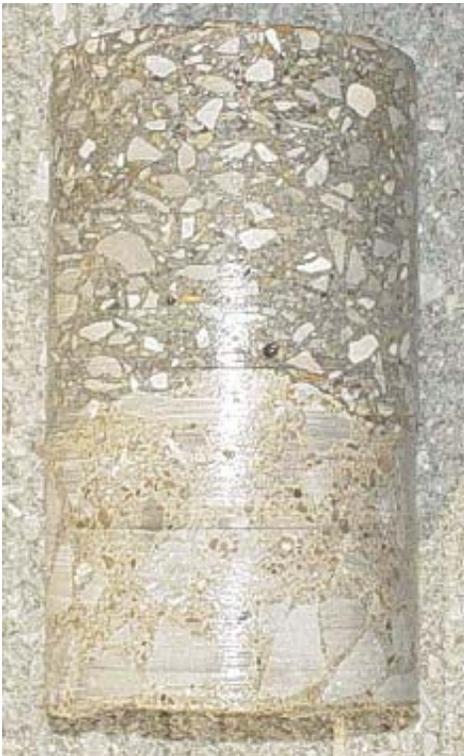
Figure 9.7. Core GT-1B

Station location 113+00.3 and 5.4 (1.646 m) feet from the face of the curb on the west side of the bridge.

- Core height 6.75 inches (171.5 mm) with 4 inch (101.6 mm) overlay.
- White residue present on bottom of core.
- Numerous voids in concrete up to 0.25 inches (6.35 mm) in diameter

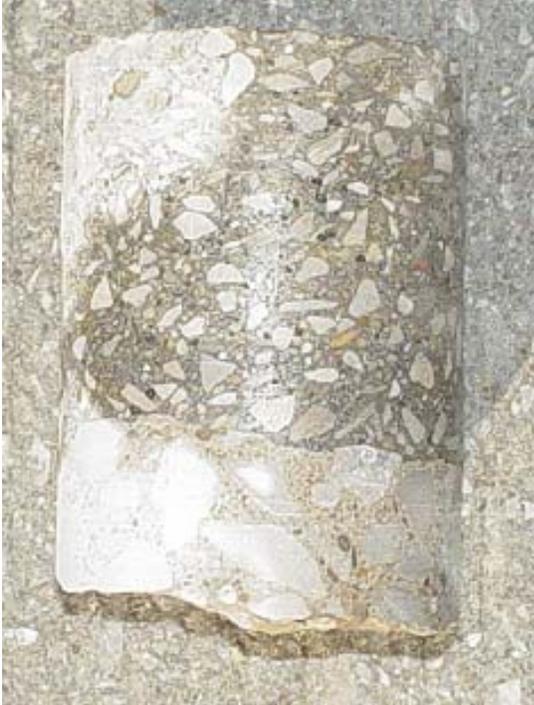
Figure 9.8. Core GT-1C

Station location 112+99.8 and 4.9 feet (1.494 m) from the face of the curb on the west side of the bridge.

- Core height 5.25 inches (133.4 mm) with 4 inch (101.6 mm) overlay.
- Core fractured due to excavation.
- Rebar at 3.5" (88.9 mm) from top.
- Numerous air voids in concrete.

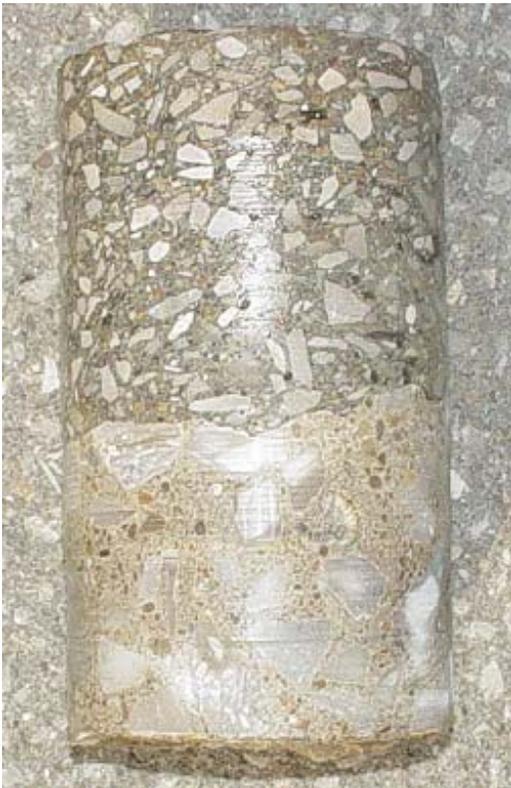
Figure 9. 9. Core GT-1D

Station location 112+99.8 and 5.3 feet (1.615 m) from the face of the curb on the west side of the bridge.

- Core height 6.75 inches (171.5 mm) with 3.75 inch (95.25 mm) overlay.
- Rebar at 5.5 inches (139.7 mm) from top.
- Heavy rust present on bottom of core.
- Large voids present in concrete up to 0.5 (12.7 mm) inches in diameter.

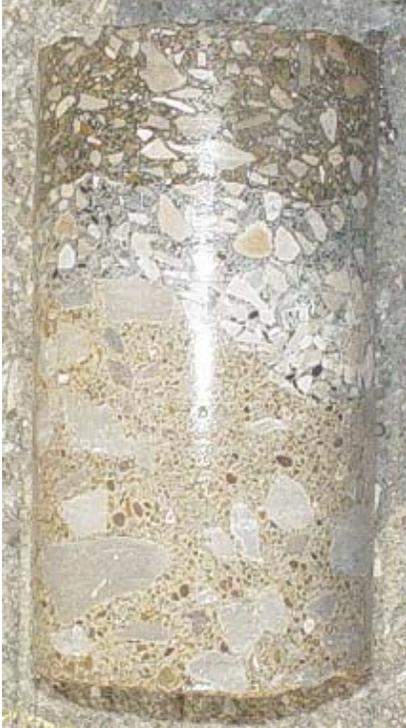
Figure 9.10. Core Number: GT-2A

Station location 113+22.4 and 5.1 feet (1.554 m) from the face of the curb on the west side of the bridge.

- Core height 7.25 (184.2 mm) inches with overlay thicknesses of 1.75 inches (44.45 mm) and 1.5 inches (38.1 mm).
- Heavy rust present on bottom of core.
- Small voids present in concrete.

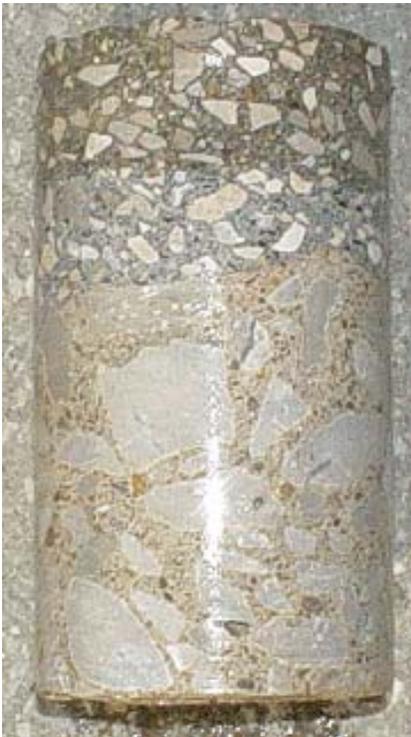
Figure 9.11. Core : GT-2B

Station location 113+22.4 and 5.6 feet (1.707 m) from the face of the curb on the west side of the bridge.

- Core height 7 inches (177.8 mm) with overlay thicknesses of 1.5 inches (38.1 mm) and 1 inch (25.4 mm).
- Heavy rust present on bottom of core.
- Small voids present in concrete.
