Evaluation of Stay-in-Place Metal Forms

for the
Ohio Department of Transportation
Office of Research and Development

State Job Number 134155

Final Report
FHWA/OH – 2006/13
May 2006

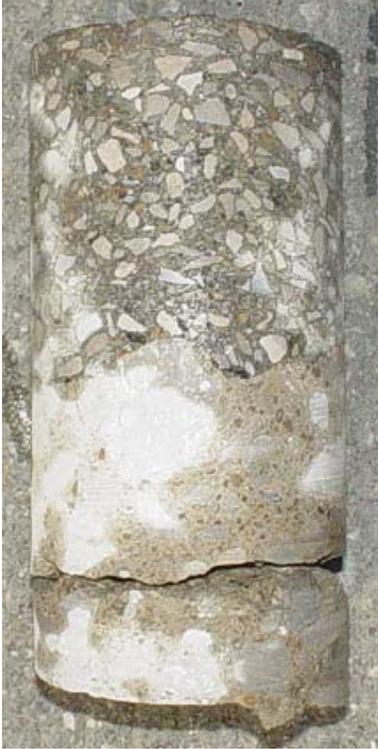
Figure 9.12. Core GT-3A

Station location 113+95.3 and 5.0 feet (1.524 m) from the face of the curb on the west side of the bridge

- Core height 7.75 inches (196.8 mm) with 4 inch (101.6 mm) overlay.
- Core fractured at 6.25 inches (158.8 mm) from the top due to extraction.
- Rebar present at 6.5 inches (165.1 mm) from the top.
- Numerous air voids in concrete.

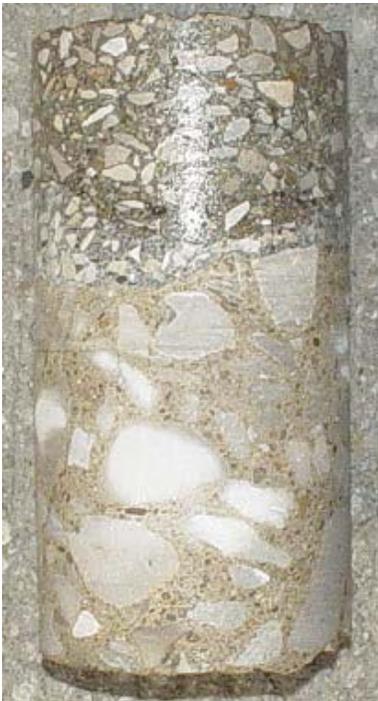
Figure 9.13. Core GT-3B

Station location 113+95.3 and 5.6 feet (1.707 m) from the face of the curb on the west side of the bridge

- Core height 7.5 inches (190.5 mm) with overlay thicknesses of 2 inches (50.8 mm) and 1 inch (25.4 mm).
- Numerous voids present in concrete.

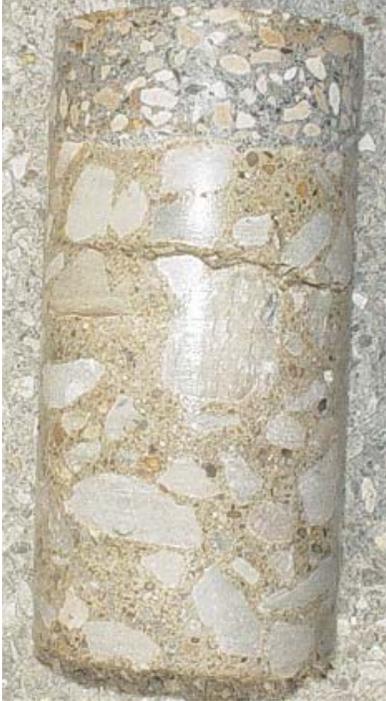
Figure 9.14. Core GT-6A

Station location 118+44.2 and 5.0 feet (1.524 m) from the face of the curb on the west side of the bridge.

- Core height 7.75 inches (196.9 mm) with 1.5 inch (38.1 mm) overlay.
- Core delaminated 3 inches (76.2 mm) from the top, above the top layer of rebar.
- Numerous voids present in concrete.

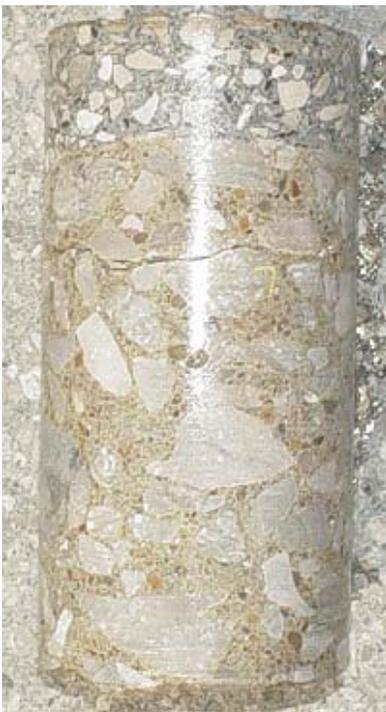
Figure 9.15. Core GT-6B

Station location 118+44.2 and 5.6 feet (1.707 m) from the face of the curb on the west side of the bridge.

- Core height 8 inches (203.2 mm) with 1.5 inch (38.1 mm) overlay.
- Core delaminated 3 inches (76.2 mm) from the top, above the top layer of rebar.
- Numerous voids in concrete up to 0.375 inches in diameter.

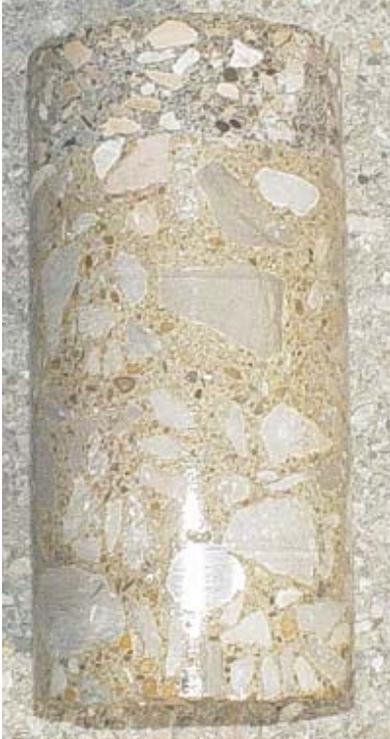
Figure 9.16. Core Number: GT-7A

Station location 118+61.2 and 5.0 feet (1.524 m) from the face of the curb on the west side of the bridge.

- Core height 8 inches (203.2 mm) with 1.5 inch (38.1 mm) overlay.
- Rebar present at 6.5 inches (165.1 mm) from the top.
- Small voids present in the concrete.

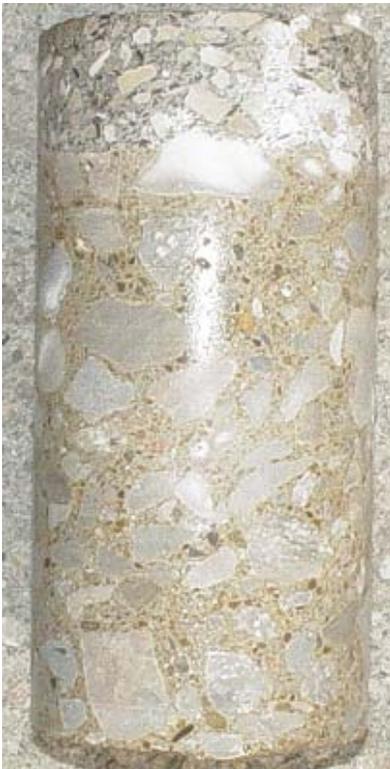
Figure 9.17. Core Number: GT-7B

Station location 118+61.2 and 5.5 feet (1.676 m) from the face of the curb on the west side of the bridge.

- Core height 8 inches (203.2 mm) with 1.5 inch (38.1 mm) overlay.
- Small voids present in the concrete.

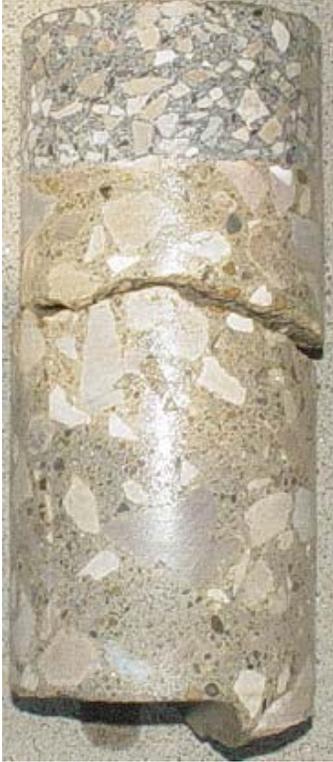
Figure 9.18. Core Number: GT-8A

Station location 119+64.8 and 3.2 feet (0.975 m) from the face of the curb on the west side of the bridge.

- Core height 8.5 inches (215.9 mm) with 2 inch (50.8 mm) overlay.
- Heavy rust present on bottom of core.
- Core delaminated 3.75 inches (95.25 mm) from the top, above the top layer of rebar.
- Numerous voids in concrete.

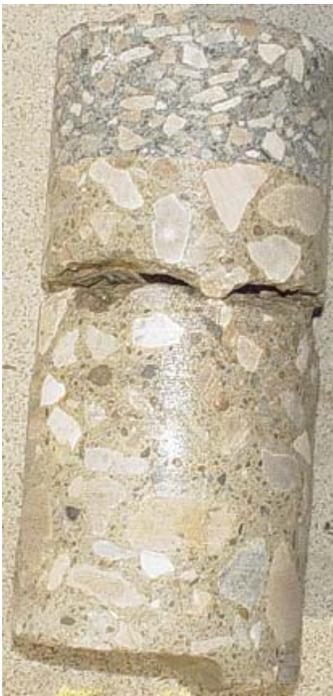
Figure 9.19. Core Number: GT-8B

Station location 119+64.8 and 3.6 feet (1.097 m) from the face of the curb on the west side of the bridge.

- Core height 8.25 inches (203.2 mm) with 2 inch (203.2 mm) overlay
- Some rust present on bottom of core
- Core delaminated 3.5 inches (203.2 mm) from top
- Rebar located at 5 inches (203.2 mm) and 7.25 inches (203.2 mm) from the top.
- Small air voids present in the concrete.

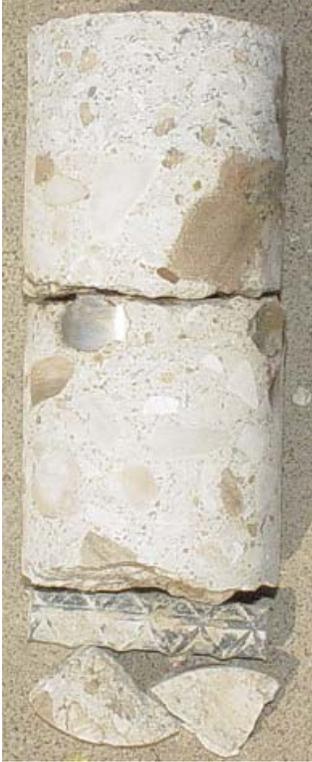
Figure 9.20 Core Number: GT-8C

Station location 119+65.3 and 3.1 feet (0.945 m) from the face of the curb on the west side of the bridge.

- Core height 8.25 inches (209.6 mm) with 2 inch (50.8 mm) overlay.
- Core delaminated 4 inches (101.6 mm) from top, just above the top layer of rebar.
- Core fractured at bottom due to extraction.
- Rebar located at 4.5 inches (114.3 mm) from the top heavily corroded.
- Rebar located at 8.25 inches (209.6 mm) from the top.
-

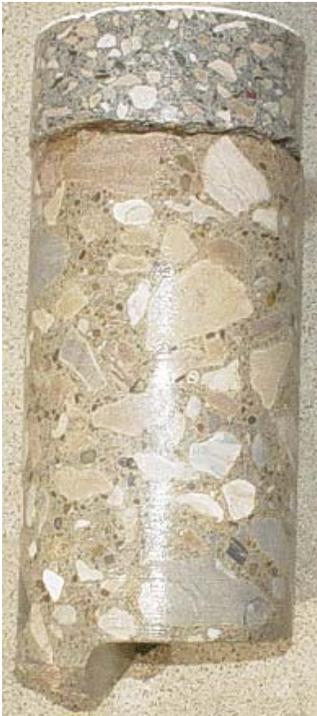
Figure 9.21. Core Number: GT-9A

Station location 119+83.0 and 4.1 feet (1.250 m) from the face of the curb on the west side of the bridge.

- Core height 8.5 inches (215.9 mm) with 1.75 inch (44.45 mm) overlay.
- Core delaminated at overlay, above the top layer of rebar.
- Rebar located at 8 inches (203.2 mm) from top.
- Numerous voids present up to 0.375 inches (9.525 mm) in diameter.

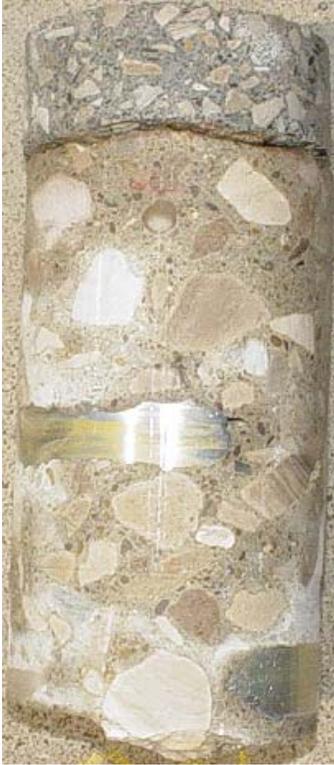
Figure 9.22. Core Number: GT-9B

Station location 119+83.0 and 4.6 feet (1.402 m) from the face of the curb on the west side of the bridge.

- Core height 8.5 inches (215.9 mm) with 1.5 inch (38.1 mm) overlay.
- Core delaminated at overlay, above the top layer of rebar.
- Rebar located at 7.25 inches (184.2 mm), 5 inches (127 mm), and 8 inches (203.2 mm) from the top.
- Numerous voids in concrete up to 0.25 inches (6.35 mm) in diameter..

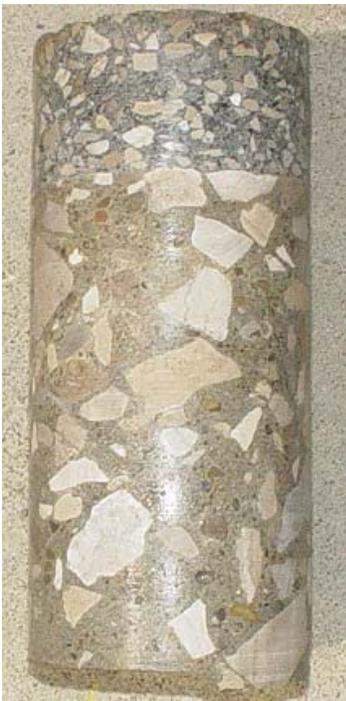
Figure 9.23. Core Number: GT-10A

Station location 0+25.7 and 1.3 feet (0.396 m) from the face of the curb on the west side of the bridge.

- Core height 8.75 inches (222.3 mm) with 2.25 inch (57.15 mm) overlay.
- Rebar located at 4.75 inches (120.7 mm) from the top with minor rust.
- Numerous voids present in concrete.

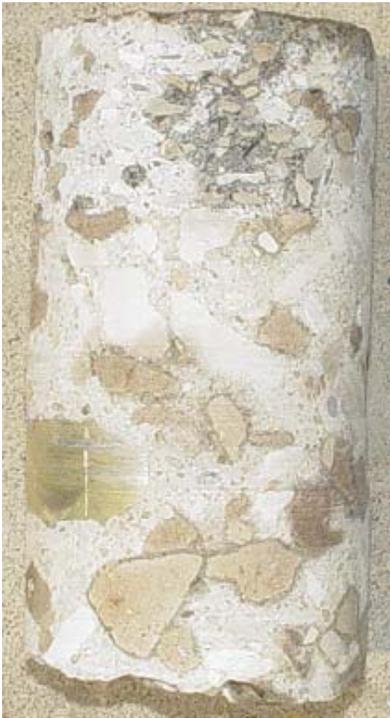
Figure 9.24. Core Number: GT-10B

Station location 0+25.8 and 1.5 feet (0.457 m) from the face of the curb on the west side of the bridge.

- Core height 10.5 inches (203.2 mm) with 2 inch (50.8 mm) overlay.
- Rebar located at 4 inches (101.6 mm), 5 inches (127 mm), and 7.5 inches (190.5 mm) from the top.
- Core fractured at bottom due to excavation.
- Small voids present in concrete

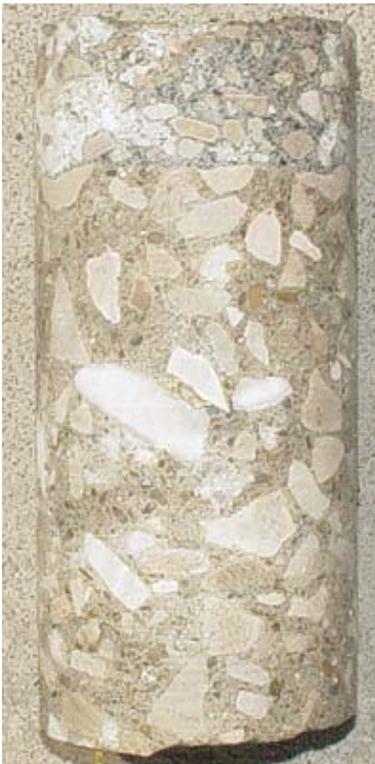
Figure 9.25. Core Number: GT-11A

Station location 1+47.2 and 5.0 feet (1.524 m) from the face of the curb on the west side of the bridge.

- Core height 8.5 inches (215.9 mm) with 1.75 inch (44.45 mm) overlay.
- Core fractured due to excavation.
- Small voids present in concrete up to 0.25 inches (6.35 mm) in diameter.

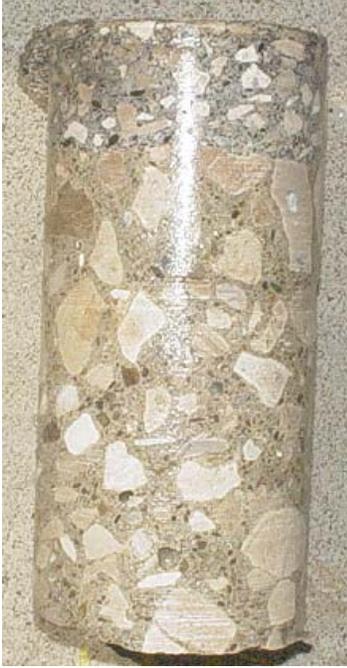
Figure 9.26. Core Number: GT-11B

Station location 1+47.2 and 5.5 feet (1.676 m) from the face of the curb on the west side of the bridge.

- Core height 8.5 inches (215.9 mm) with 1.75 inch (44.45 mm) overlay.
- Numerous voids in concrete up to 0.25 inches (6.35 mm) in diameter.

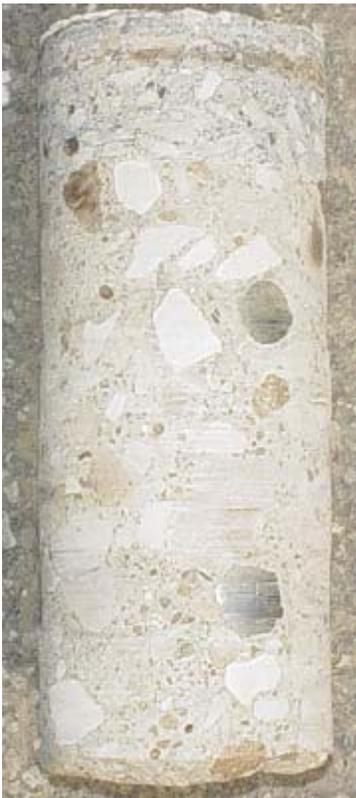
Figure 9.27. Core Number: GT-16A

Station location 7+29.8 and 3.0 feet (0.914 m) from the face of the curb on the west side of the bridge.

- Core height 10 inches (254 mm) with 2 inch (50.8 mm) overlay.
- Rebar located at 3.75 inches (95.25 mm) and 7.5 inches (190.5 mm) from the top.
- Small amounts of voids in concrete.

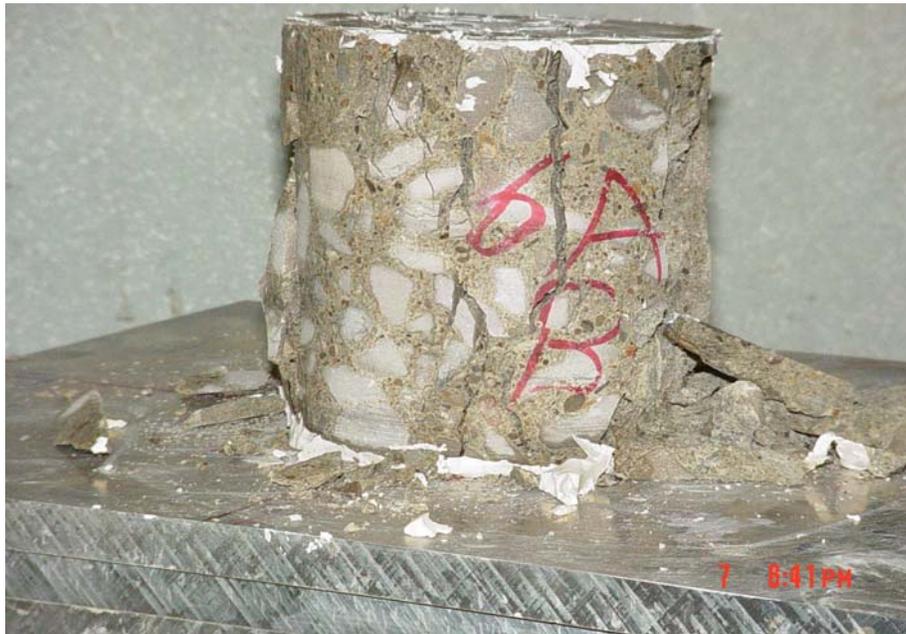
The design strength of the concrete for OTT-2-28.41 is 3,000 psi (20.69 MPa) . The average compressive strength found in the tests was 4,490 psi (30.96 MPa). All failures were columnar. The test results are consistent with the design strength, but display a wide range. The reason for the wide range is not completely understood. Part of the wide range is certainly due to the low L/D ratio for some cores and the fact that some cores come from regions with delaminations. Figure 9.29 shows the testing of a typical specimen and table 9.3 gives the compression test results.

9.29c: Columnar Failure

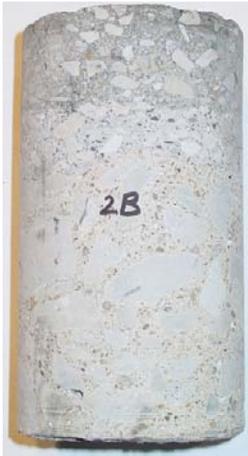
- 7.13 in. (181.1 mm) height.
- 1.66 in. (42.16 mm) thickness of wearing surface.
- Fine aggregates were in the wearing surface and coarse aggregates in the remaining thickness.
- More porosity in the wearing surface.
- Honey combing of 0.4 in. (10.16 mm) size at 5 in. (127 mm) and 0.25 in. (6.35 mm) at 6.25 in. (158.8 mm).
- Severe rust and salt traces on the bottom of the core.
- The concrete in the region of the valley of the SIPMF was broken.

Figure 9.32. Core 2B shows more porosity in the wearing surface

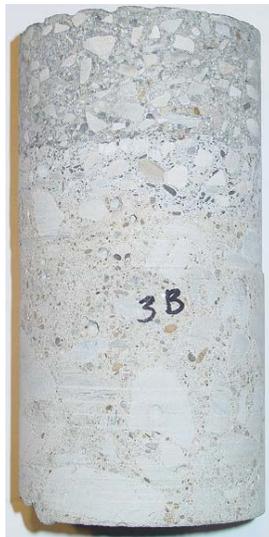
- 7.5 in. (190.5 mm) height.
- 2 wearing surface layers of 2 in. (50.8 mm) and 1.66 in. (42.16 mm) thicknesses.
- Fine aggregates were in the wearing surface and coarse aggregates in the remaining thickness.
- More porosity in the wearing surface.
- Some honey combing at several places.
- Voids of 0.2 in. (5.08 mm) at 3in. (76.2 mm), 3.75 in. (95.25 mm) and 4.75 in. (120.7 mm)
- Some salt traces on the bottom of the core.
- The concrete in the region of the valley of the SIPMF was broken.

Figure 9.34. Two wearing surface layers

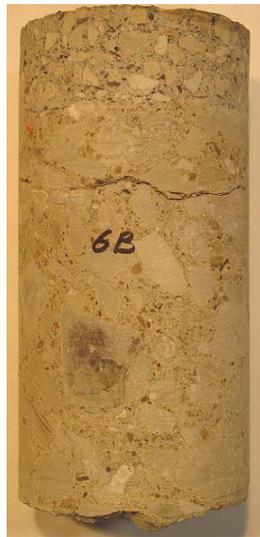
- 7.5 in. (190.5 mm) height.
- Wearing surface layer of 1.5 in. (38.1 mm).
- Fine aggregates were in the wearing surface and coarse aggregates in the remaining thickness.
- More porosity in the wearing surface.
- Some honey combing at several locations.
- Voids of 0.4 in. (10.16 mm) at 2.75 in. (69.85 mm) and 0.13 in. (3.302) at 1.75 in. (44.45 mm).
- Horizontal crack at 2.88 in. (73.15 mm)
- The concrete in the region of the valley of the SIPMF was broken.

Figure 9.36. Core 6B shows horizontal crack

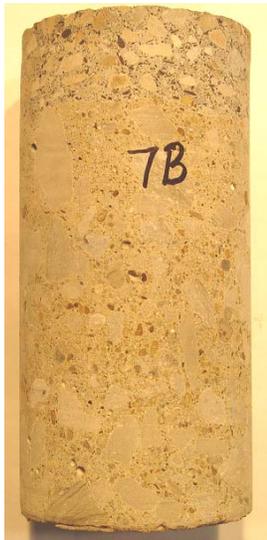
- 8.0 in. (203.2 mm) height.
- Wearing surface layer of 1.5 in. (38.1 mm)
- Fine aggregates were in the wearing surface and coarse aggregates in the remaining thickness.
- More honey combing in the wearing surface.
- Low porosity in both layers.
- Small voids at several locations.
- Small traces of salt at the bottom of the core.
- The concrete in the region of the valley of the SIPMF was broken.

Figure 9.37. Core 7B shows more honey combing in the wearing surface

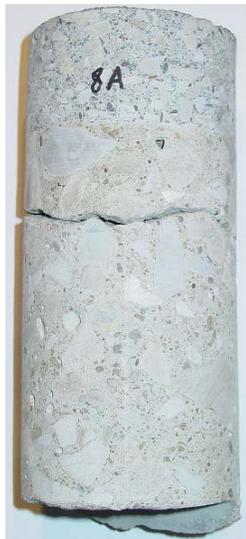
- 8.3 in. (210.8 mm) height.
- Wearing surface layer of 2.0 in. (50.8 mm).
- Fine aggregates were in the wearing surface and coarse aggregates in the remaining thickness.
- More honey combing in the wearing surface.
- Voids of size 0.5 in. (12.7 mm) at 4.5 in. (114.3 mm), 0.4 in. (10.16 mm) at 5.5 in. (139.7 mm), and 0.2 in. (5.08 mm) at 2.5 in. (63.5 mm).
- Severe rust traces at the bottom of the core from SIPMF.
- The core was broken at 3.5 in. (88.9 mm).
- The concrete in the region of the valley of the SIPMF was broken.

Figure 9.39. Core 8A
broken in the middle

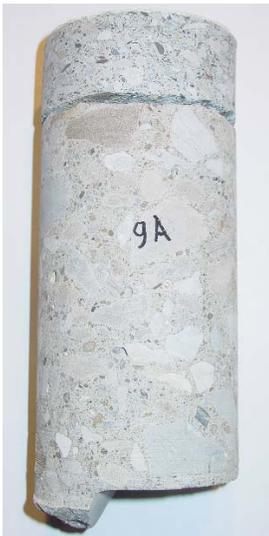
- 8.13 in. (206.5 mm) height.
- Wearing surface layer of 1.75 in. (44.45 mm).
- Fine aggregates were in the wearing surface and coarse aggregates in the remaining thickness.
- Honey combing of 0.5 in. (12.7 mm) at 7.0 in. (177.8 mm).
- Voids of size 0.25 in (6.35 mm). at 5.25 in. (133.4 mm), 6.25 in. (158.8 mm) , and 7.5 in. (190.5 mm)
- Reinforcement bar had small traces of rust.
- The core was broken at the bottom of the wearing surface.
- The concrete in the region of the valley of the SIPMF was broken.

Figure 9.41. Core 9A broken at the bottom of wearing surface

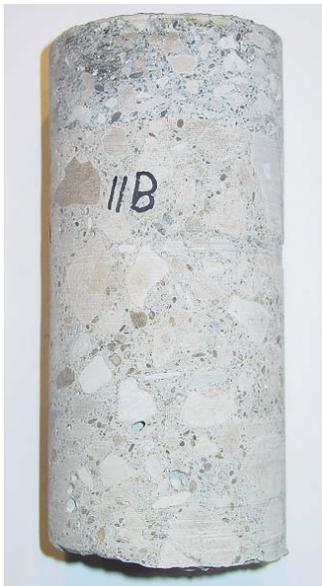
Core 11B (Figures 9.44-9.45)

- 8.25 in. (209.6 mm) height.
- Wearing surface layer of 2.75 in. (69.85 mm)
- Fine aggregates were in the wearing surface and coarse aggregates in the remaining thickness.
- Honey combing in both layers.
- Voids of 0.32 in. (8.127 mm) size at 3.25 in. (82.55 mm), 4.0 in. (101.6 mm) , and 7.0 in. (177.8 mm)
- The concrete in the region of the valley of the SIPMF was broken.

Figure 9.44. Honey combing in both layers

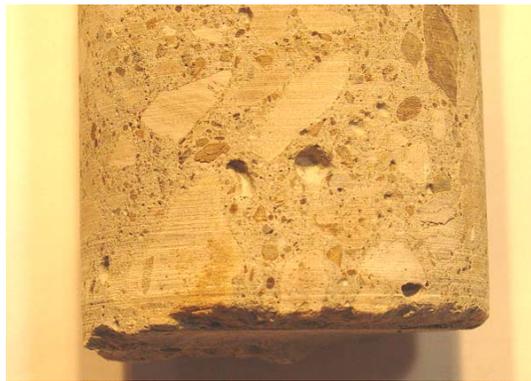
Figure 9.45. Voids and honey combing

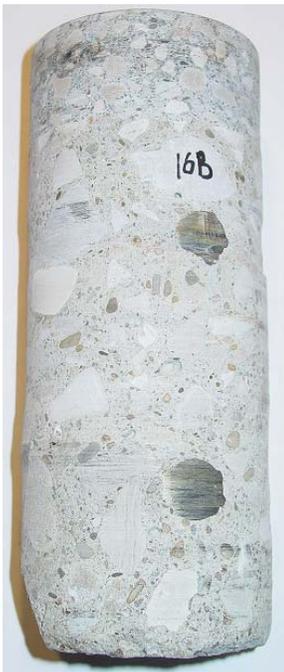
Core 16B (Figures 9.46-9.47)

- 9.75 in. (174.8 mm) height.
- Wearing surface layer of 2.0 in. (50.8 mm).
- Fine aggregates were in the wearing surface and coarse aggregates in the remaining thickness.
- More porosity in the wearing surface.
- Honey combing in both layers.
- Voids of 0.38 in. (9.652 mm) size at 5.75 in. (146.1 mm).
- 2 reinforcement bars with small traces of rust.
- Salt traces at the bottom of the core.
- The concrete in the region of the valley of the SIPMF was broken.

Figure 9.46. Core 16B with 2 reinforcement bars

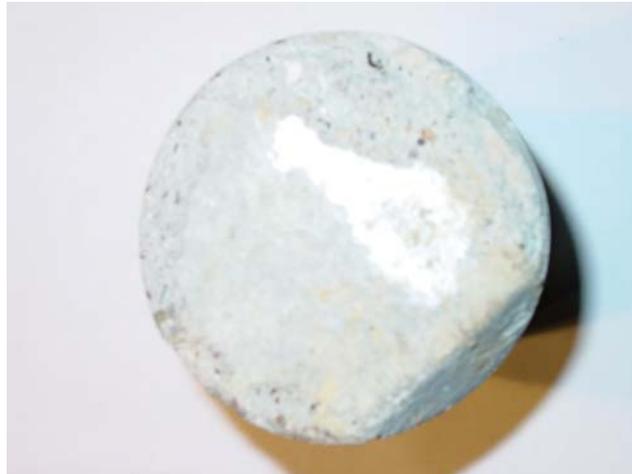
Figure 9.47. Salt traces at the bottom

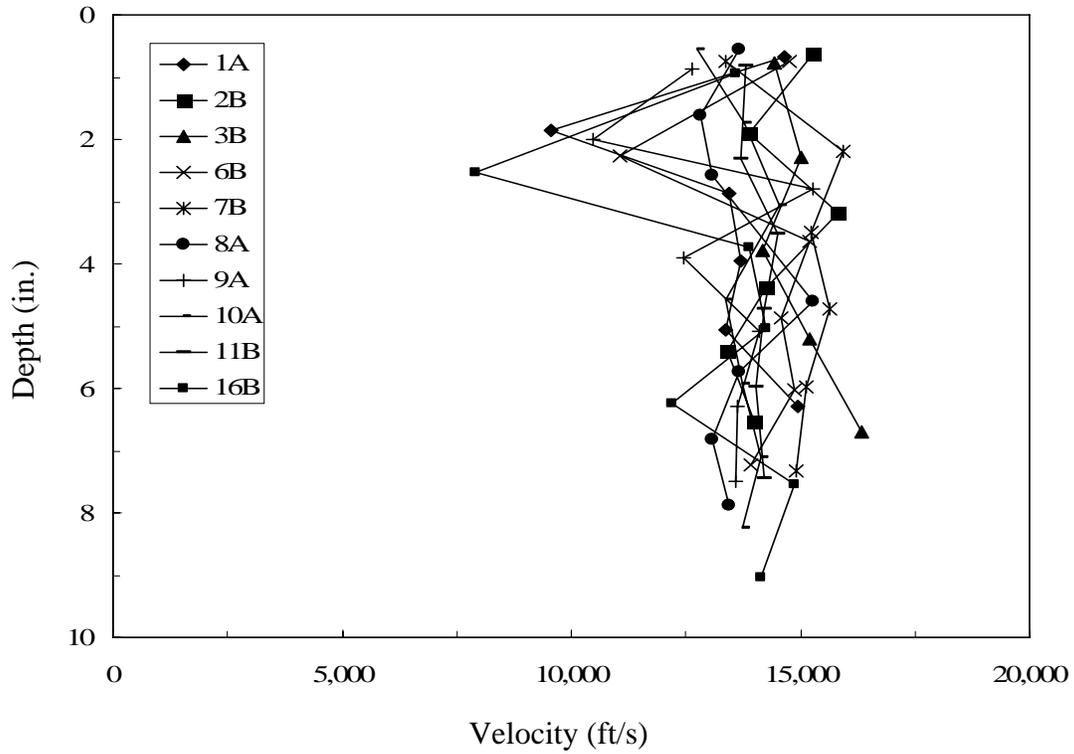
Figure 9.58. Velocity profiles for all the cores

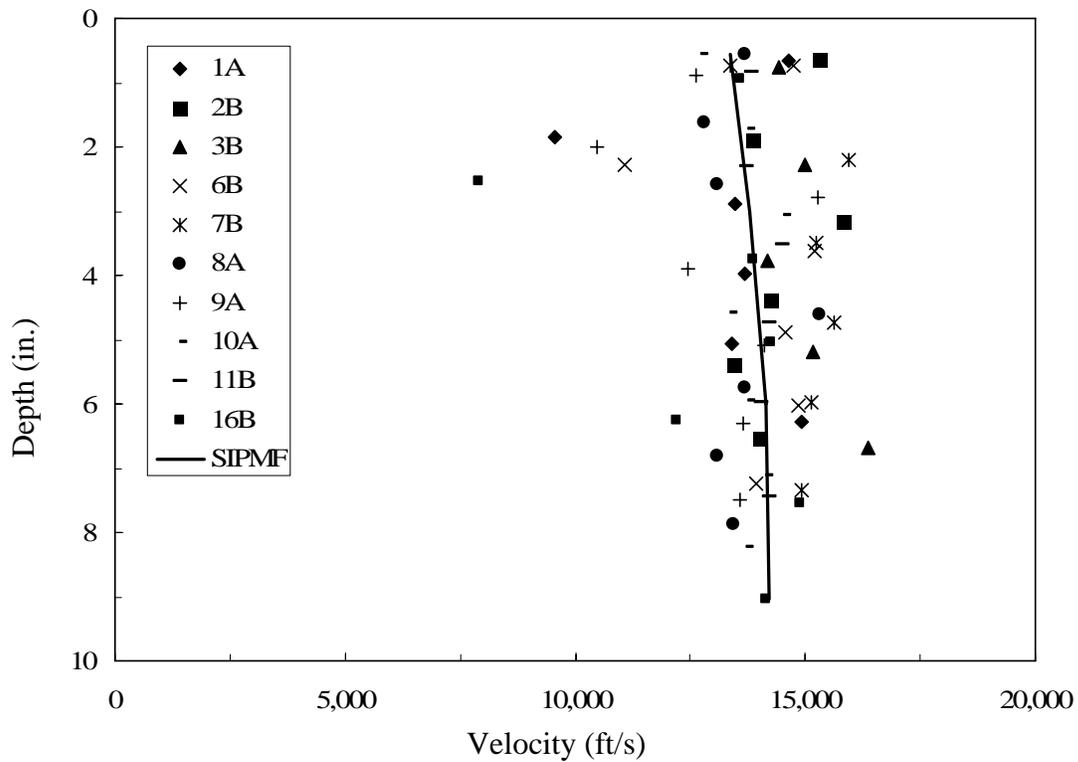
Figure 9.59. Summary of all ultrasonic pulse velocity measurements with depth
1 ft/s = 0.30 m/s

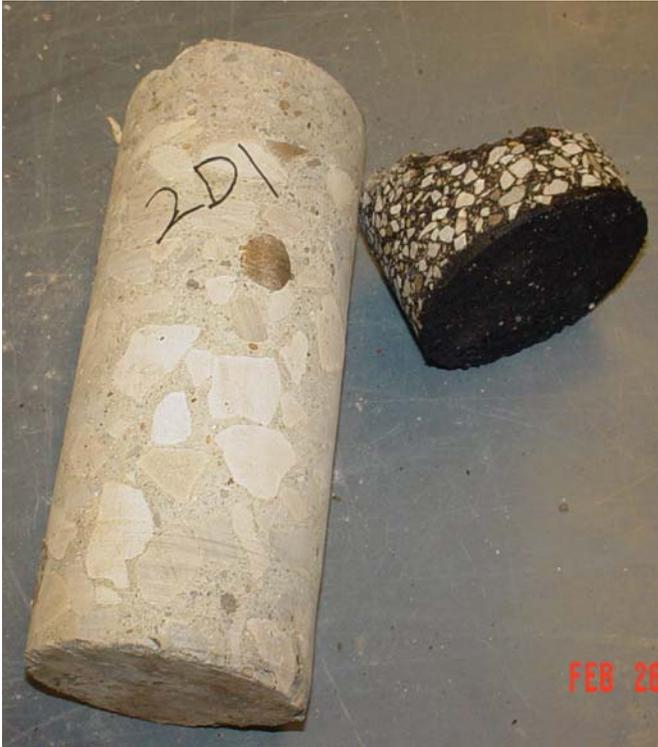
Core Number: 2D1

- Original core length 8.5 inches.
- No bond between SIPMF and deck.
- Rebar shows traces of rust.

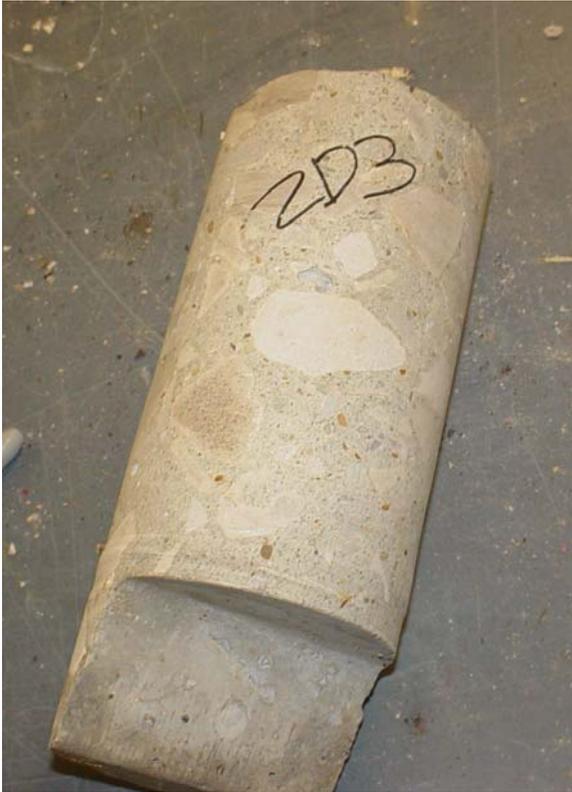
Core Number: 2D3

- Original core length 8 – 10 inches.
- Numerous voids present in concrete up to 1/2 inch in diameter.
- No bond between SIPMF and deck. White residue found on SIPMF and core.

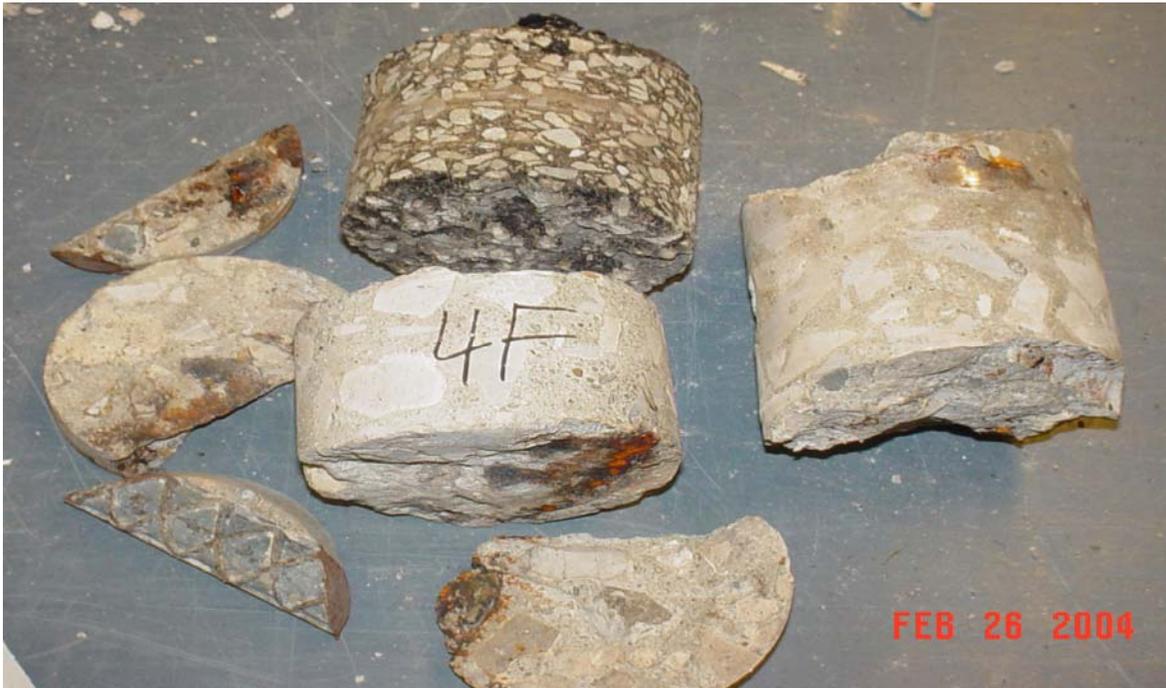
Core Number: 4F

- Total length 7 inches.
- Core fractured at both rebar locations due to severe corrosion of rebar.
- Numerous voids present up to 1/4 inch in diameter.
- No bond SIPMF and deck. Bottom of core rubblized.

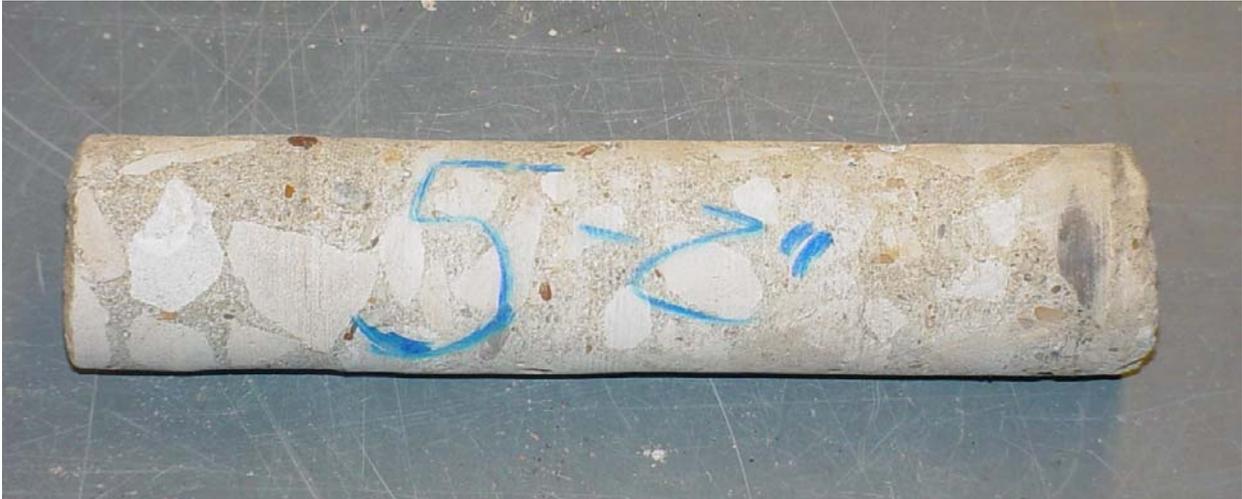
Core Number: 5 – 2”

- Rebar shows traces of rust.
- Numerous small voids up to 1/8 inch in diameter.

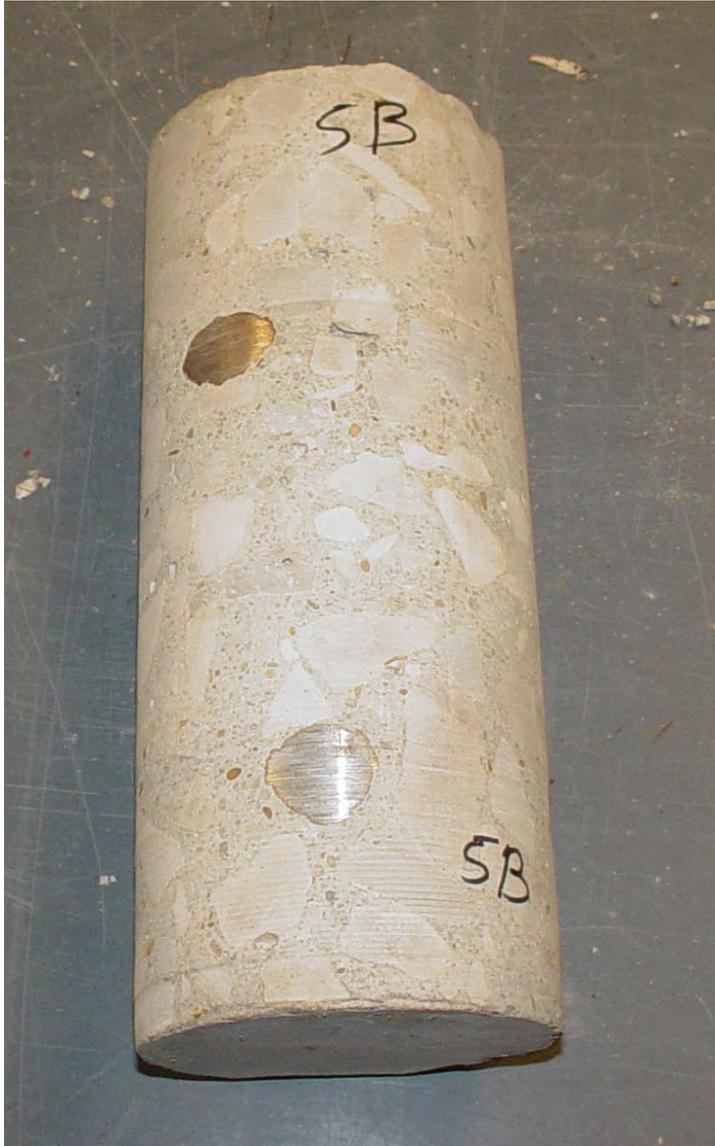
Core Number: 5B

- Original Length was 9.5 inches.
- Rebar in good condition.
- Voids present in concrete up to 1/4 inch in diameter.
- No bond SIPMF and concrete.

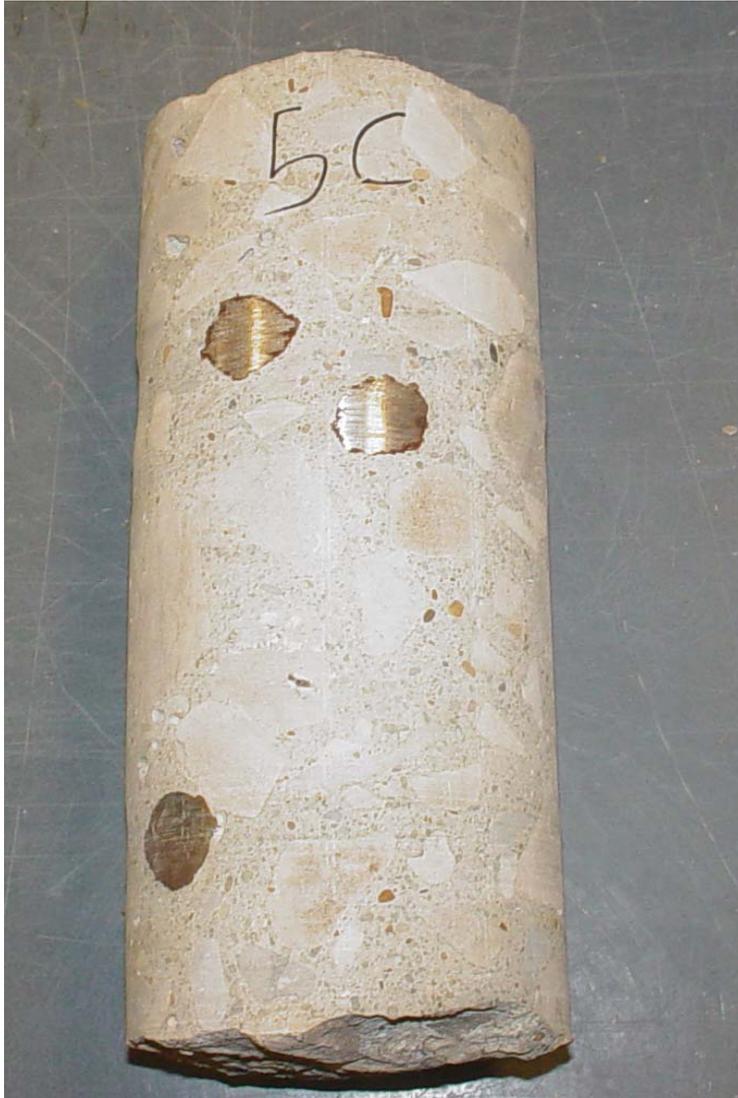
Core Number: 5C

- Length of core 9.5 inches.
- Rebar shows traces of rust.
- Numerous voids in concrete up to 1/2 inch in diameter.
- No bond SIPMF and concrete. Bottom of core, where in contact with SIPMF, rubblized.

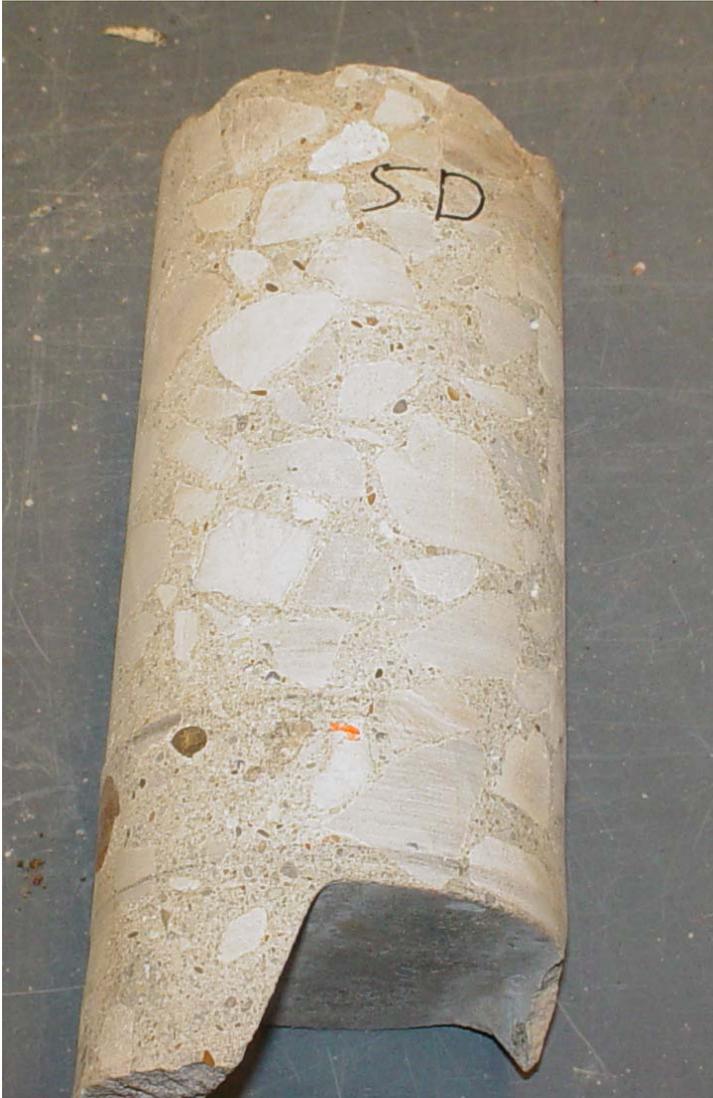
Core Number: 5D

- Length 8 – 9.5 inches.
- Rebar shows traces of rust.
- No bond SIPMF and deck. White residue found on SIPMF and concrete.
- Numerous voids up to 1/8 inch in diameter.

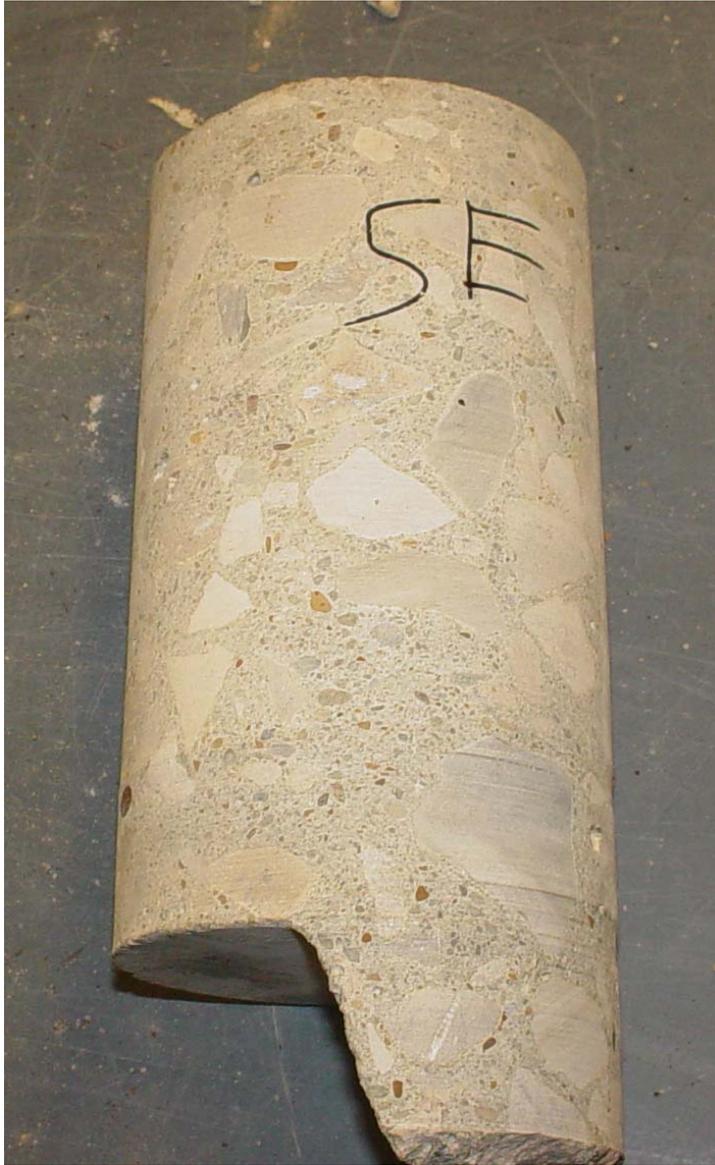
Core Number: 5E

- Length 7.75 – 9.5 inches
- Numerous voids present in concrete up to 1/4 inch in diameter.
- No bond SIPMF and deck. White residue found on bottom of core
- No rebar in core.

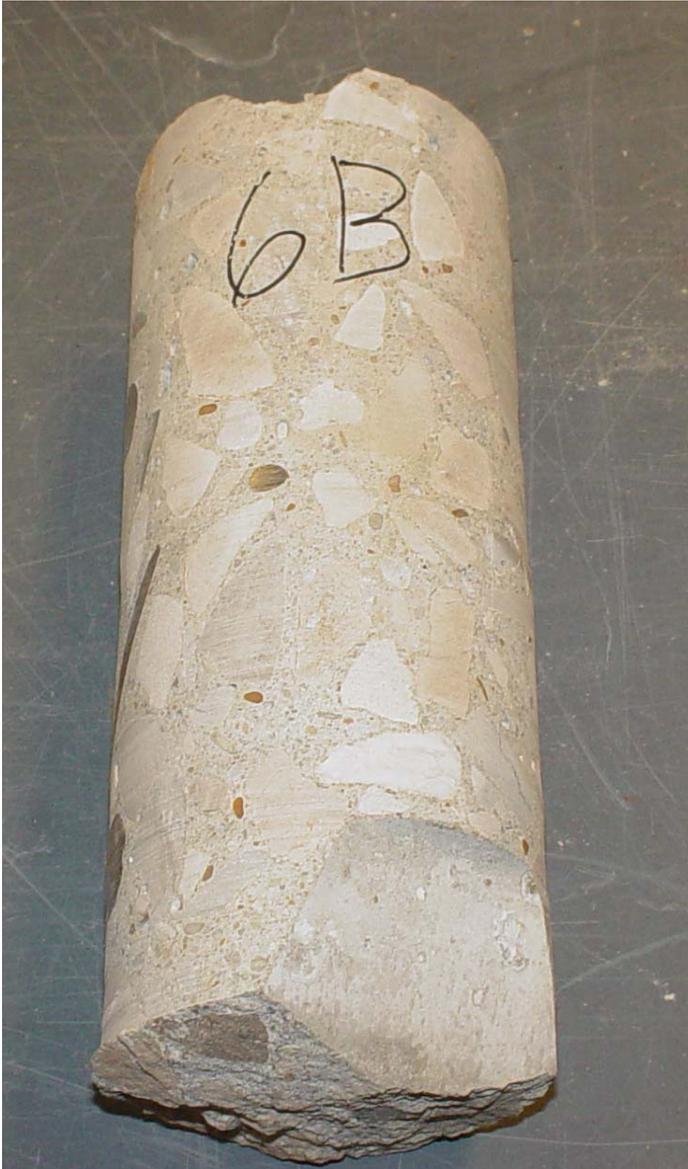
Core Number: 6B

- 7.875 inches in height, 9.75 inches with the concrete in the region of the valley of the SIPMF.
- Two reinforcement bars located at 3 inches and 7.5 inches from the top.
- Bars are not coated and show some rust traces.
- Small region of honeycombing at 3 inches from the top surface.
- Concrete broken in region of SIPMF.

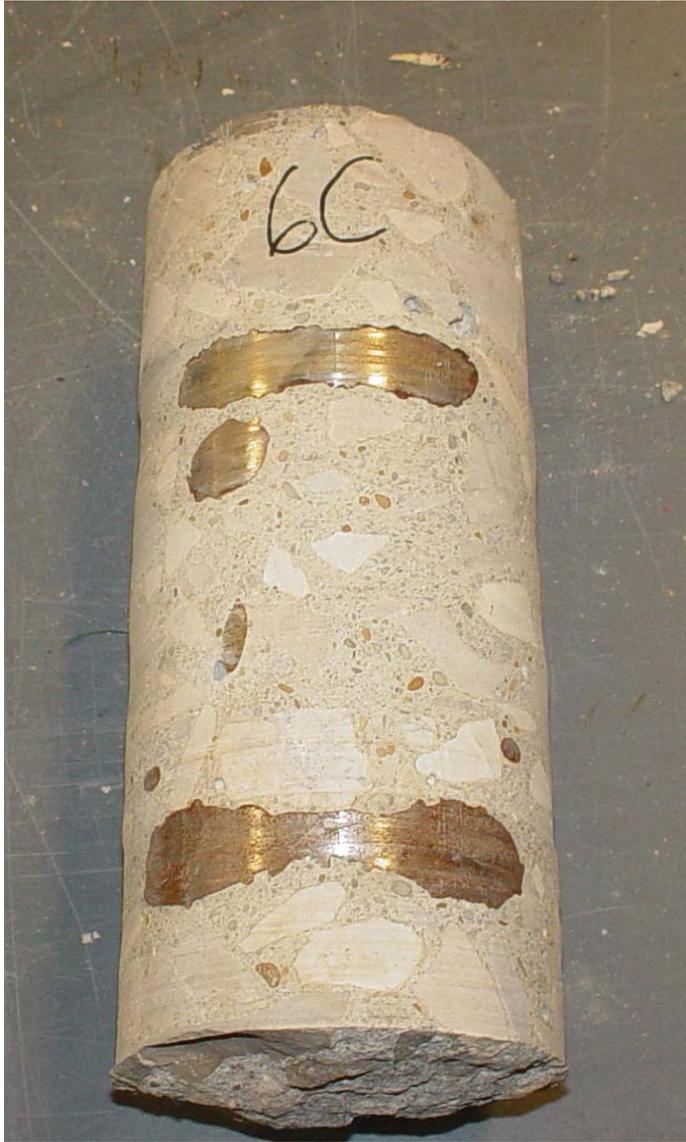
Core Number: 6C

- 7.88 inches in height, 9.875 in. with the concrete in the region of the valley of the SIPMF.
- Three reinforcement bars located at 3 inches, 4 inches, and 7.5 inches from top surface.
- Bars are not coated and show traces of rusting.
- Areas of medium to large voids at 1 inch and 2.25 inches from top.

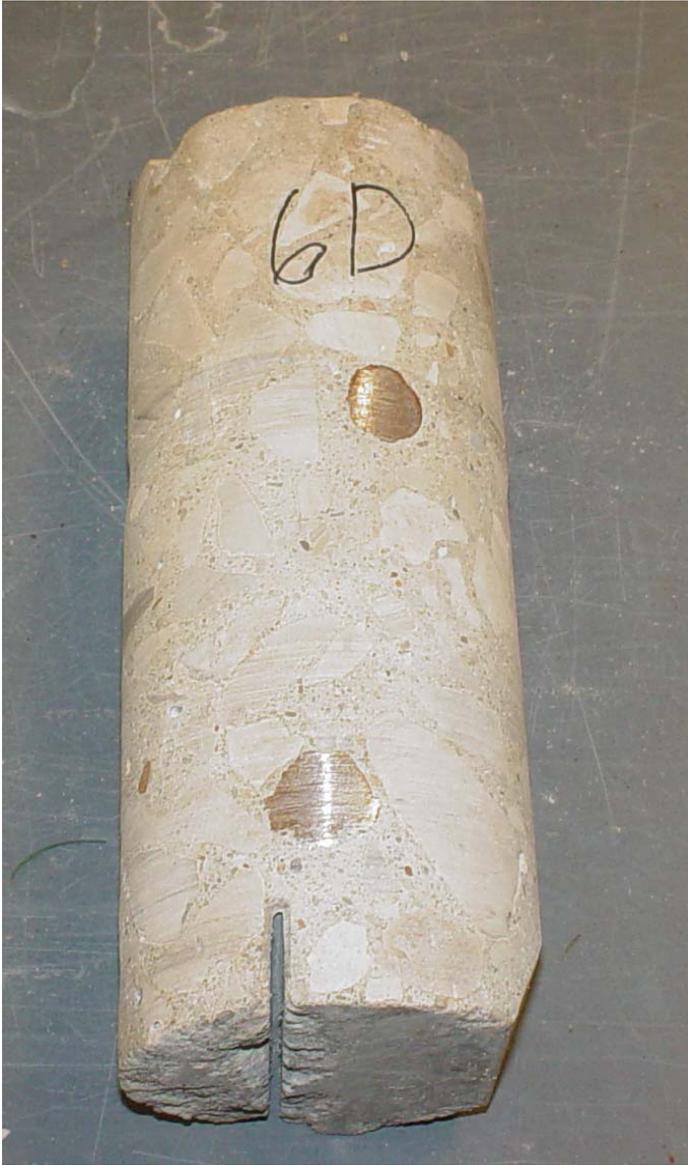
Core Number: 6D

- Length 9.5 inches.
- No bond SIPMF and deck. Bottom of core beginning to deteriorate.
- Rebar shows traces of rust.
- Numerous voids in concrete up to 3/16 inch in diameter.

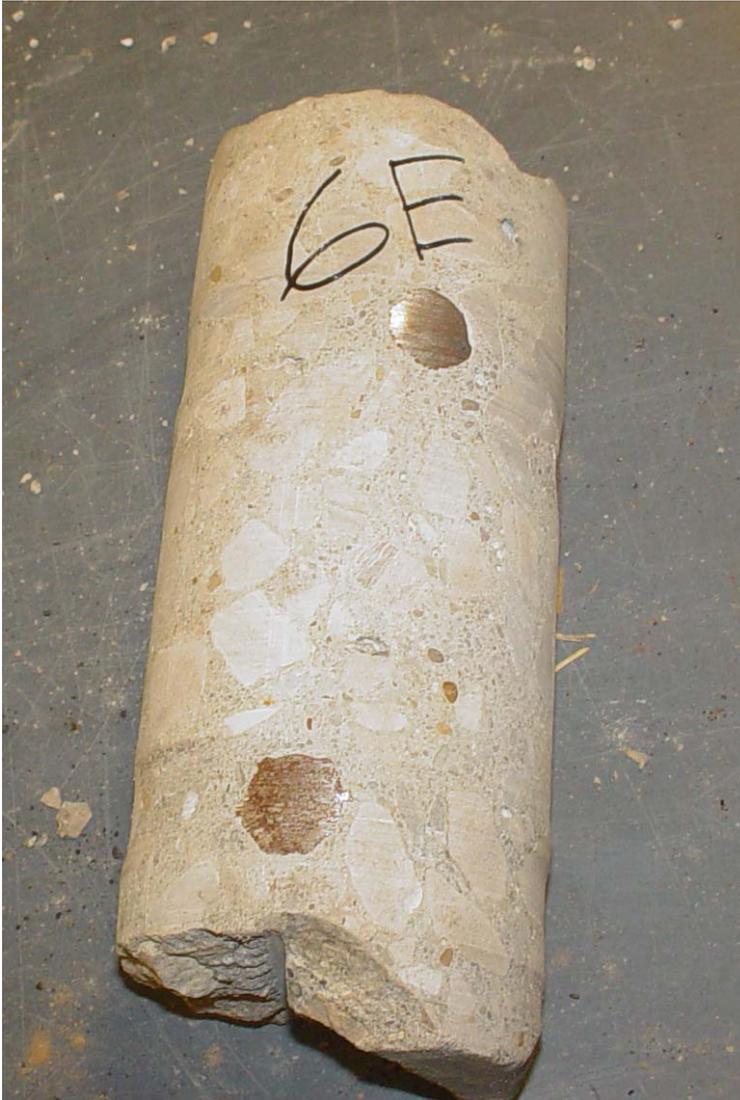
Core Number: 6E

- Length 8.5 – 9.5 inches.
- No bond between SIPMF and concrete.
- Rebar severely rusted.
- Numerous voids present in concrete up to 3/8 inch in diameter.
- Bottom of core fractured during extraction of core.

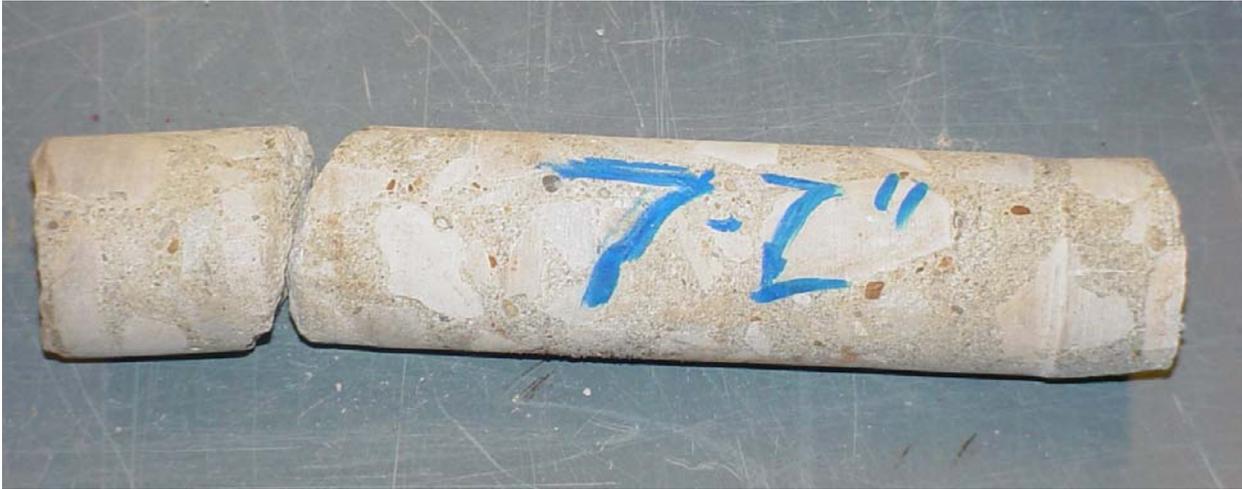
Core Number: 7 – 2”

- Original length 5.5 inches.
- Core fractured 1 inch below top of core due to extraction core.
- Numerous void present in concrete up to 1/8 inch in diameter.

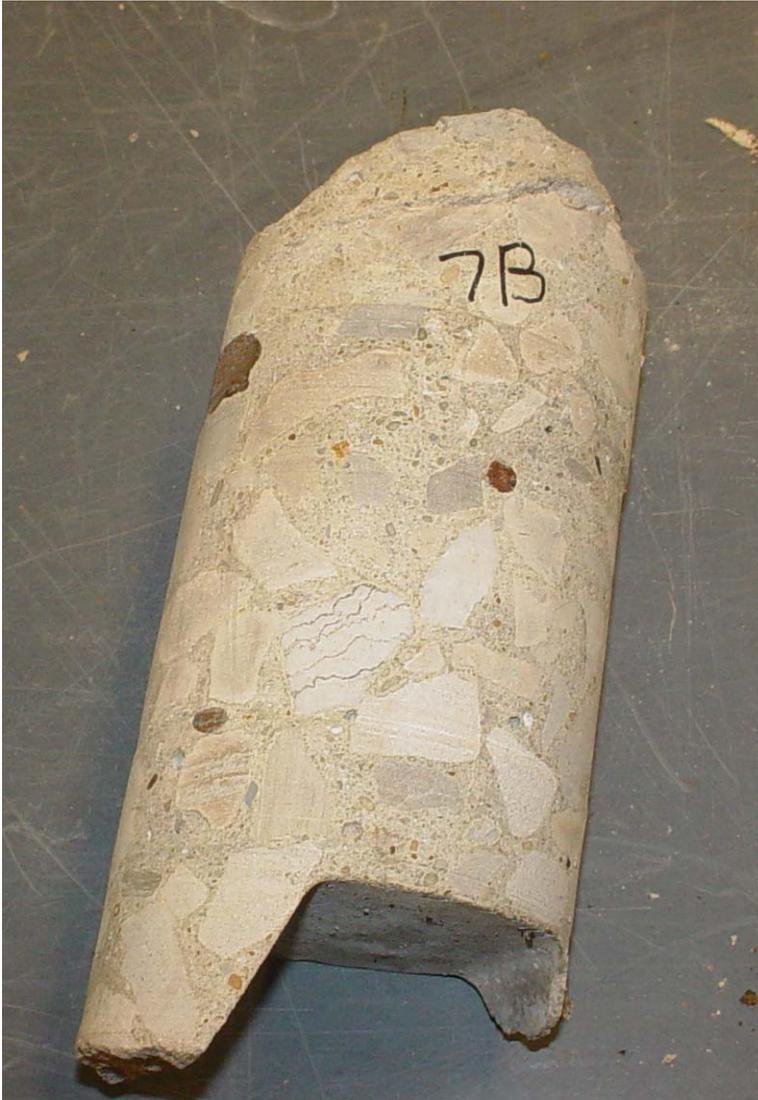
Core Number: 7B

- Length 7.25 – 8.75 inches.
- No bond between SIPMF and deck. White residue found on SIPMF and concrete.
- Fractured 1 inch below top due to many voids in concrete.
- Rebar shows traces of rust.
- Numerous voids present in concrete up to 1/8 inch in diameter.

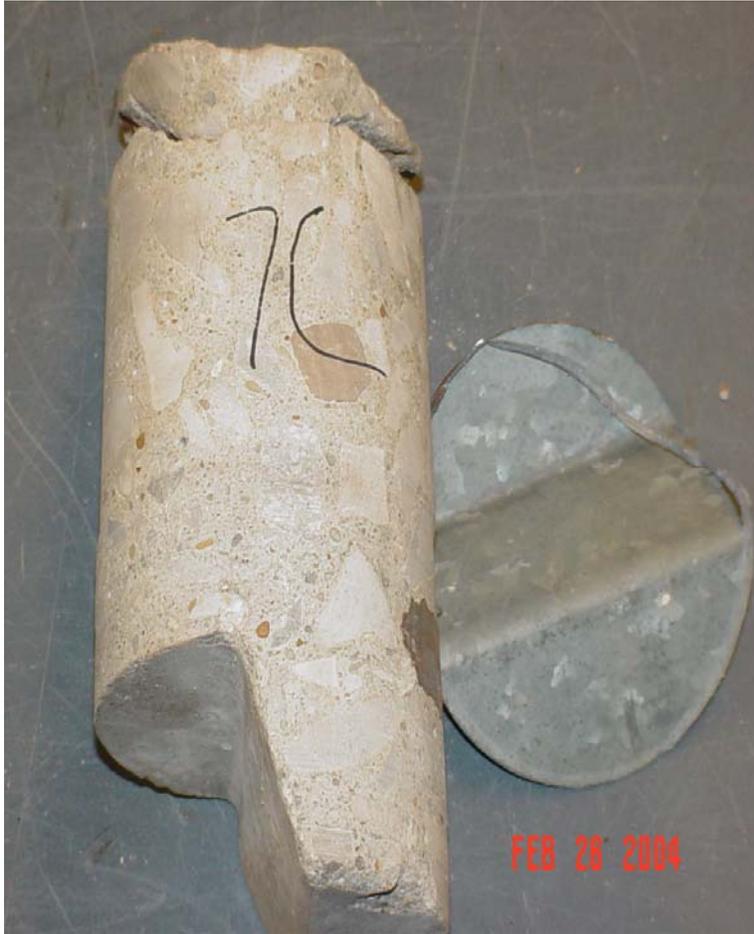
Core Number: 7C

- Length 6.25 – 8 inches.
- No bond SIPMF and concrete. White residue found on SIPMF and concrete.
- Rebar shows traces of rust.
- Core fractured 1 inch below top of core due to numerous voids.
- Numerous voids up to 1/8 inch in diameter.
