Evaluation of Stay-in-Place Metal Forms

for the
Ohio Department of Transportation
Office of Research and Development

State Job Number 134155

Final Report
FHWA/OH – 2006/13
May 2006

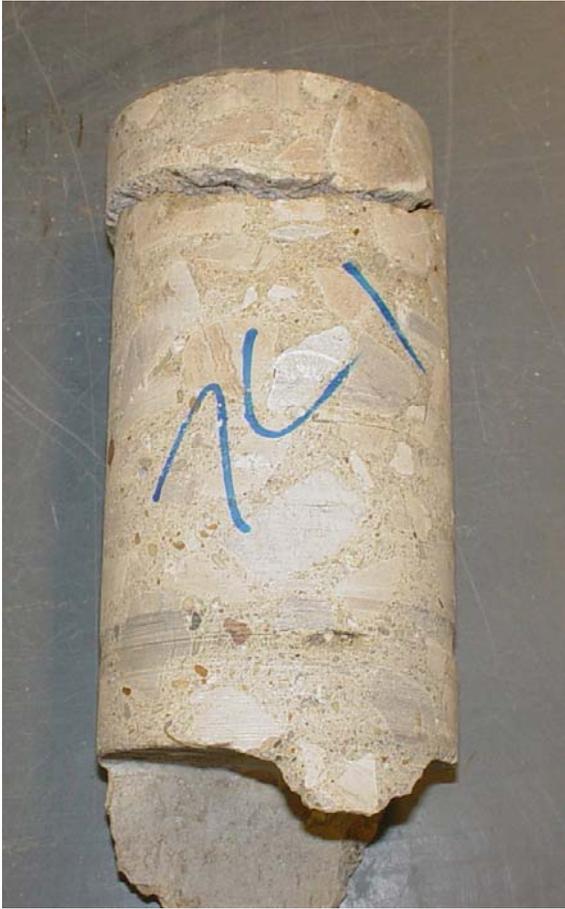
Core Number: 7C1

- Length 7.25 – 9.5 inches.
- Core fractured 1.25 inches below top due to numerous voids.
- No bond SIPMF and concrete. White residue found on bottom of core.
- Rebar shows traces of rust.
- Numerous voids in concrete up to 3/8 inch in diameter.

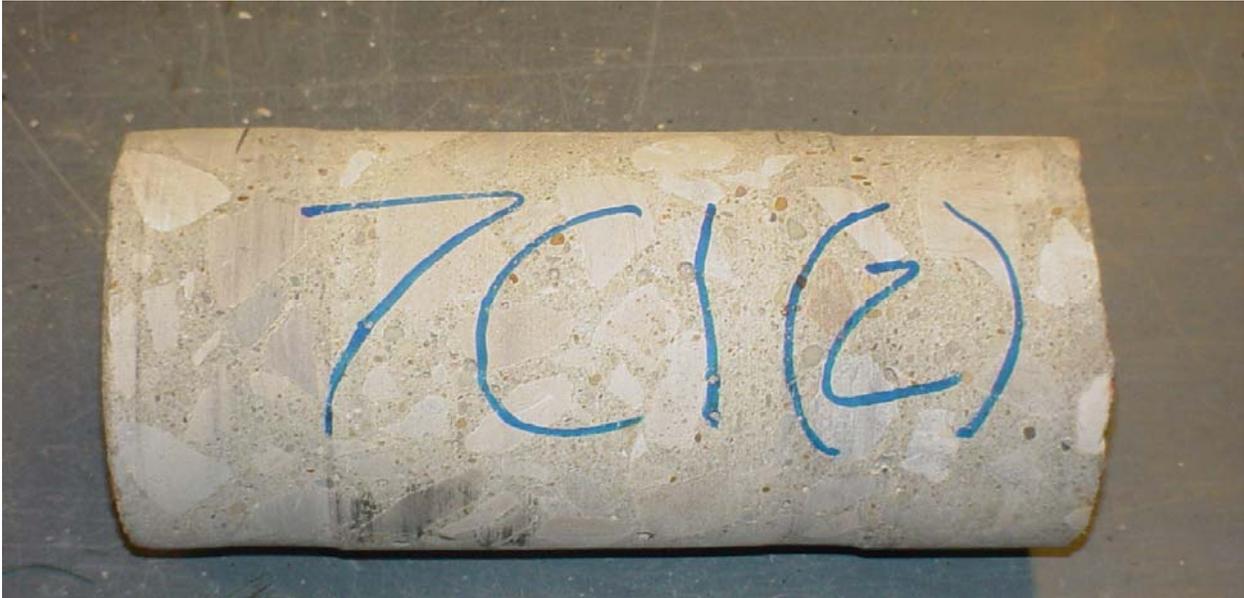
Core Number: 7C1 (2)

- Length 9.25 inches.
- No bond SIPMF and concrete. Rust present on bottom of core.
- Rebar shows traces of rust.
- Numerous voids in concrete up to 1/4 inch in diameter.
- Length 9.25 inches.

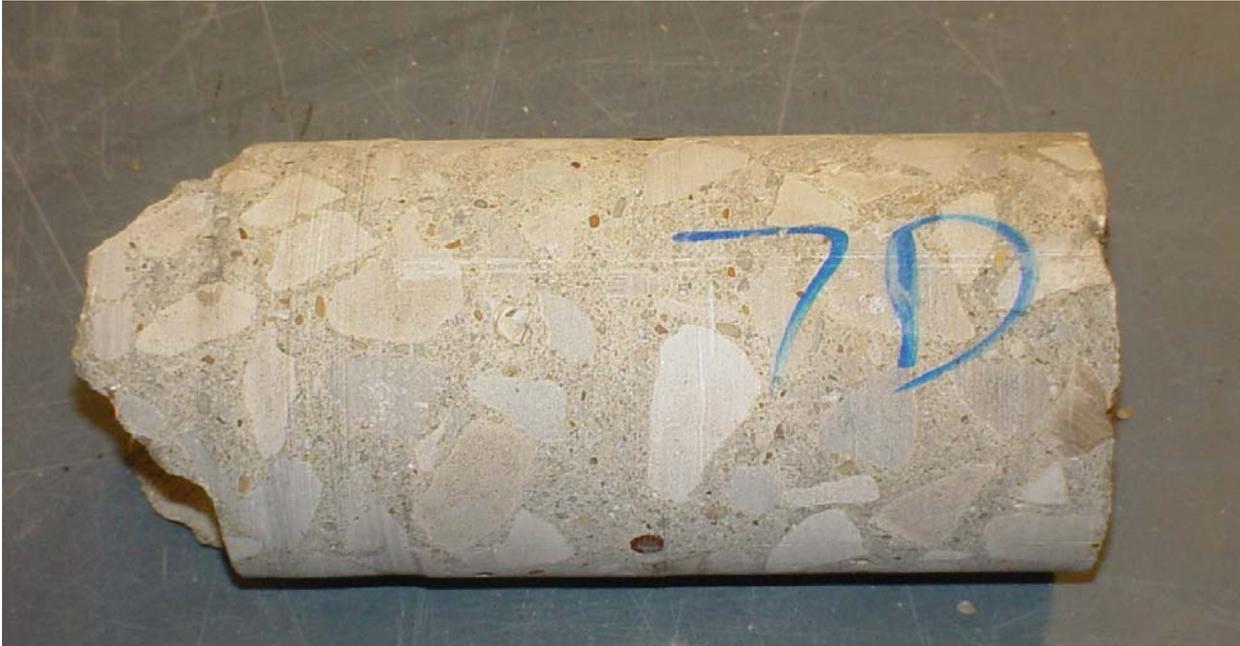
Core Number: 7D

- 7.5 inches in height, 9 inches with the concrete in the region of the valley of the SIPMF.
- Area of voids at 3.75 inches from the top.
- Reinforcement bar located at 6 inches from the bottom surface.
- Bars are not coated and show some rust.
- Small voids present in concrete.

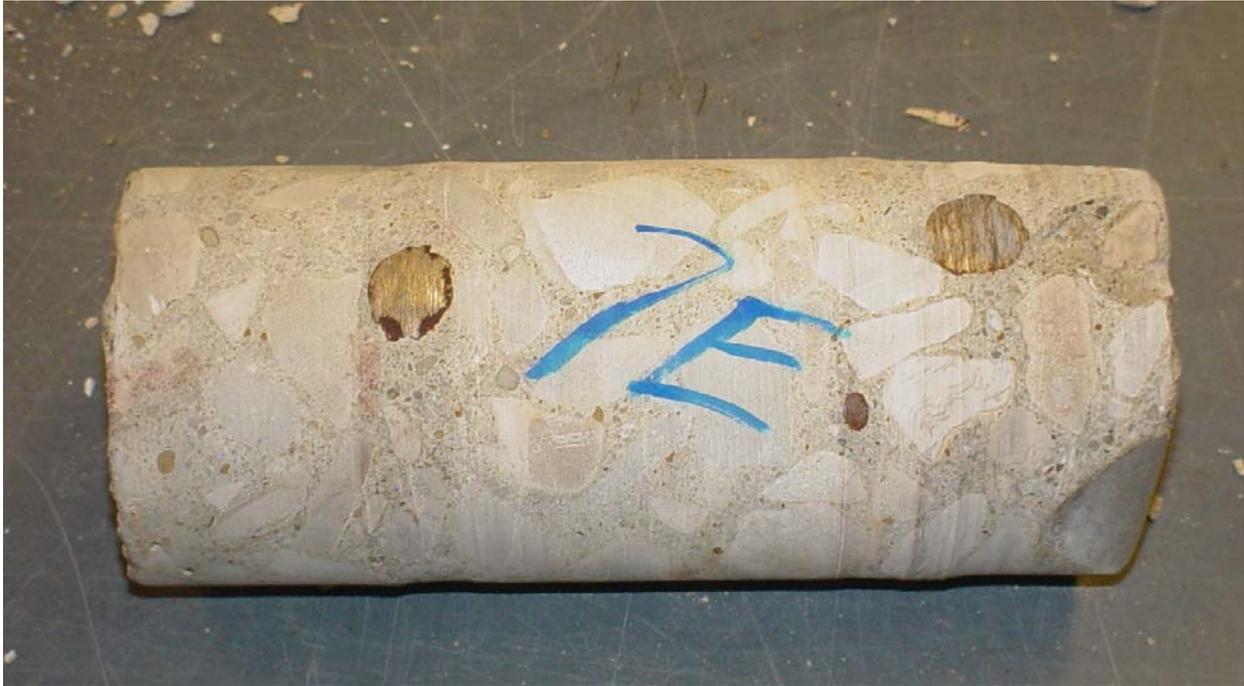
Core Number: 7E

- Length 9.75 inches.
- No bond between SIPMF and concrete. White residue found on SIPMF and concrete.
- Bottom of core rubblized and honeycombing present on one side.
- Rebar traces of rust.

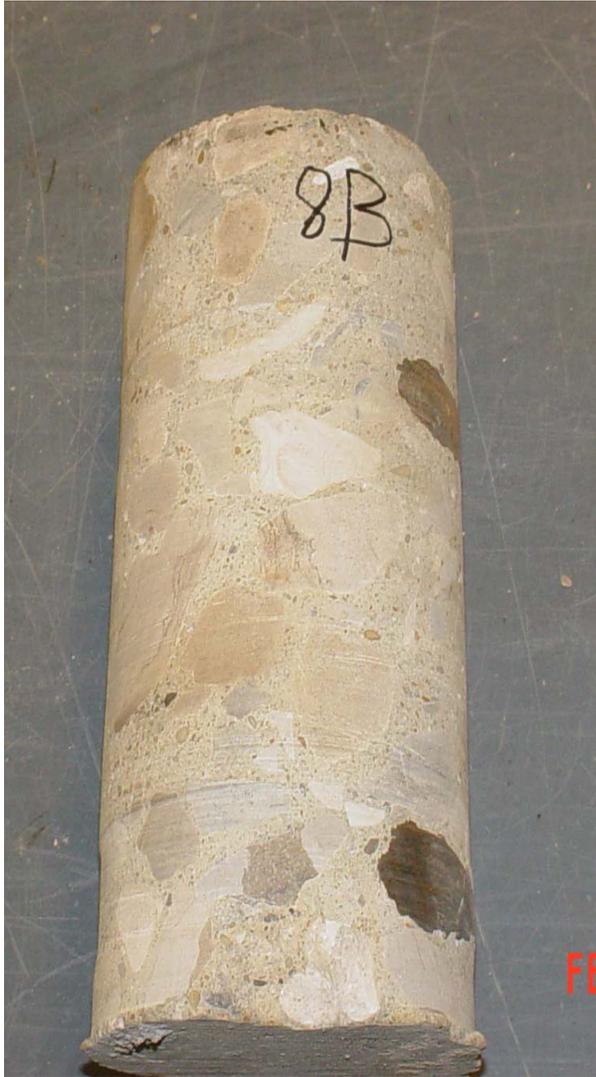
Core Number: 8B

- Core length 9 inches.
- Rebar shows traces of rust.
- Bottom chipped due to excavation of core.
- Concrete in good condition.

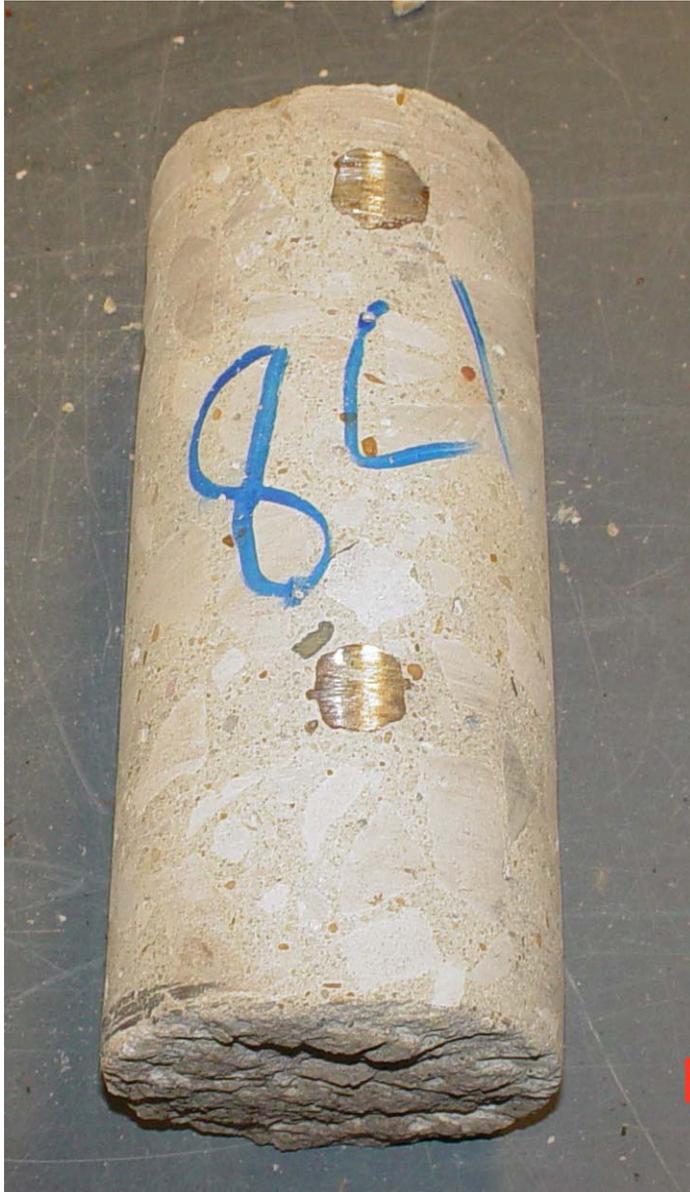
Core Number: 8C1

- Core length 9.5 inches.
- Rebar shows traces of rust.
- Numerous voids present in concrete up to 1/4 inch in diameter.

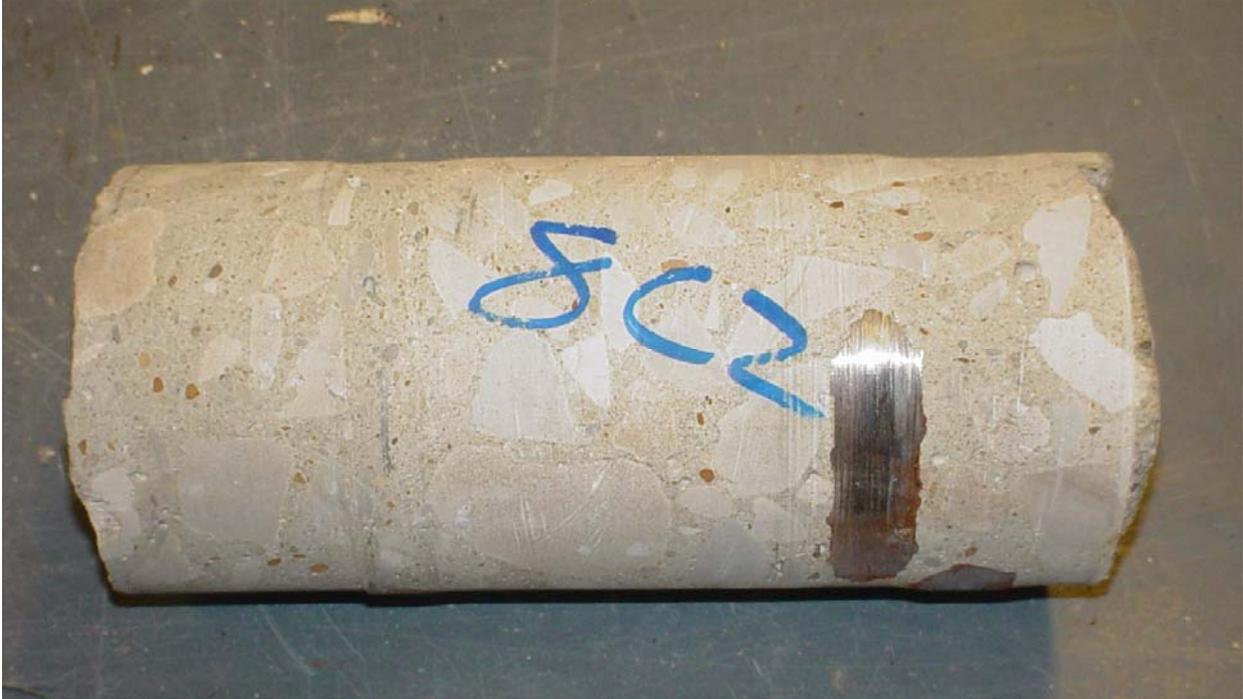
Core Number: 8C2

- Core 9 inches in height.
- Three reinforcement bars located at 2.5 inches, 6.75 inches, and 7.75 inches from the top surface.
- Bars are not coated and show slight signs of rust.
- Small voids present in concrete.

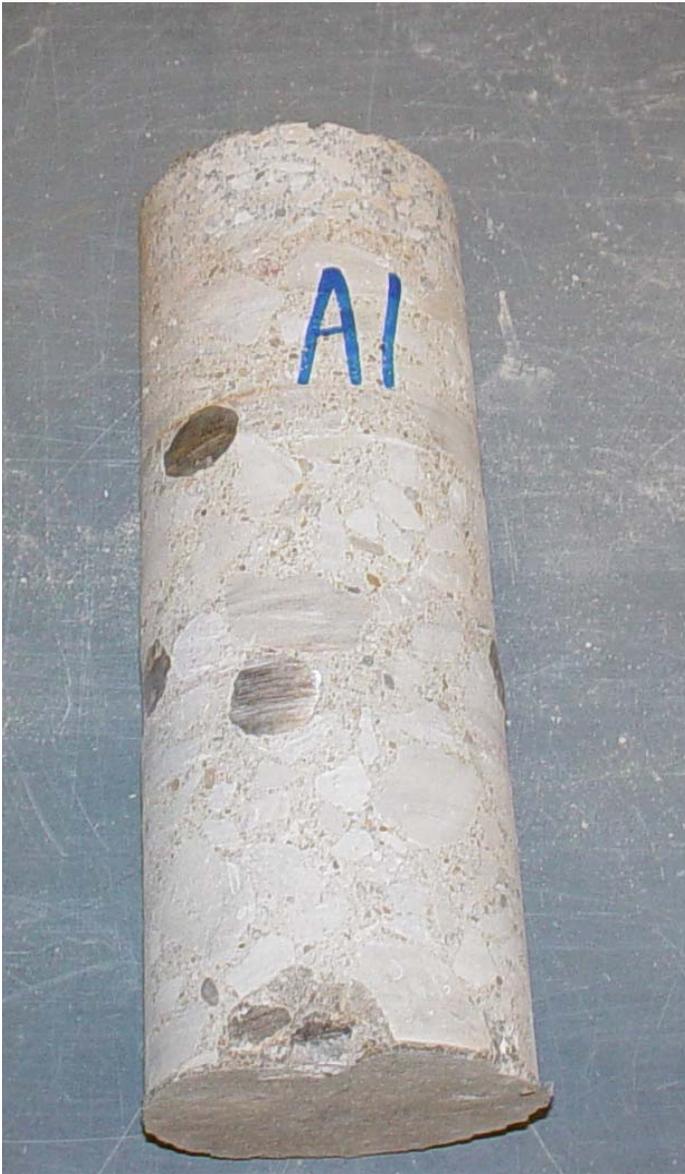
Core Number: A1

- Core height 11 inches.
- Three reinforcement bars, non-epoxy coated located at 4 inches, 6 inches, and 7 inches from top surface.
- Some rust traces on bars.
- Small region of honeycombing located at 2.5 in. from top surface.

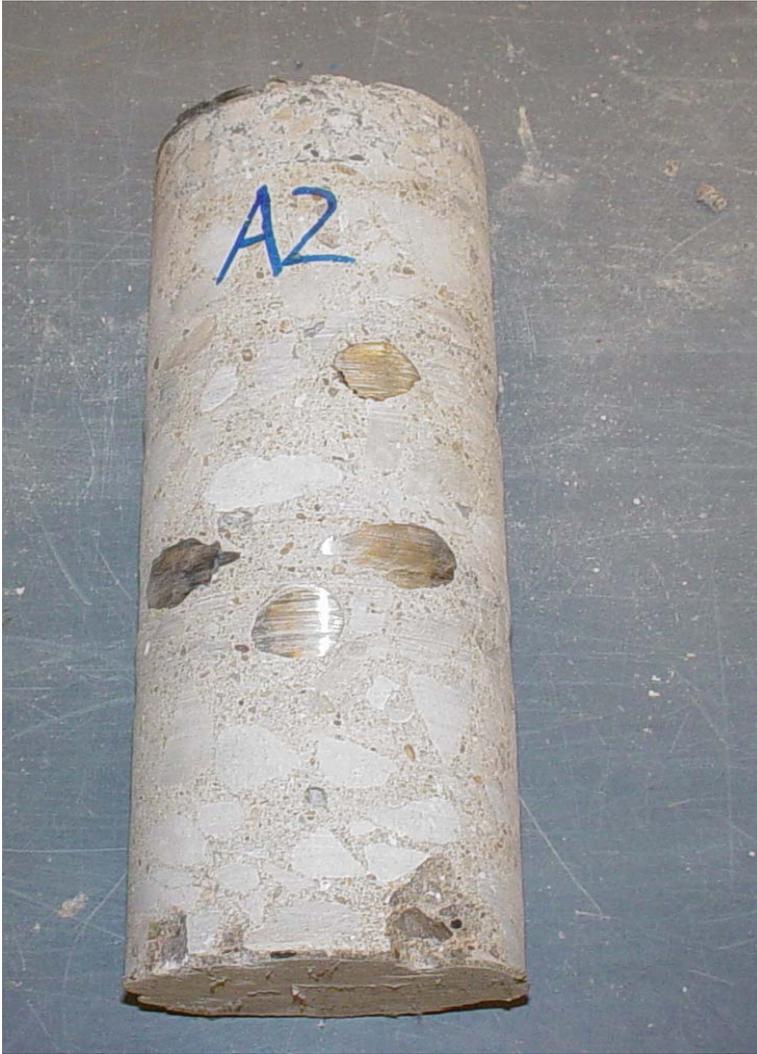
Core Number: A2

- Core length 11 inches with 1.75 in wearing surface.
- Rebar shows traces of rust.
- Numerous amounts of voids in concrete up to 1/4 inch in diameter.
- Bottom of core damage during excavation.

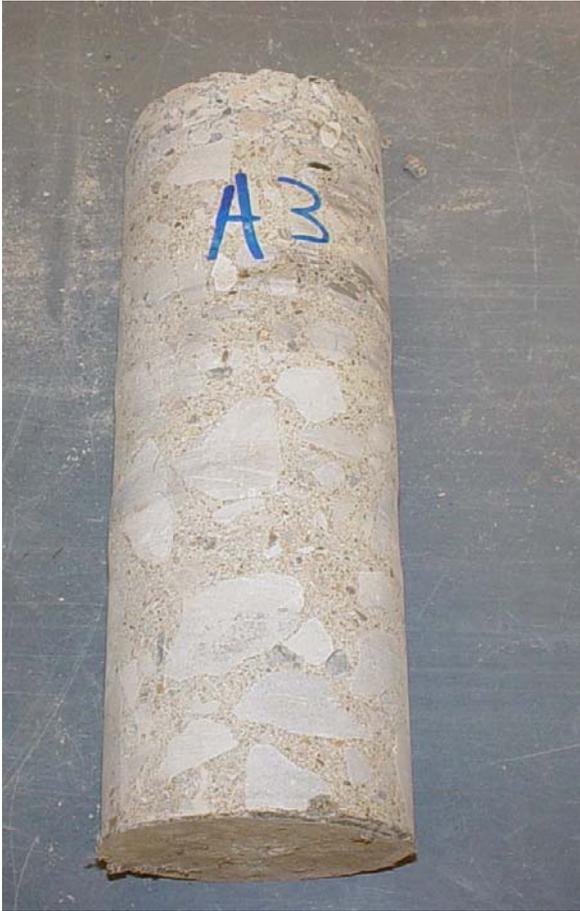
Core Number: A3

- Core length 11 inches with 1.25 inch wearing surface.
- Rebar shows traces of rust.
- Numerous amounts of voids in concrete up to 1/4 inch in diameter.

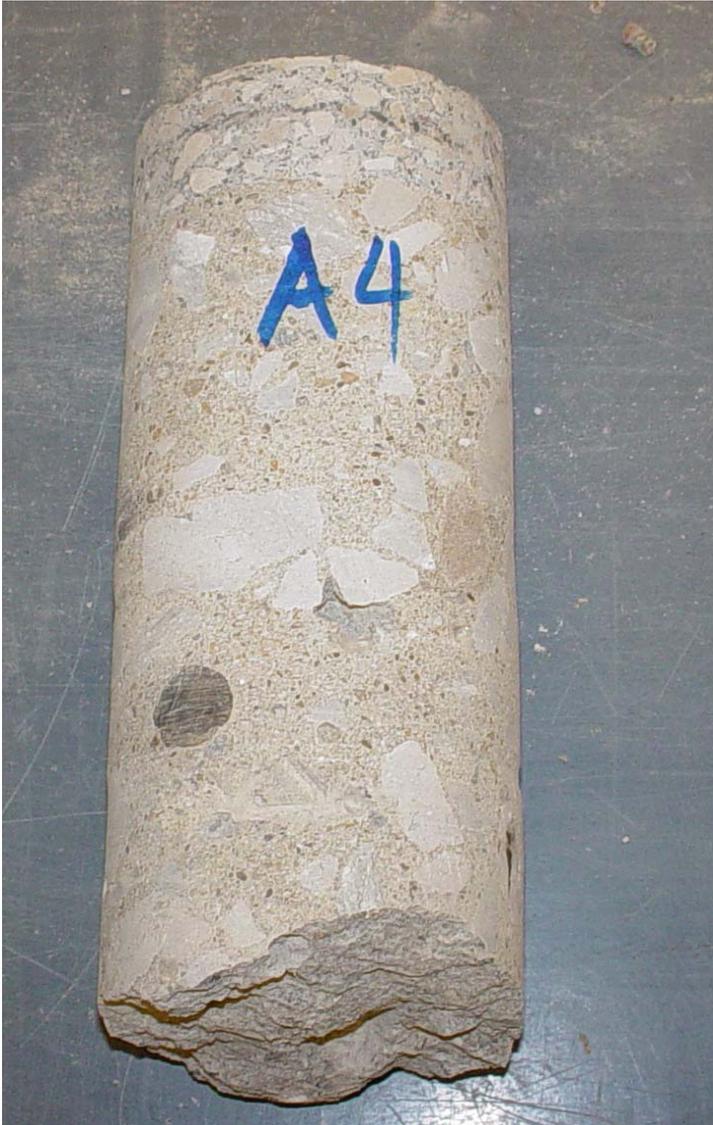
Core Number: A4

- Core length 10.75 inches with 1.5 inch wearing surface.
- Rebar shows traces of rust.
- Numerous amounts of voids in concrete up to 1/4 inch in diameter.
- Large void 3 inches from top, 7/8 inches long and 1/4 inch wide.
- Core fractured 9 inches below top due to large amounts of voids.

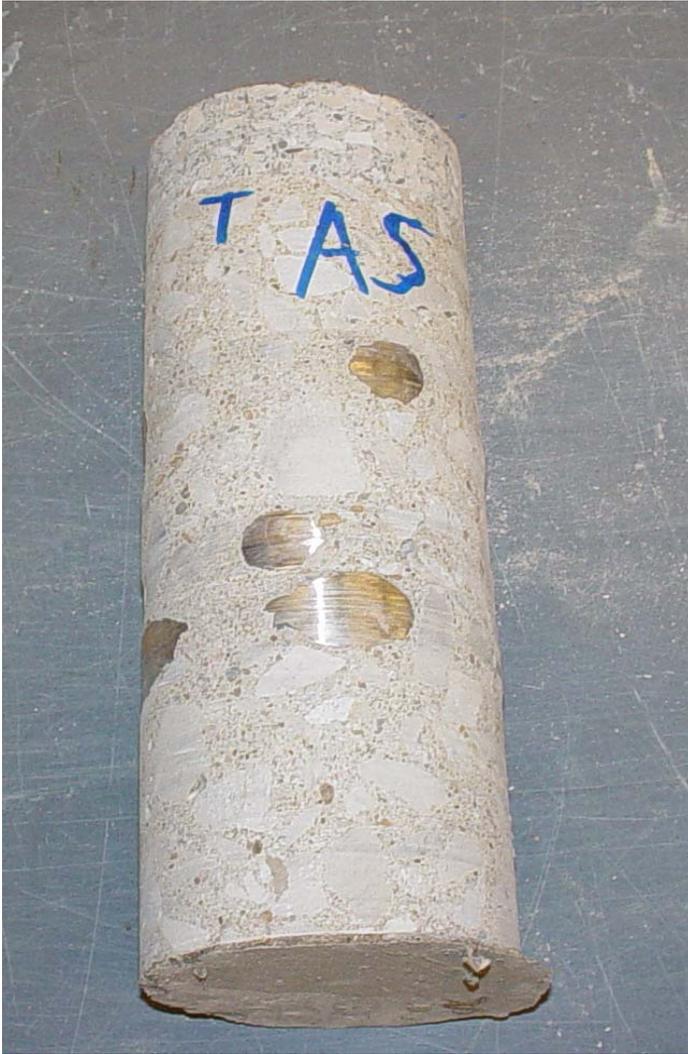
Core Number: A5

- Core height 11 inches.
- Three reinforcement bars located at 4.5 inches, 6.5 inches and 7.5 inches from the top surface.
- Bars are not coated and show some rust traces.
- Region of honeycombing at 2.5 inches and 6.5 inches from top.
- Small voids present in concrete.

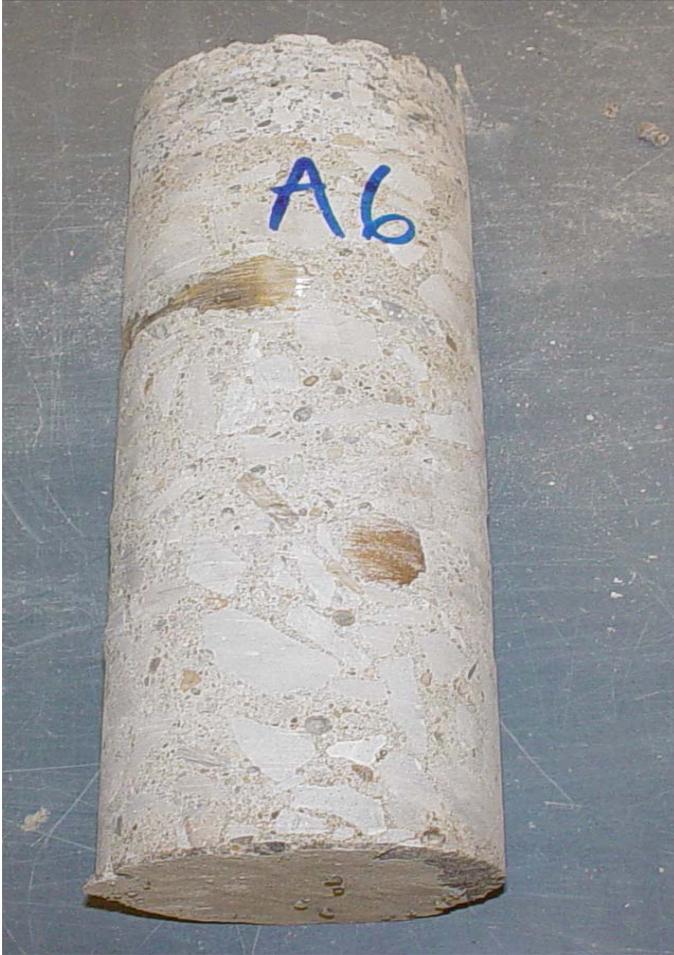
Core Number: A6

- Core length 11.25 inches with 1.75 inch wearing surface.
- Rebar shows traces of rust.
- Numerous amounts of voids in concrete up to 1/4 inch in diameter.

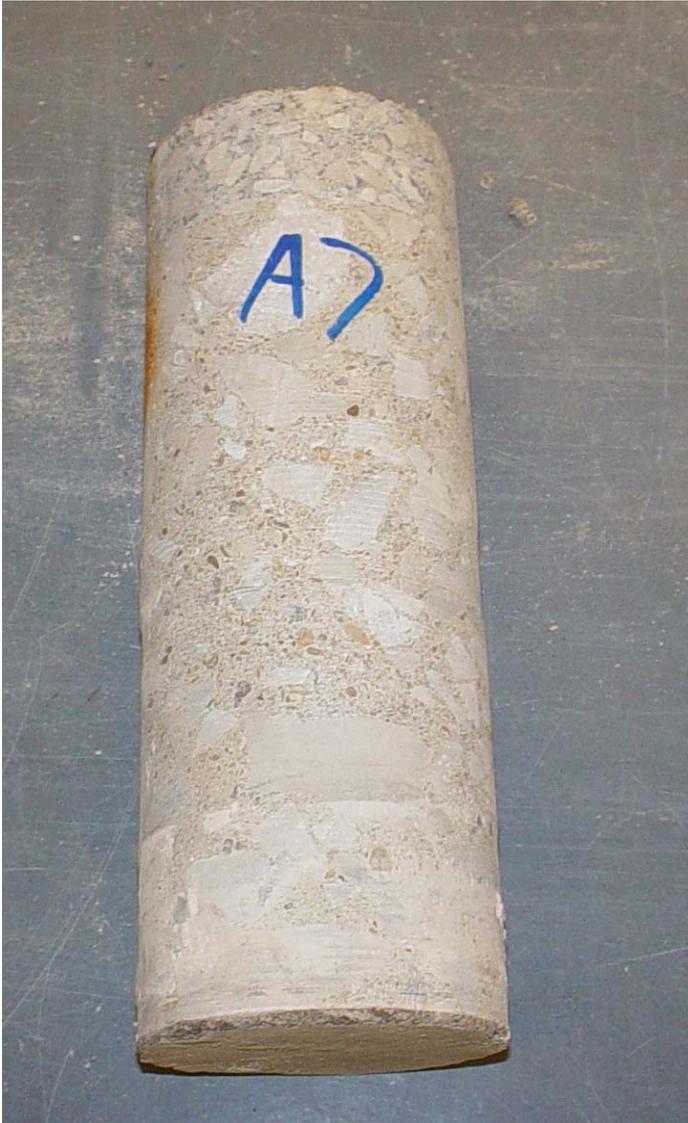
Core Number: A7

- Core length 10.75 inches with 1.75 inch wearing surface.
- Numerous amounts of voids in concrete up to 1/4 inch in diameter.

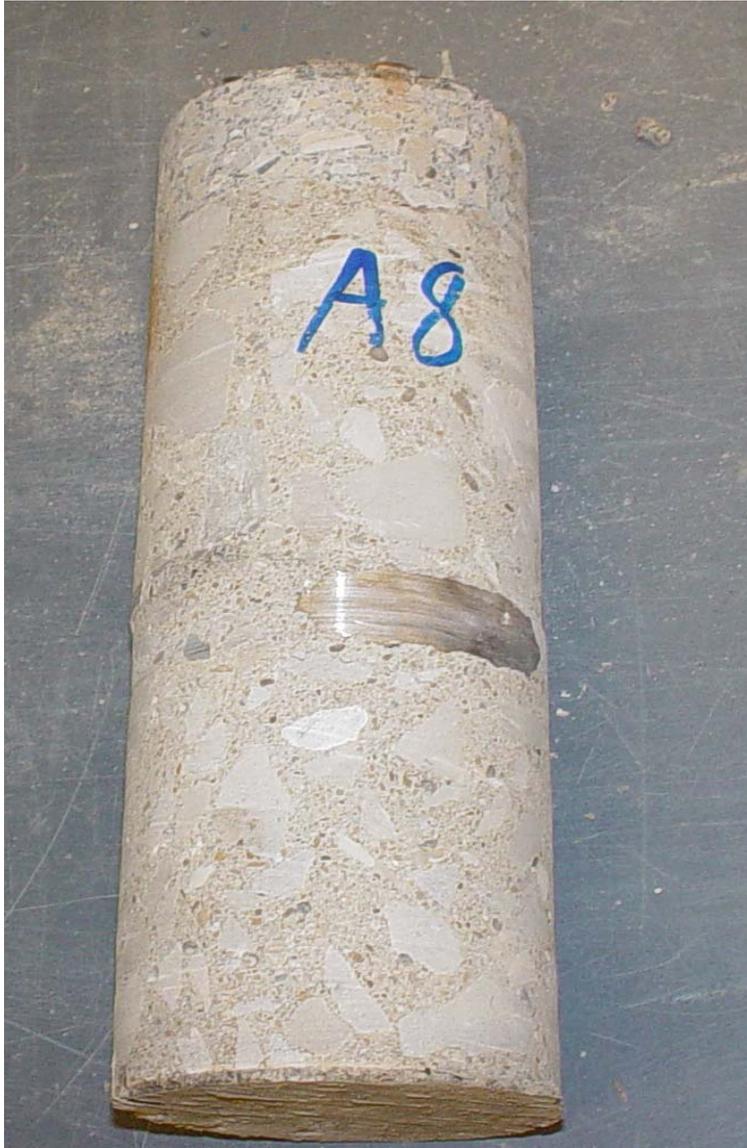
Core Number: A8

- Core length 11 inches with 1.75 inch wearing surface.
- Numerous amounts of voids in concrete up to 3/8 inch in diameter.
- Rebar shows traces of rust.

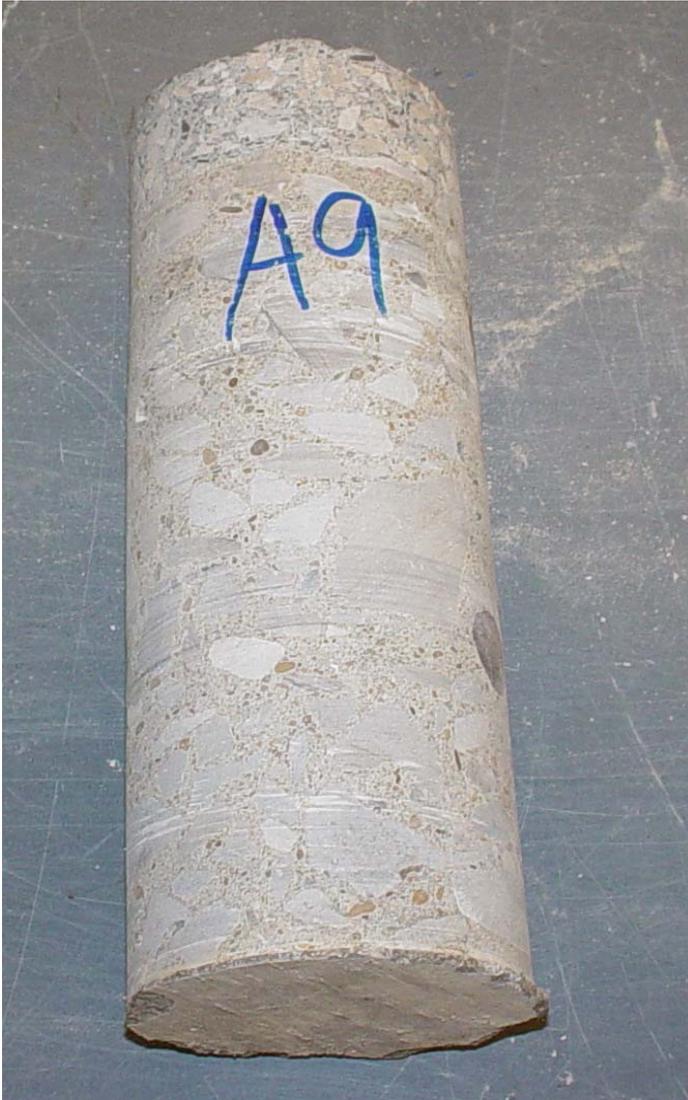
Core Number: A9

- Core height 11 inches.
- Two reinforcement bars located at 3 inches and 7.5 inches from top surface.
- Bars are not coated and show severe rusting.
- Region of honeycombing at 4 inches from top.

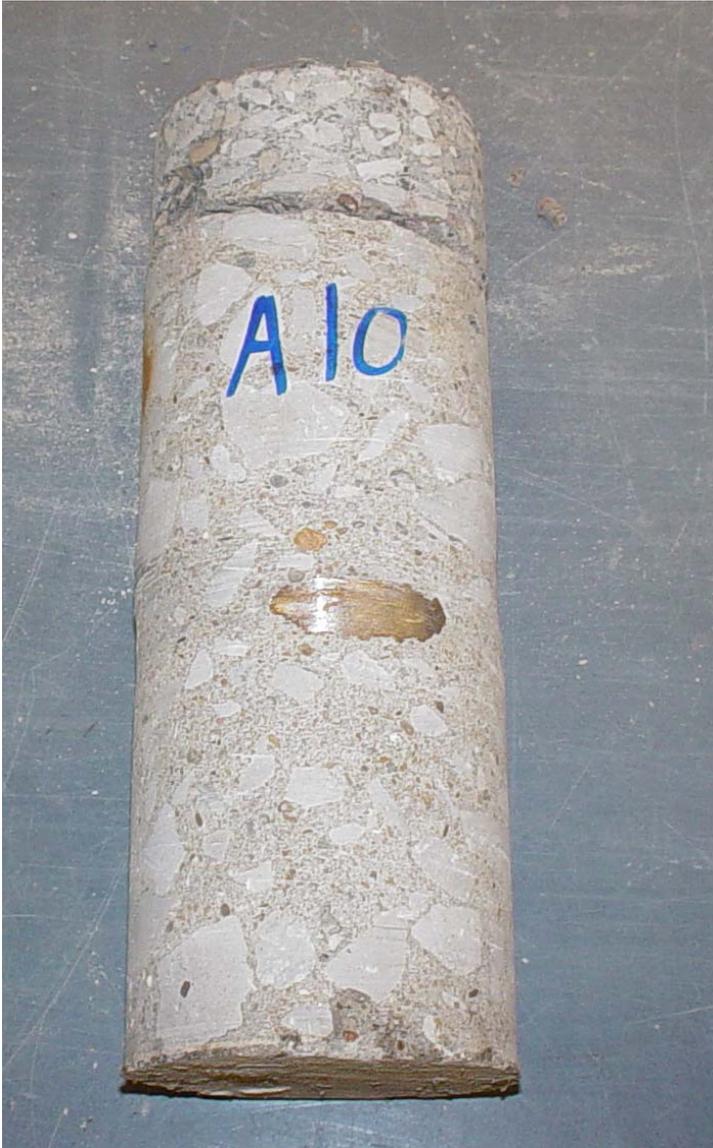
Core Number: A10

- Core length 11 inches with 1.75 inch wearing surface.
- Numerous amounts of voids in concrete up to 3/8 inch in diameter.
- Rebar heavily rusted.
- Core fractured where wearing surface meets deck due to a large amount of voids.

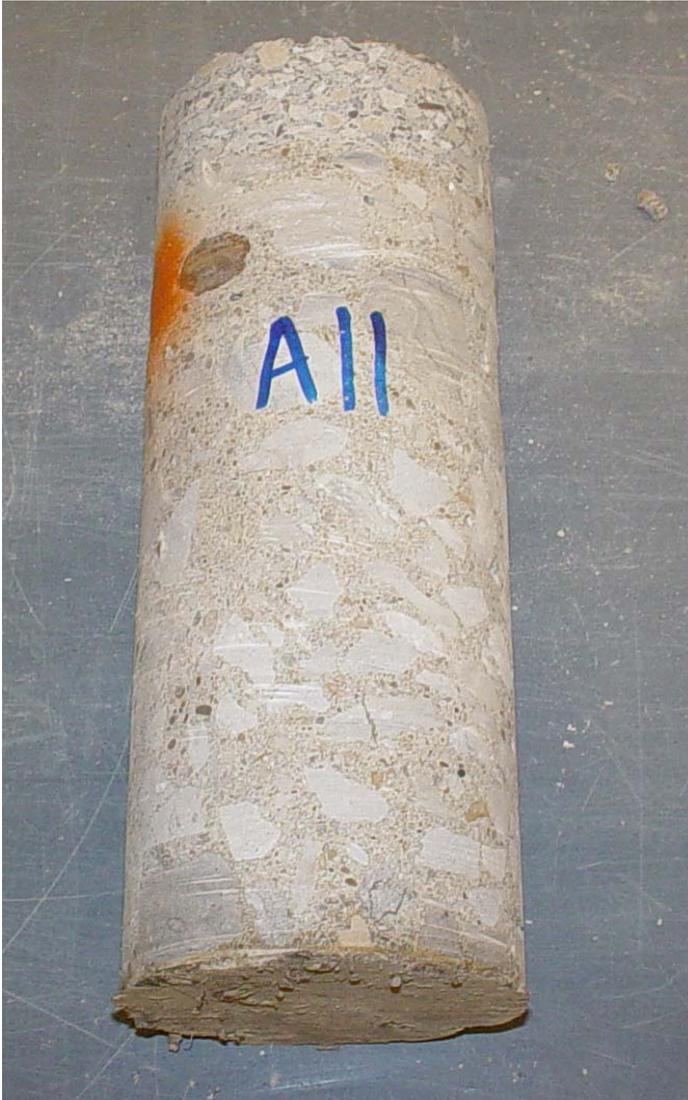
Core Number: A11

- Core height 10.75 inches.
- Regions of moderate to large voids located at 7 inches from top surface.
- Two reinforcing bars, non-epoxy coated located at 3 inches and 4 inches from top surface.
- The bars show severe rusting.

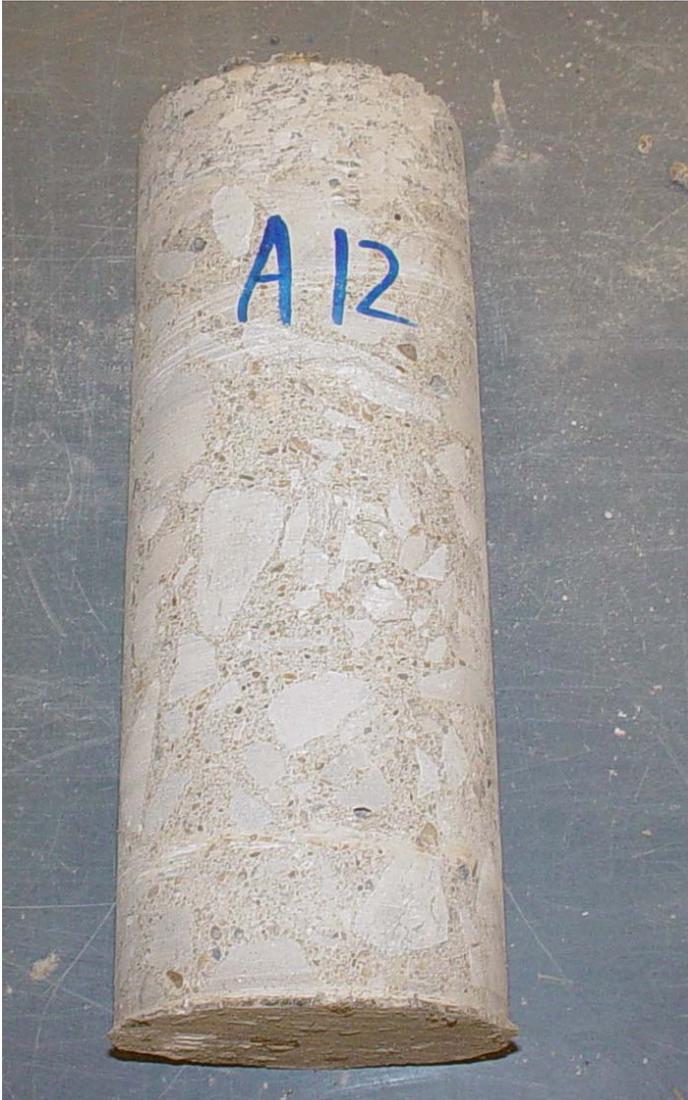
Core Number: A12

- Core length 10.75 inches with 1.5 inch wearing surface.
- Numerous amounts of voids in concrete up to 5/16 inch in diameter.

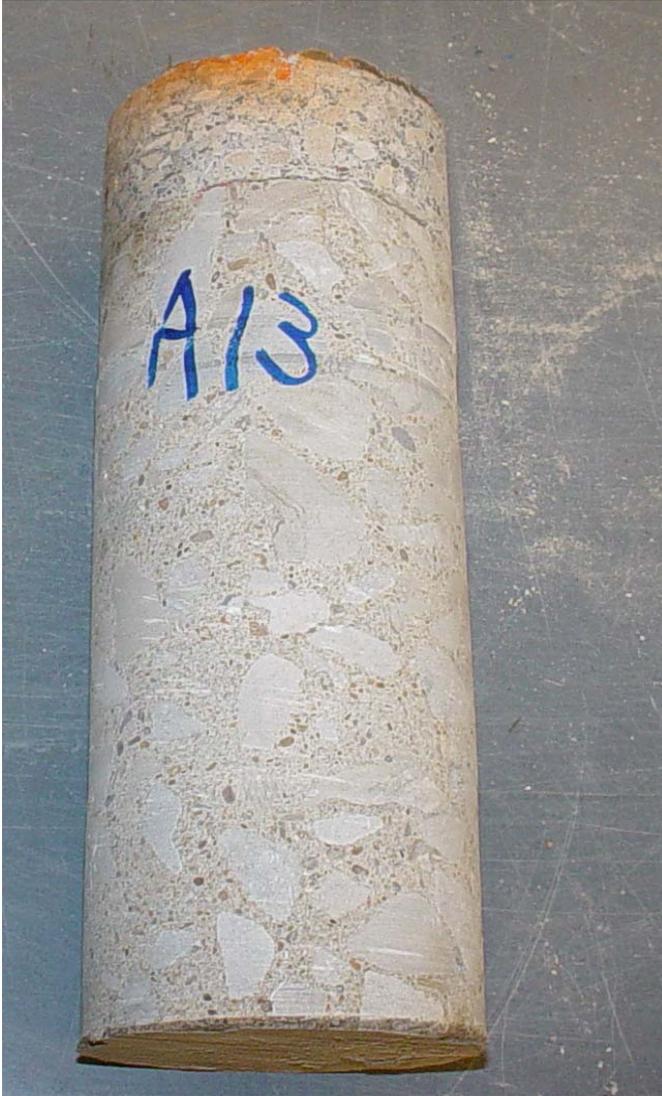
Core Number: A13

- Core length 10.75 inches with 1.75 inch wearing surface.
- Numerous amounts of voids in concrete up to 1/8 inch in diameter.
- Rebar shows traces of rust.
- Aggregate cracked 5.5 inches from top, crack is 1 3/8 inch long.
- Core cracked wear wearing surface meets deck. Crack is 1/4 a way around core.

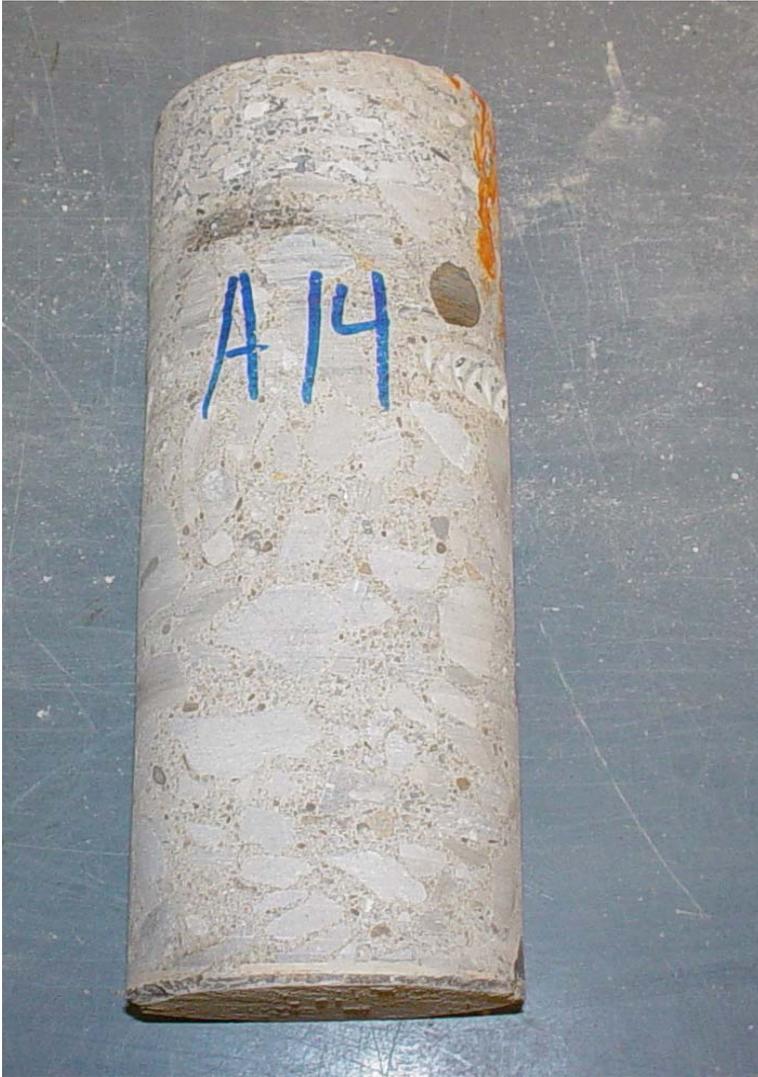
Core Number: A14

- Core length 10.75 inches with 2 inch wearing surface.
- Numerous amounts of voids in concrete up to 3/8 inch in diameter.
- Rebar shows traces of rust.

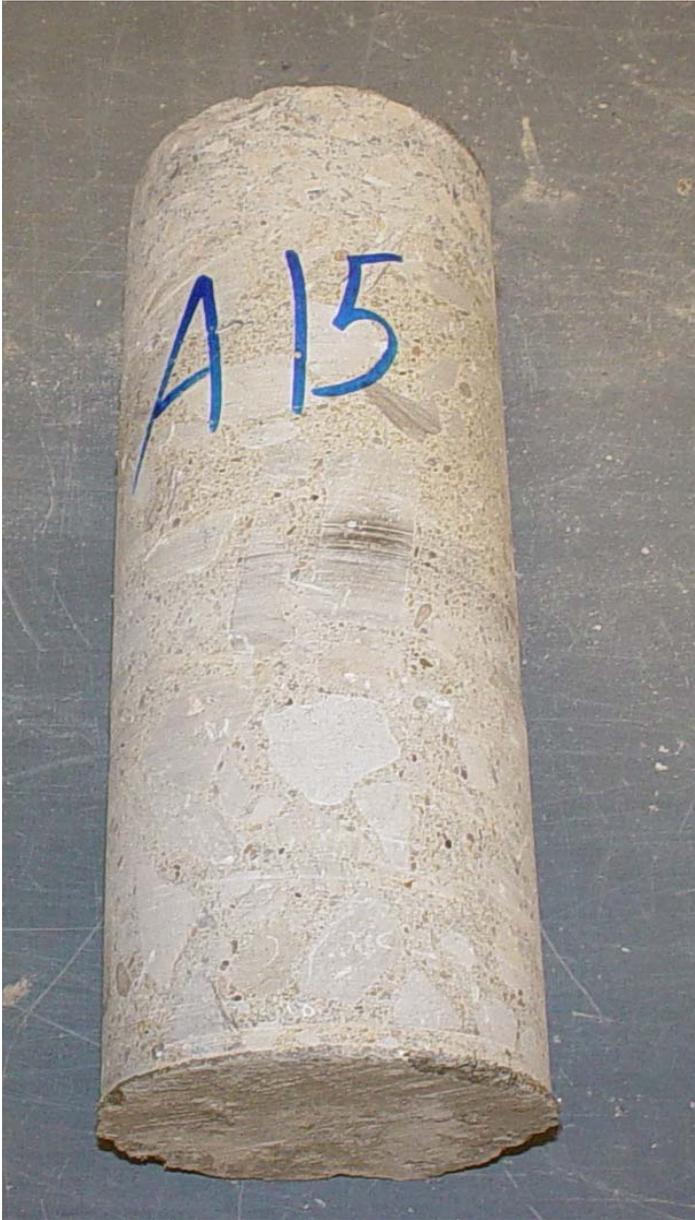
Core Number: A15

- Core length 10.75 inches with 1.75 inch wearing surface.
- Numerous amounts of voids in concrete up to 3/8 inch in diameter.
- Rebar heavily rusted.

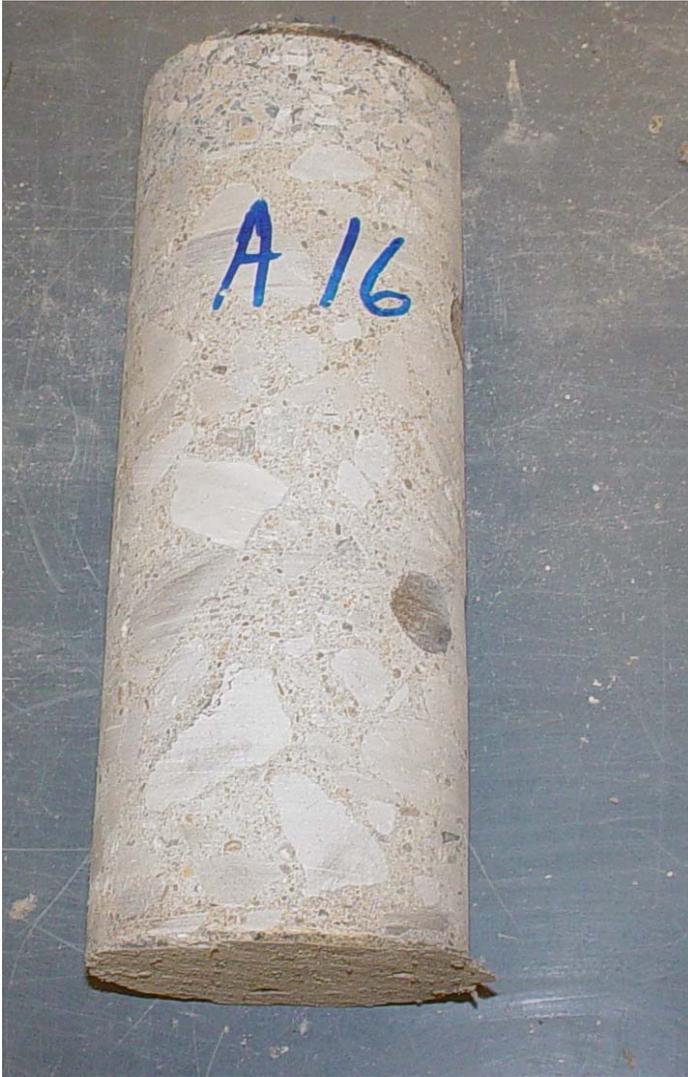
Core Number: A16

- Core height 10.5 inches. .
- Two reinforcement bars located at 3.5 inches and 7 inches from the bottom surface.
- The upper bar shows severe rusting while the lower shows some rust traces.
- Region of honeycombing located at 6 inches from top.
- Region of large voids at the top-wearing surface.

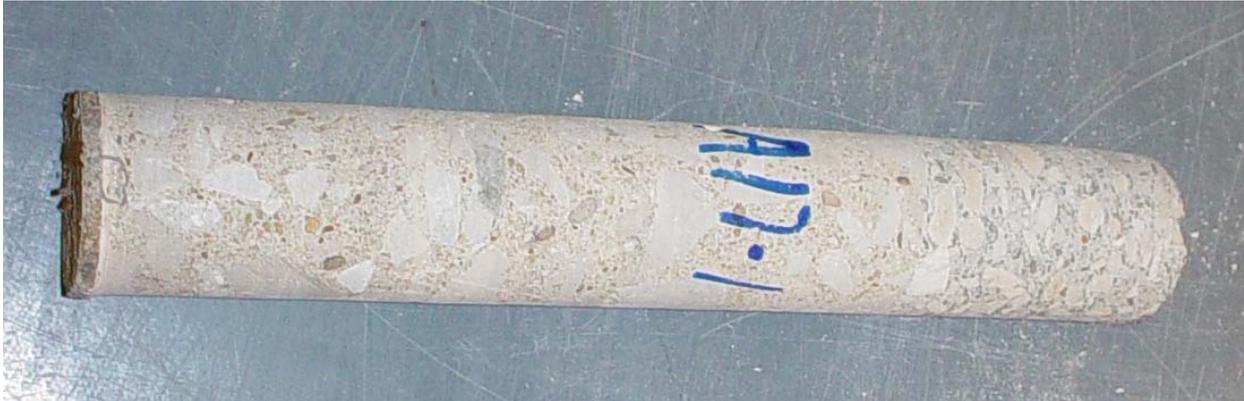
Core Number: A17-1

- Core length 10 inches with 2.75 inch wearing surface.
- Numerous voids present in concrete up to 1/4 inch in diameter.

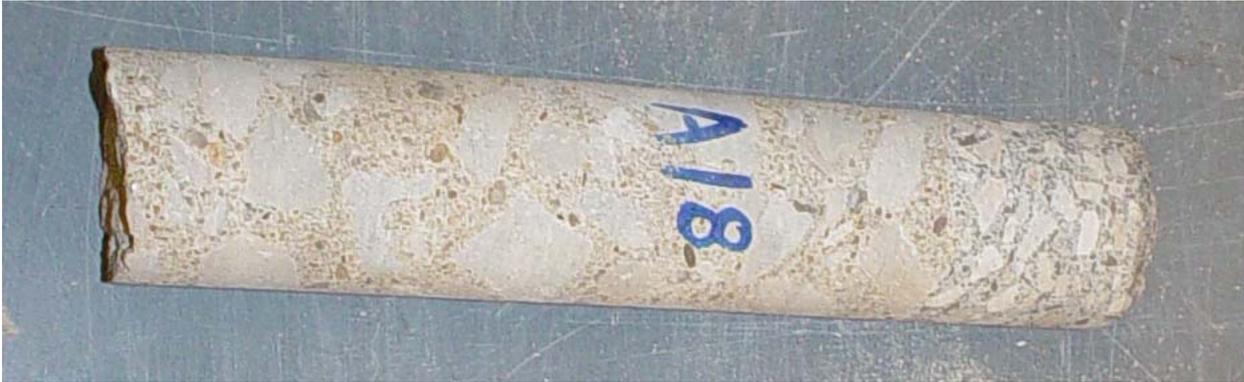
Core Number: A18

- Core length 8.5 inches with 2 inch wearing surface.
- Numerous voids present in concrete up to 1/8 inch in diameter.
- Core cracked longitudinally 3 inches from top. Length of crack 2.5 inches.

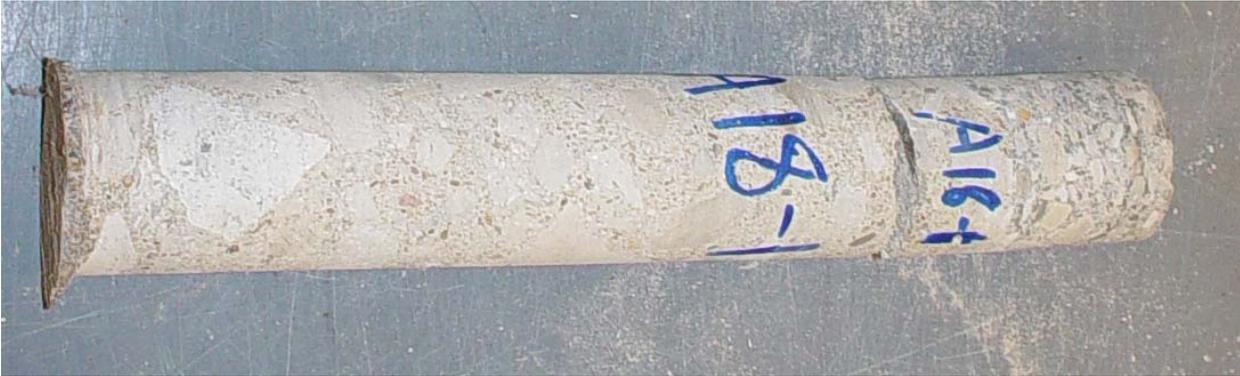
Core Number: A18-1

- Core length 10.75 inches with 2 inch wearing surface.
- Numerous voids present in concrete up to 3/8 inch in diameter.
- Core fractured during excavation.

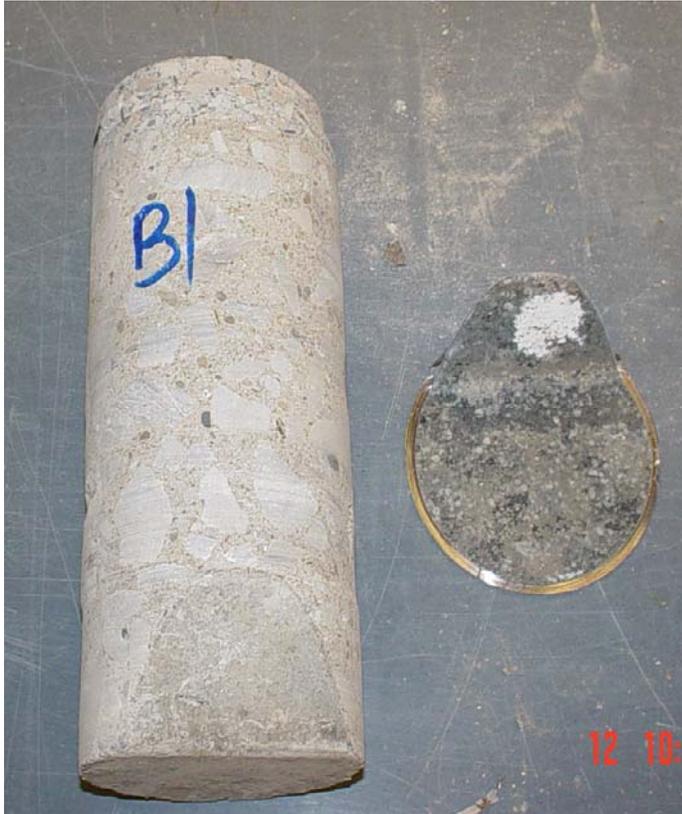
Core Number: B1

- Core height 7.25 inches, 9.25 inches with the concrete in the region of the valley of the SIPMF.
- Two reinforcement bars located at 3.5 inches and 6.5 inches from top.
- Small region of honeycombing at 2.5 inches from top surface.
- Bars are not coated and show some rust.

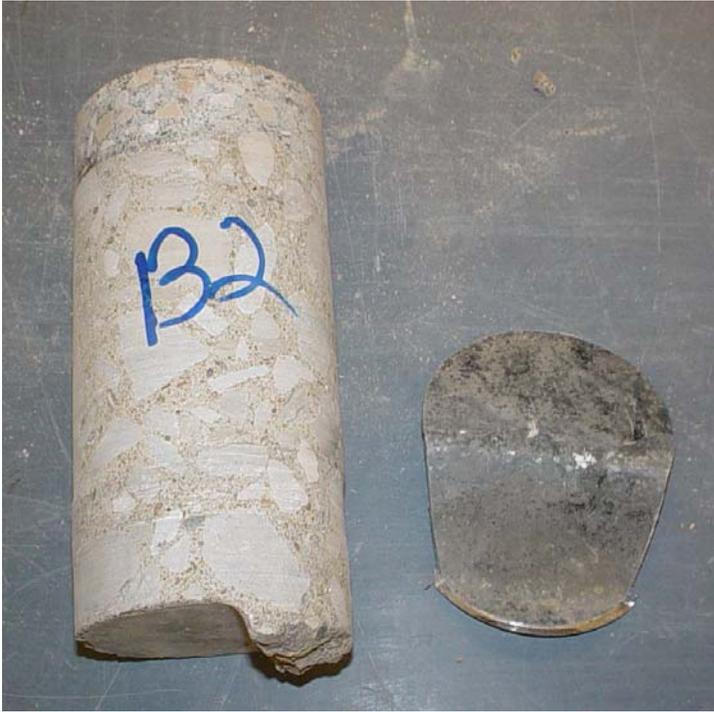
Core Number: B2

- Core length 7.5 inches with 1.25 inch wearing surface.
- Numerous amounts of voids up to 1/4 inch in diameter.
- No bond SIPMF and concrete. White residue and rust present on SIPMF and concrete.

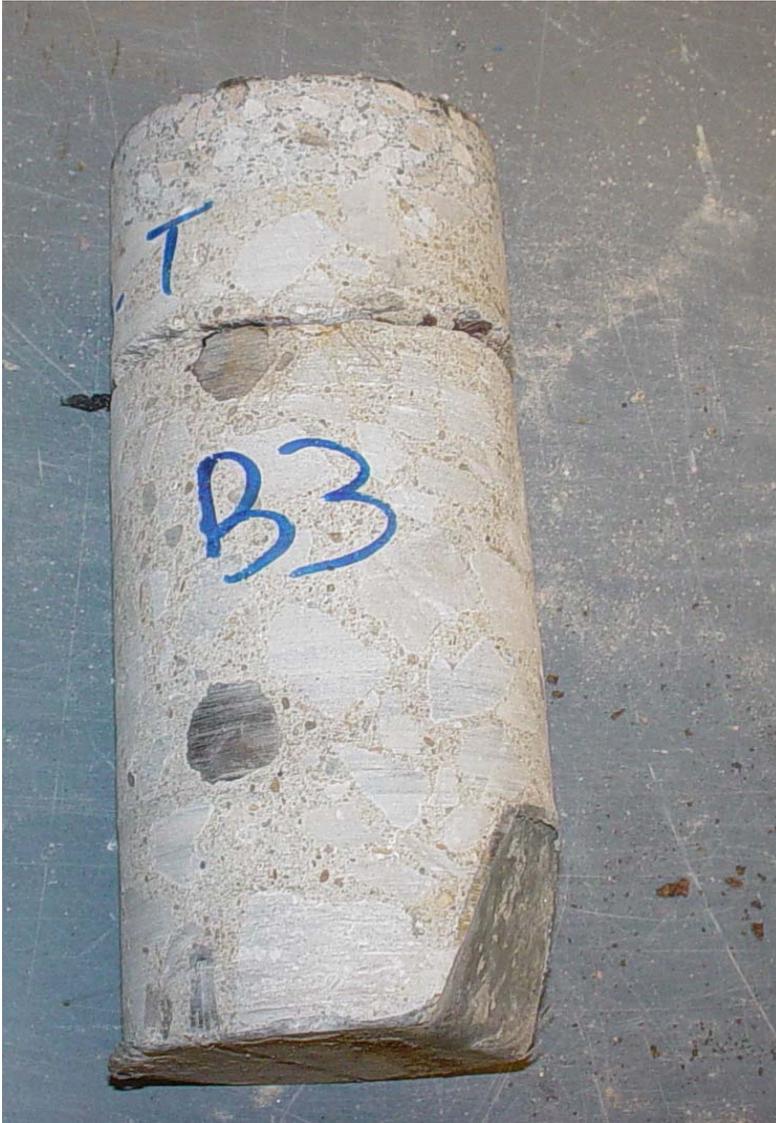
Core Number: B3

- Core length 9.25 inches with 1.25 inch wearing surface.
- Good bond between SIPMF and deck. Bottom of concrete beginning to rubbelize.
- Core fractured 2.75 inches from top due to heavy rusting of rebar.
- Bottom rebar shows traces of rust.
- Numerous voids in concrete up to 1/8 inch in diameter.

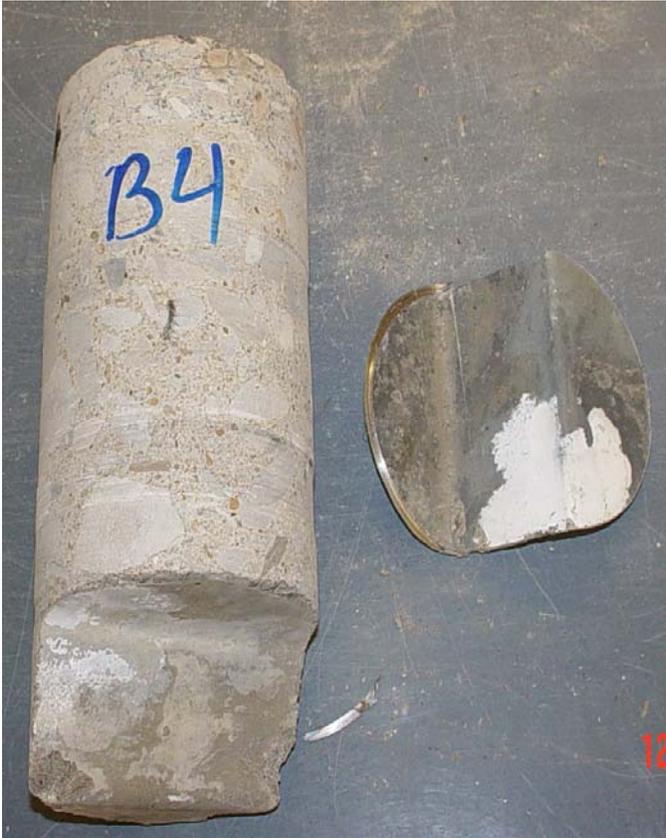
Core Number: B4

- Core height 7 inches, 9 inches with the concrete in the region of the valley of the SIPMF.
- Regions of small voids.
- Two reinforcing bars located at 1 inch and 3 inches from bottom surface, and show some rust traces.
- Brown and white traces on the SIPMF.
- Region of honeycombing at 6 inches from bottom.
